7 SAMPLE STREET
CITY

PRE-PURCHASE INSPECTION REPORT

PRE-PURCHASE INSPECTION REPORT		
<i>Subject to 'Conditions Assumptions and Limitations' attached</i>		
Purchaser;	R. Paul	Telephone; 9762-0382
Purchaser address;	84 Boronia Road, Boronia.	
Property address;	7 Sample Street, City.	
Date of report;	03/04/2007	
Date of inspection;	02/04/2007	
DESCRIPTION OF THE BUILDING AND MATERIALS USED IN CONSTRUCTION:		
The single storey dwelling is of timber frame construction with brick veneer exterior walls, internal plasterboard wall and ceiling lining, timber floor, aluminium windows and conventional roof covered with concrete tiles. The thermal ceiling insulation is in place. The fixed appliances appear to be in a well used condition. The required smoke alarm is in place.		
SERVICES CONNECTED TO THE PROPERTY:		
Electricity;	Mains supply.	
Gas;	Mains supply.	
Water;	Mains supply.	
Sewerage;	Septic system.	
SITE DETAILS:		
The building site is located on the East side of the street with a moderate slope. Site drainage would appear to be adequate. The paving is satisfactory. The boundary fence is adequate. A few trees are closer than mature height would allow. (As a general rule trees should

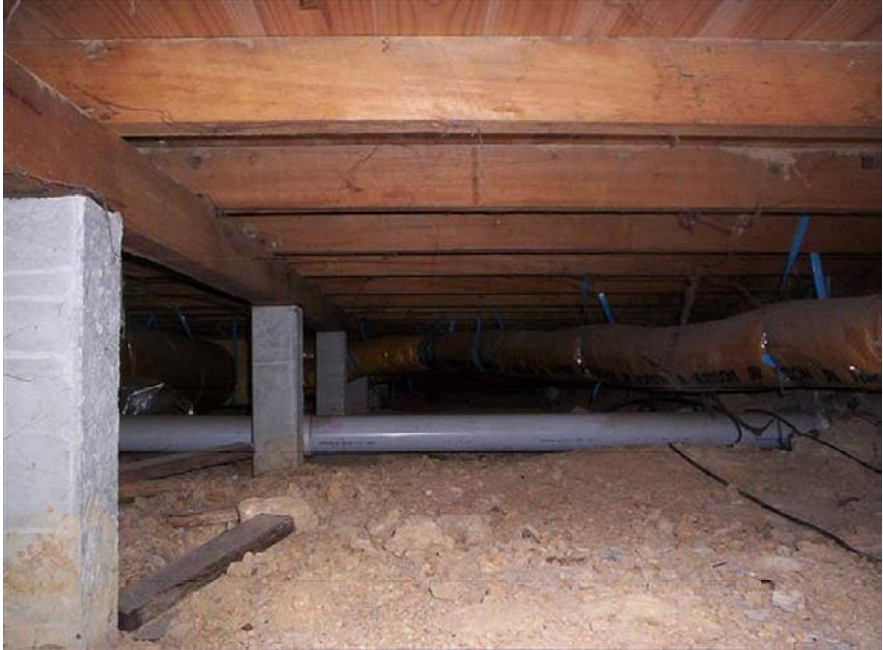
DWELLING		External
Windows, external	There are no defects visible or evident externally. Refer also windows (internal).	122
Walls, external	There are minor cracks in the exterior walls near the Kitchen.	123
Stair	There are no defects visible or evident in the stair.	124
Eaves	There are no defects evident in the visible eaves.	125
Gutter	There are no defects visible or evident in the roof gutter.	126
Downpipes	There are no defects visible or evident in the downpipes.	127
Stumps	There are no defects evident in the visible stumps.
