## Just Inspections

## Building Inspection Report

AS4349.1- 2007

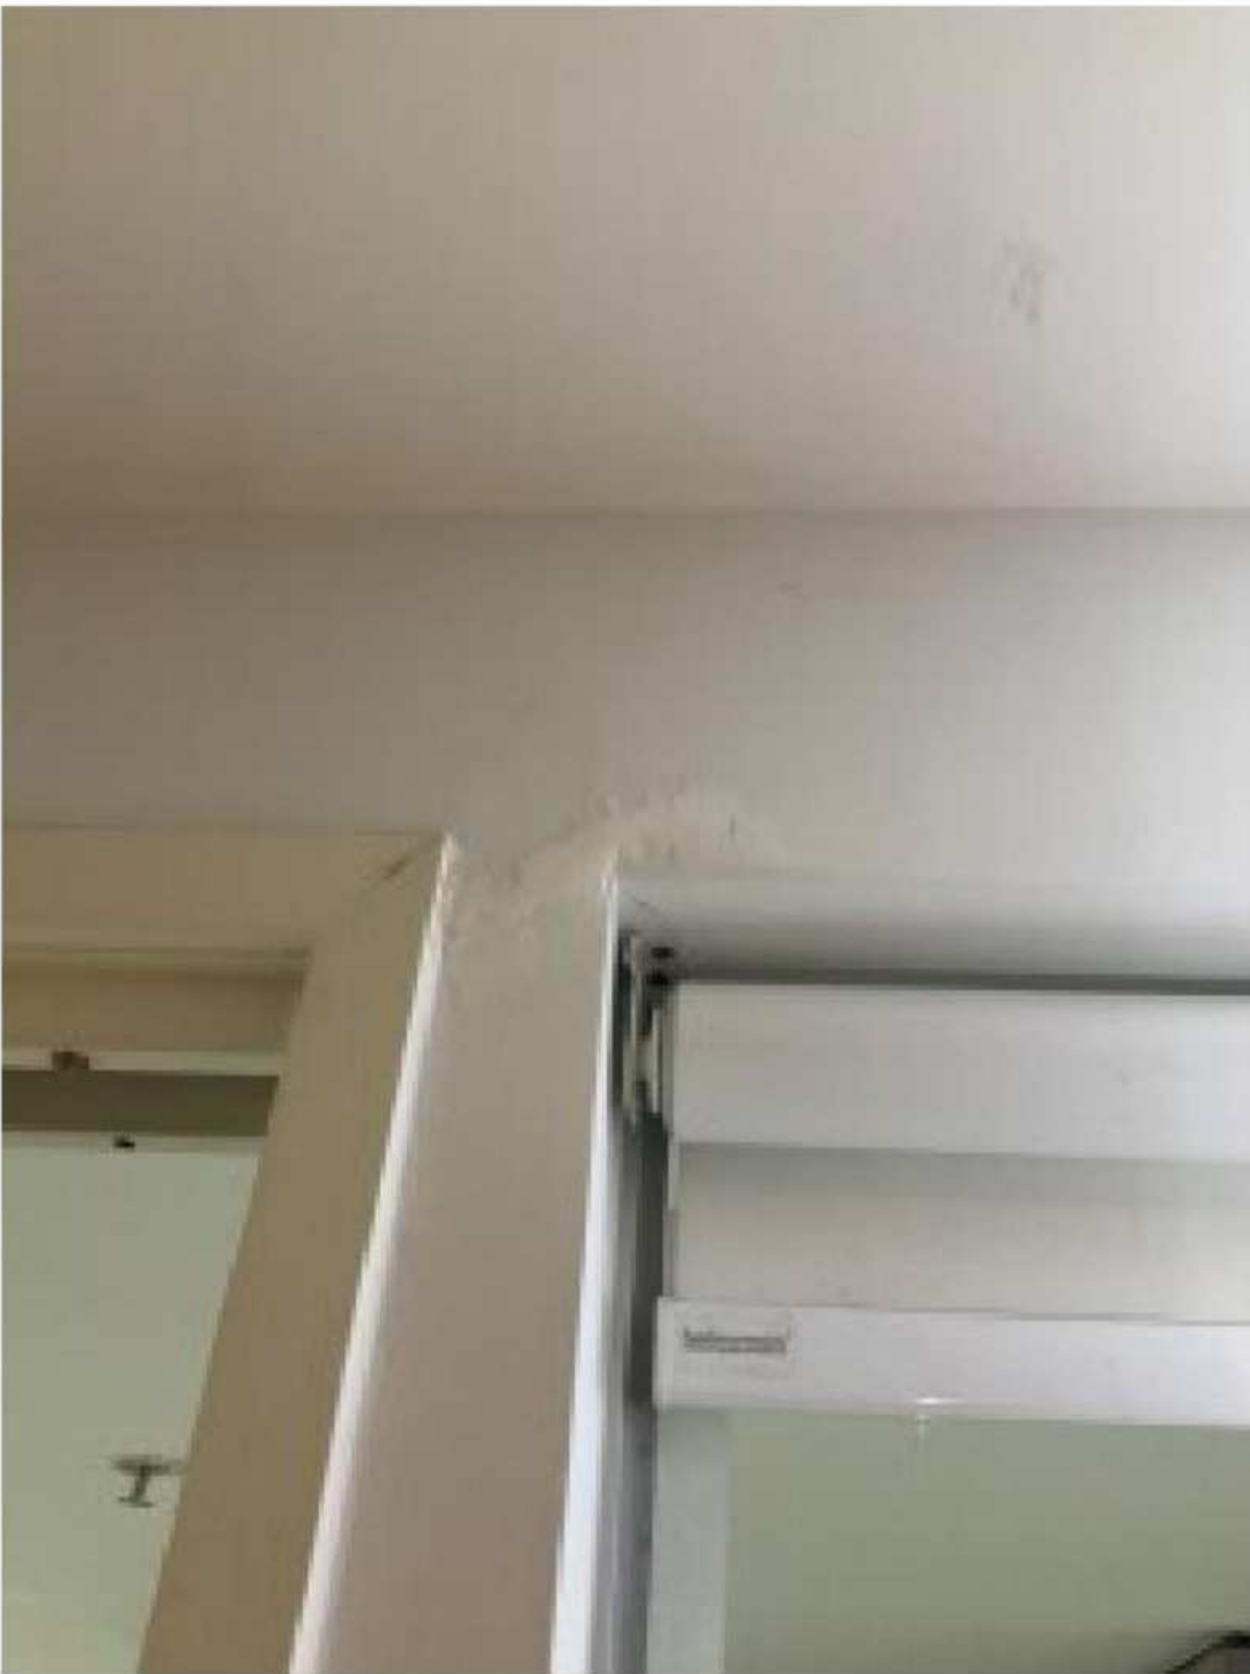
The photograph reveals minor patched cracking around the window frame, indicating potential movement or settlement in the structure. While not immediately severe, these cracks may allow moisture ingress over time, potentially leading to further deterioration. It is advisable to monitor these cracks for any changes in size or appearance and consider engaging a professional to assess the structural integrity. Remedial action may be necessary to prevent future issues and maintain the overall condition of the property.

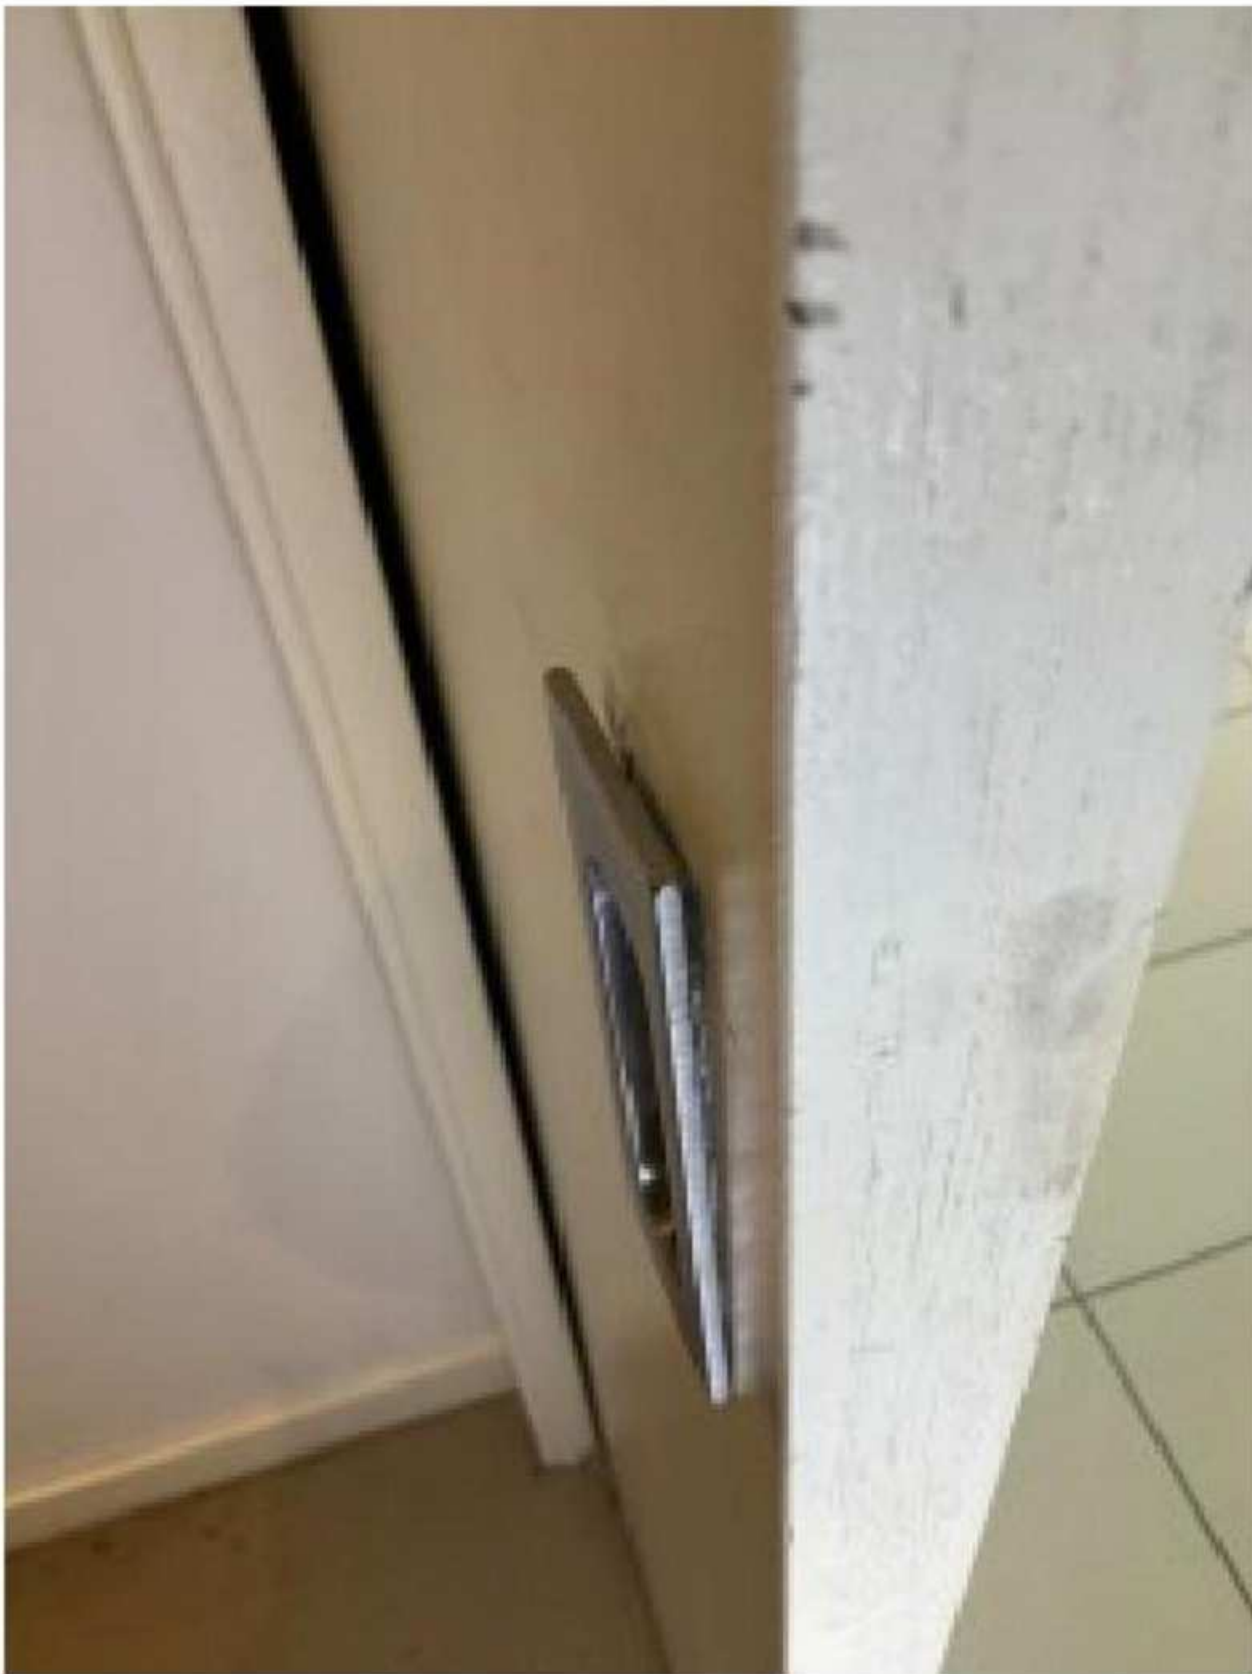
The image shows damage to the door frame, where the latch plate is prominently misaligned and loose. This misalignment could hinder the door's ability to latch properly, affecting its functionality and security. The visible wear around the damaged area suggests frequent usage without repair, potentially leading to further deterioration if not addressed. It is recommended to realign and secure the latch plate to ensure proper operation and maintain the door's structural integrity.

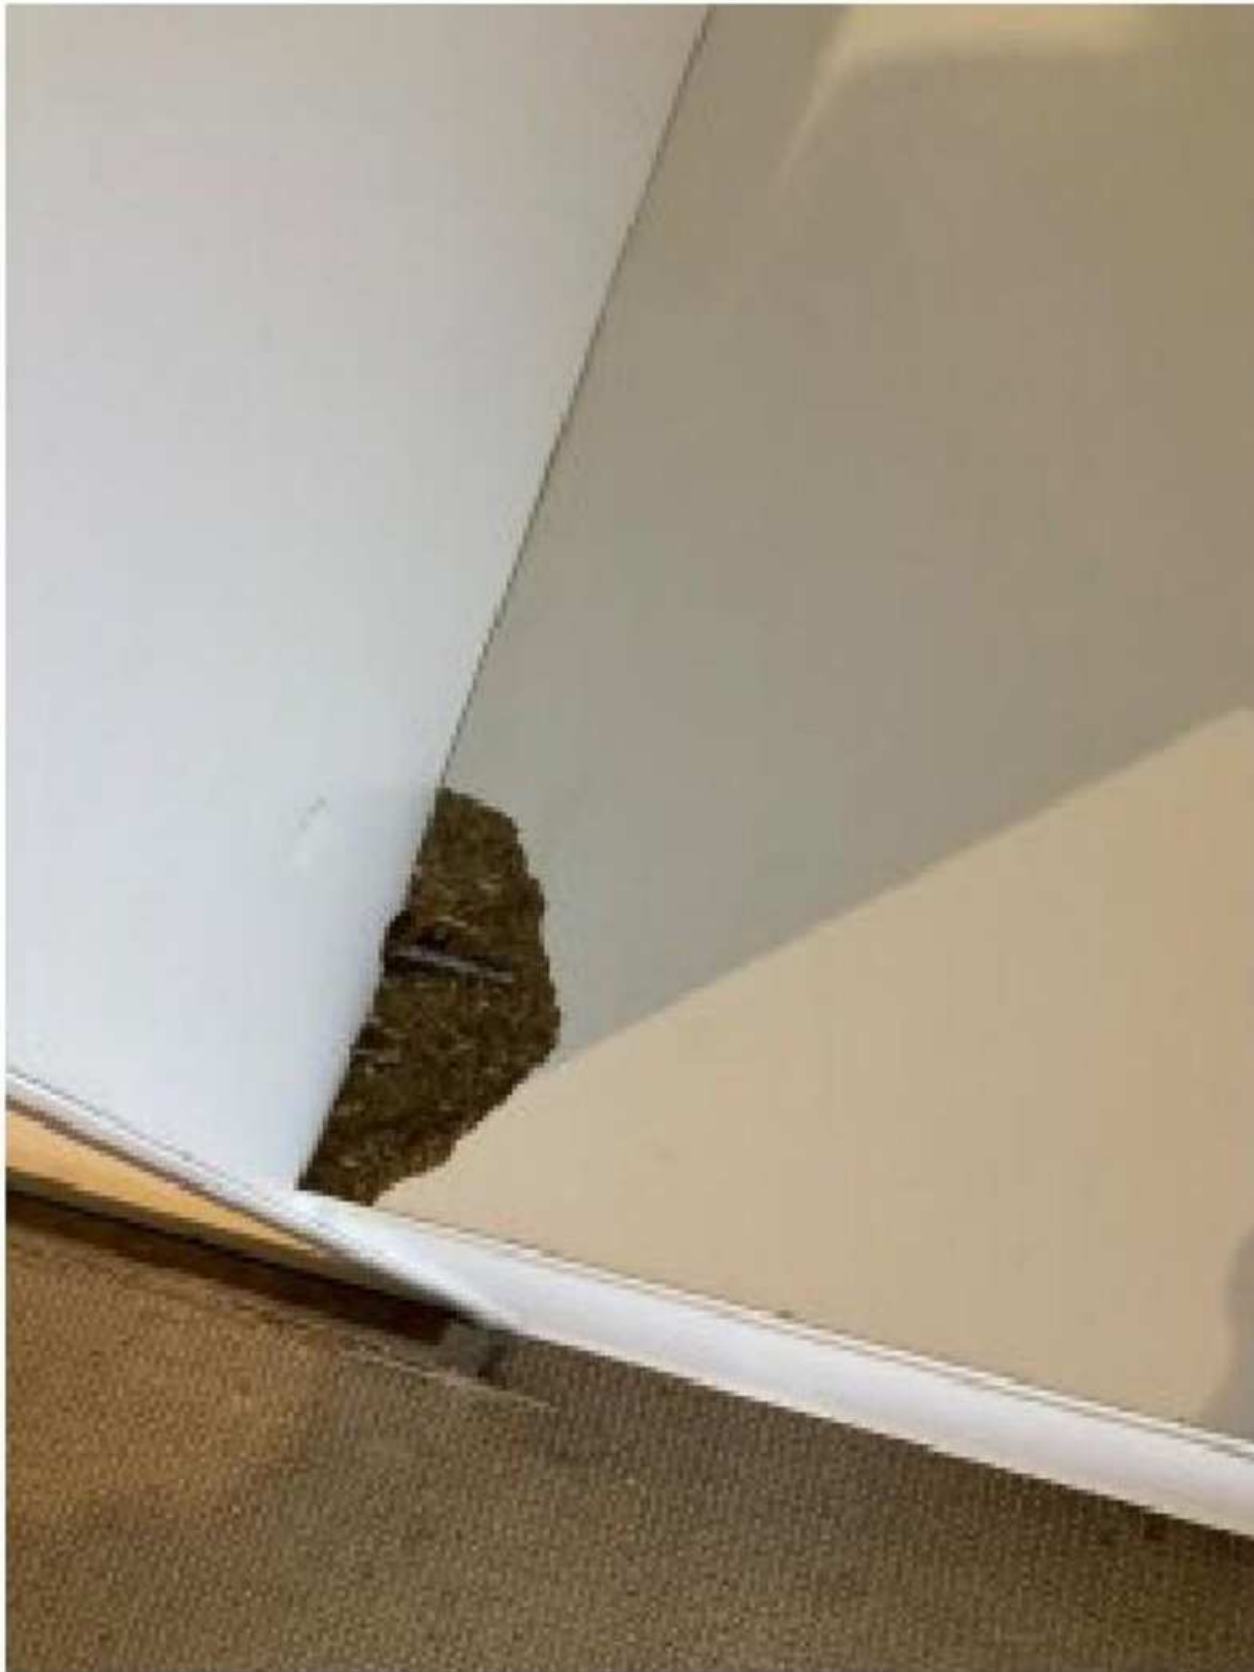
There is damage to a wardrobe, where a noticeable section of the interior panel has deteriorated. This damage exposes the underlying materials, such as fiberboard or similar. It is recommended that the damaged panel be repaired or replaced to prevent further issues and ensure the structural integrity of the wardrobe is maintained.

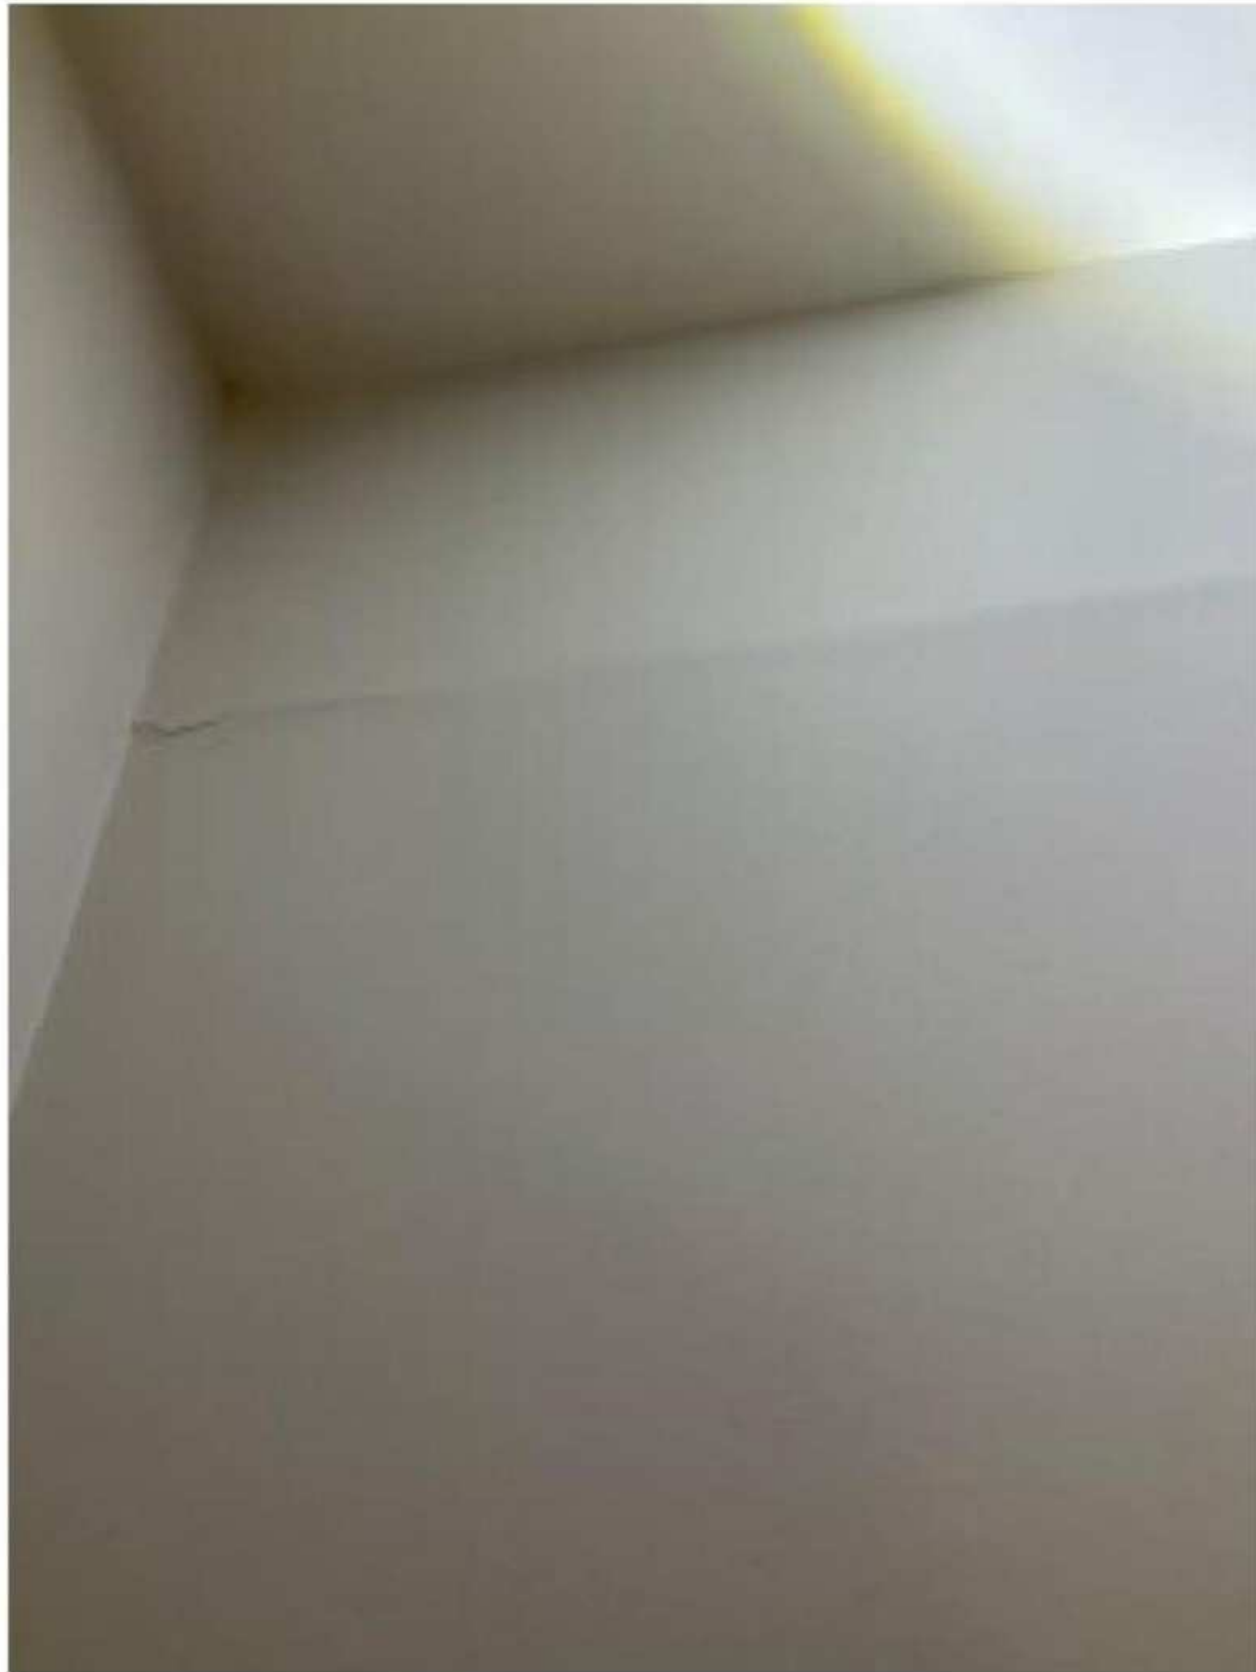
The inspection has identified a minor cosmetic defect in the interior wall, characterized by a faint crack extending along the surface. This crack appears superficial; however, it could affect the aesthetic quality of the wall. It is recommended to monitor the condition over time and consider professional cosmetic repair if it worsens. Regular maintenance and monitoring can ensure the defect does not develop into a more significant problem.

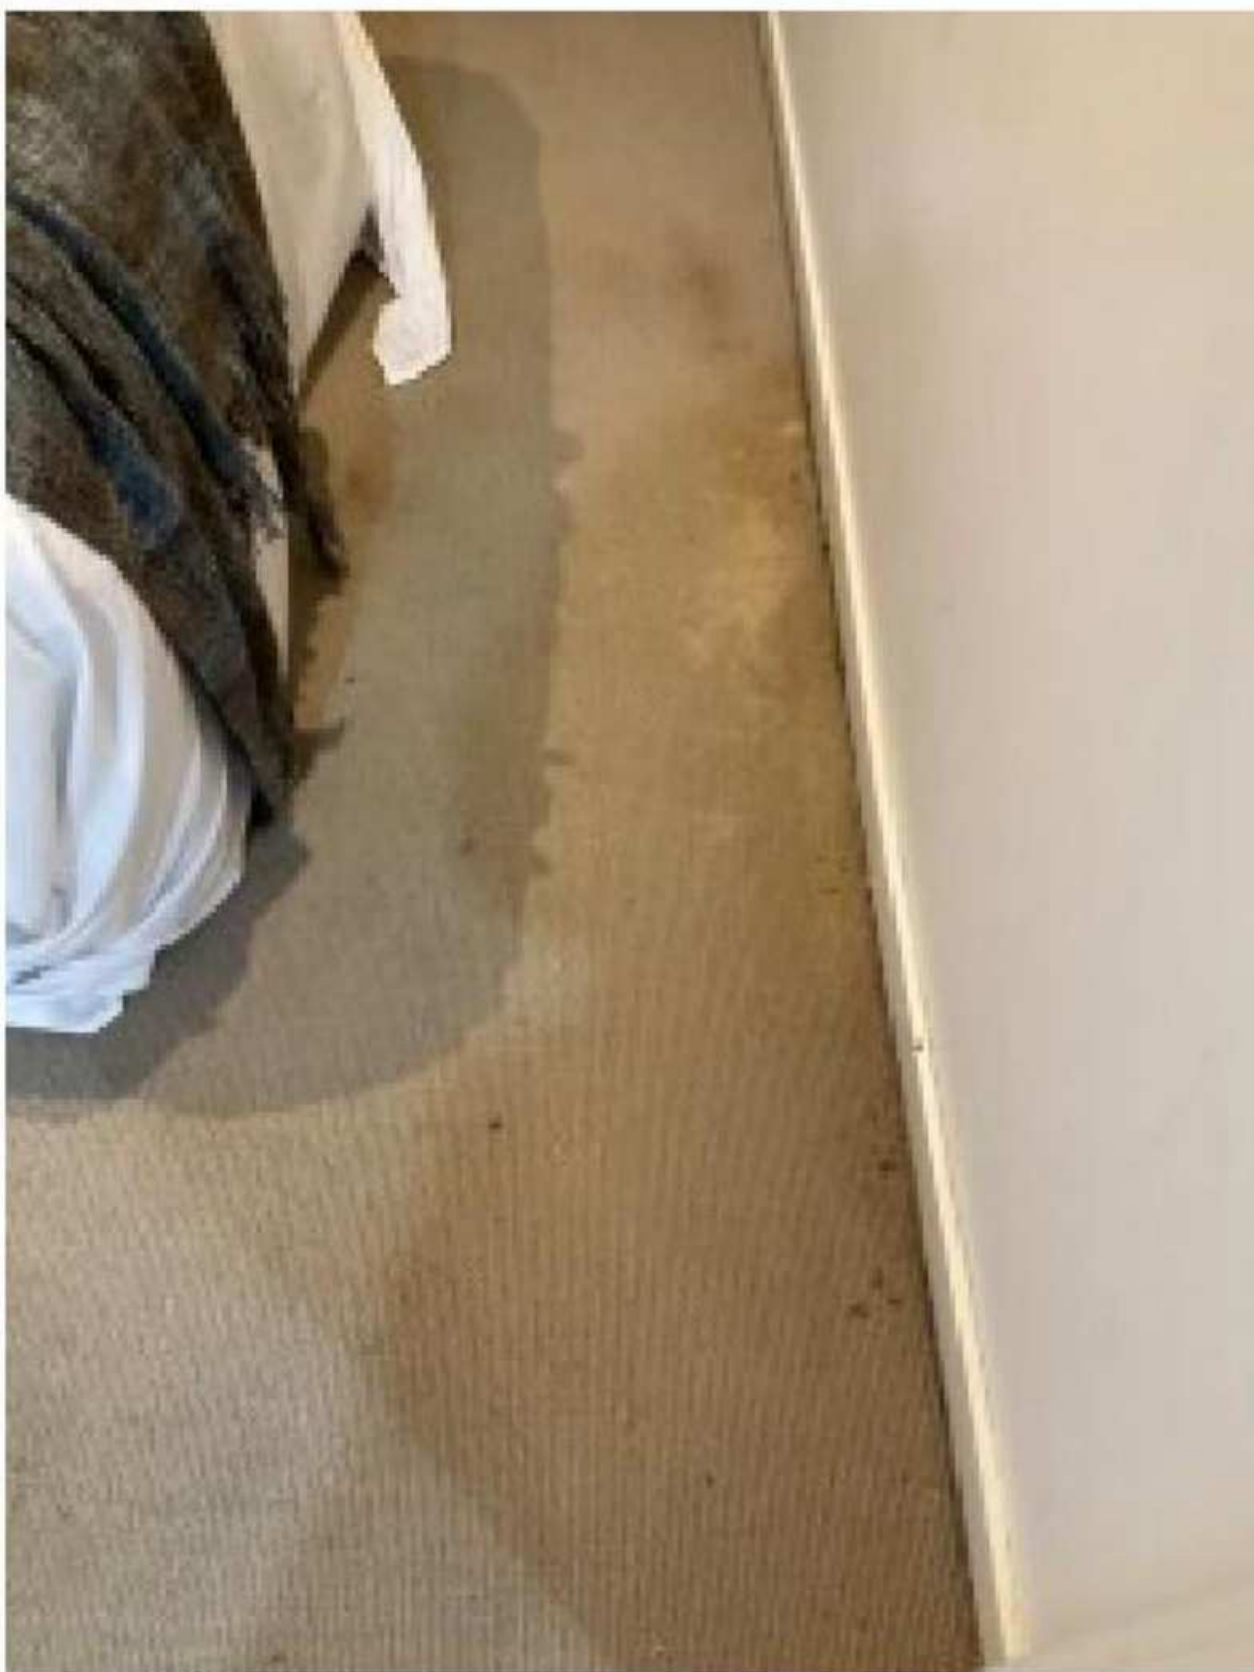
Stain and discolouration were observed on the carpet. With general wear or previous spills and detract from the overall appearance. Replacement on the affected carpet is recommended.

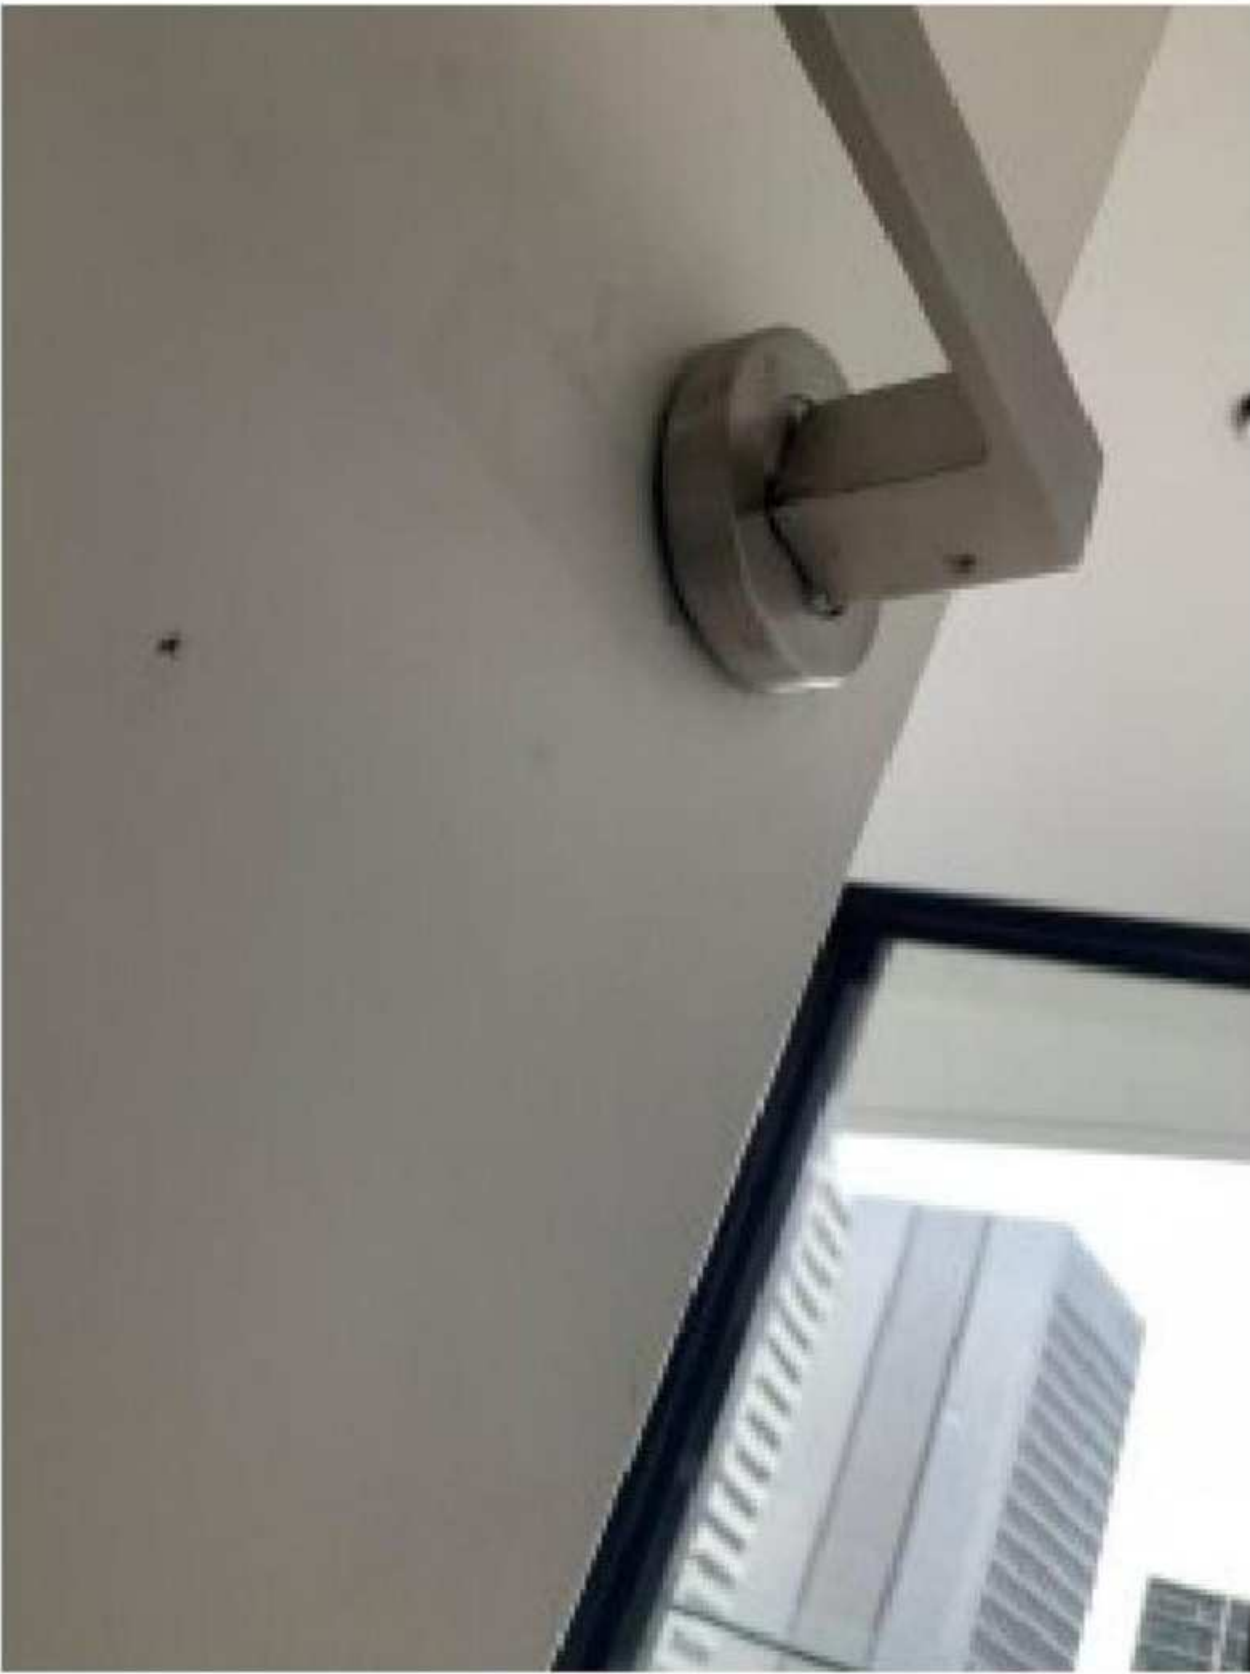
The door's alignment appears to be slightly off, which may affect its ability to open and close smoothly. The handle is positioned at an angle that could cause functional issues, leading to increased wear over time. Immediate attention is recommended to adjust and secure the hardware to prevent further misalignment and ensure proper operation.

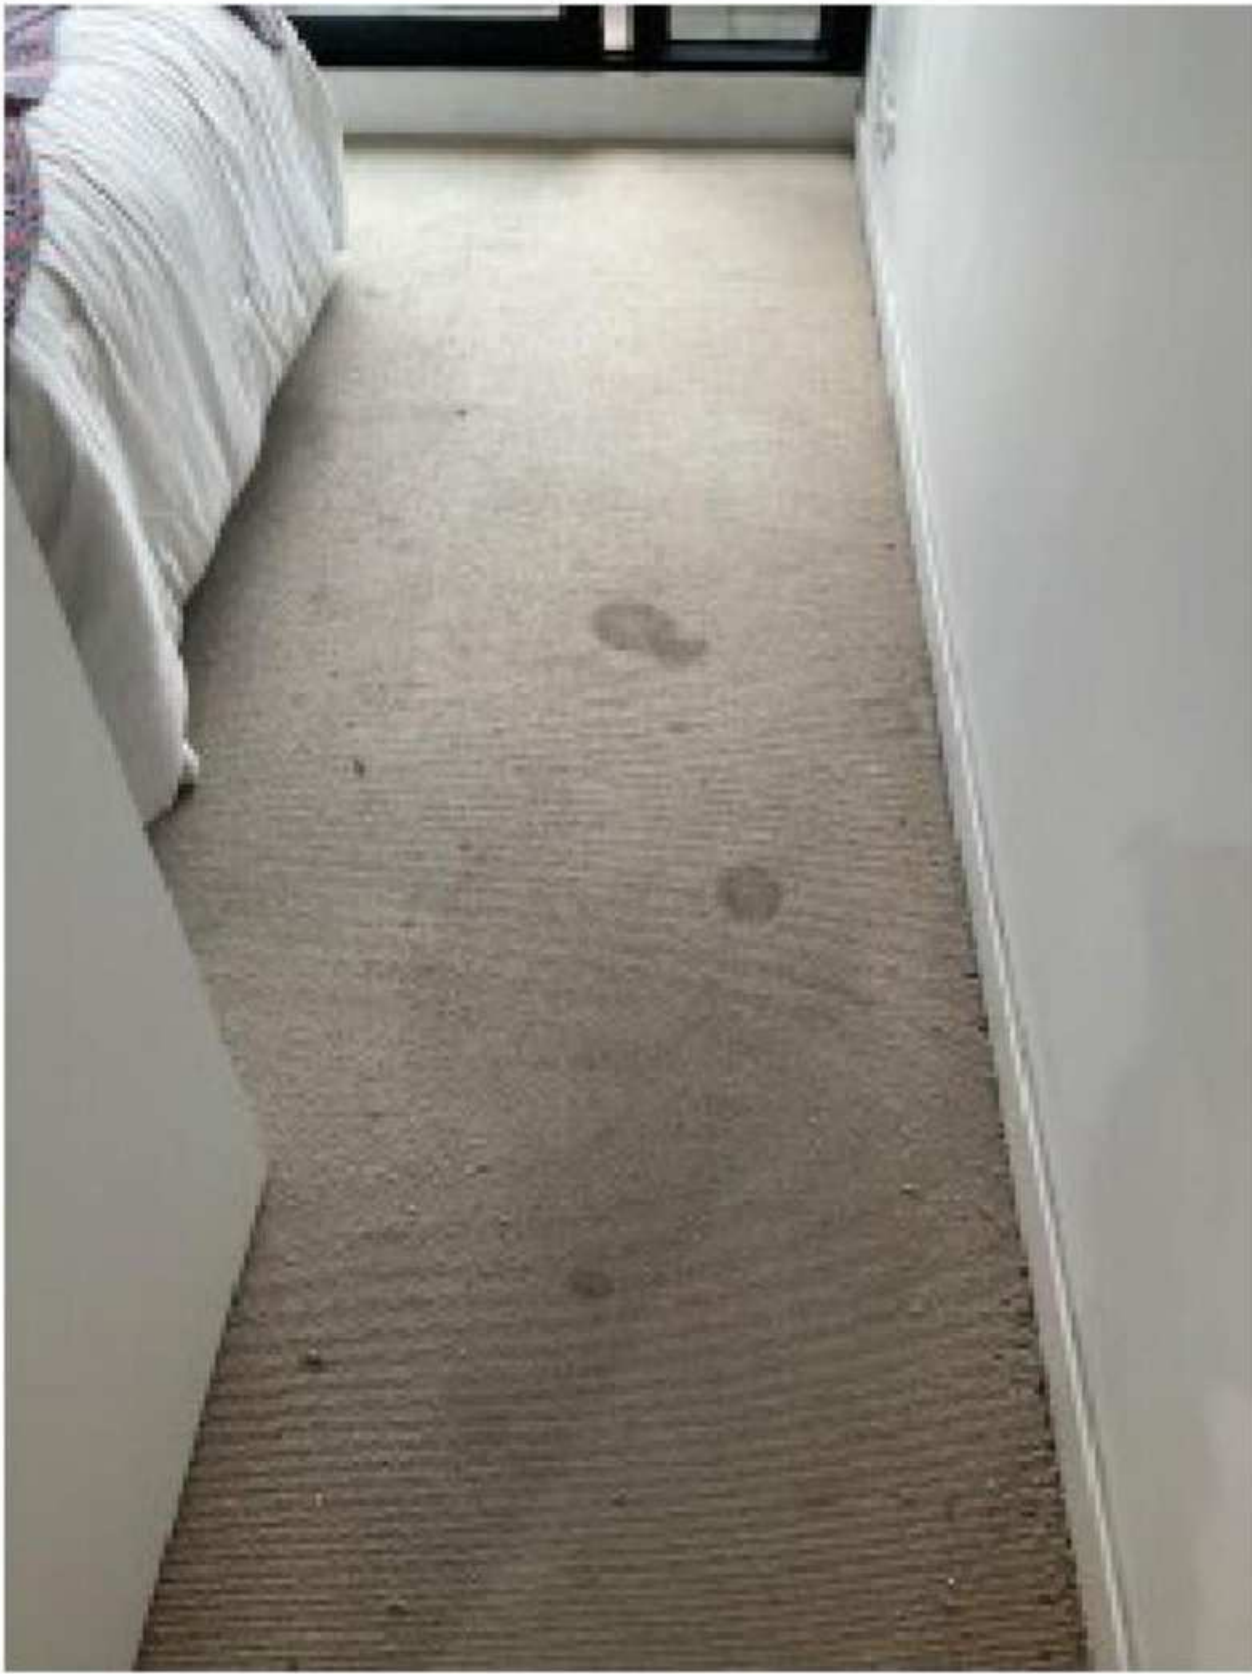
The carpet in the inspected area shows visible signs of wear and staining. There are multiple noticeable spots and marks that could indicate past spills or high foot traffic. Edges of the carpeting appear slightly frayed, which could worsen over time. This condition may require professional cleaning or possible replacement to restore its original appearance and ensure longevity.

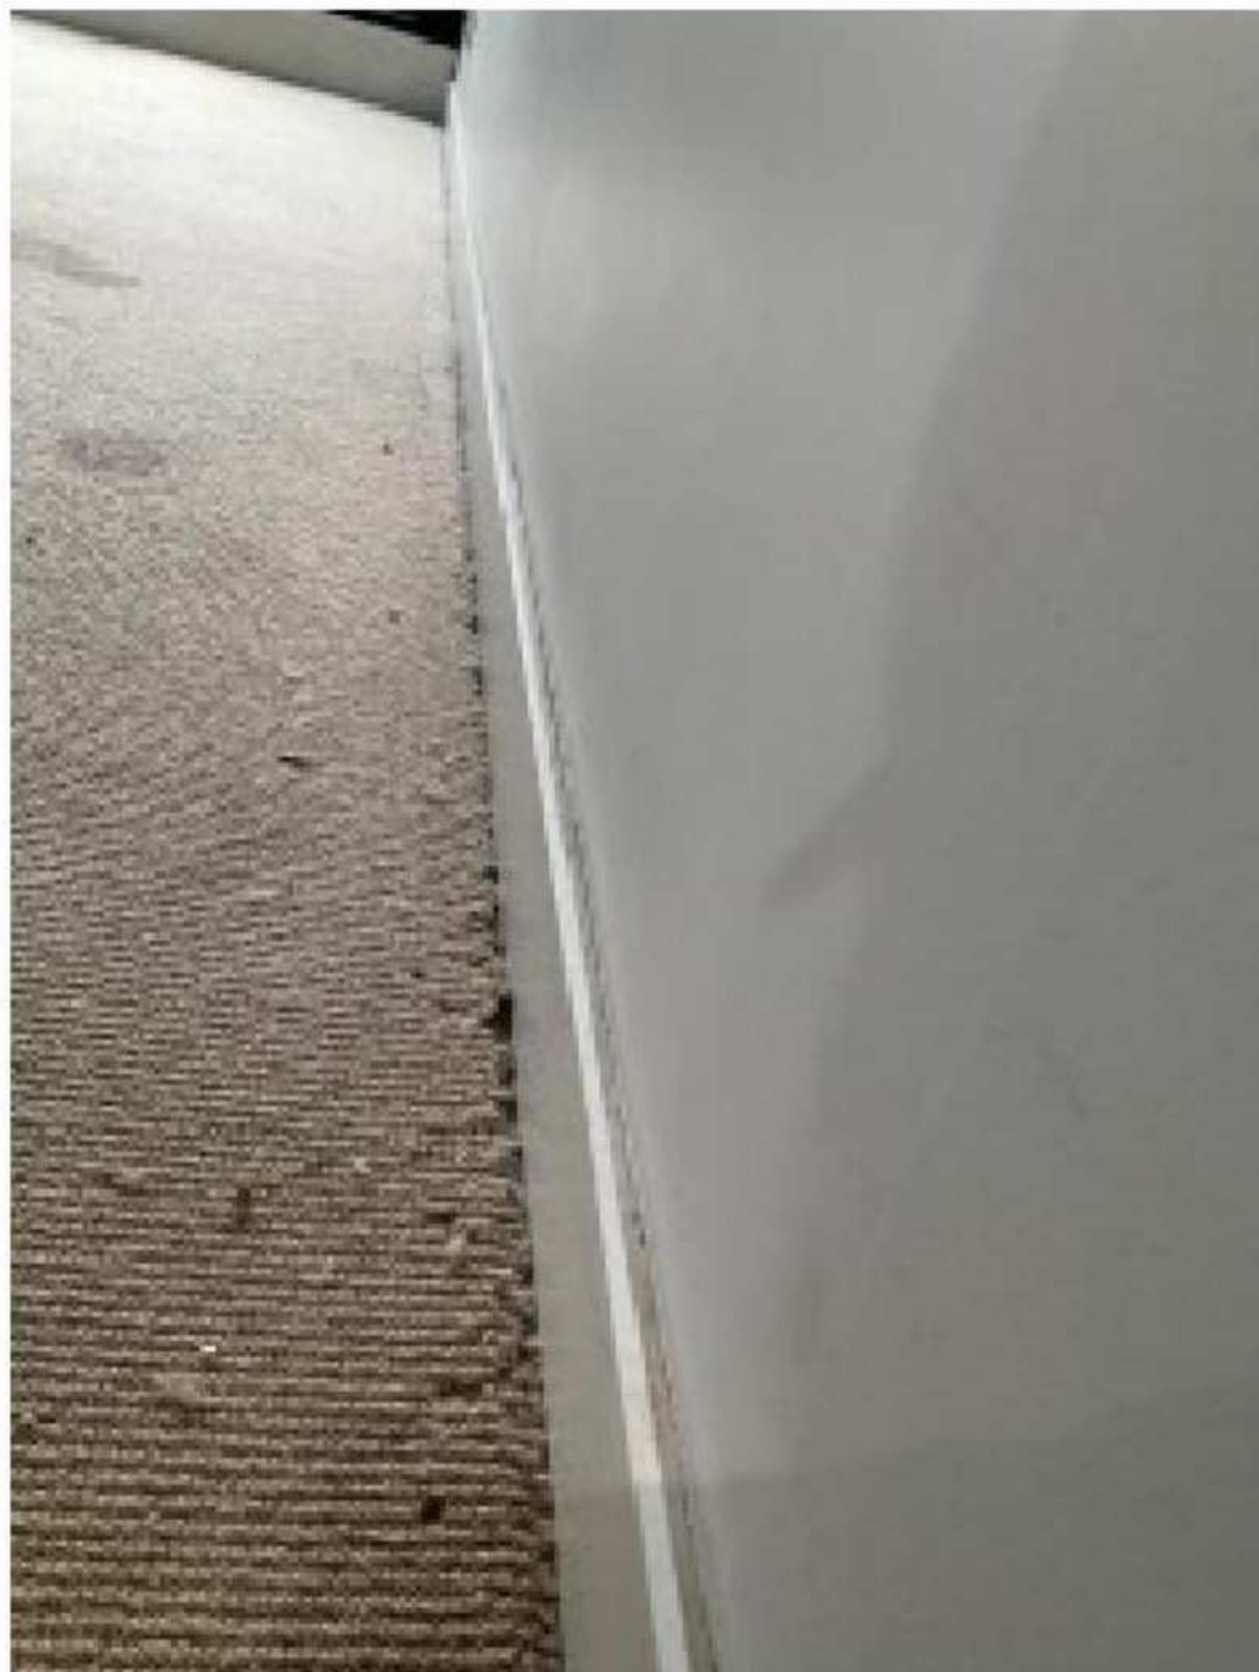
The carpet is shrinking away from the skirting. Consider consulting a professional for evaluation and potential corrective measures or replacement.

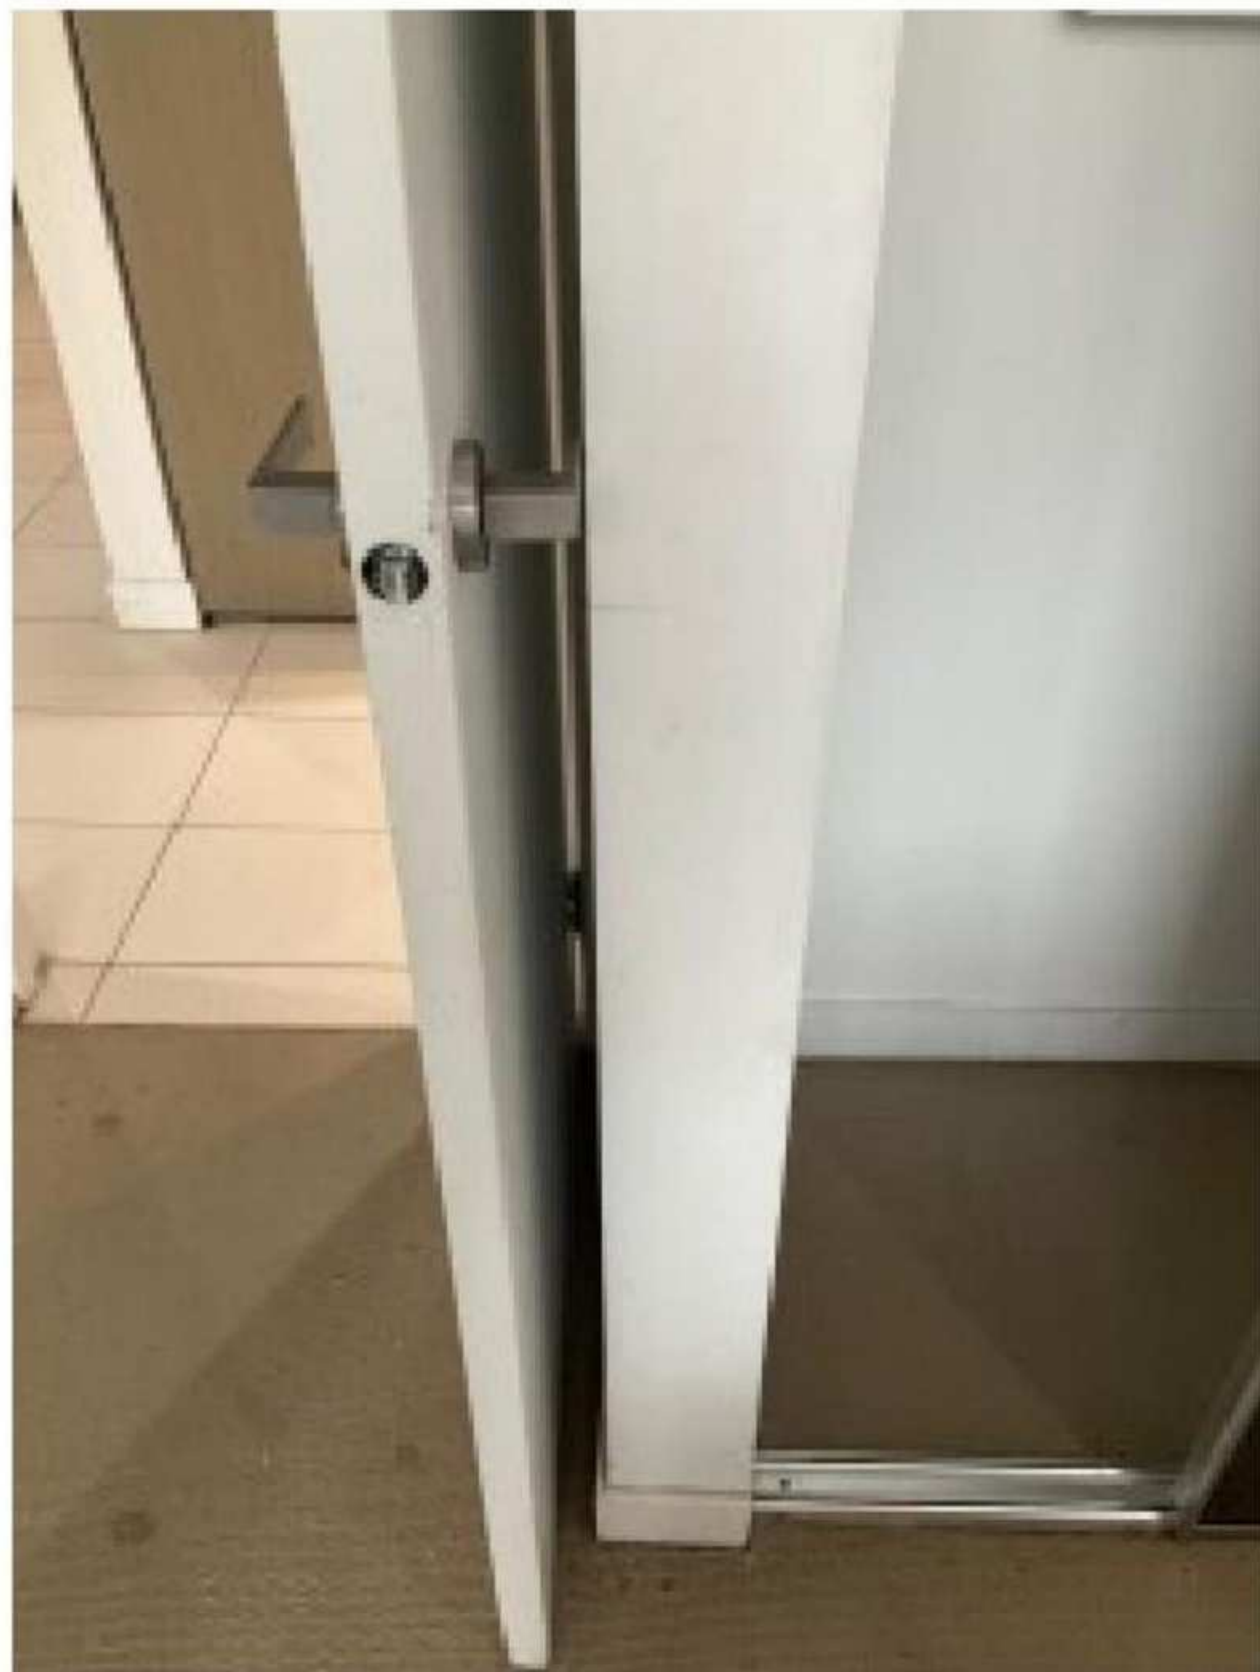
No door stop fitted at the time of inspection

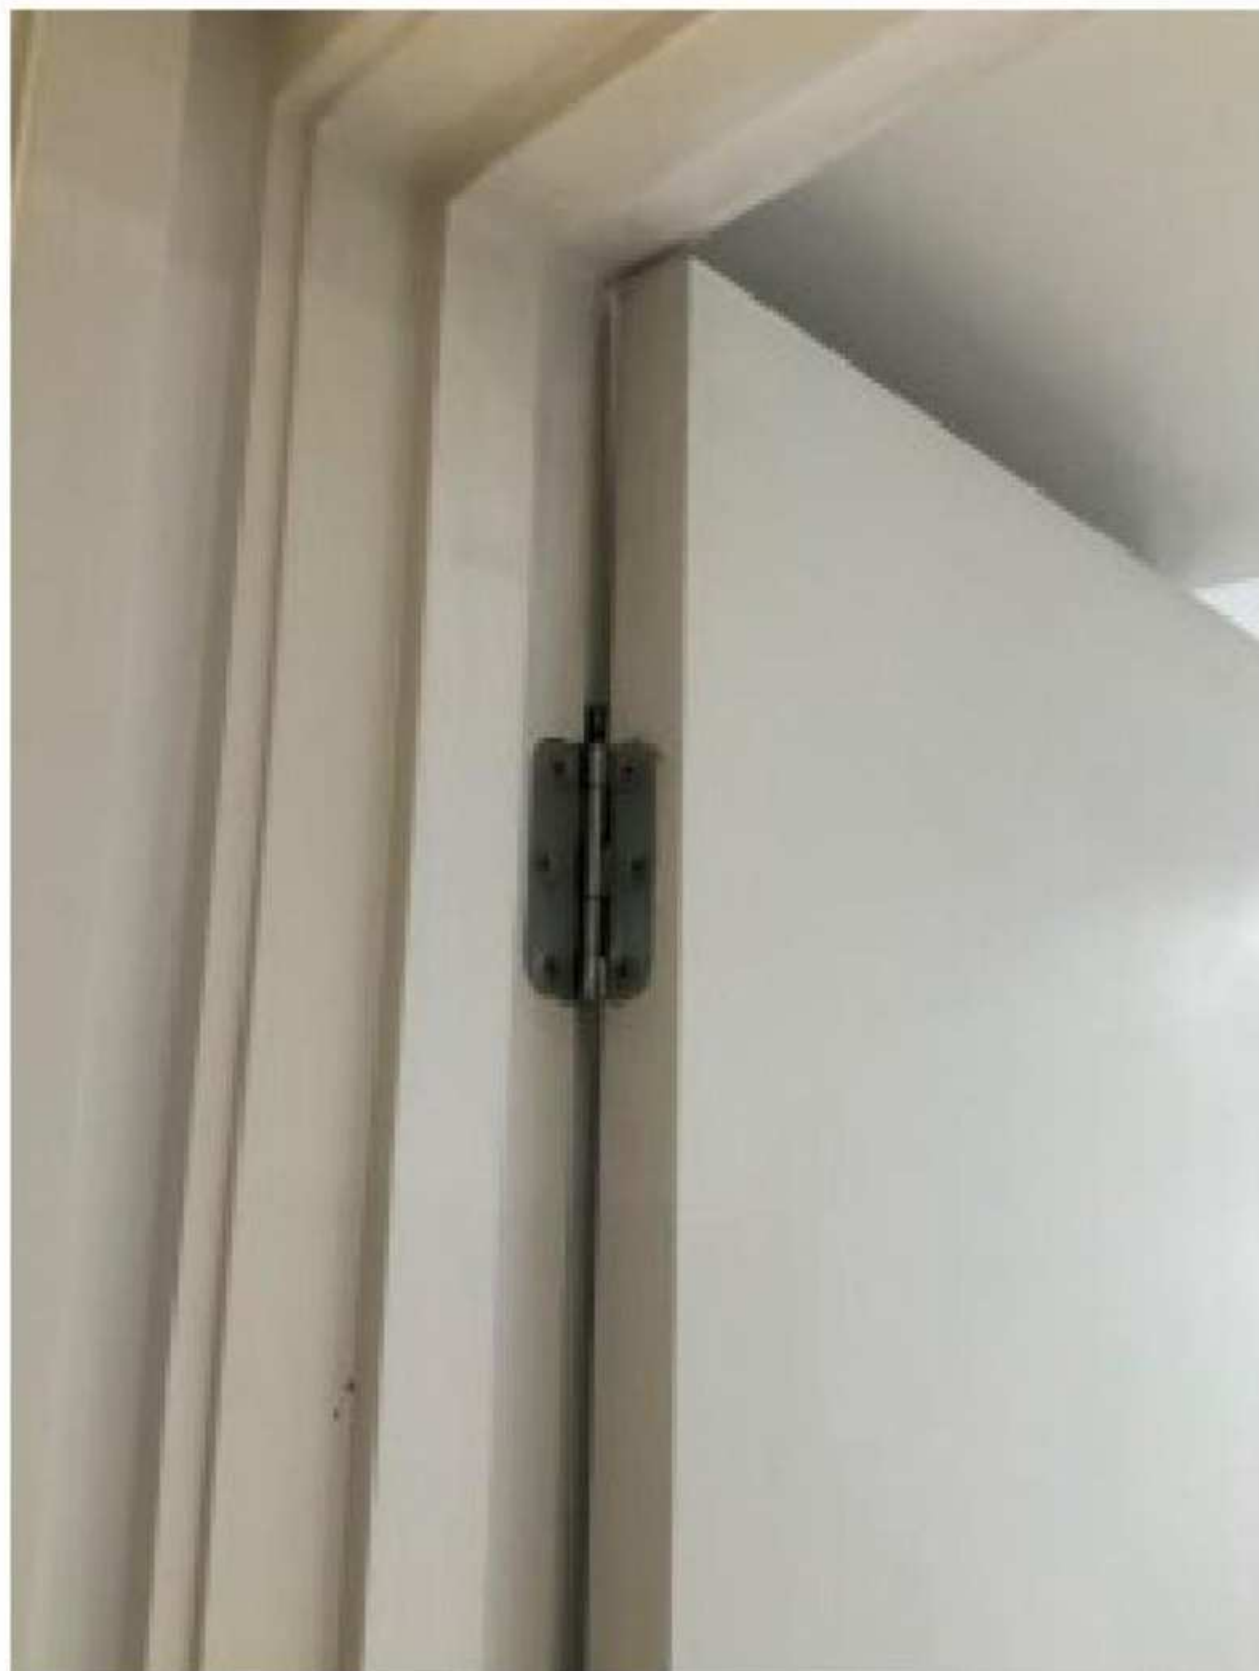
It appears the one of the door hinges pin is popping up from the fixing position. Recommended to fix the hinges to ensure smooth operation and proper alignment.
