## Just Inspections

## Building Inspection Report

AS4349.1- 2007

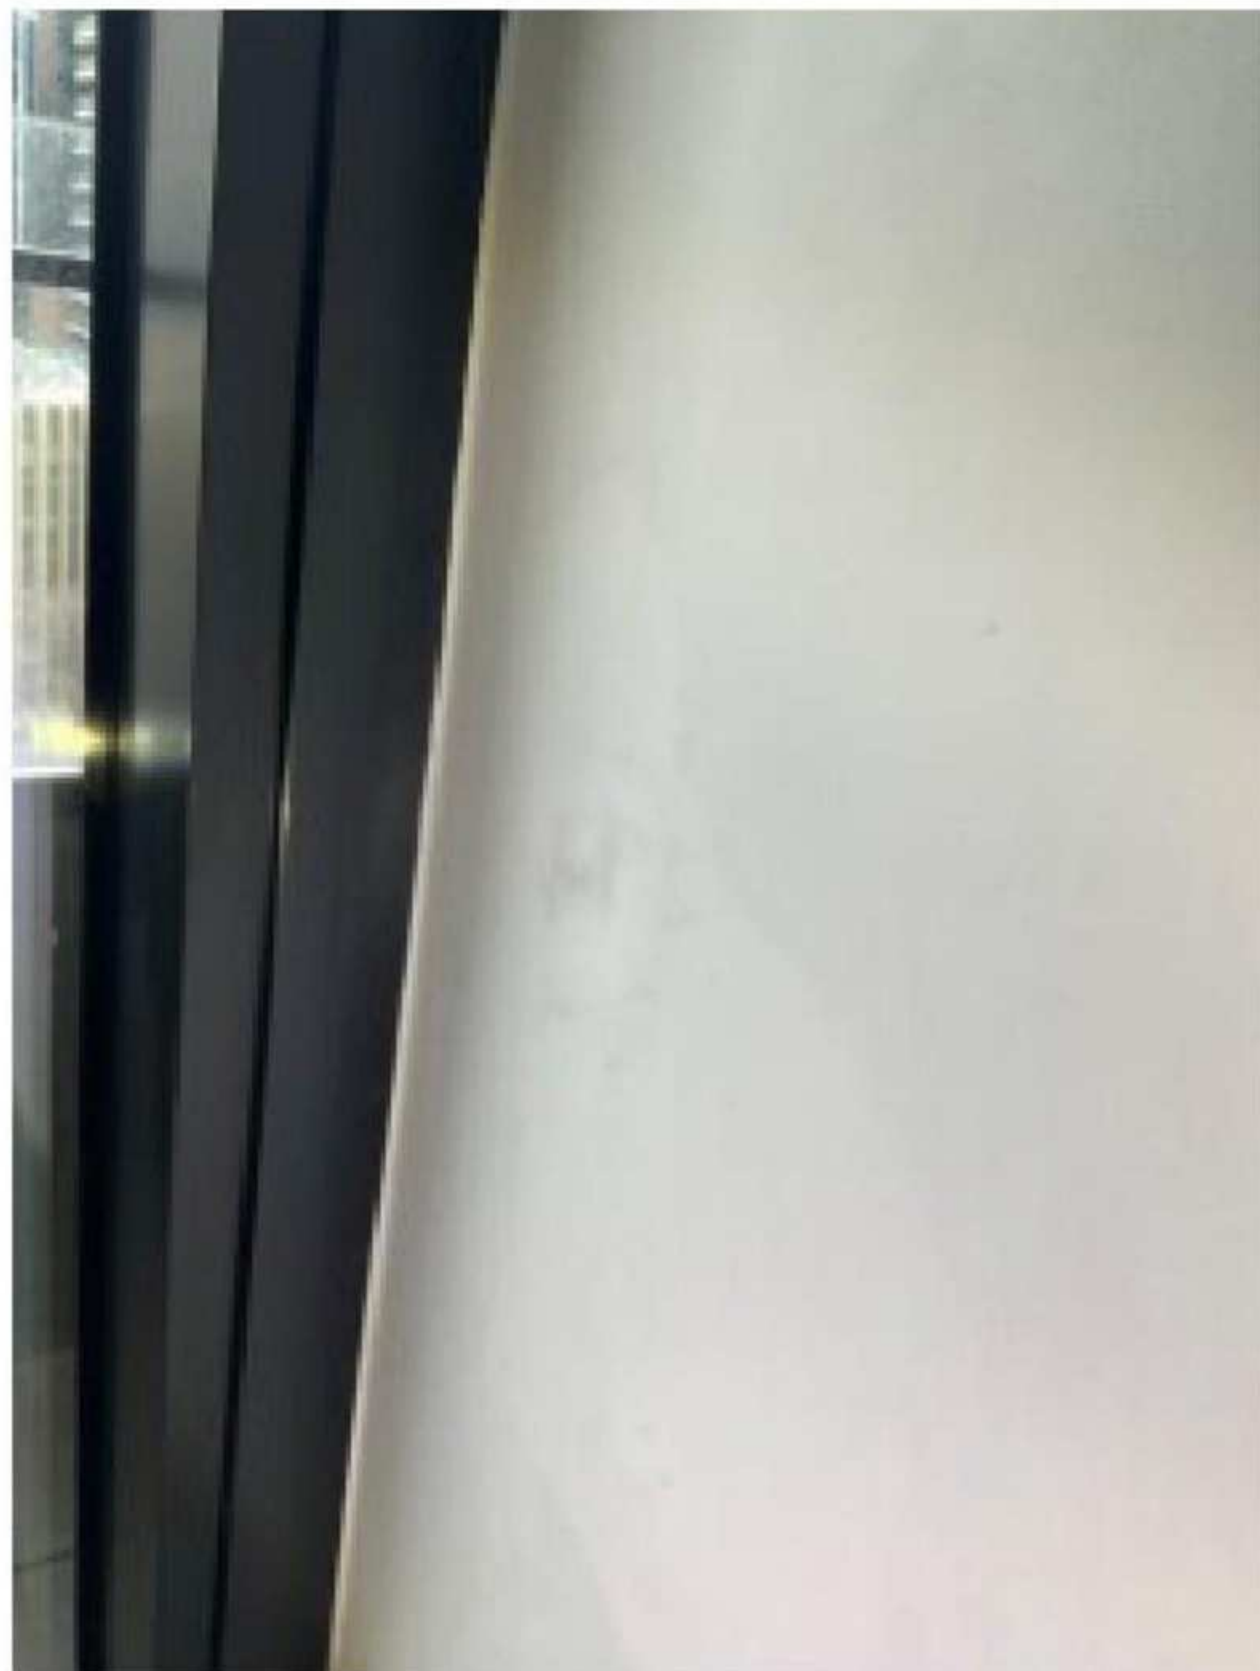
A patched section of the wall was observed. The repair appears visible and may indicate previous damage or repair work.

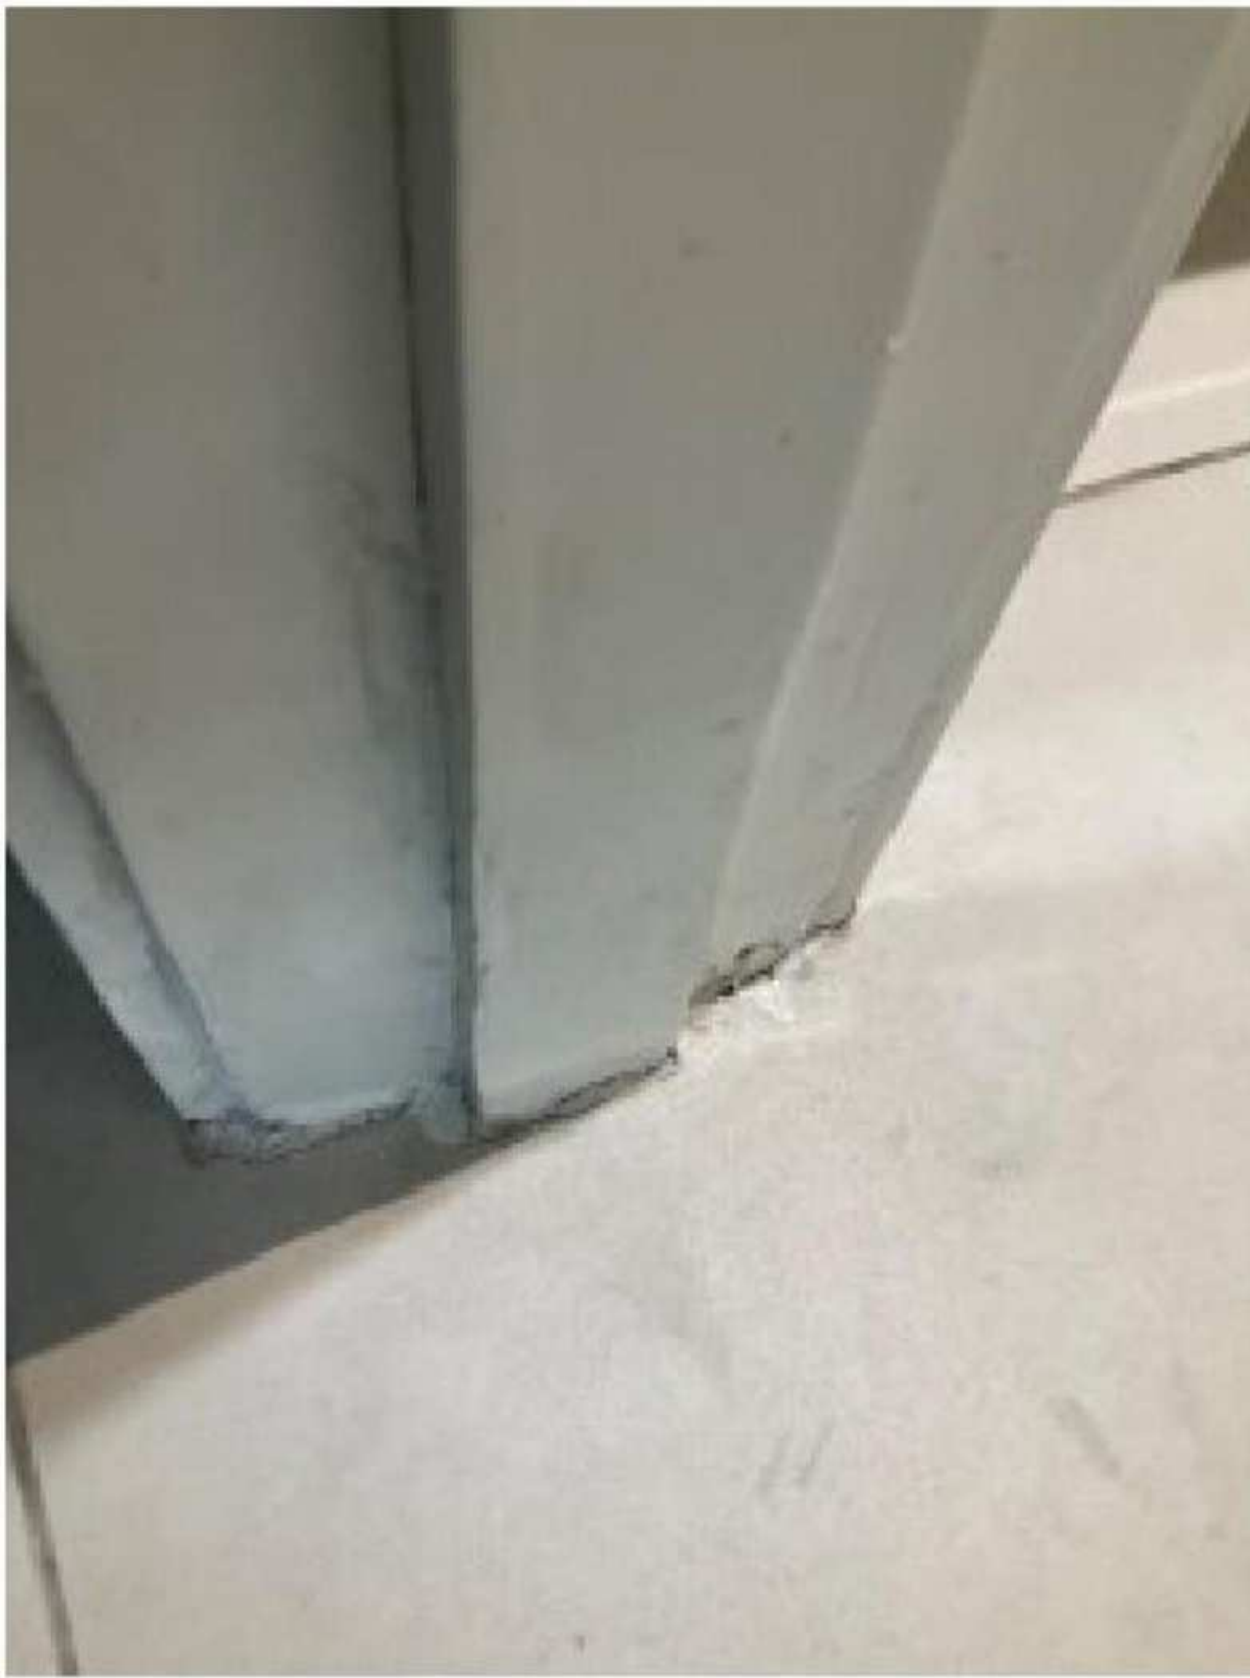
The image indicates an issue with the base of a door frame where signs of moisture ingress are evident. There is visible deterioration of the paint and slight expansion of the frame material, suggesting possible water damage. Consider evaluation and repair by a professional to prevent escalation of the defect.

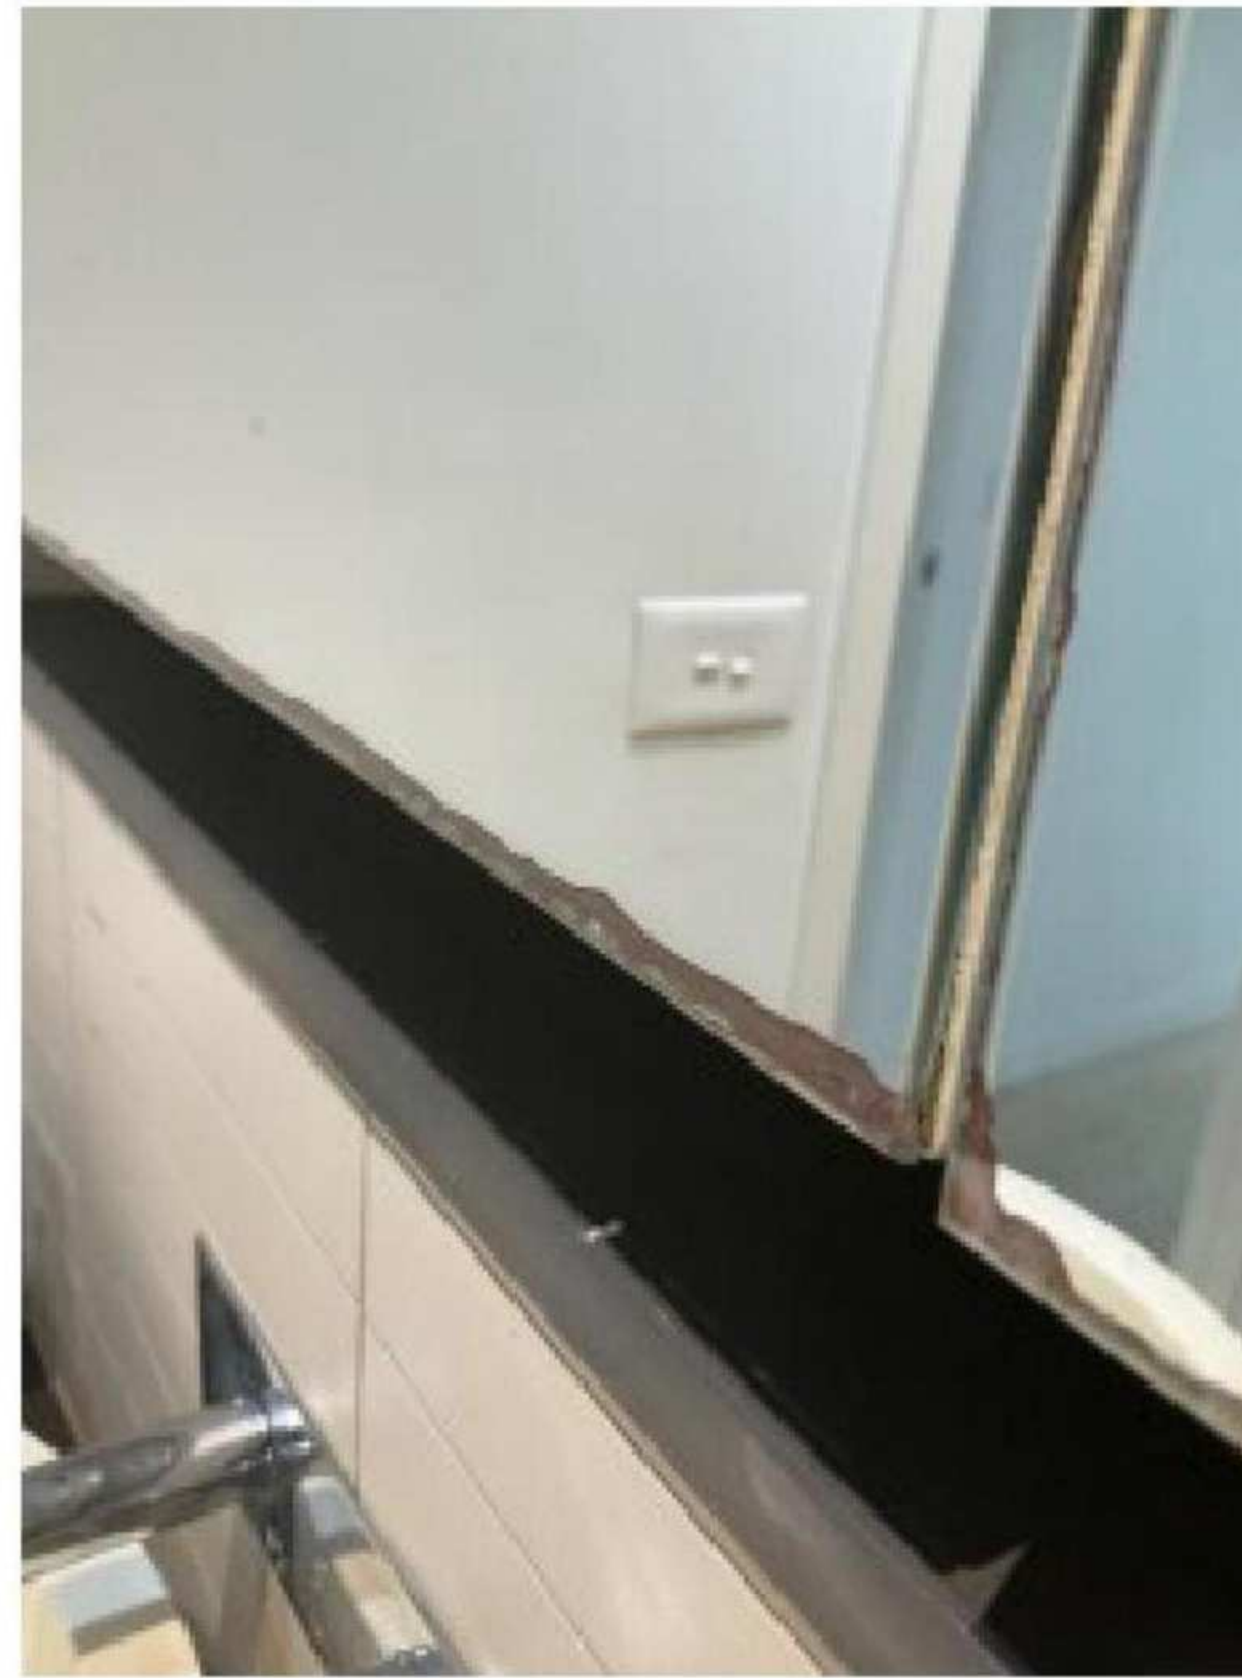
The mirror exhibits signs of deterioration, with noticeable DE silvering along the edges. This condition is typically caused by prolonged exposure to moisture, potentially compromising the visual appeal and functionality of the mirror. While not a structural concern, this defect may necessitate replacement to restore aesthetic quality. Attention to ventilation and moisture control in the surrounding area is advisable to prevent further damage.

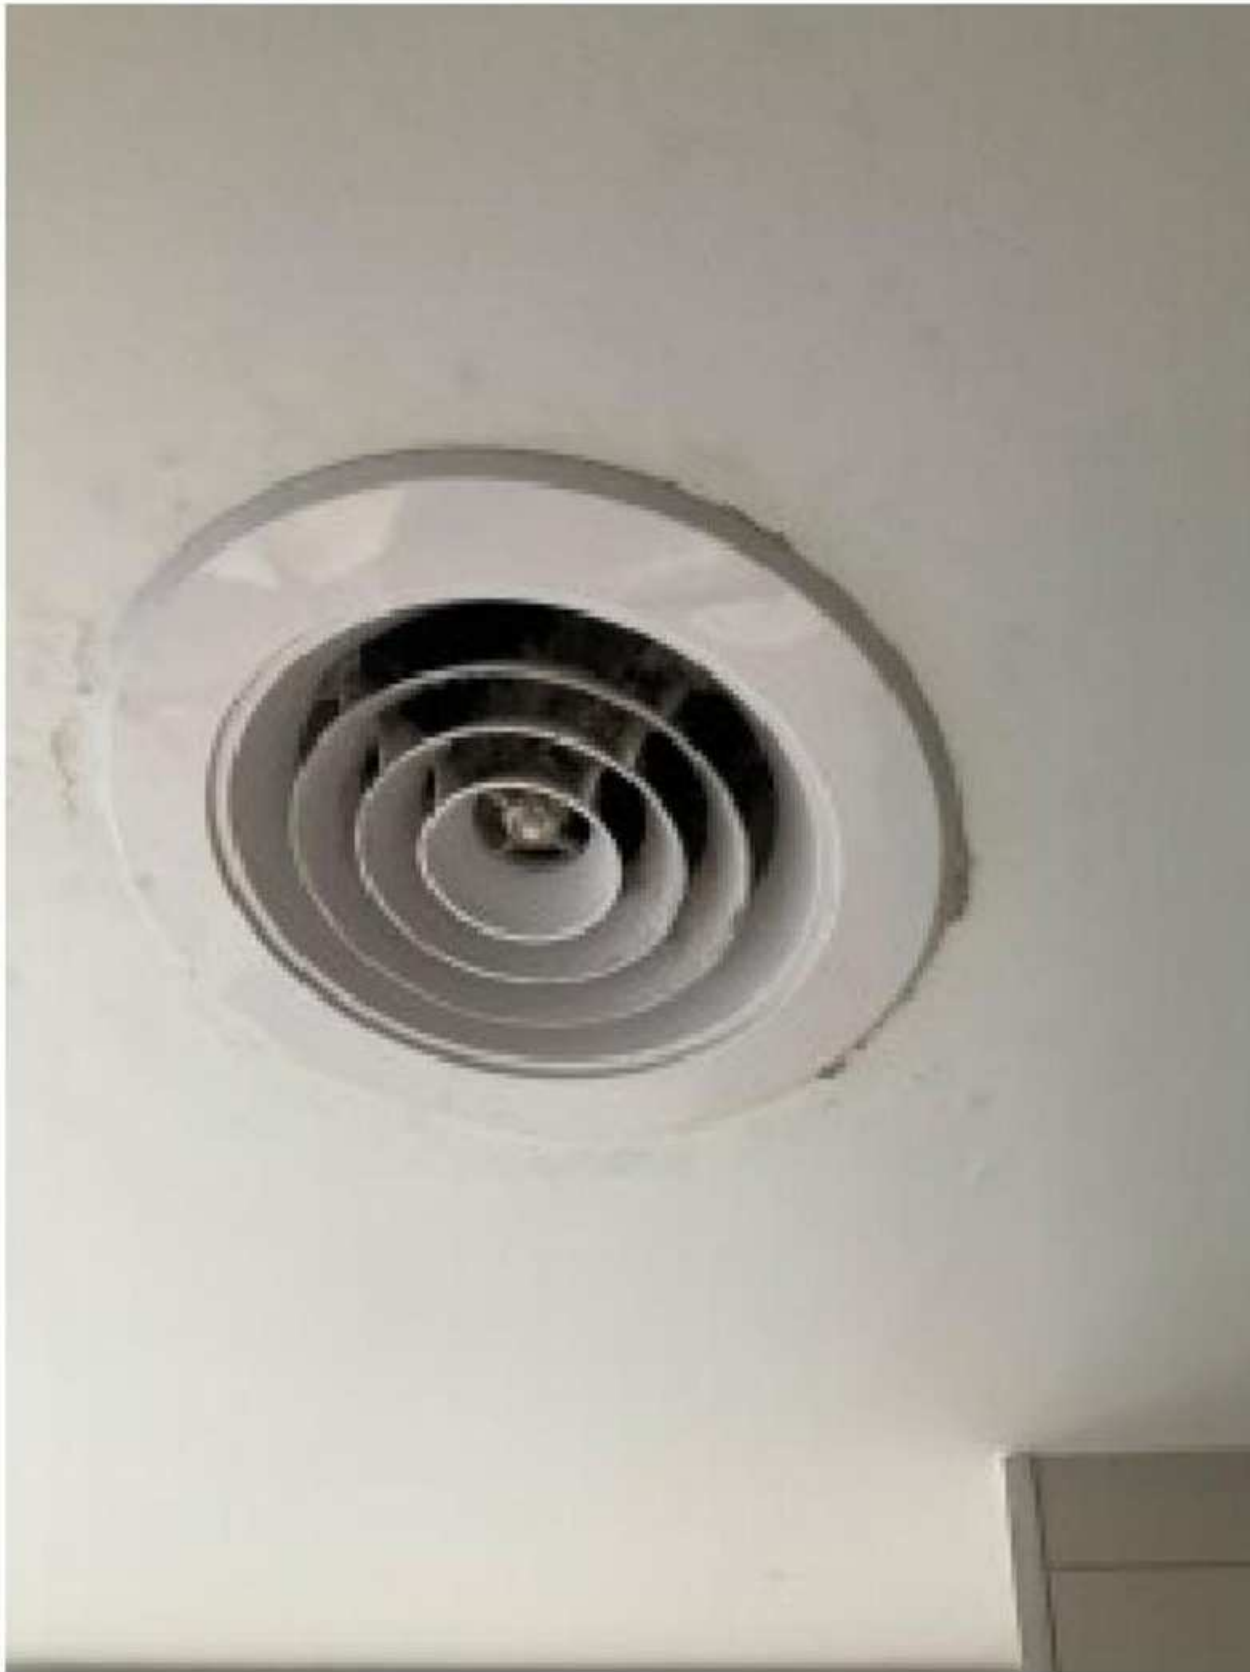
The ceiling shows signs of moisture damage around the ventilation duct, likely due to ventilation unoperational at the time of inspection, which can lead to mould growth if not addressed. The surrounding paint is starting to bubble and peel, suggesting that moisture is consistently accumulating. It is advisable to investigate the source of the moisture and ensure the area is sealed and ventilated properly to prevent further deterioration. Regular maintenance and assessment could prevent potential long-term issues related to air quality.

There is a possible ventilation issue in the bathroom.  
Recommend a plumber be engaged to investigate issues.

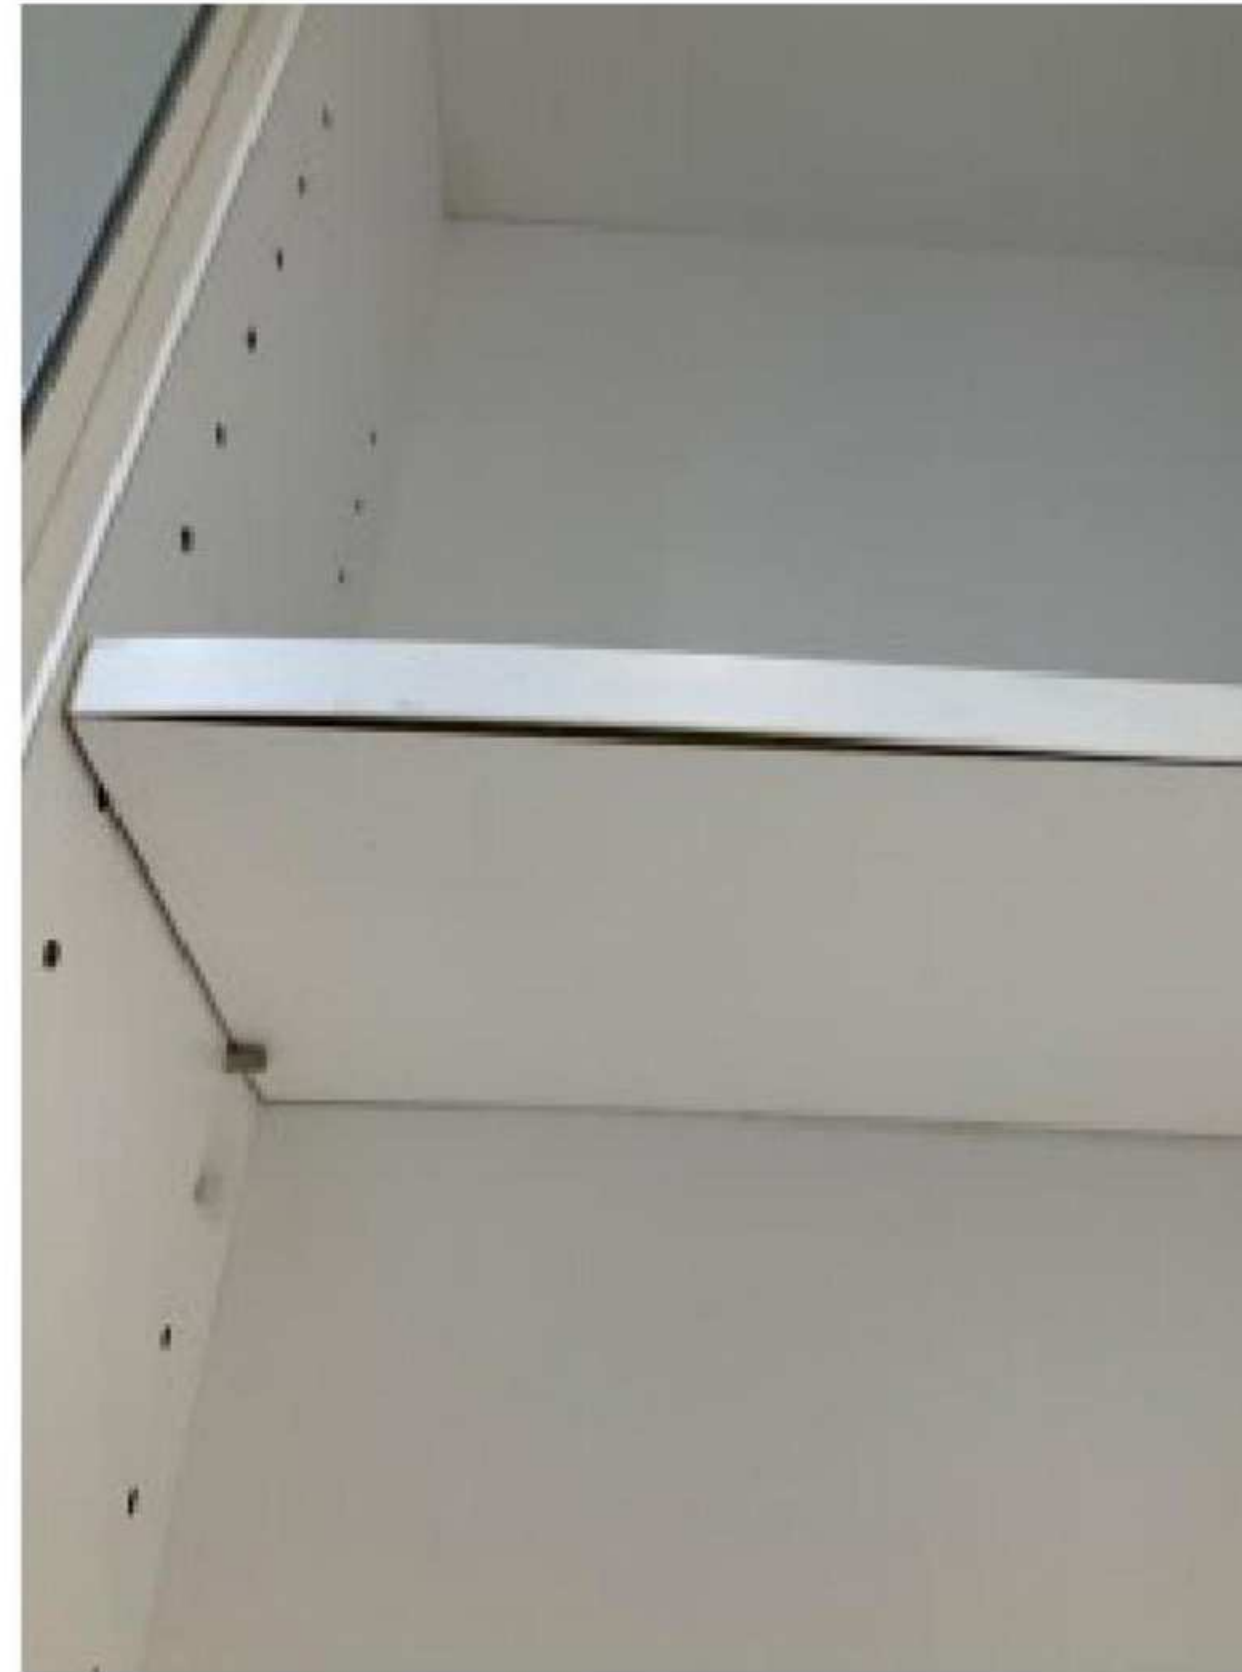
The interior shelf displays a noticeably chipped edge. Consider repair or replacement to maintain the unit's functionality and appearance.

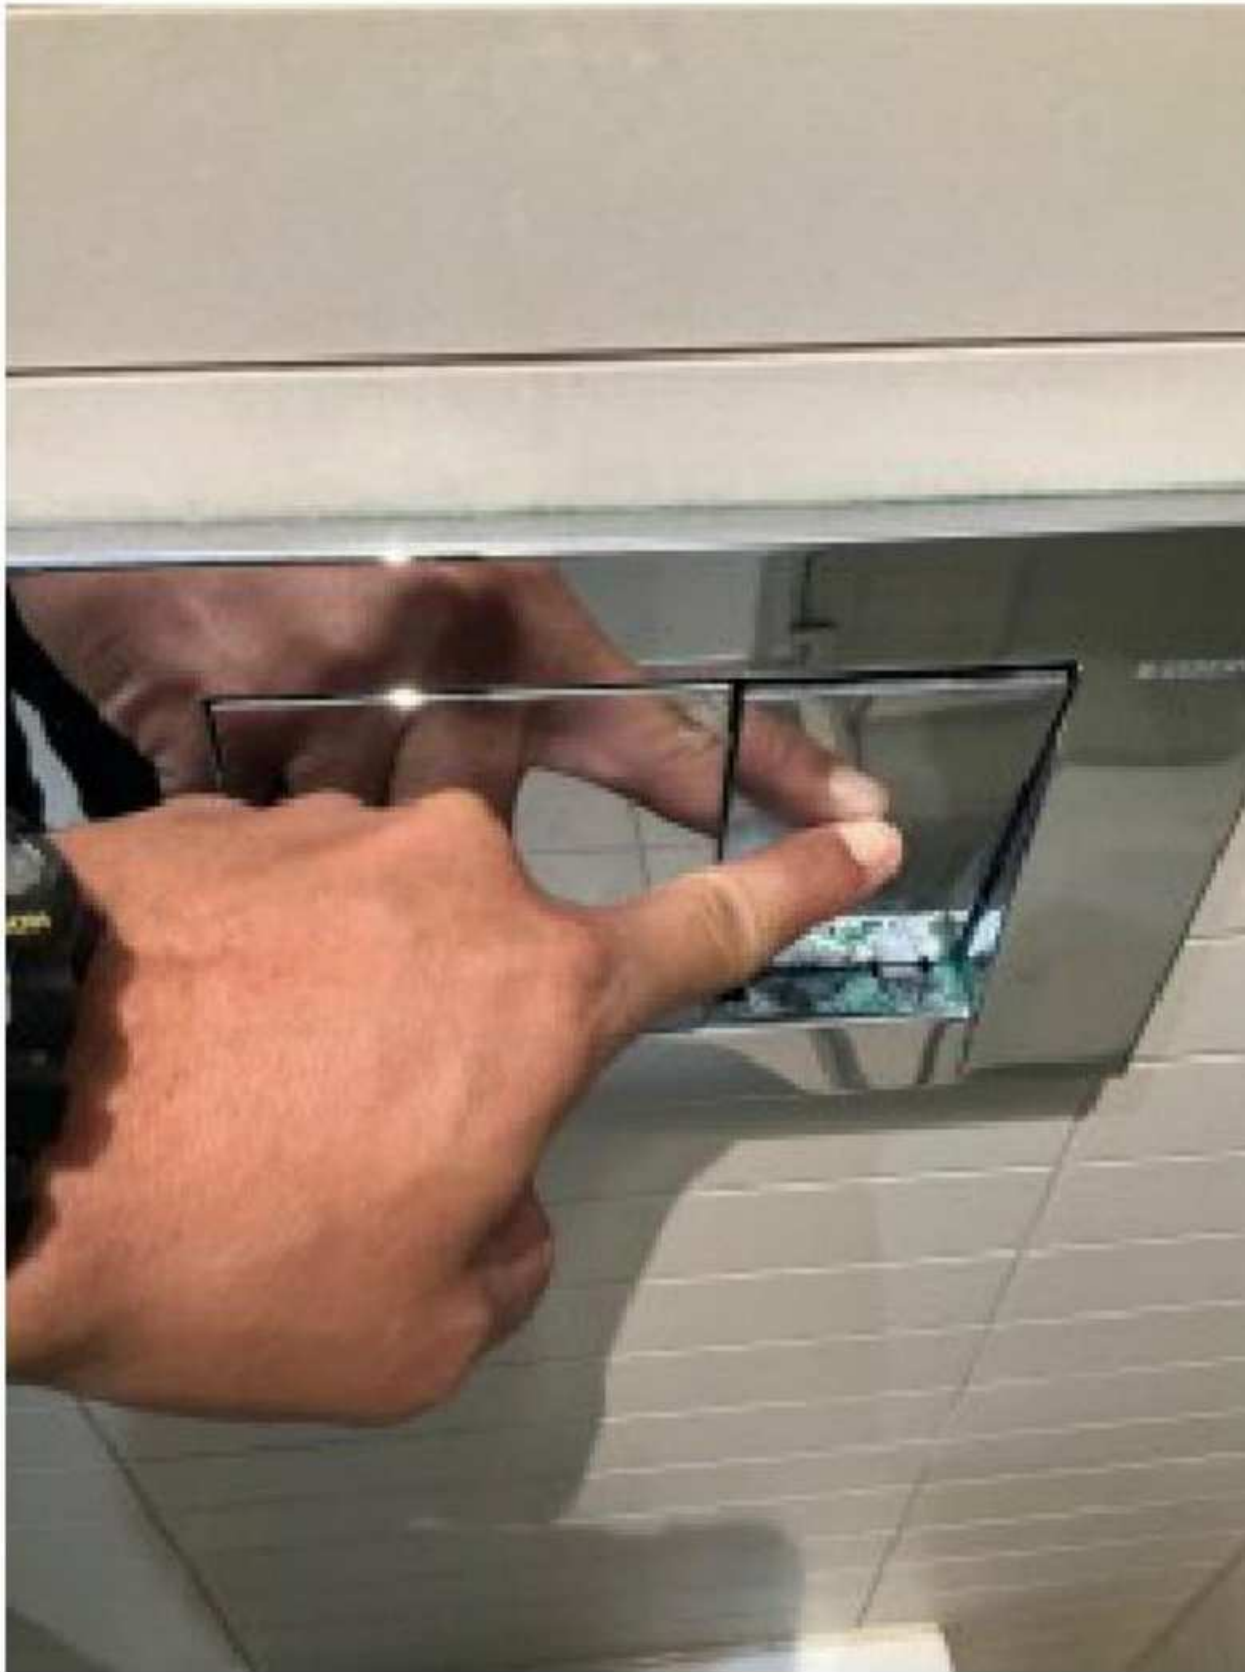
The flush plate on the toilet shows signs of deterioration and is not working, with visible corrosion and mineral buildup around the edges. This likely results from prolonged exposure to moisture, or inadequate ventilation in the bathroom. It is recommended that the issue be addressed promptly to prevent further damage and ensure proper operation of the toilet system.

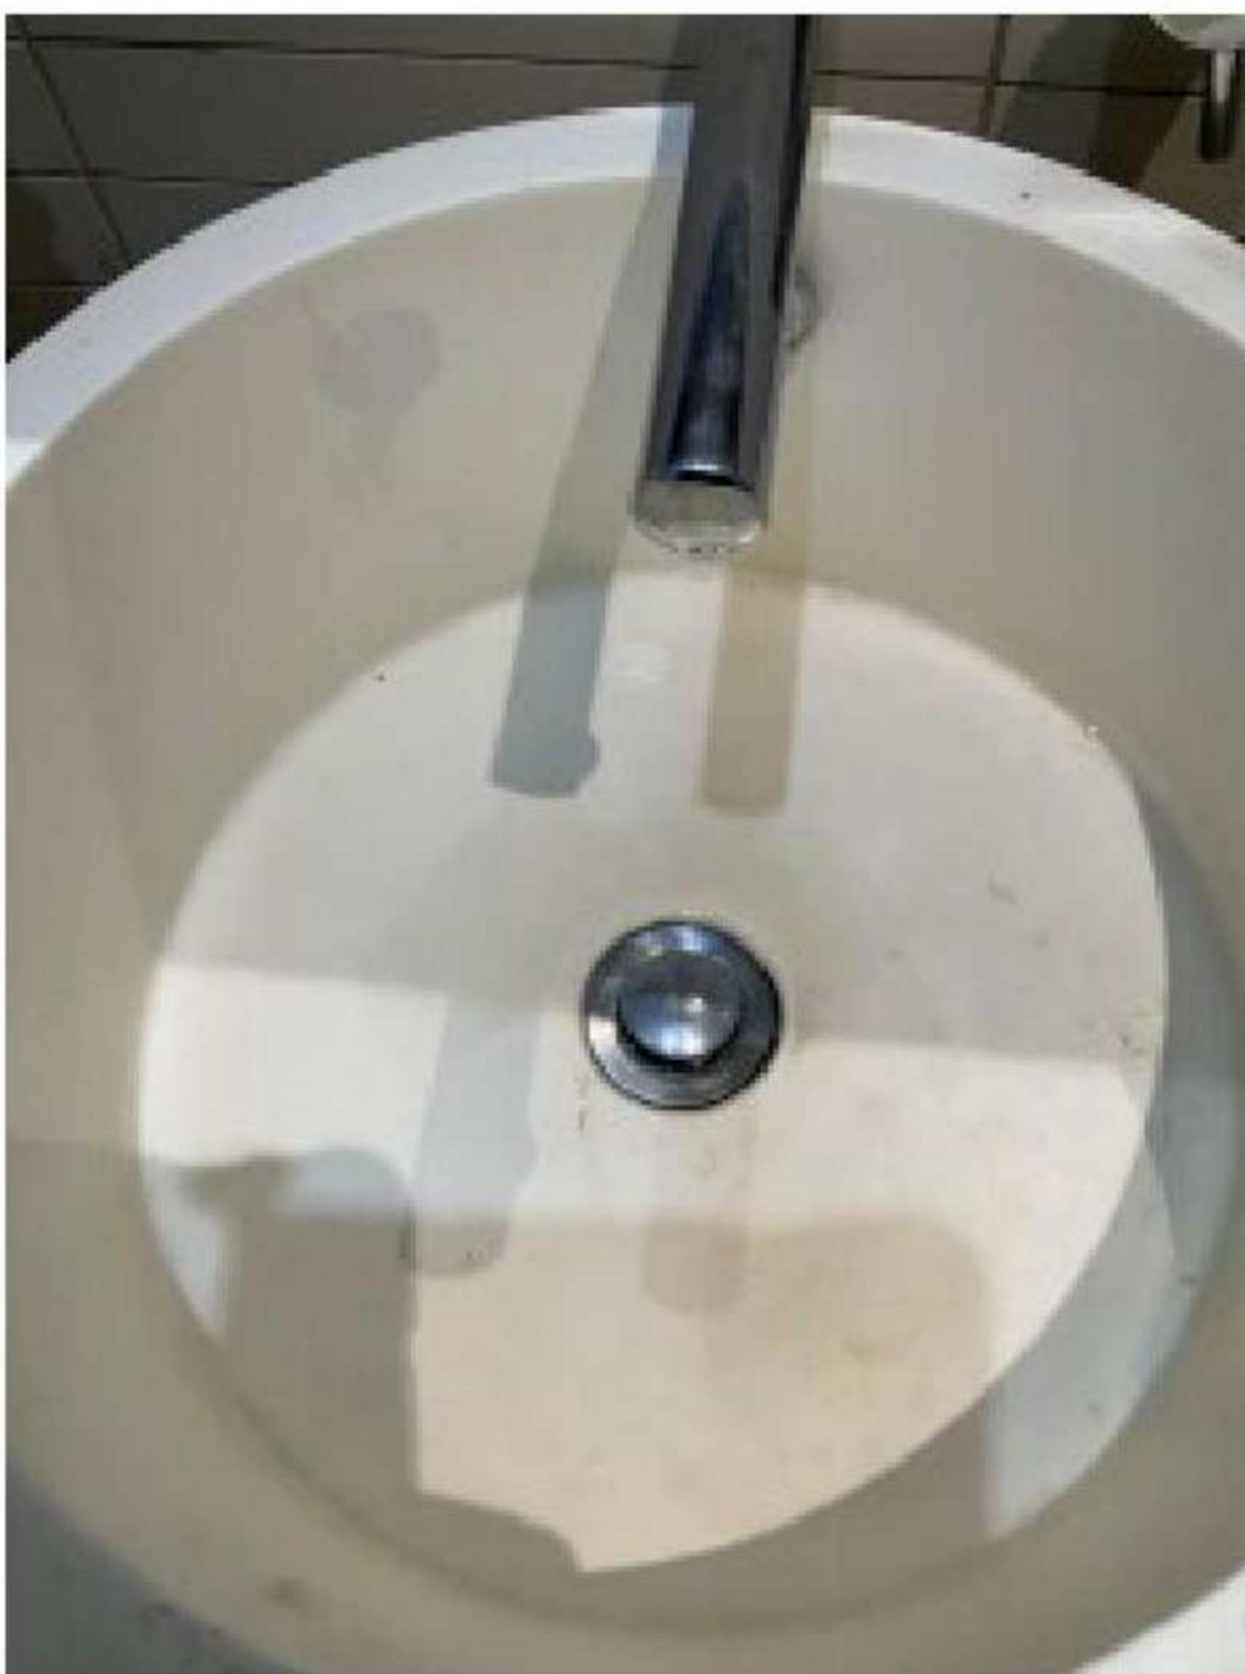
The sink basin shows signs of wear, including discoloration and surface staining. The tap is functional, but the finish is slightly worn, suggesting age and use. Regular cleaning and maintenance are advisable to prevent further deterioration, although the sink is currently operational.

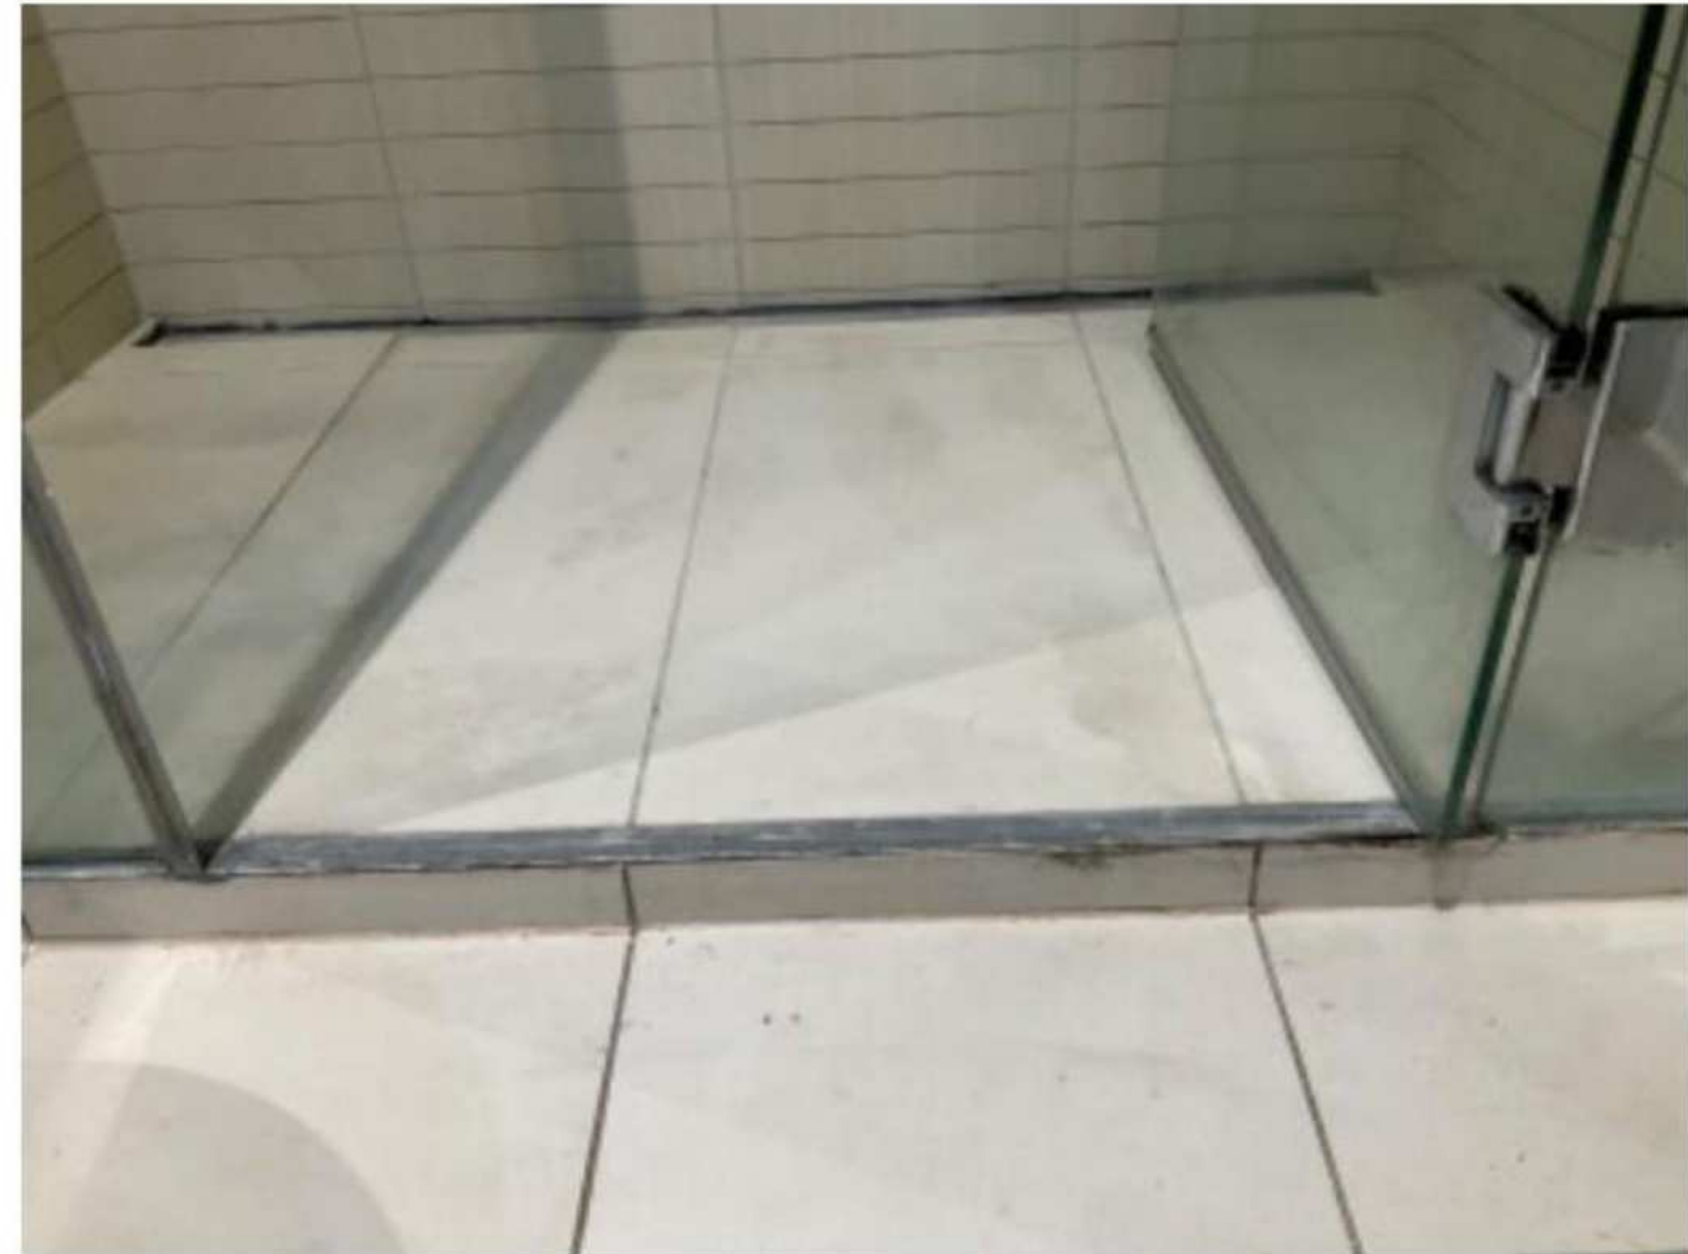
The shower area exhibits signs of moisture seepage, as evidenced by discoloured and stained tile grout, which may indicate insufficient sealing or improper drainage. The metal frame shows visible corrosion, suggesting prolonged exposure to moisture. These conditions could potentially lead to further deterioration and might require professional evaluation to prevent escalation. It is recommended to assess the sealing and ensure proper maintenance to enhance longevity and functionality.

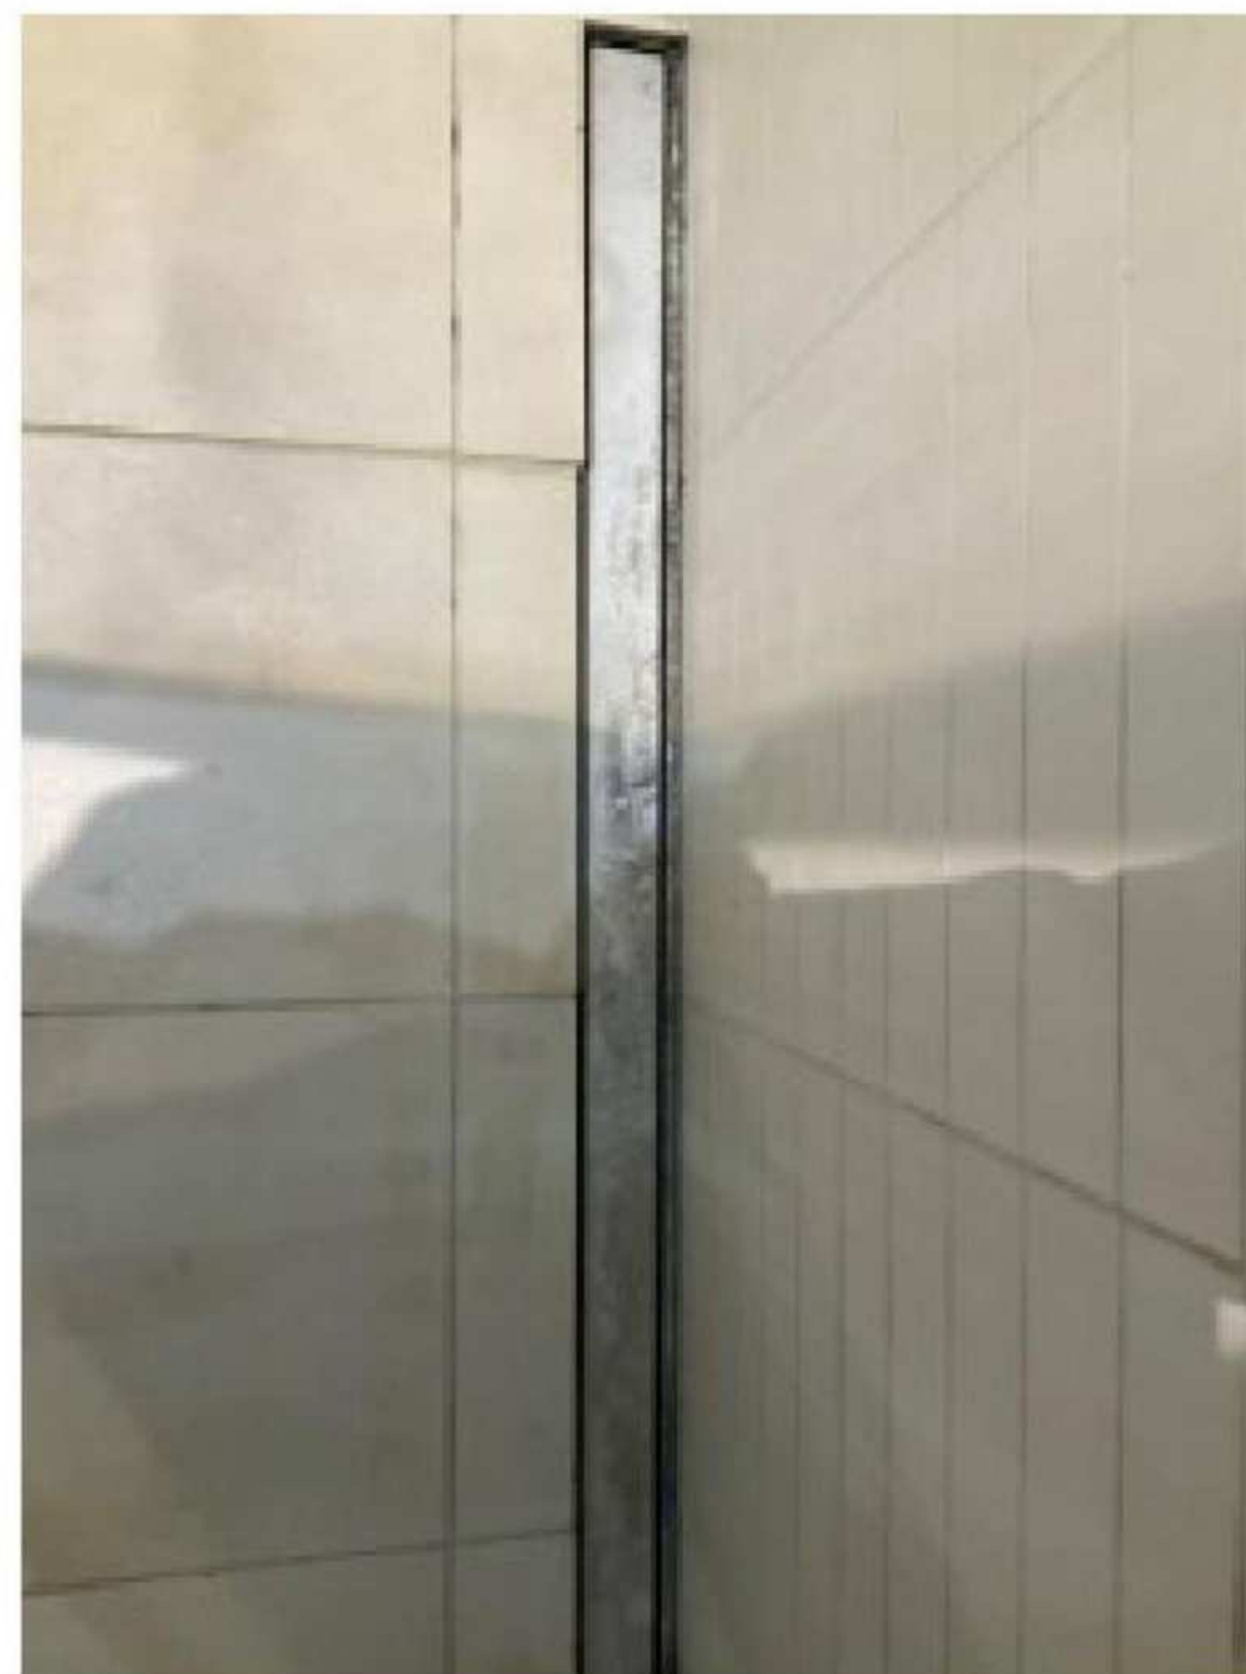
The tile grout and metal strip at the base of the wall exhibit signs of deterioration, likely due to prolonged exposure to moisture. There is visible discoloration and potential mould growth along the grout lines, suggesting insufficient sealing. The metal strip also shows signs of rust. It is advisable to clean, reseal, and possibly replace the affected materials to prevent further damage and maintain a healthy environment.

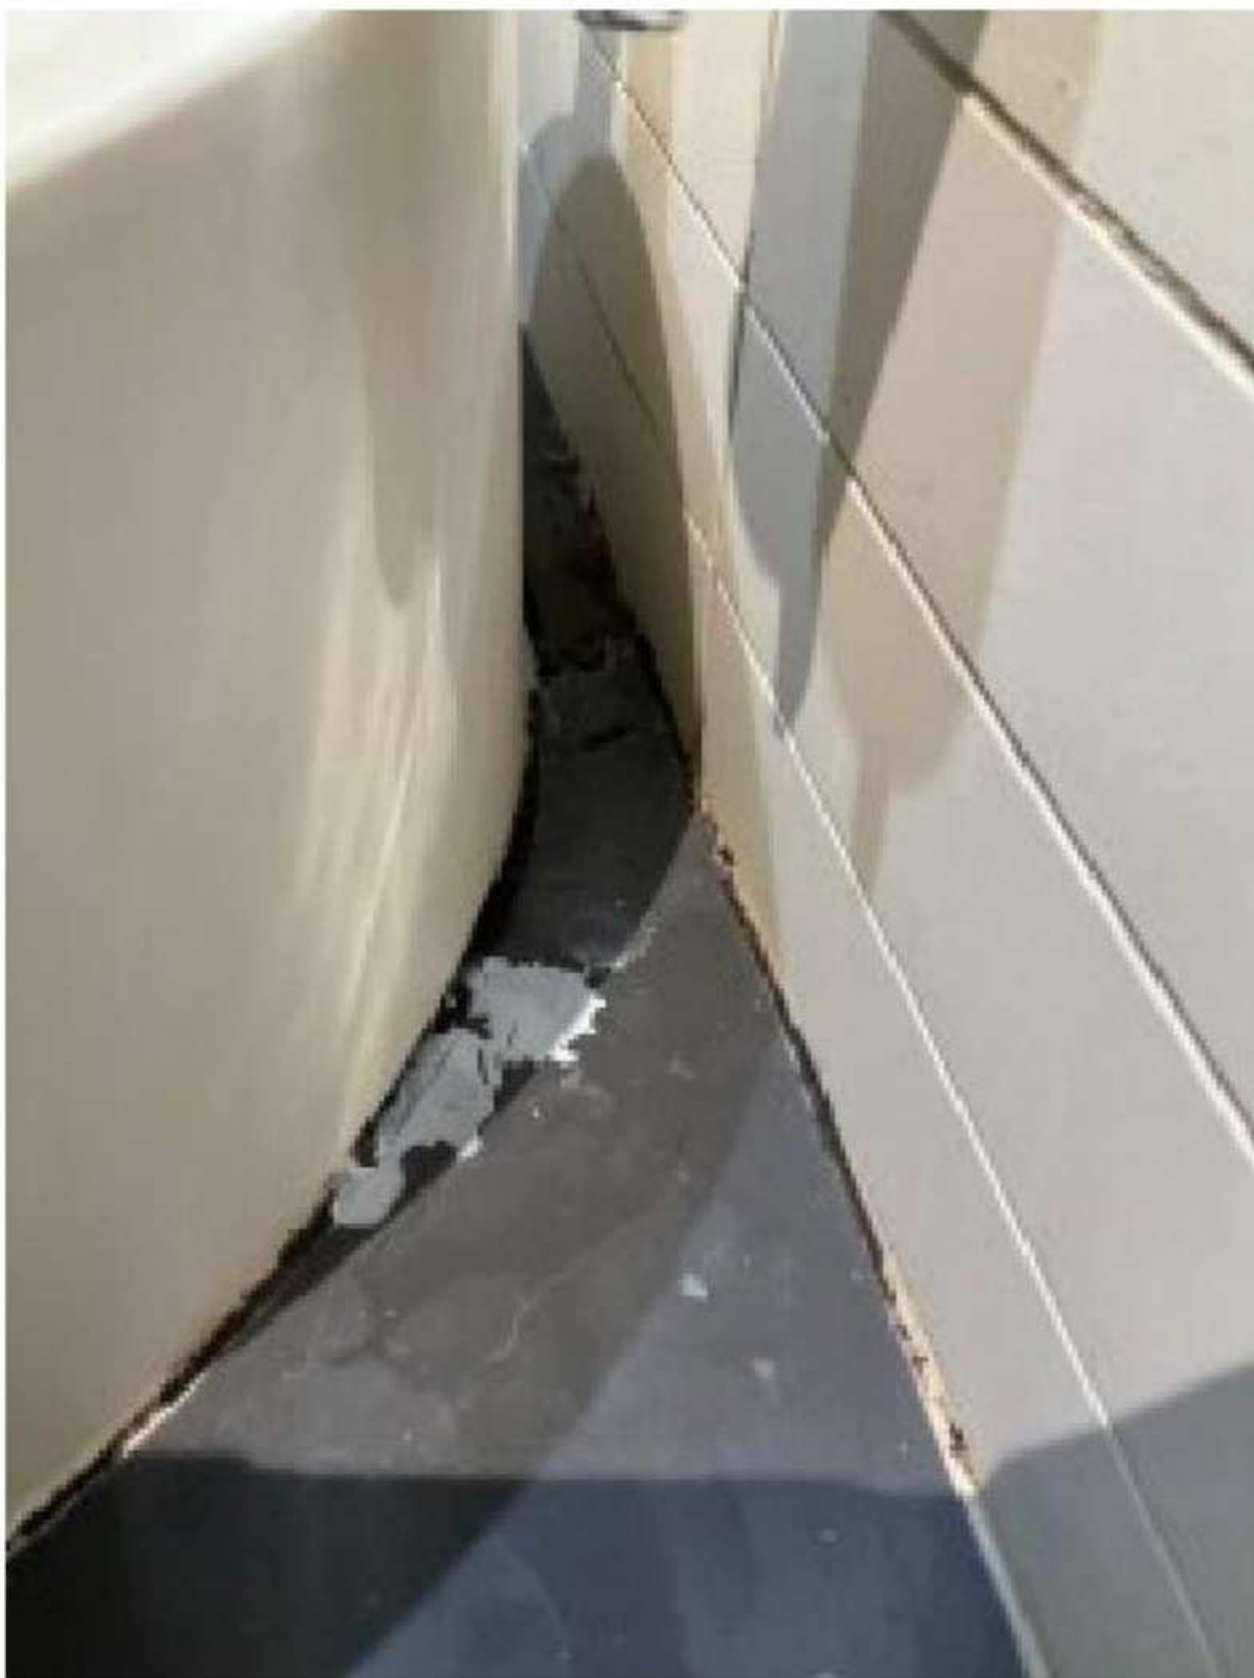
The inspection revealed evidence of mould growth along the joint between the wall tiles and the countertop . This appears to be due to inadequate sealing, which may allow moisture to penetrate and accumulate. To prevent further damage, it is recommended that the existing sealant be removed and replaced with a high-quality, waterproof sealant to inhibit moisture ingress and mould development. Regular maintenance will also be essential to ensure prolonged protection and durability of the area.
