## Just Inspections

## Building Inspection Report

AS4349.1- 2007

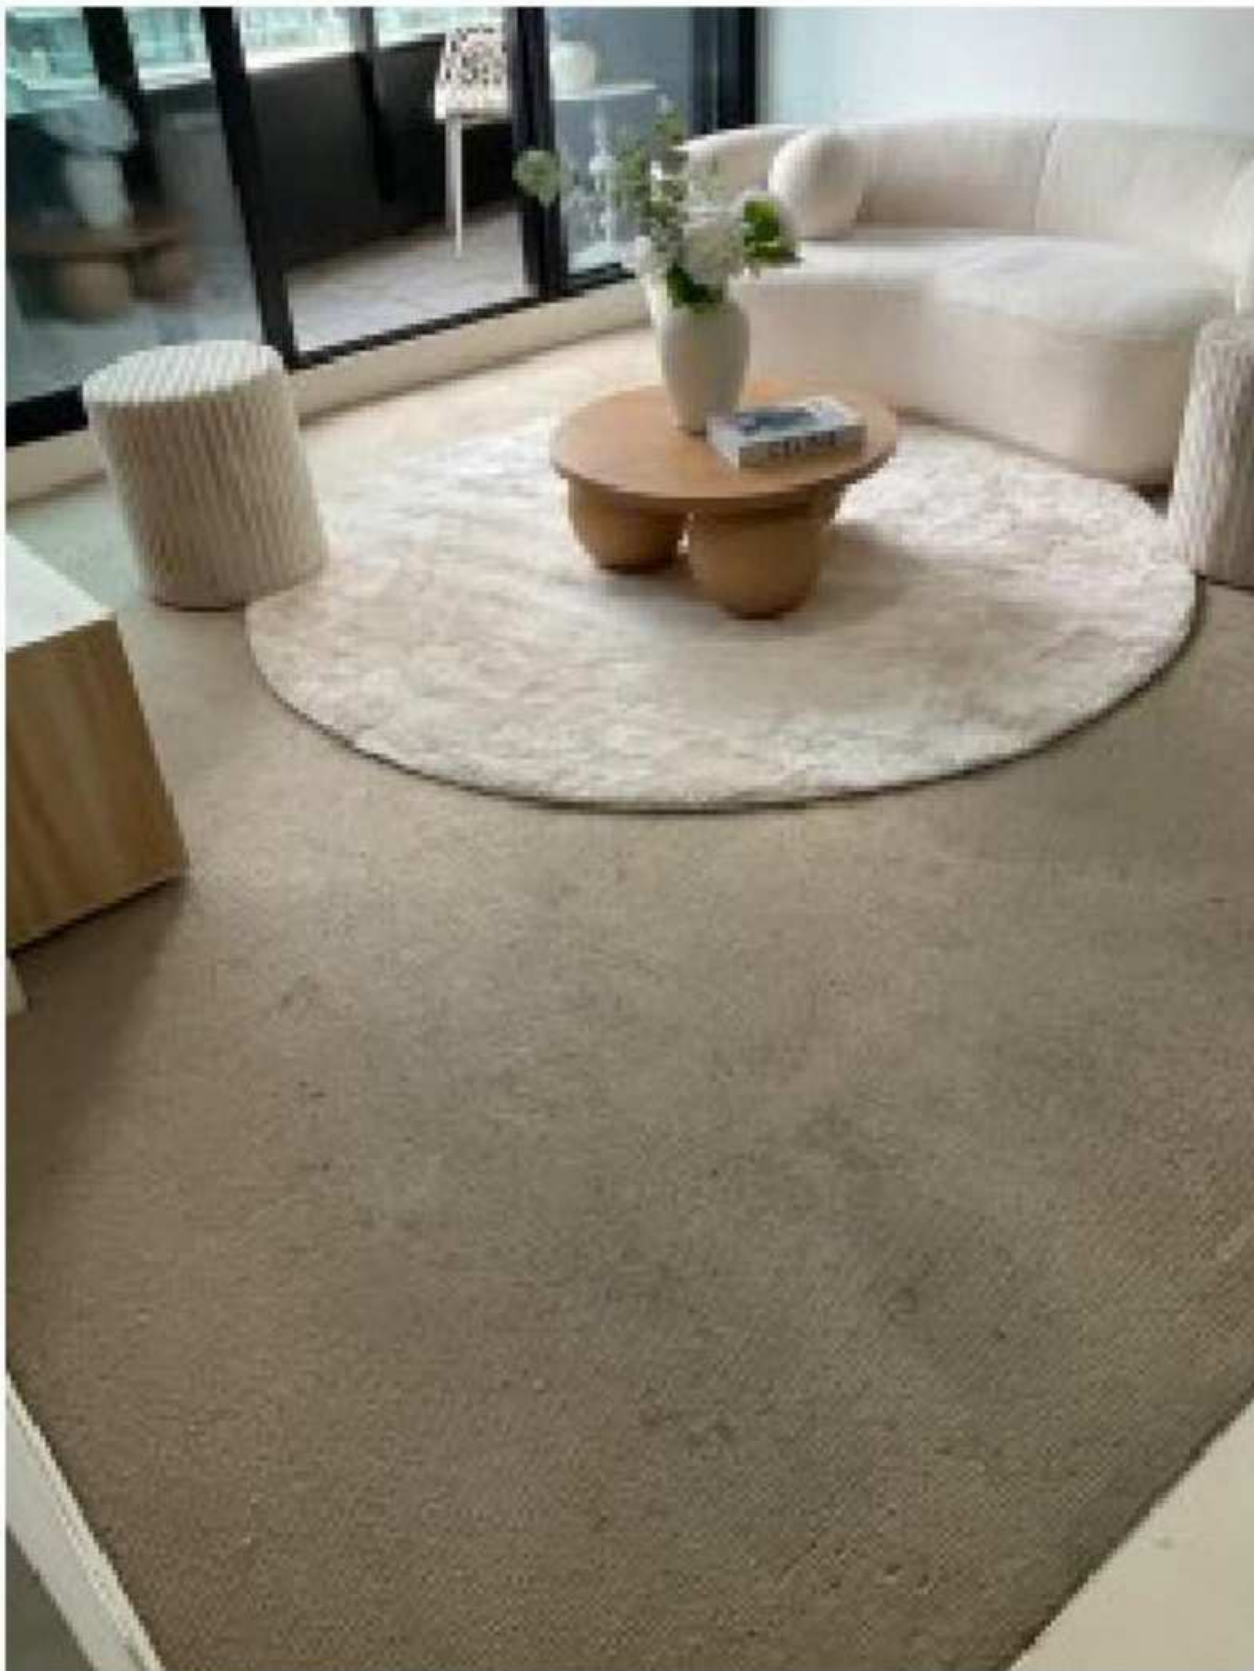
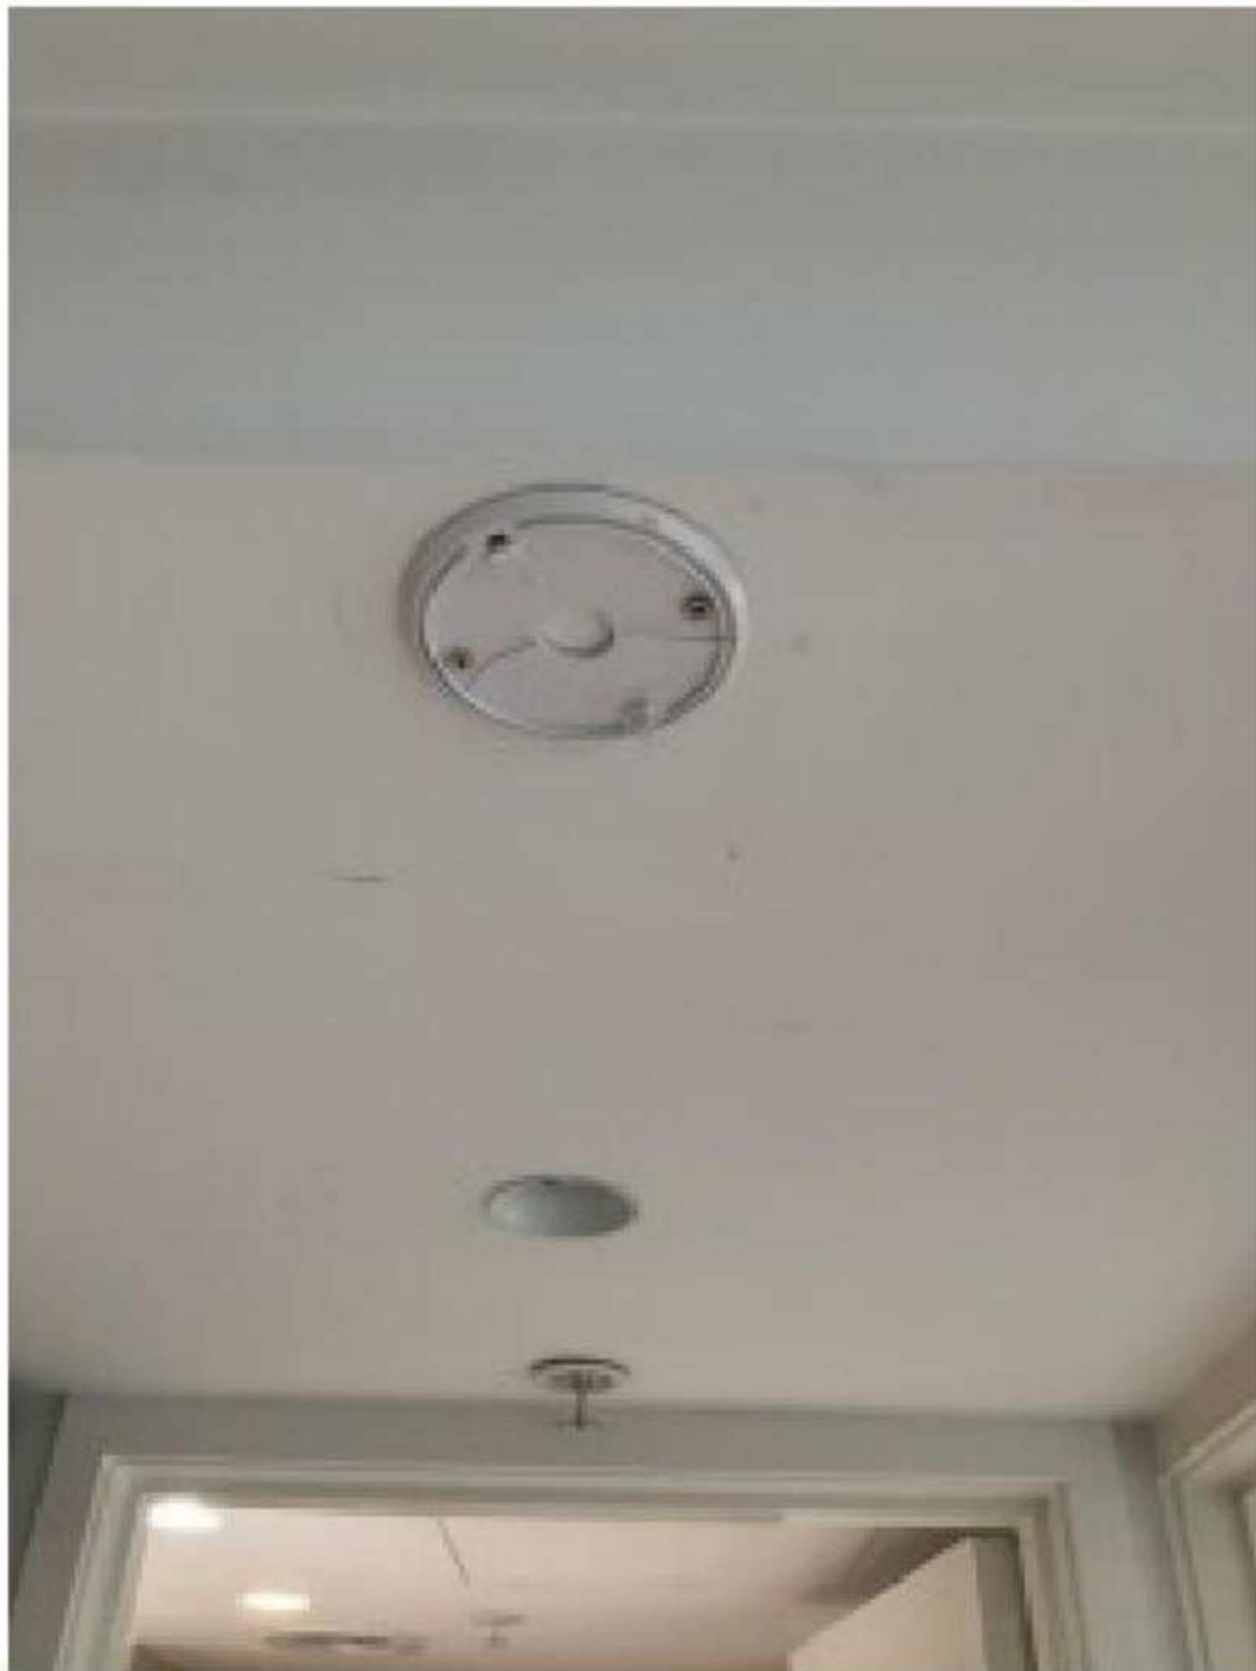
Smoke detector not in place at the time of inspection

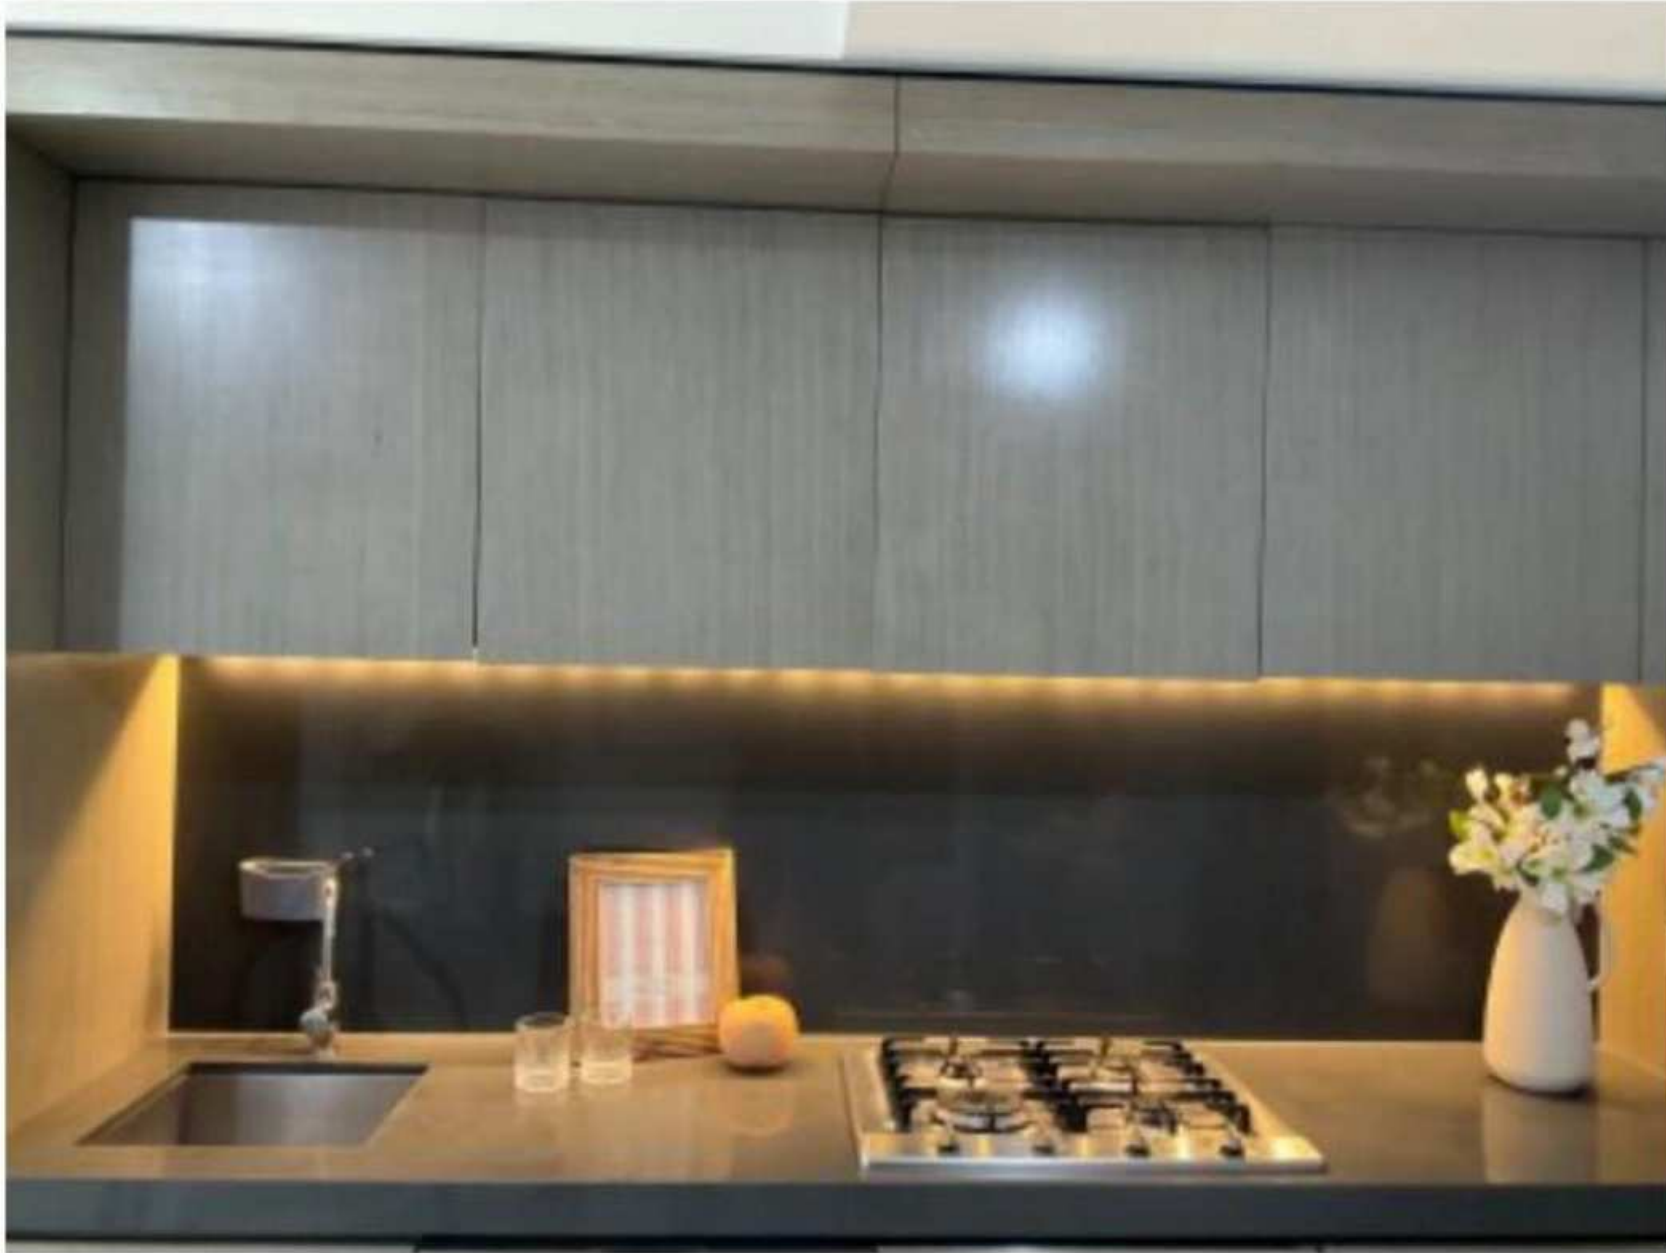
The kitchen door cabinet is misaligned. Recommended to adjust the cabinet hinges to realign the door, and replace any worn or damaged hardware if necessary.

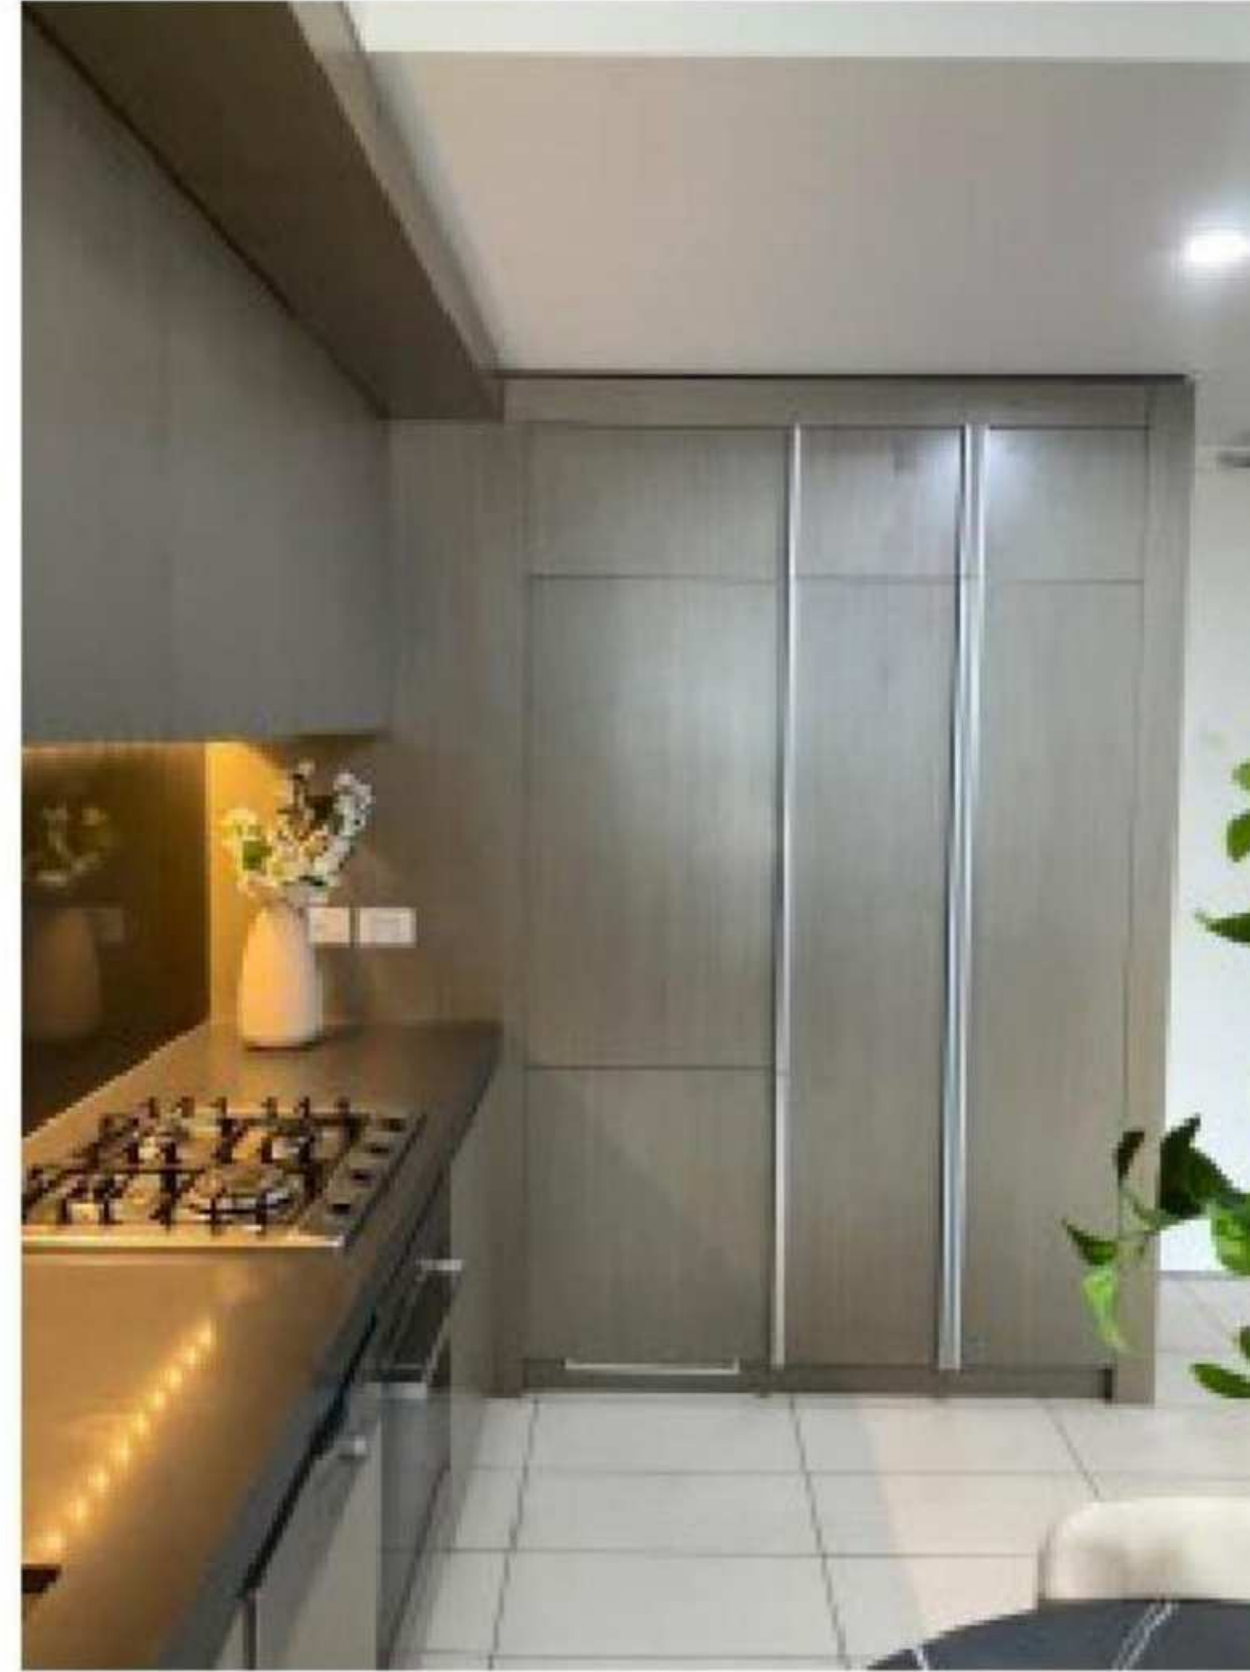
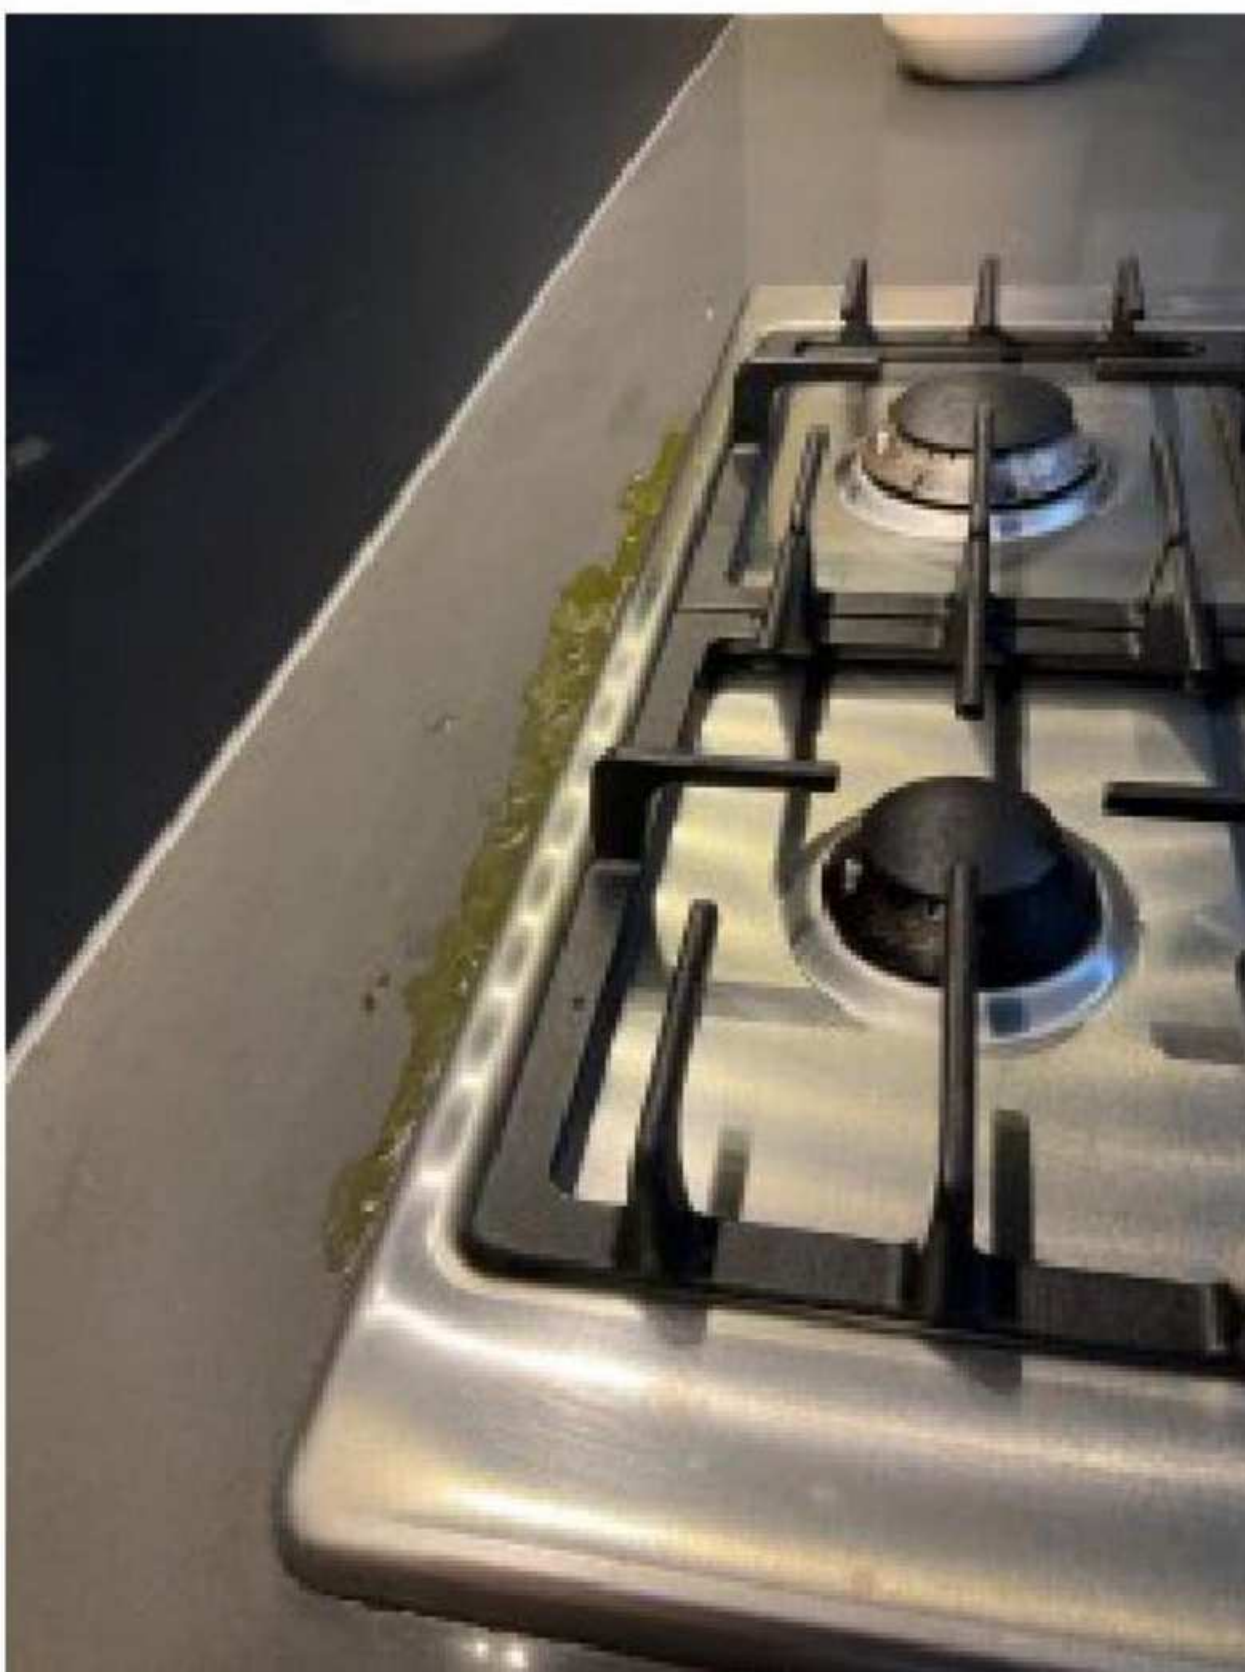
The cooktop is operational but exhibits signs of residue build-up. Regular maintenance should be considered to ensure the longevity and efficiency of the appliance.

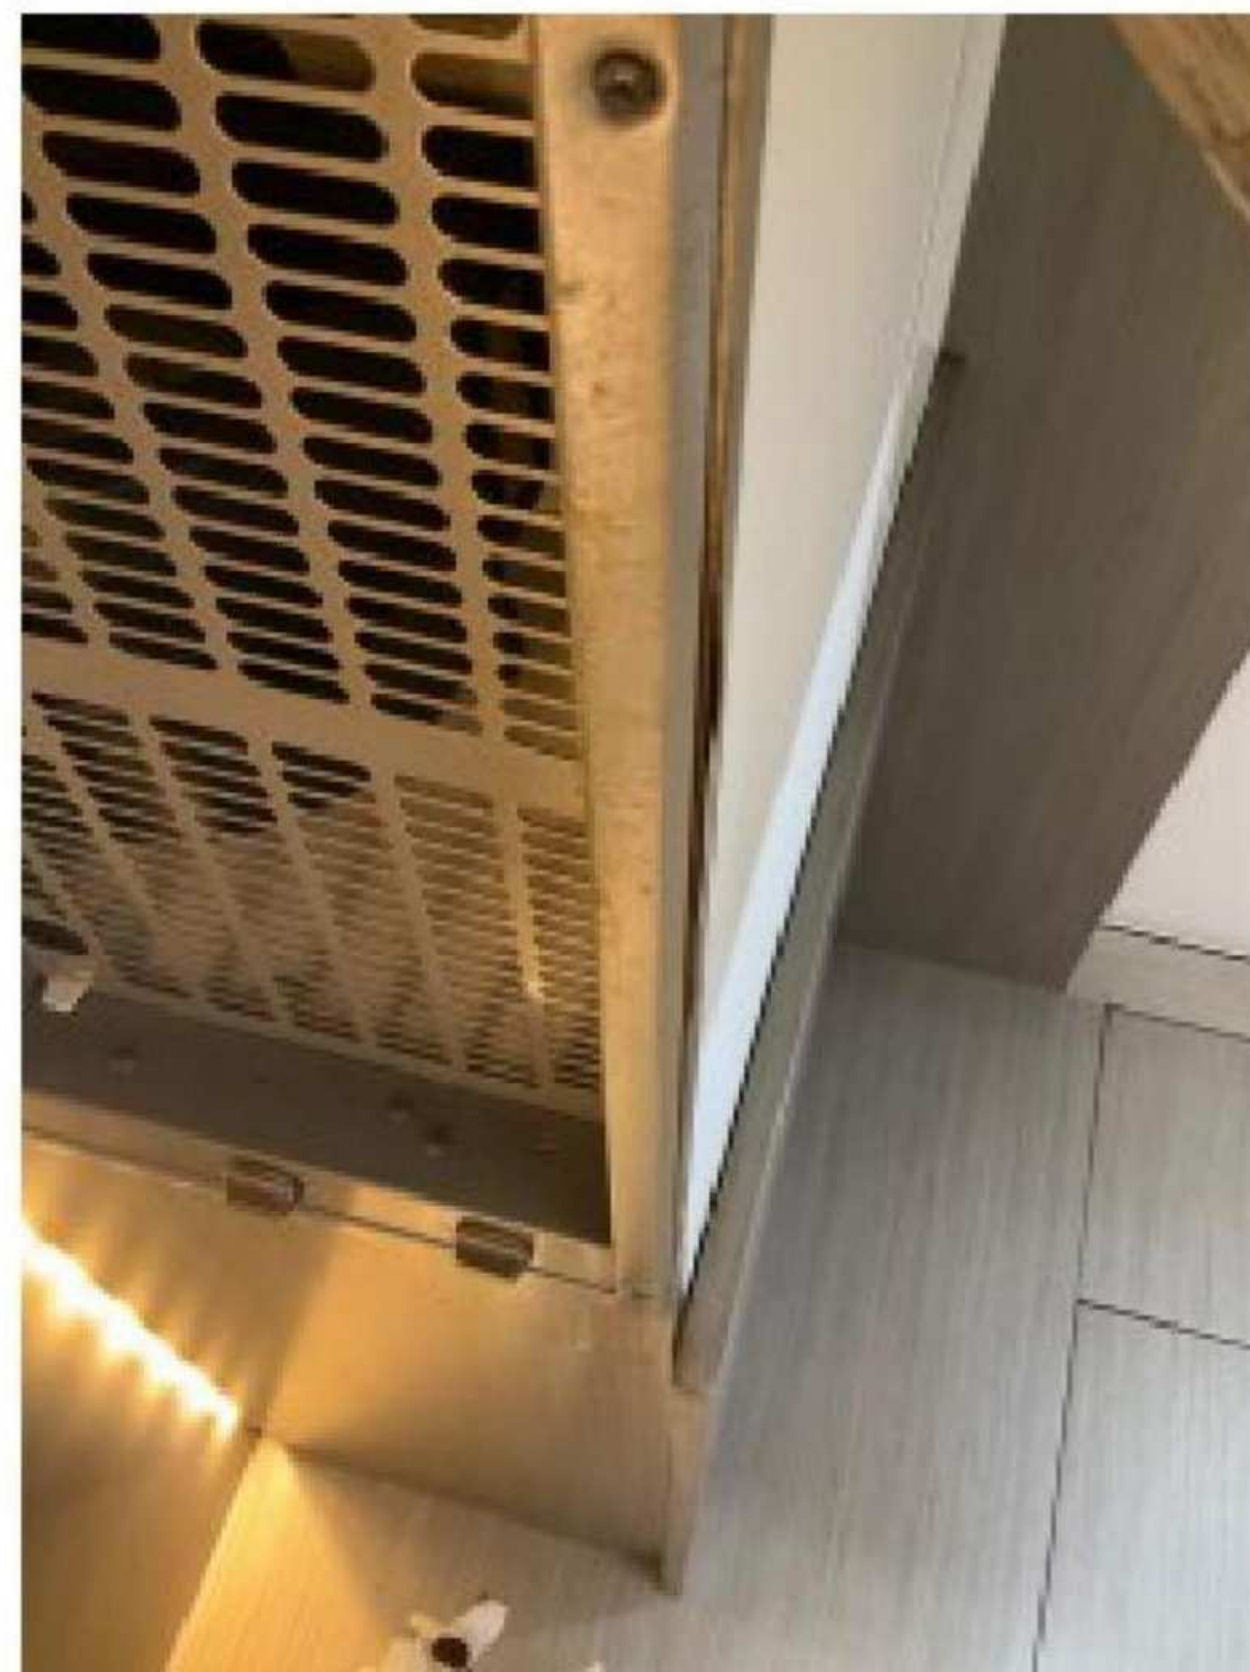
Veneer is peeling between edge of rangehood and panel of the cabinetry. Repair or replacement might be necessary to prevent further deterioration and maintain the integrity of the cabinetry and surrounding area.

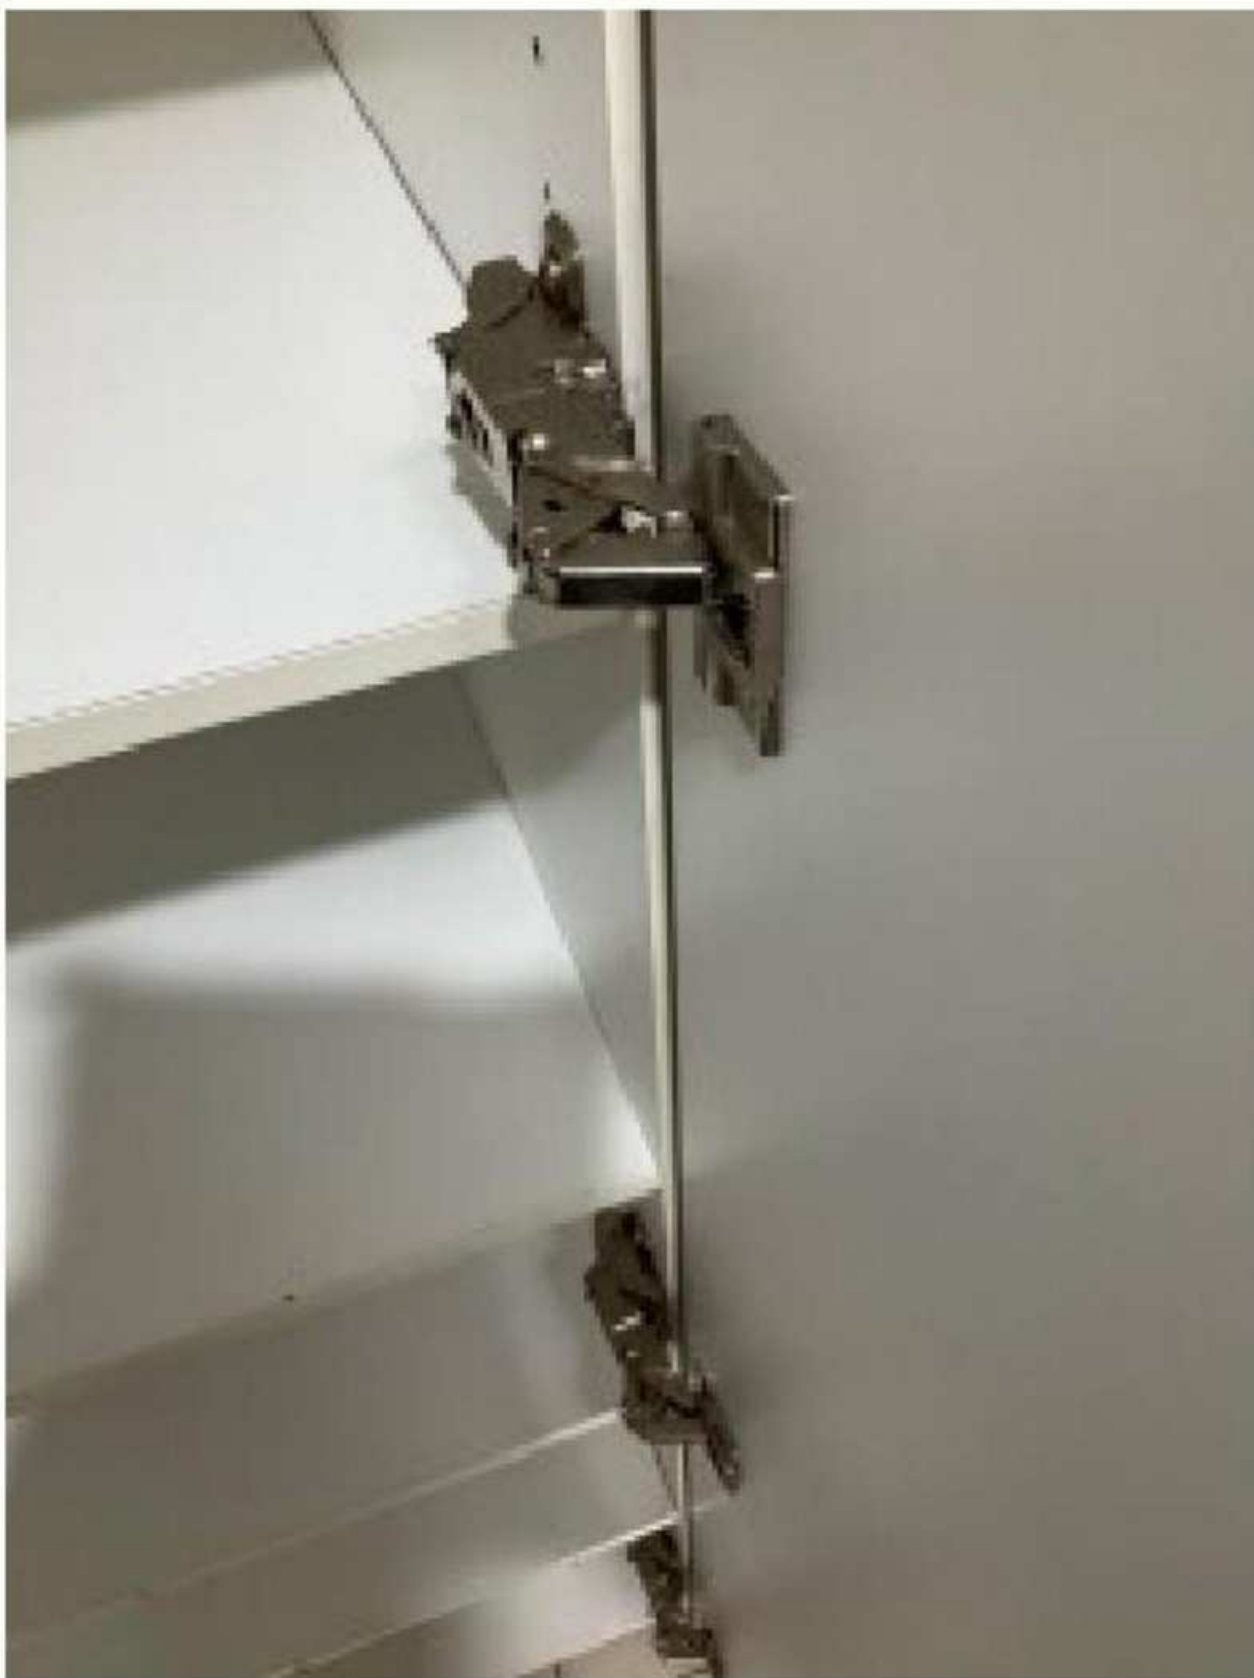
The image shows hinges with visible rust and corrosion, suggesting poor maintenance and potential exposure to moisture. The hinge's compromised condition could affect the kitchen door functionality, making it difficult to open or close smoothly. Repair or replacement is recommended to restore proper operation and prevent further deterioration.

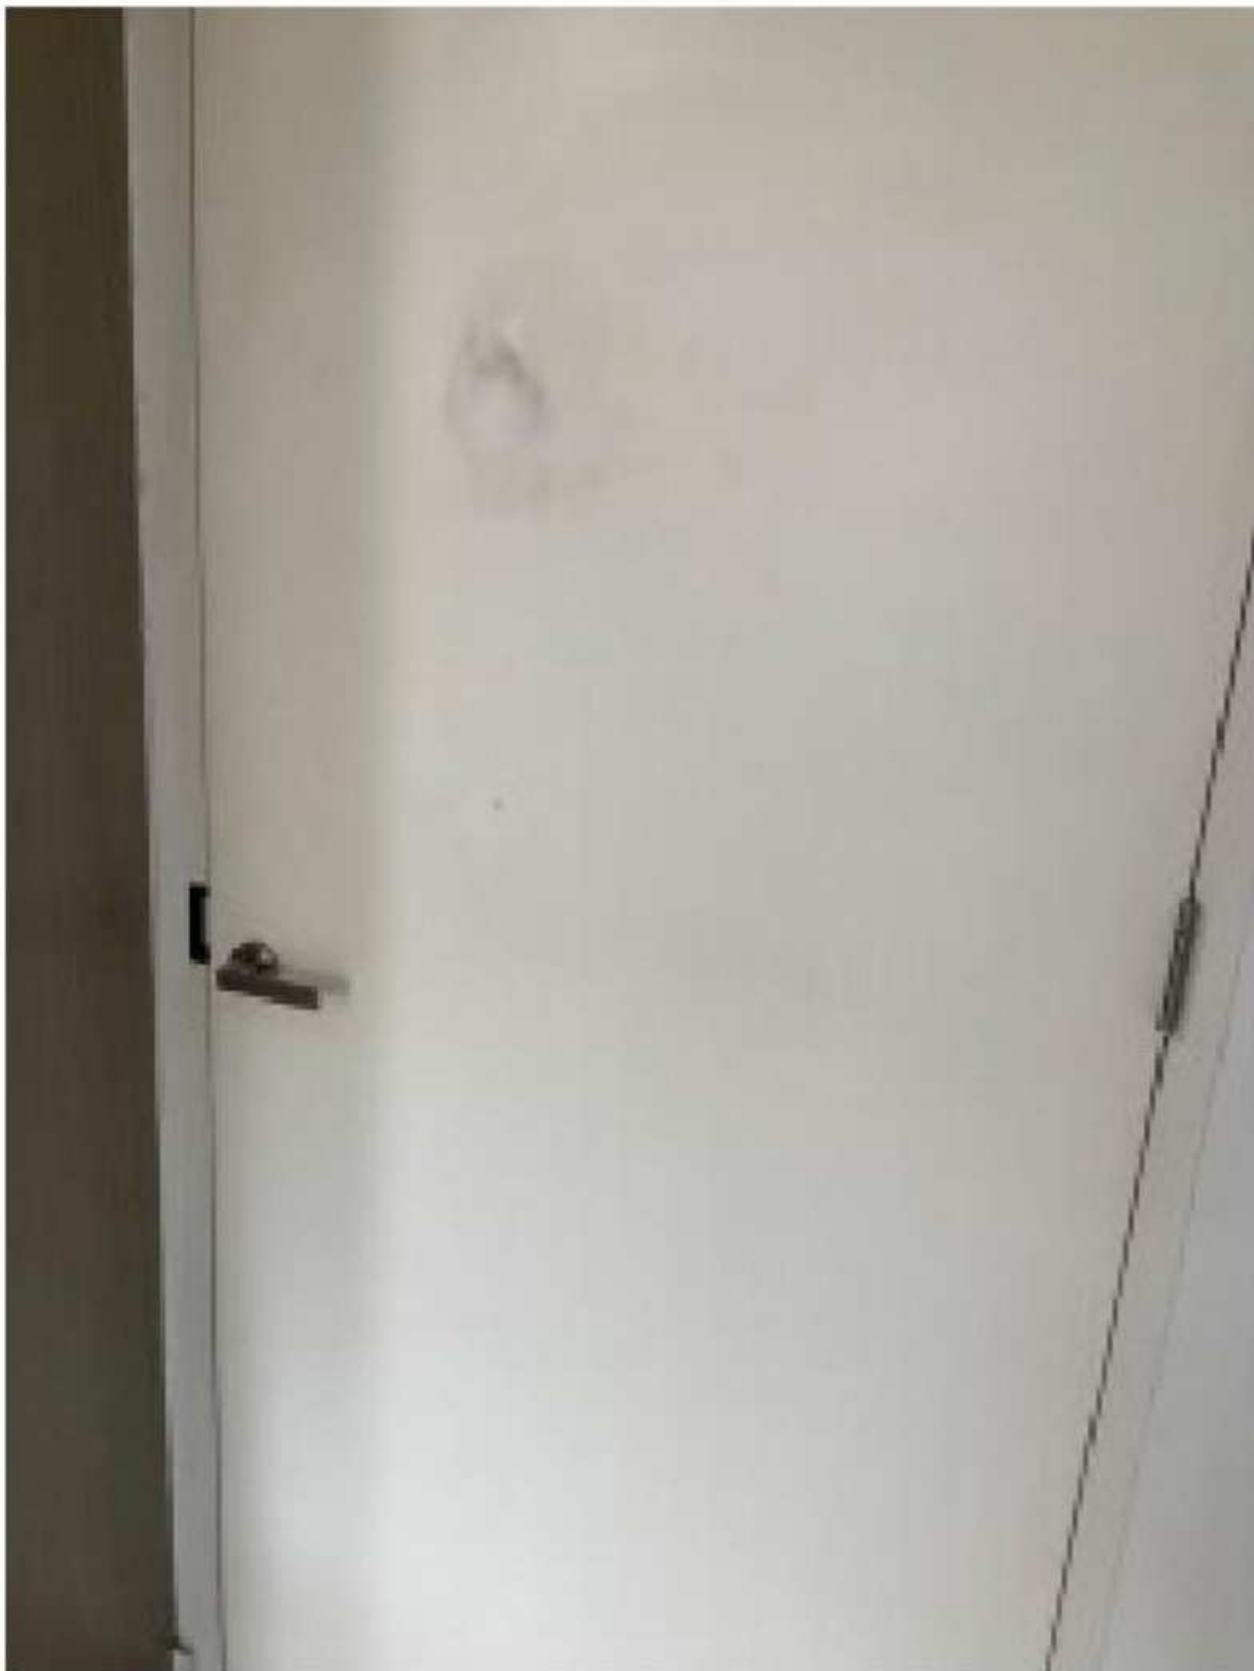
The inspected property shows a patch on the interior wall where the paint surface is uneven and appears to have undergone some repair work. The affected area may require additional smoothing and repainting to achieve a consistent finish with the surrounding wall. There is no immediate structural concern; however, addressing this cosmetic issue will improve the overall appearance.

The image shows visible wear and chipping on the door frame, which may indicate inadequate maintenance or general wear over time. This could potentially lead to further deterioration if not addressed. It is recommended to evaluate the need for repairs or repainting to prevent further damage and maintain the aesthetic appeal and functionality of the door. Regular maintenance will ensure the longevity of the fixture and preserve the overall quality of the property.

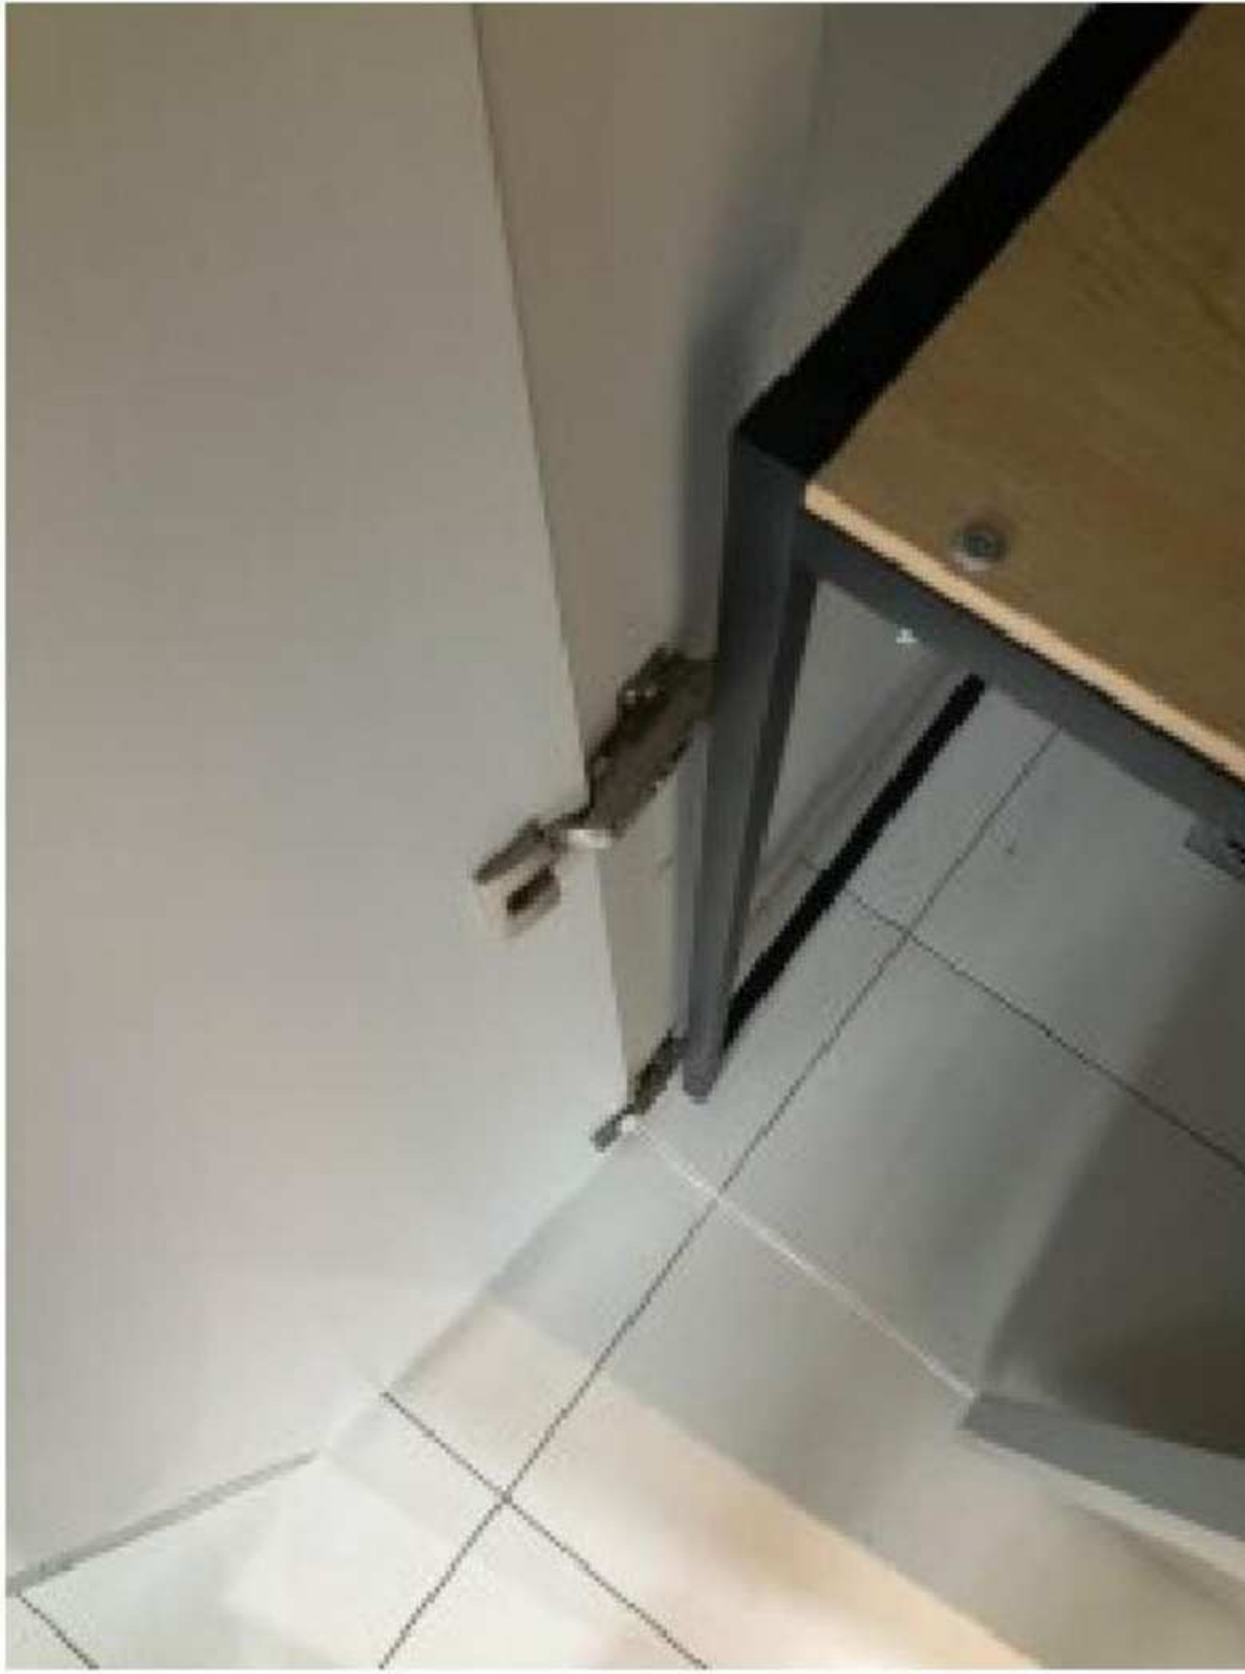
The image shows corrosion and rust on the metal hinge, which may impact the functionality and stability of the door or fixture it supports. The presence of rust suggests exposure to moisture and could potentially lead to further deterioration if not addressed. It is recommended to repair or replace the hardware.

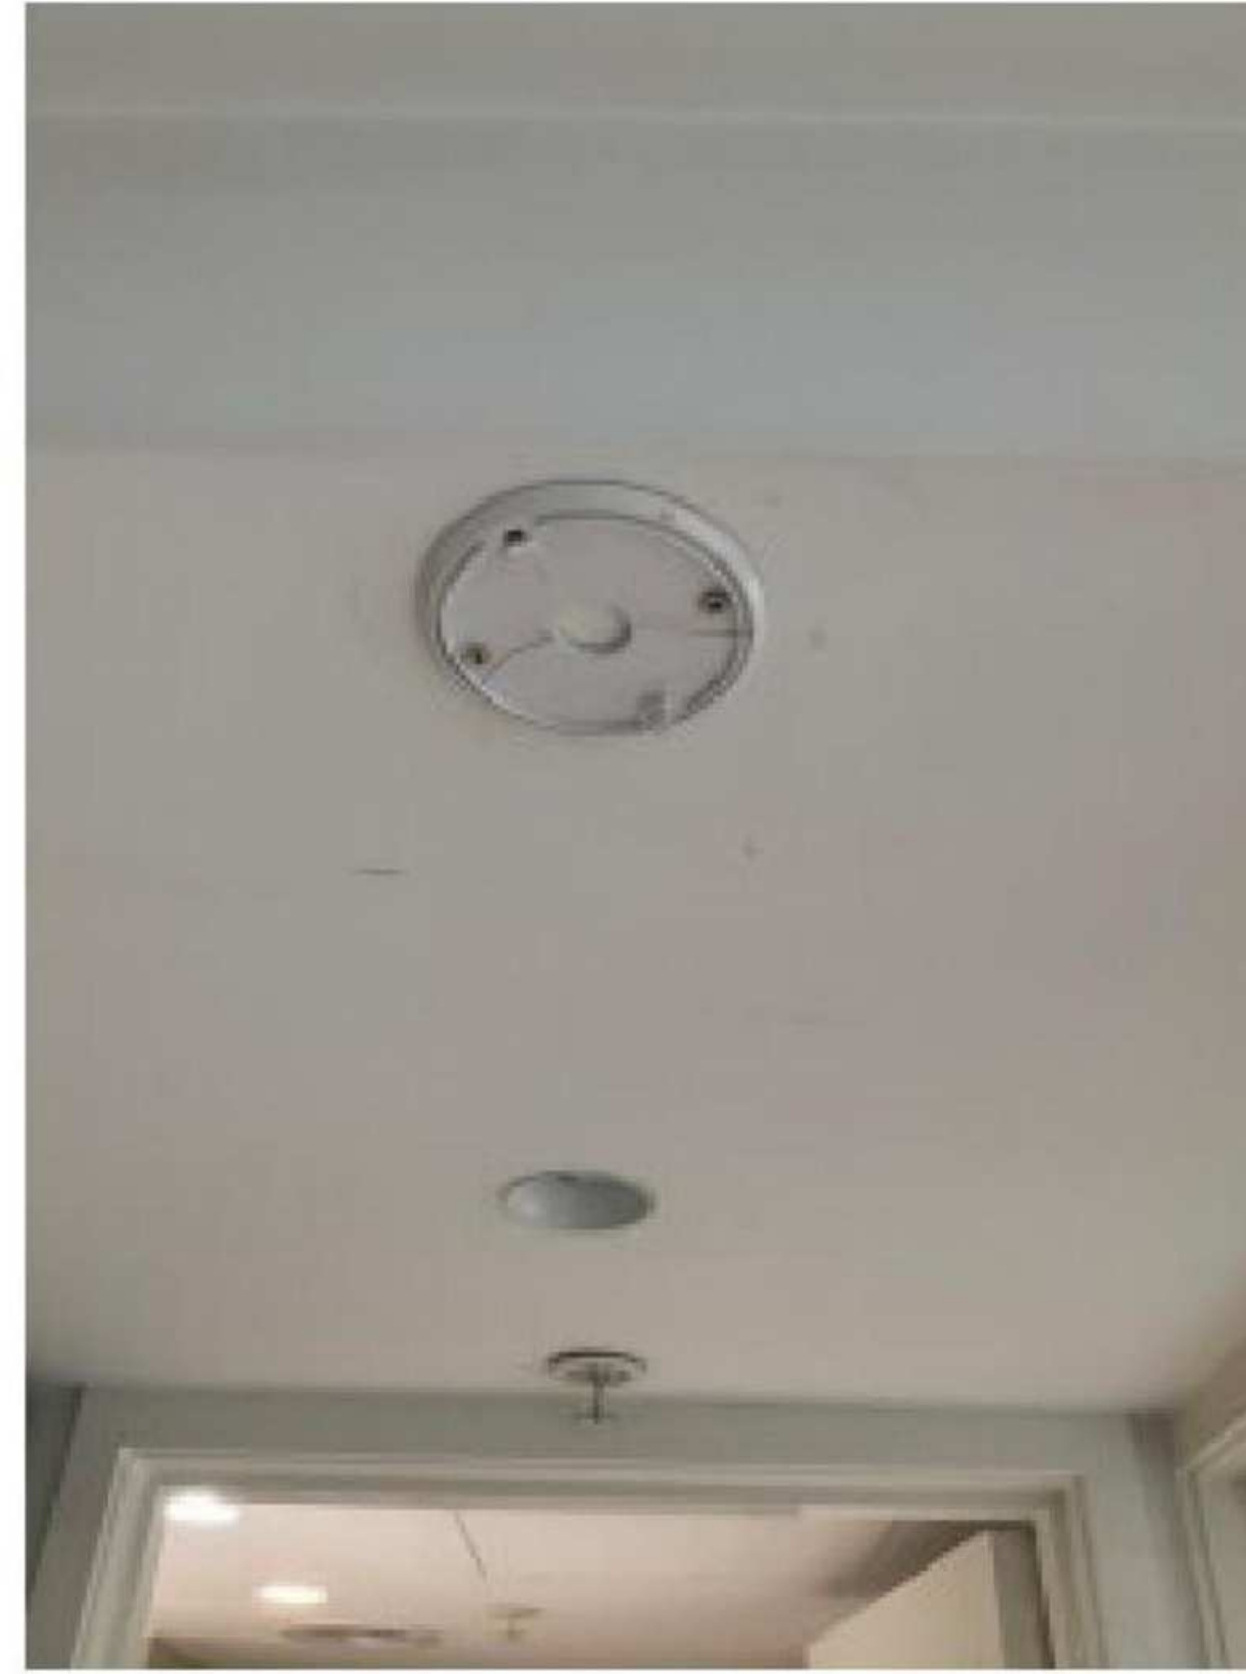
Smoke detector not in place at the time of inspection
