## Just Inspections

## Building Inspection Report

AS4349.1- 2007

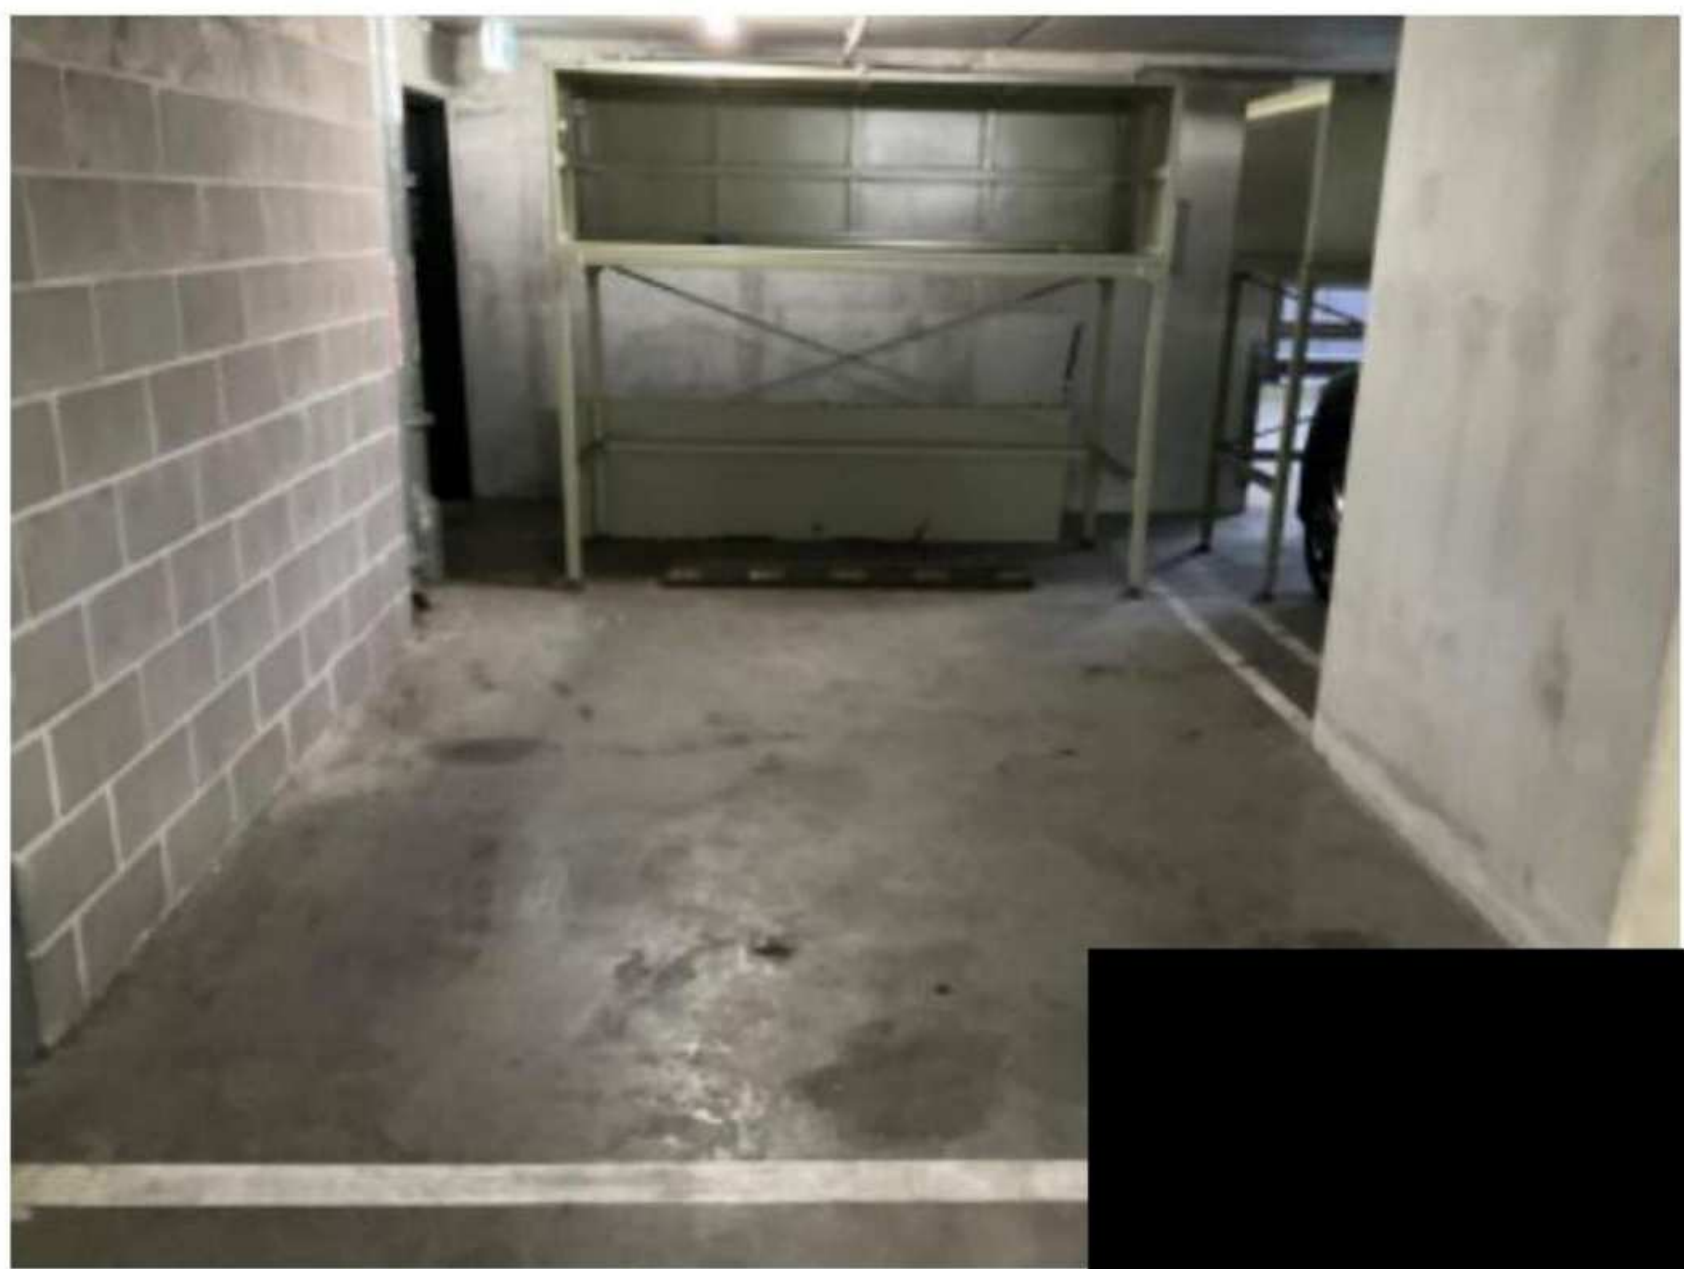
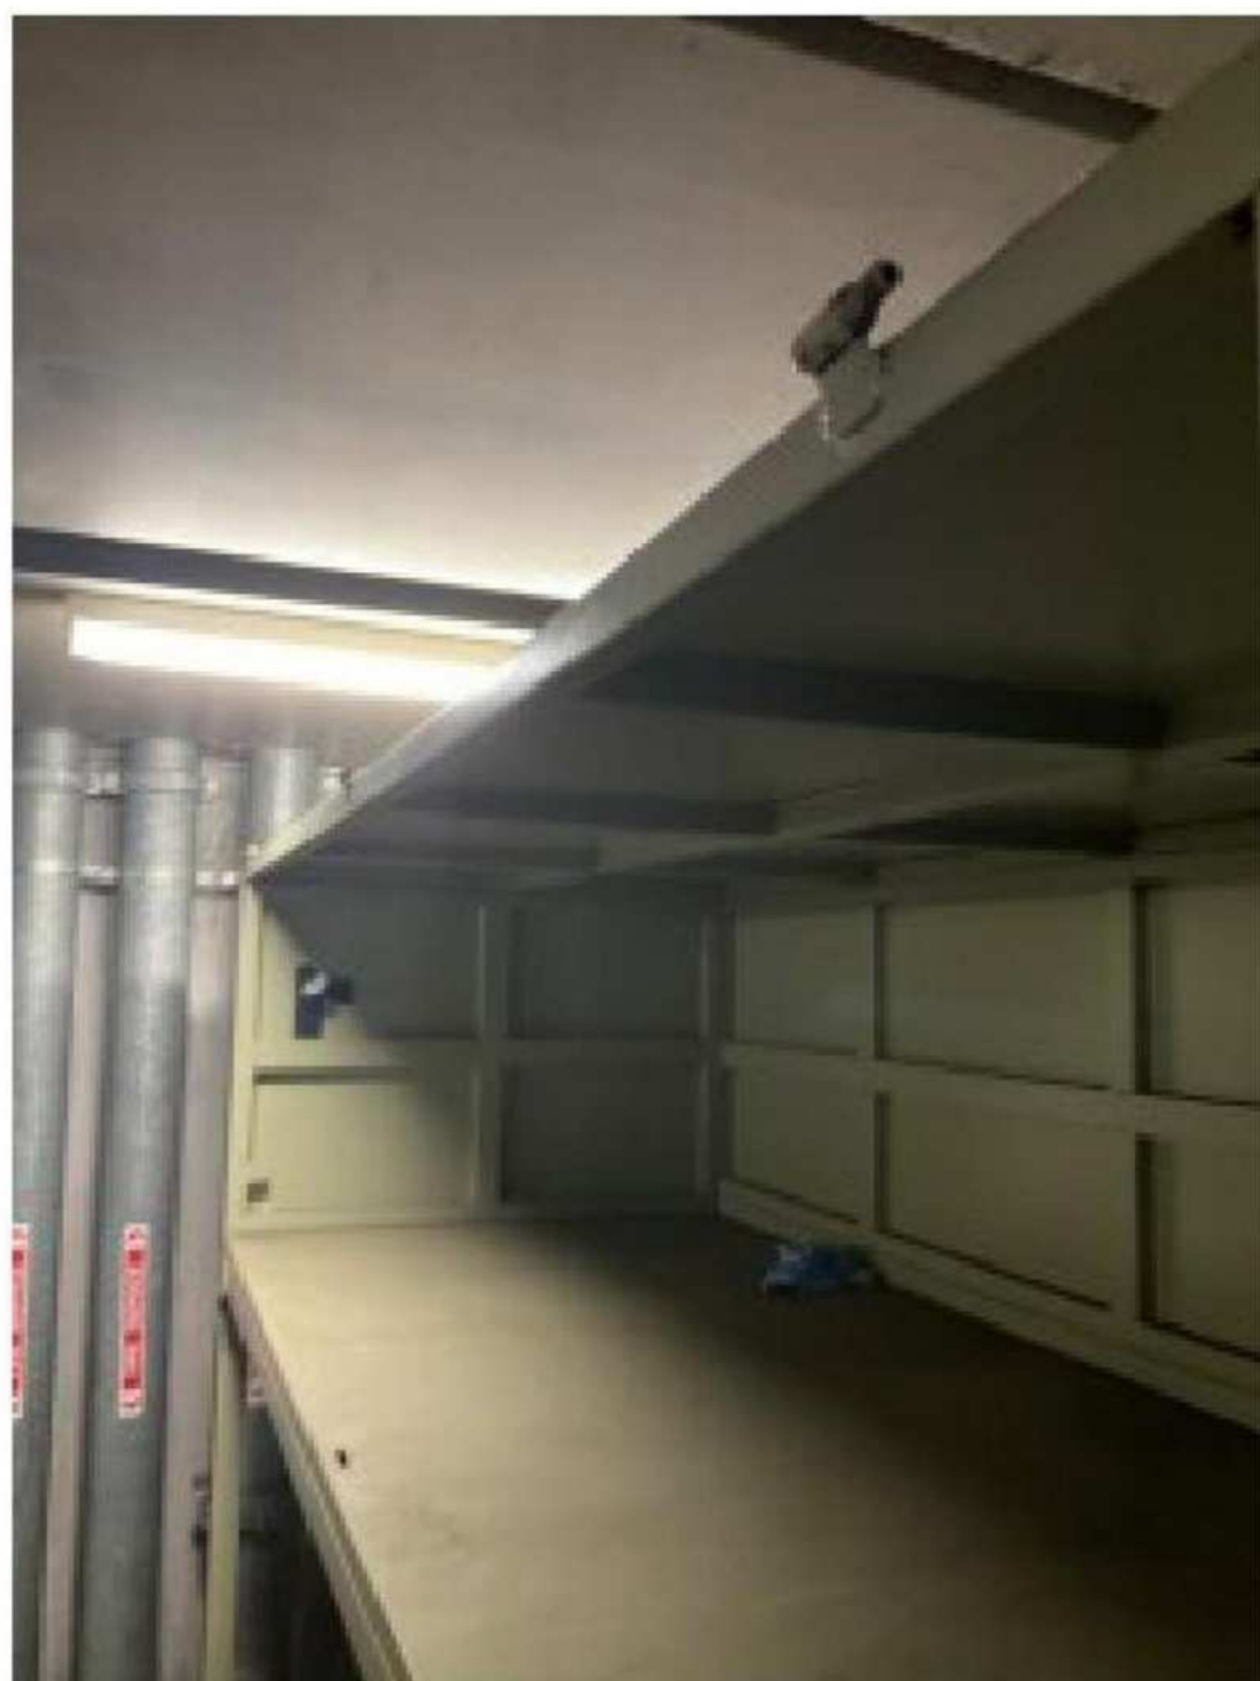
The storage room door in the car park is detached from its hinges. Recommended to repair the components and reattach and ensure it operates correctly and locks securely.
