## Just Inspections

## Building/Property & Timber Pest Inspection

**AS4349.1-2007 & AS4349.3-2010**

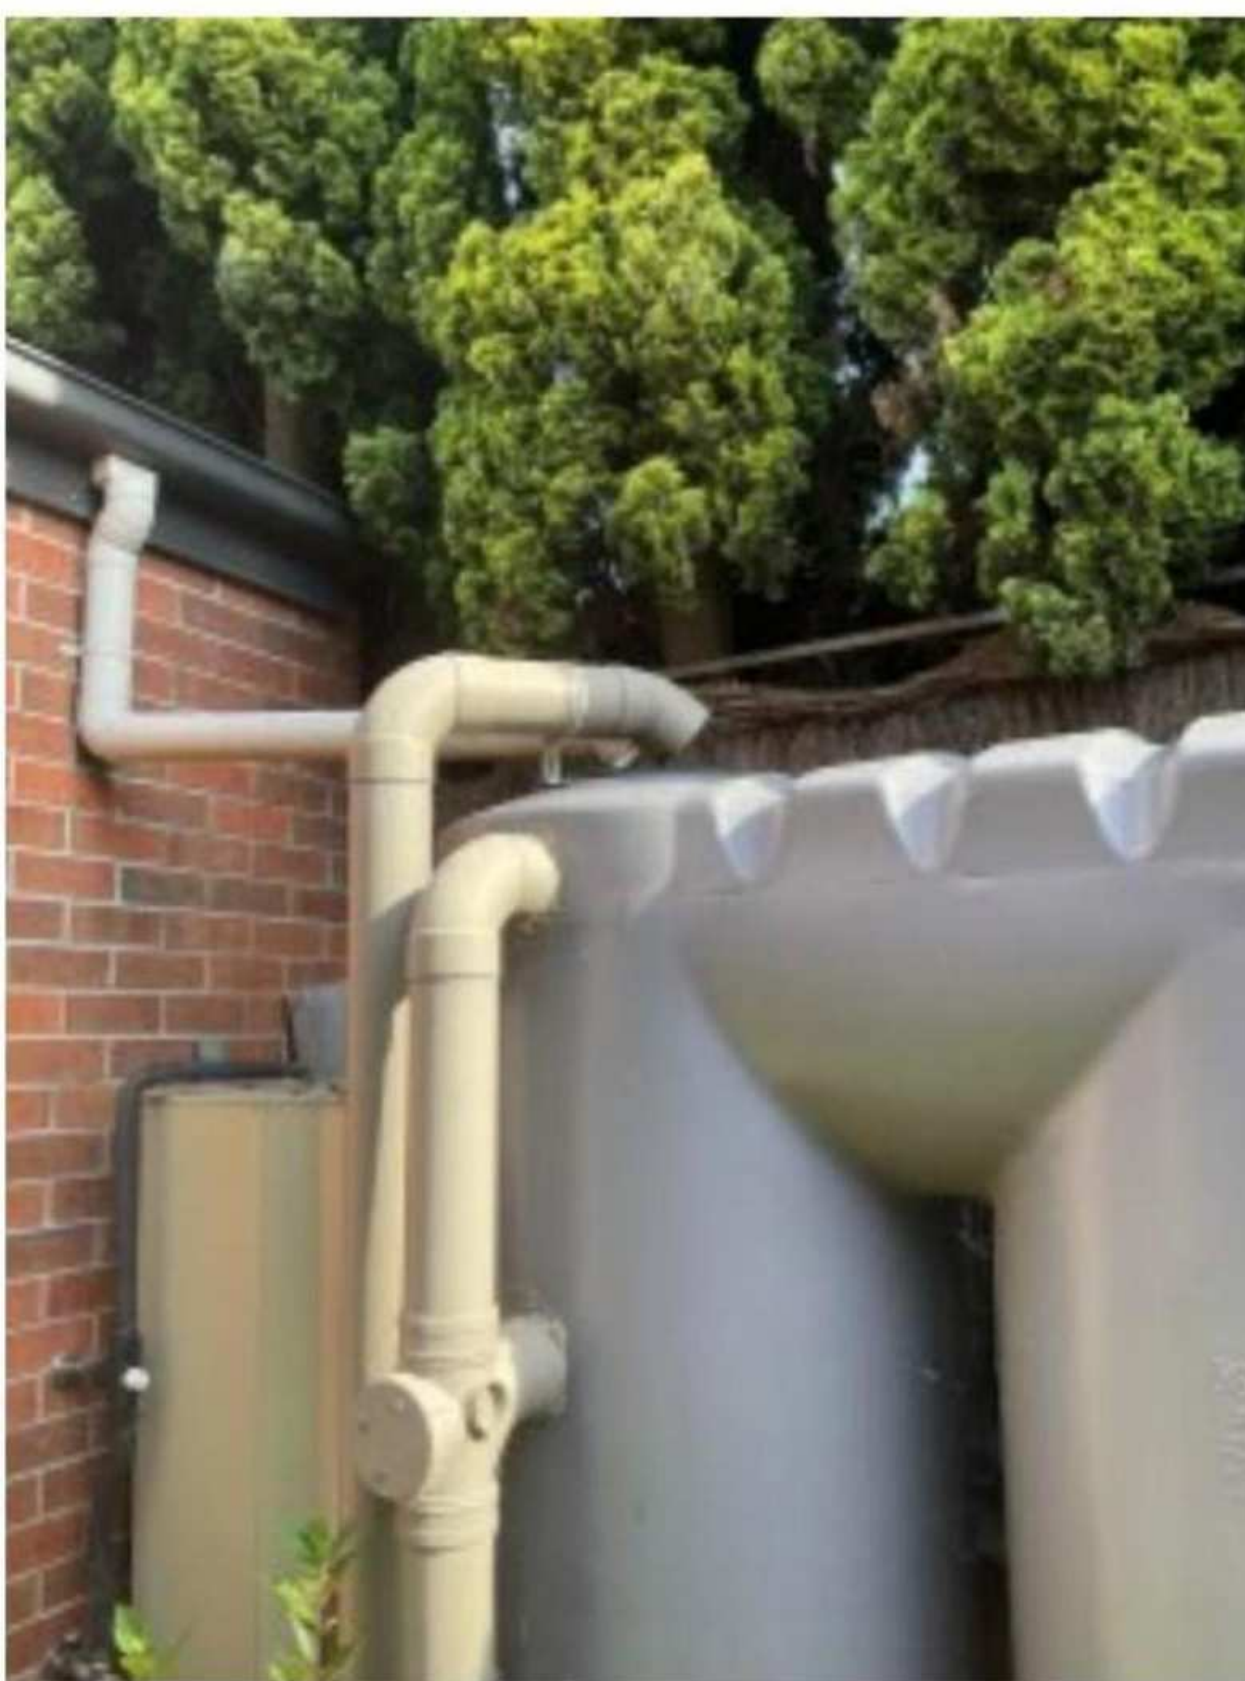
Down pipe connection not connecting directly to the water tank potentially leading to issues with water flow and leaks. It is recommended to assess and rectify by qualified plumber.

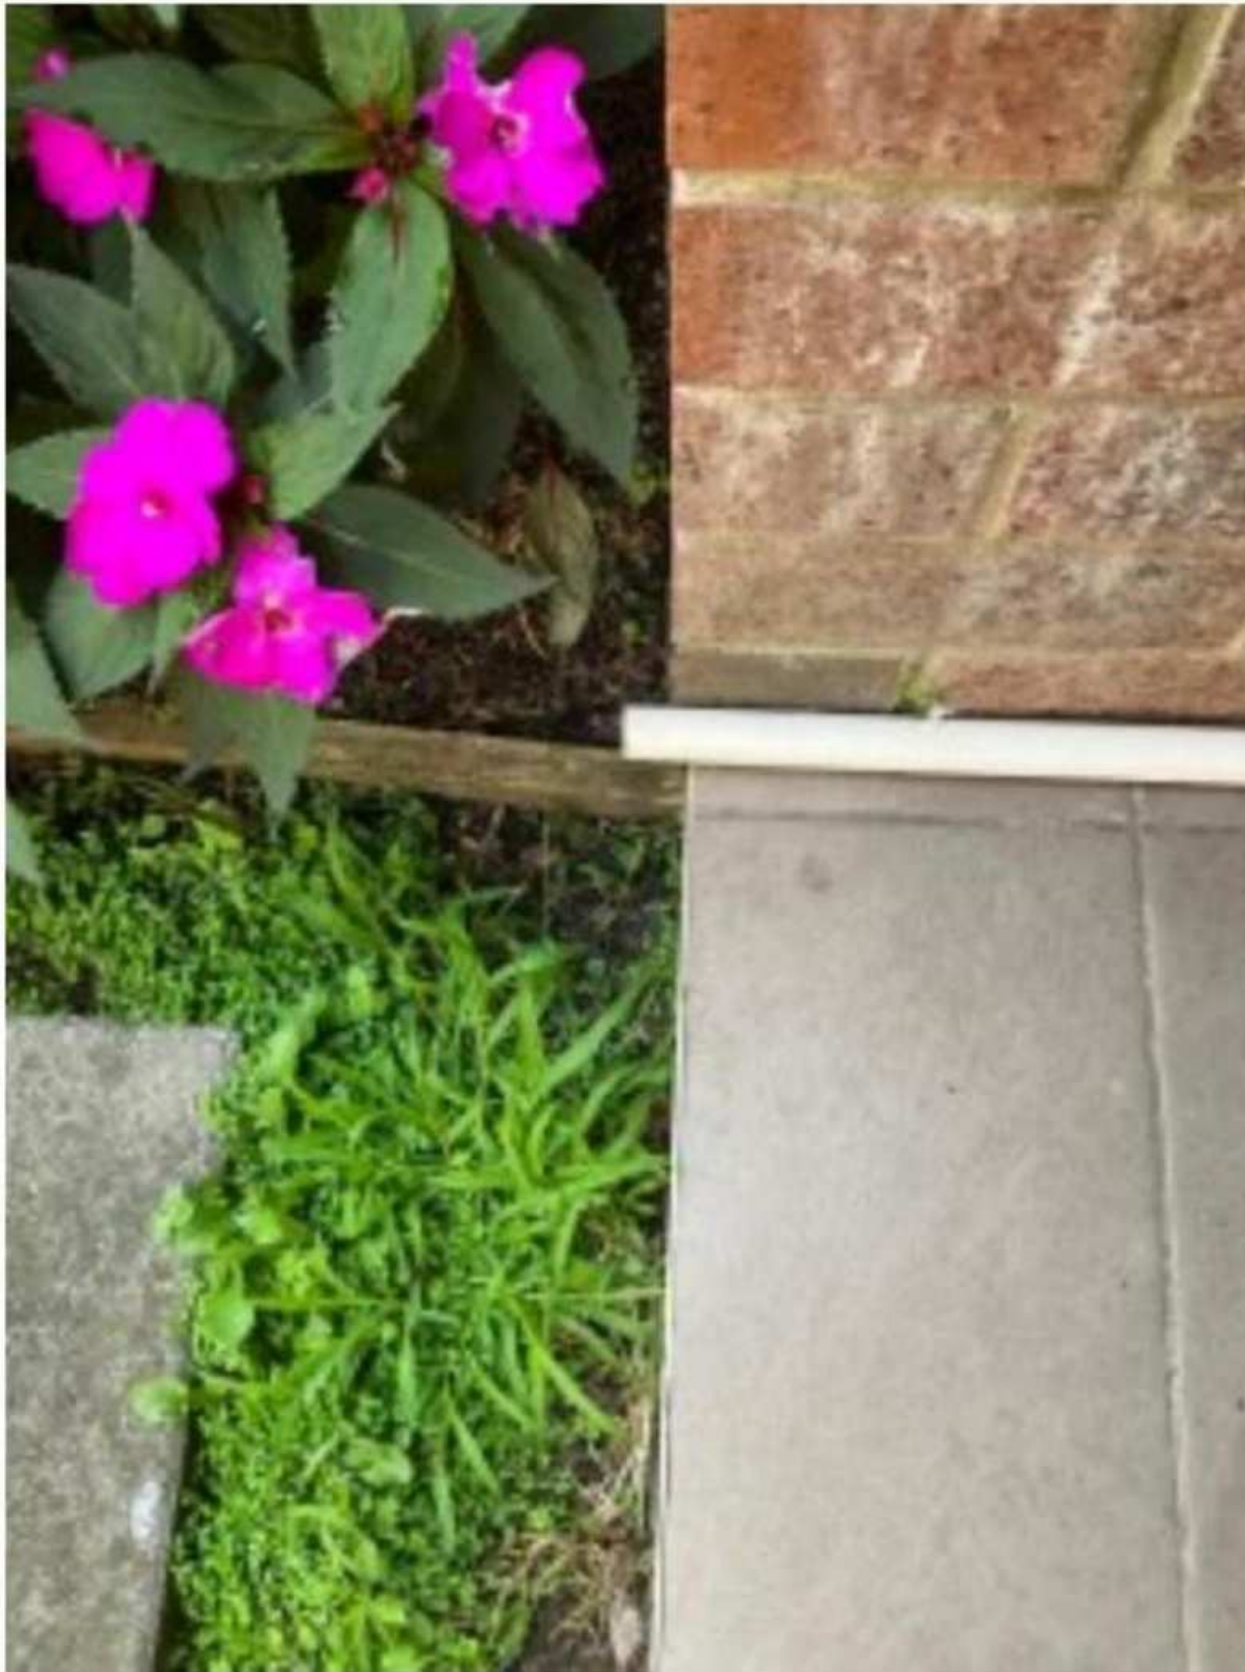
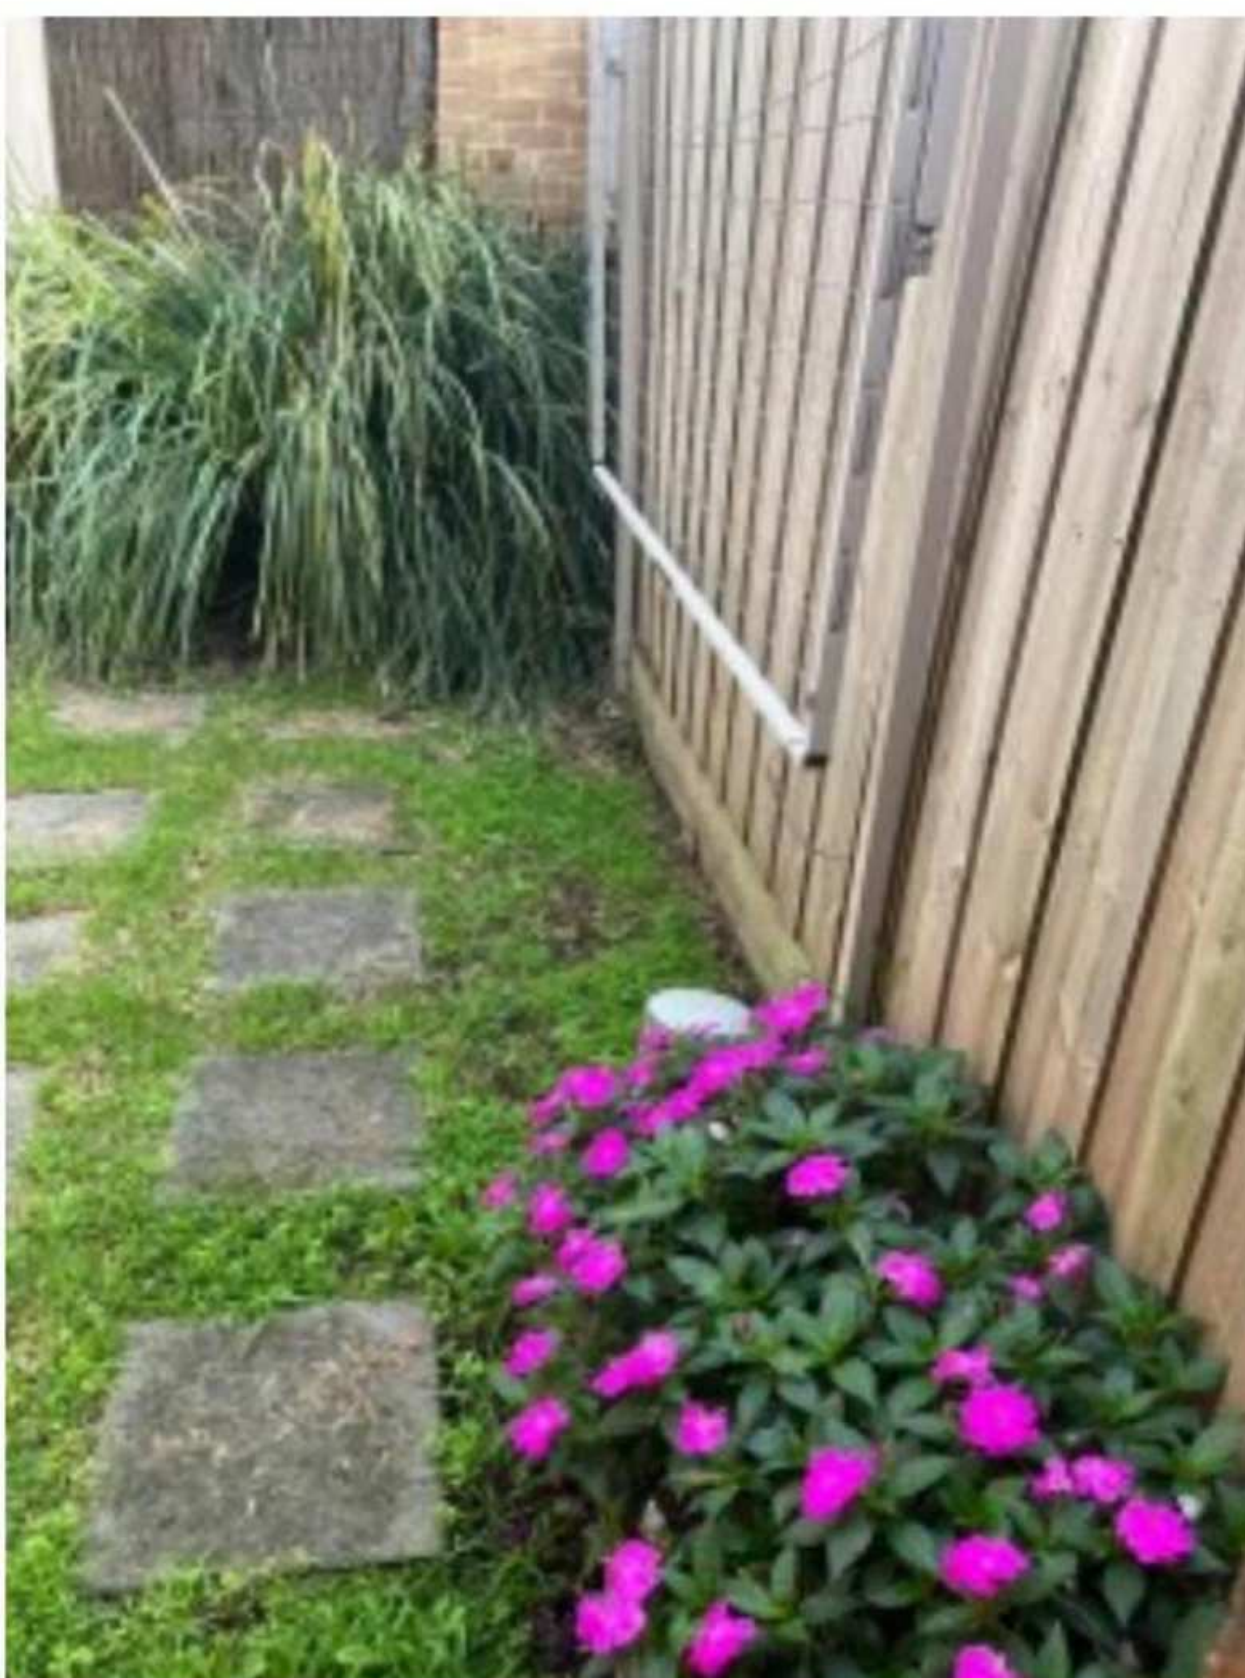
Vegetation is growing against the wall, potentially exacerbating moisture retention and contributing to decay or pest attraction. It is advisable to address these issues by improving drainage and managing vegetation to protect the building from potential damage.

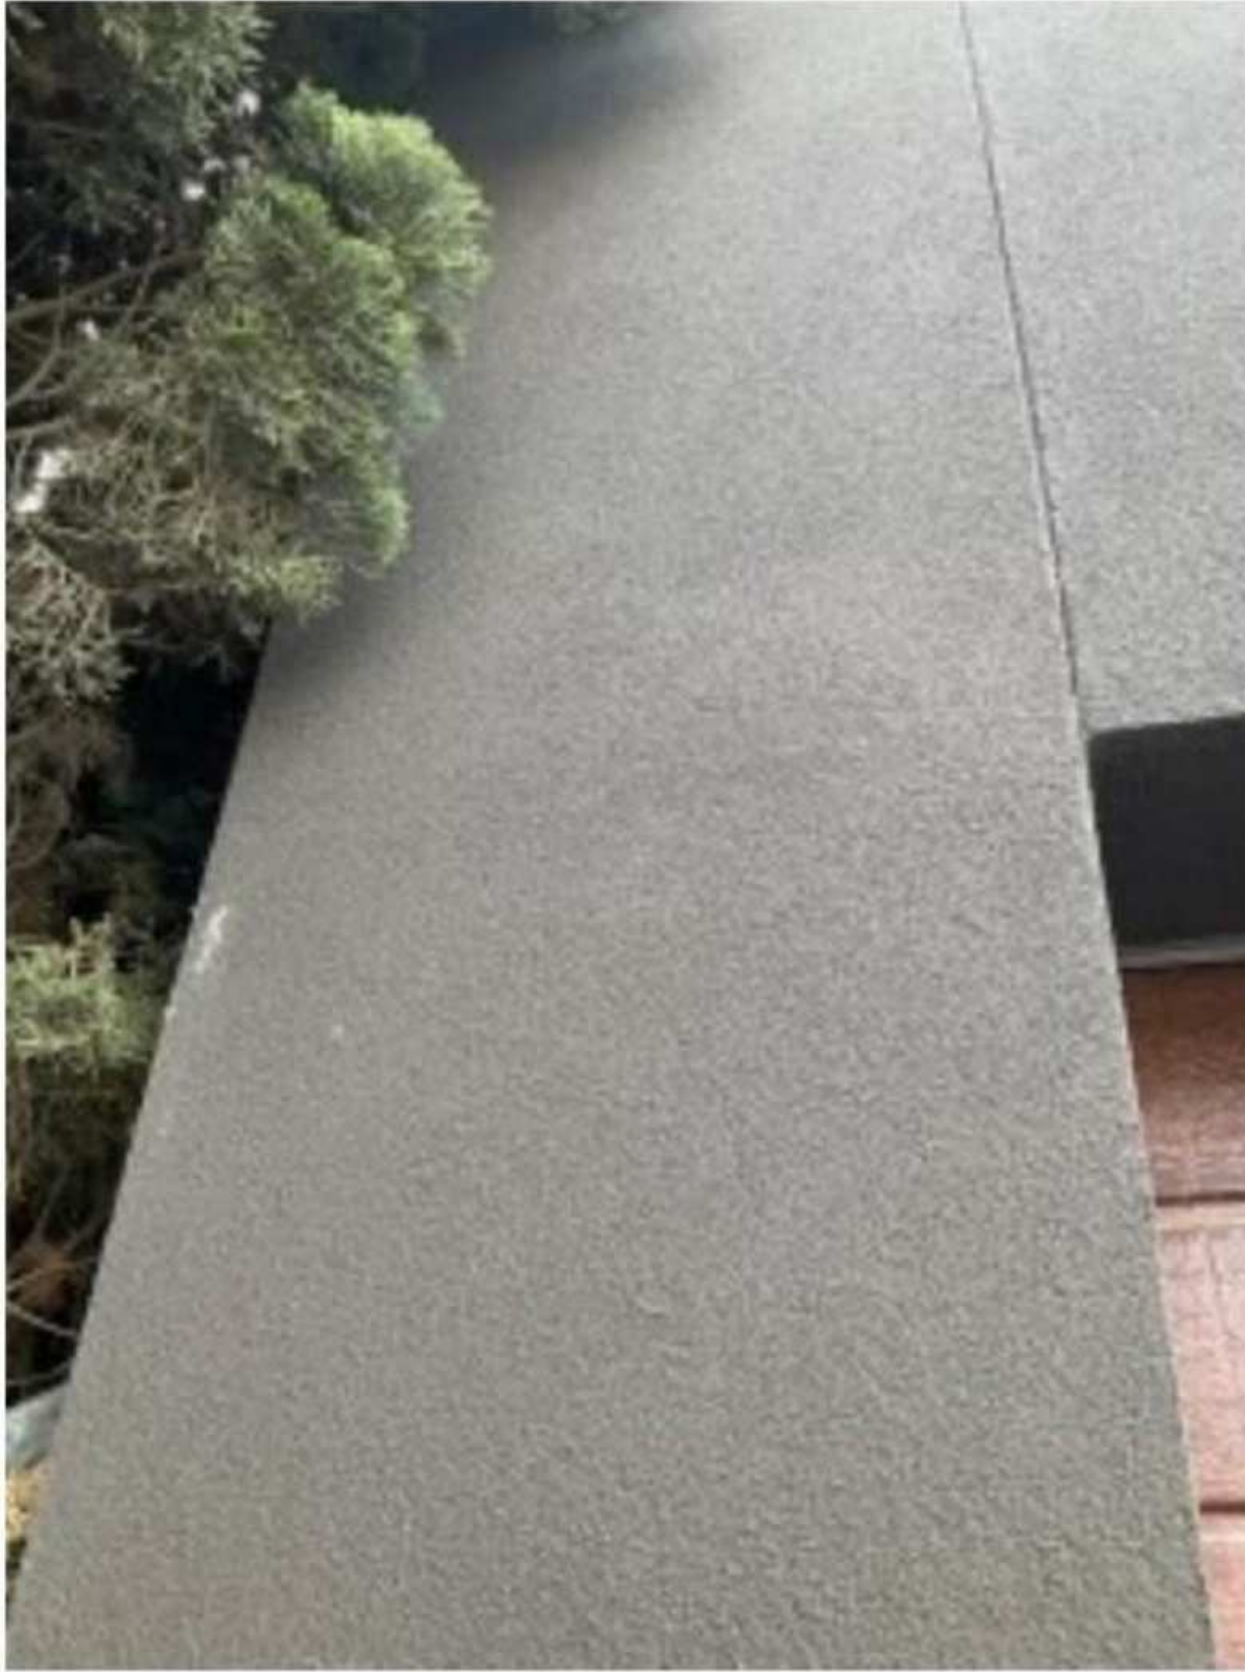
#### **Hairline crack on outside garage wall**

rendered wall surface shows signs of hairline cracking, with an evident horizontal crack and minor diagonal fissures. This issue may indicate underlying movement or stress in the structure, potentially from temperature fluctuations, settling, or moisture intrusion. It is recommended to continue monitoring to determine if there are any significant structural concerns and to prevent potential water ingress or further deterioration. Addressing the cause promptly will help maintain the wall's integrity and prevent escalation of damage.

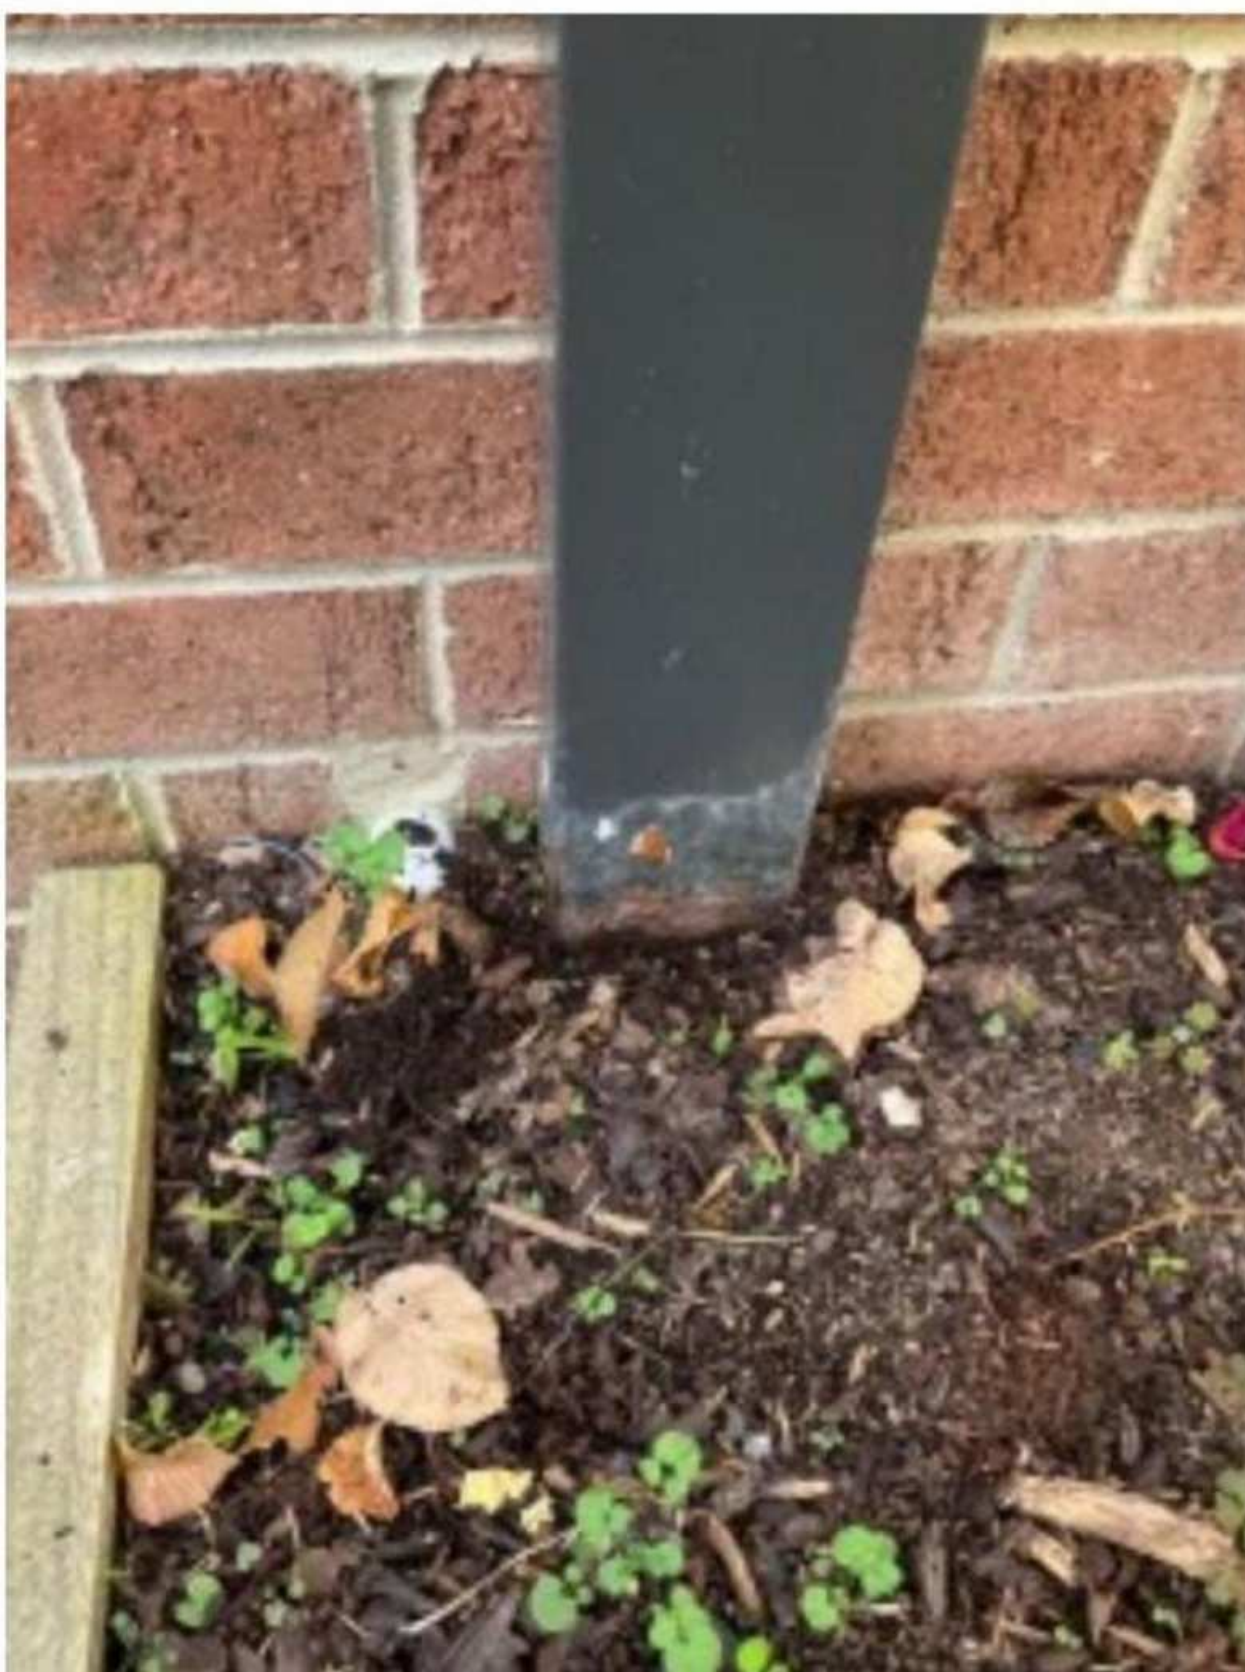
#### **Corroded downpipe at base**

Corrosion at the base of a downpipe in contact with soil. Prolonged exposure to moisture can exacerbate the leakage risk. It is recommended that the affected area be treated through rust removal and protective coating.

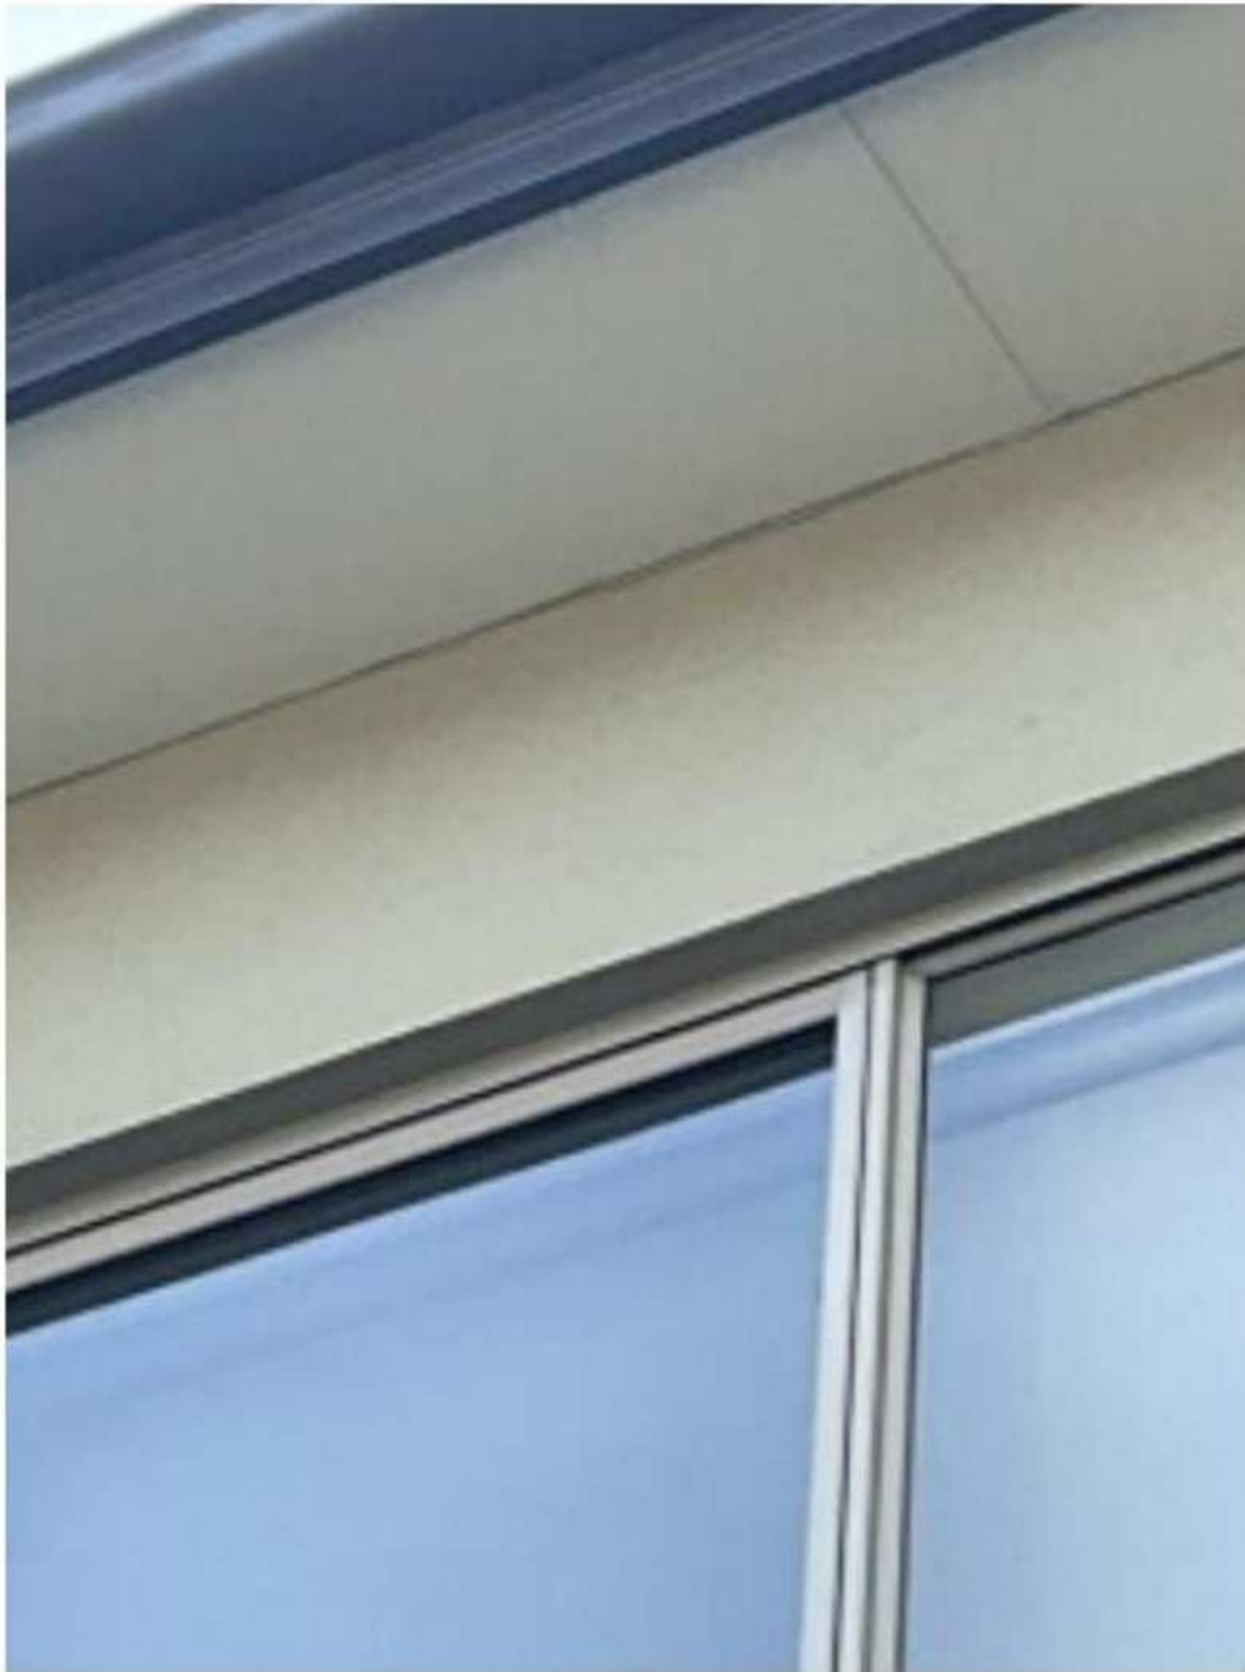
**Hairline crack between adjoining rendered wall and eaves**

Regular monitoring and potential repair work may be necessary to prevent further damage.

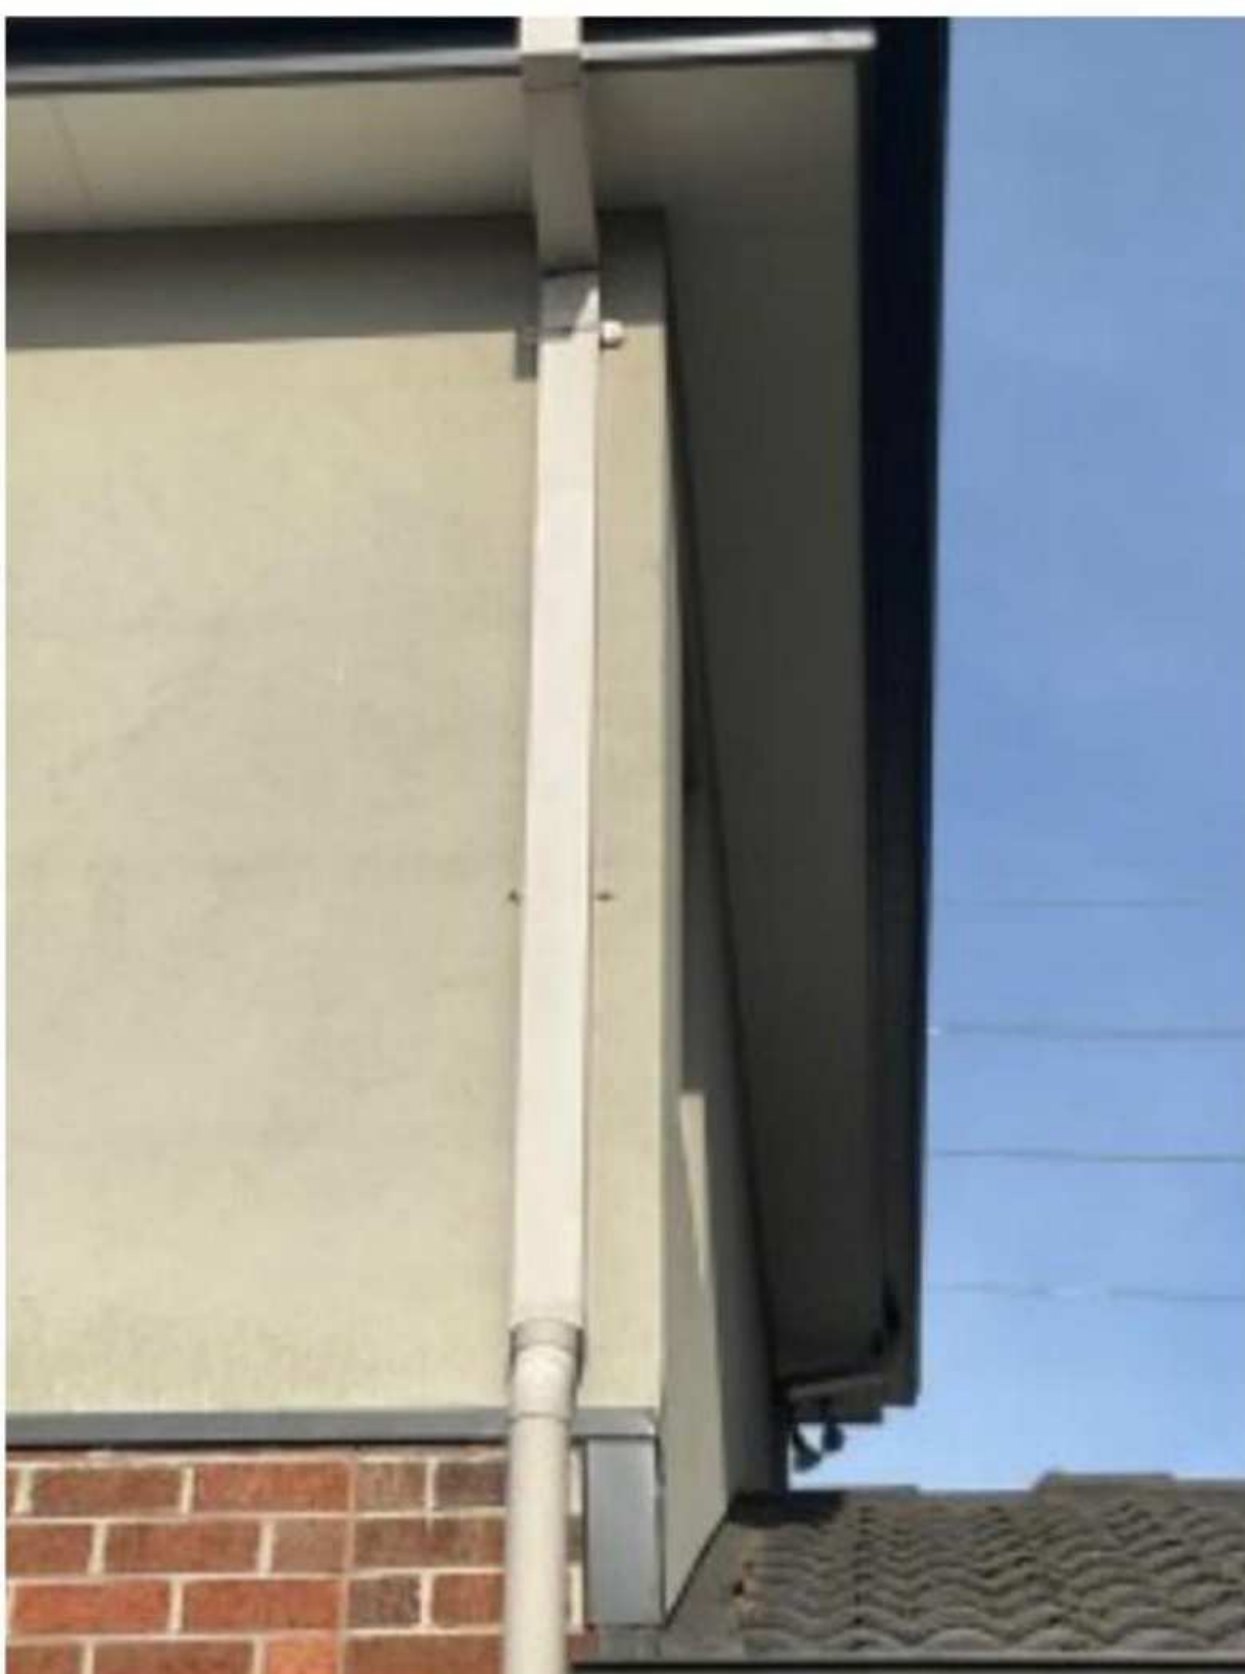
**Inadequate fastening**

The downpipe exhibits signs of inadequate fastening, with several missing or improperly secured screws. It is recommended to refasten the downpipe with appropriate fixtures, reducing the risk of damage and maintaining proper water drainage.

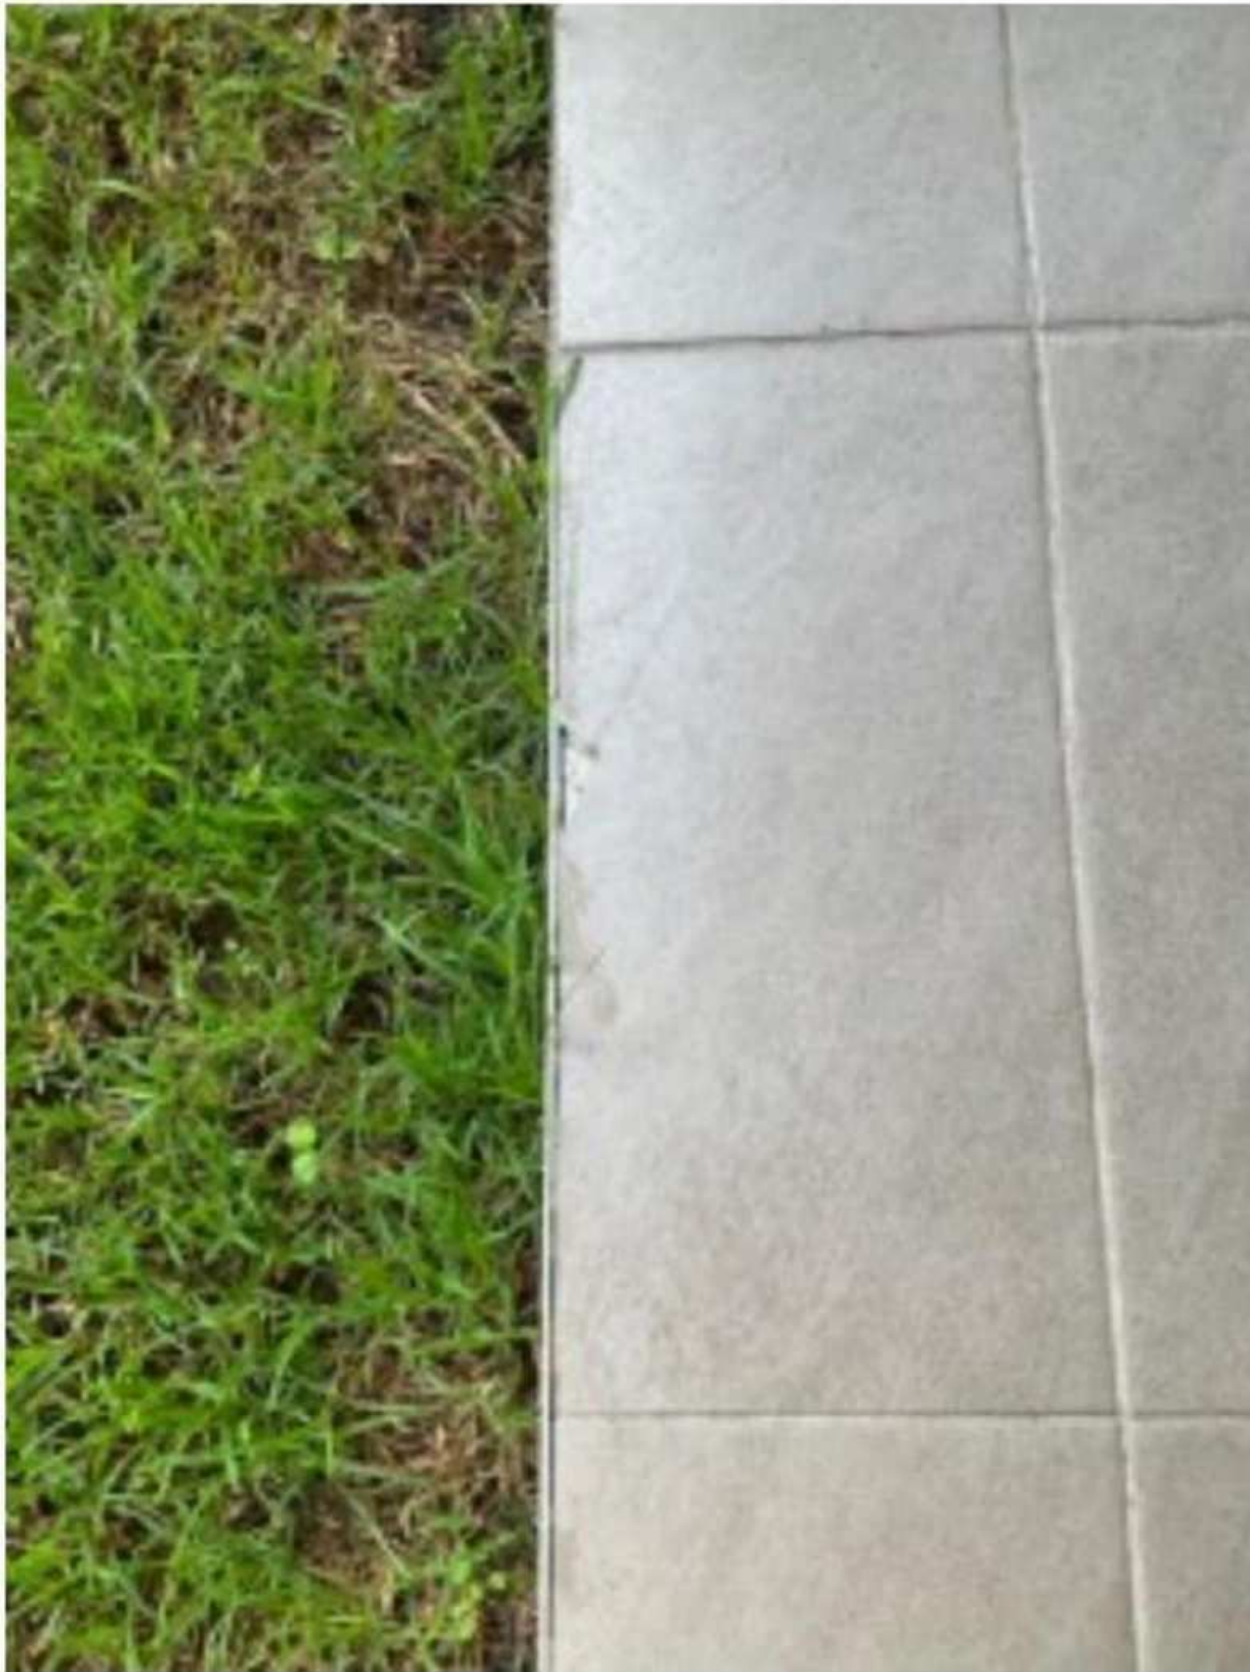
**Broken floor tile**

The inspection reveals a chipped corner in one of the exterior tiles. This defect exposes the underlying material, which may lead to further deterioration if not addressed. The damaged area could potentially allow water ingress, increasing the risk of further damage over time. Repair is recommended to maintain the durability and aesthetic appeal of the tiling.

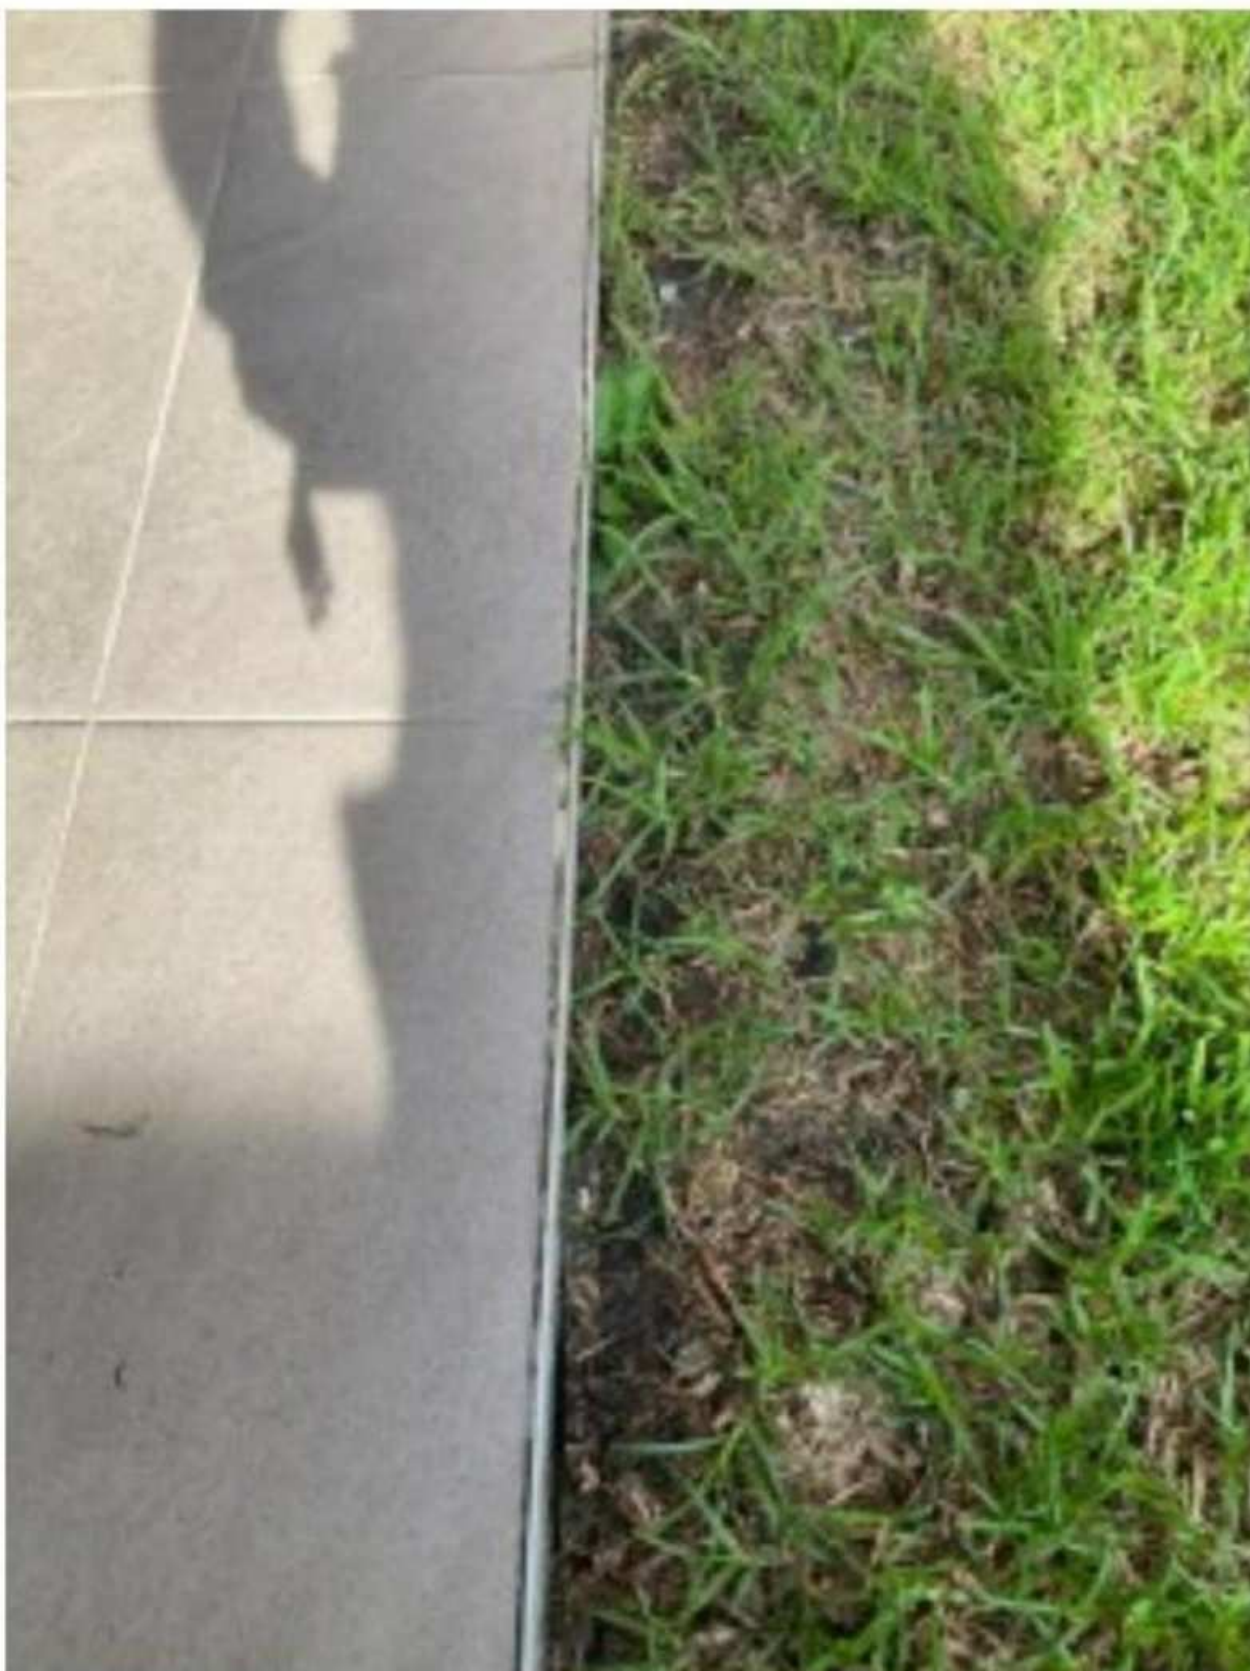
The inspection revealed that several outdoor tiles exhibit inadequate joint fill, creating visible gaps that might allow water to penetrate beneath the tiles. This could potentially lead to loosening of the tiles or water pooling. It's recommended that these joints are properly sealed to prevent potential moisture damage and ensure durability of the tiling installation. Proper sealing would also help maintain the structural integrity and aesthetics of the area.

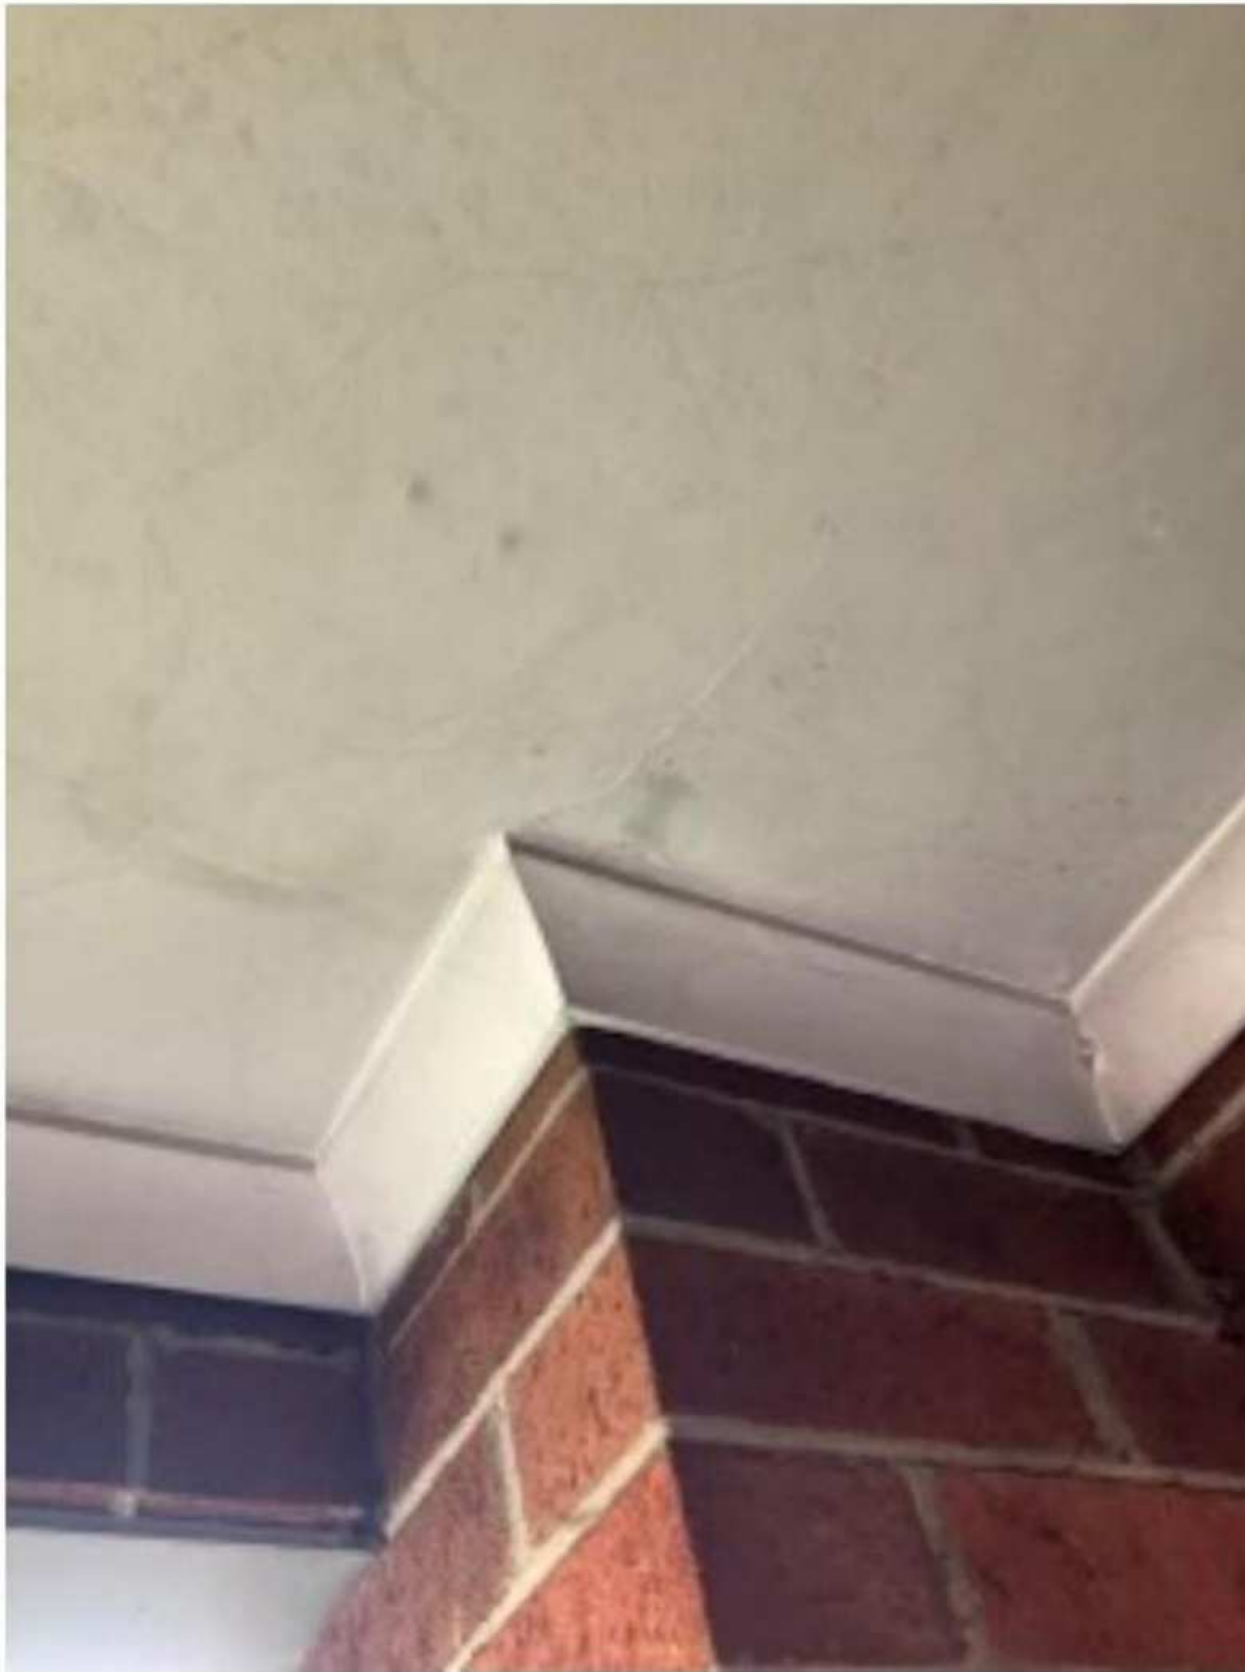
**Hairline crack on eaves porch area**

A noticeable crack along the interior ceiling. This defect suggests possible structural movement or settling over time. Regular monitoring and potential repair work may be necessary to prevent further damage.
