## Just Inspections

## Building/Property & Timber Pest Inspection

**AS4349.1-2007 & AS4349.3-2010**

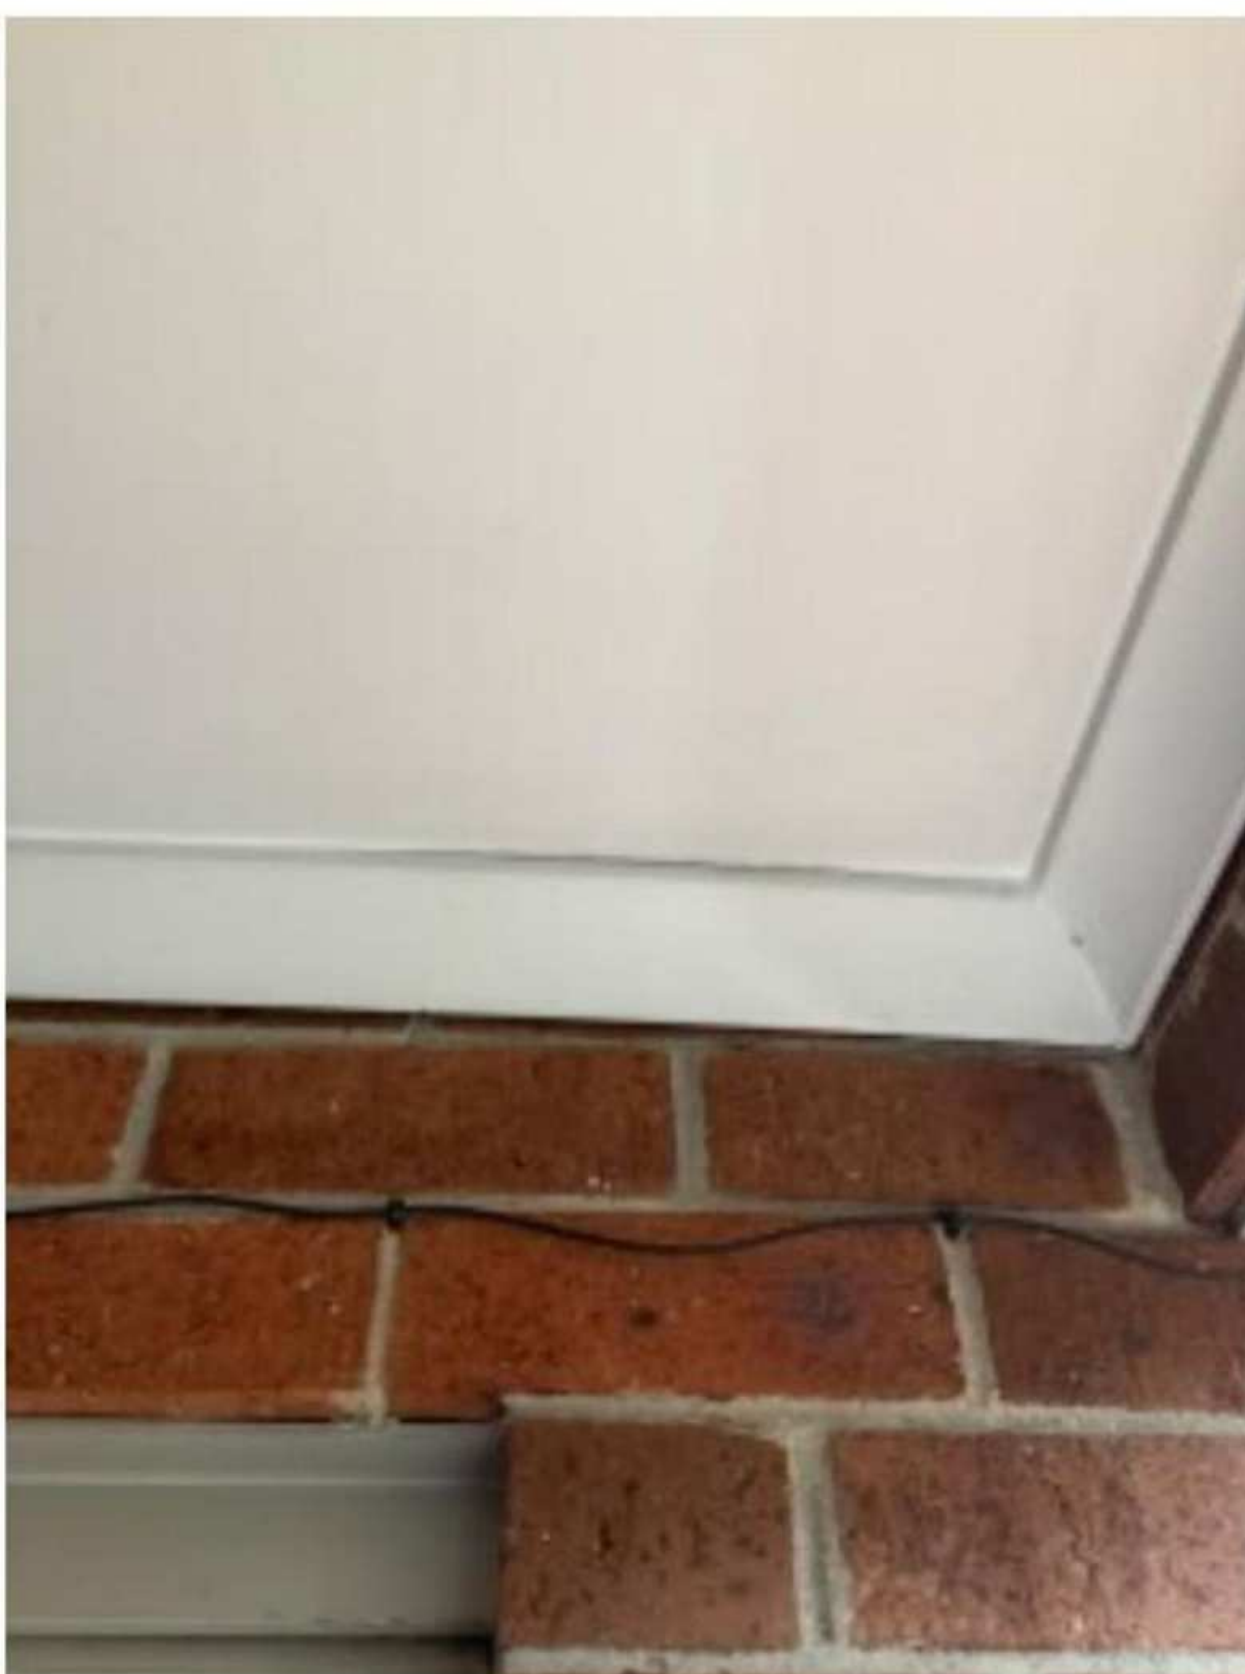
Hairline crack on corner between ceiling and cornice this defect suggests possible movement over time. Regular monitoring and potential repair work may be necessary to prevent further damage.

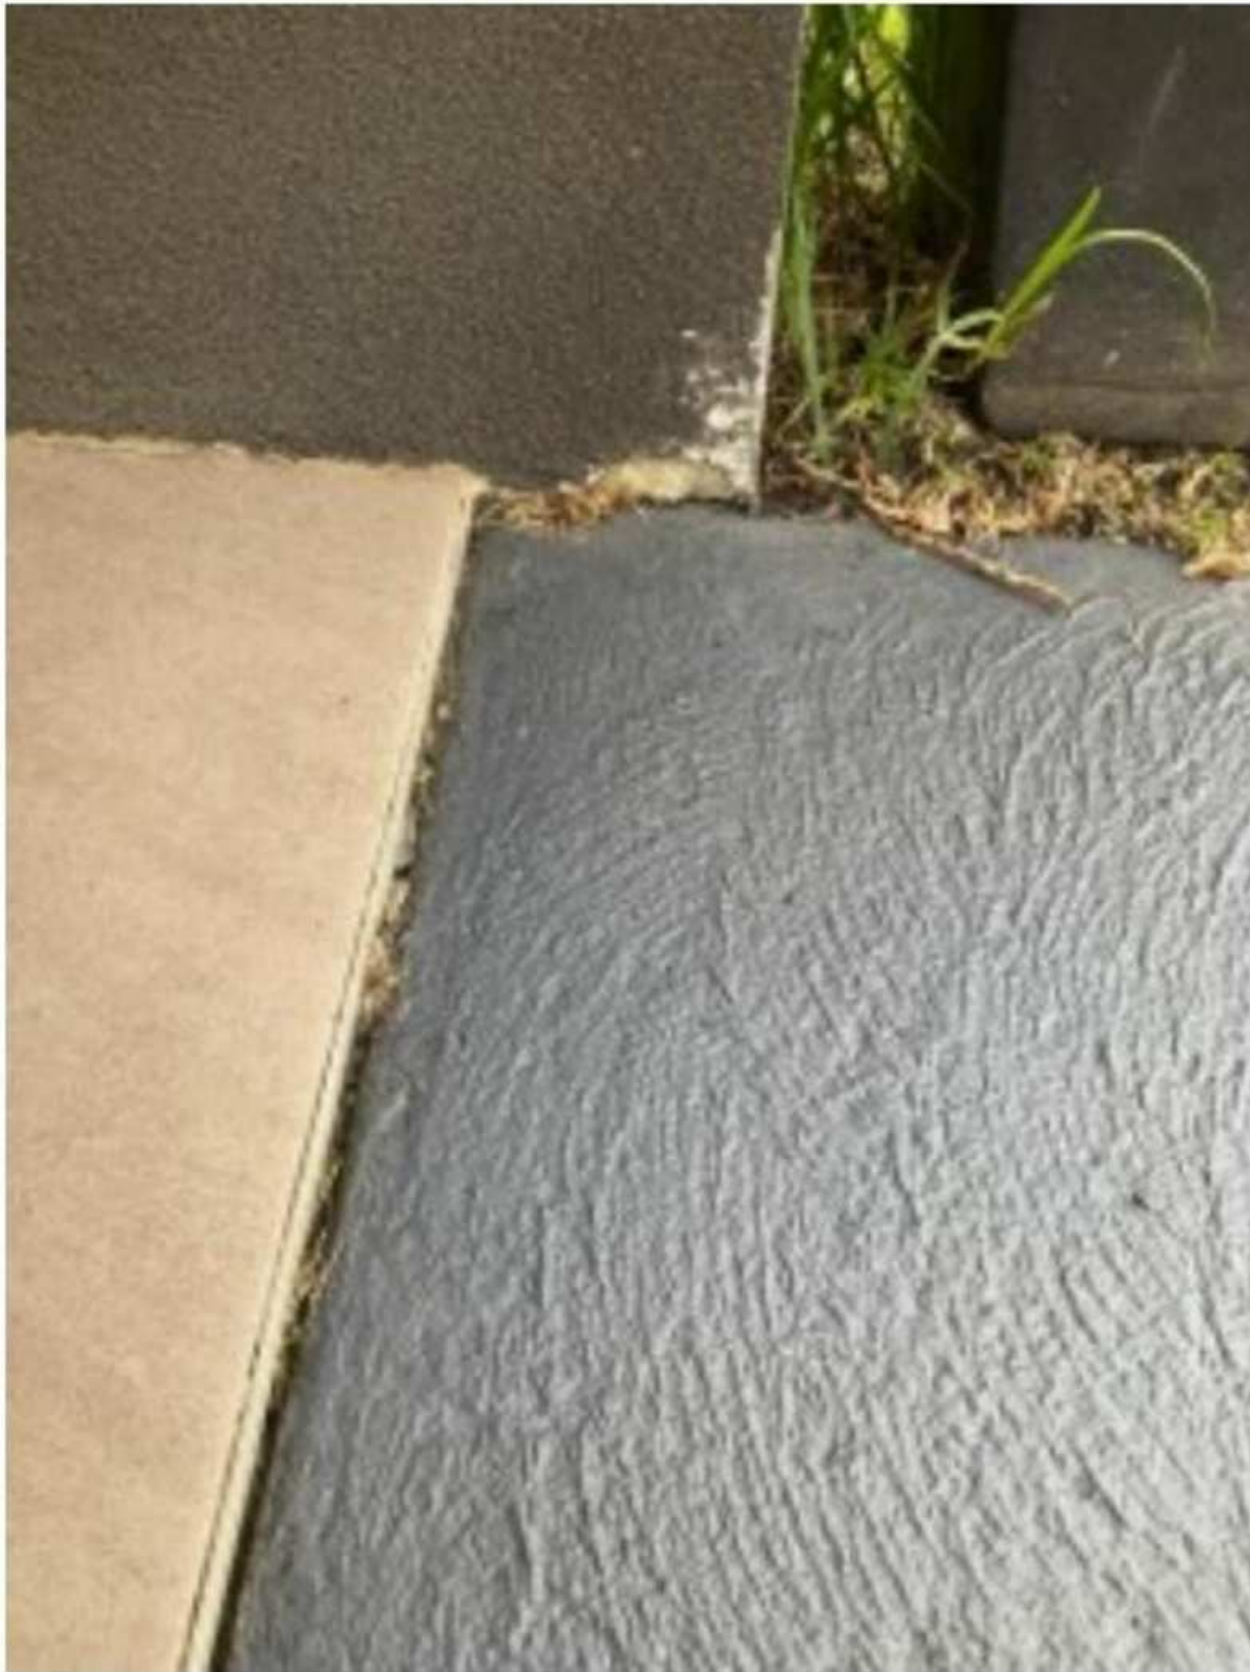
Chip at the bottom of rendered wall and a gap likely resulting from wear and tear, ground movement or settling over time. Repair by tradesman.

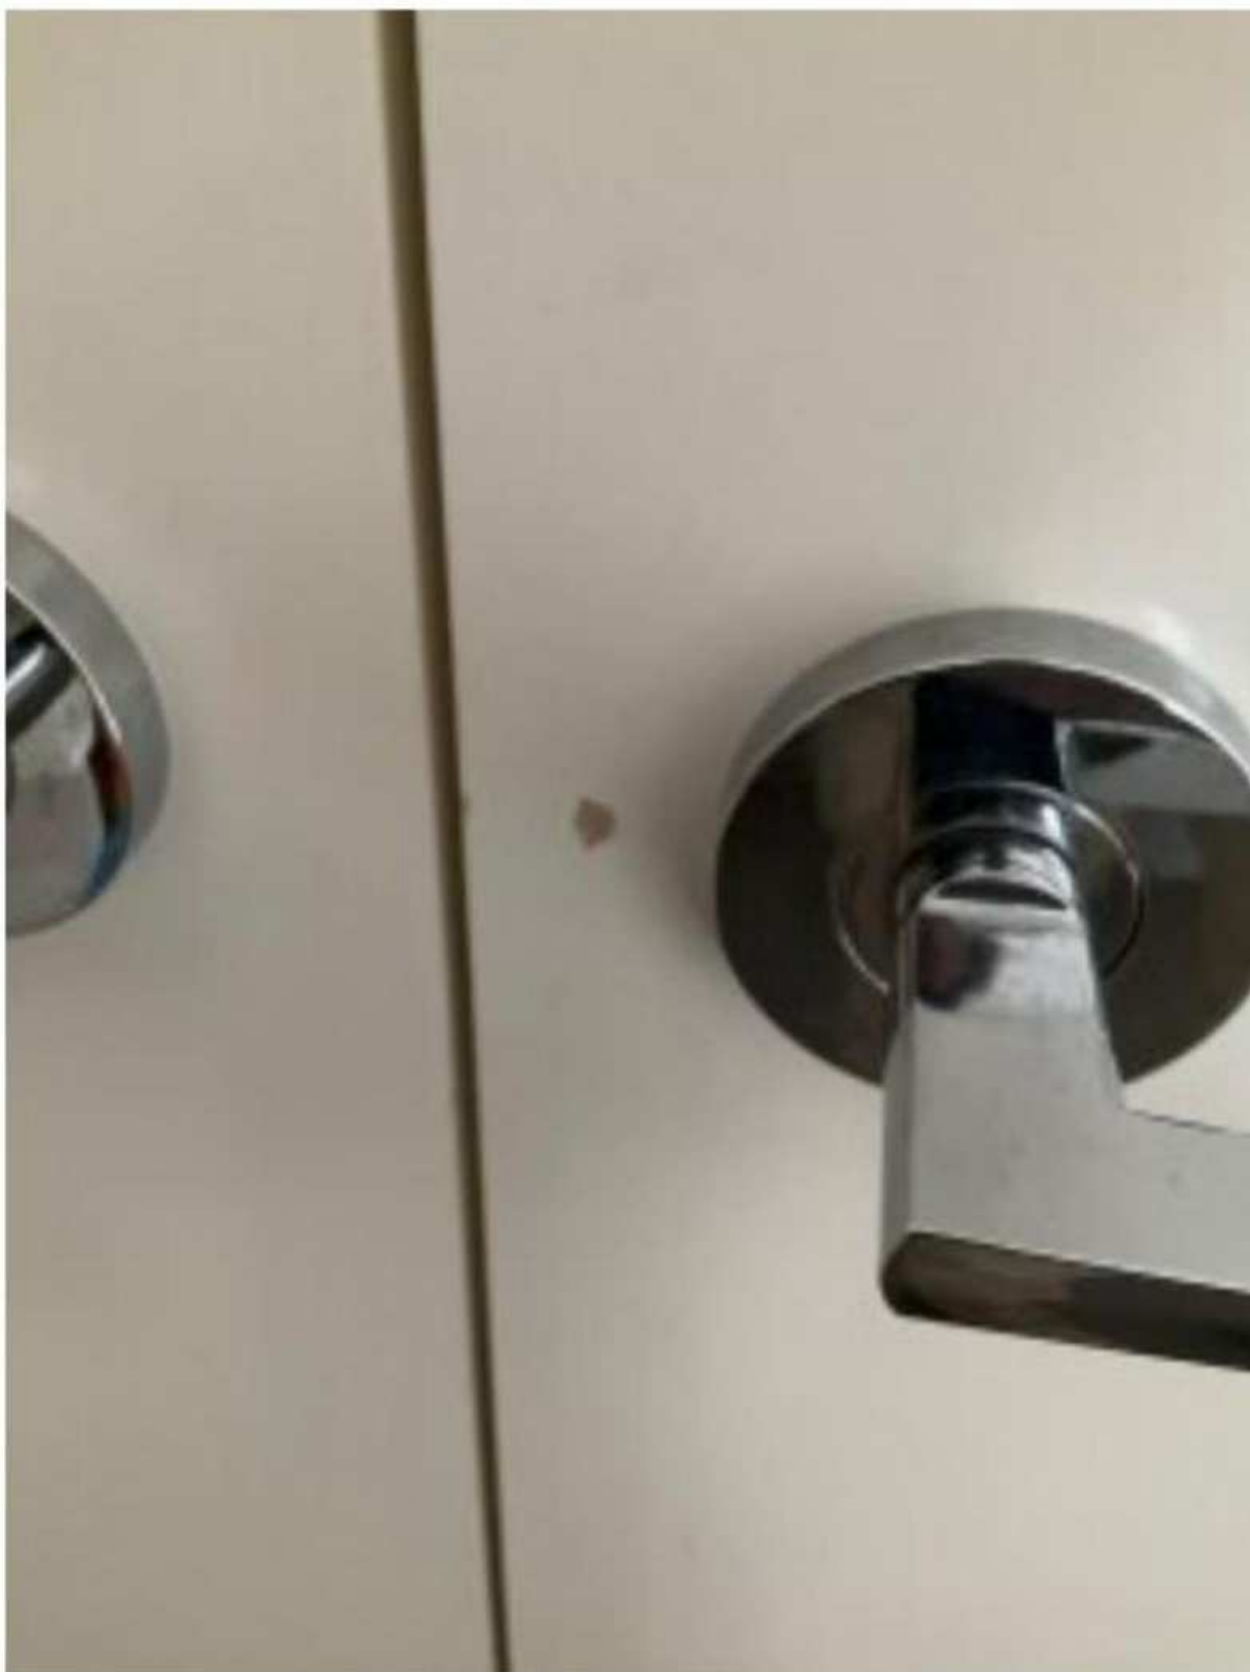
Bedroom

Minor damage to bedroom door. Handyman can repair.

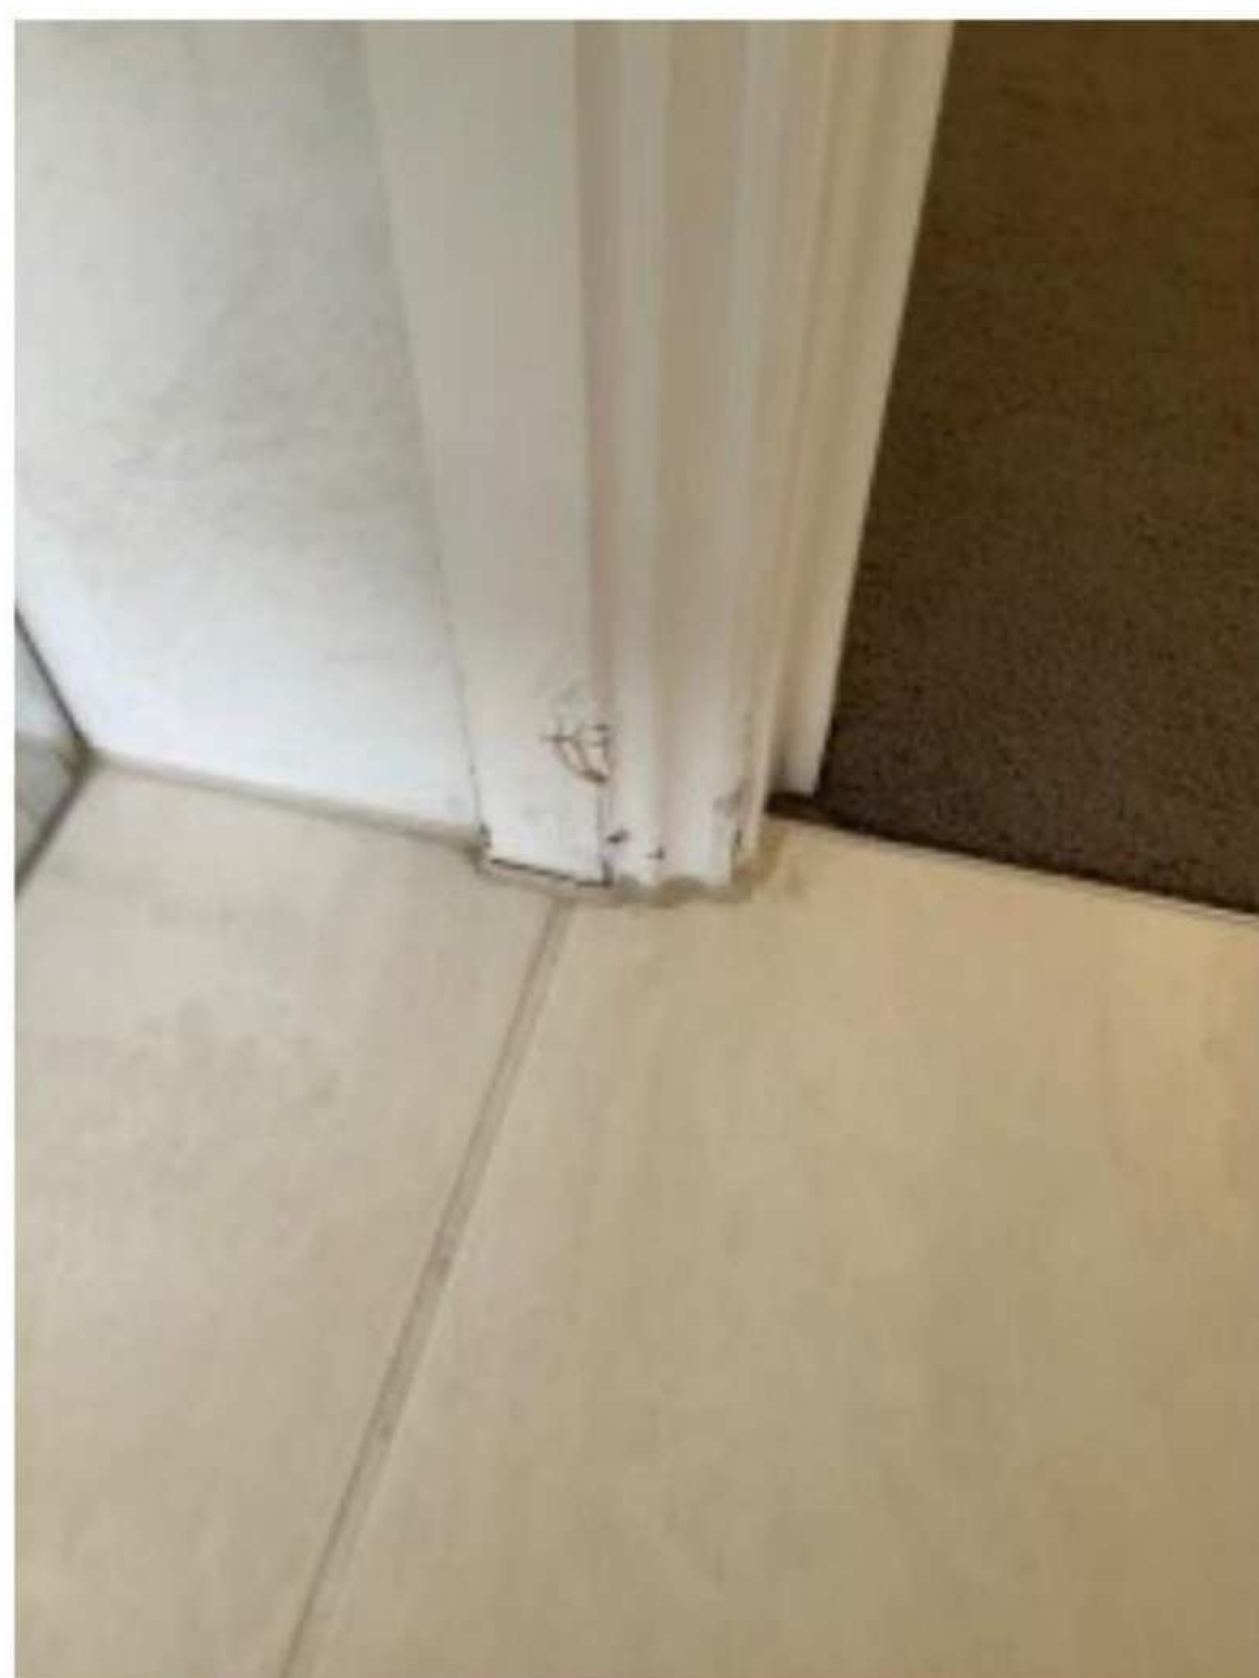
Bathroom

The door frame shows visible signs of damage, with peeling paint and a section of chipped wood at the base. This may be the result of wear and tear or potential water exposure. It is recommended to assess the extent of the damage and carry out necessary repairs to maintain. Regular maintenance and sealing may prevent further deterioration in the future.

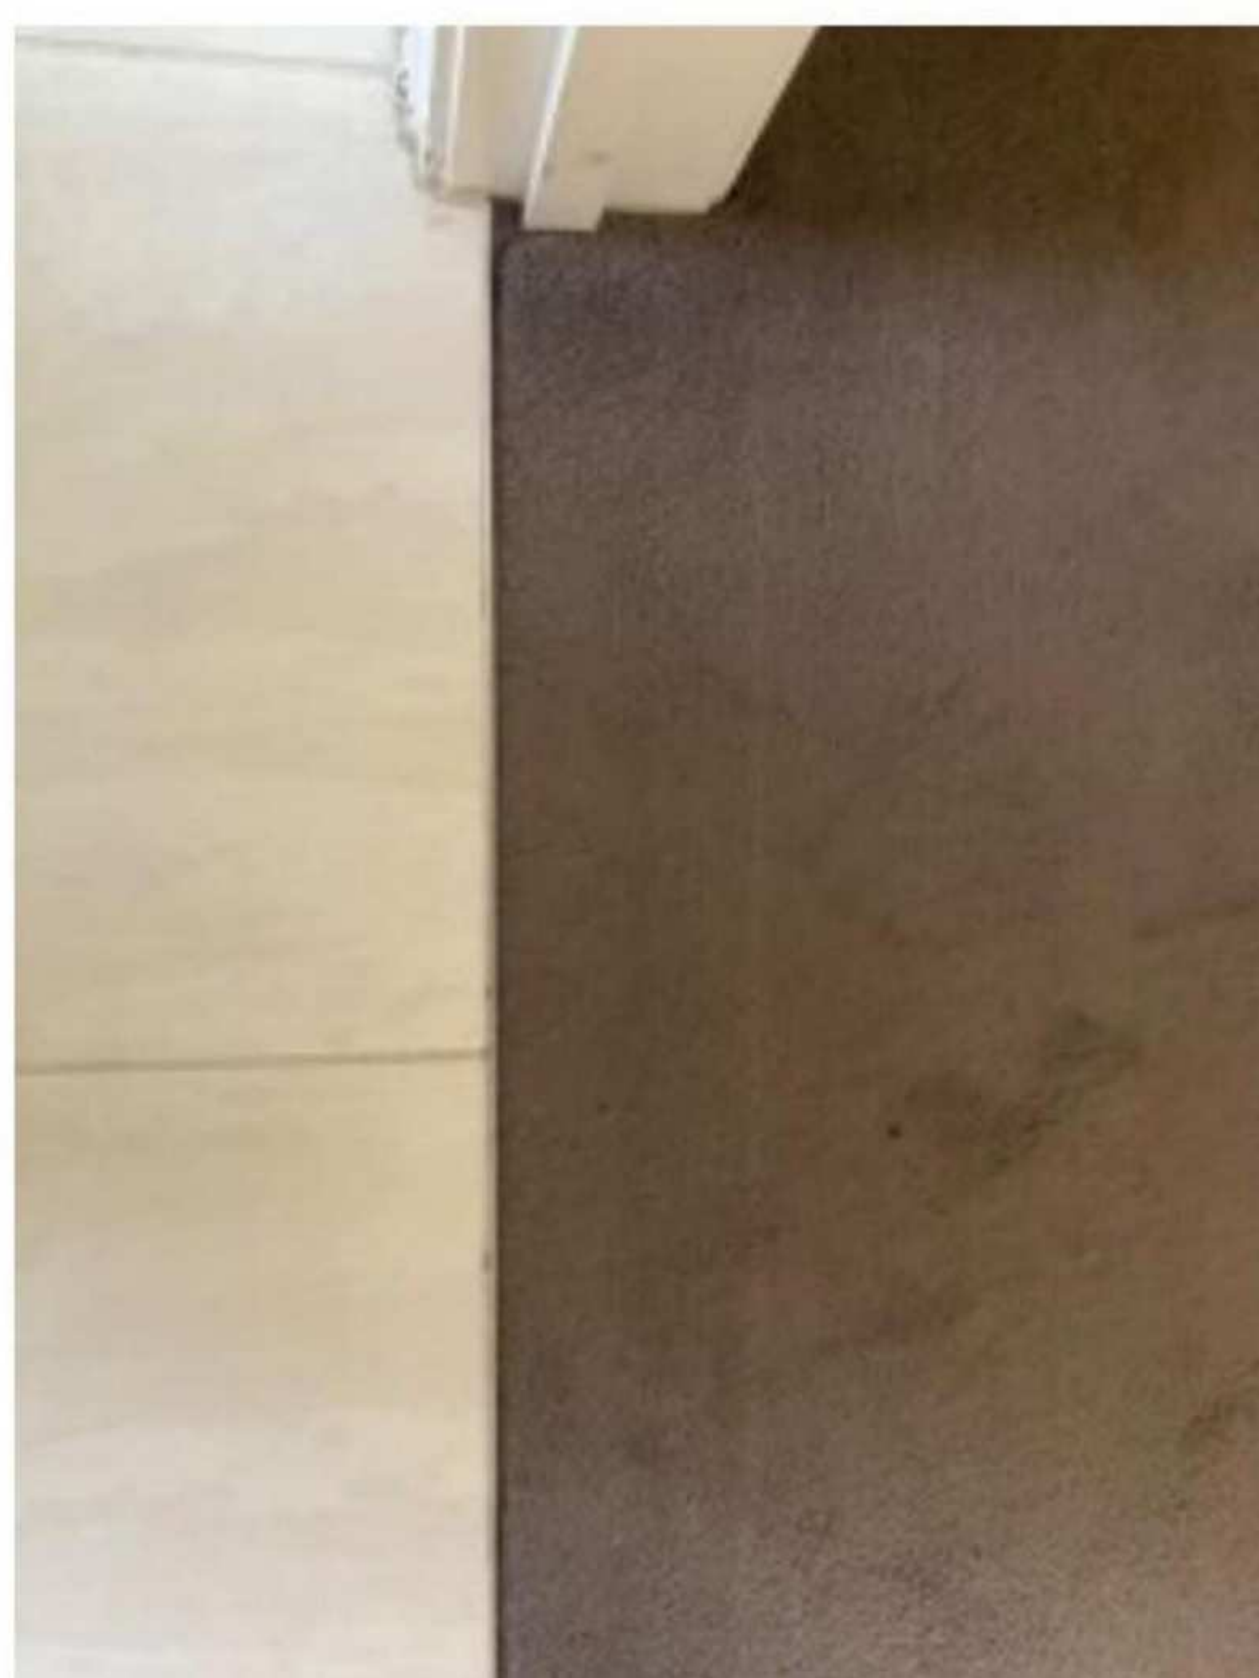
Missing grout this may lead to potential water ingress and compromise the integrity of the surrounding tiles. It is recommended to re grout to prevent further damage and ensure the longevity and stability of the floor surface in this area.

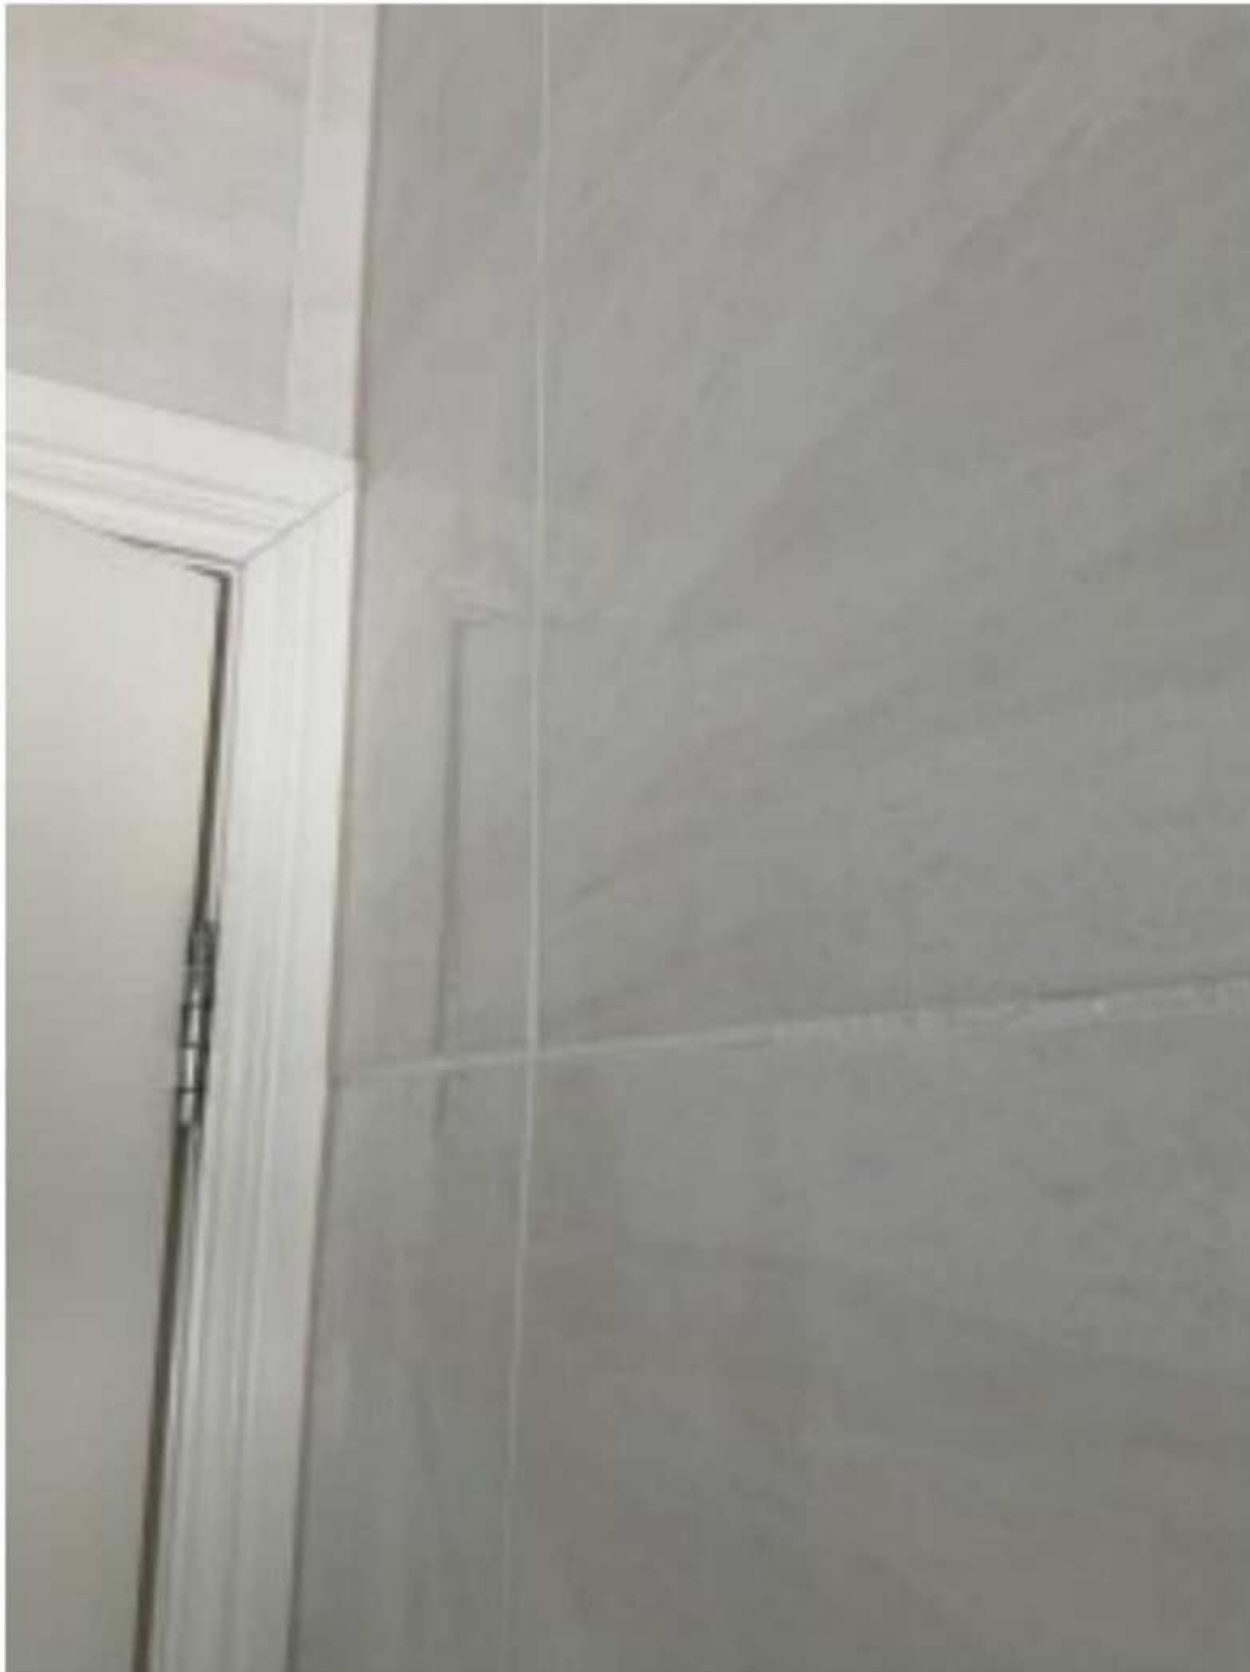
Visible signs of grout deterioration. It is recommended to re grout to prevent further damage and ensure the longevity and stability of the wall tile surface in this area.

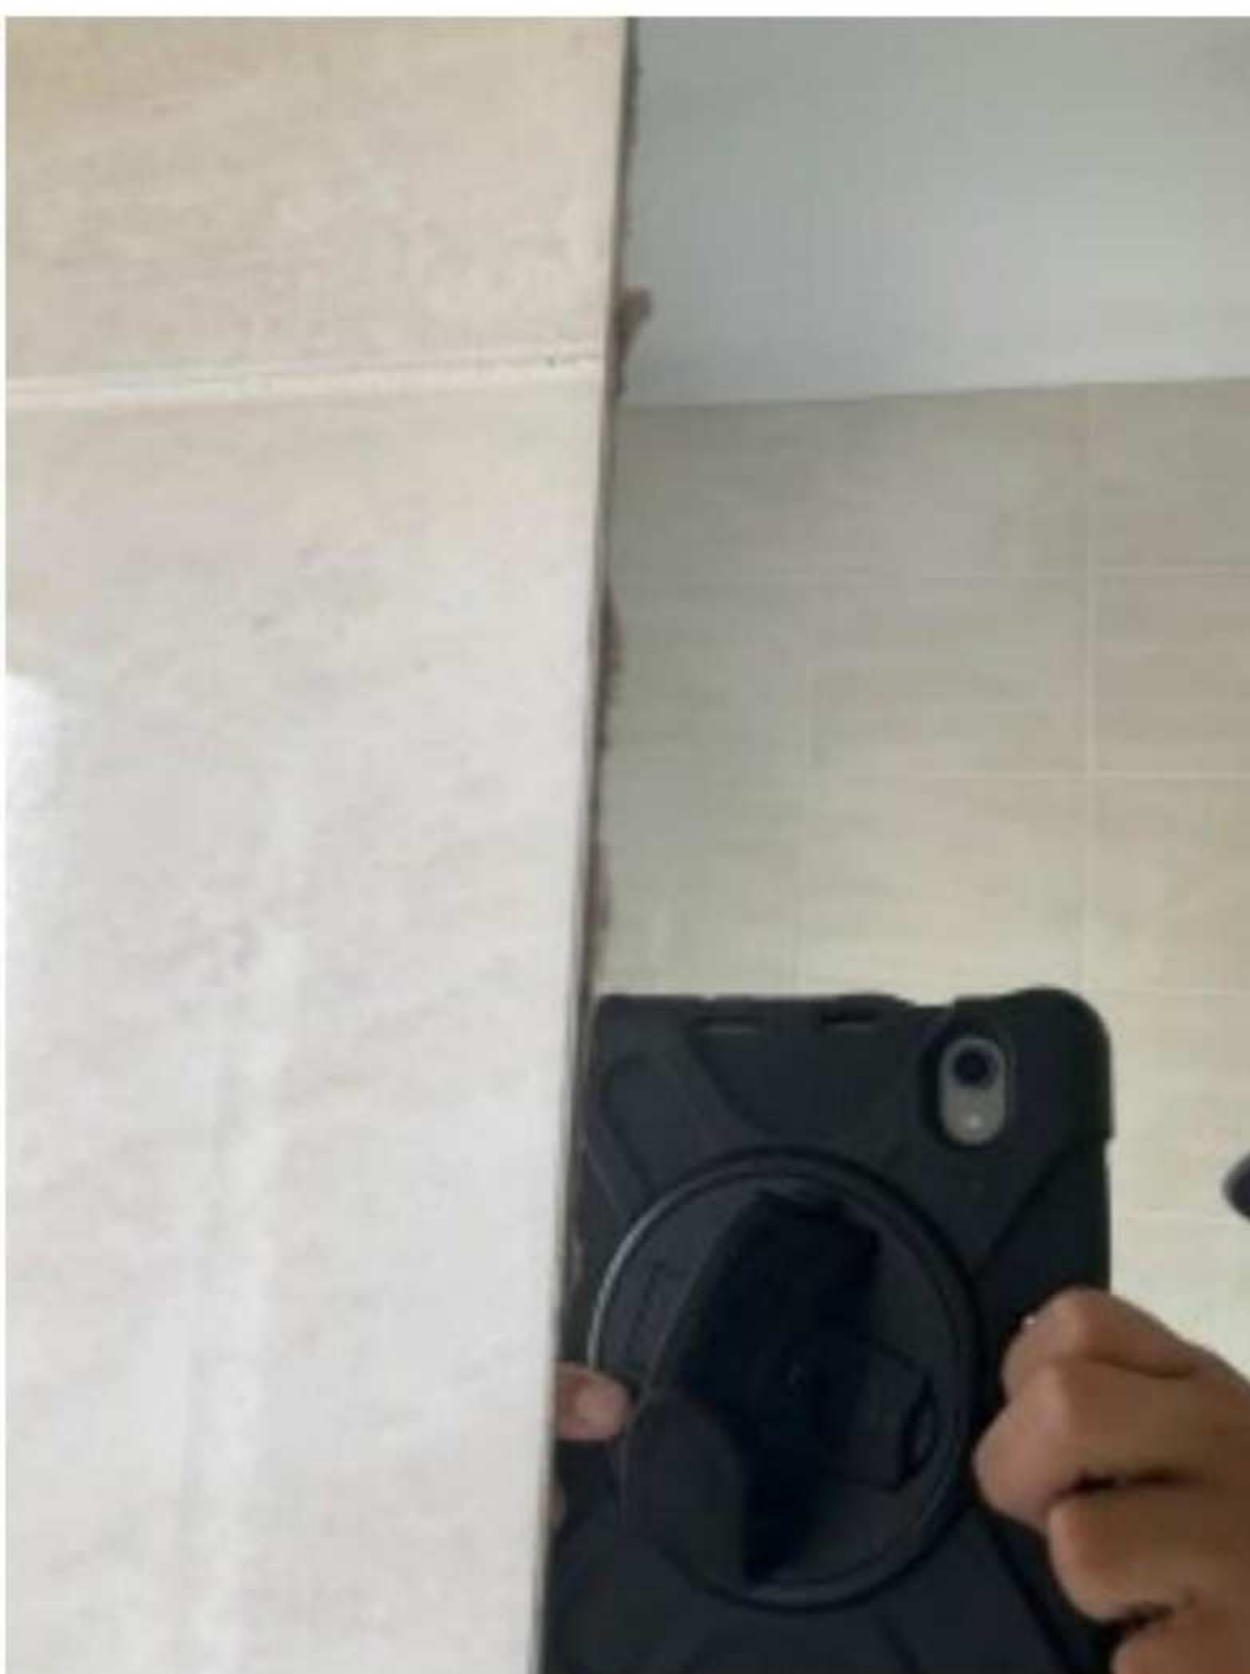
The mirror in the bathroom shows visible deterioration. Repairing or replacing are recommended.

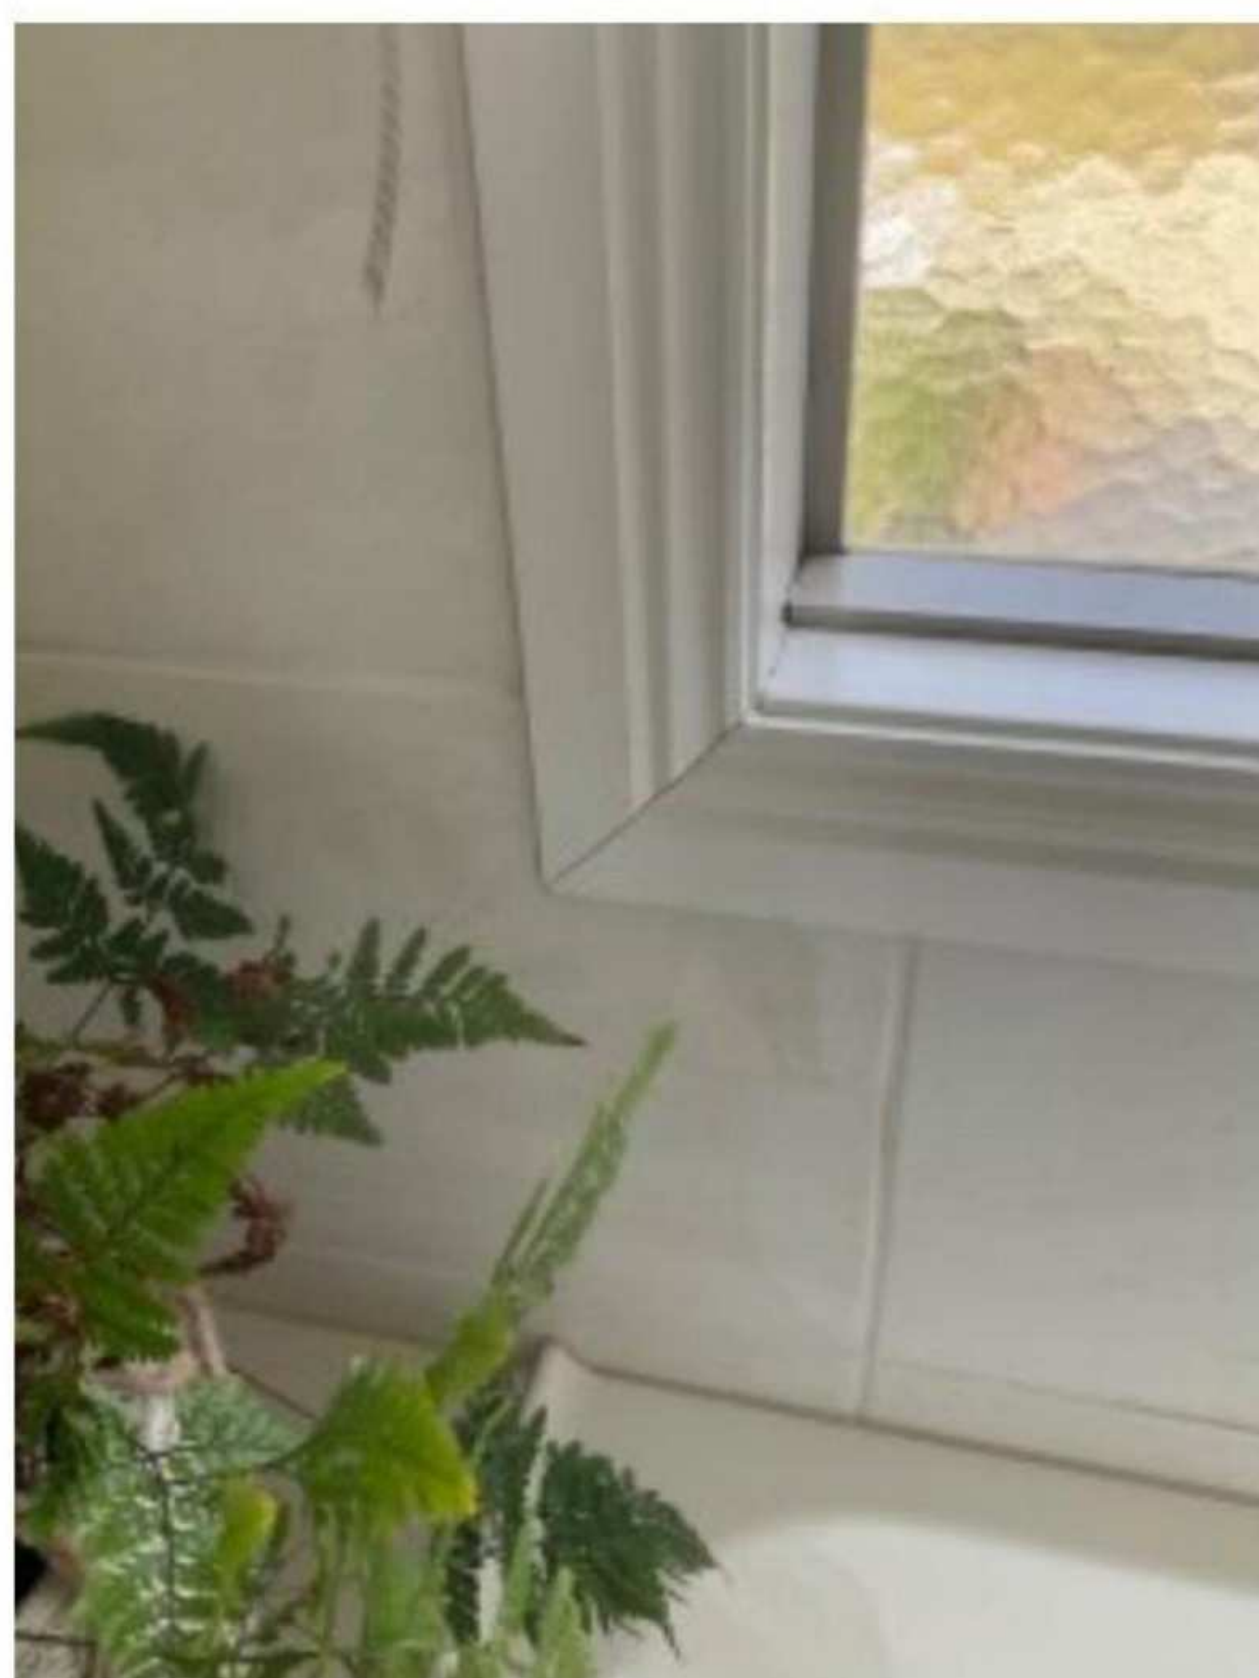
The window frame exhibits noticeable cracking at the corners. This could indicate potential movement or settlement. Rectification may involve repairing or resealing affected sections to ensure durability and effective sealing. If cracking worsens over time, it is recommended to engage a suitably qualified specialist for further investigation.

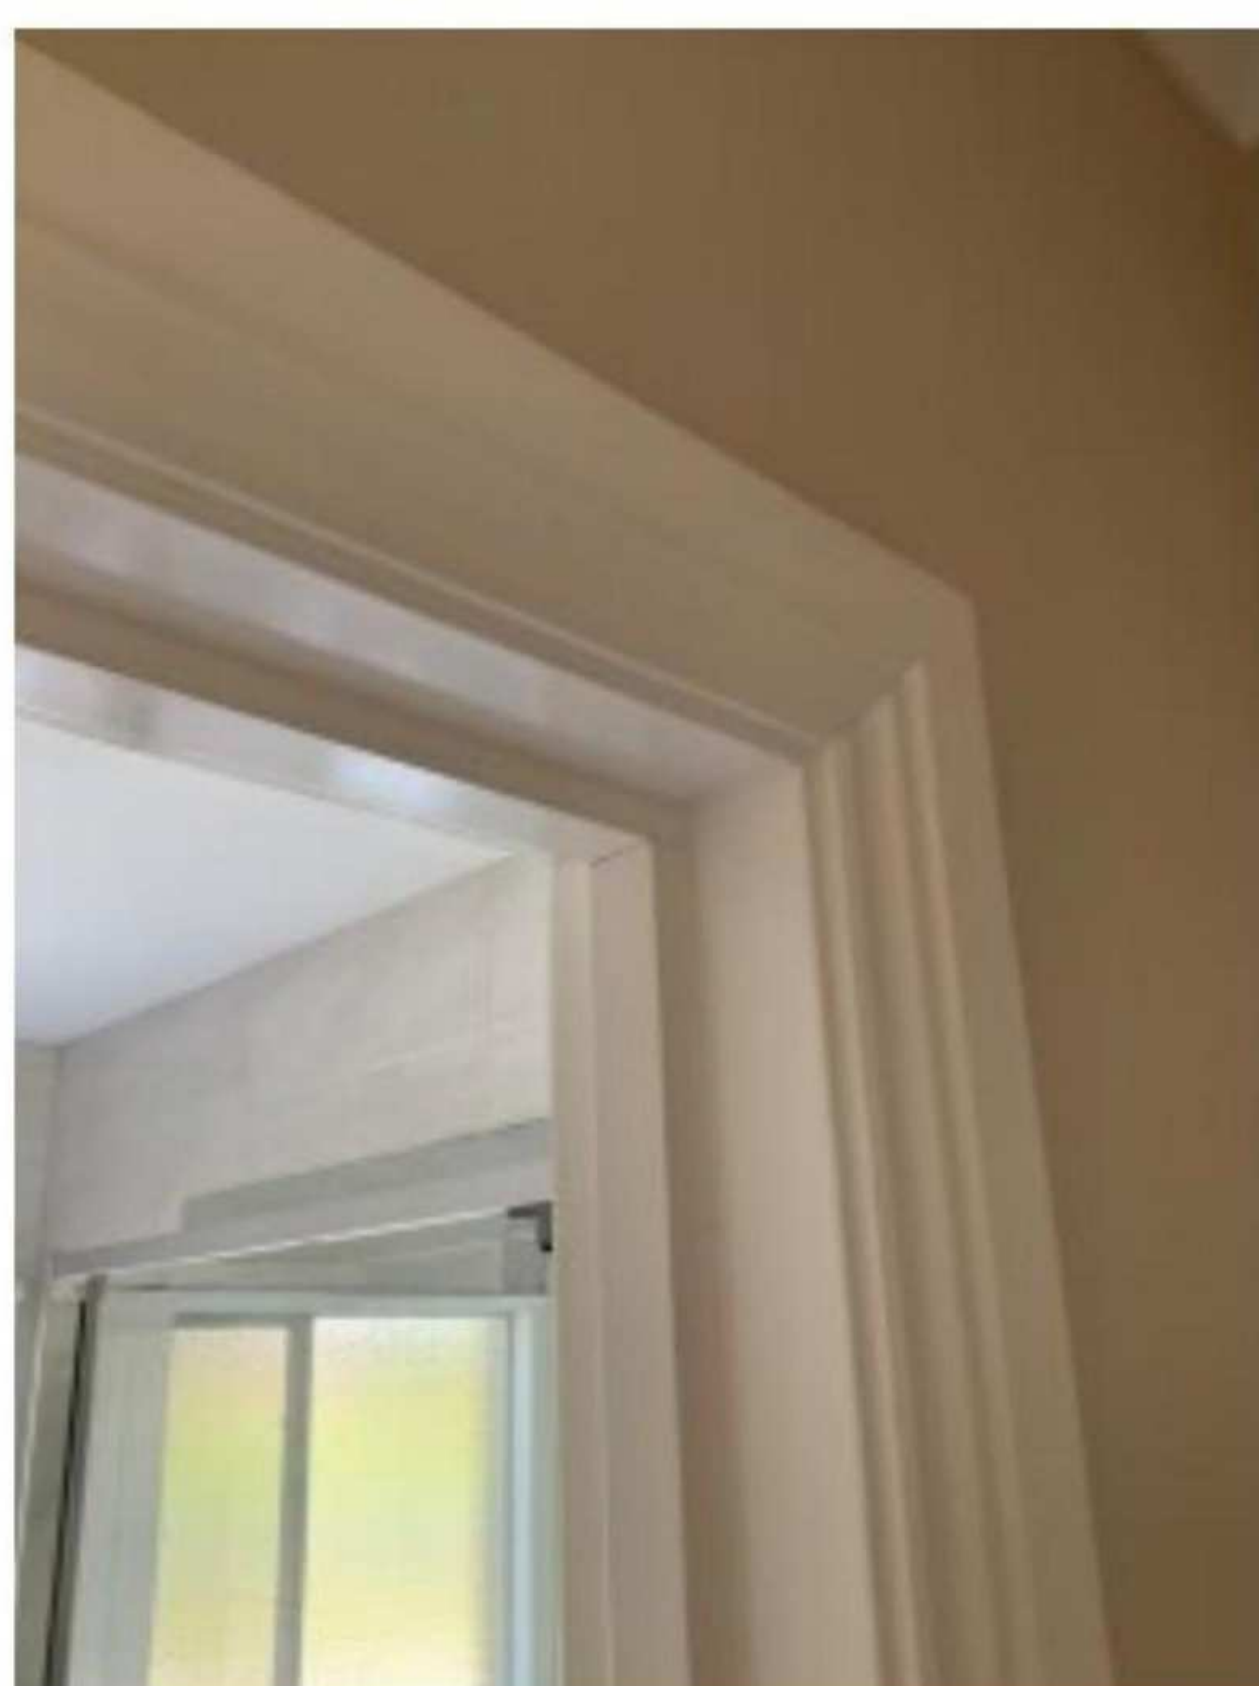
Door frame visible crack at the corner. This could indicate potential movement. Rectification by qualified tradesperson.
