## Just Inspections

## Building/Property & Timber Pest Inspection

**AS4349.1-2007 & AS4349.3-2010**

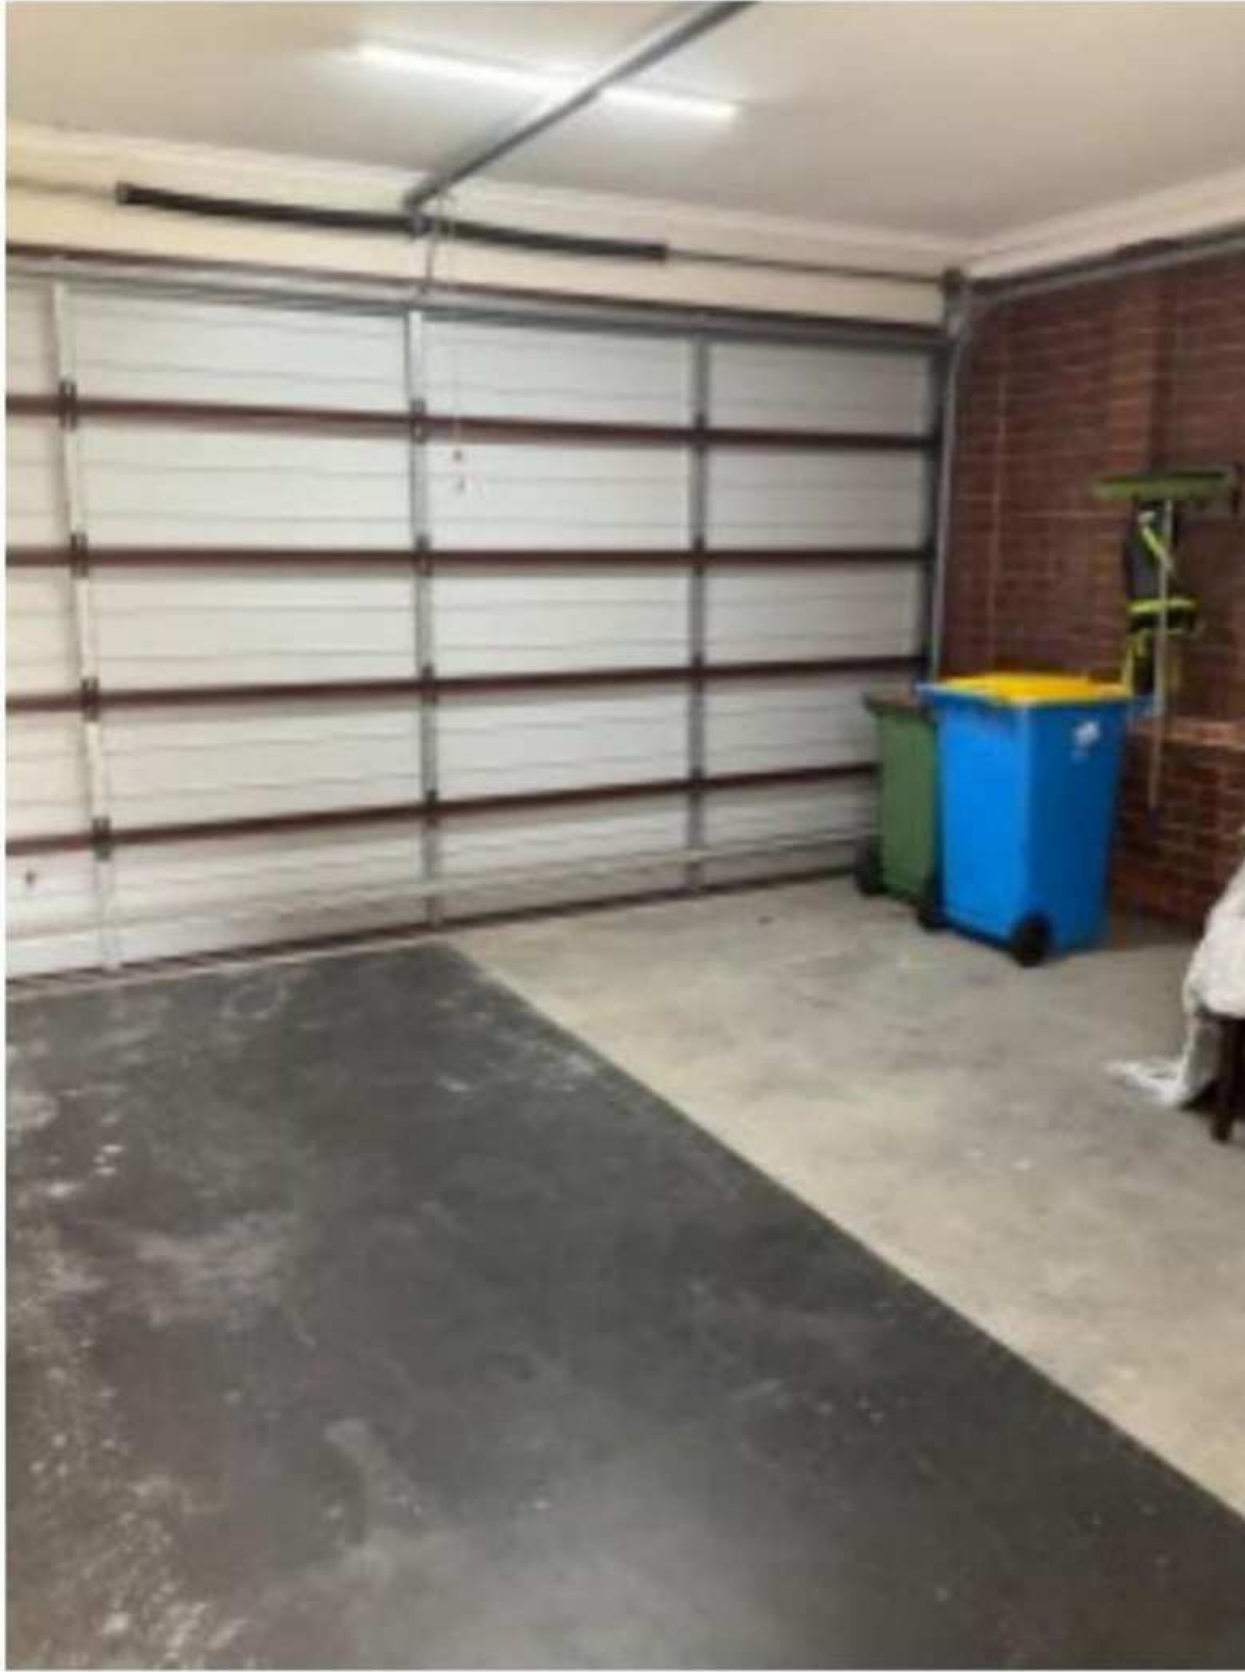
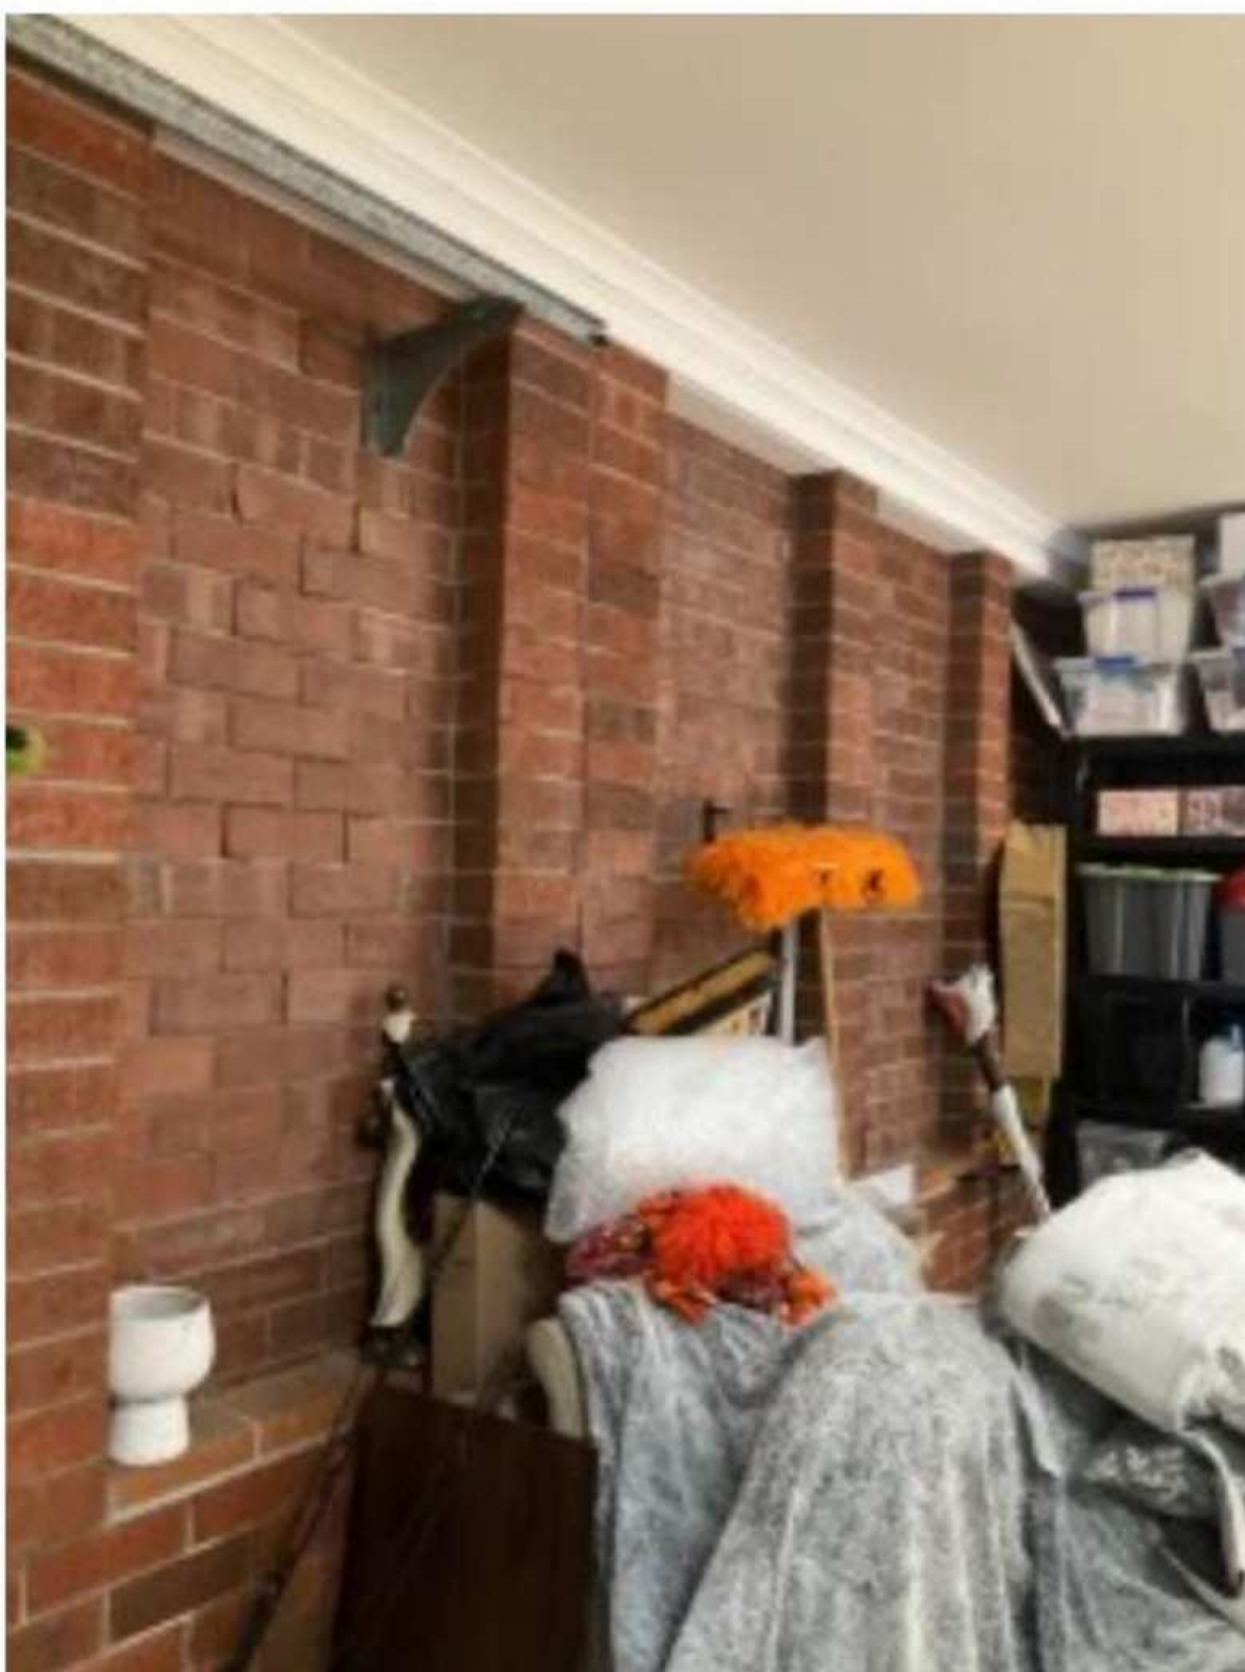
Other: Garage

The brick wall showing visible moisture. This condition can allow moisture ingress and weaken the integrity of the wall. It is recommended to have the affected sections repointed by a qualified professional to restore the wall's stability and prevent potential damage. Regular maintenance should be considered to ensure the longevity of the masonry work.

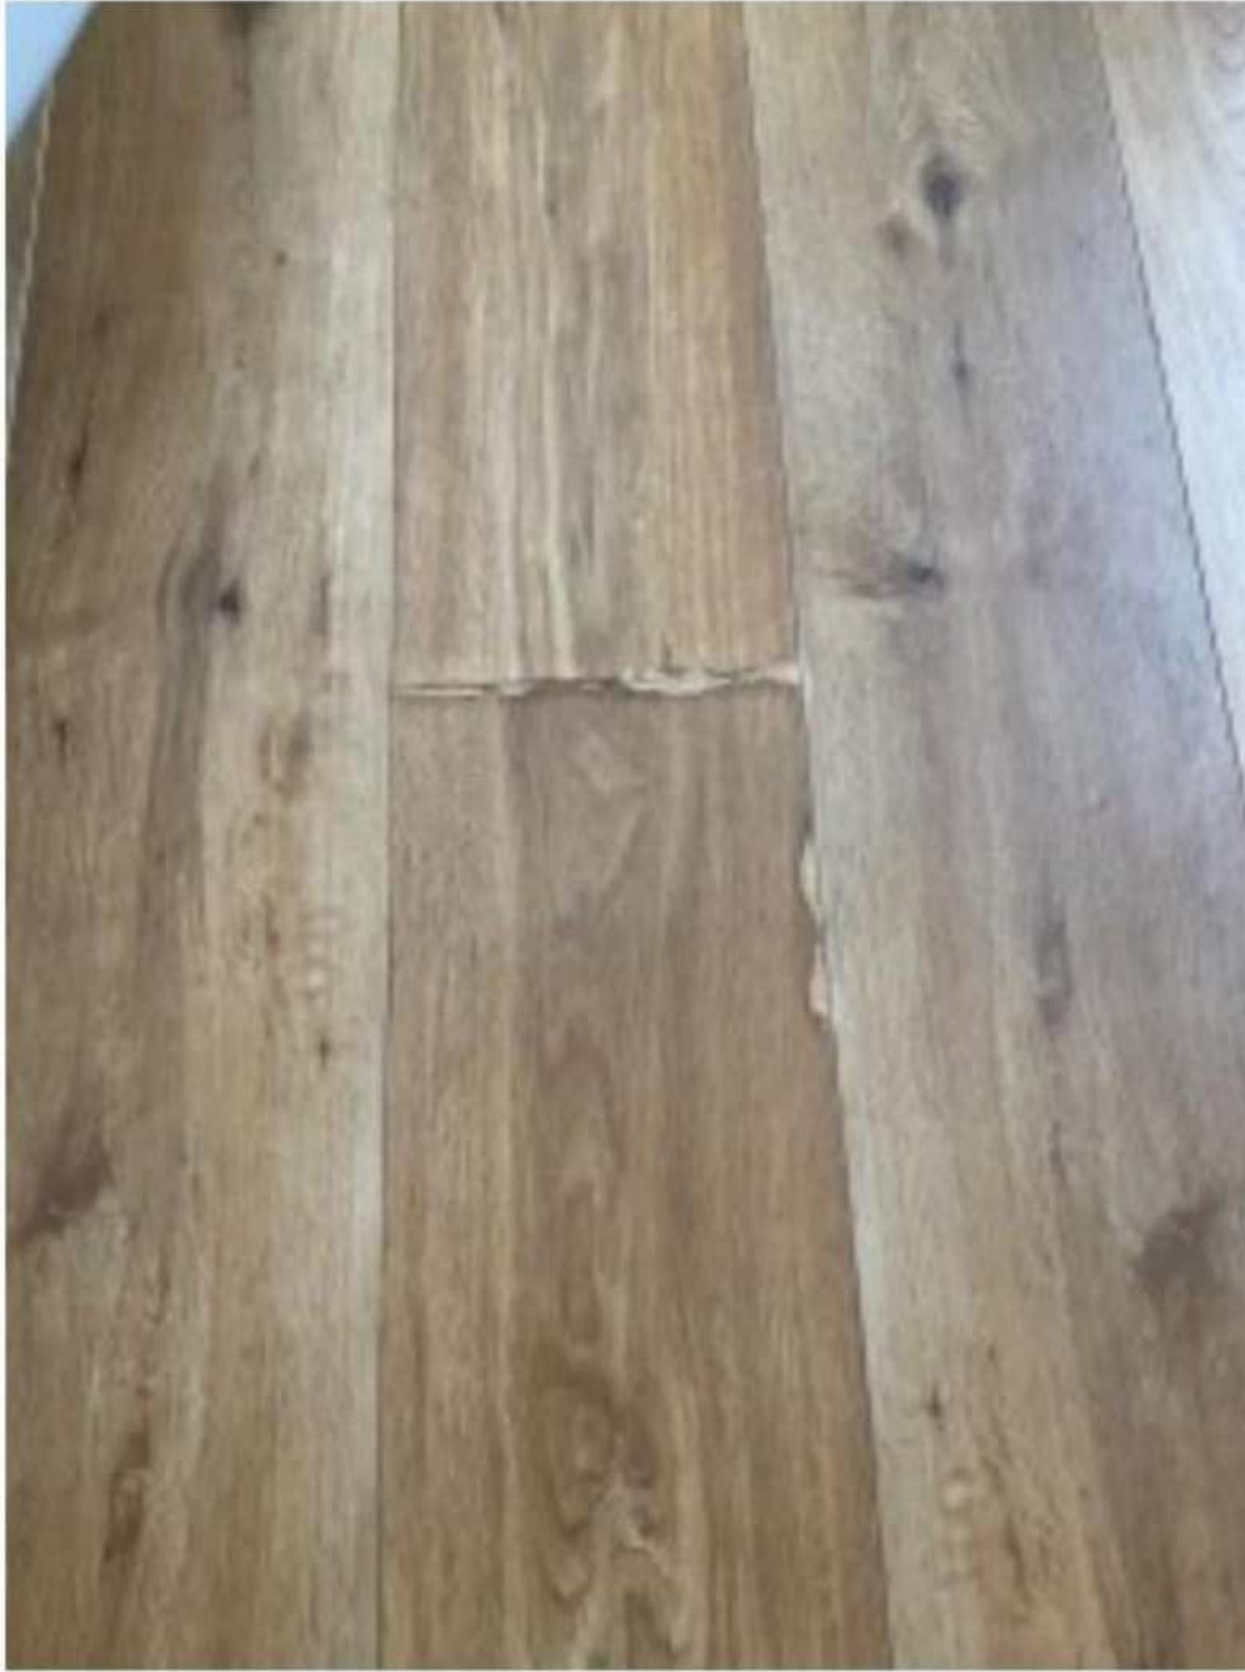
Other: Living area

The flooring shows signs of damage, with visible peeling and separation at the seams of the wood panels. This condition may lead to further deterioration if left unaddressed, potentially compromising the flooring's structural integrity. Timely repair or replacement of the affected areas might be necessary to prevent further issues and maintain the quality and appearance of the floor.

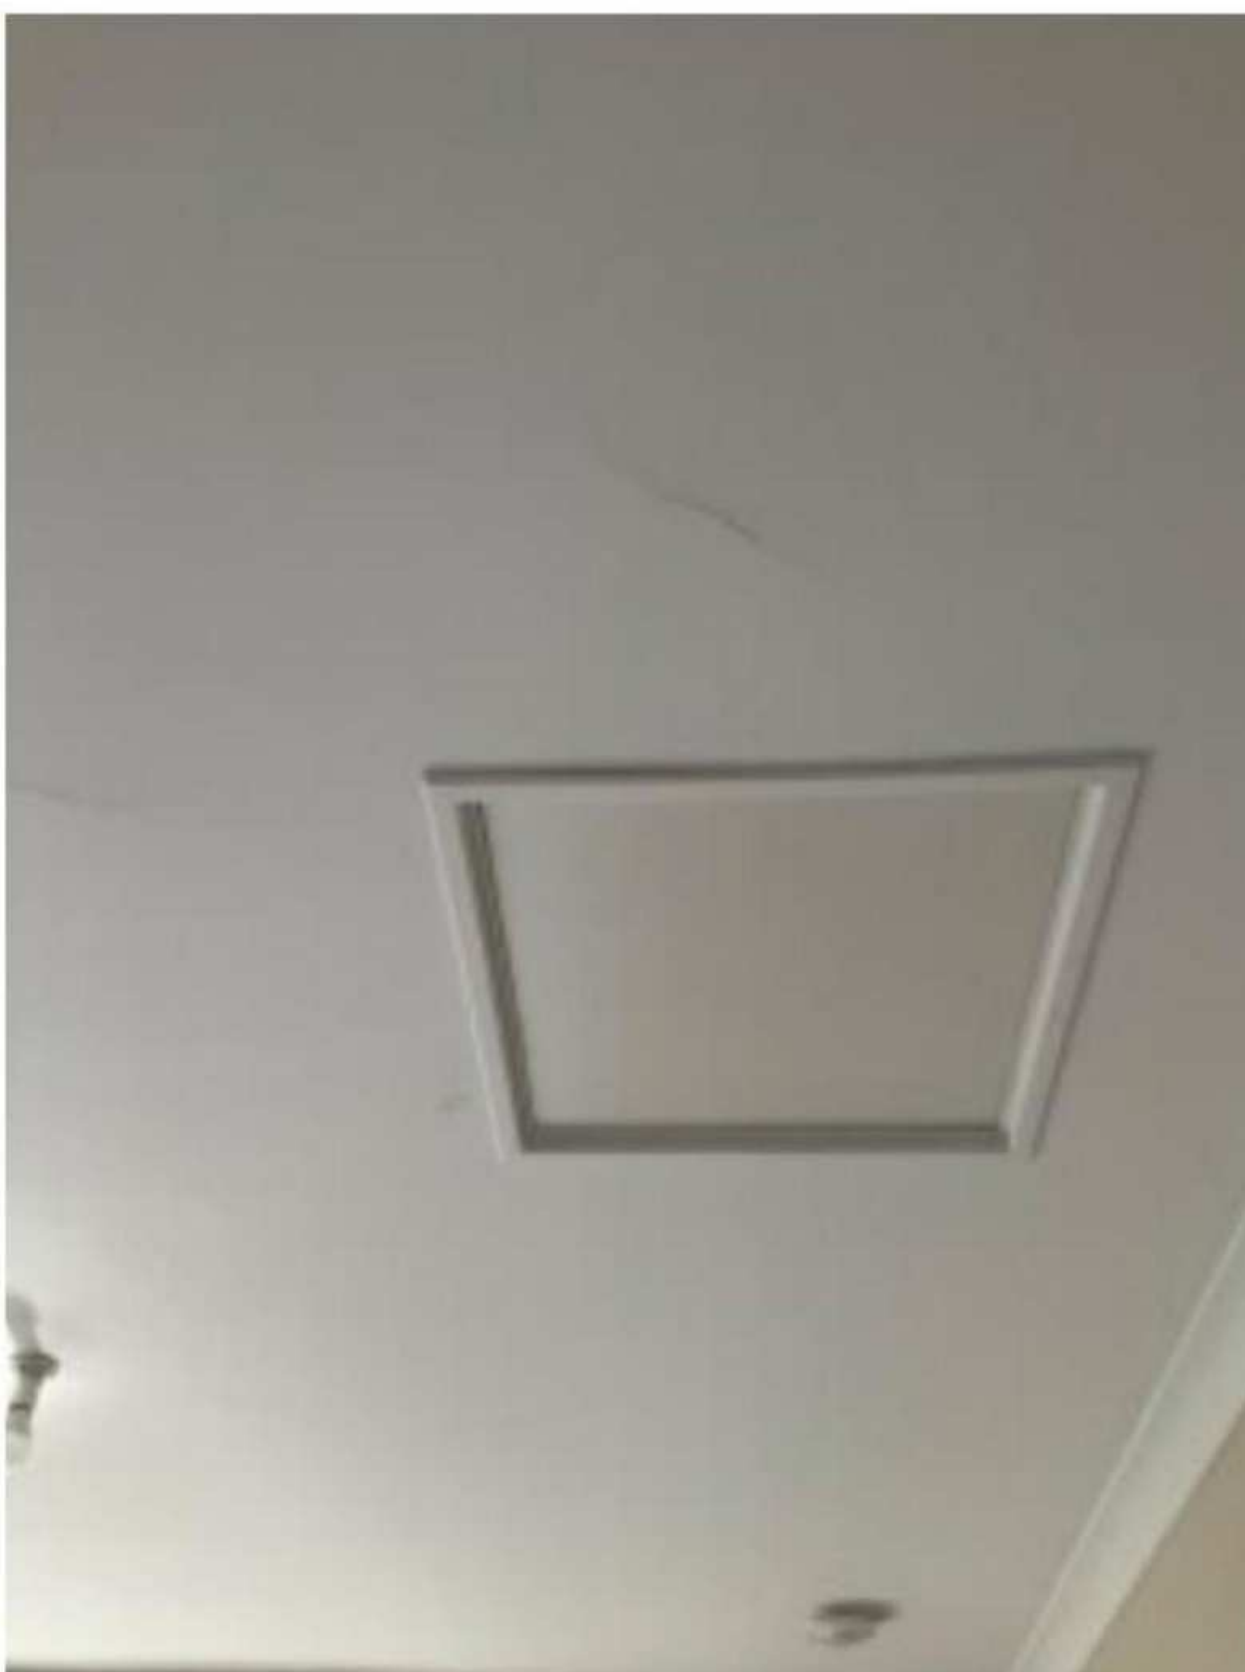
Other: 2nd level ceiling

The ceiling exhibits a noticeable crack adjacent to an access panel. This crack may suggest minor movement or settling of the ceiling materials. While the integrity of the overall structure does not seem compromised, it is recommended to monitor the crack for any progression. Minor repairs may be required to prevent further damage and ensure aesthetic appeal is maintained. Regular inspection by a qualified professional is advised to assess any underlying issues.

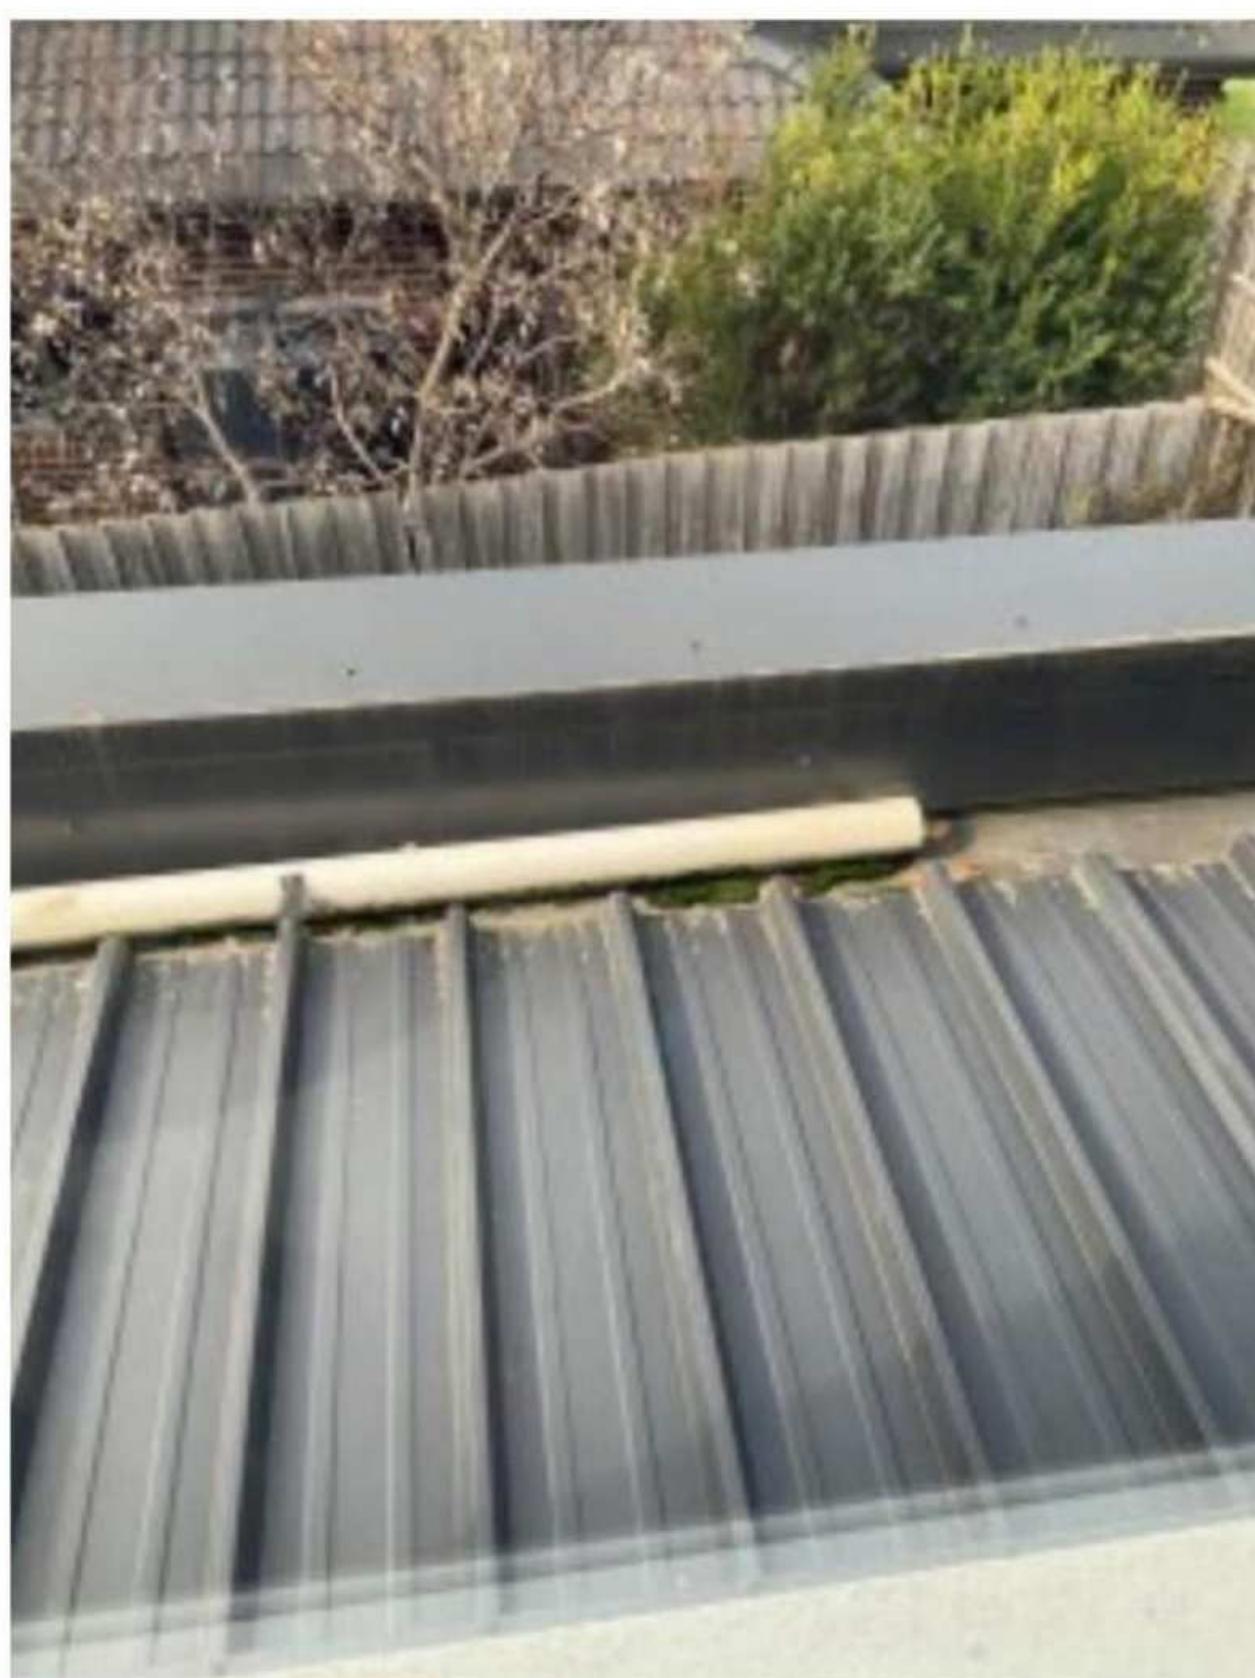
### **Roof space exterior**

Visible signs of moss a growth along the edge of the roof gutter . This can potentially lead to water pooling and subsequent roof deterioration, affecting its integrity. Regular maintenance and possibly enhancing the drainage system would be advisable to prevent further issues and ensure roof longevity.

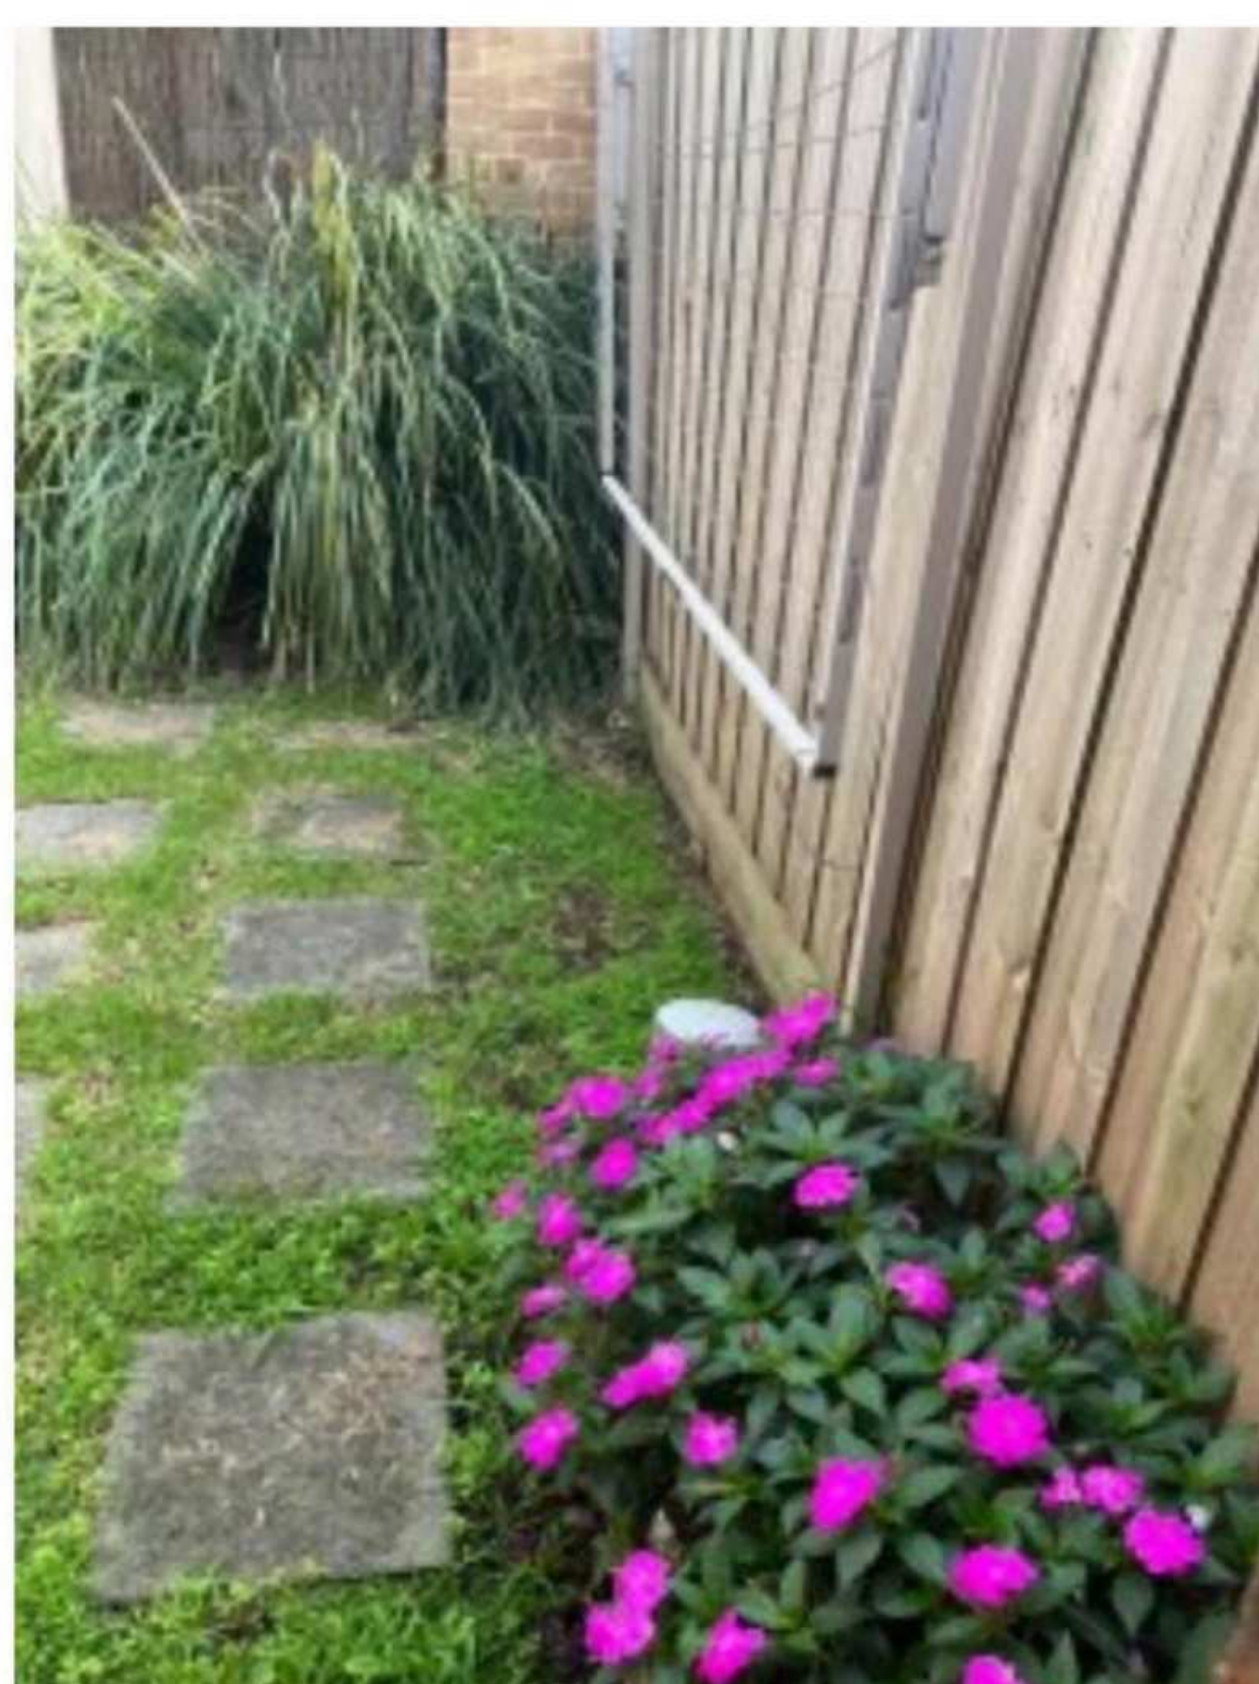
Vegetation is growing against the wall, potentially exacerbating moisture retention and contributing to decay or pest attraction. It is advisable to address these issues by improving drainage and managing vegetation to protect the building from potential damage.

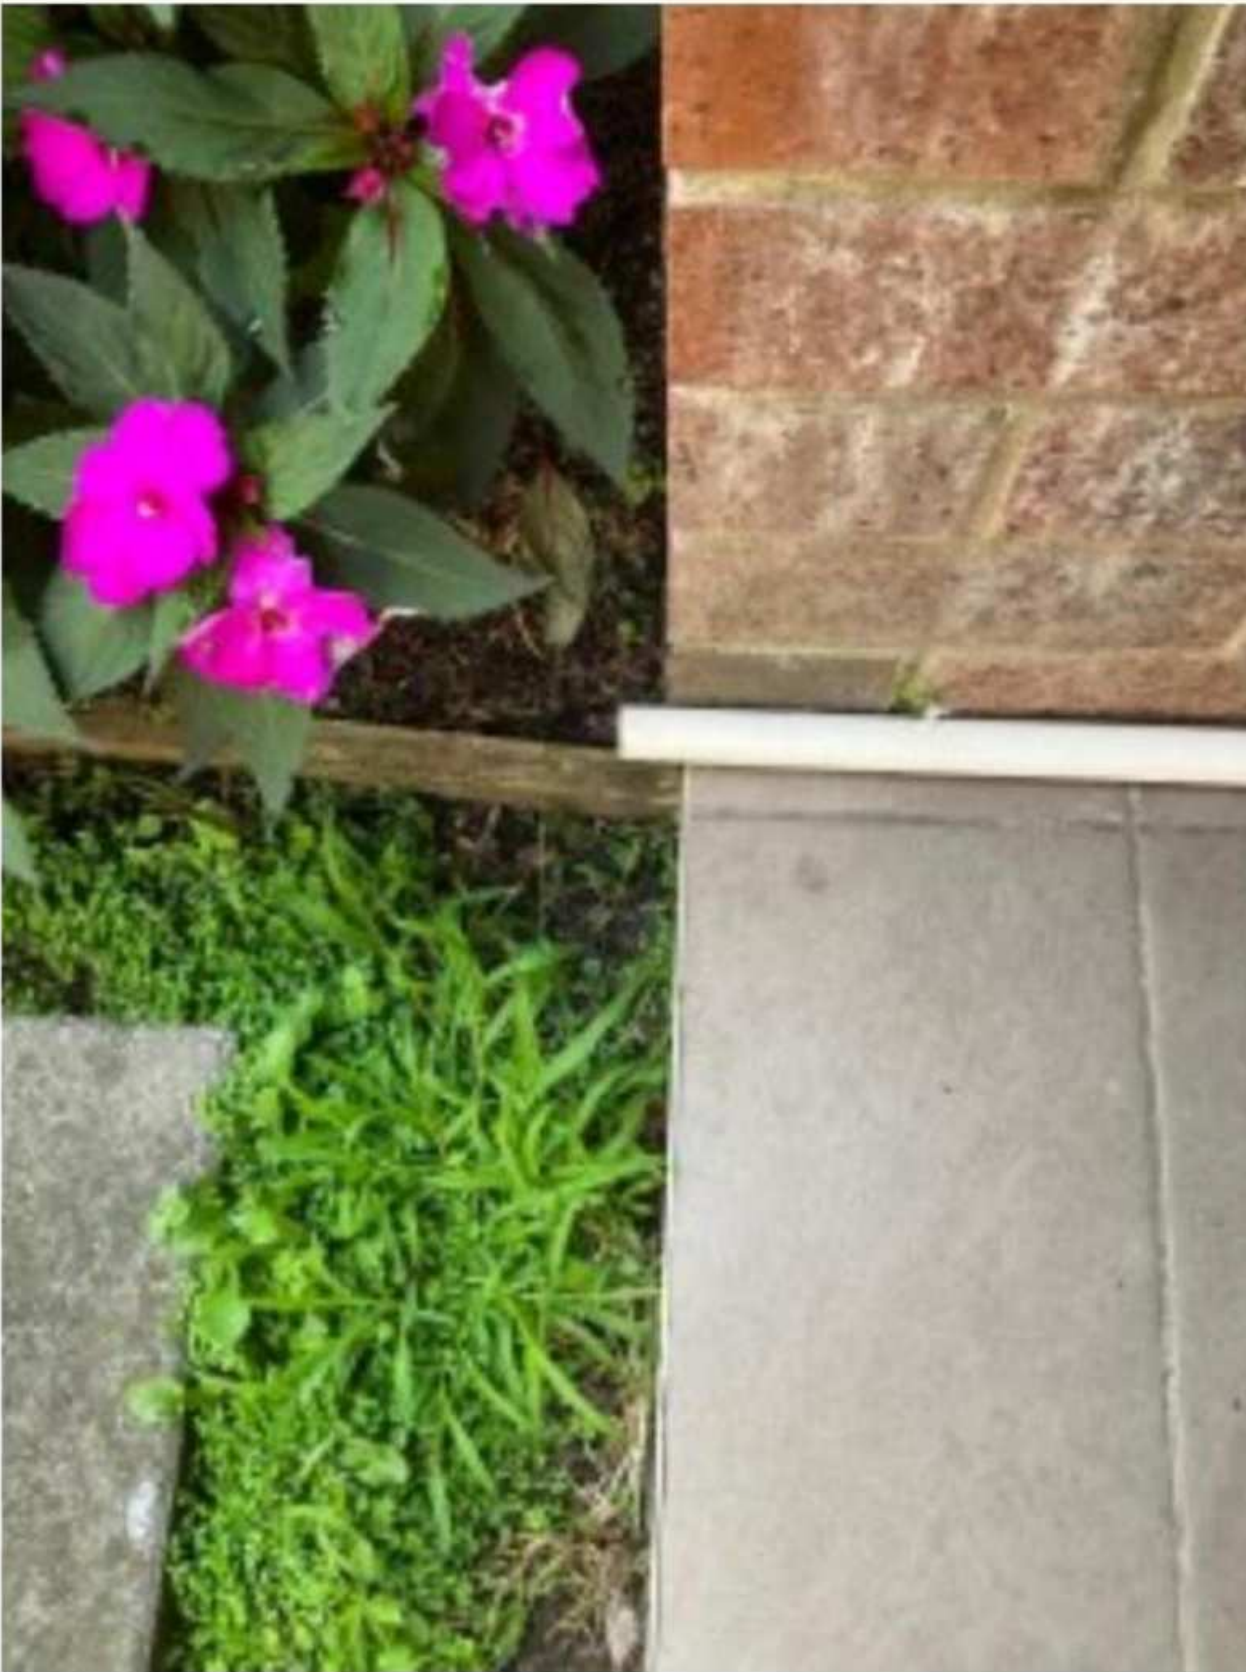
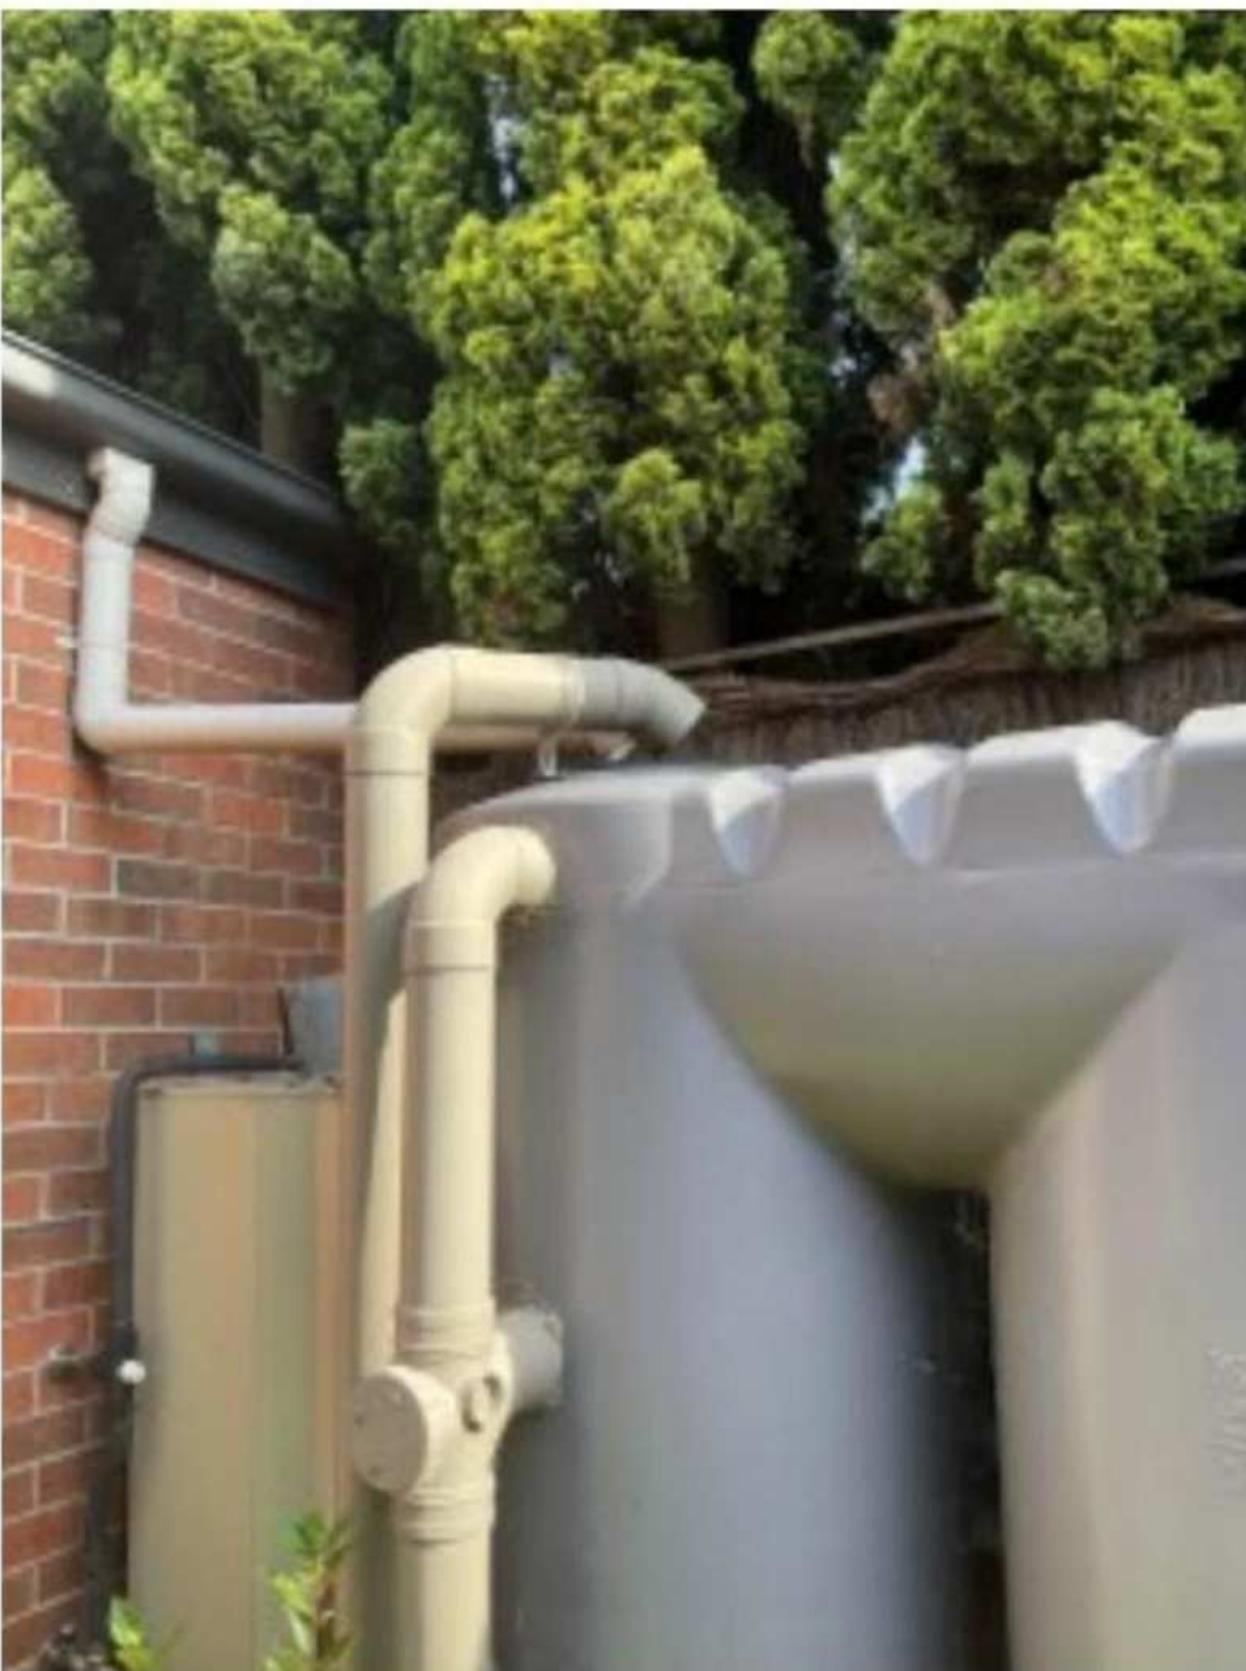
Down pipe connection not connecting directly to the water tank potentially leading to issues with water flow and leaks. It is recommended to assess and rectify by qualified plumber.

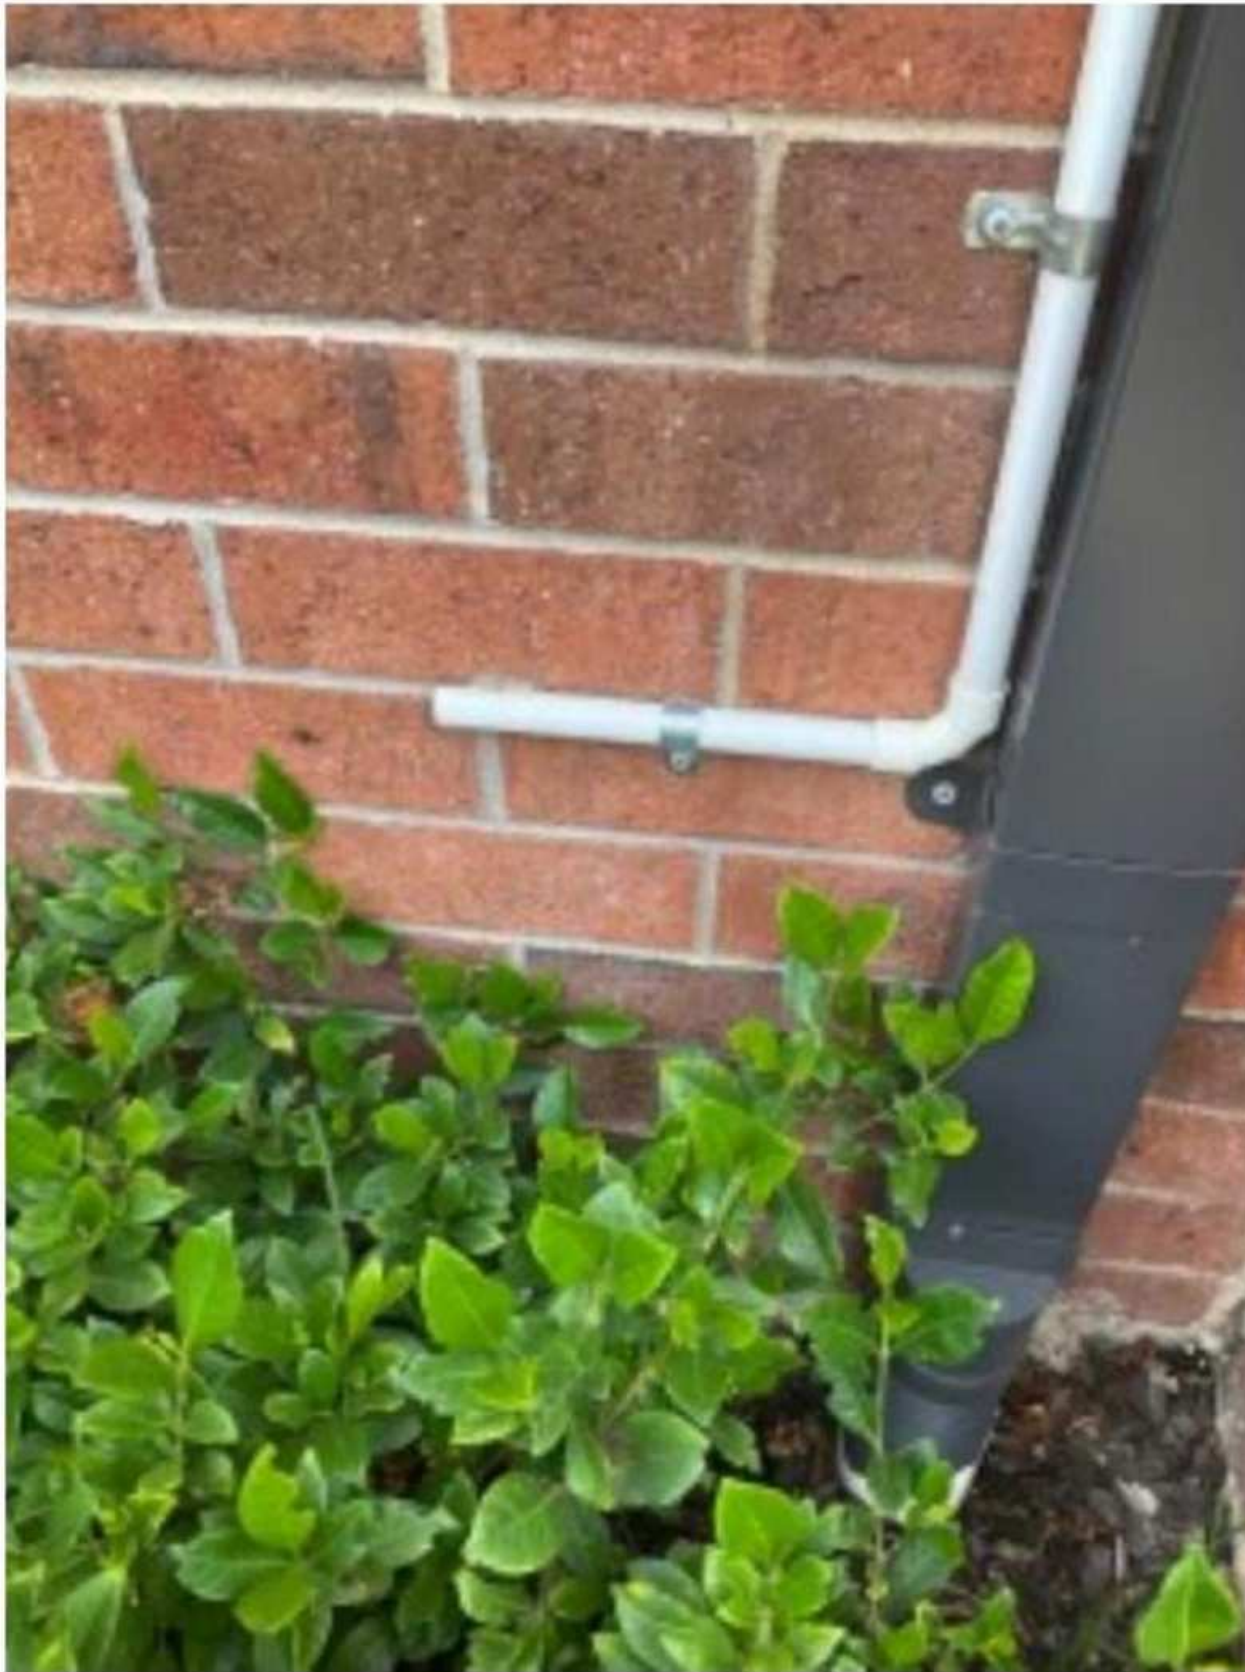
Drainpipe not connected to storm drainage system. This can lead to potential issues such as moisture retention against the wall, which might cause damage over time. It is recommended to engage a qualified plumber to connect.
