Thank you for the opportunity to carry out a dilapidation inspection at the above property in order to document existing cracking prior to the commencement of construction works at your property.

The two-storey property is of single skin brick and timber frame construction with brick veneer exterior walls, internal brick walls and timber ceilings, timber windows and a pitched roof clad with concrete tiles.

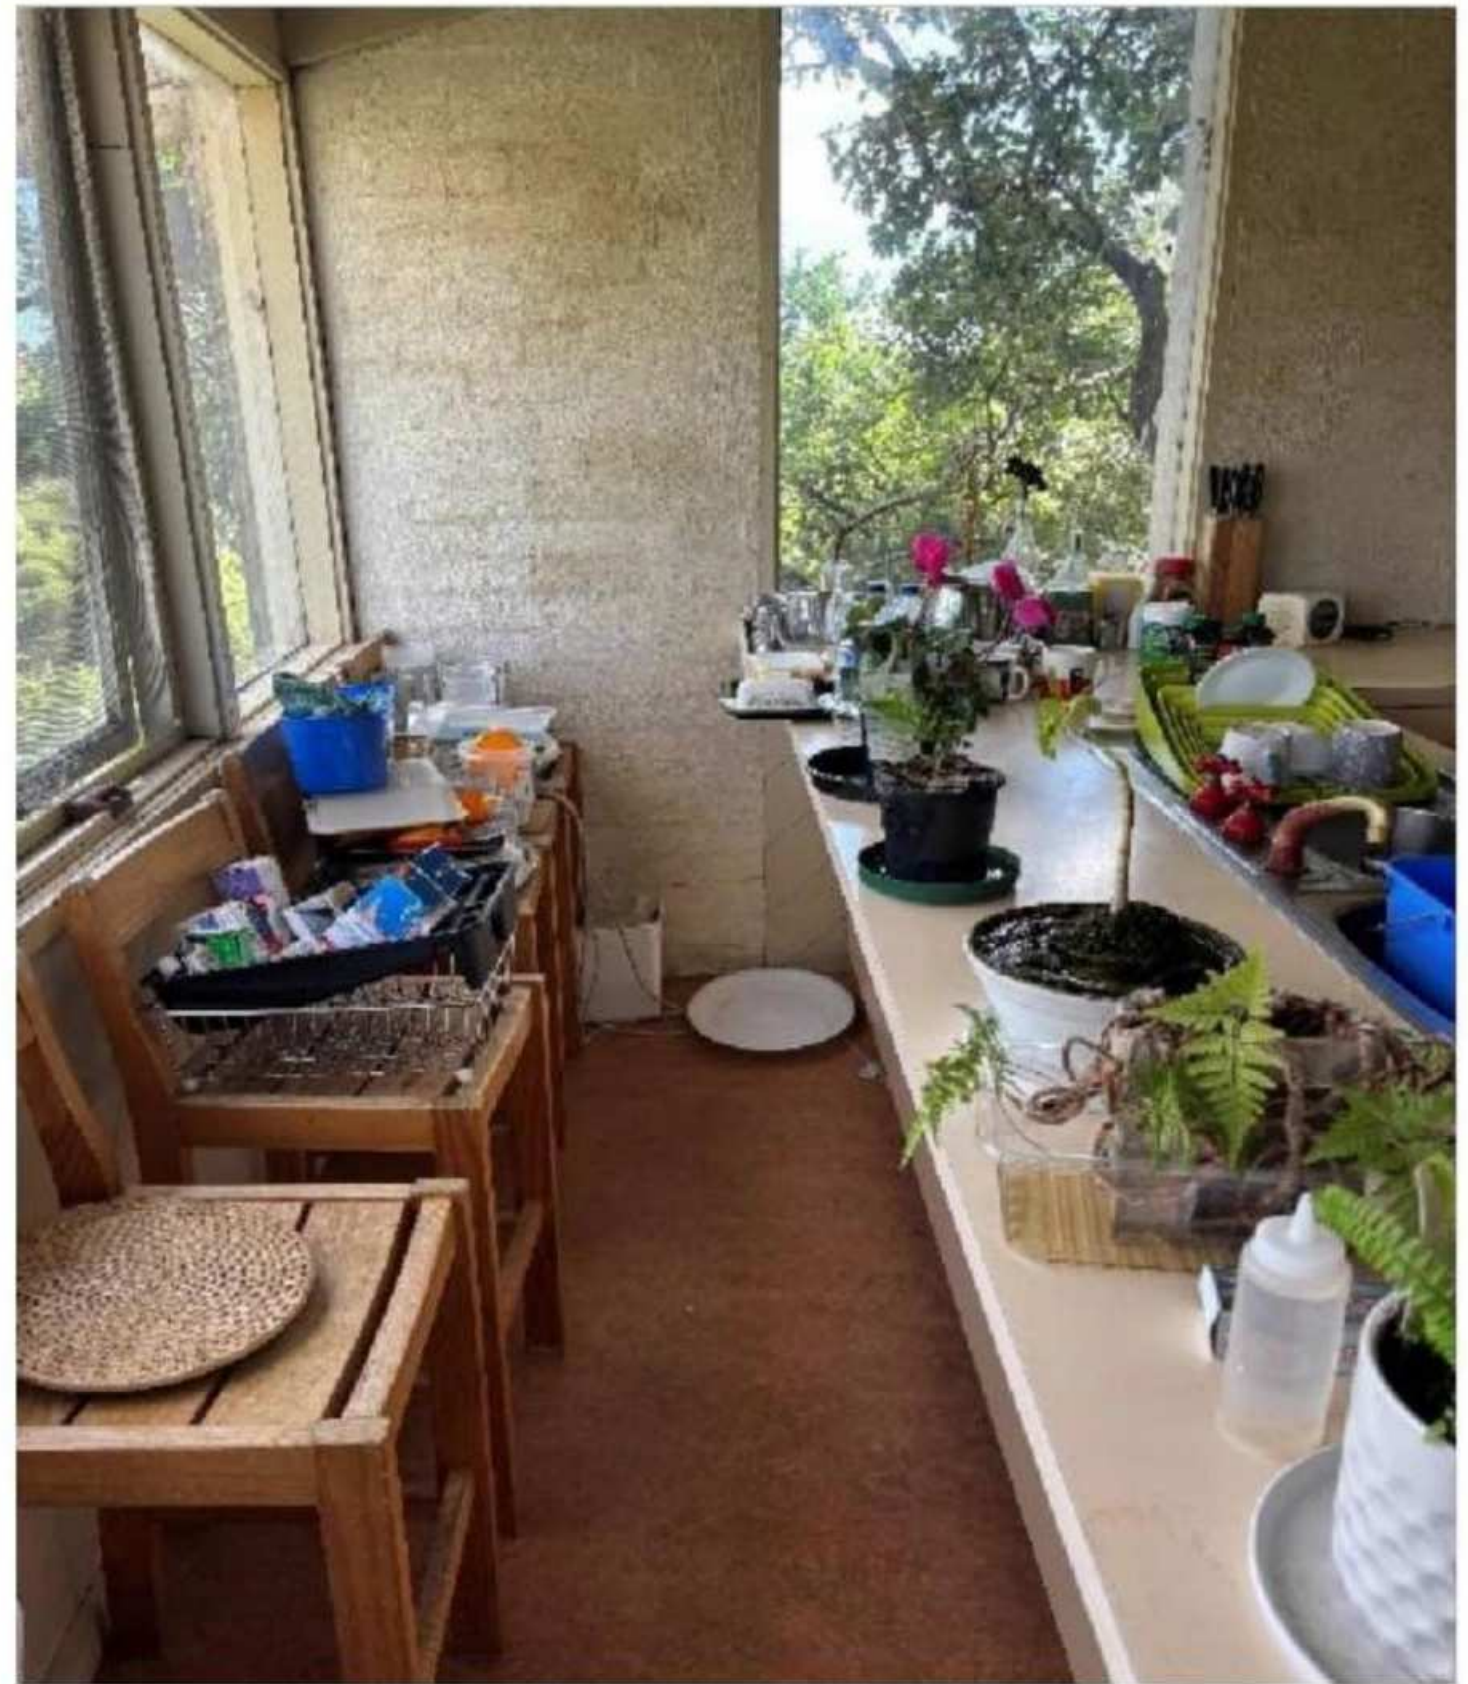
Kitchen Evidence of fine cracking to northern wall.  
Evidence of water damage (severe) to ceiling & water ingress.

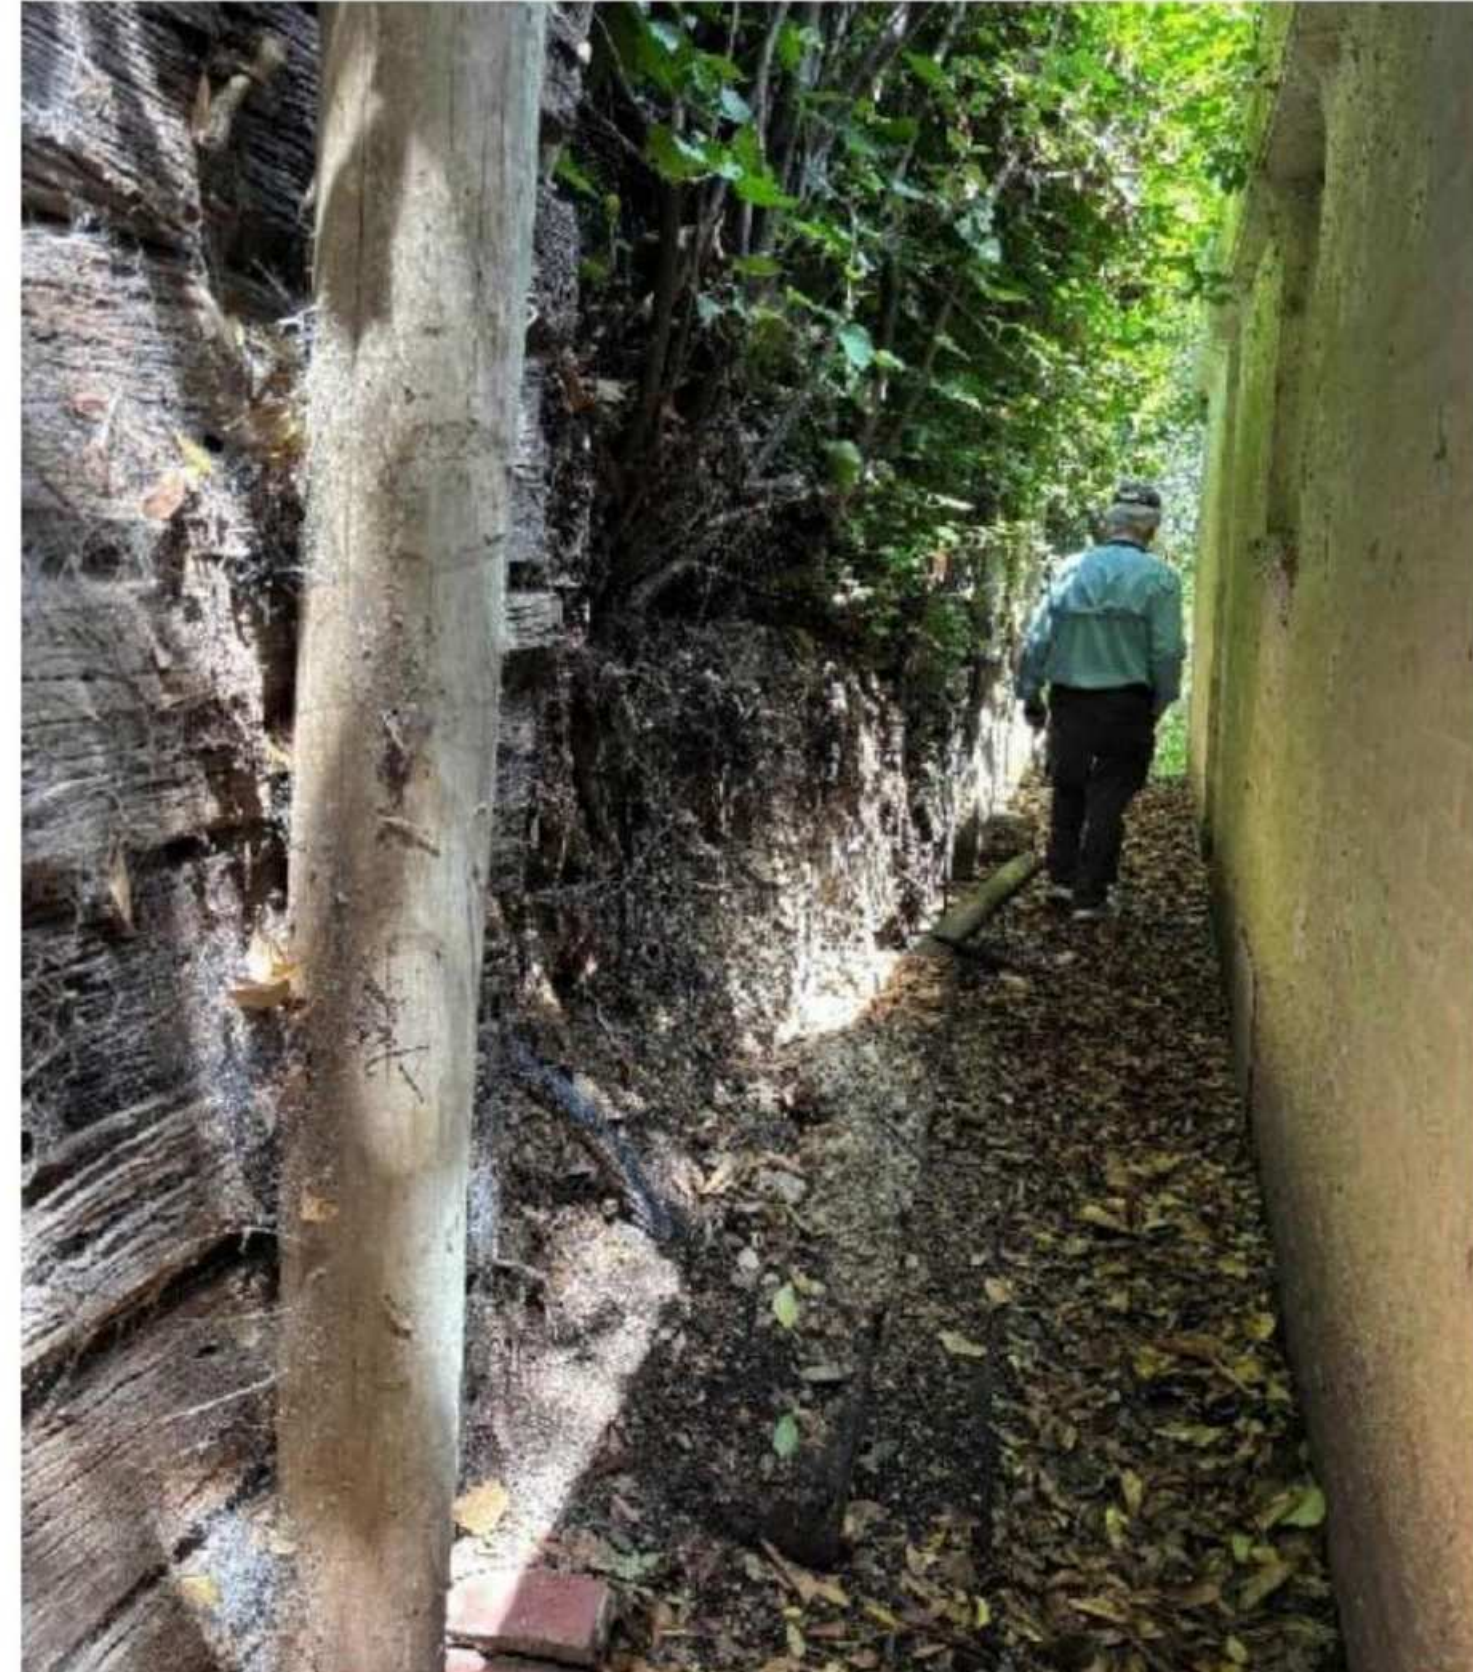
South side retaining wall

Retaining Walls Timber retaining walls on the southern side have collapsed in some sections with one area in very bad condition.  
Timber retaining walls on the eastern side are severely deteriorated.

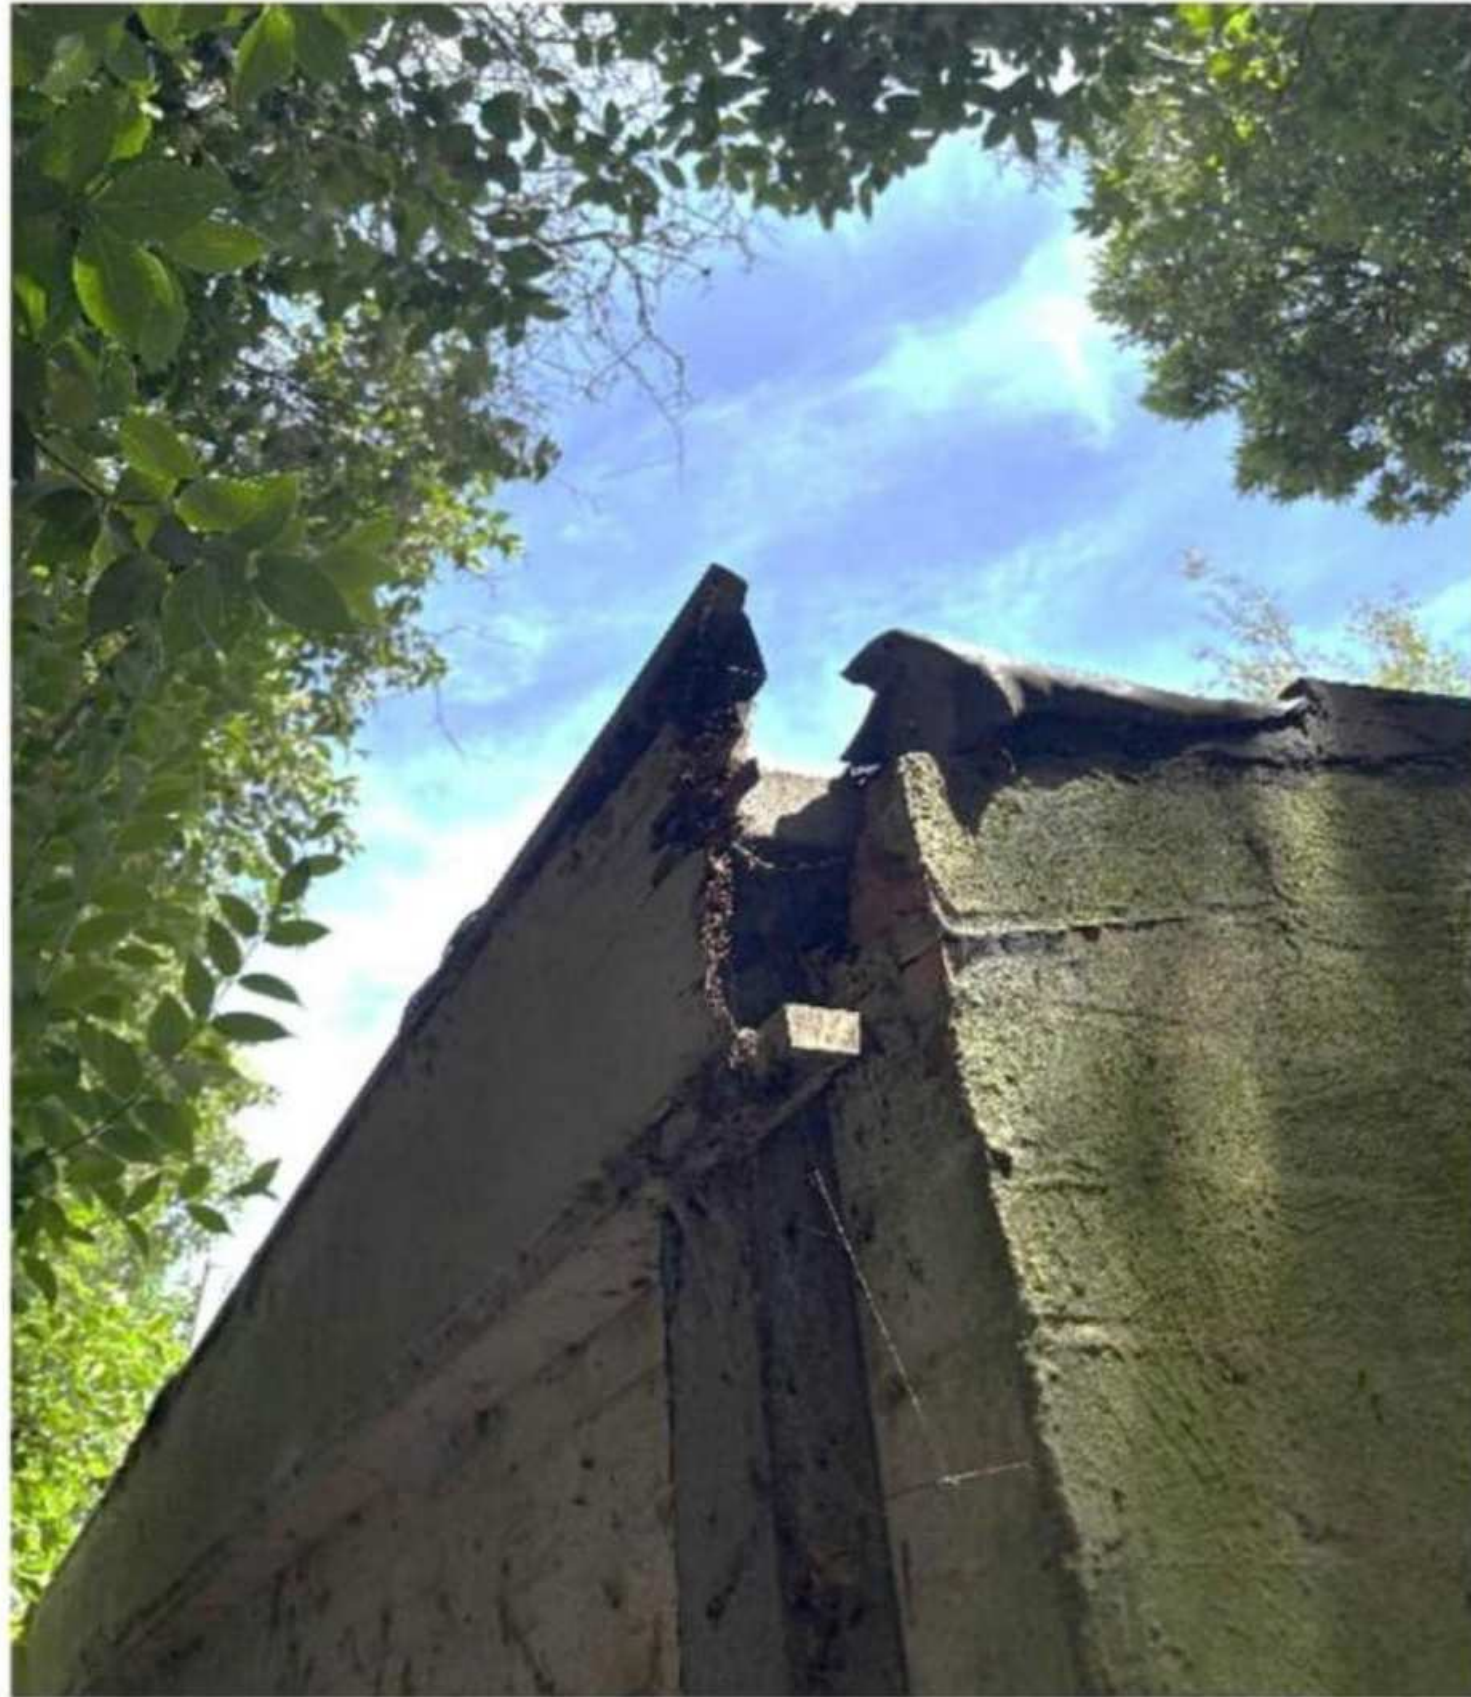
External Walls Timber fascia on southern side of dwelling have rotted.  
Fine cacking to brick wall on eastern wall (next to light).  
Evidence of repairs to external brick wall.  
Evidence of fine cracking to brick wall on western side.  
Evidence of fine cracking to brick wall on eastern front wall.  
Evidence of fine cracking to brick wall on southern side wall and northern side of the carport.  
Evidence of fine cracking to brick wall on north/western wall.

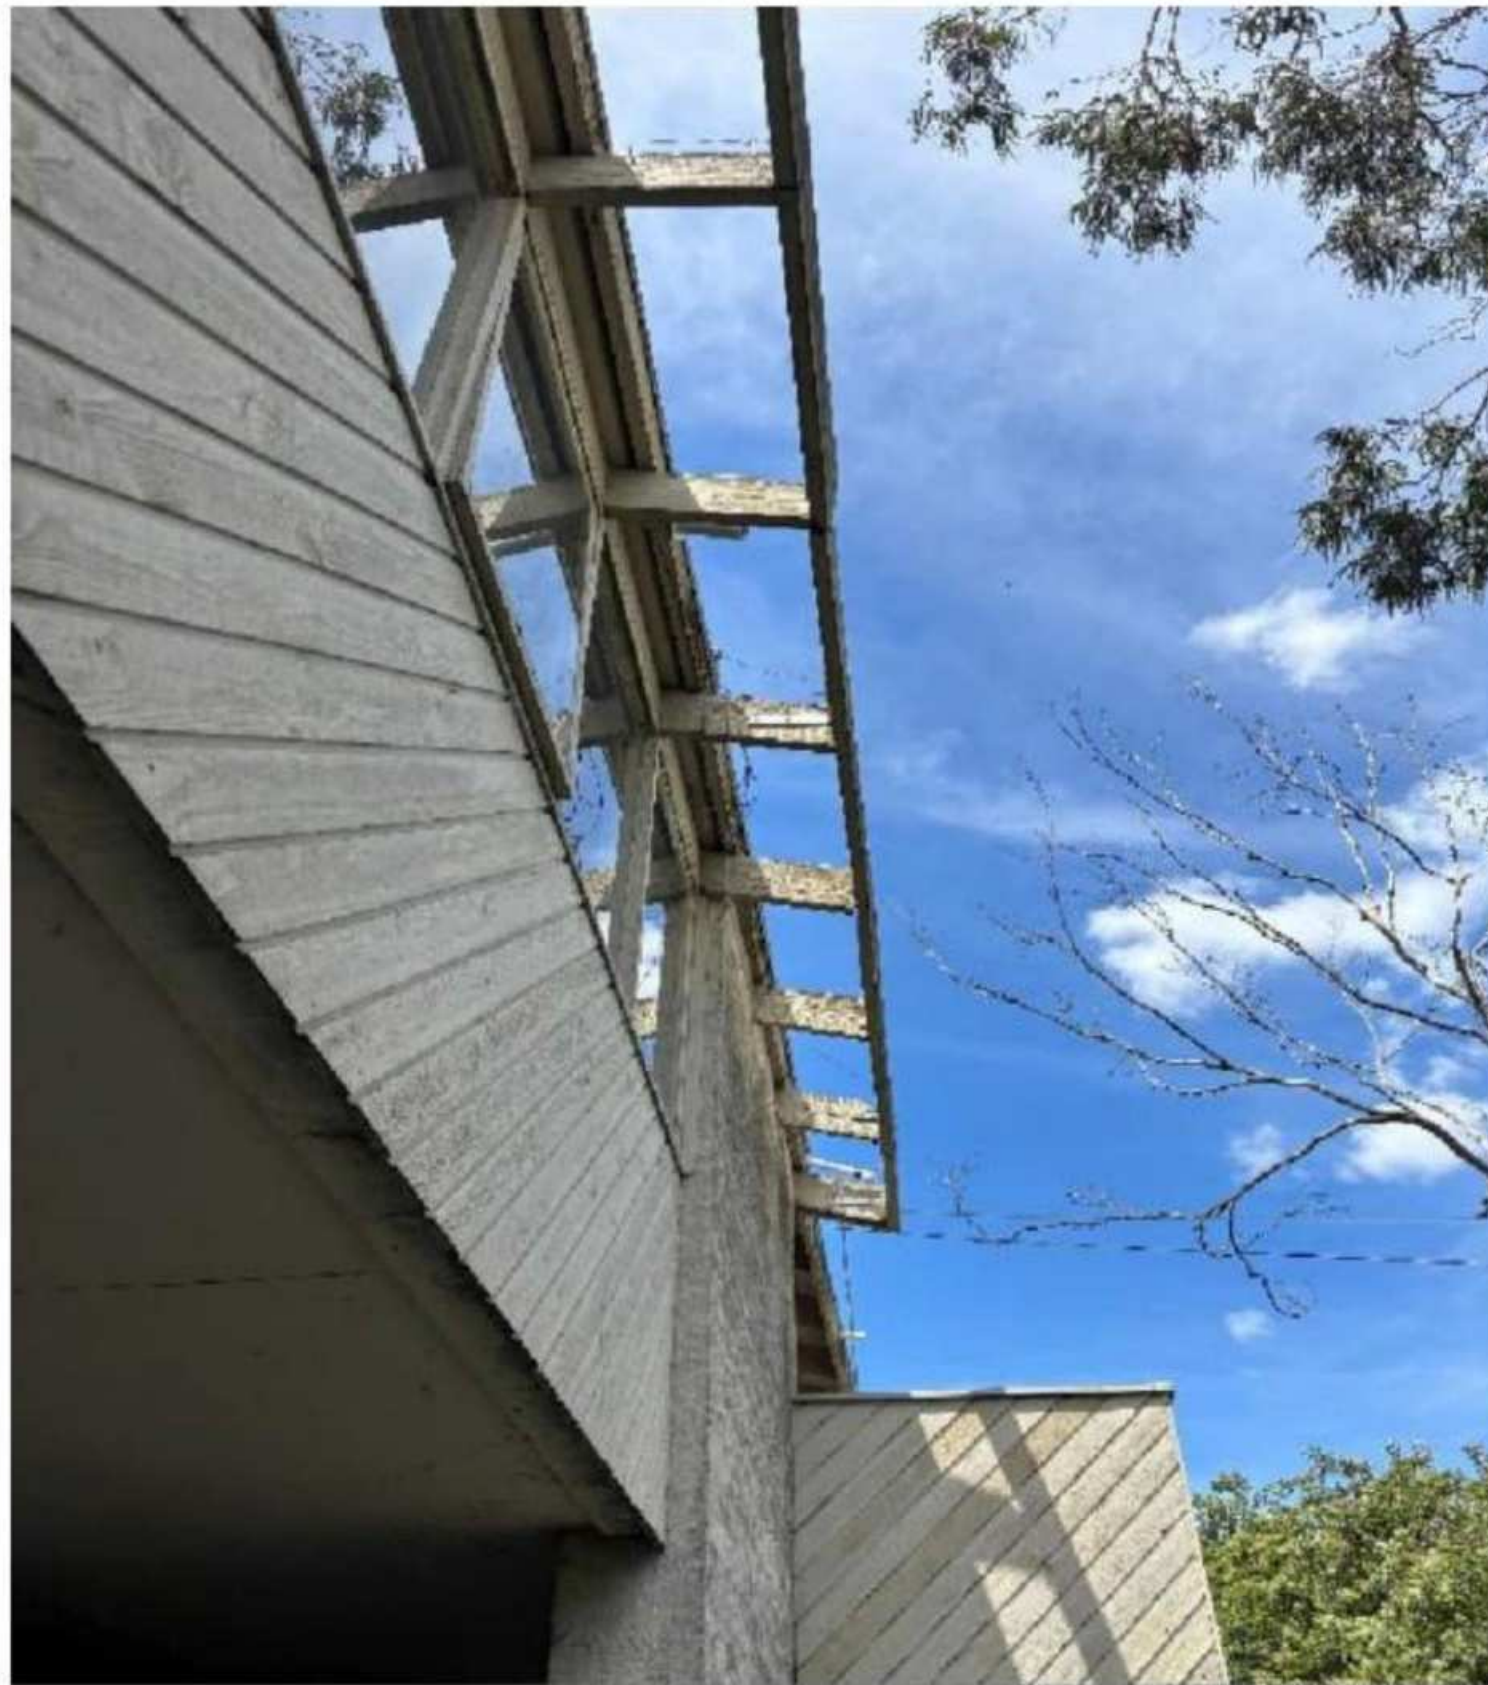
External rafter

Exposed Rafters Exposed rafters and other exposed timber frame (pergola) are deteriorated and rotted.

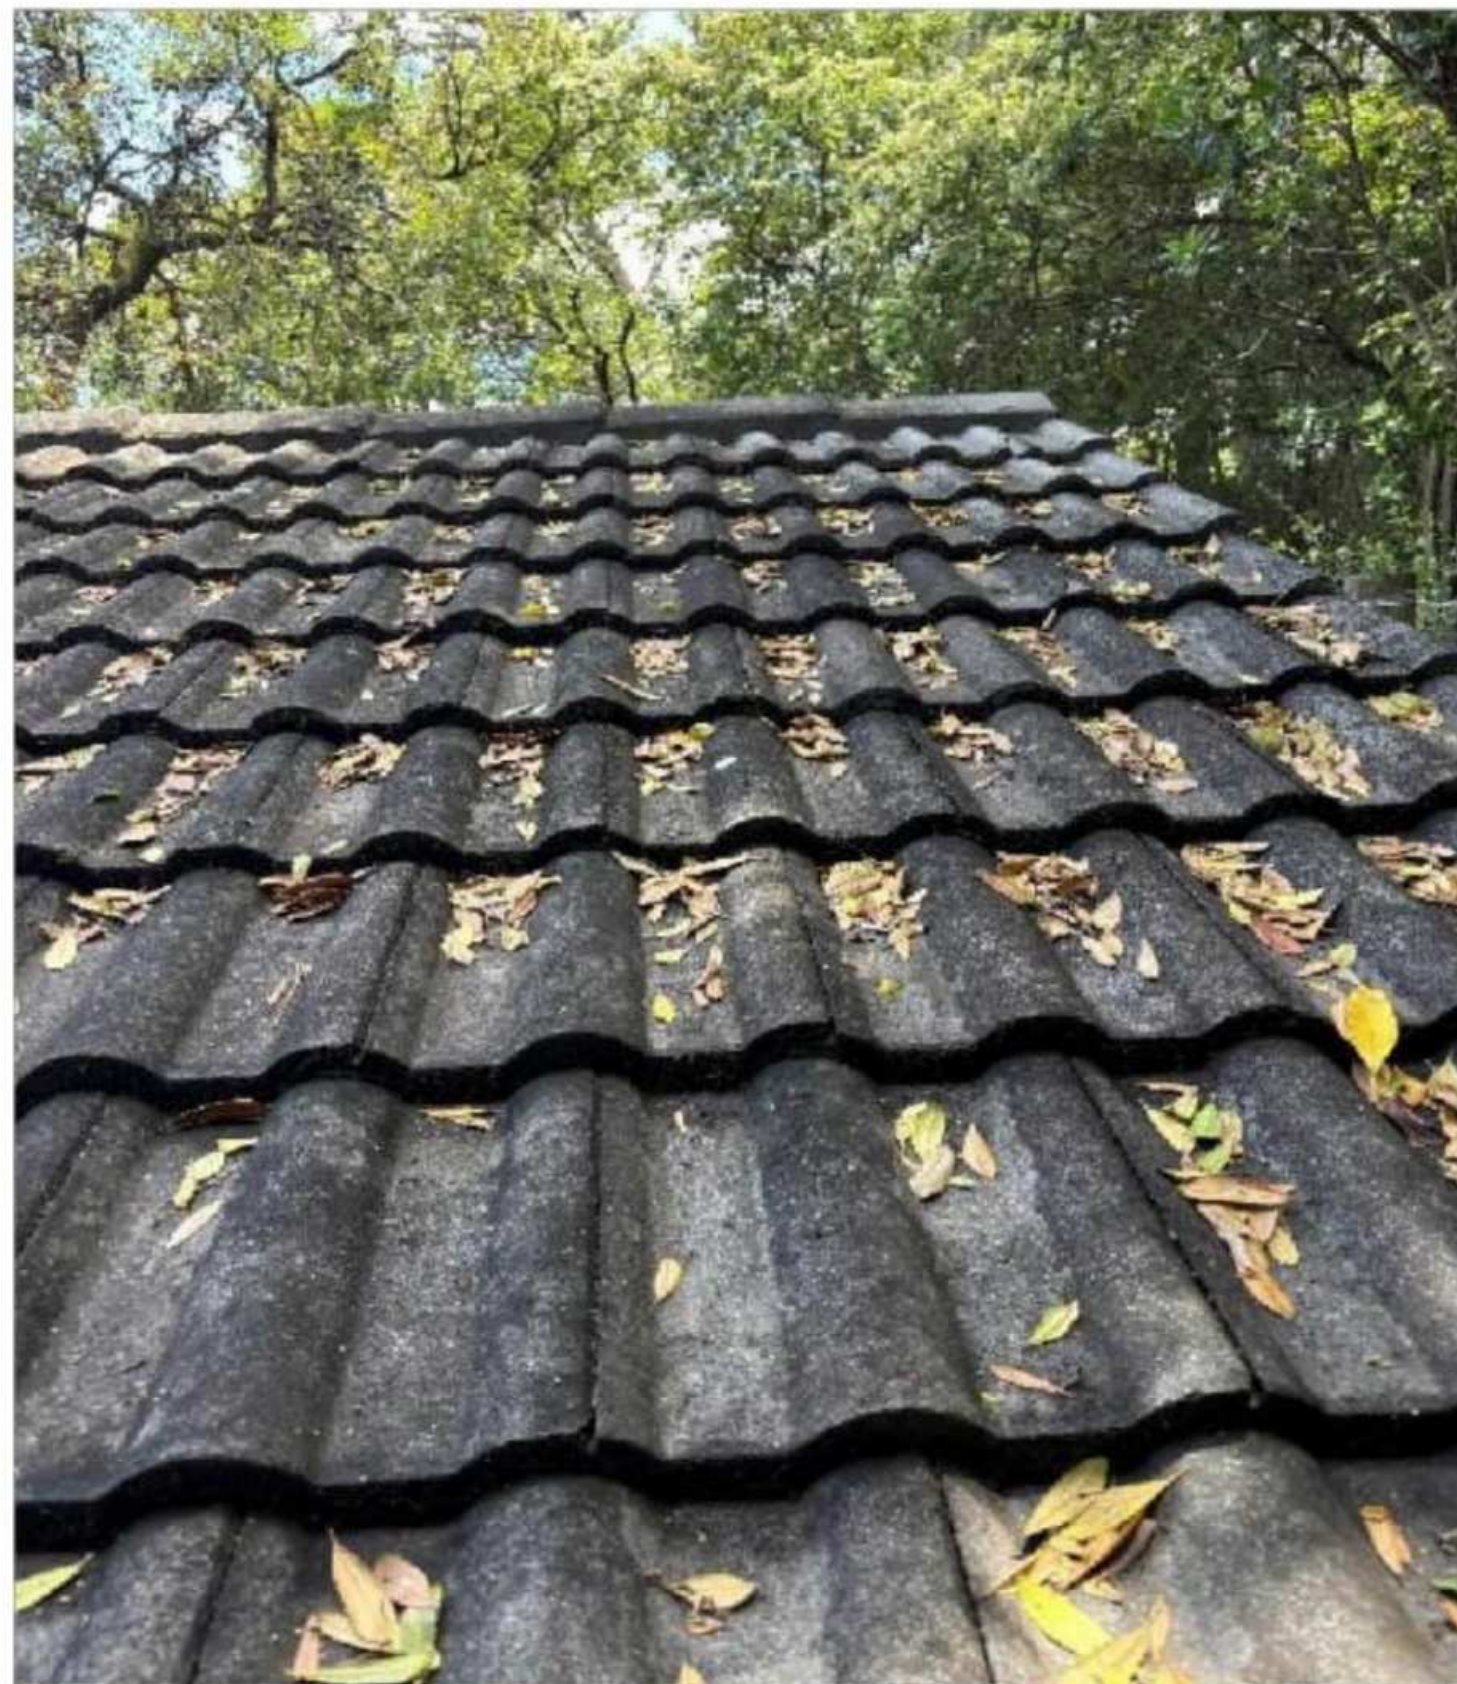
Roof tiles

Roof Tiles Chipped roof tiles.
