Thank you for the opportunity to inspect the preparation and application of paintwork of your home under construction. We attended the site on Wednesday, 27 November, 2024 and make the following comment on the quality and compliance of the works to date;

# Quality Assurance Inspection

Preparation and application of paintwork and workmanship only.

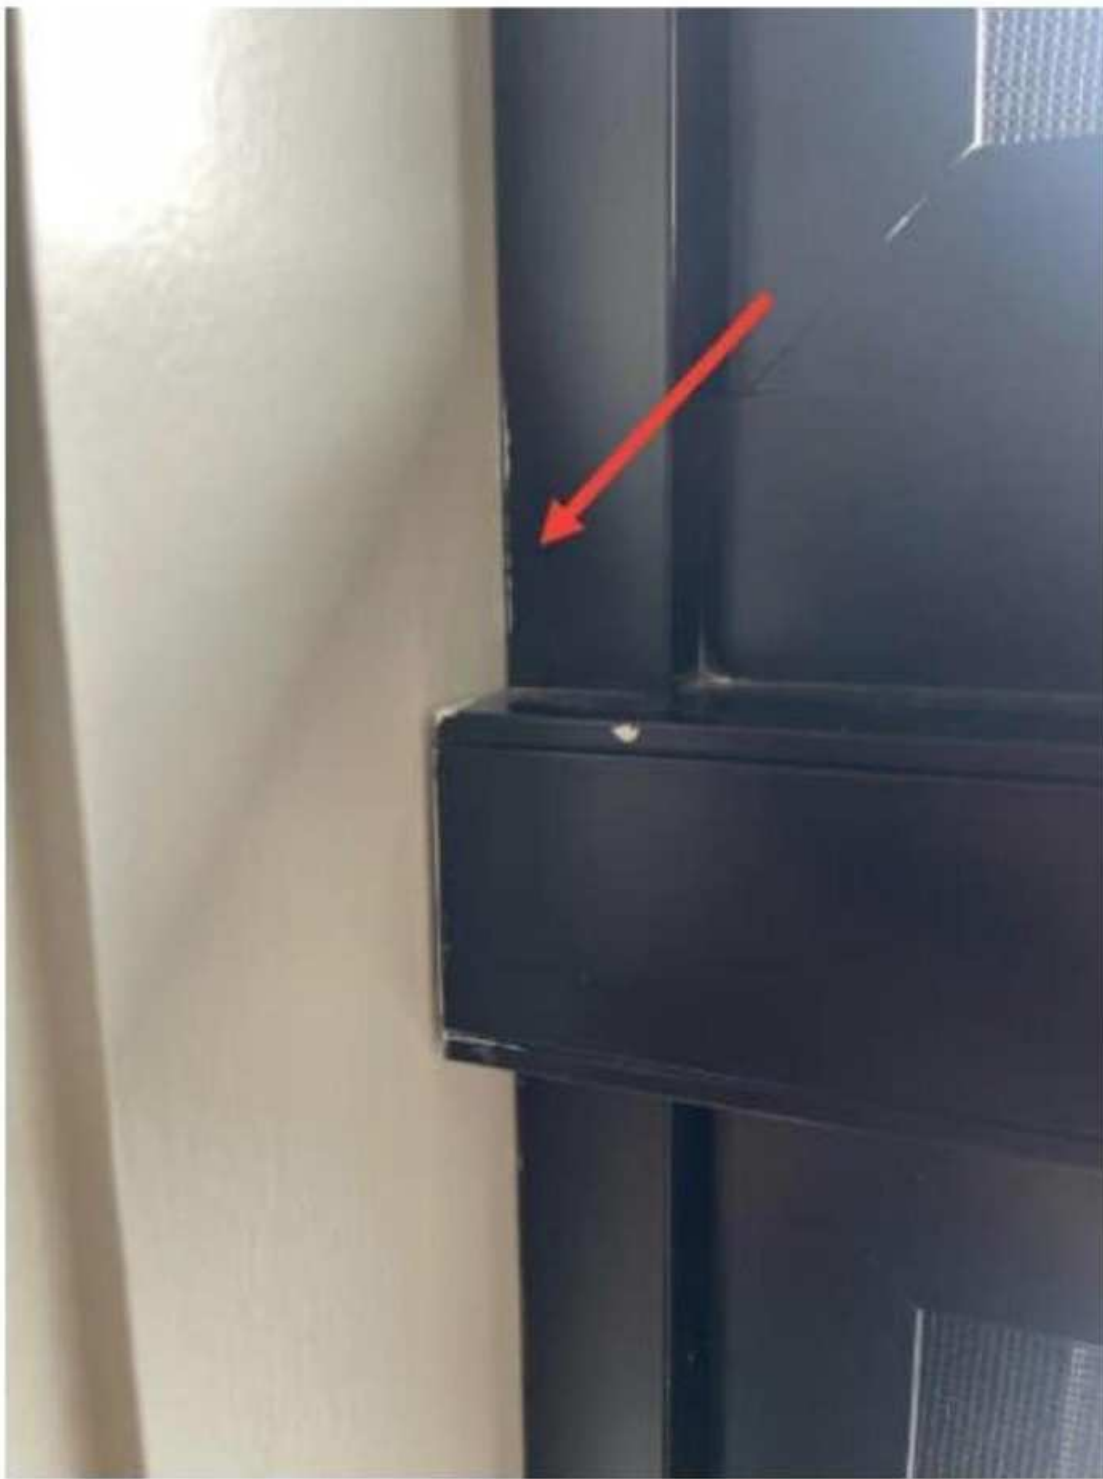
Cleaning of paintwork is required around multiple window frames.

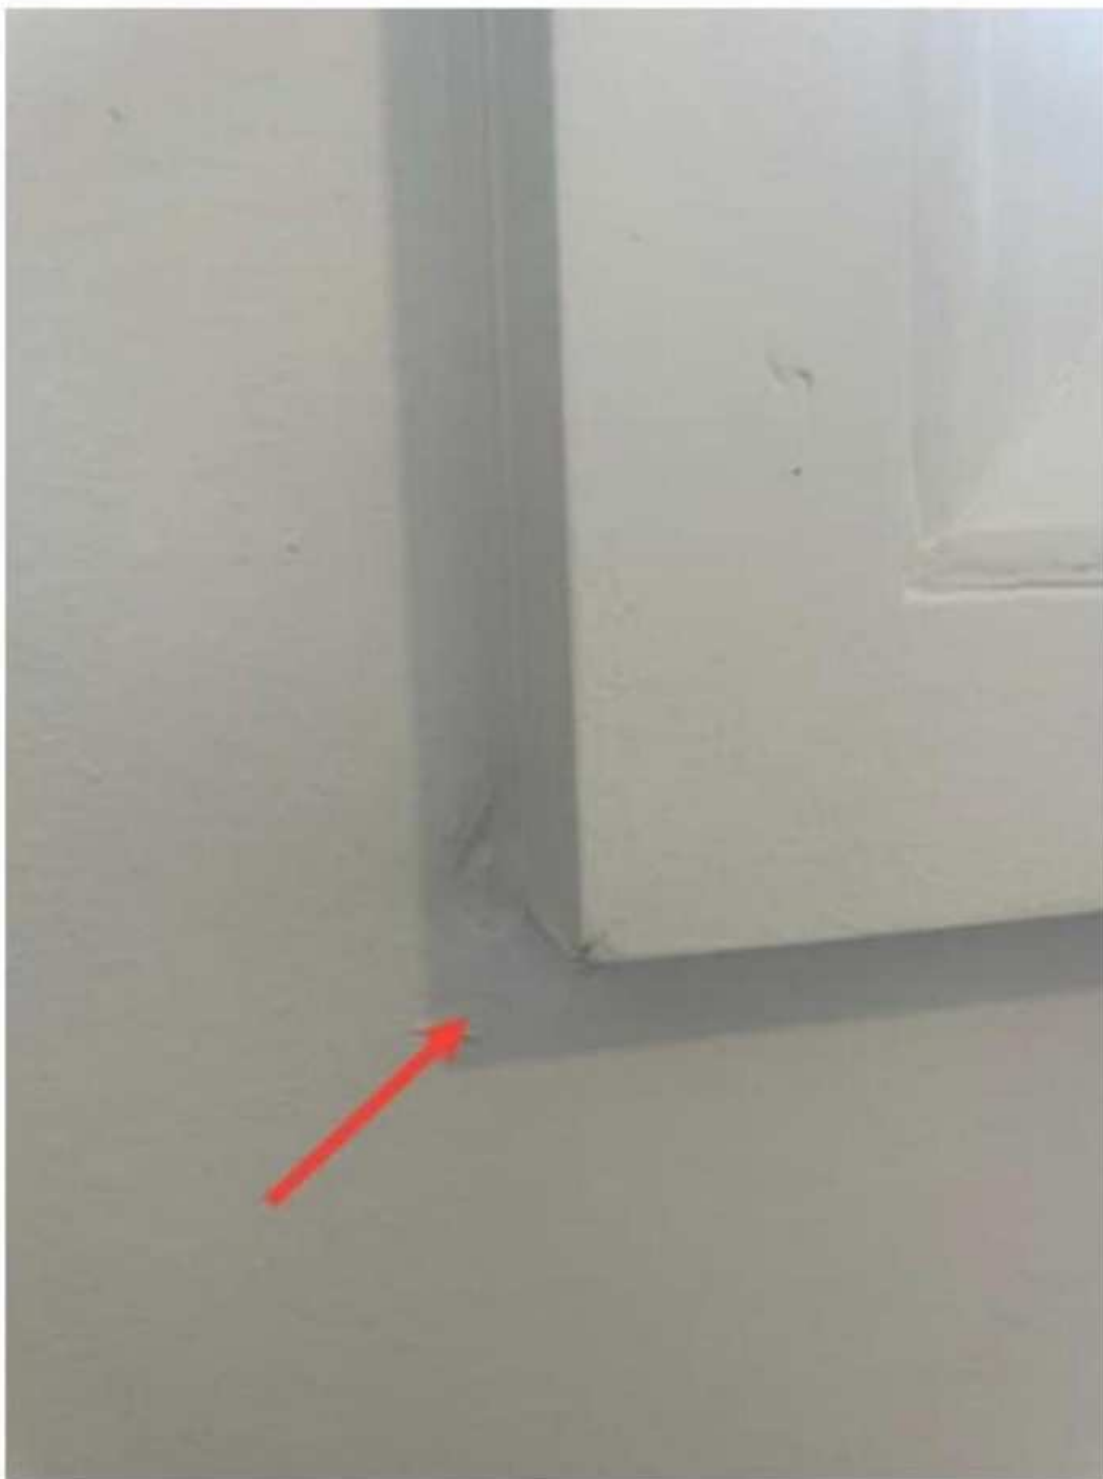
Damaged noted to plaster walls around window sills and architraves.

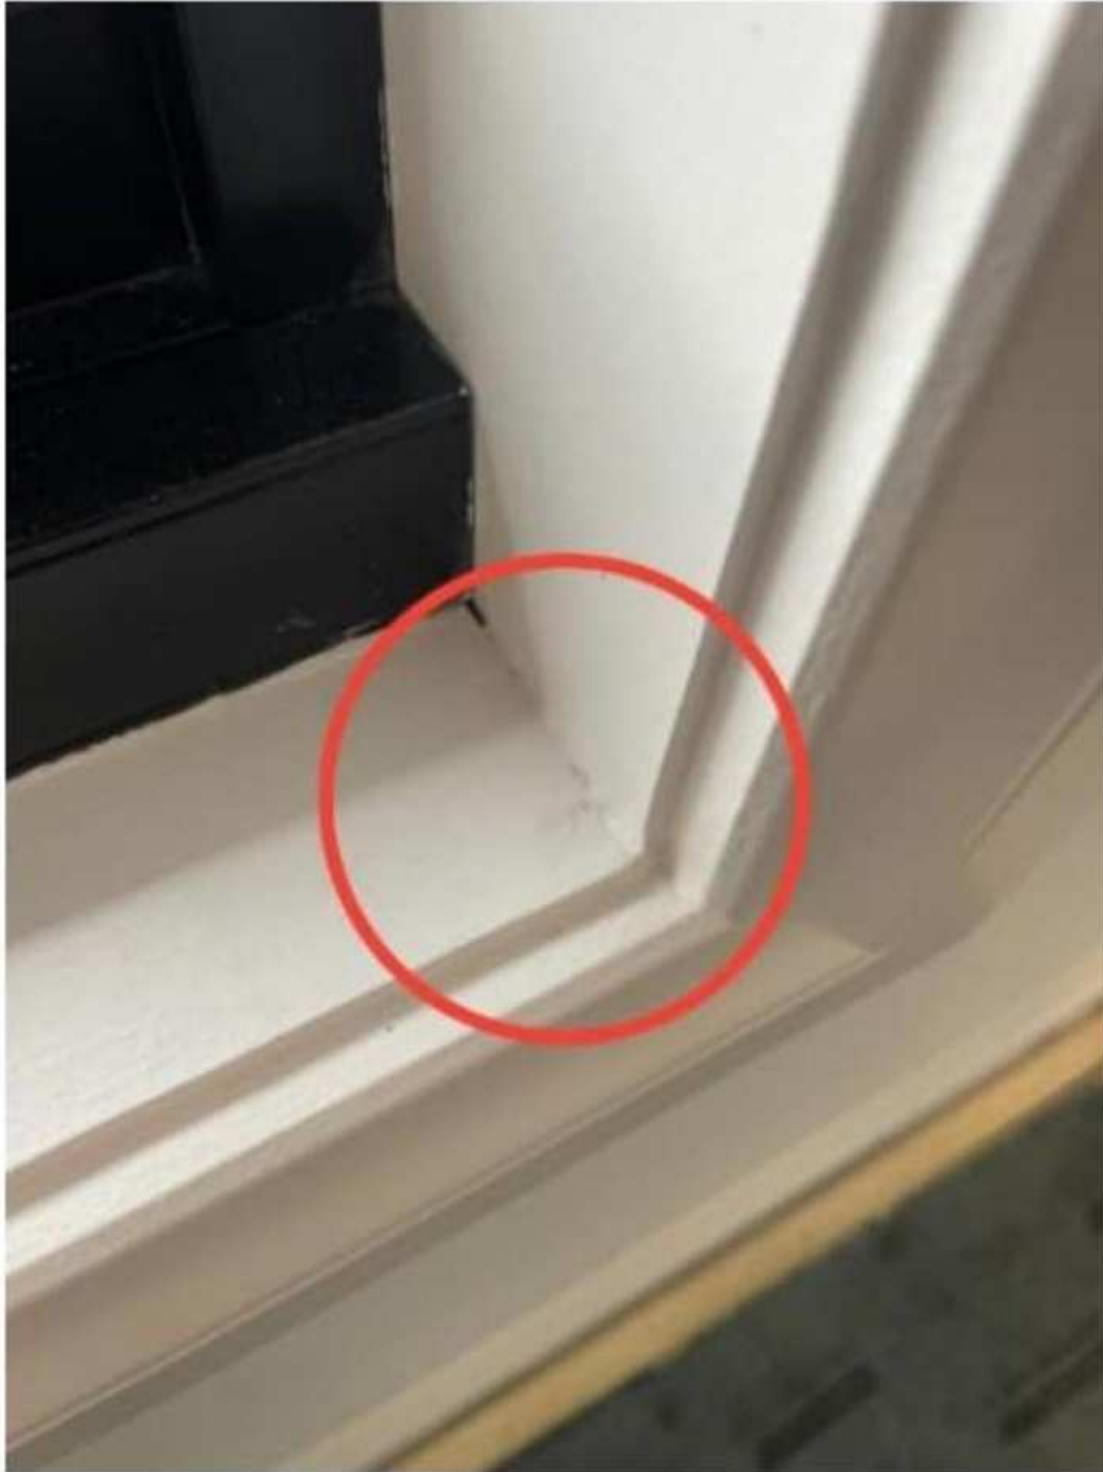
Damage and gaps noted around the window sills and reveals.

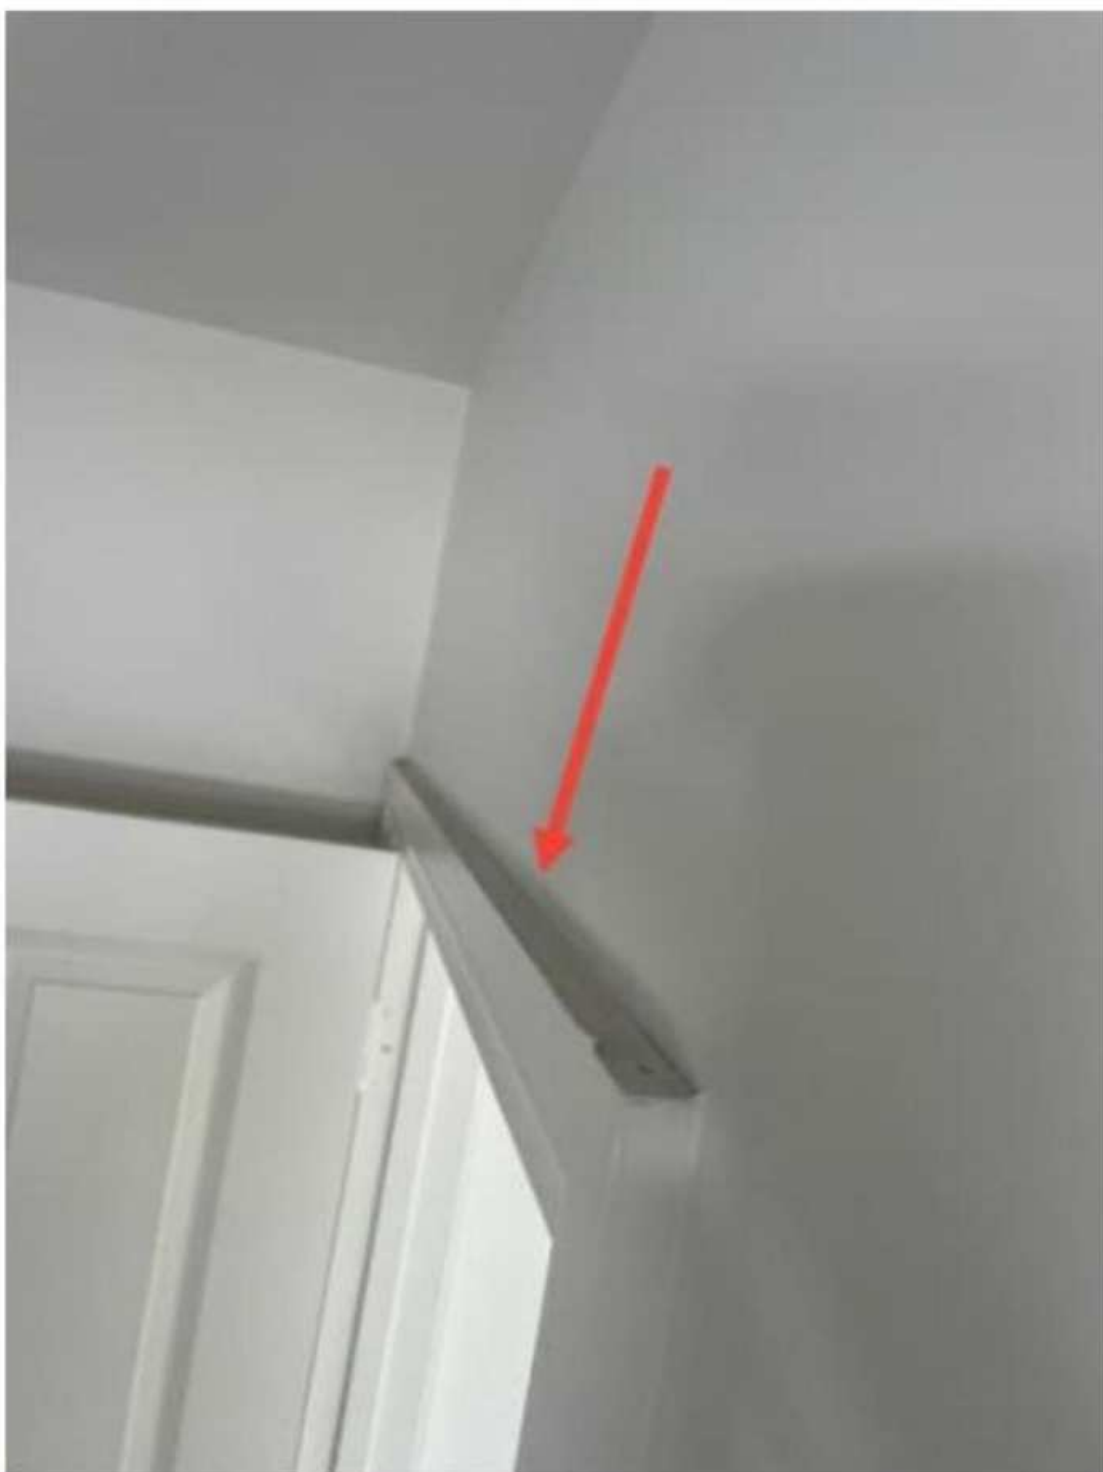
Top architraves around openings are not painted.

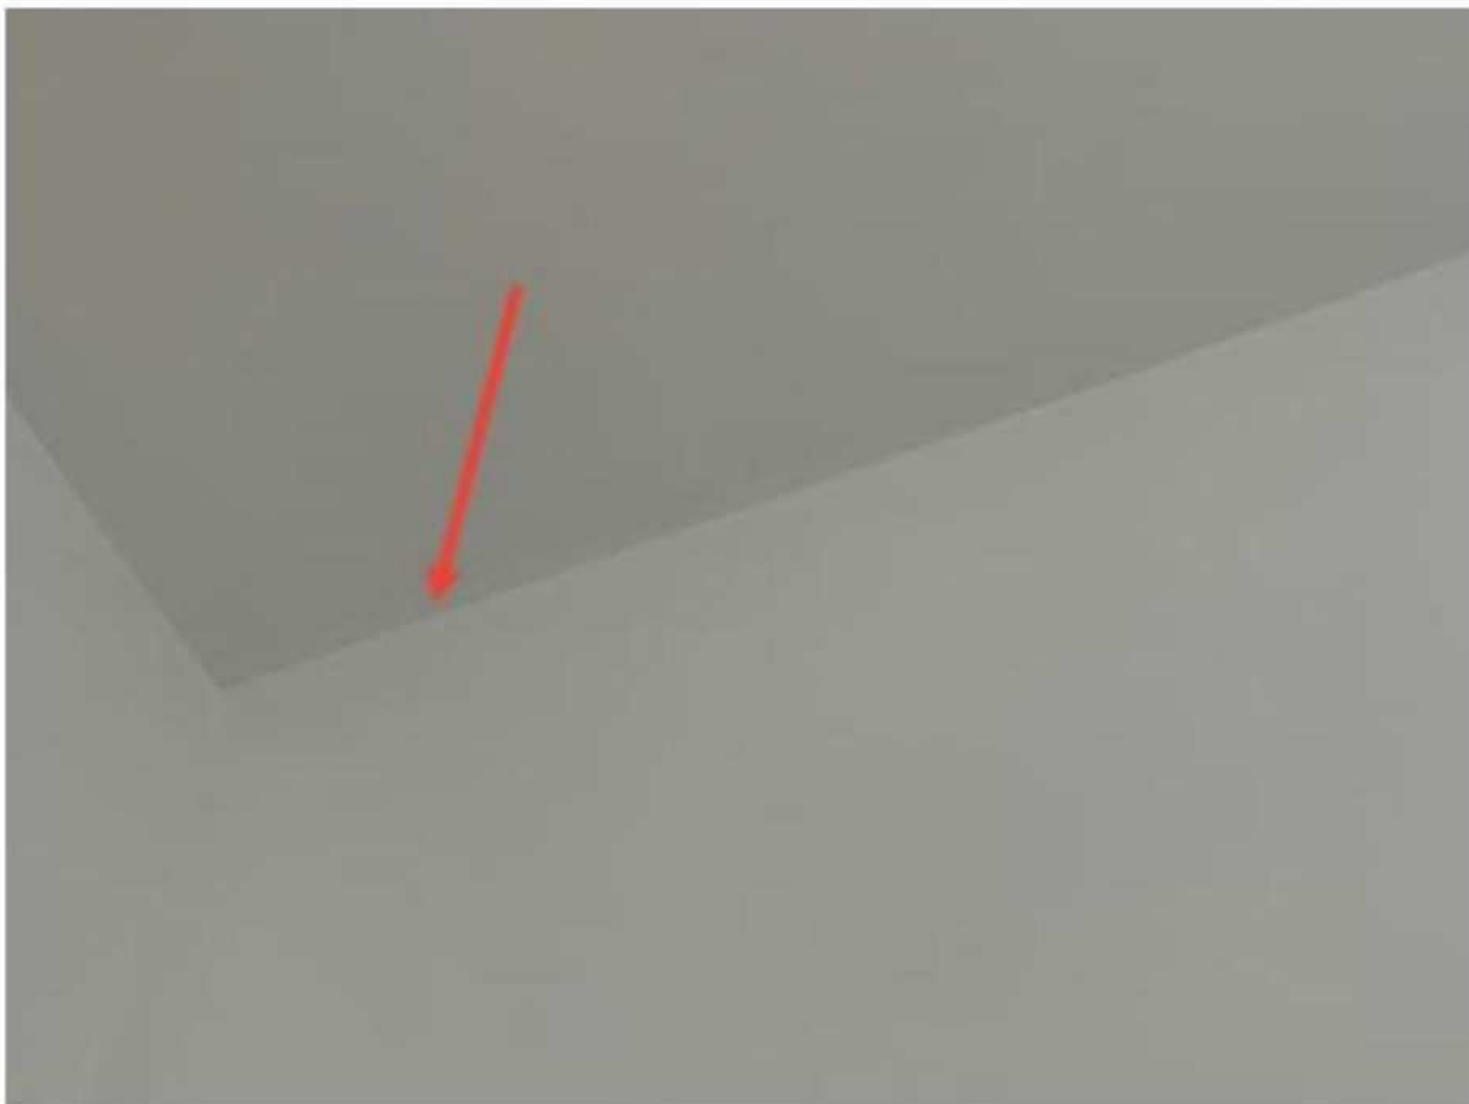
The cutting in to paintwork appears to be improperly applied around the ceiling to wall junctions around the dwelling.

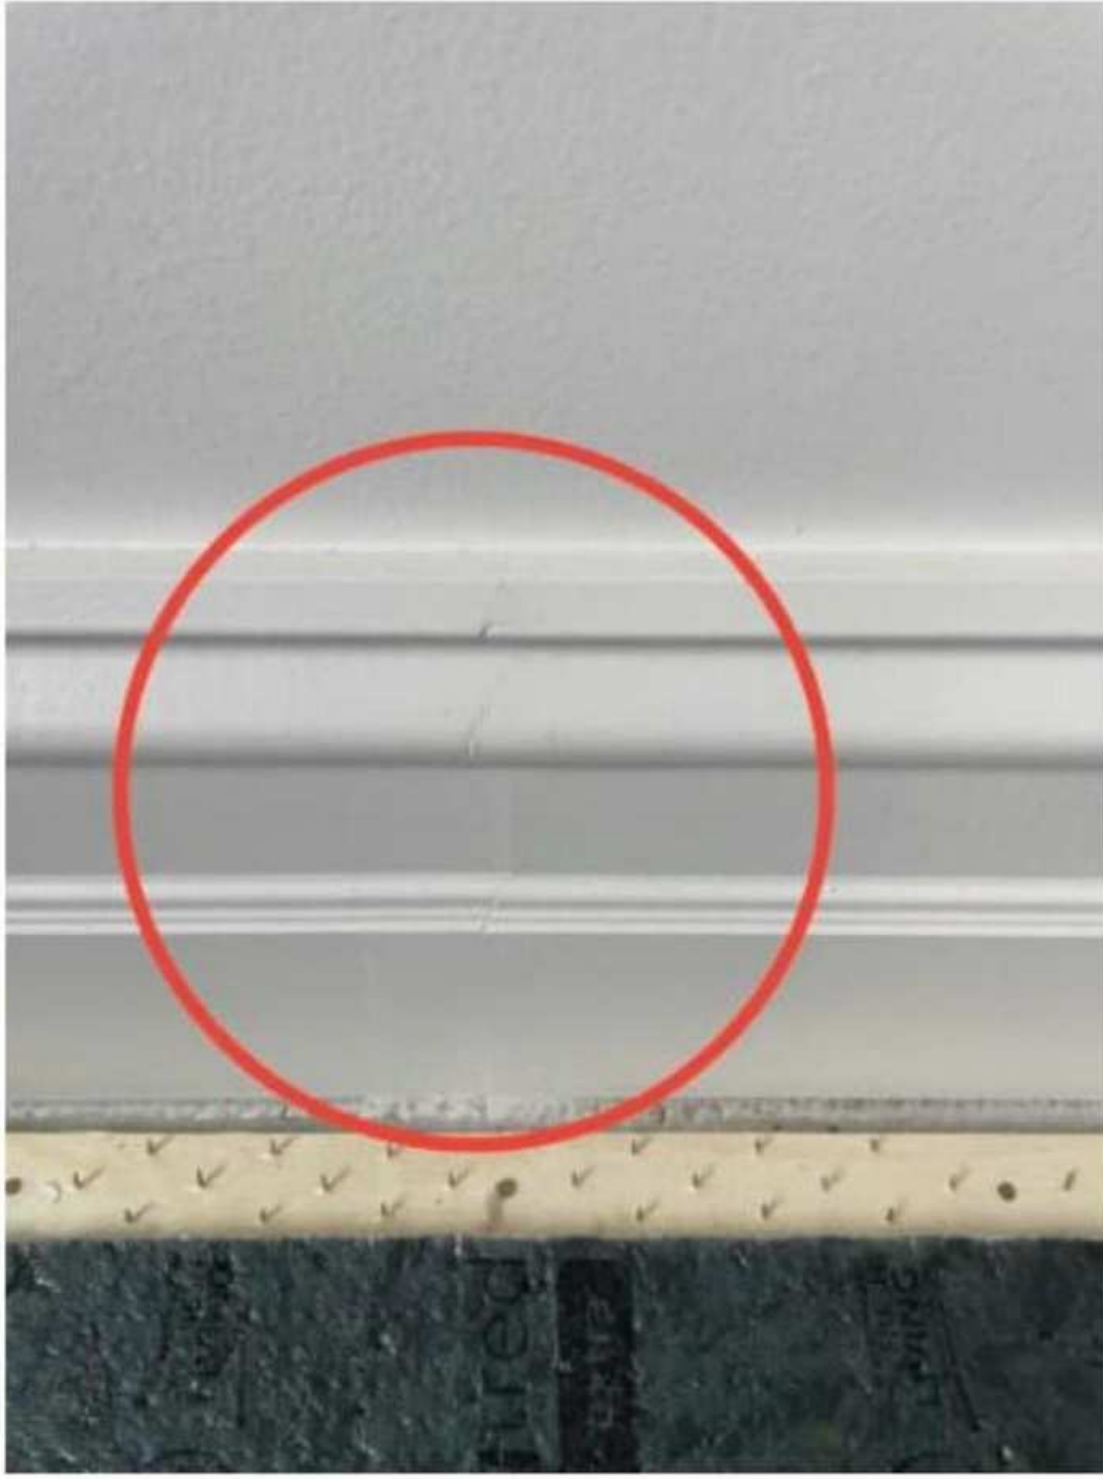
Poor workmanship finishes to skirting boards located around the dwelling.

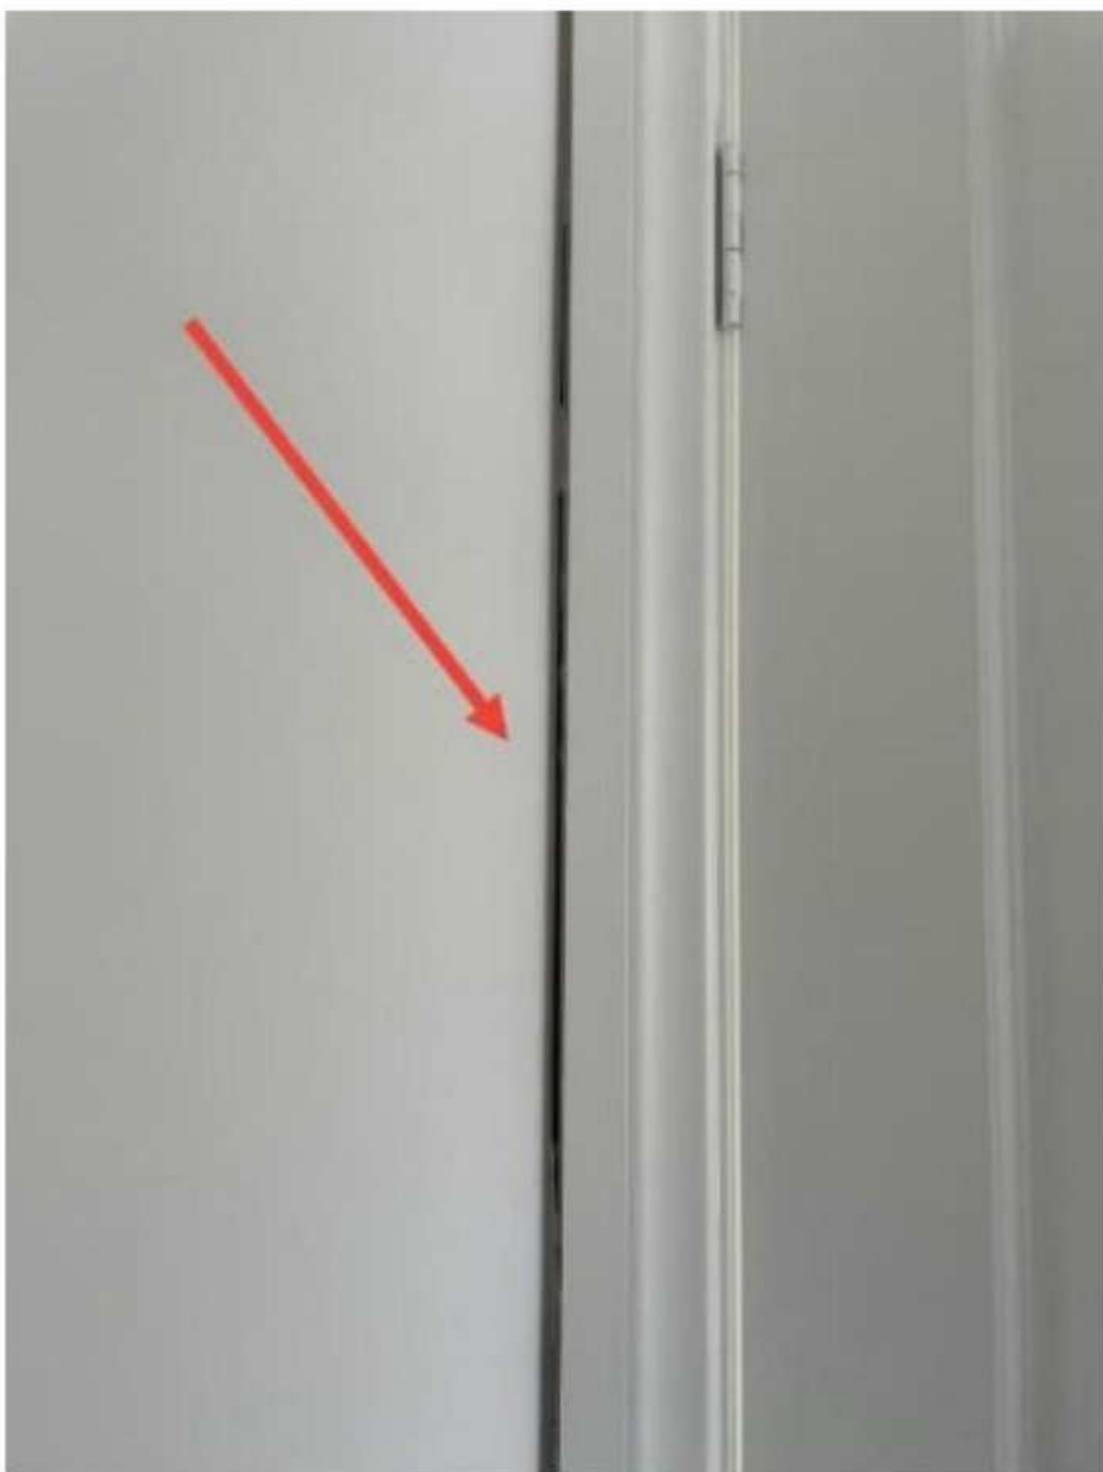
Gaps noted in parts around openings and wall to wall junctions and to do not appeared to be complete.

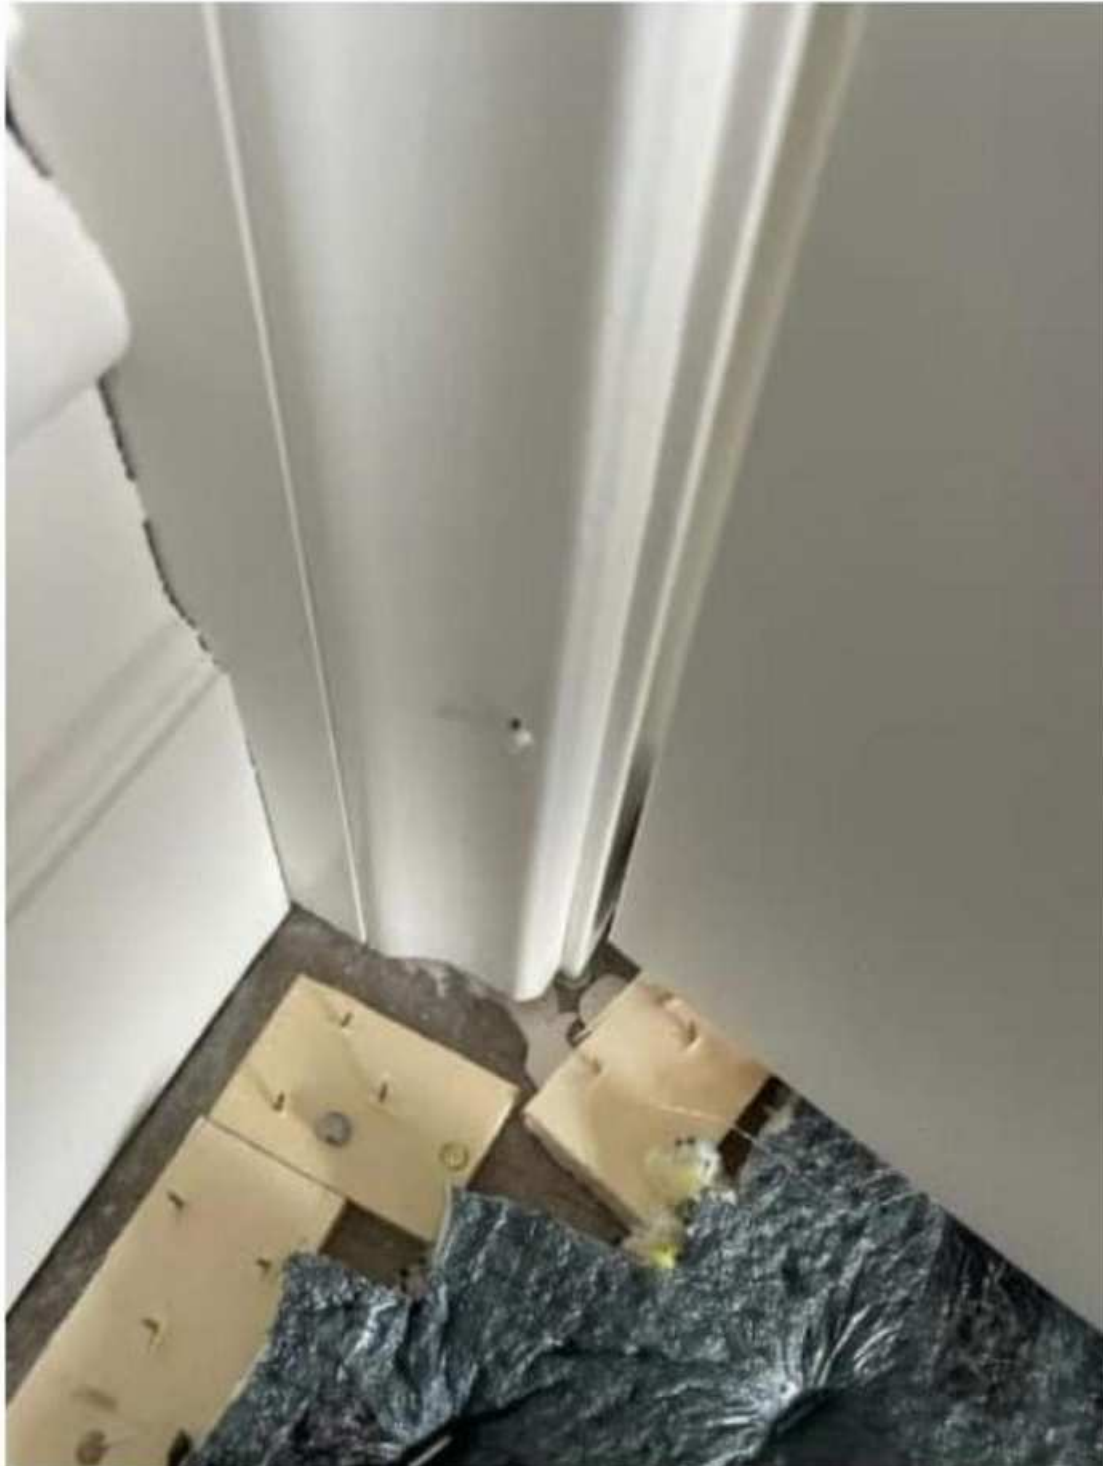
Nail popping noted around multiple locations through the dwelling to parts where extension has been constructed.

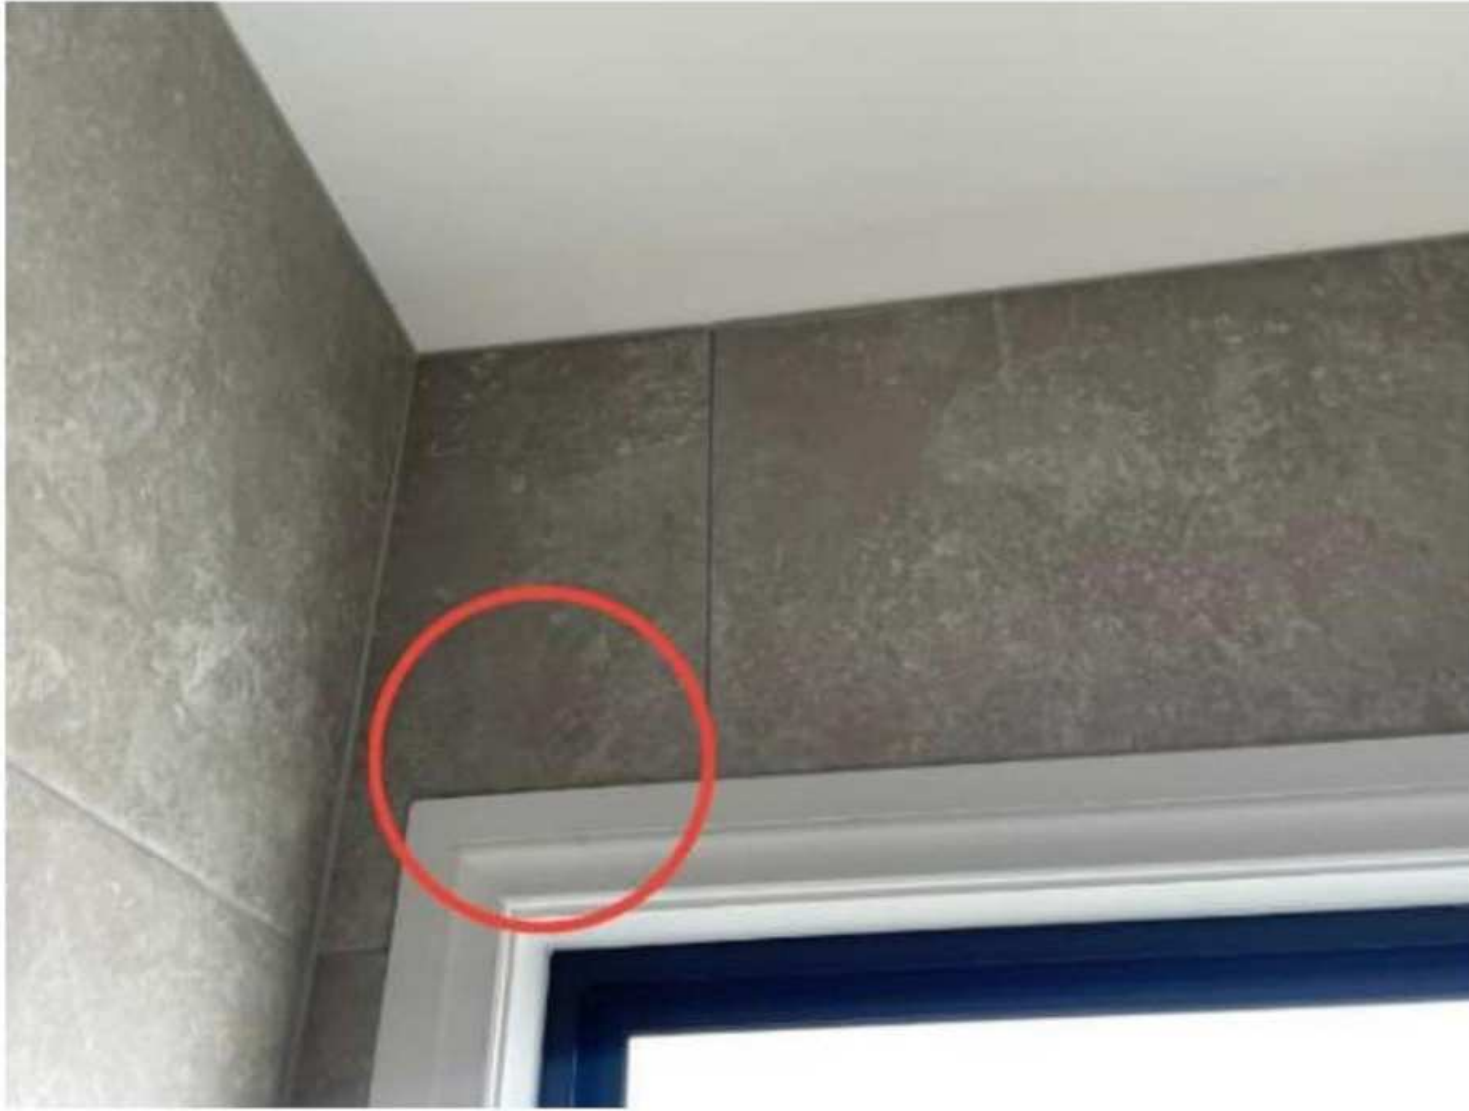
Sections around bathroom tiles appeared to be damaged and inadequately sealed and grouted.

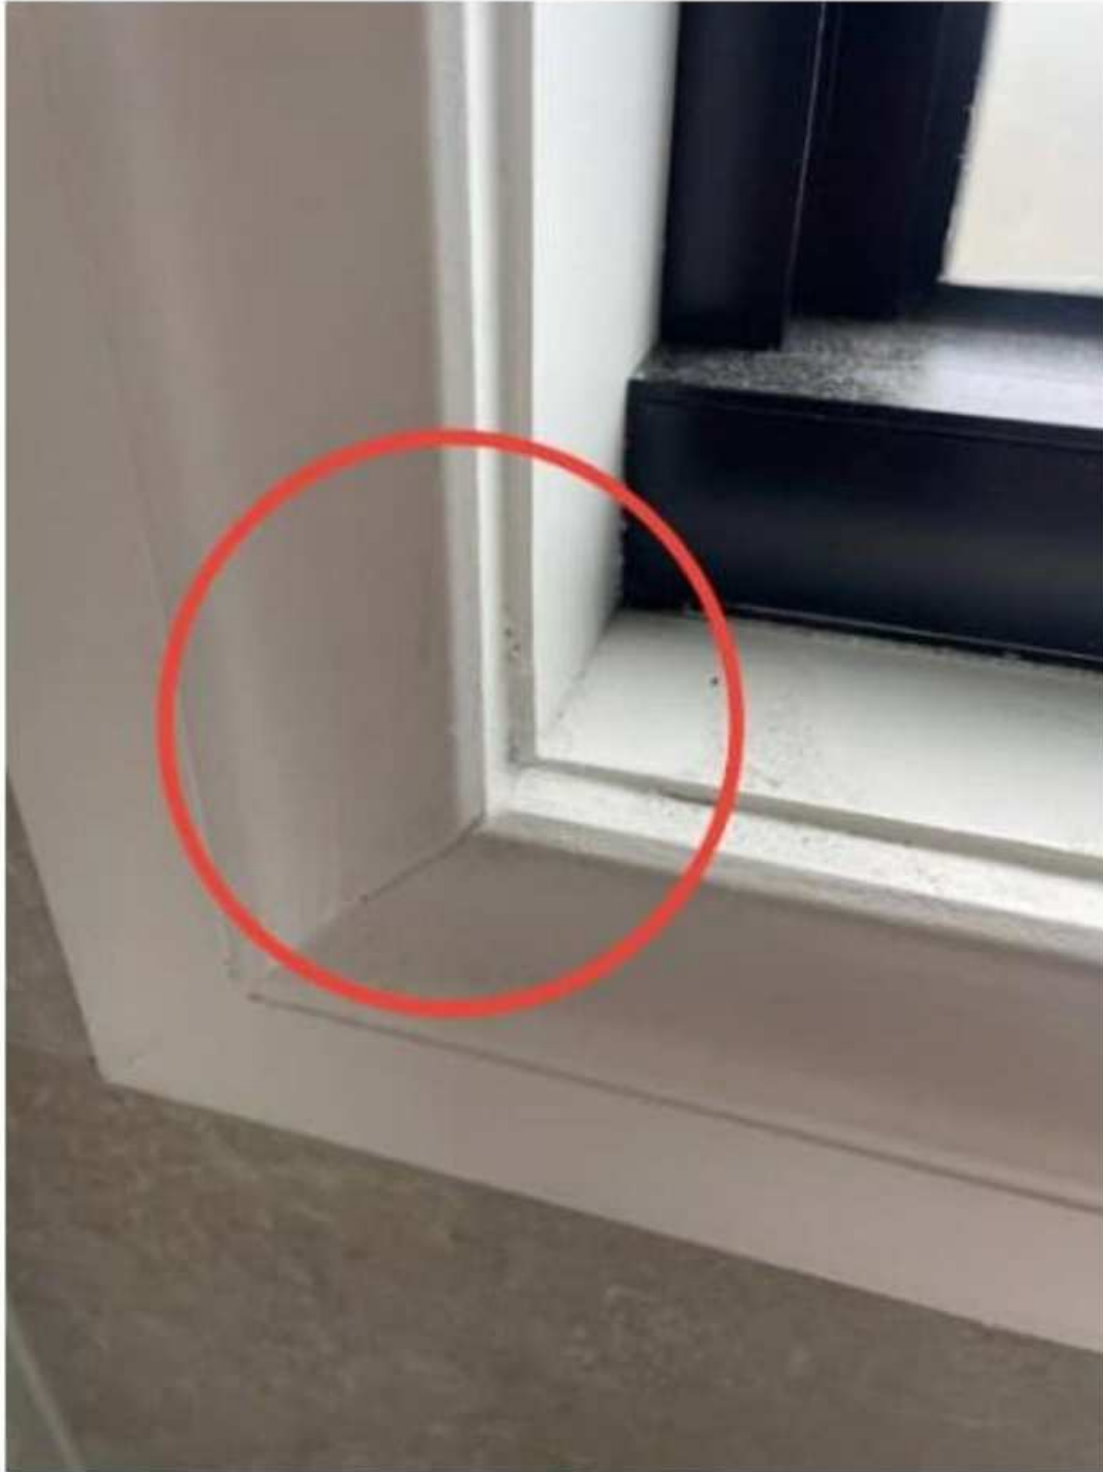
Damaged noted to the sills and architraves.

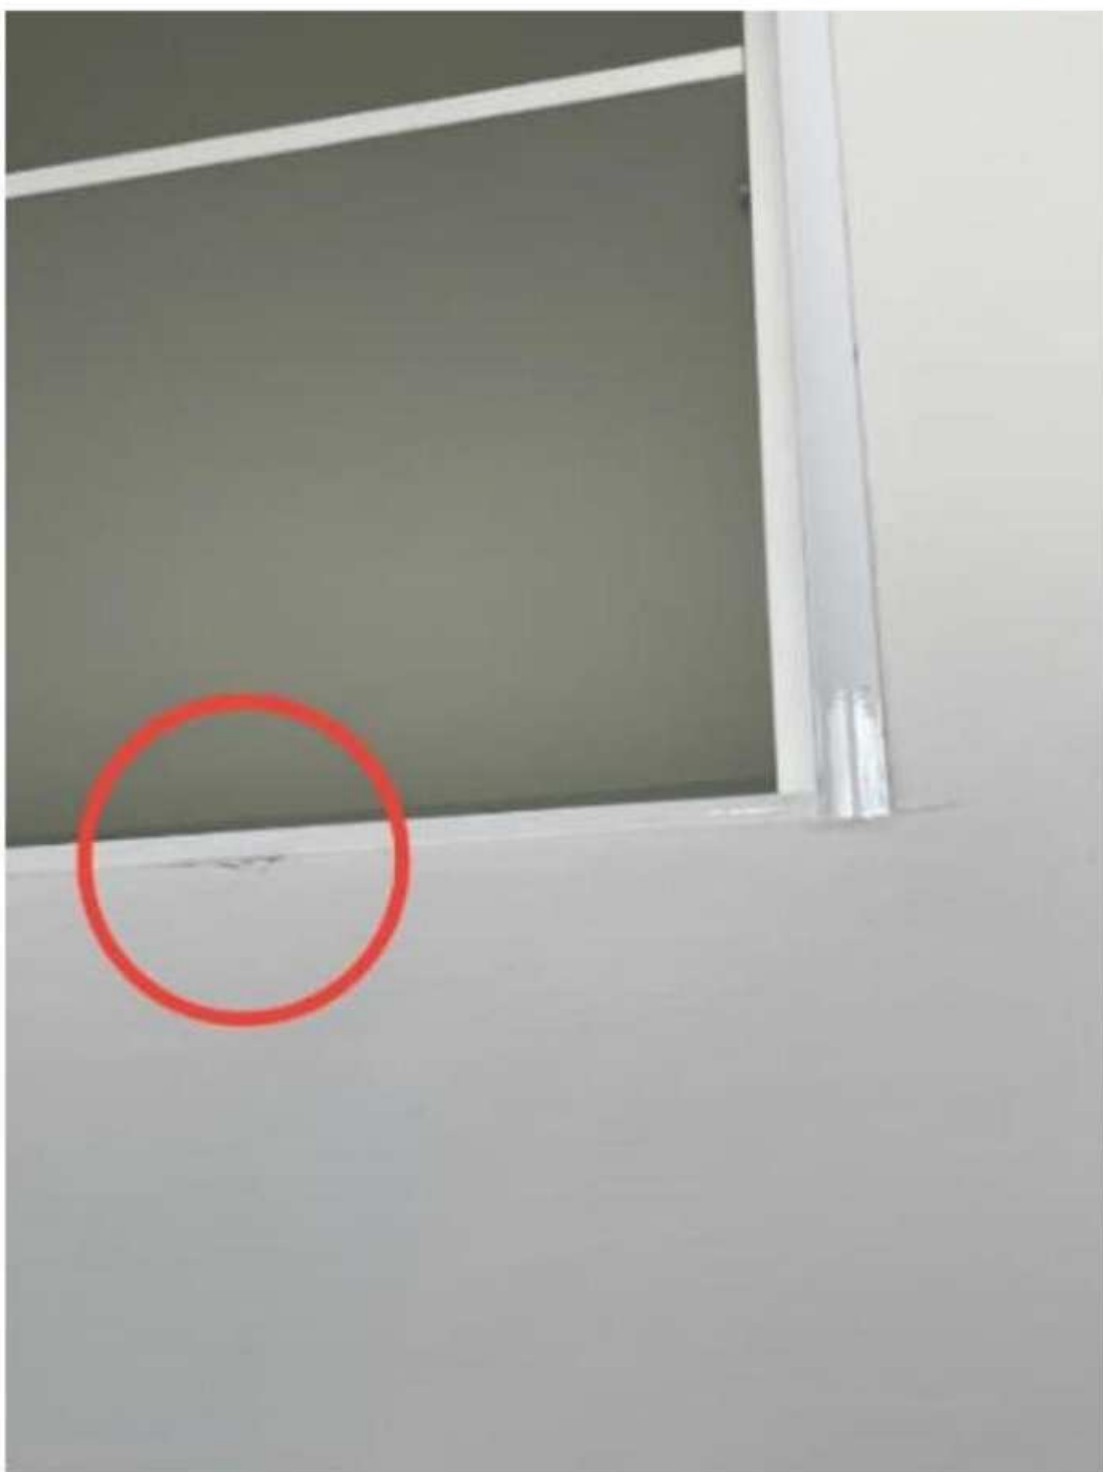
Damaged sections noted around bulk heads.

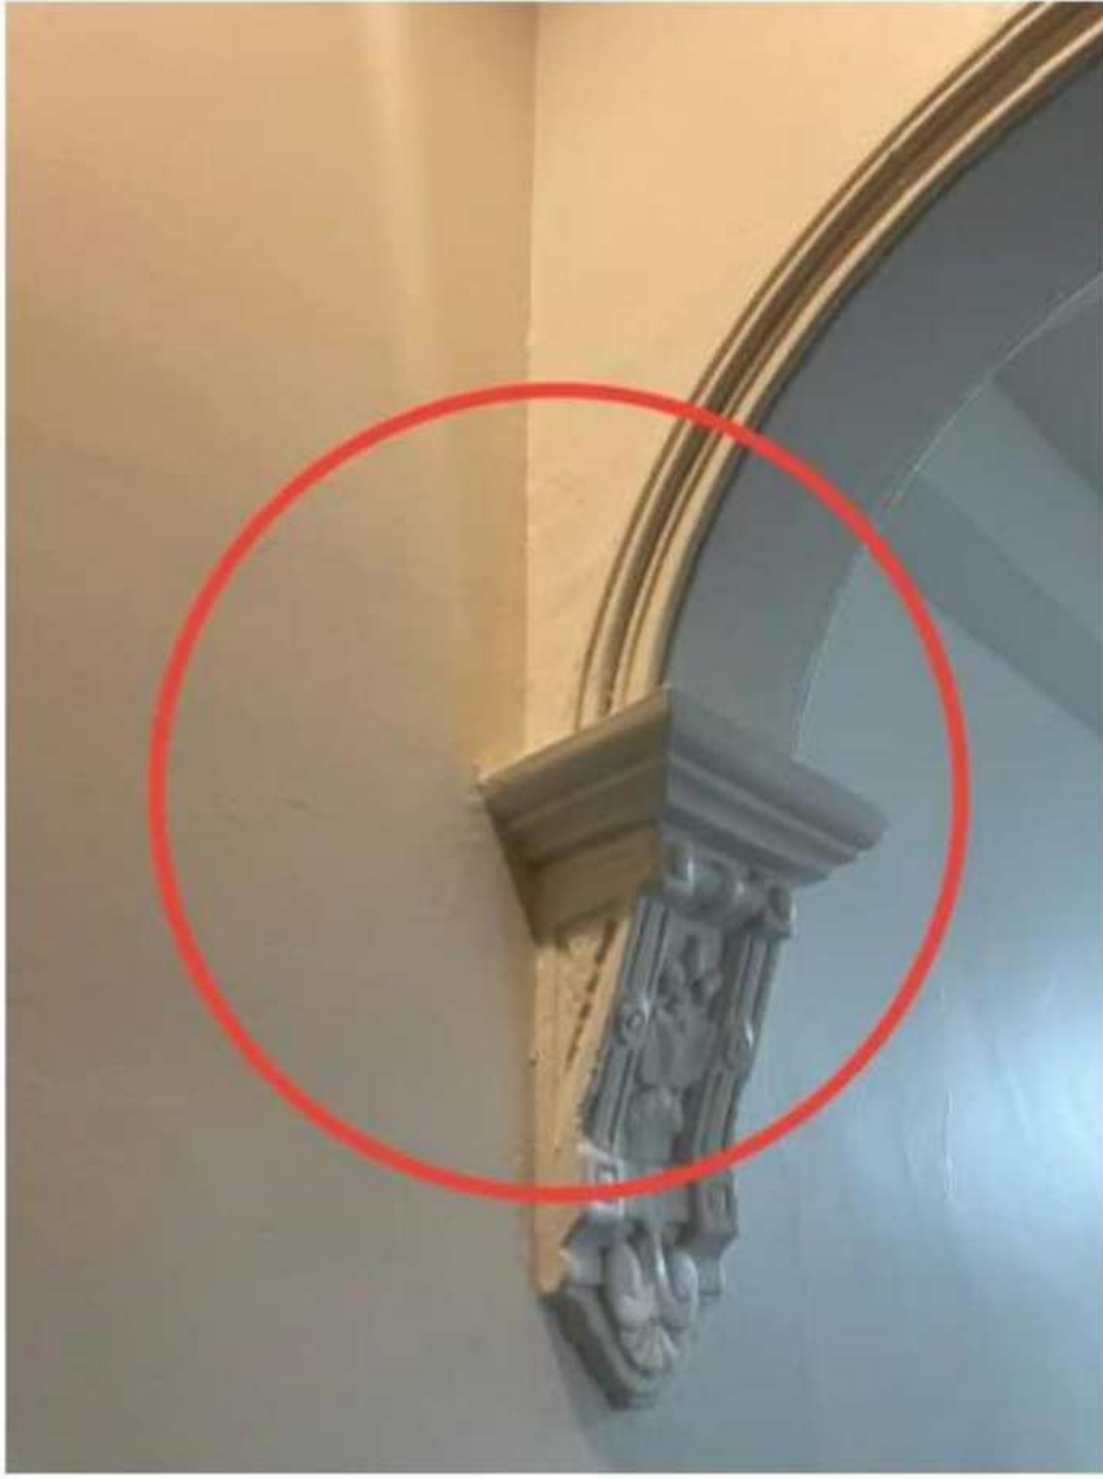
Preparation of existing walls and elements appeared to be defective.

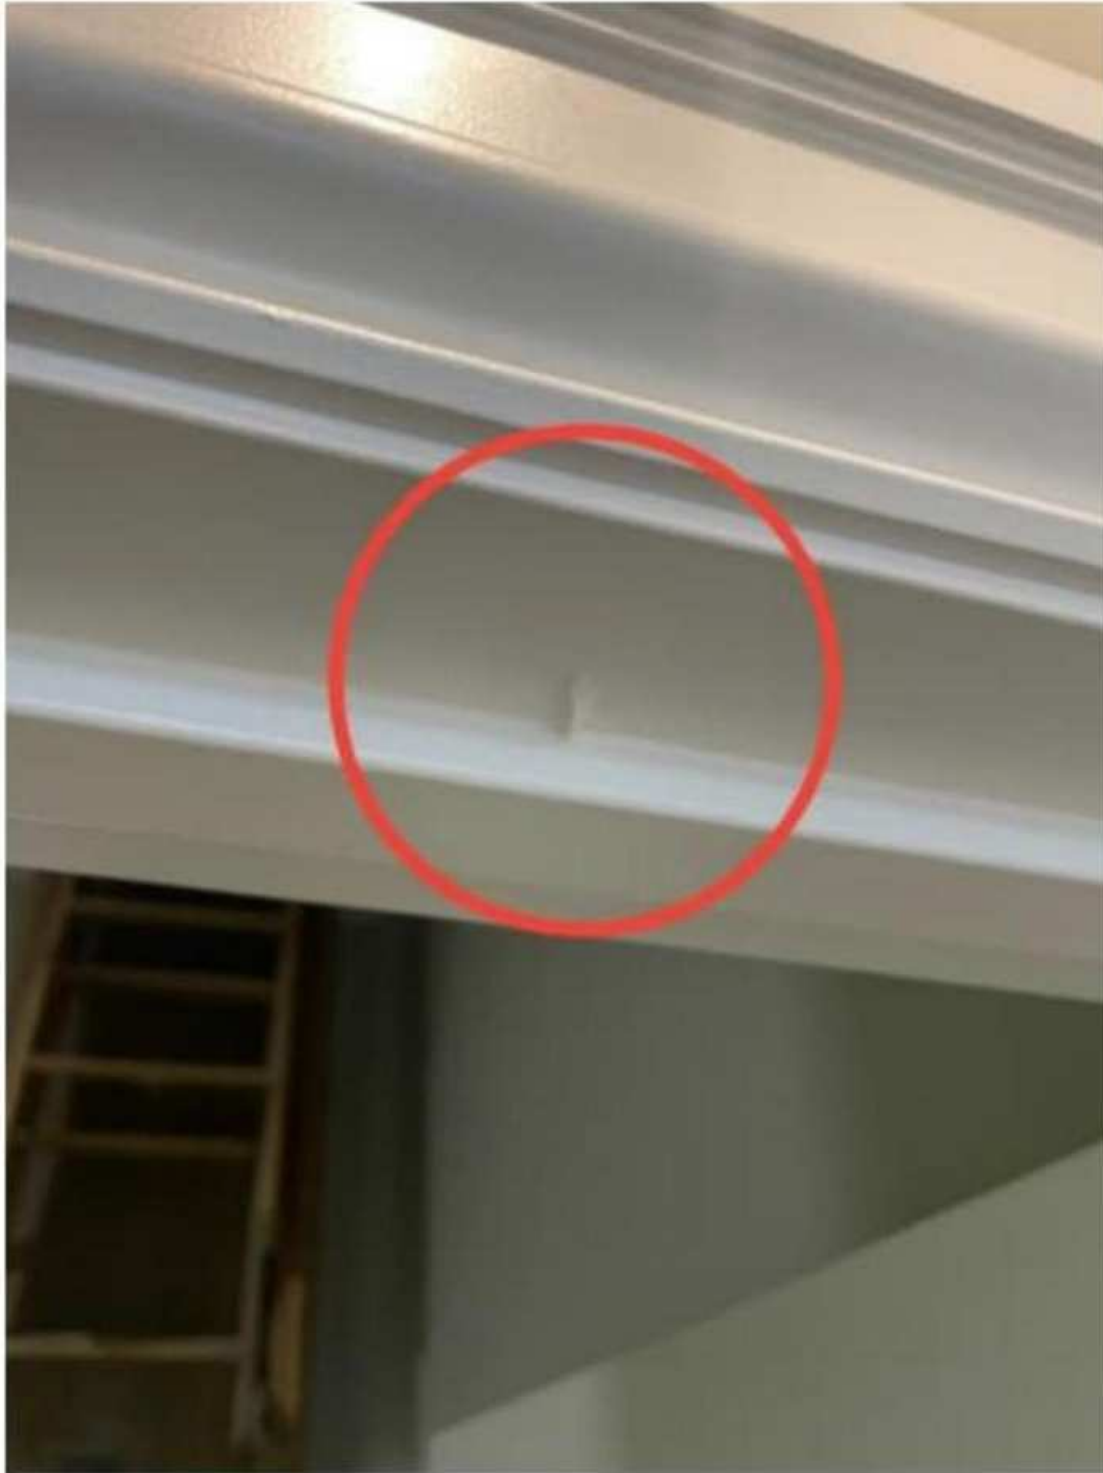
Multiple damage and nail popping, infilled holes found throughout and around the openings architraves.

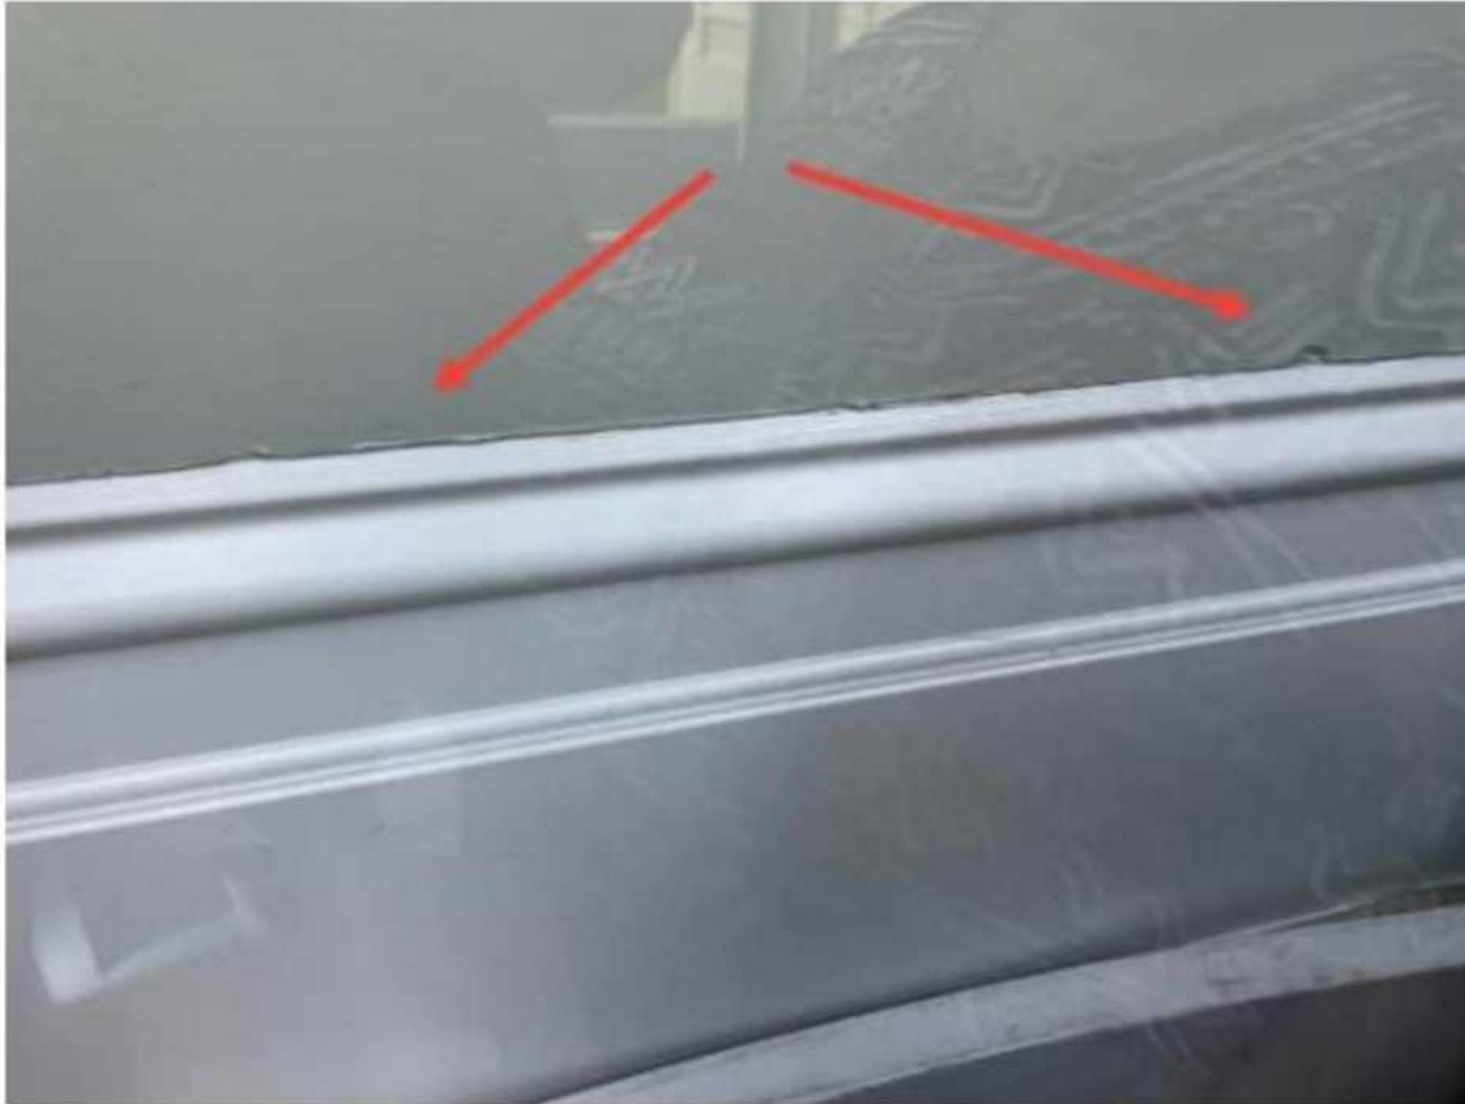
Damage and paint defects sighted to the lift well space as well as incomplected works.
