Thank you for the opportunity to inspect the preparation and application of paintwork of your home under construction. We attended the site on Wednesday, 27 November, 2024 and make the following comment on the quality and compliance of the works to date;

# Quality Assurance Inspection

Preparation and application of paintwork and workmanship only.

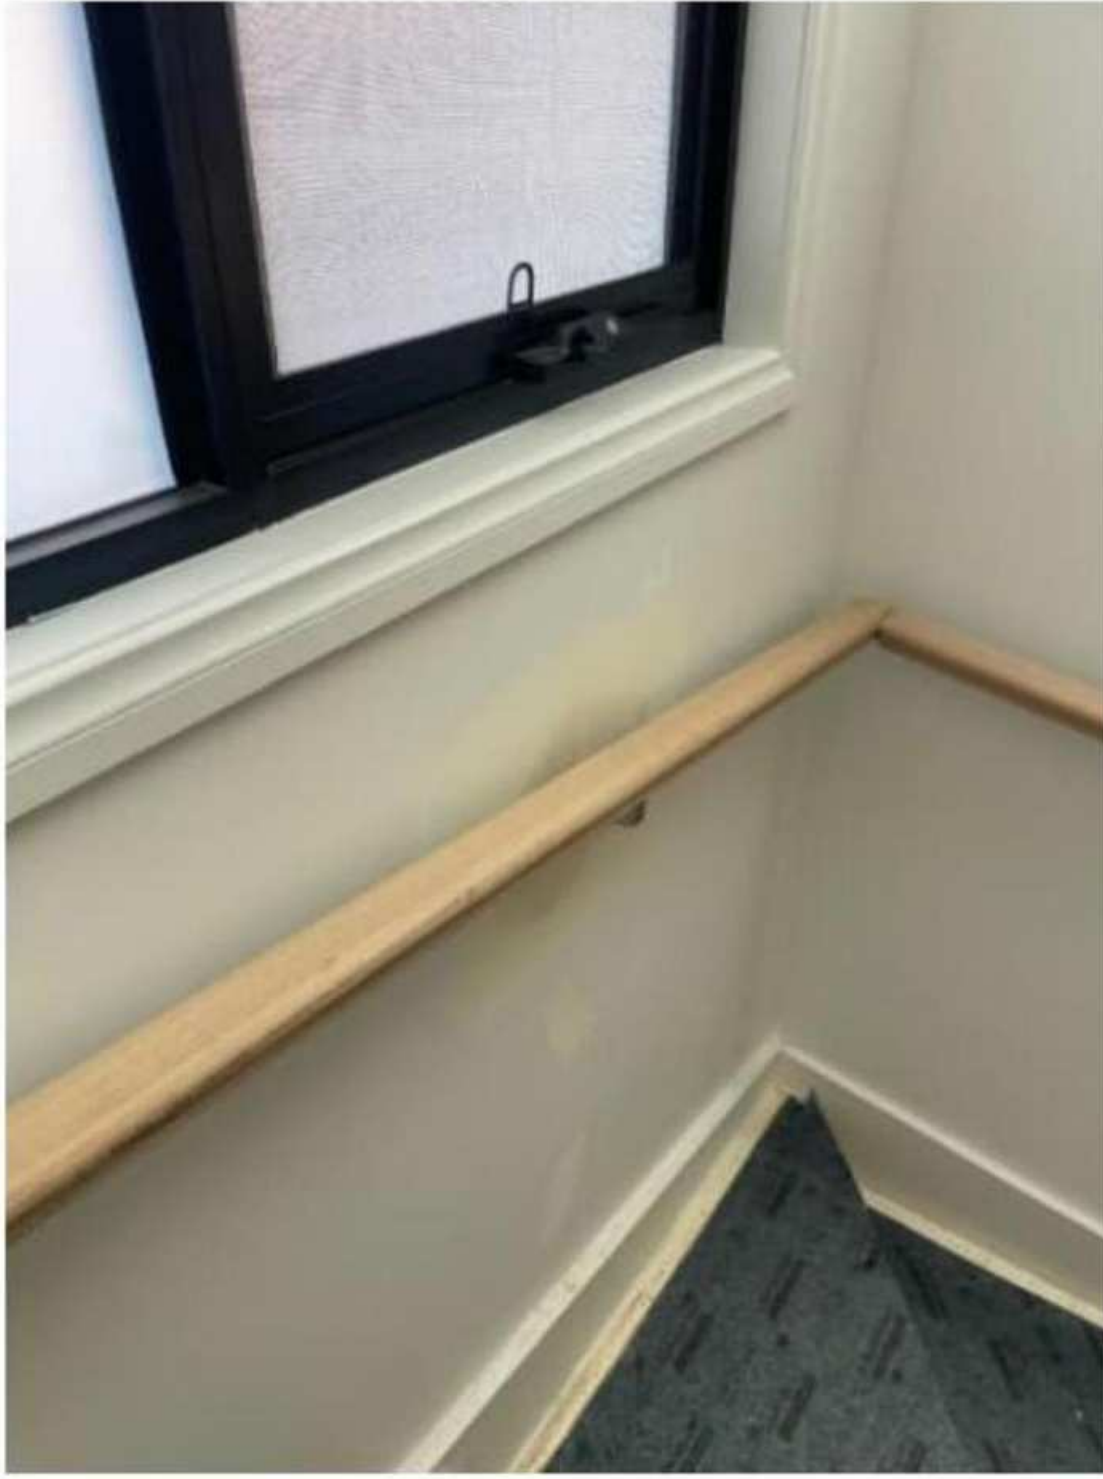
Stairwell areas painting is incomplete.
