## Just Inspections

## Building Inspection Report

AS4349.1- 2007

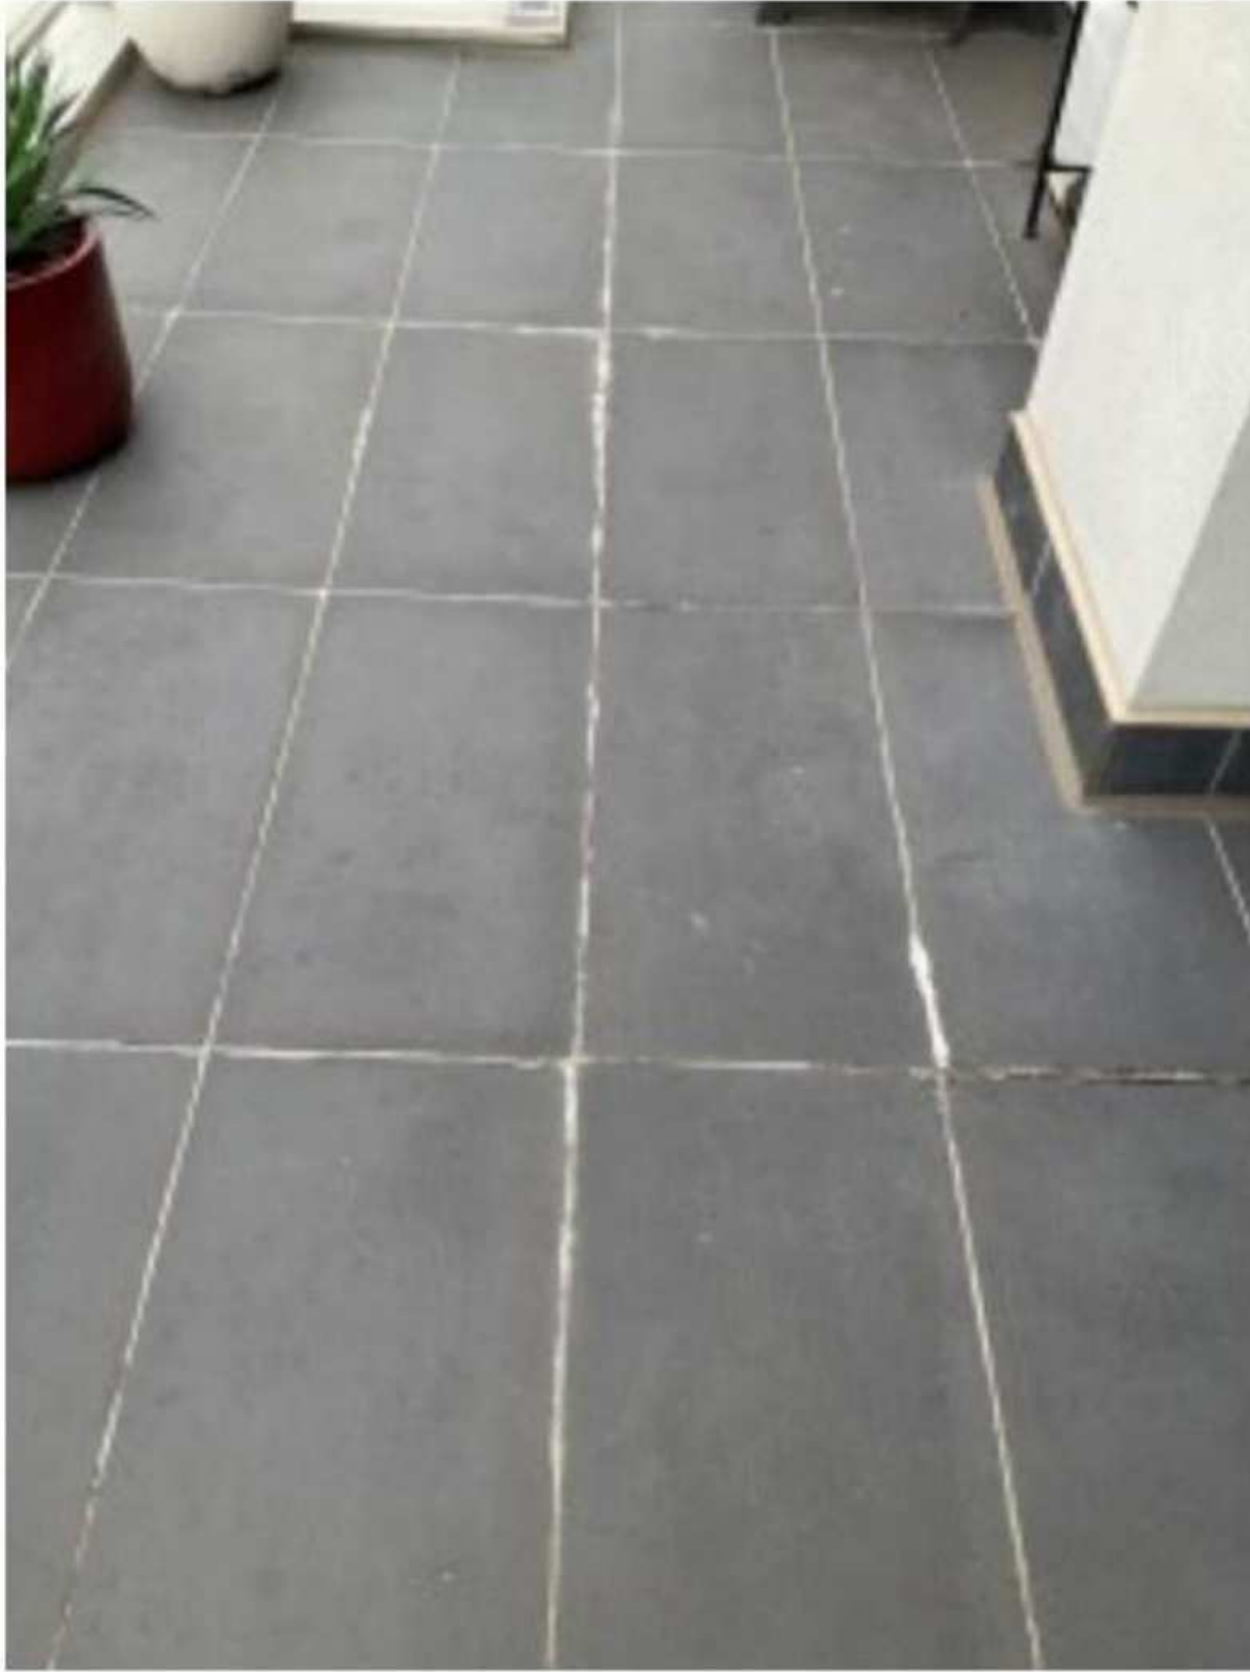
The photograph reveals evidence of efflorescence along the grout lines of floor tiles. This white, powdery substance indicates that moisture is migrating through the grout, leaving behind mineral deposits as it evaporates. While typically a cosmetic issue, ongoing efflorescence may suggest potential underlying moisture problems that could affect the integrity of the tiling over time. It's advisable to monitor the source of moisture and take corrective actions if needed to prevent further occurrence and preserve the condition of the flooring.

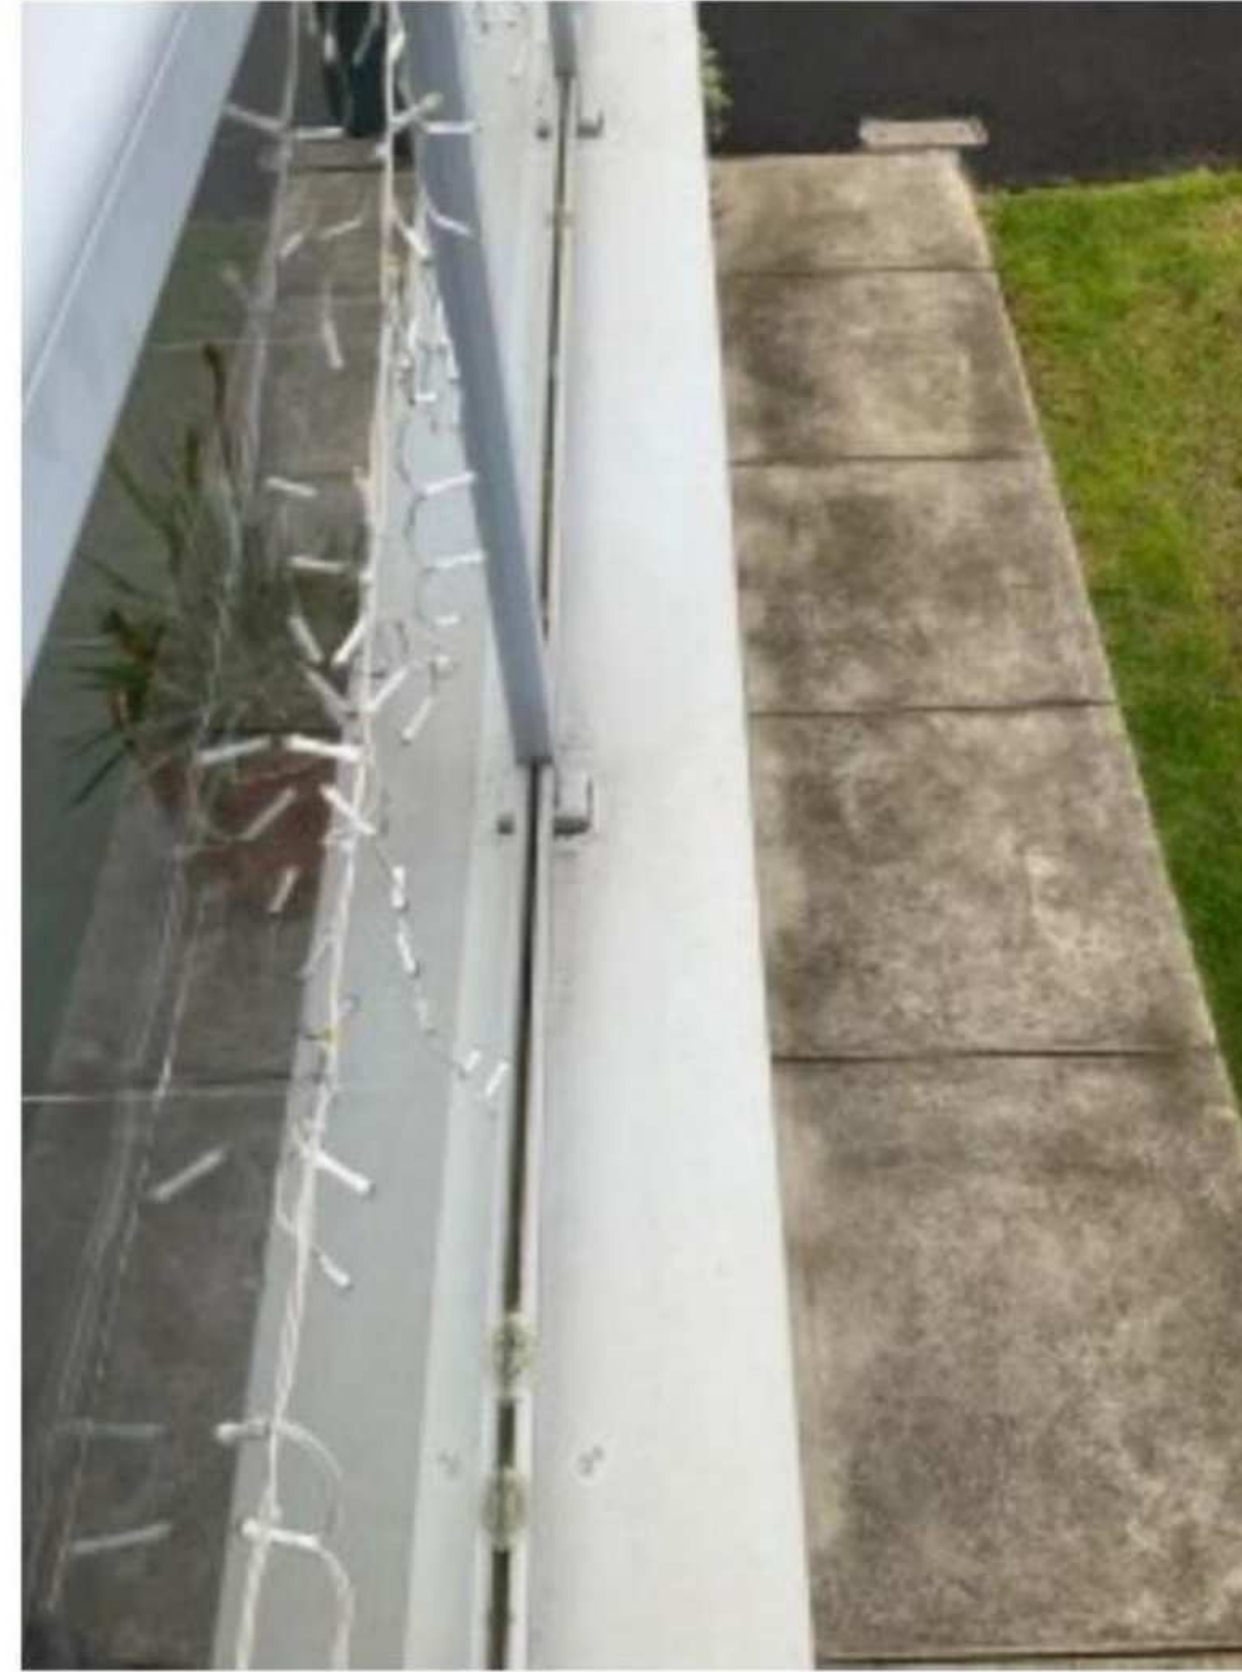
The railing exhibits signs of weathering, including the accumulation of dirt and grime along the base. There are visible growths, possibly lichen or mould, suggesting moisture retention. This condition can potentially compromise the integrity of the railing over time. Regular cleaning is recommended to prevent further deterioration and ensure structural safety.

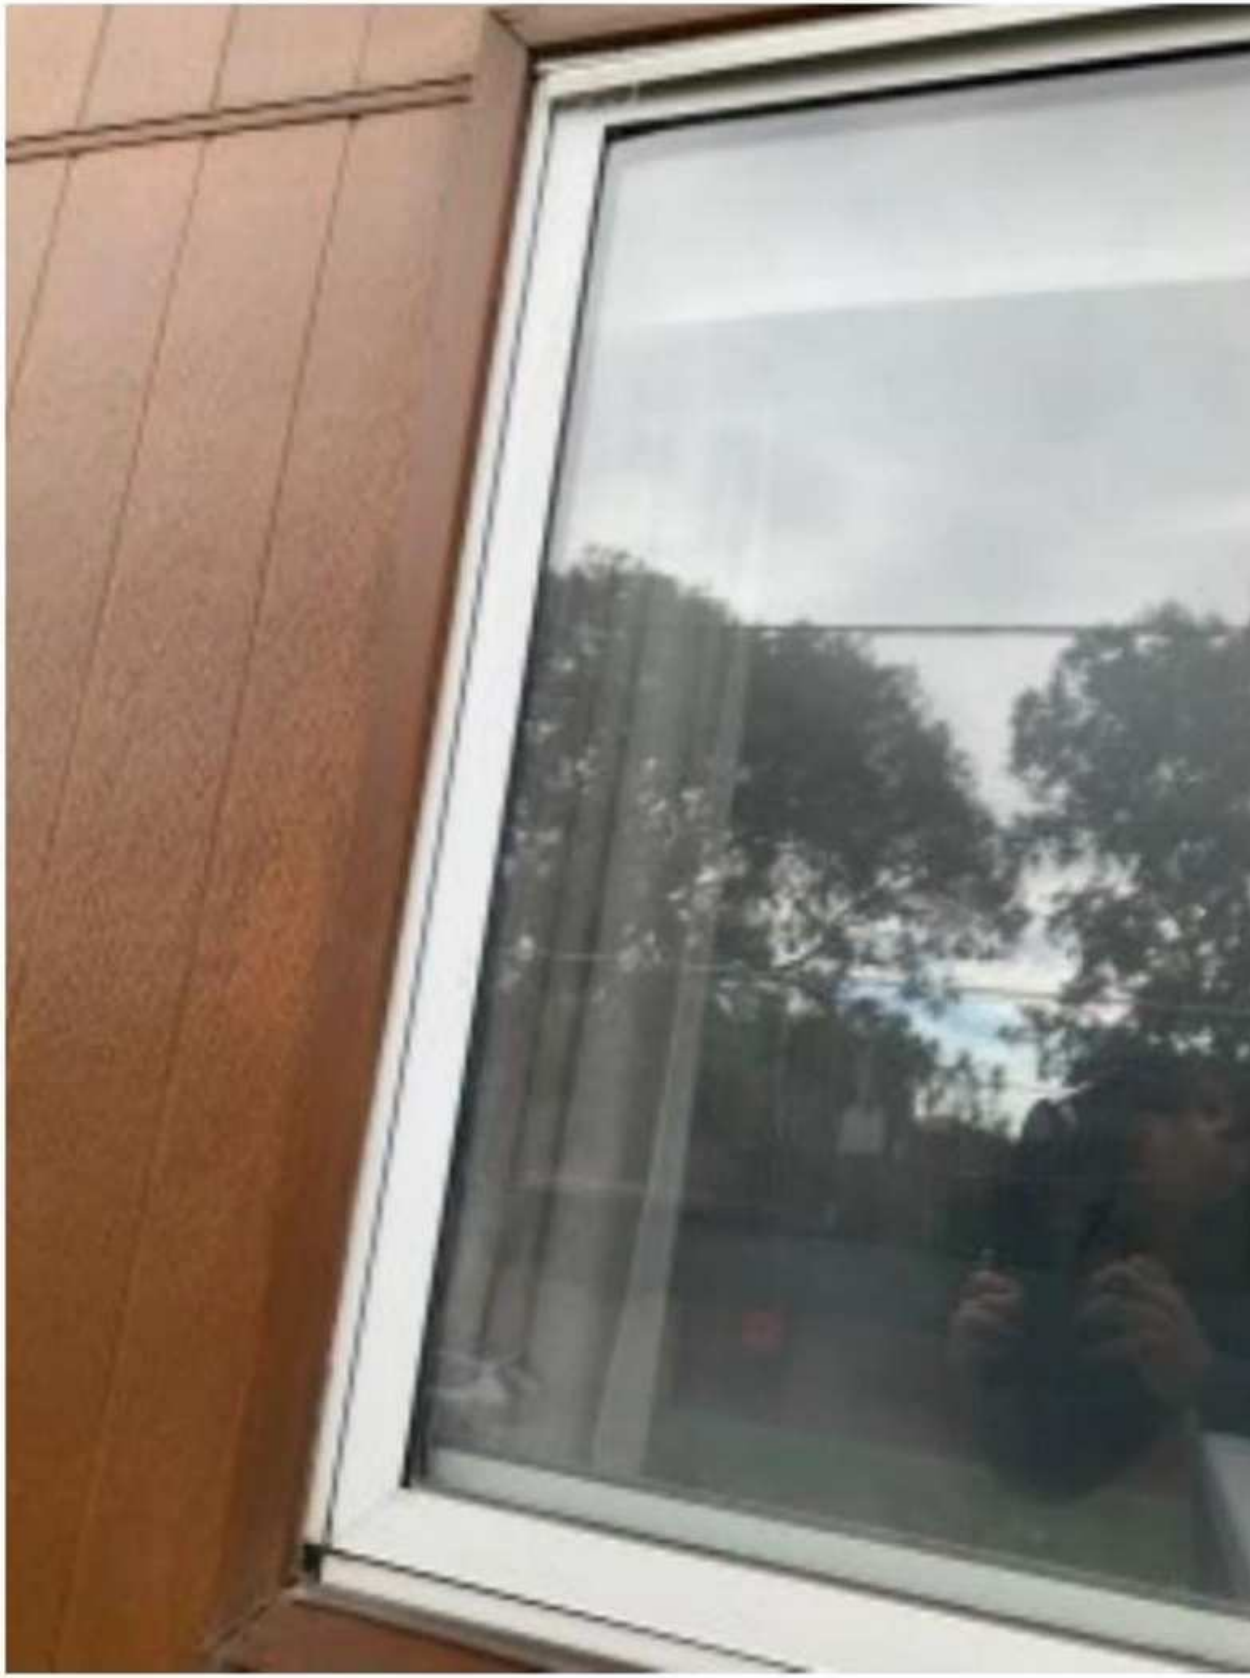
The window frame exhibits signs of wood rot and noticeable gaps and potential water ingress points. These gaps can lead to moisture penetration, potentially causing damage to surrounding materials. It's advisable to address this defect by resealing the frame to prevent further deterioration.

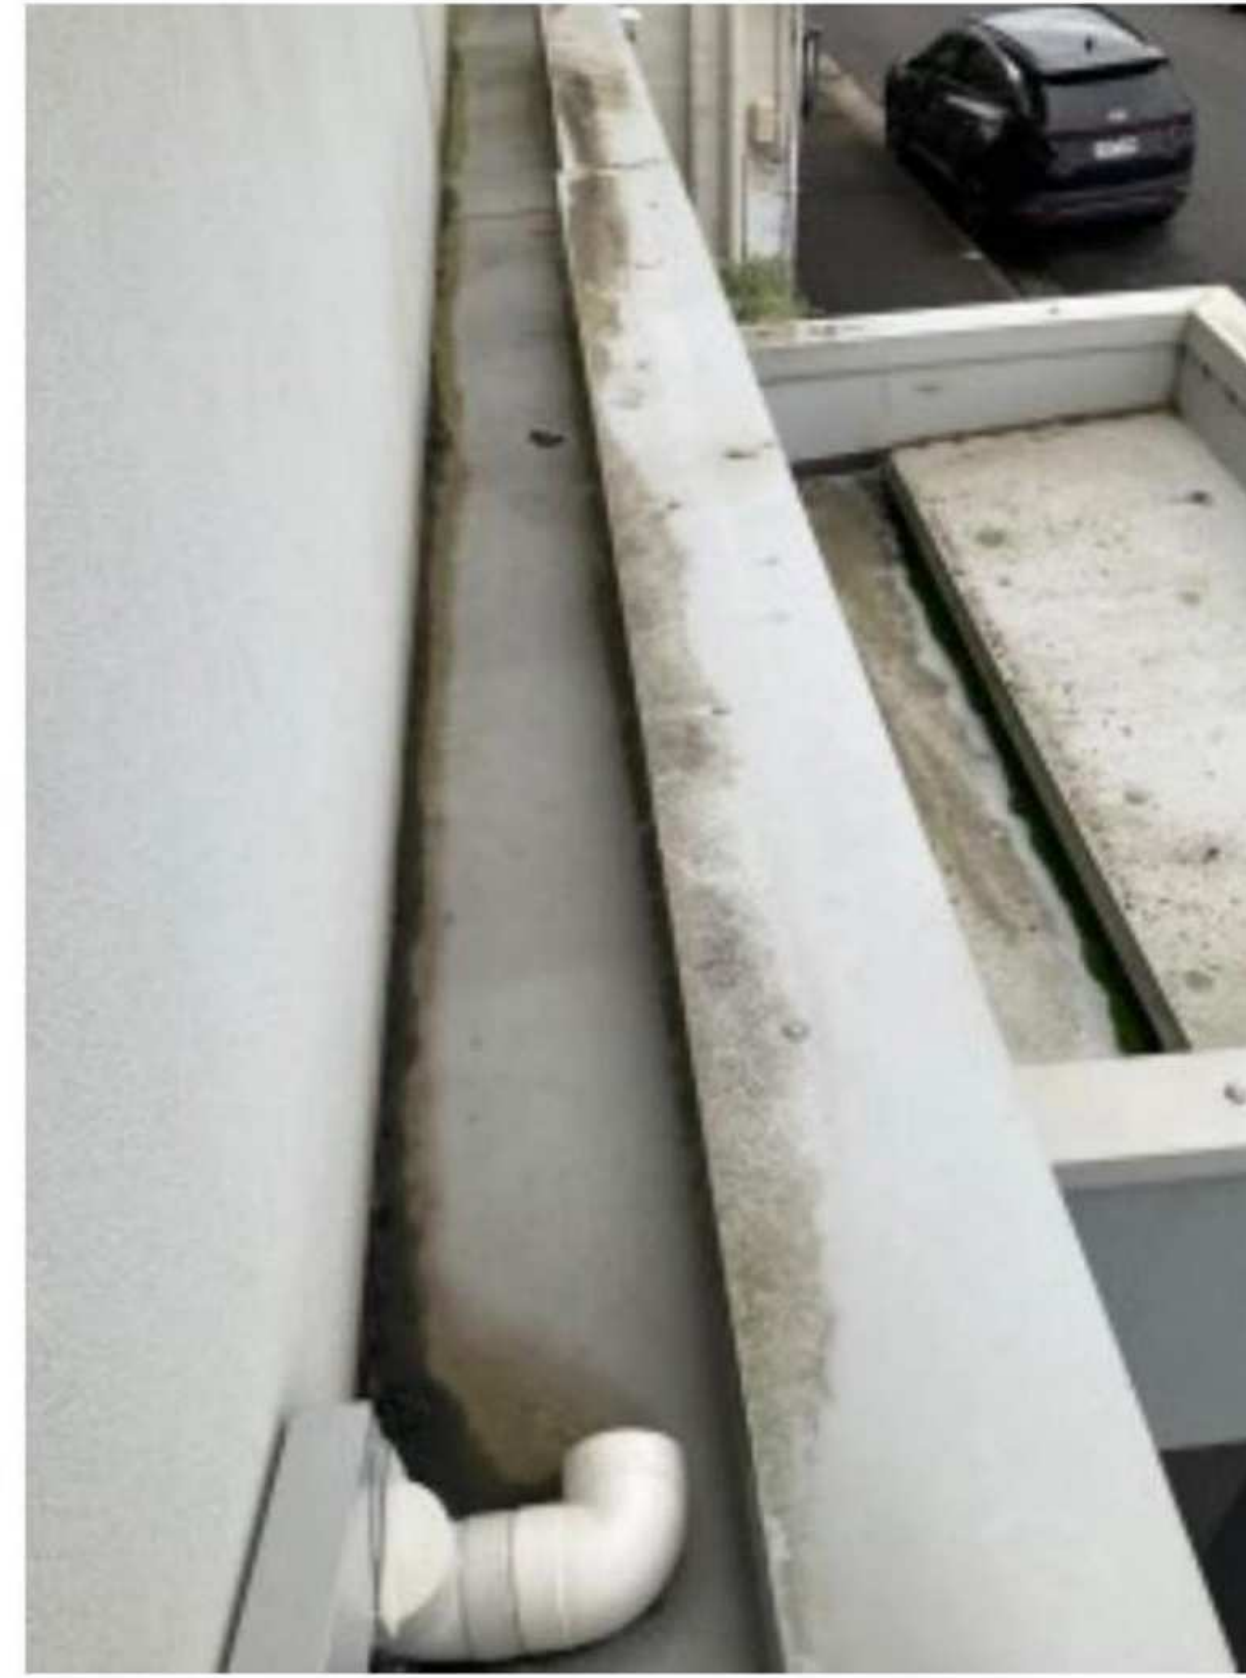
The roof gutter shows signs of poor maintenance, evidenced by significant moss and algae buildup along the edges. This accumulation suggests water retention issues, which may lead to long-term damage if not addressed. Proper cleaning of the gutter are recommended to ensure effective water flow and to prevent potential water damage to the adjacent structures. Regular maintenance will help mitigate any future issues related to improper water drainage.

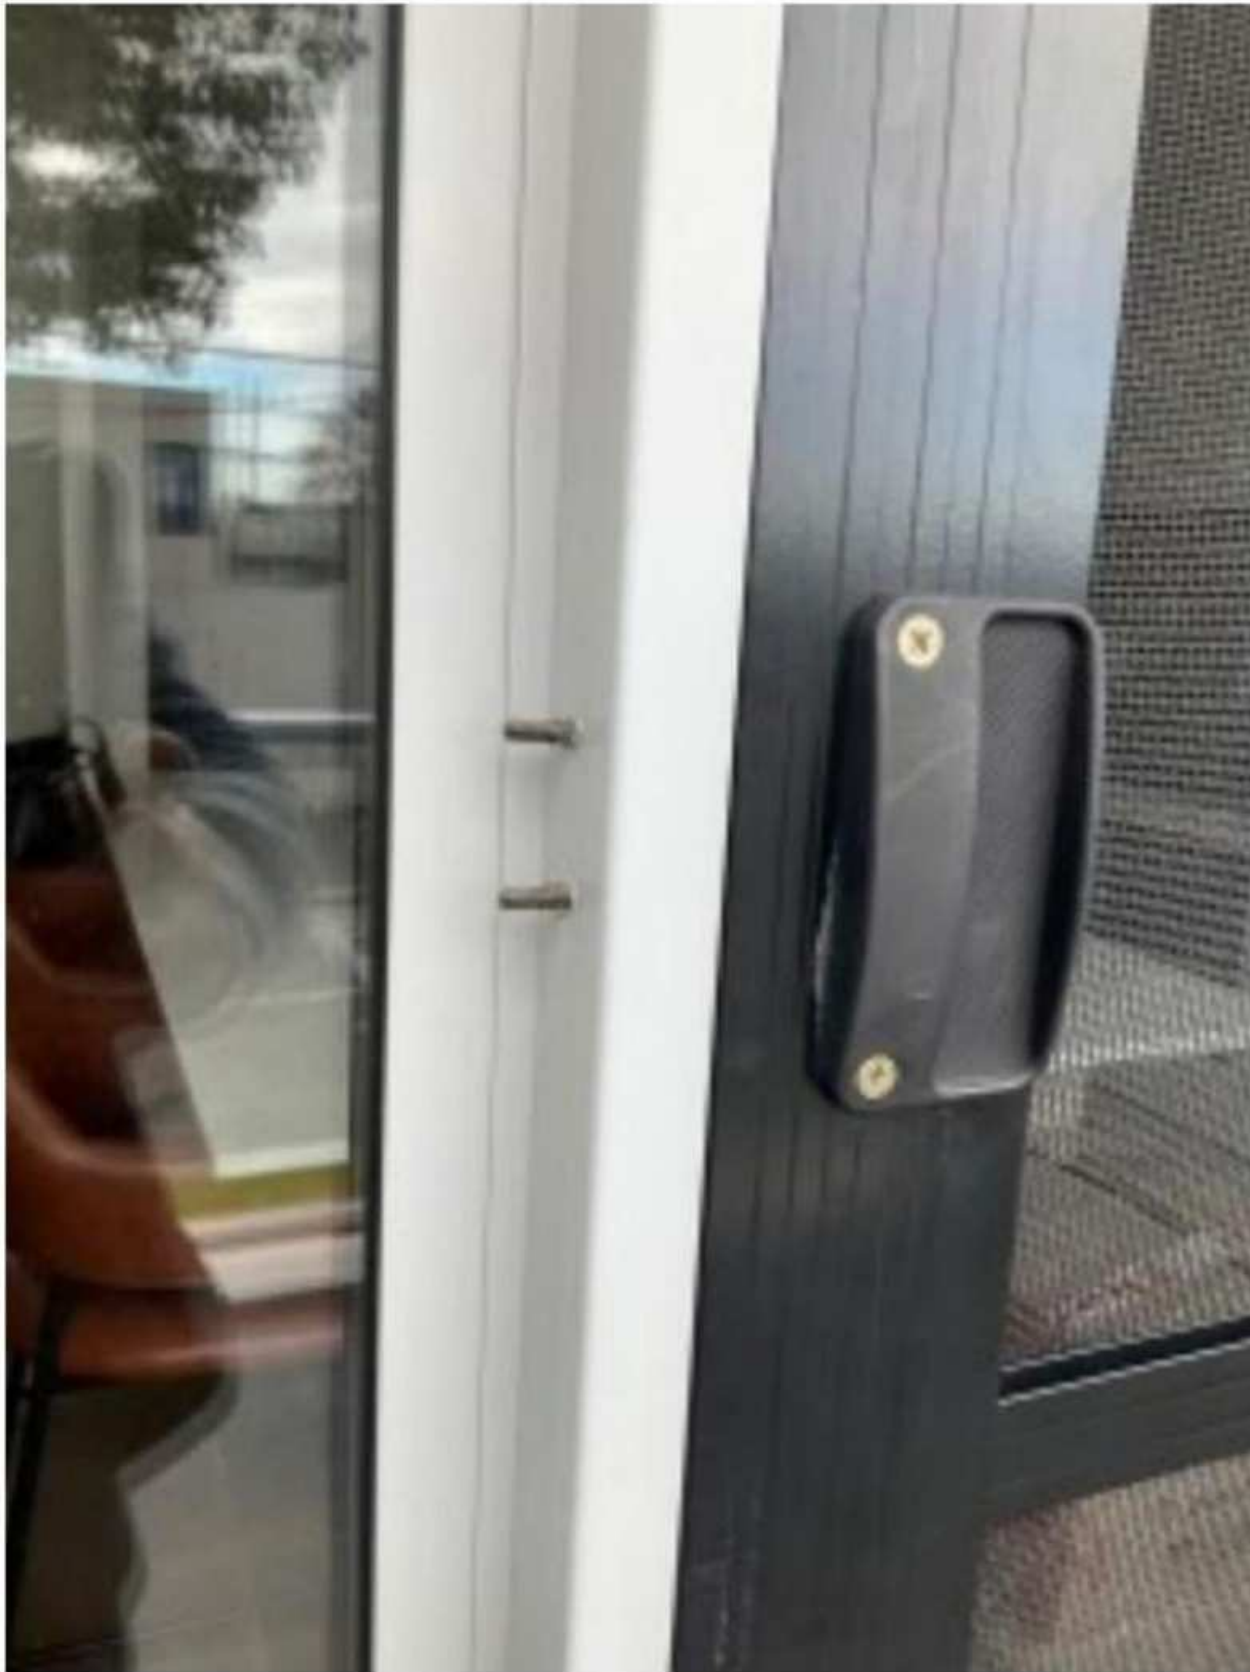
Incorrect screws used for sliding door installation. Handyman to rectify.

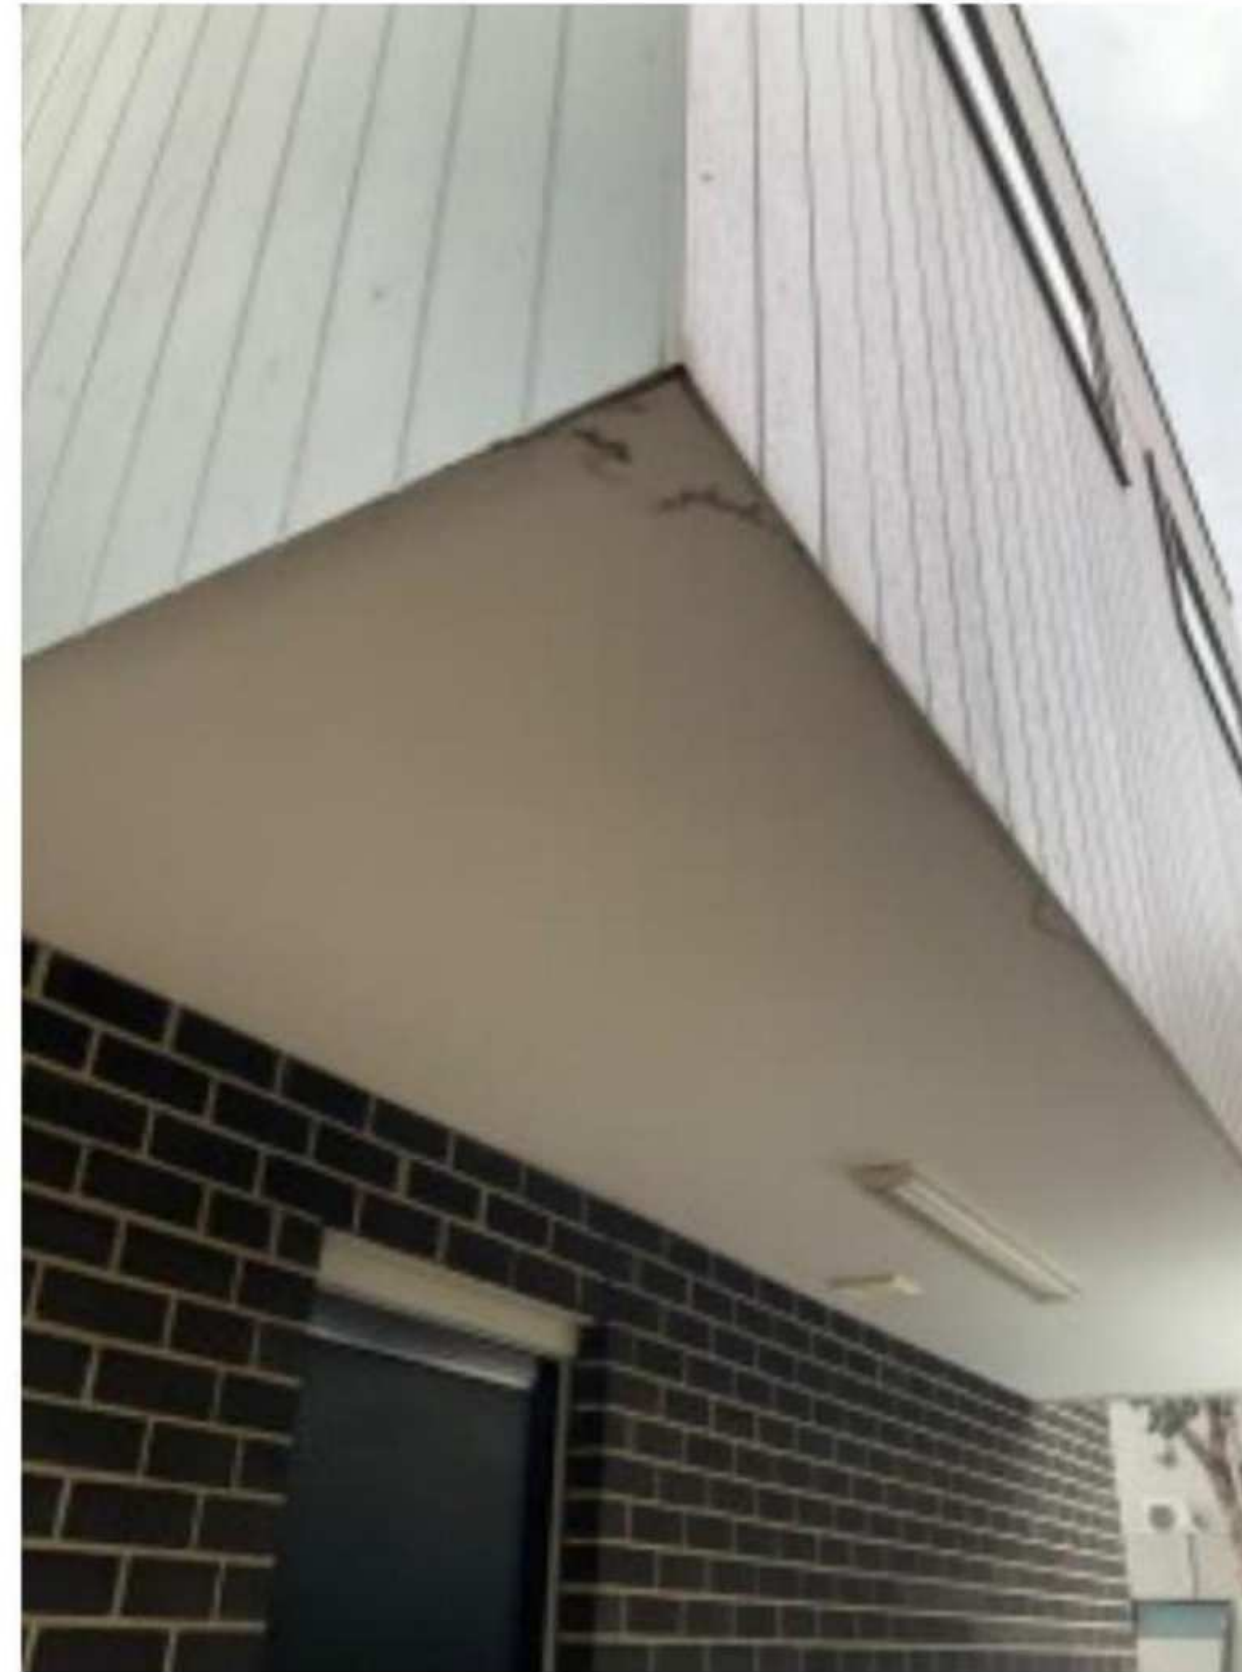
The property exhibits visible water stains and possible mould growth along the underside of the eaves. Immediate attention is advised to identify the source of moisture and conduct necessary repairs to prevent further deterioration and maintain the integrity of the building. Regular maintenance and monitoring are recommended to avoid recurring problems.

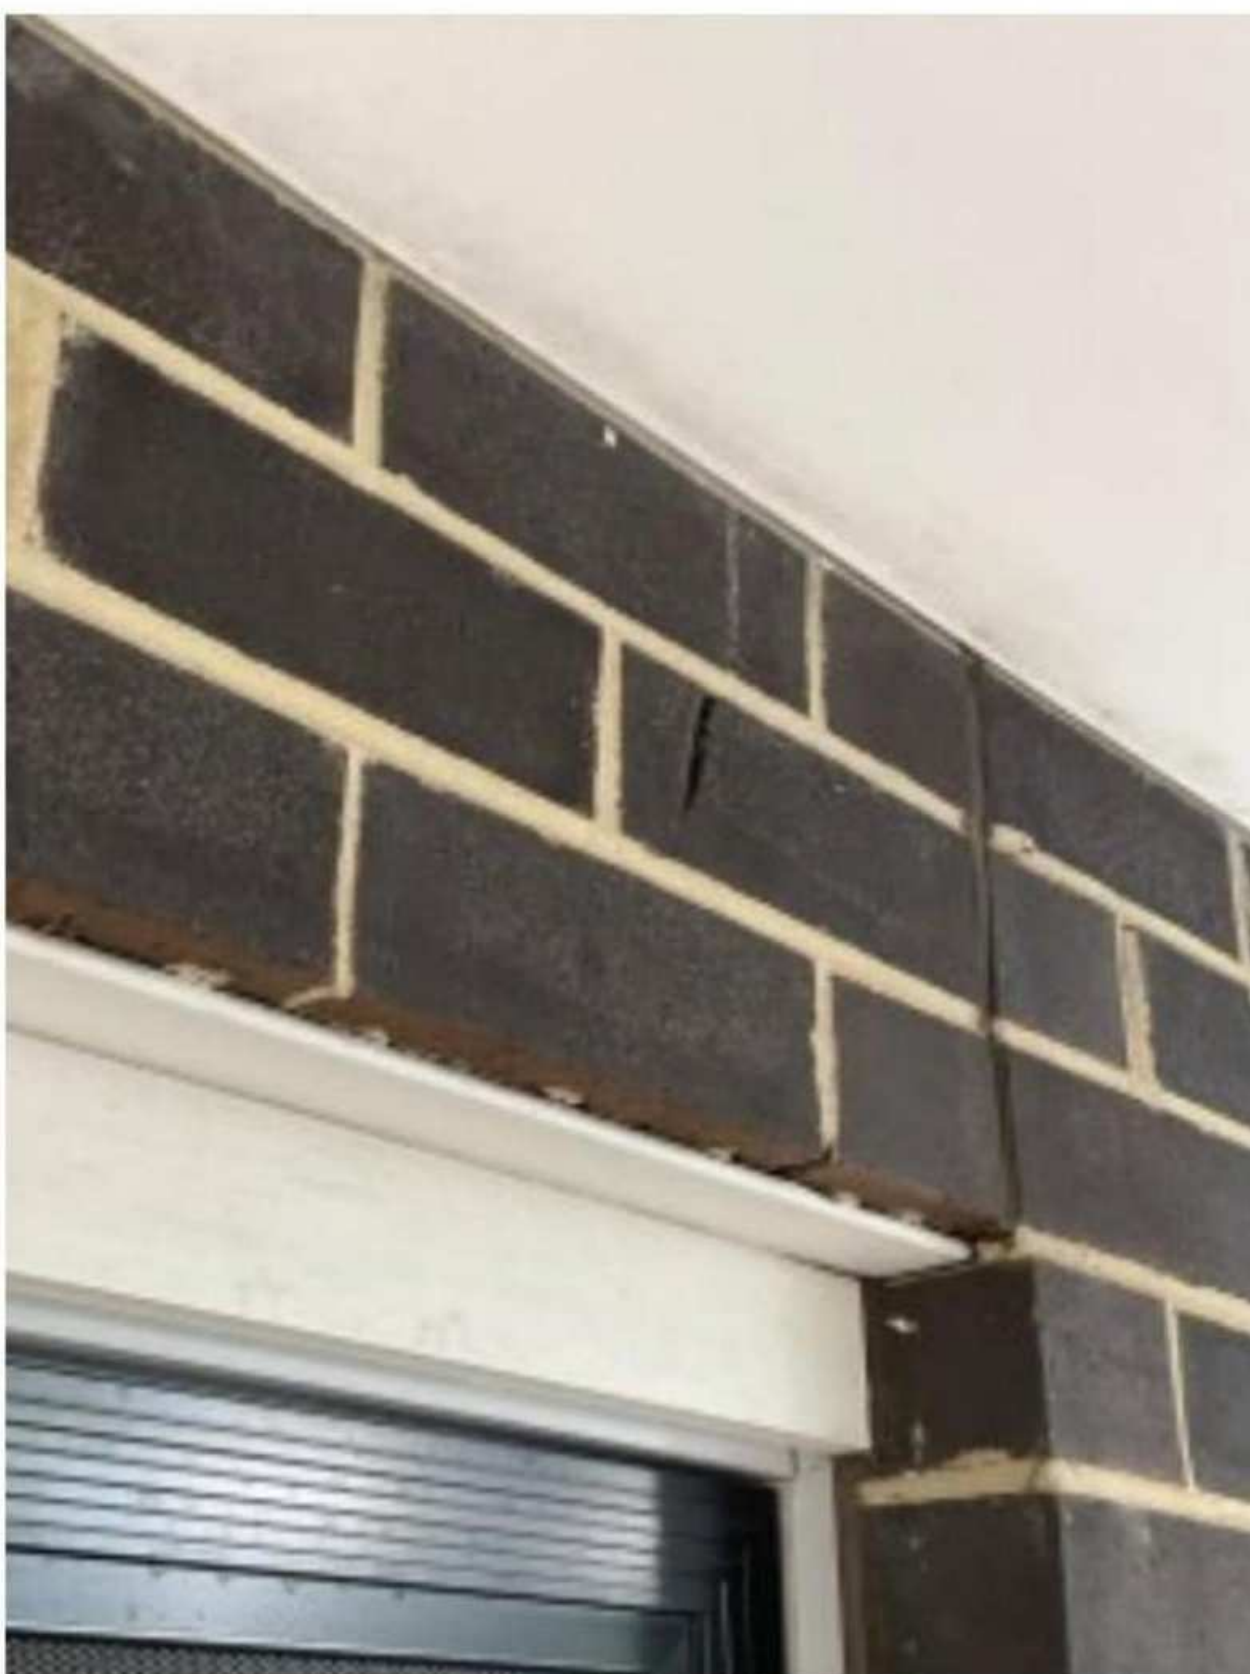
There is a crack in one of the bricks above the window. Repair or replacement is recommended to prevent water penetration.

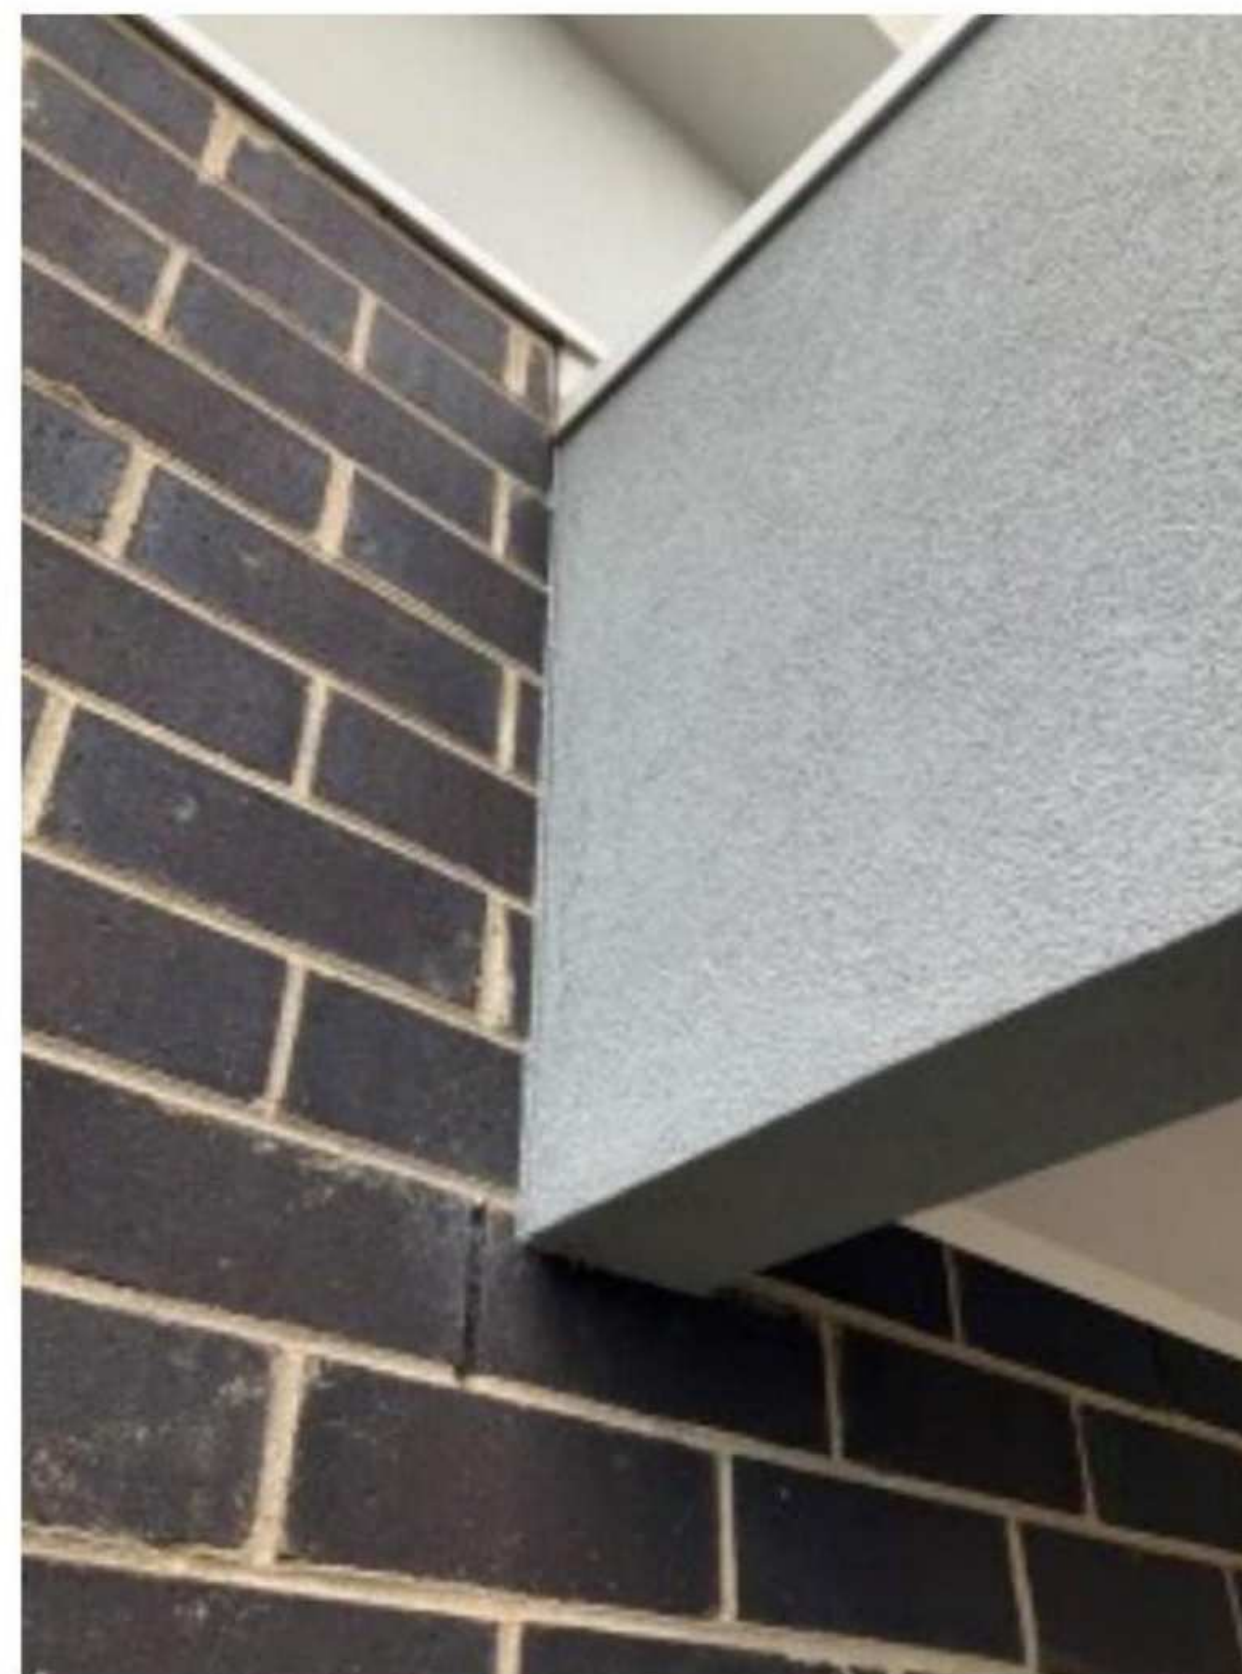
The exterior surface displays a noticeable crack where the rendered wall meets the brickwork. This separation indicates potential movement or settling issues that may require attention to prevent water ingress or further damage. Monitoring for any progression and repair would be advisable to maintain the integrity of the structure.

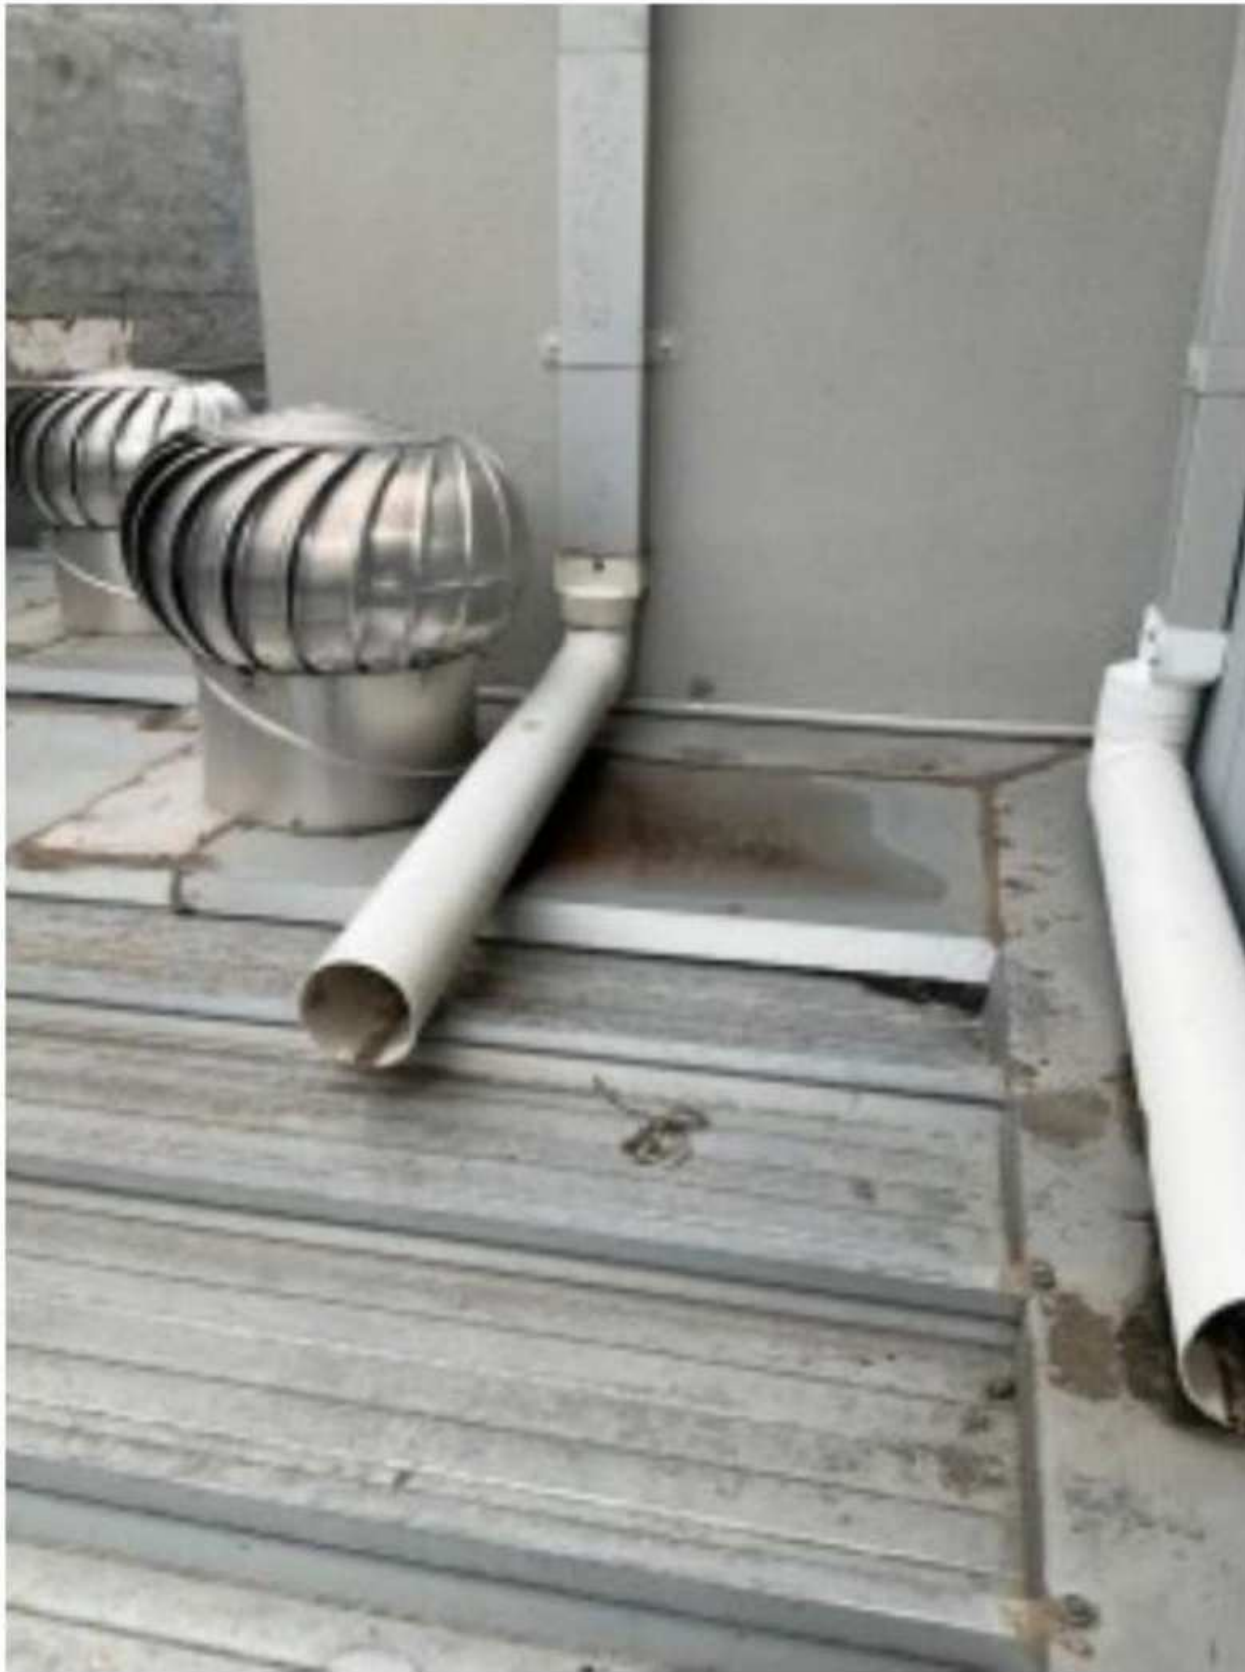
There is visible pooling of water on the roofing material. Regular inspection and maintenance are recommended to avoid further deterioration.

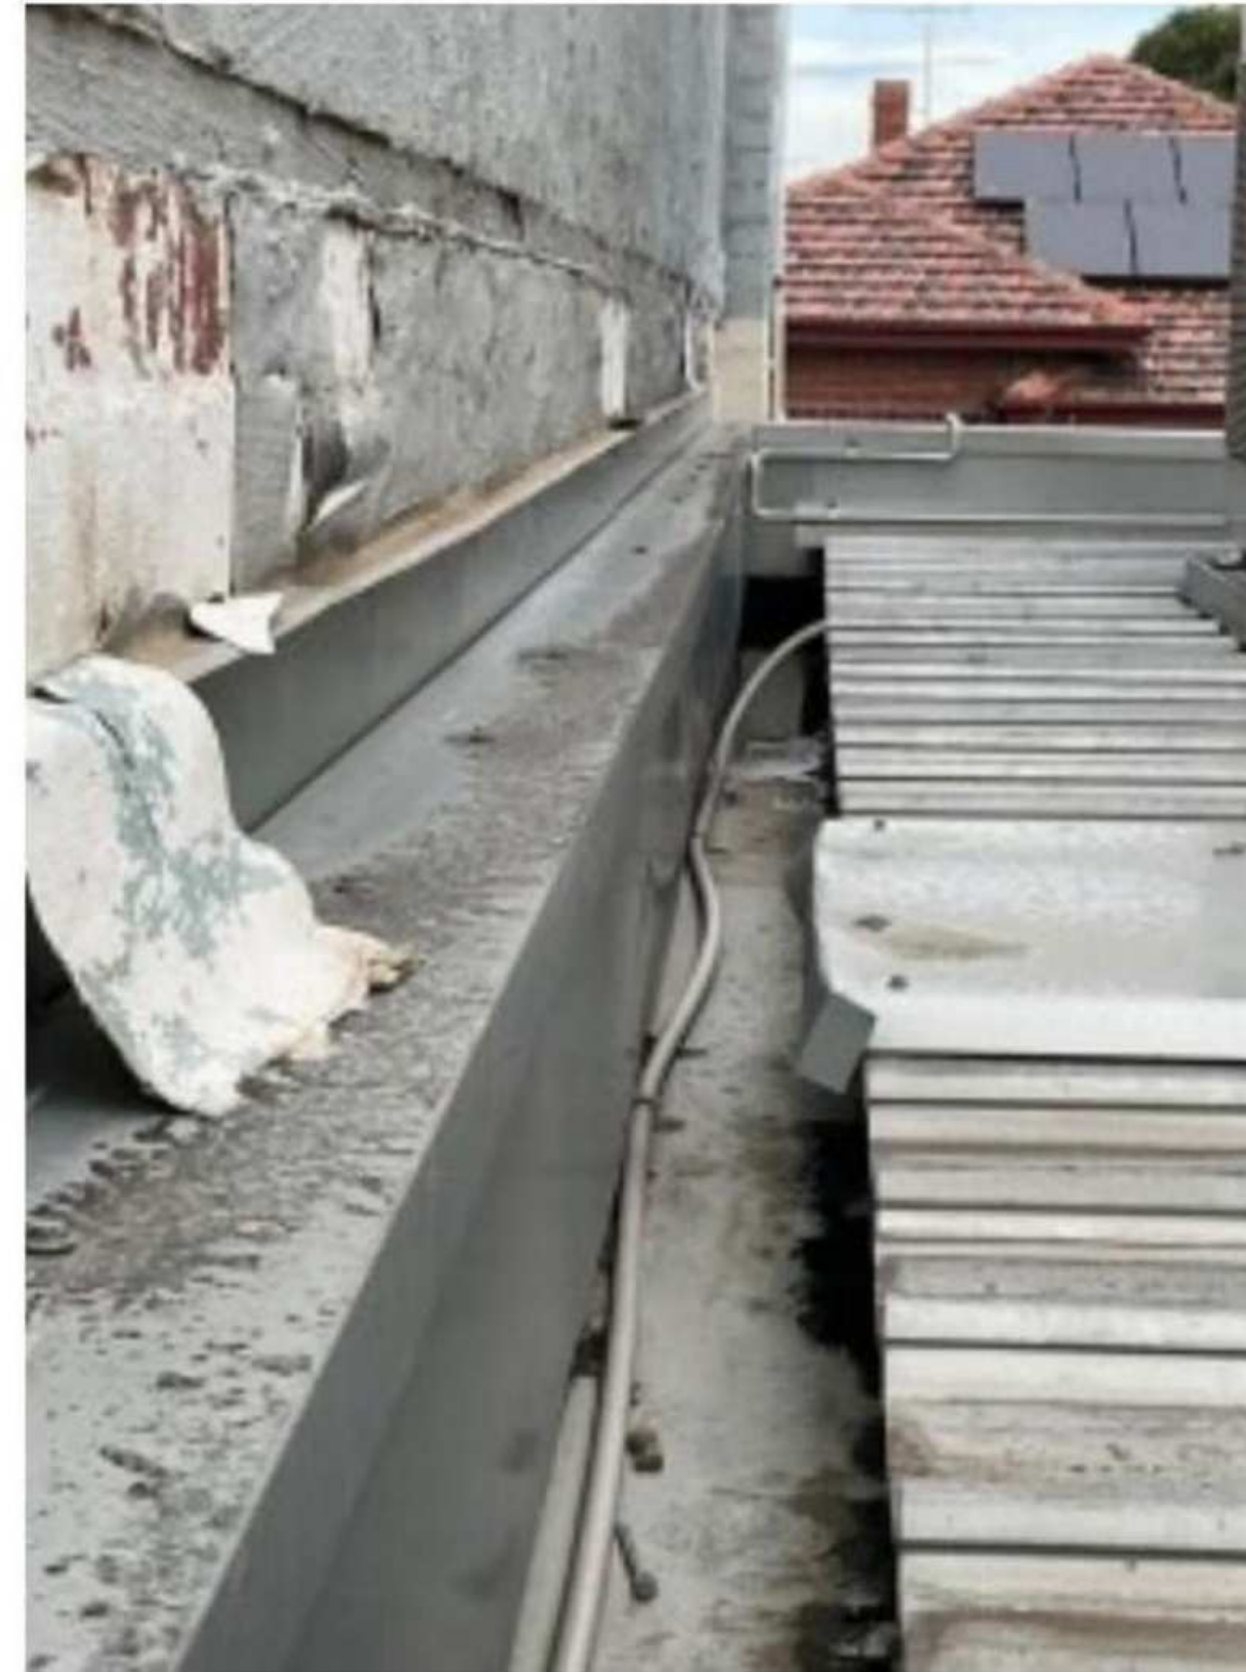
The presence of debris and water pooling on the gutter surface, contributing to moisture retention and possible corrosion. Recommend gutter cleaning to prevent water moisture and potential leaking.
