## Just Inspections

## Building Inspection Report

AS4349.1- 2007

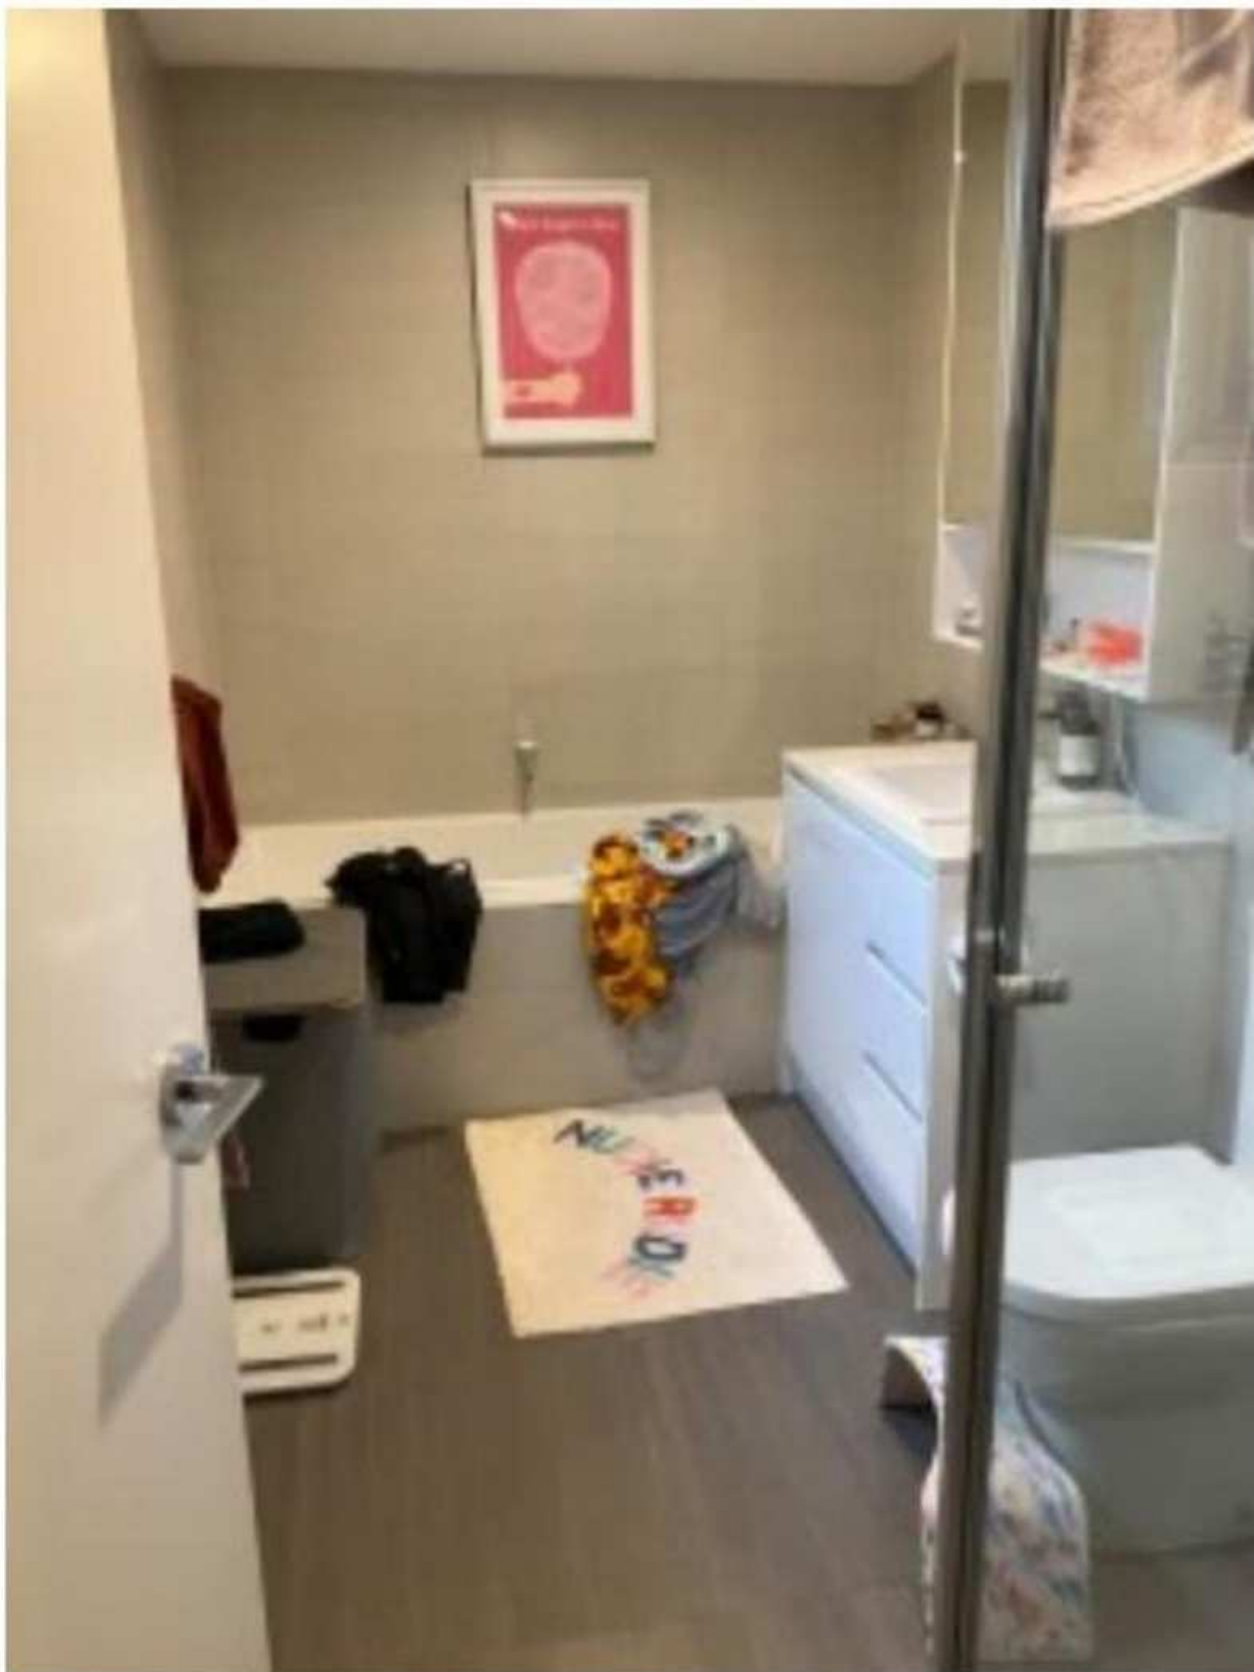
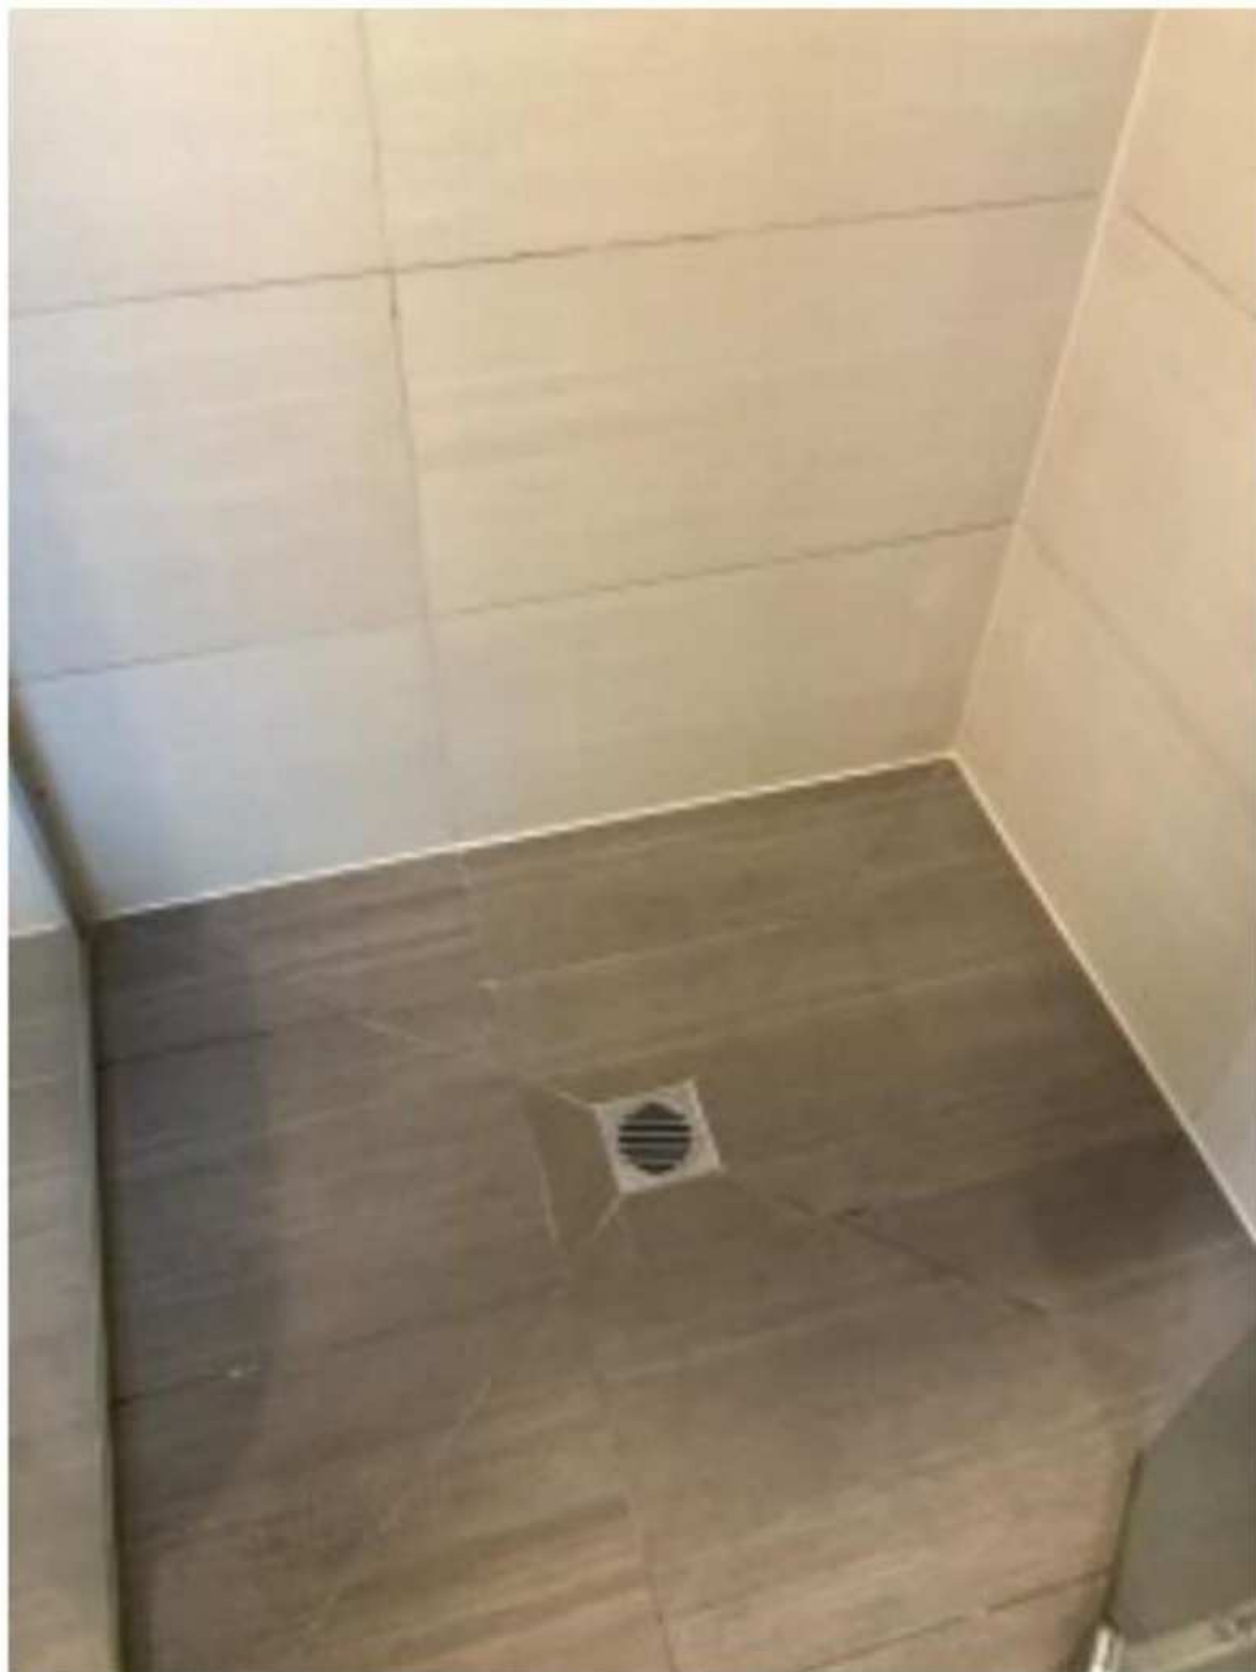
Visible signs of mould growth on the wall tiles and shower base in the bathroom. Recommend regular cleaning to prevent grout deterioration

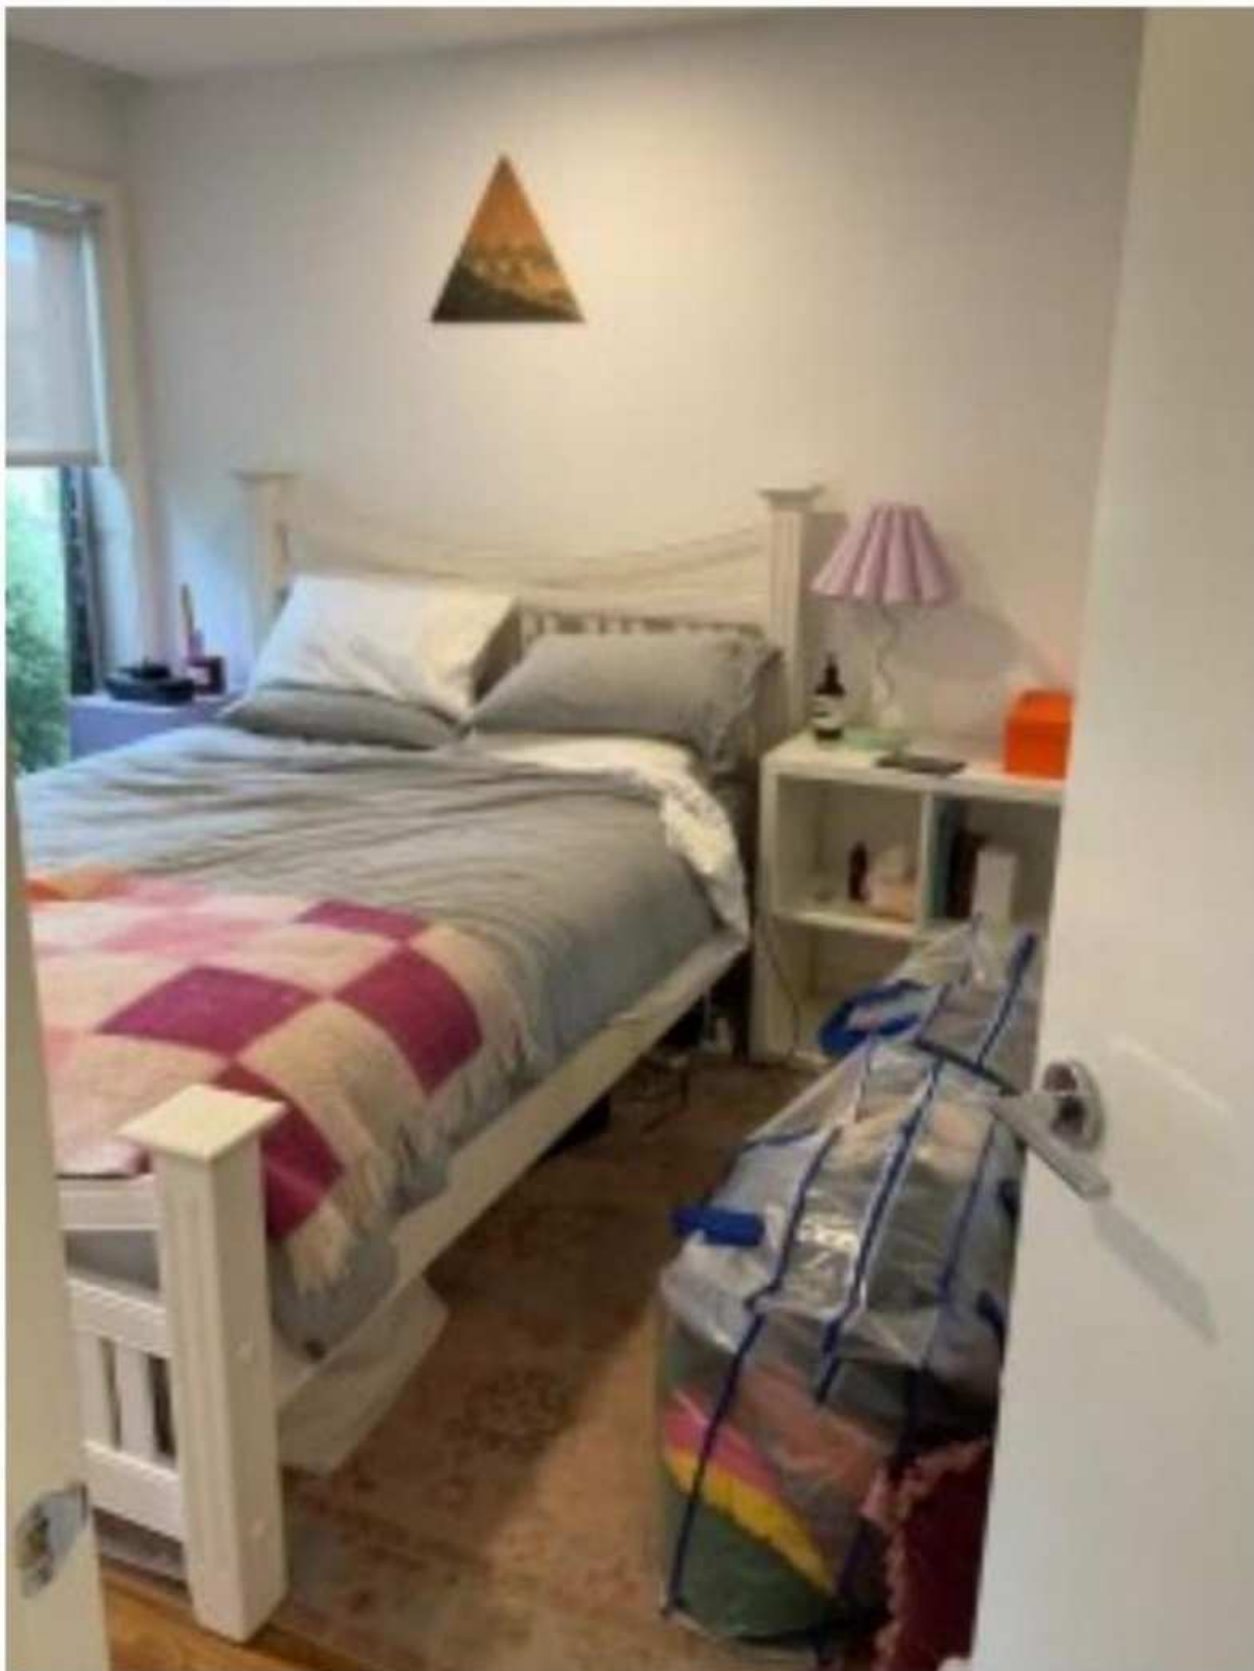
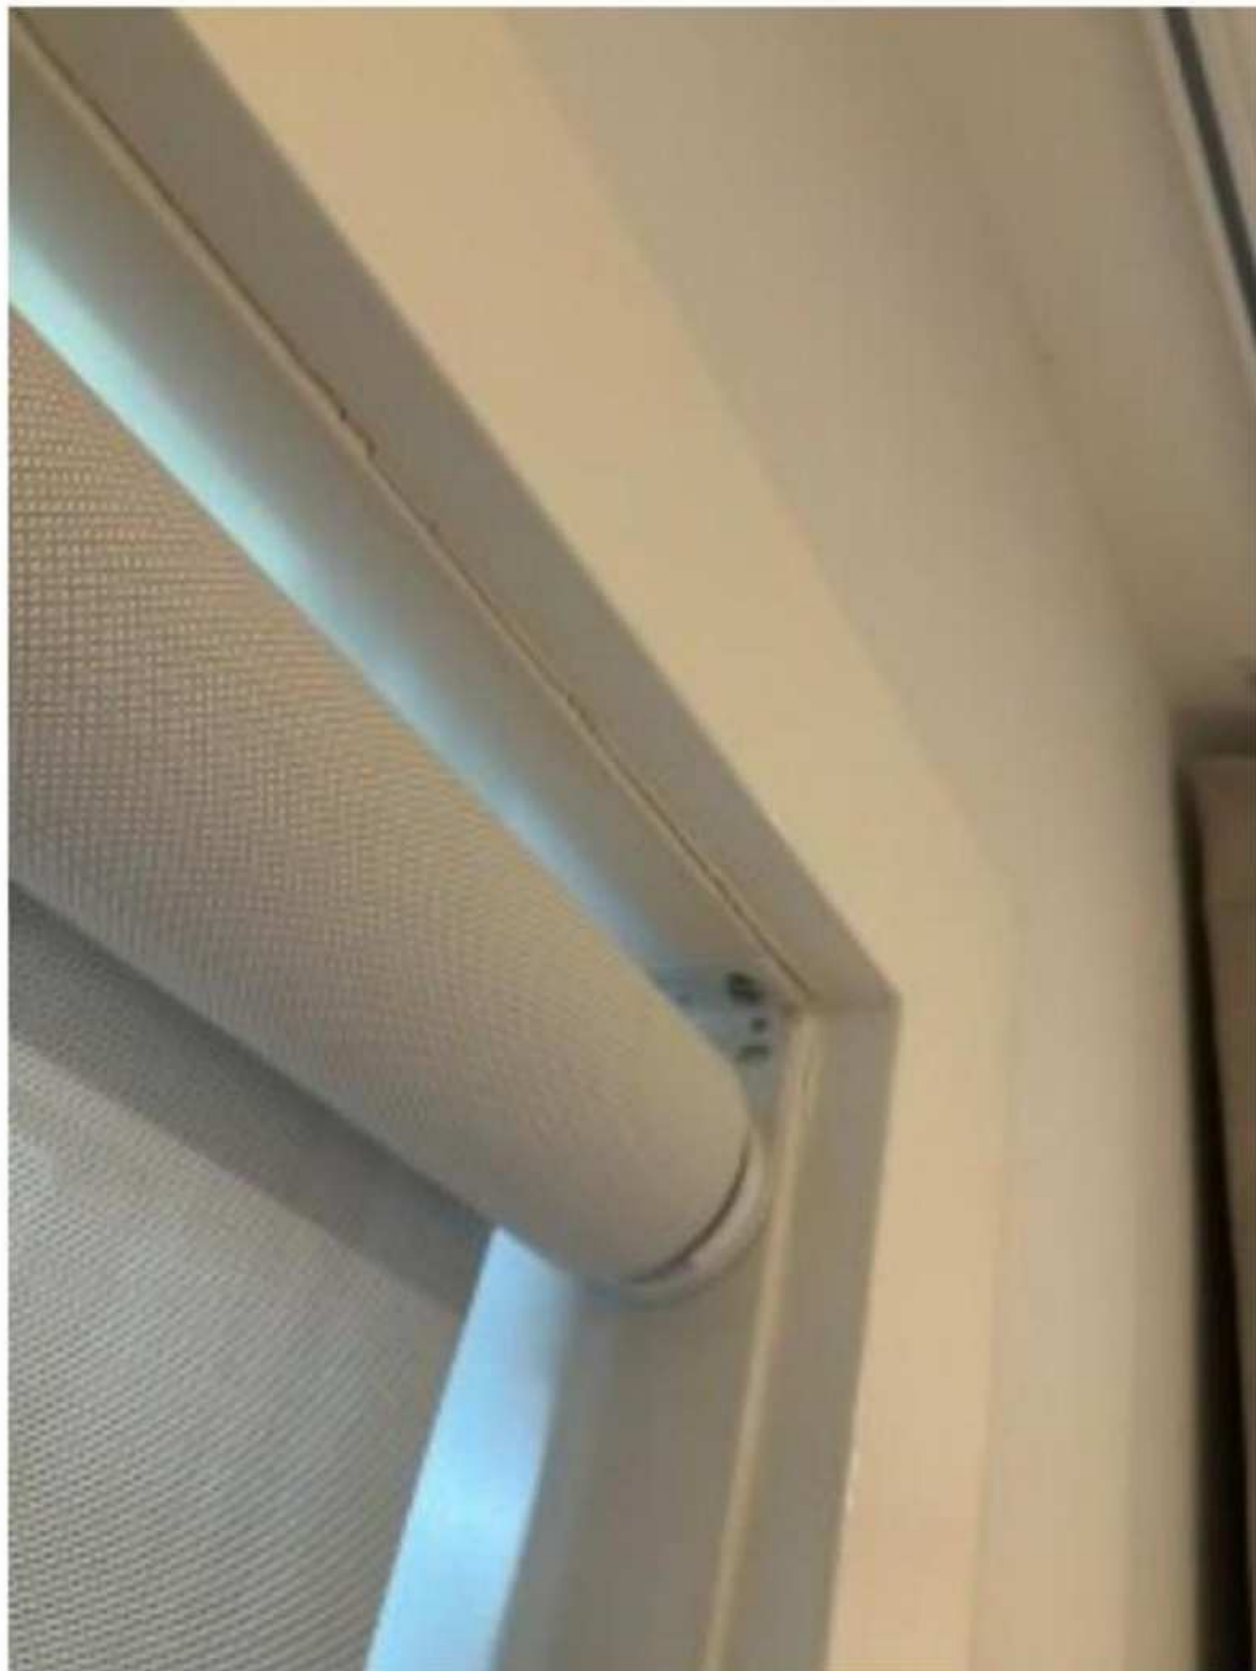
The window frame exhibits noticeable cracking along the inner edges, which could indicate minor structural movement or settling. Though currently superficial, these cracks may allow moisture ingress over time if not promptly sealed and maintained. Regular monitoring and timely repairs are recommended to prevent potential deterioration.

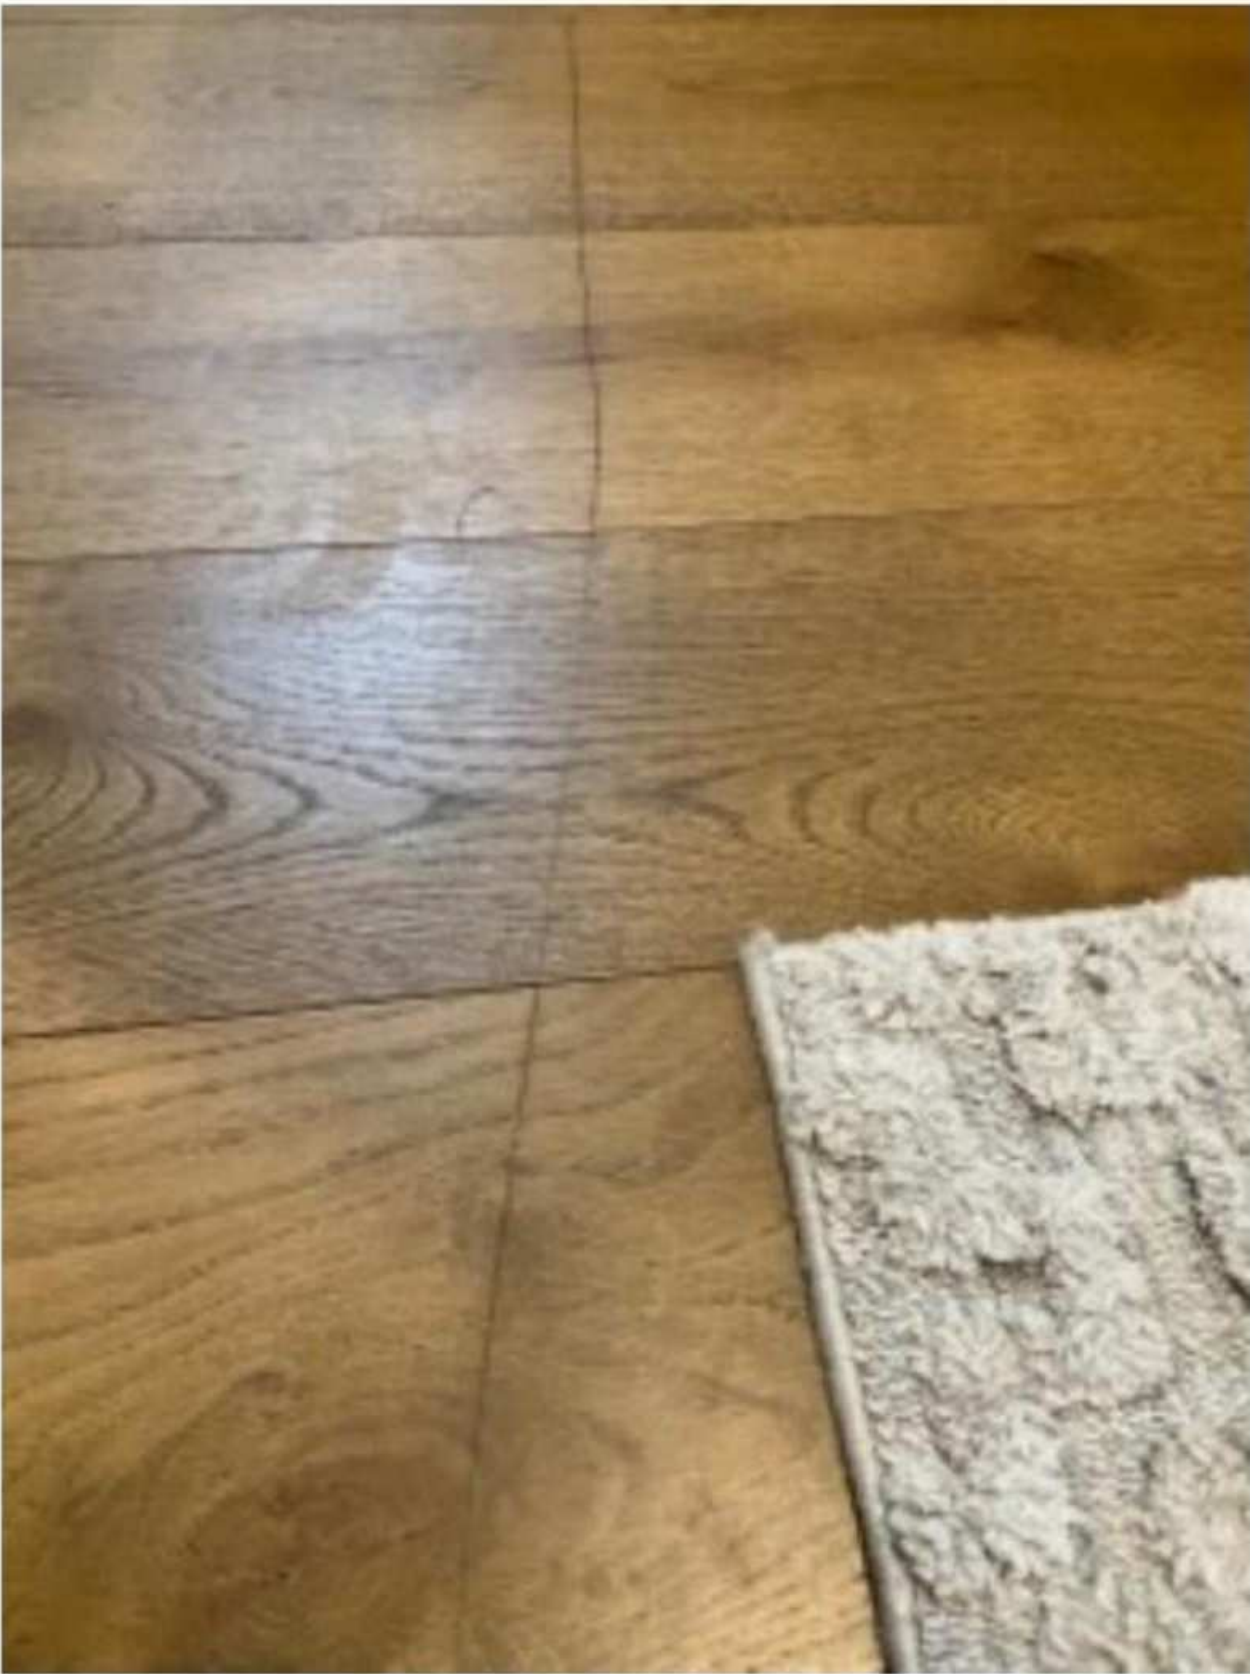
The image indicates a scratch on a timber floorboard. This defect could compromise the aesthetic appeal. Further inspection is recommended to determine the cause and assess whether repairs or replacements are necessary.

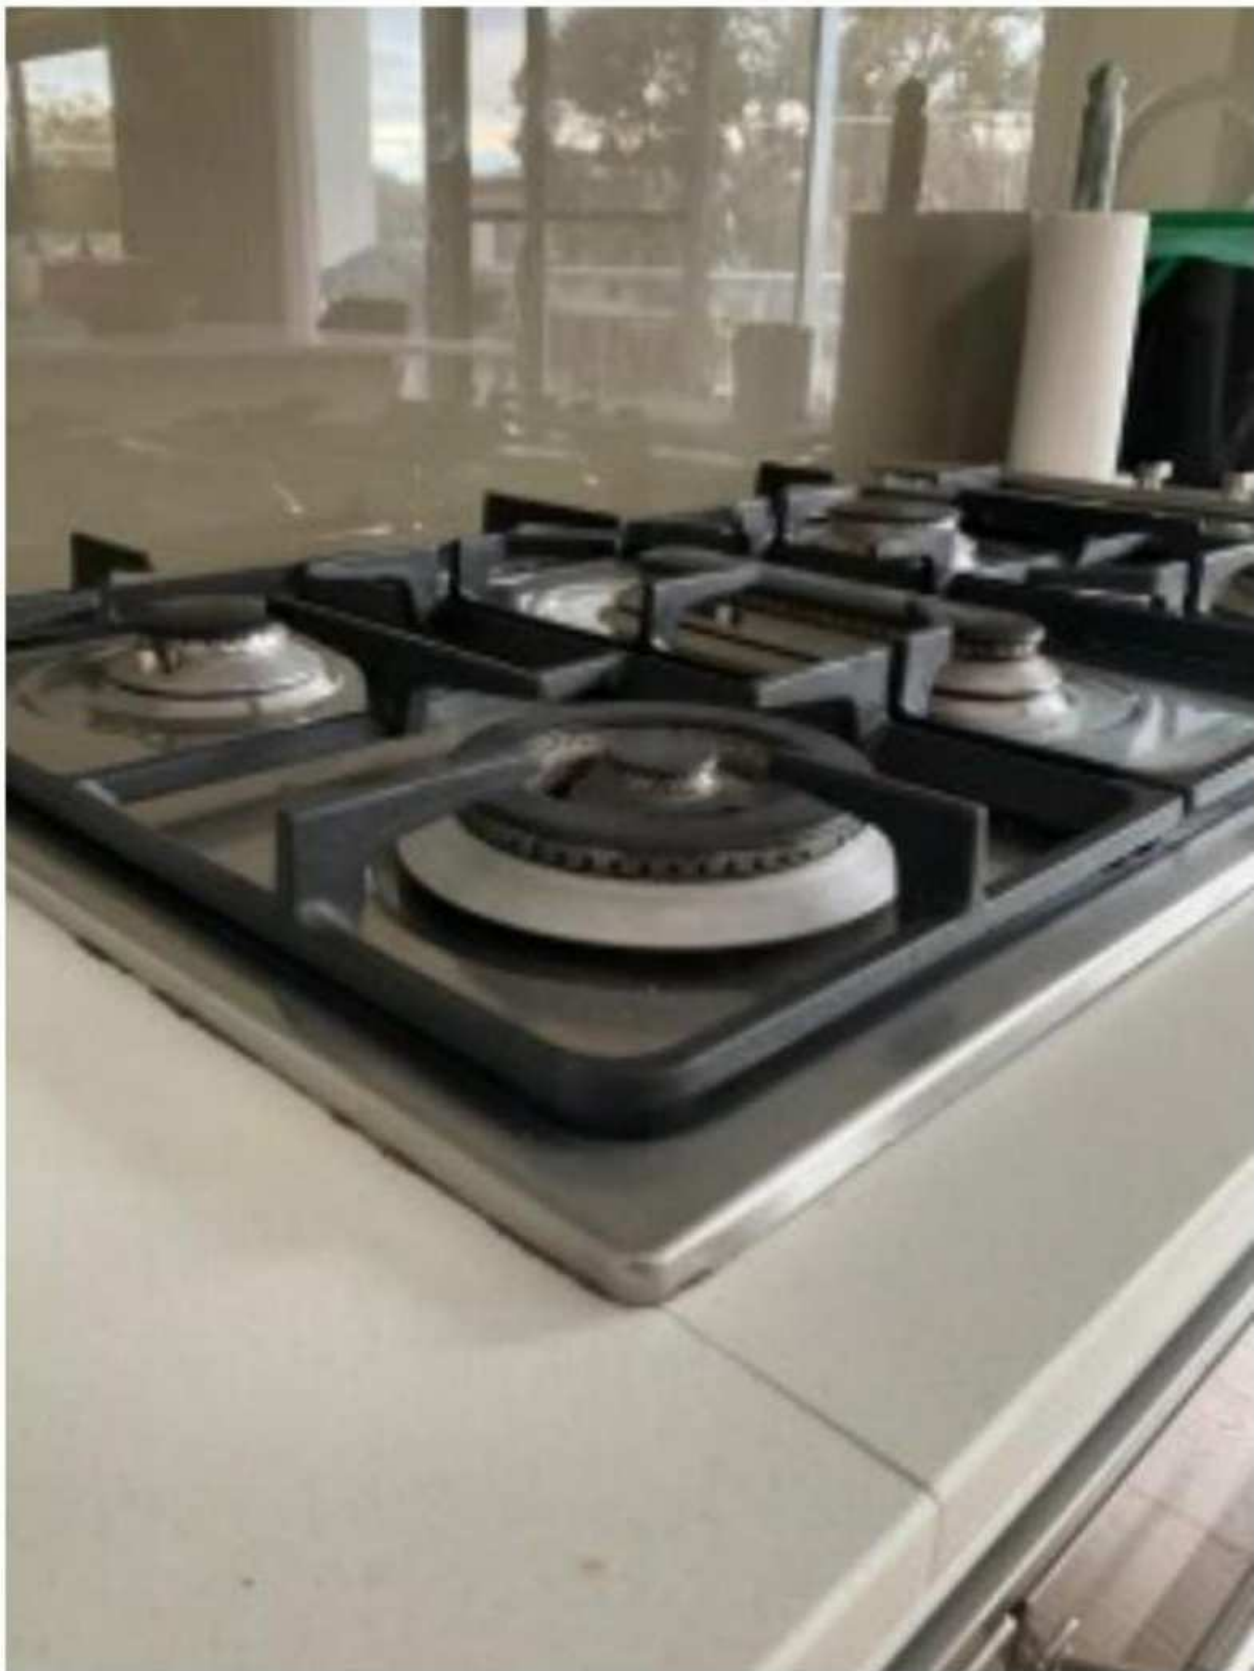
The gas cooktop installation shows sealant deterioration between the appliance and the surrounding countertop, which may result in moisture entry and accumulation. The lack of a proper seal may also compromise the countertop's integrity over time. It is recommended to have a qualified tradesperson address this issue by ensuring a secure and well-sealed fit to prevent potential deterioration and maintain the kitchen's overall functionality and appearance.

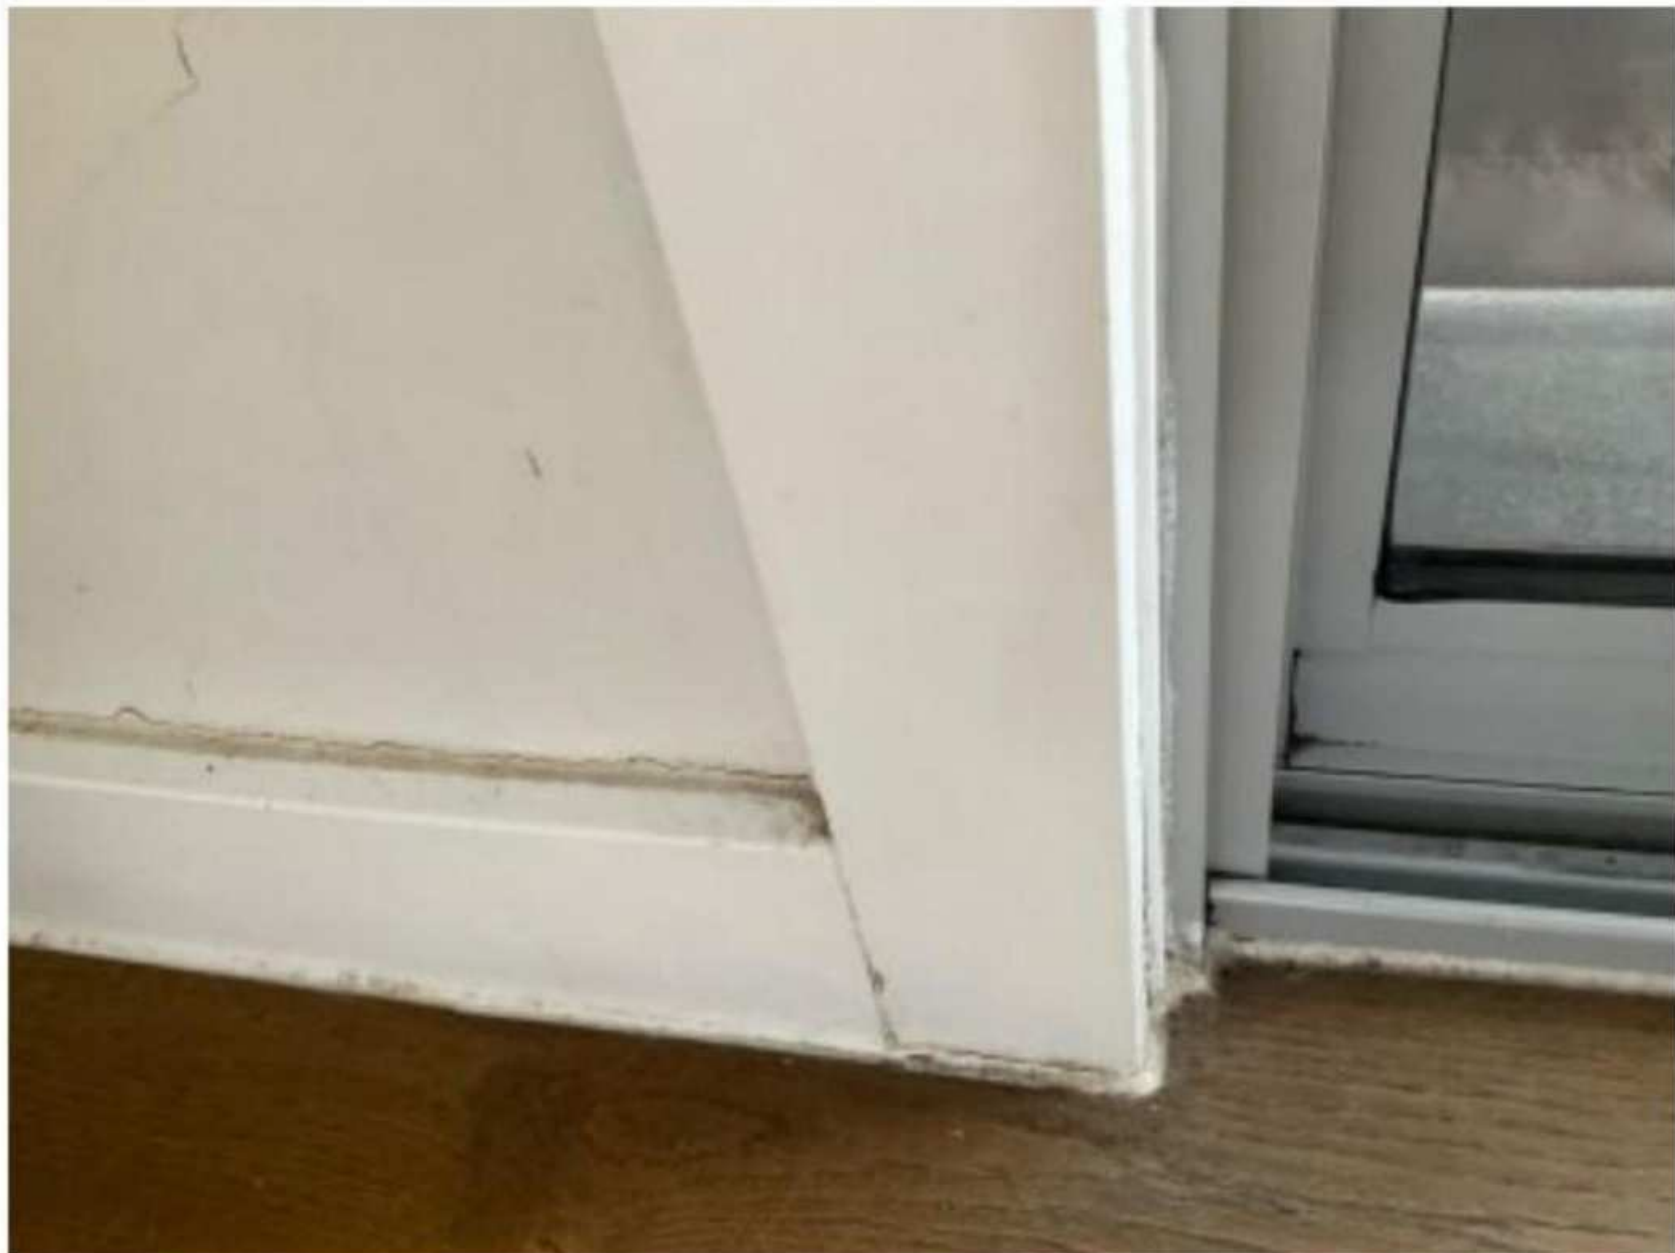
The image presents evidence of minor cracks and gaps in the wall near the door frame. The separation between the wall and floor potentially allowing moisture ingress. It is advisable to repair the gaps to ensure the integrity of the structure is maintained and to prevent future complications.

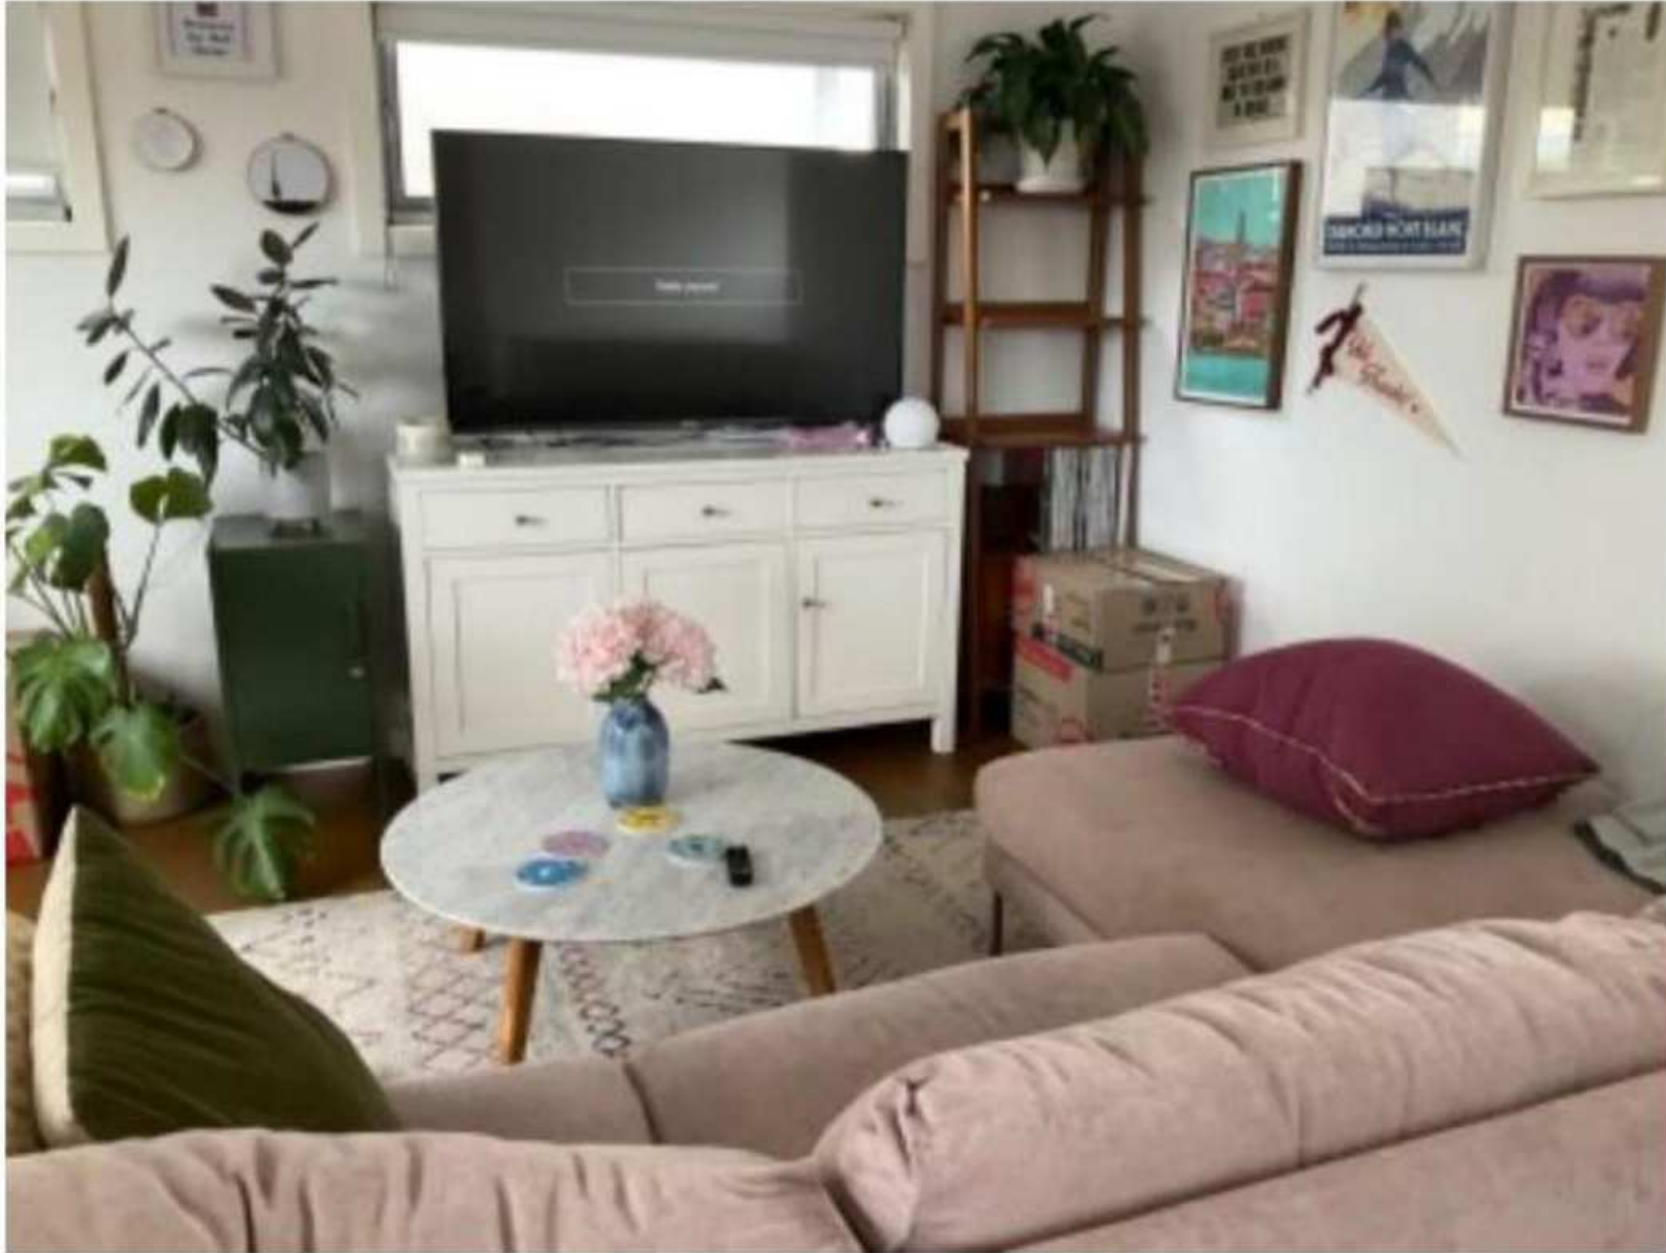
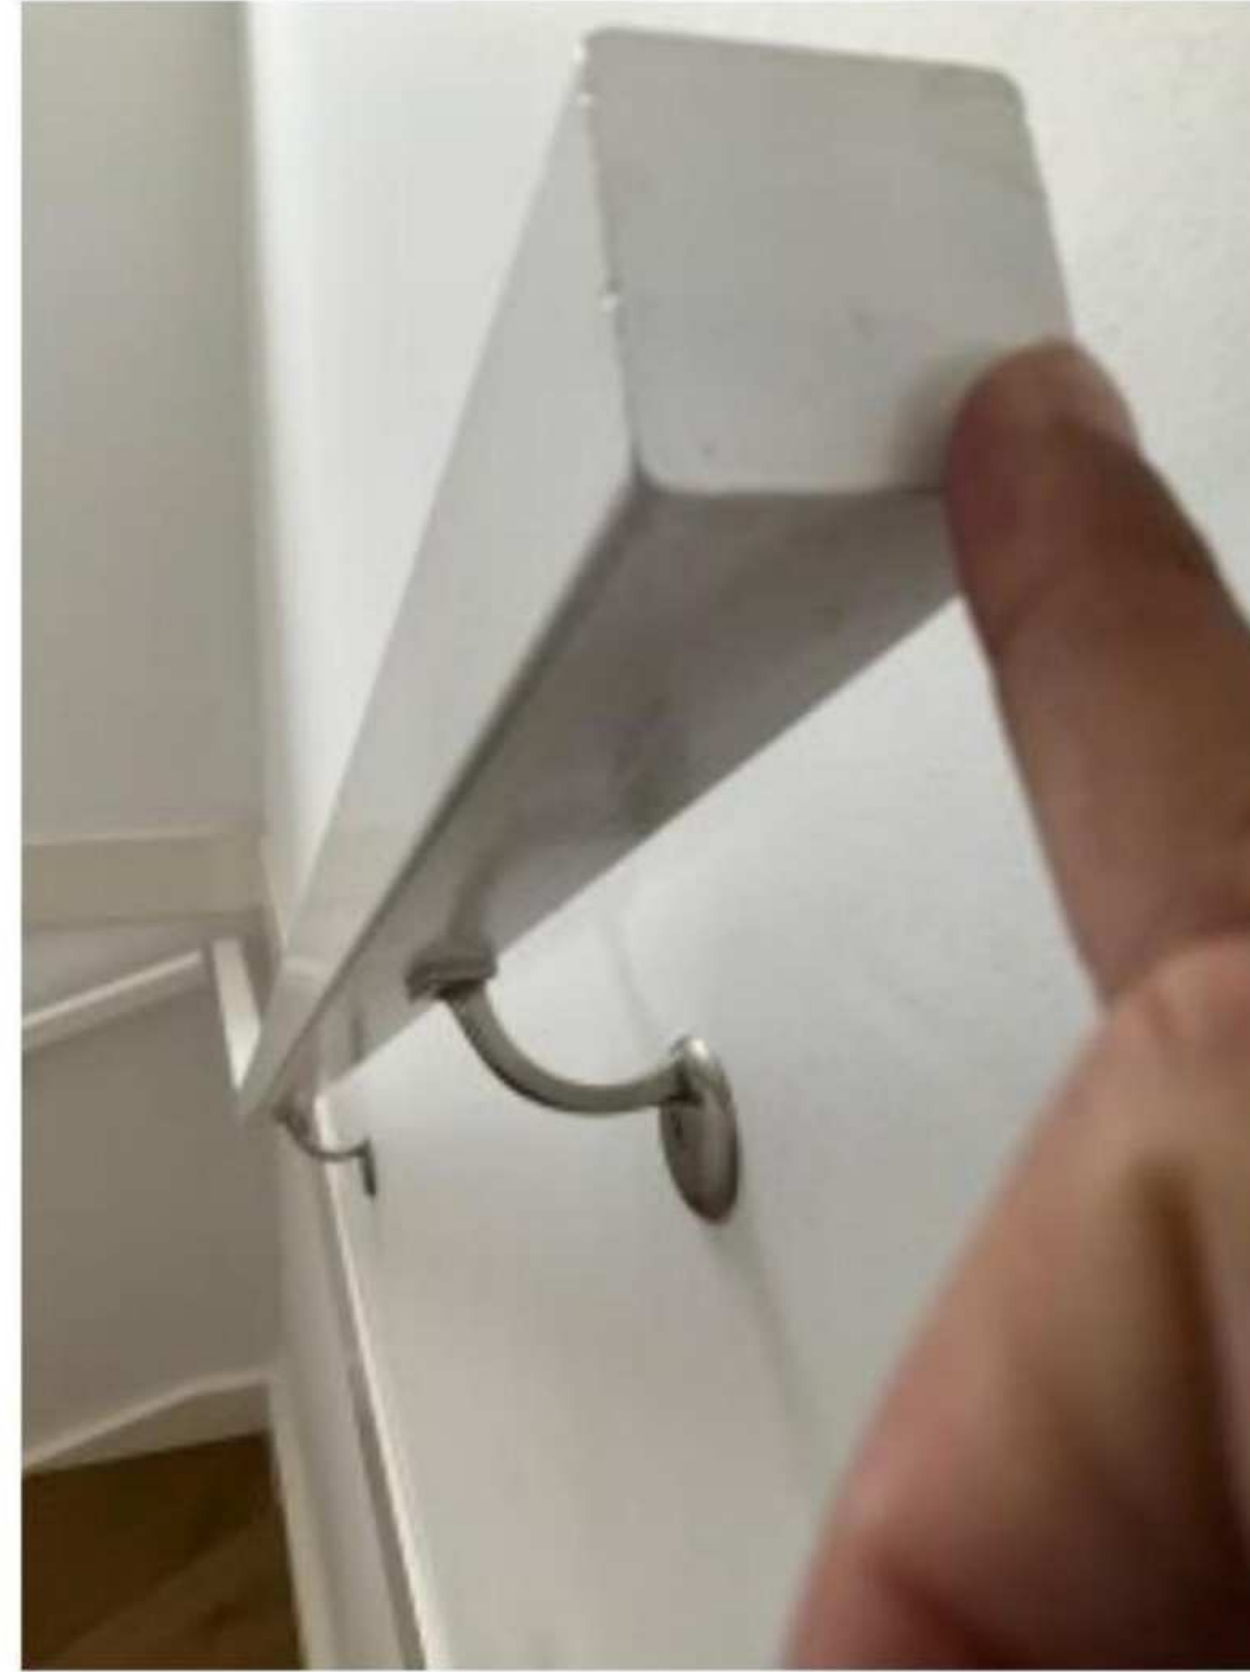
The handrail was found to be loose at the time of inspection, excessive movement was noted, which reduce its effectiveness and could pose a safety risk to occupants. It is recommended to be secured by a qualified tradesperson to ensure stability.

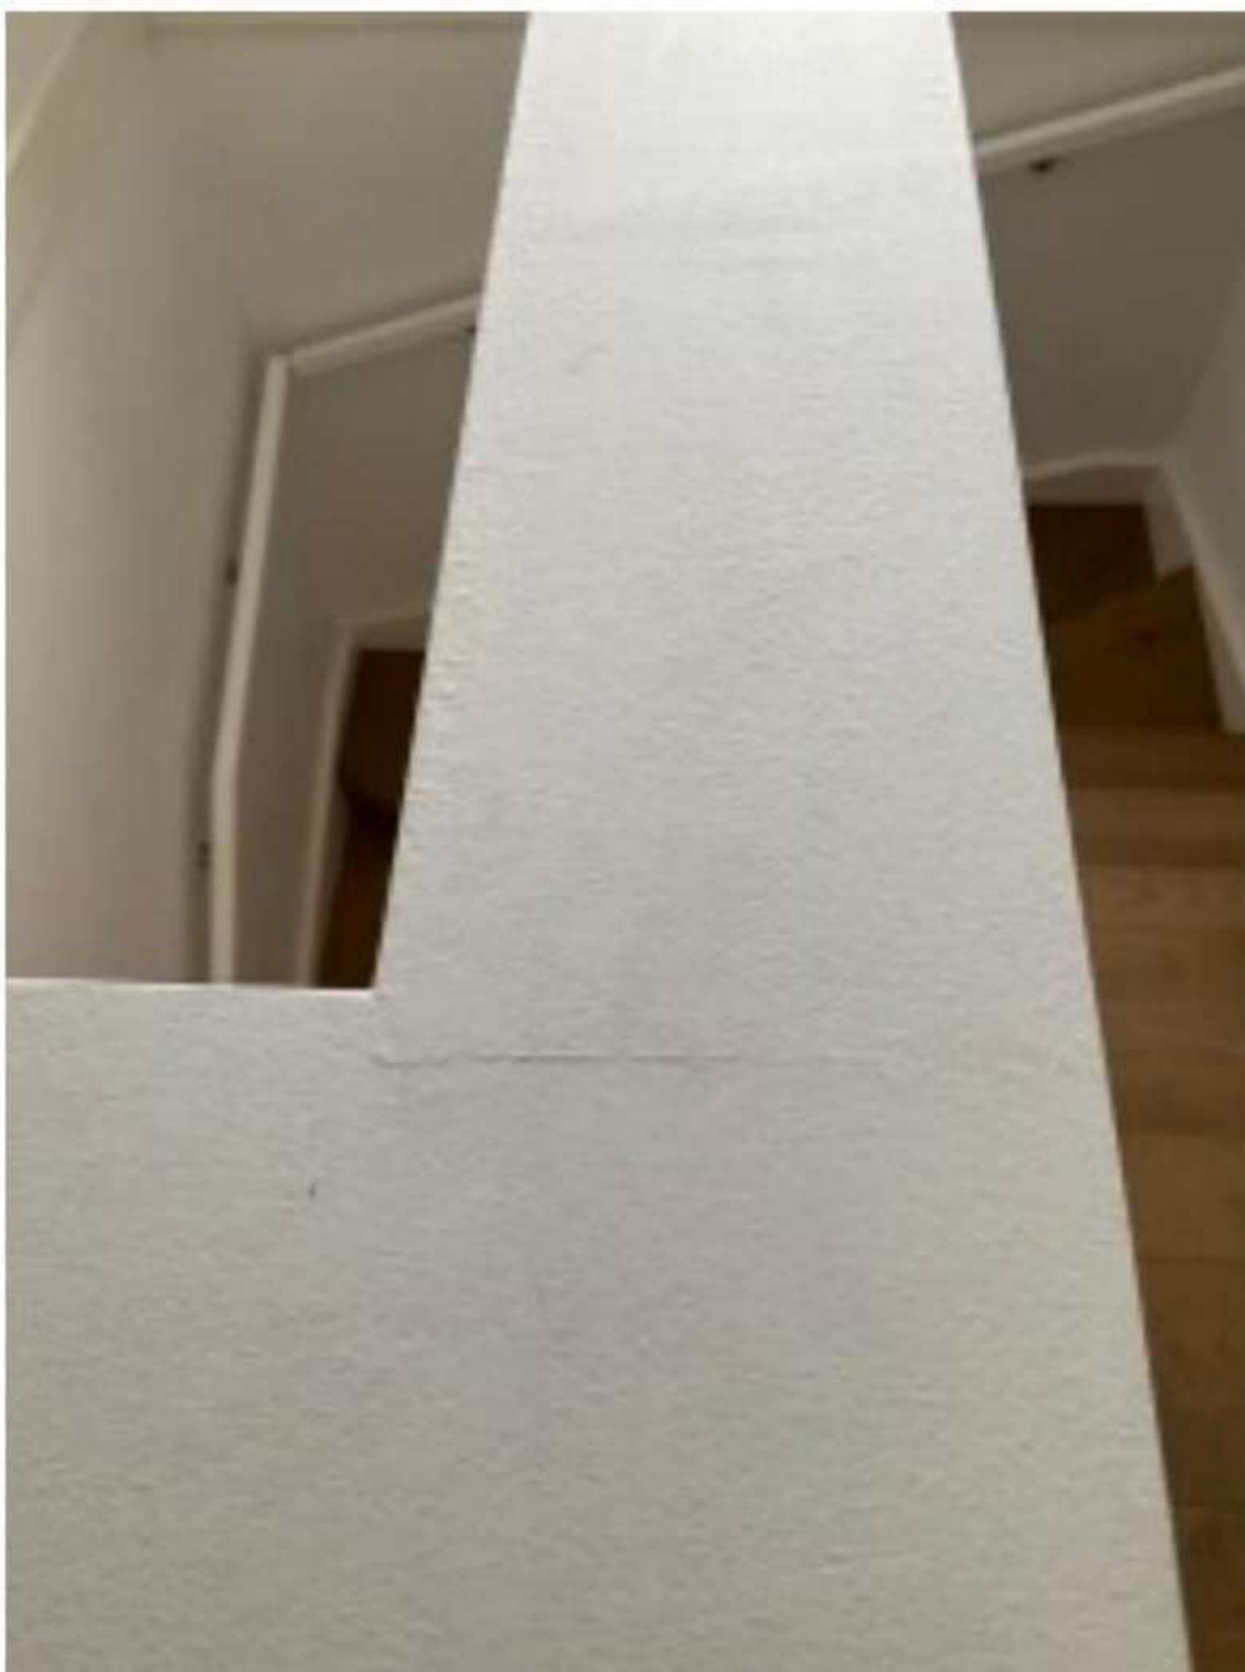
The image shows a minor crack line along the painted surface. The defect appears to be a minor cosmetic issue. Requires simple repair and repainting to restore the aesthetic appeal of the area.
