## Just Inspections

## Building Inspection Report

AS4349.1- 2007

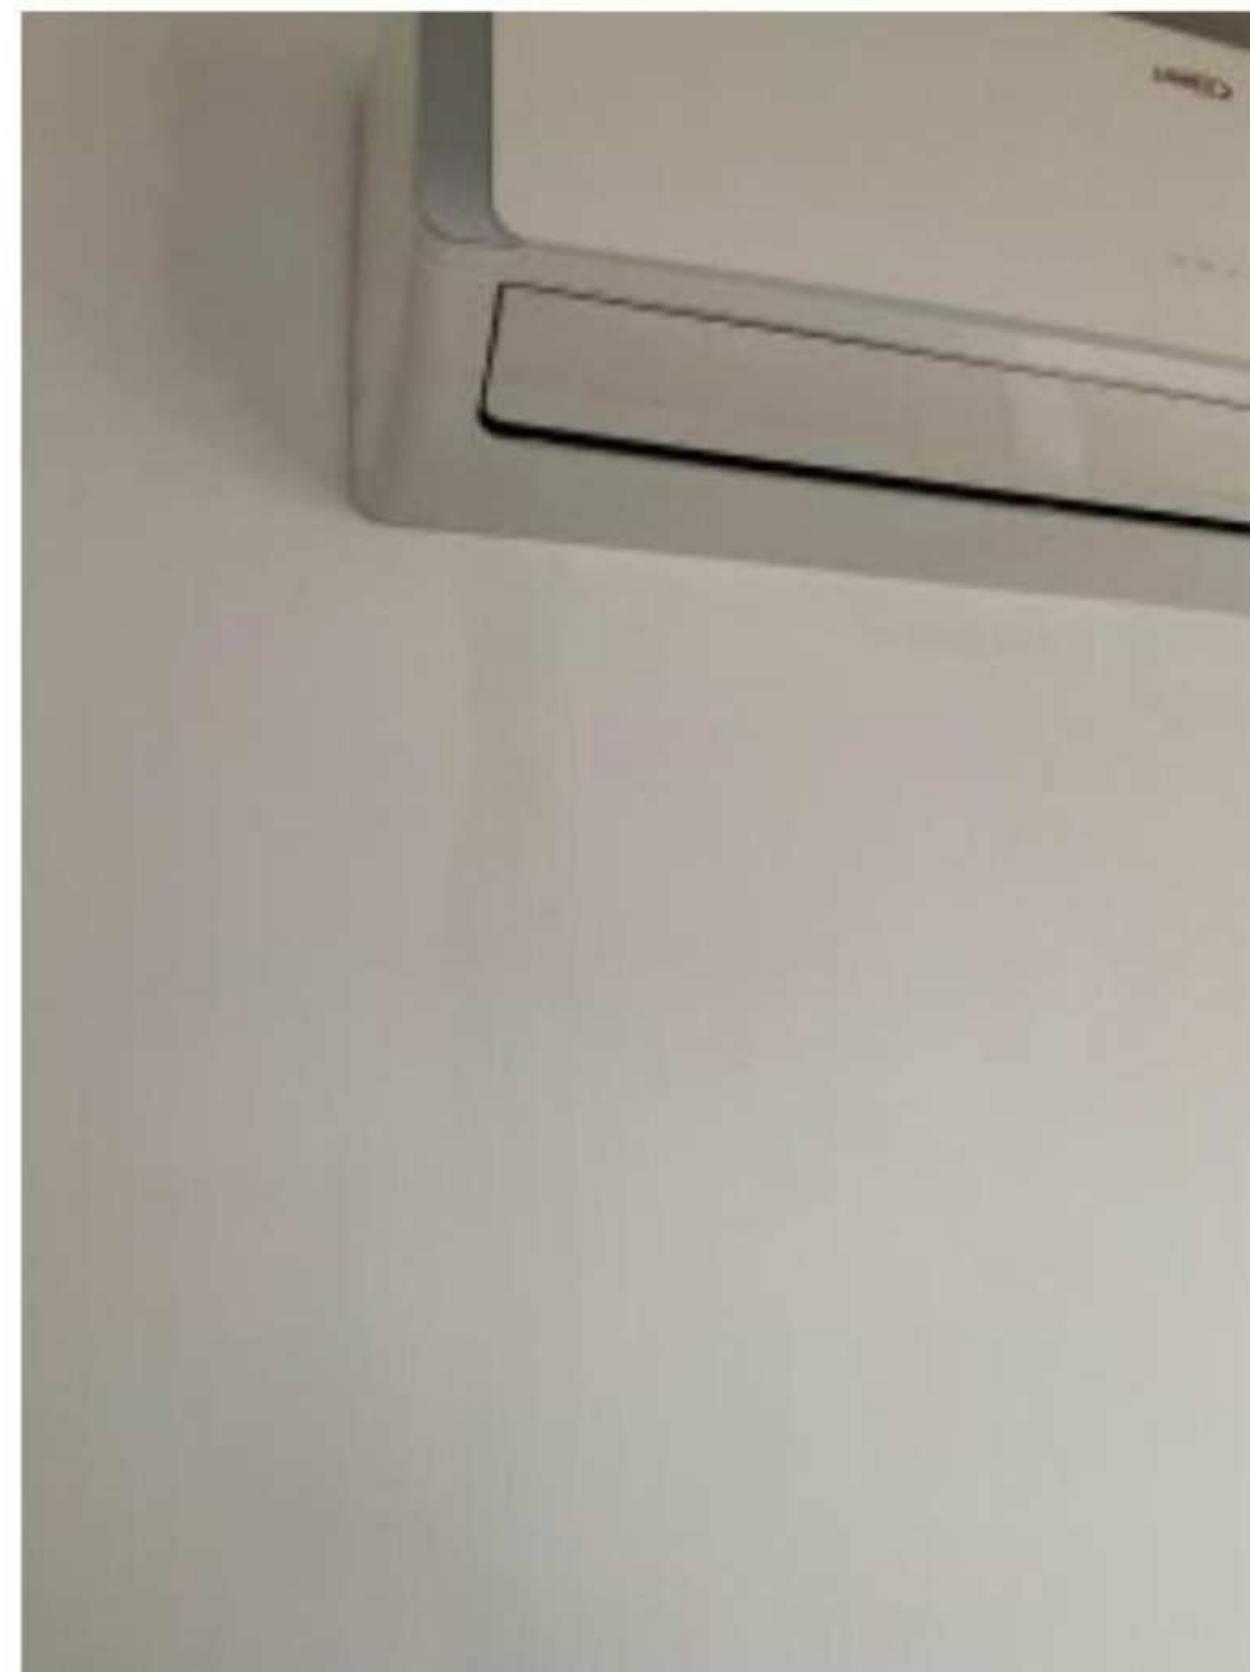
The wall beneath the air conditioning unit shows signs of water staining, suggesting a potential leak or condensation issue from the unit above. This could lead to moisture damage. Recommended assessment and monitor are advised to prevent further damage and ensure the longevity of both the unit and the wall structure.
