## Just Inspections

## Building Inspection Report

AS4349.1- 2007

| <b>Appointment Date</b> | Mon 29 Jun 2026 2:00PM - 3:00PM |

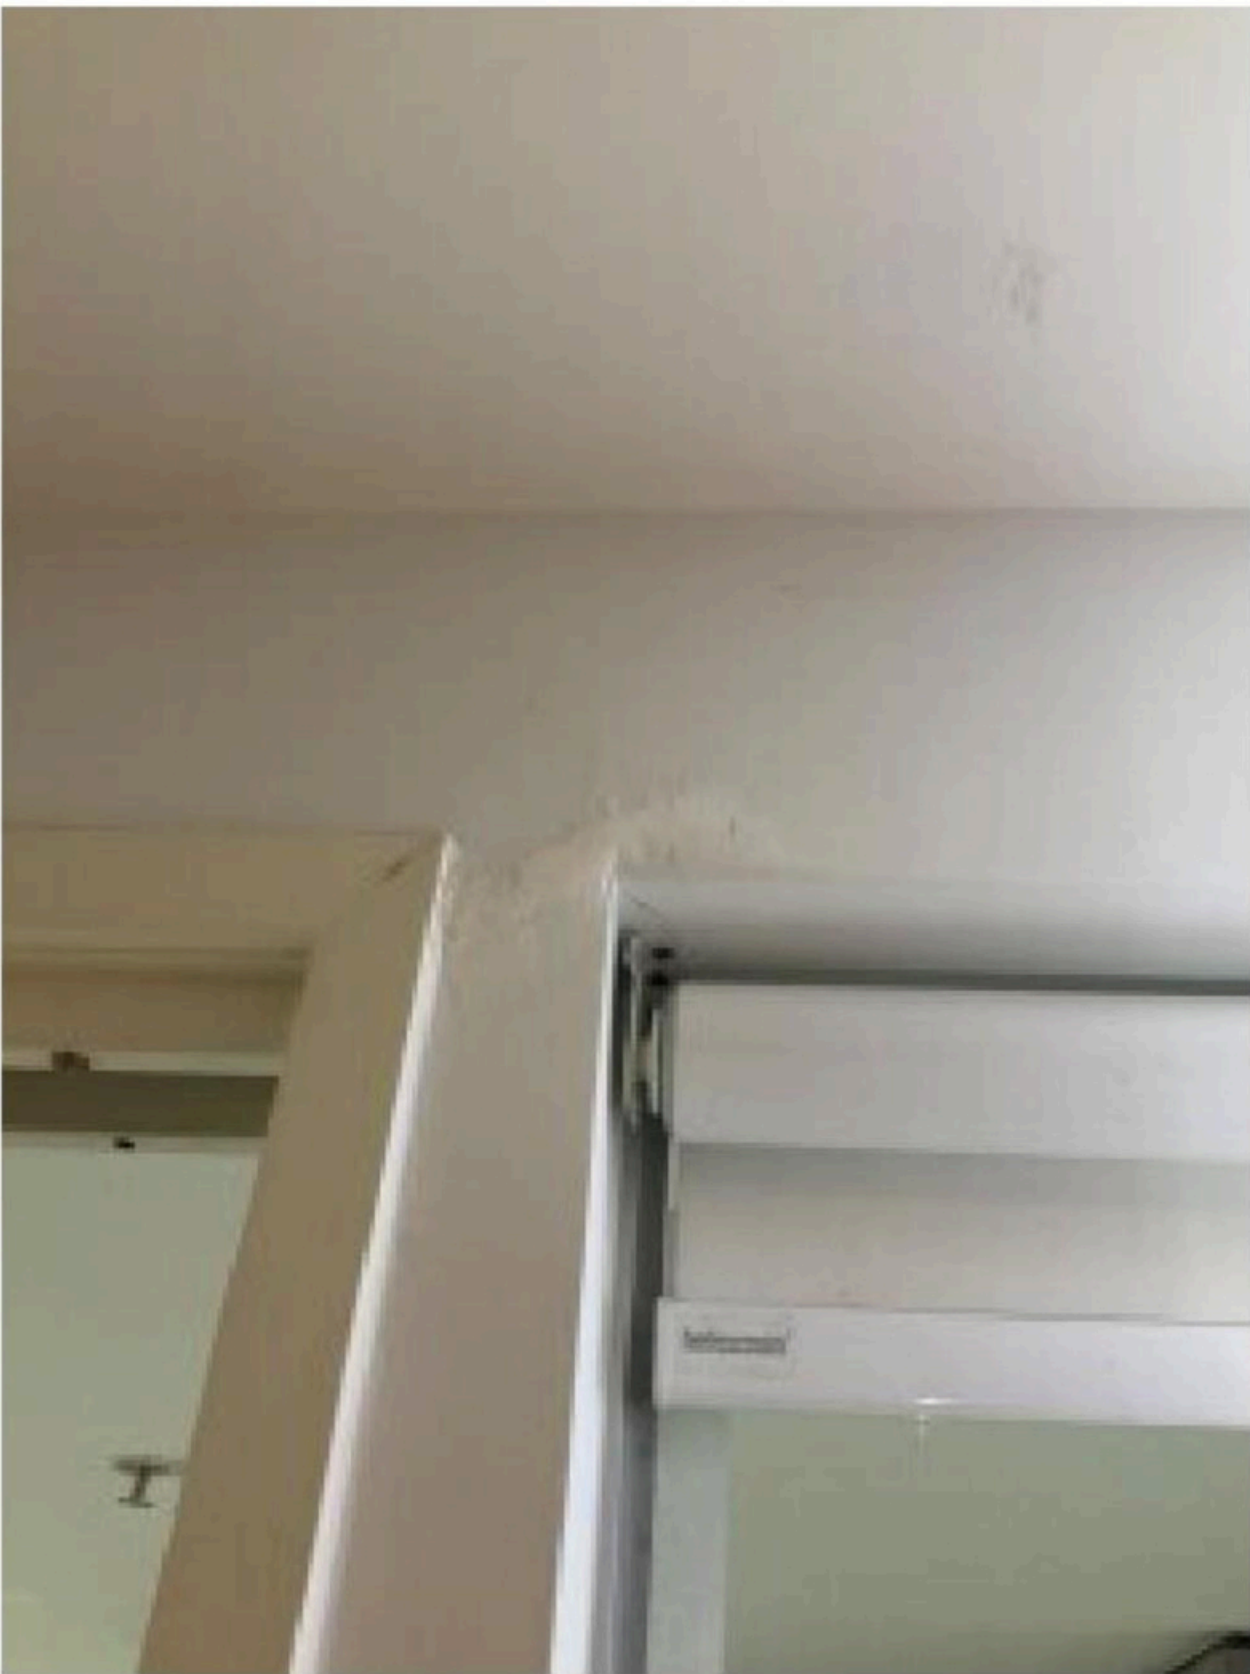
The photograph reveals minor patched cracking around the window frame, indicating potential movement or settlement in the structure. While not immediately severe, these cracks may allow moisture ingress over time, potentially leading to further deterioration. It is advisable to monitor these cracks for any changes in size or appearance and consider engaging a professional to assess the structural integrity. Remedial action may be necessary to prevent future issues and maintain the overall condition of the property.

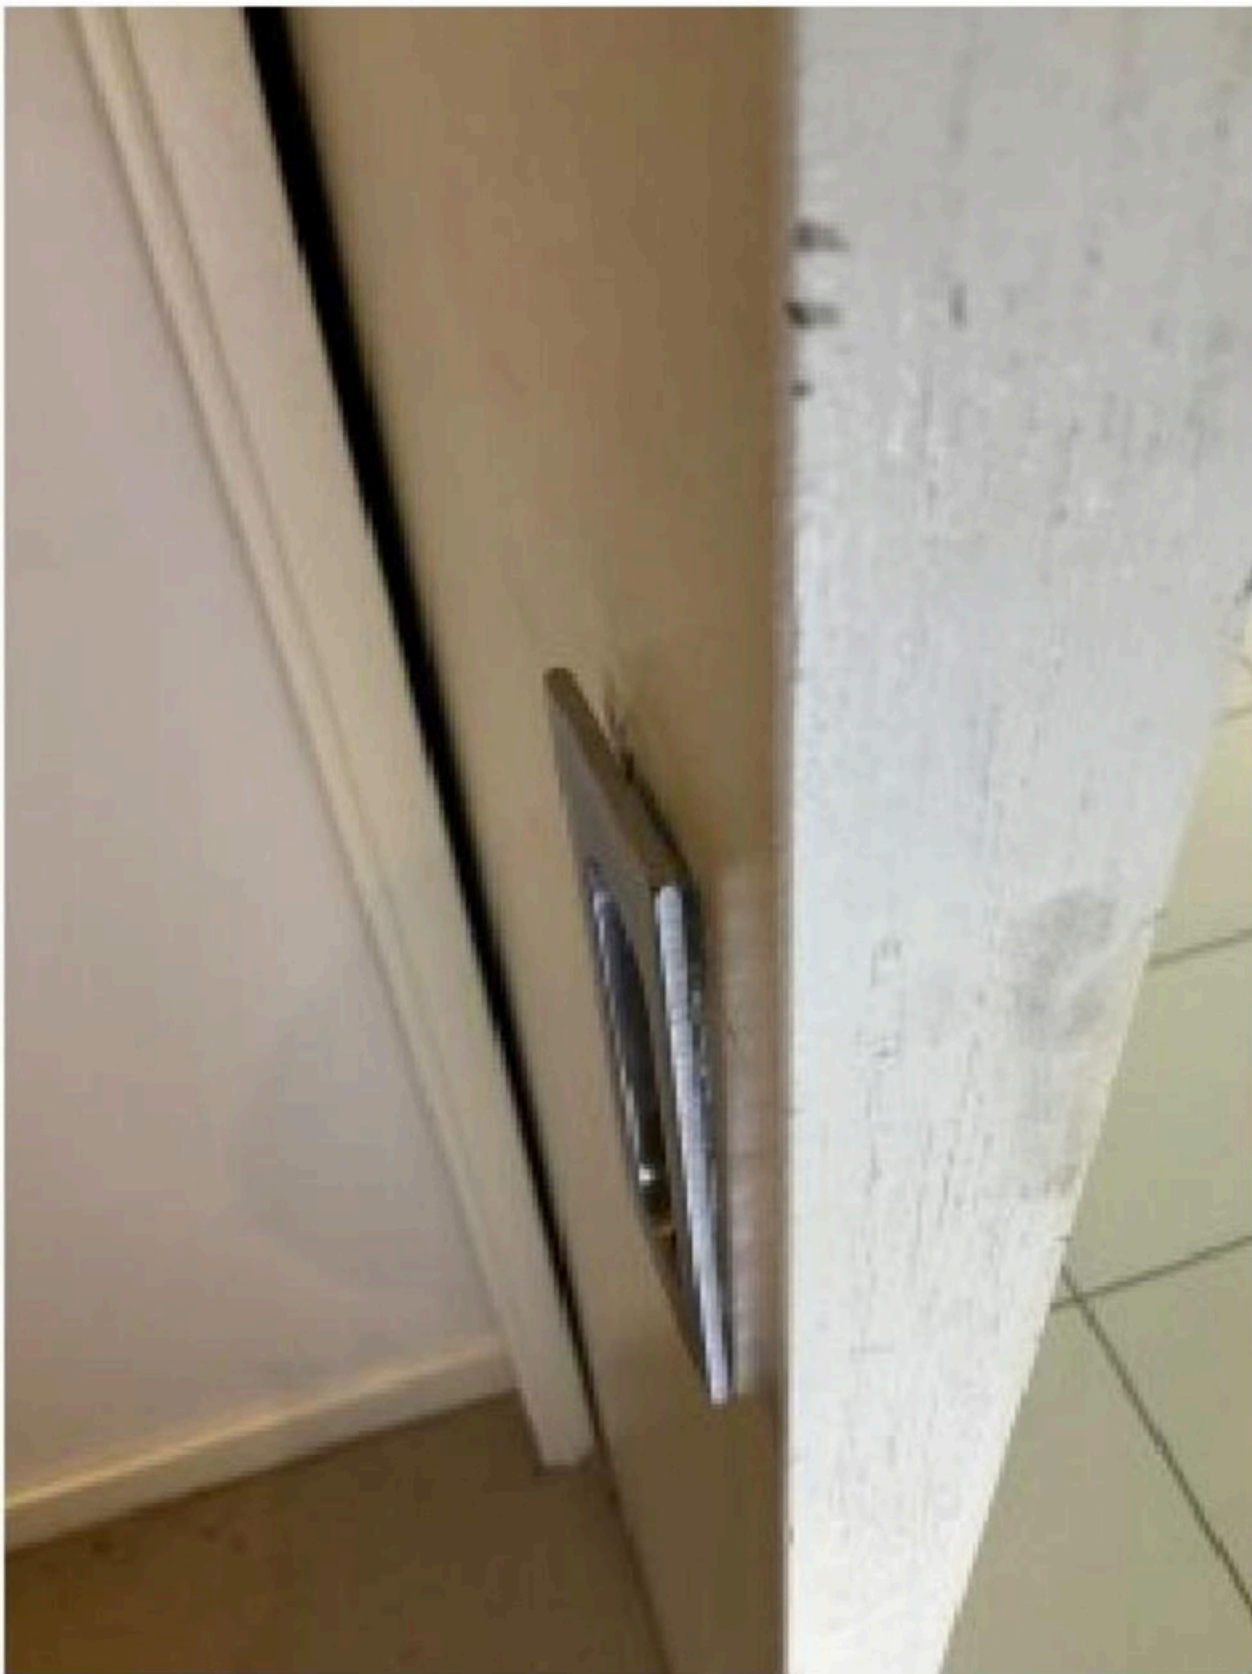
The image shows damage to the door frame, where the latch plate is prominently misaligned and loose. This misalignment could hinder the door's ability to latch properly, affecting its functionality and security. The visible wear around the damaged area suggests frequent usage without repair, potentially leading to further deterioration if not addressed. It is recommended to realign and secure the latch plate to ensure proper operation and maintain the door's structural integrity.

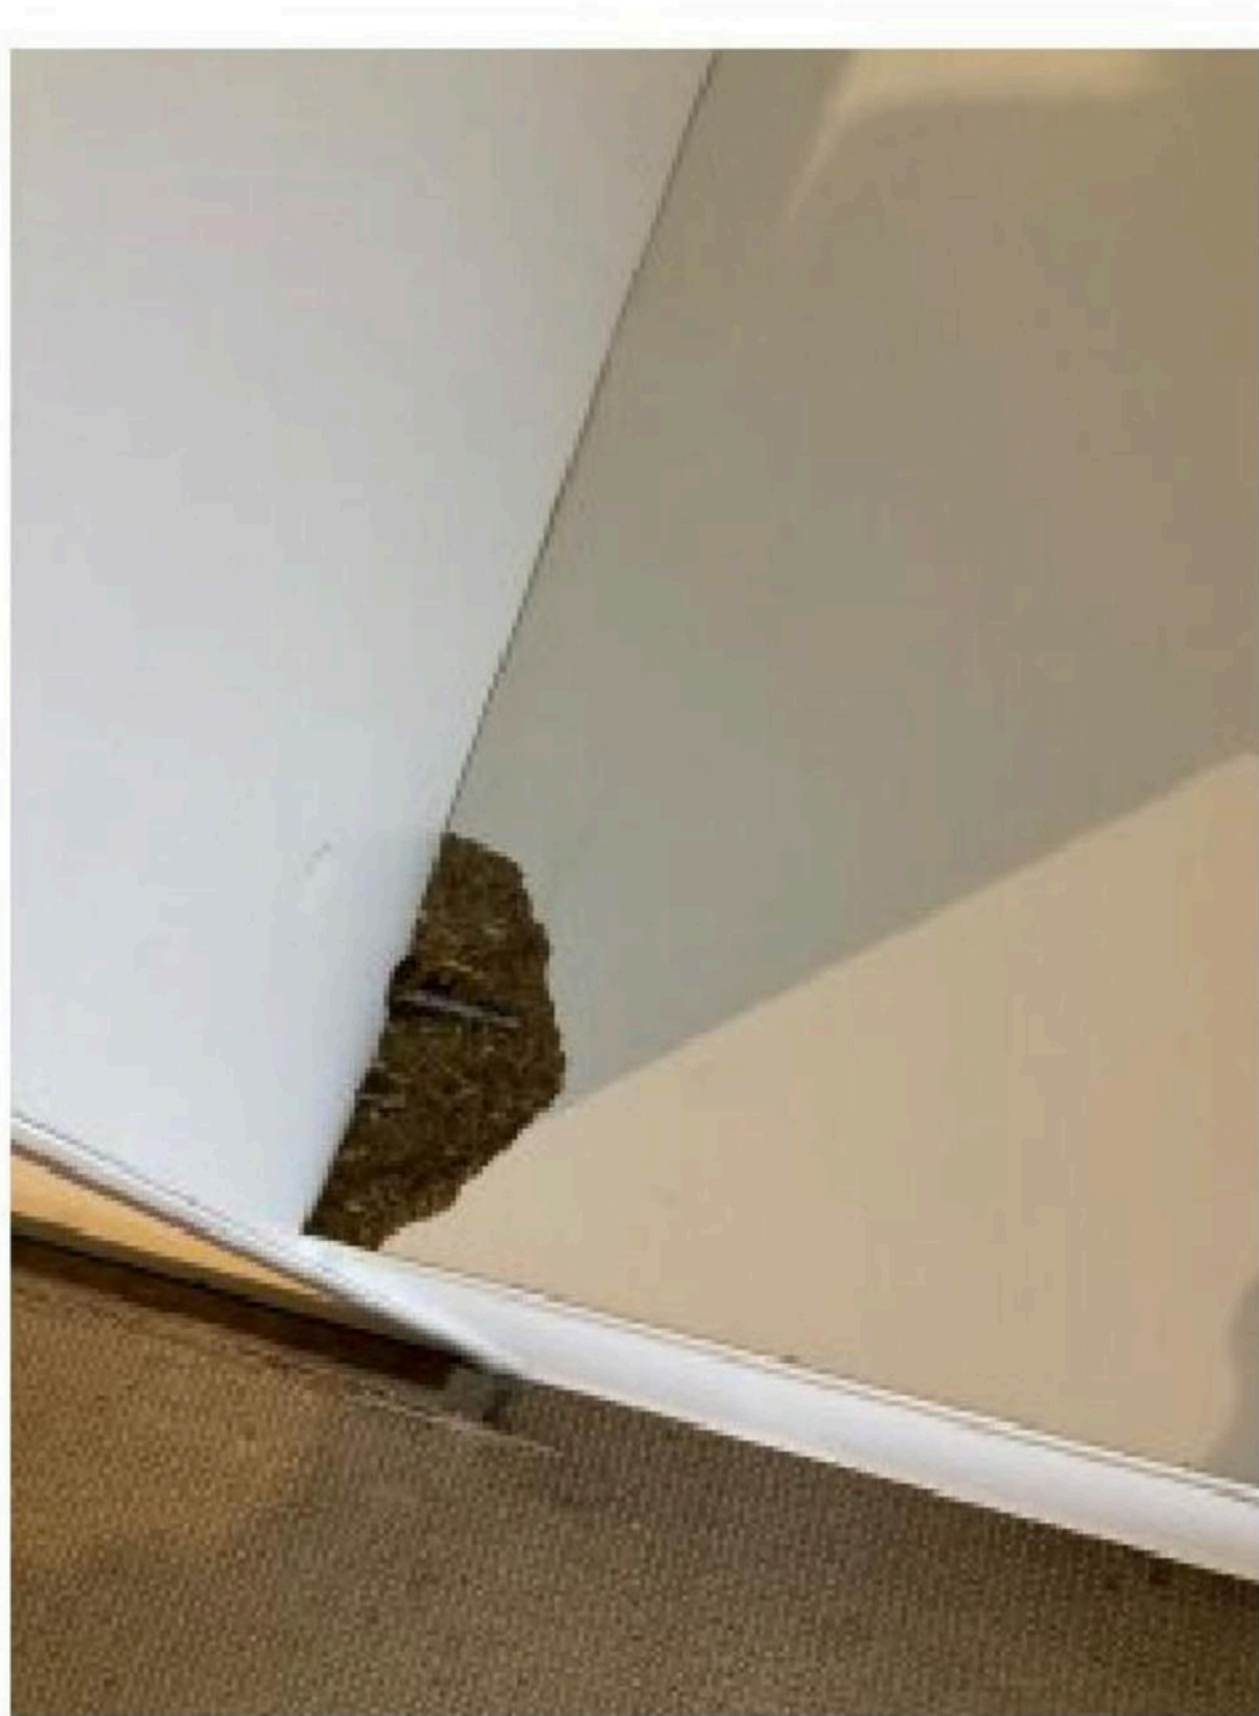
There is damage to a wardrobe, where a noticeable section of the interior panel has deteriorated. This damage exposes the underlying materials, such as fiberboard or similar. It is recommended that the damaged panel be repaired or replaced to prevent further issues and ensure the structural integrity of the wardrobe is maintained.

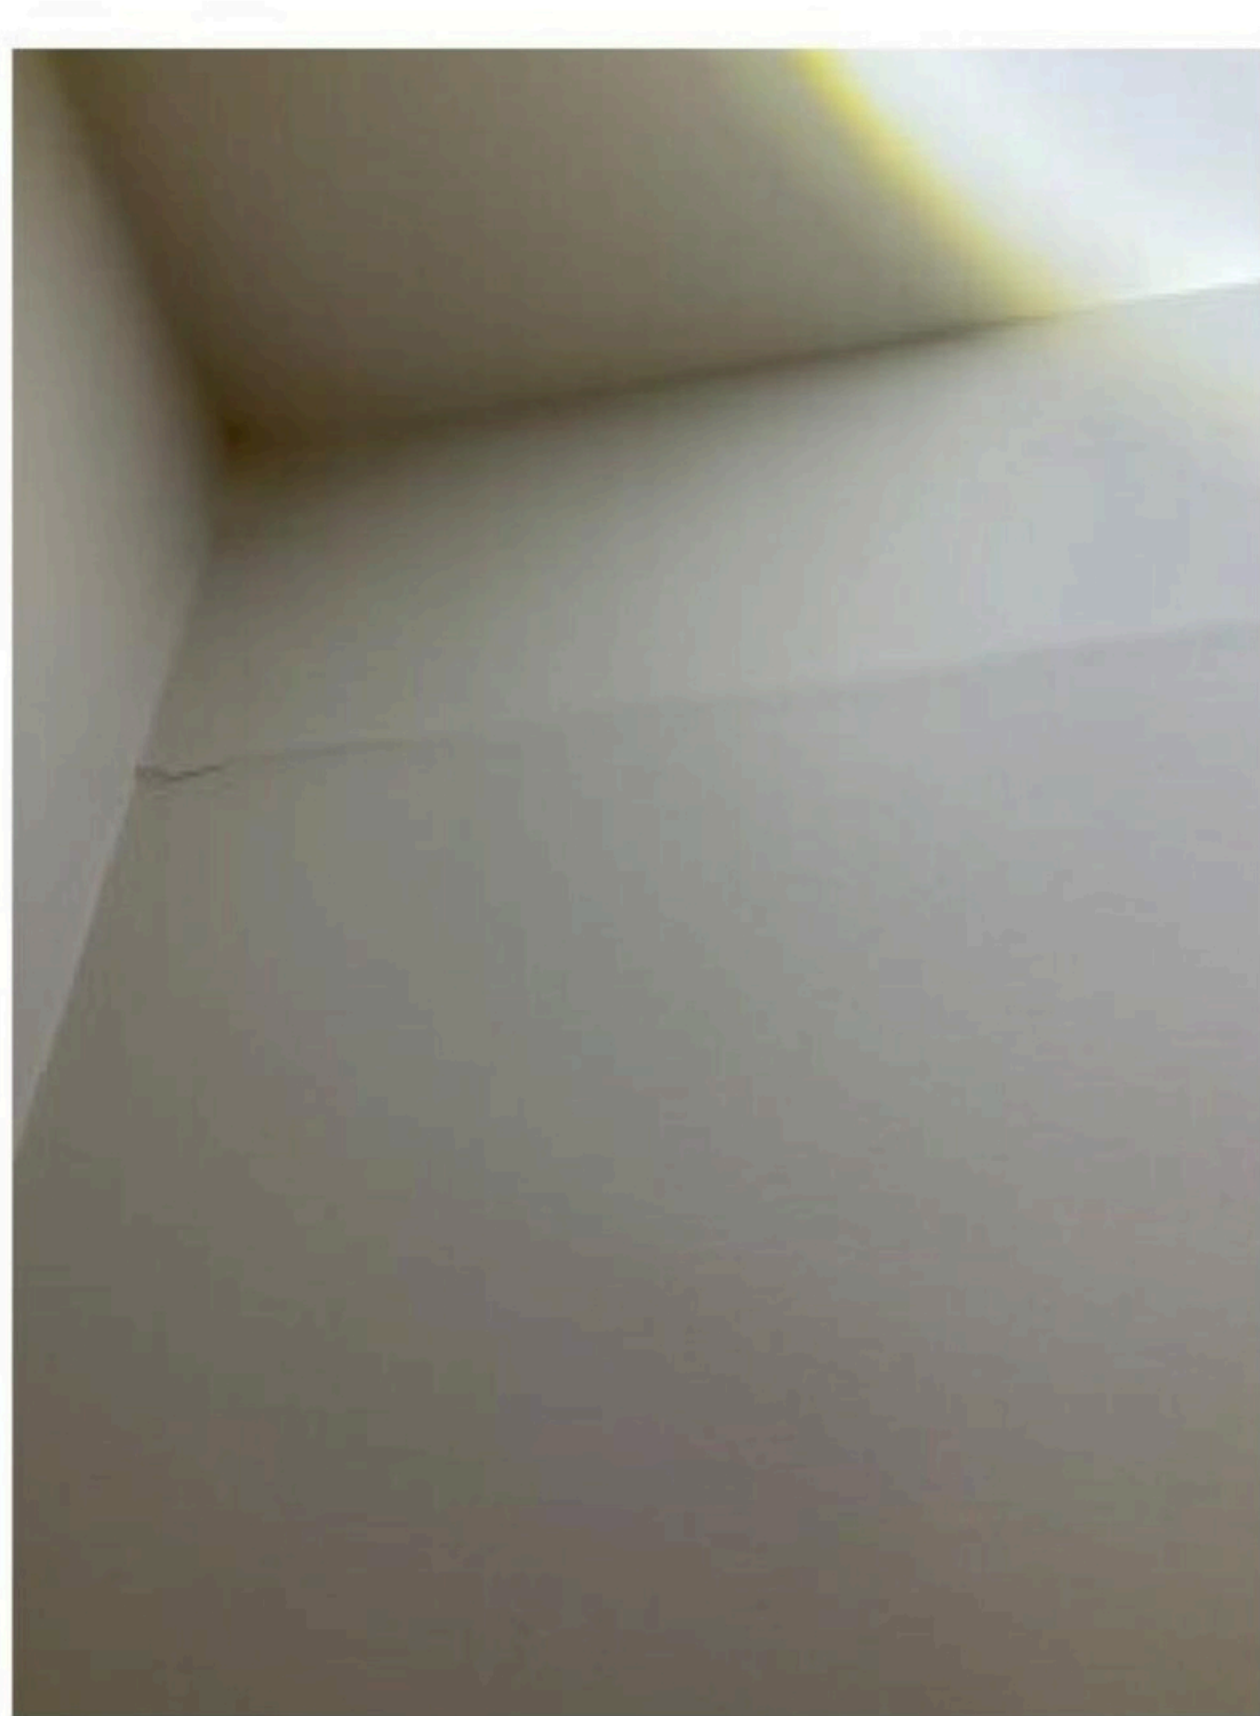
The inspection has identified a minor cosmetic defect in the interior wall, characterized by a faint crack extending along the surface. This crack appears superficial; however, it could affect the aesthetic quality of the wall. It is recommended to monitor the condition over time and consider professional cosmetic repair if it worsens. Regular maintenance and monitoring can ensure the defect does not develop into a more significant problem.

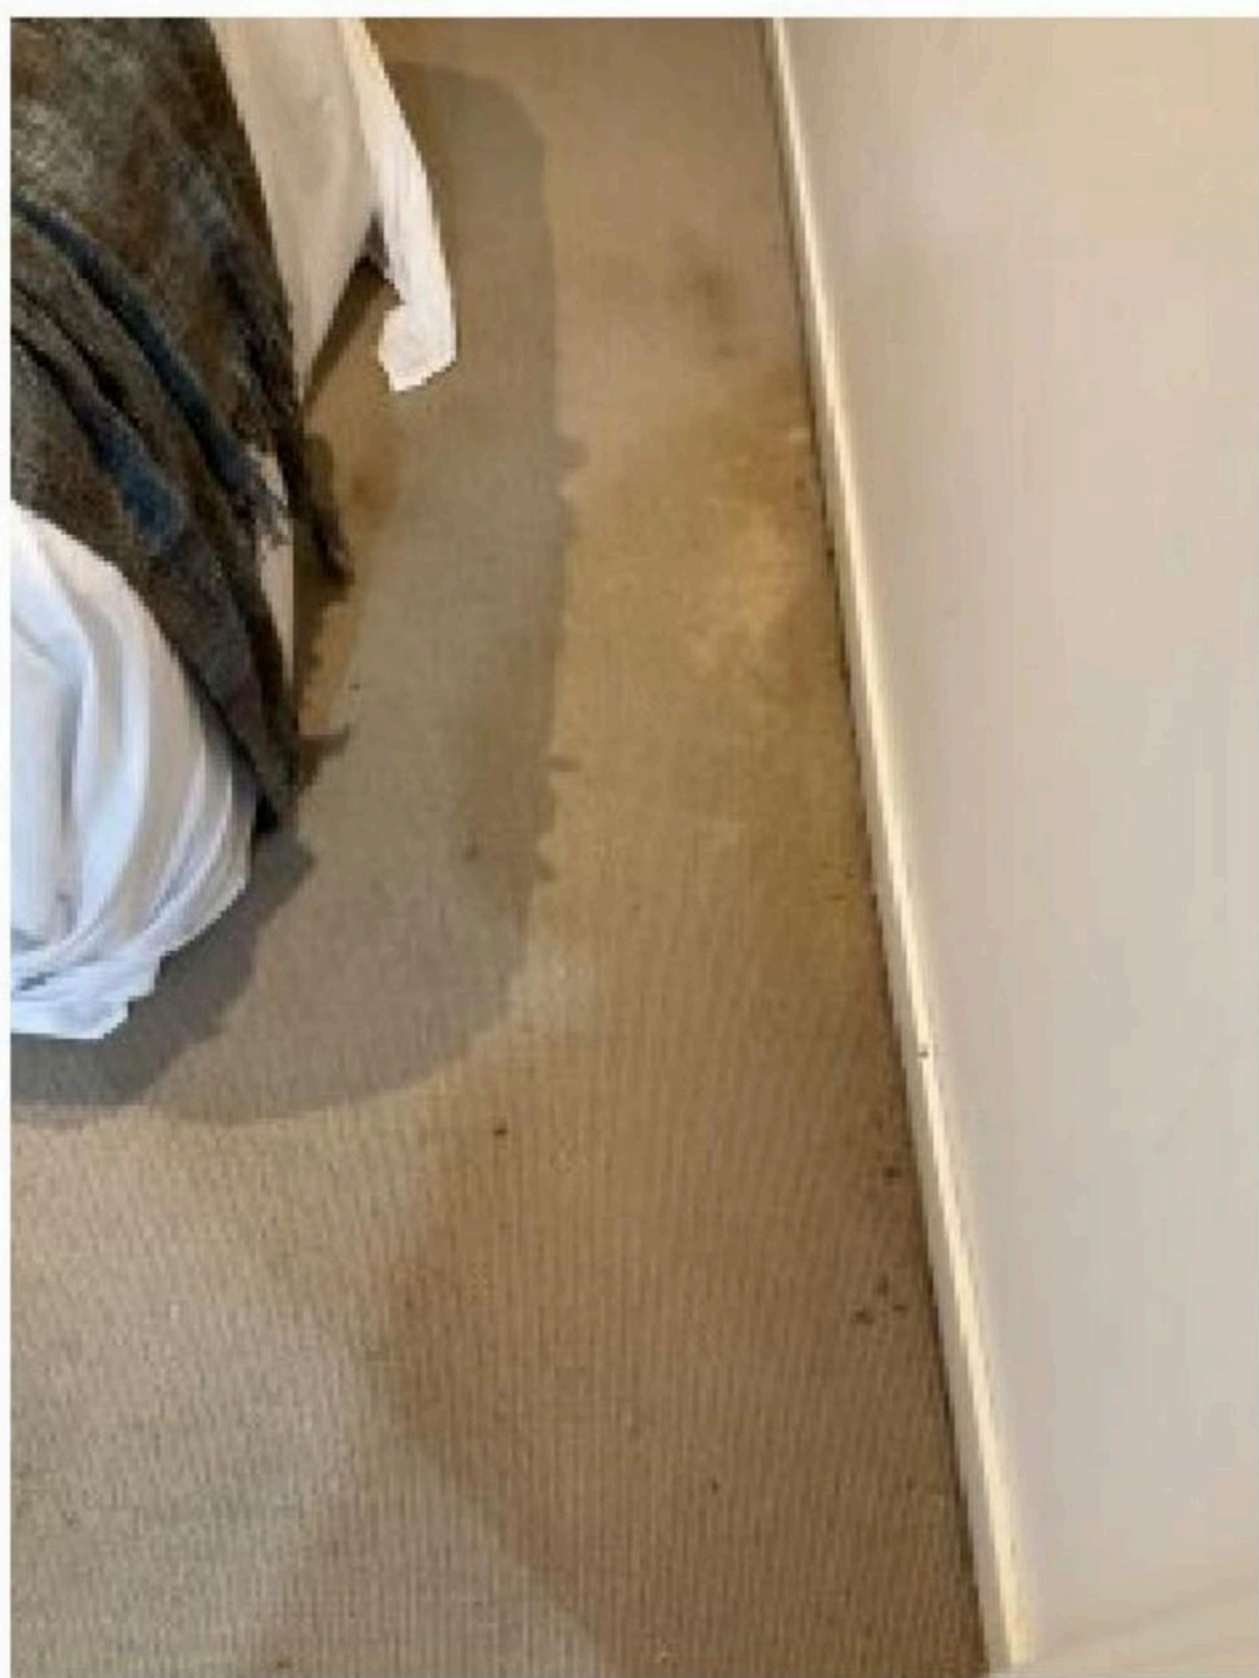
Stain and discolouration were observed on the carpet. With general wear or previous spills and detract from the overall appearance. Replacement on the affected carpet is recommended.

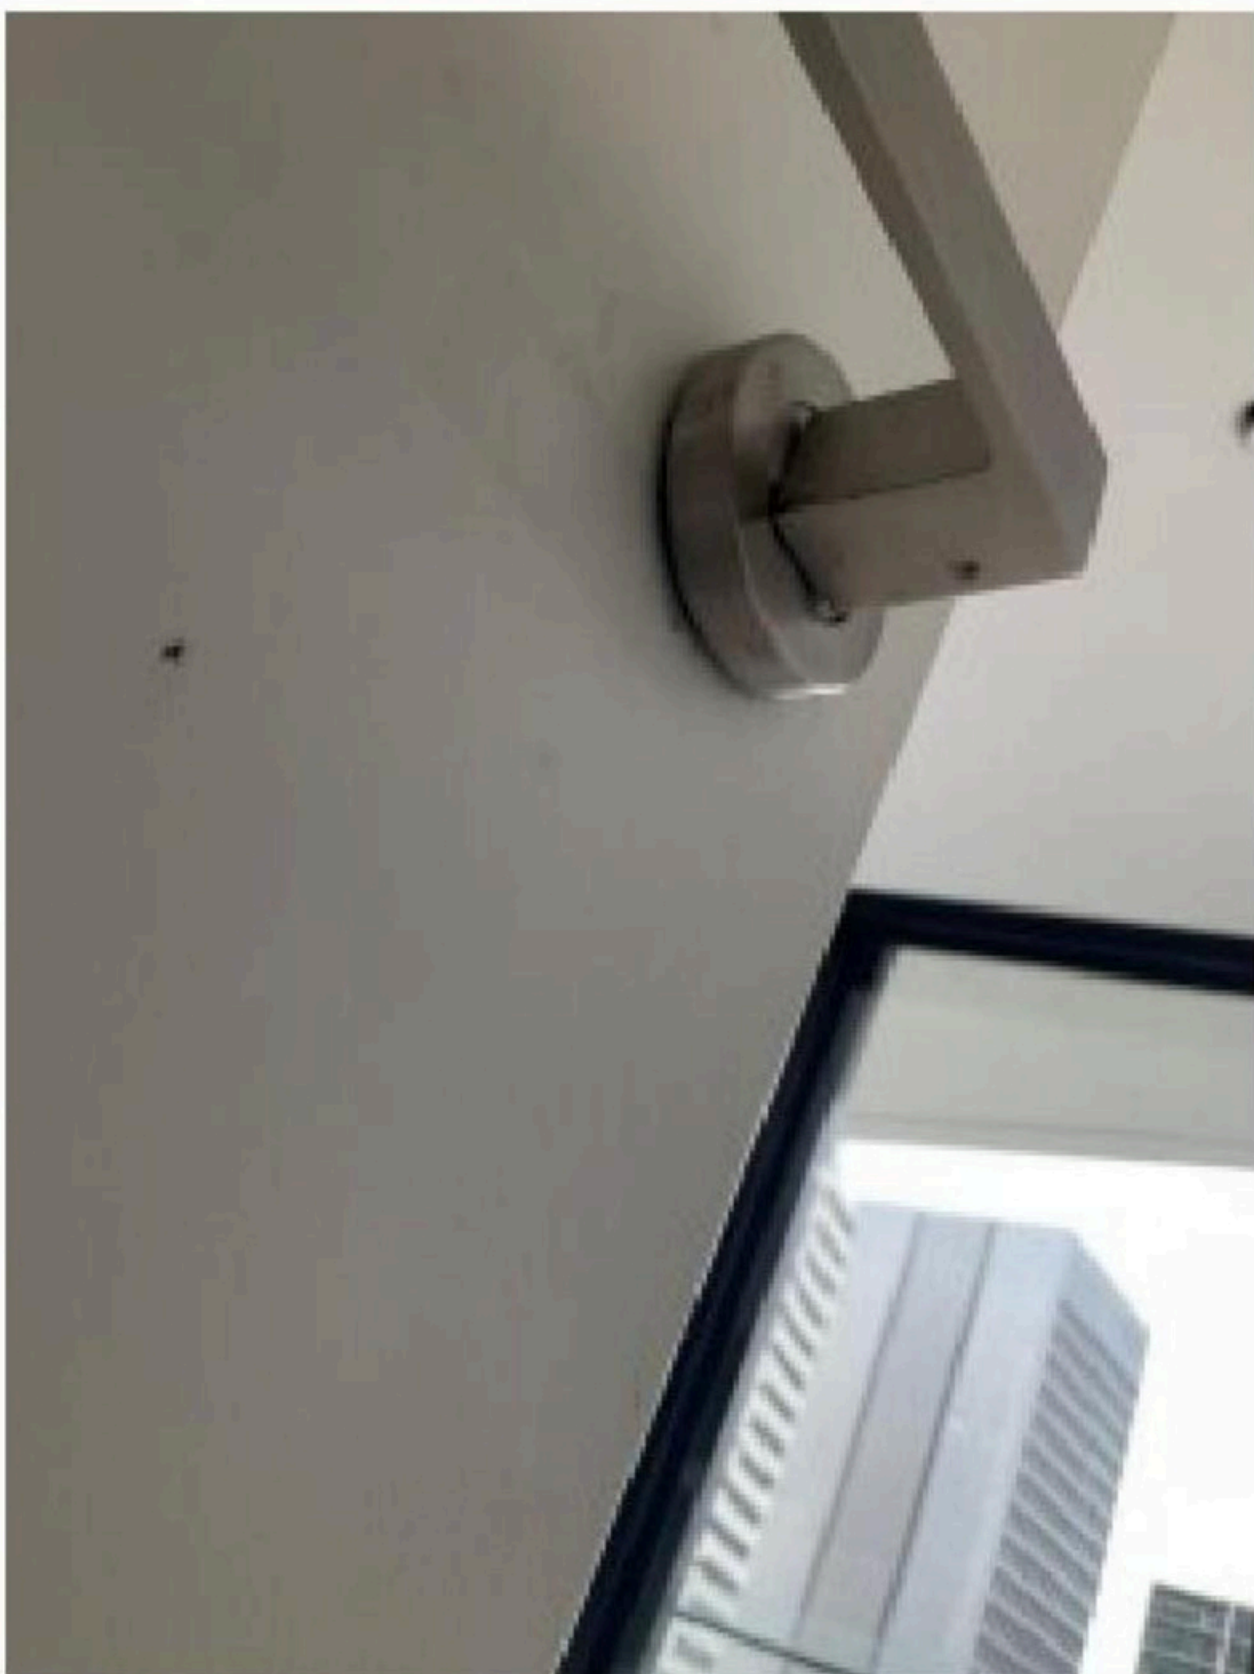
The door's alignment appears to be slightly off, which may affect its ability to open and close smoothly. The handle is positioned at an angle that could cause functional issues, leading to increased wear over time. Immediate attention is recommended to adjust and secure the hardware to prevent further misalignment and ensure proper operation.

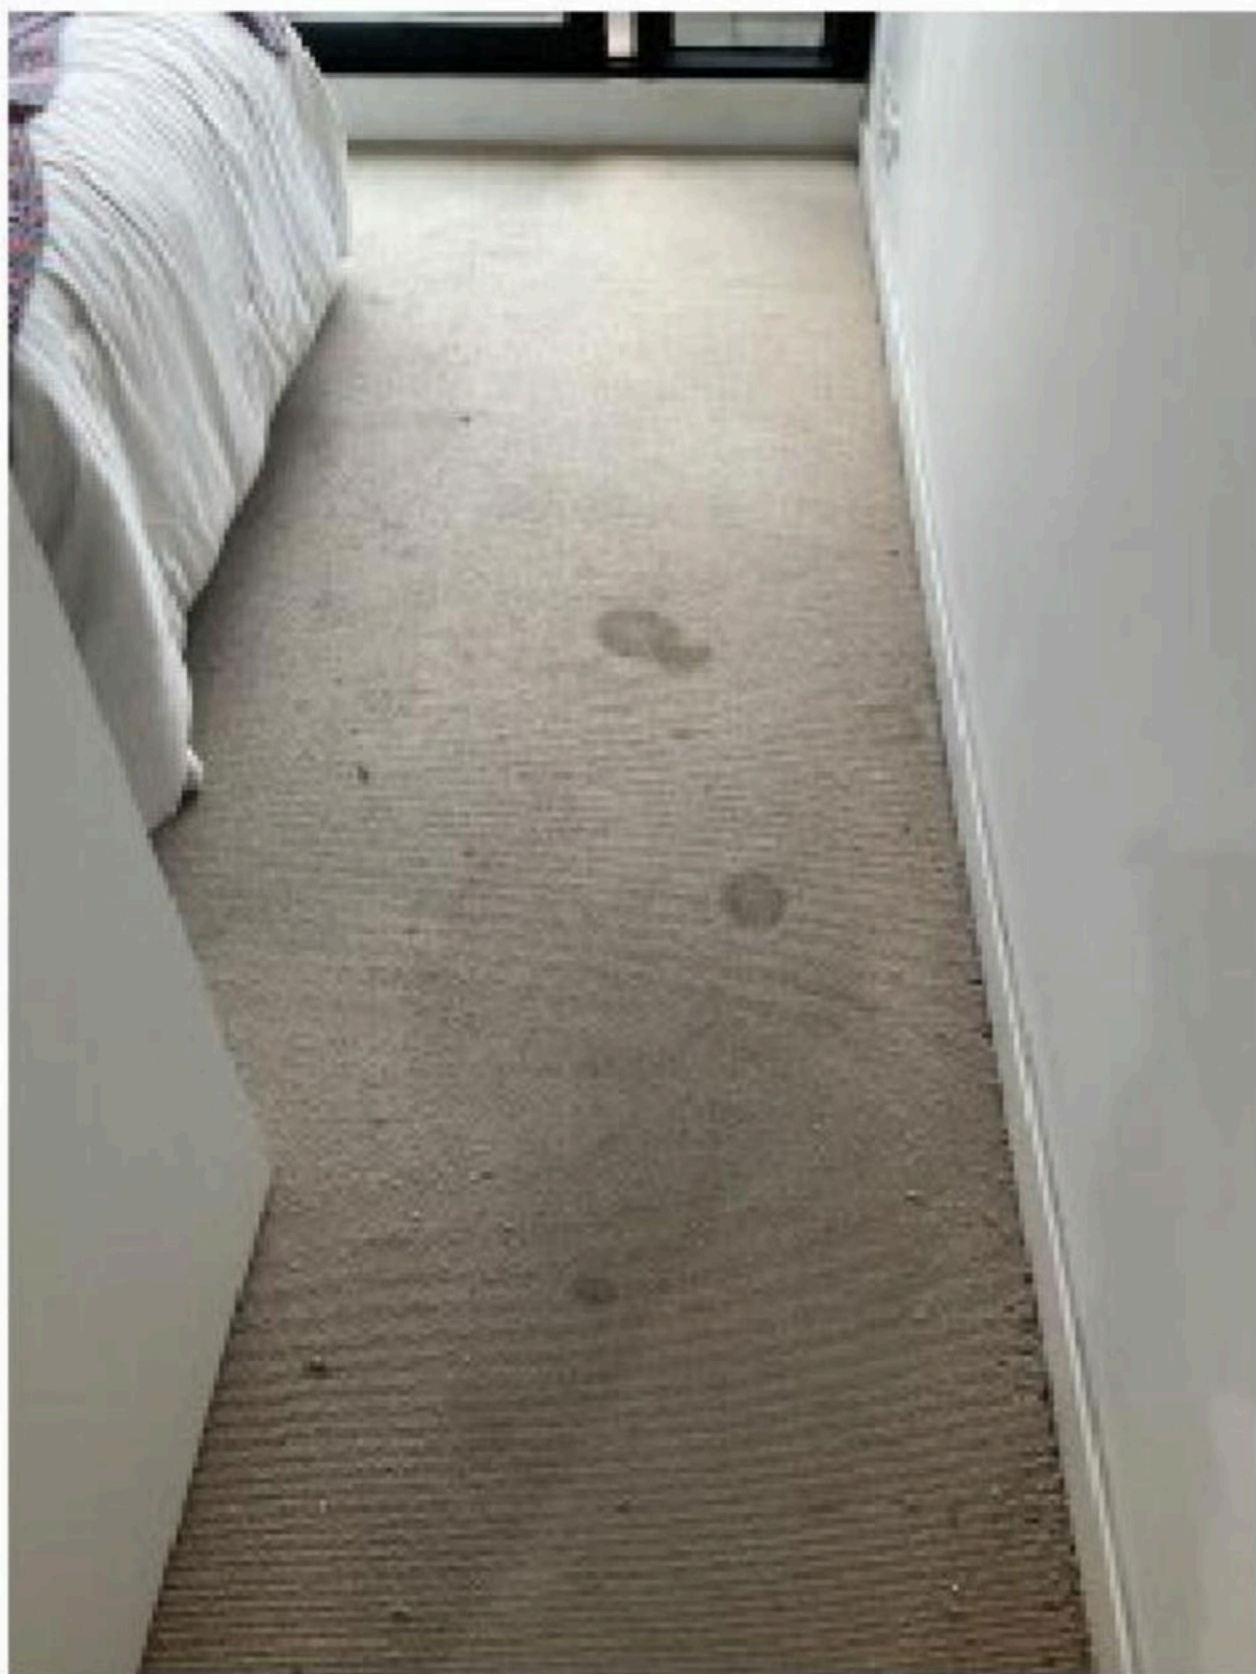
The carpet in the inspected area shows visible signs of wear and staining. There are multiple noticeable spots and marks that could indicate past spills or high foot traffic. Edges of the carpeting appear slightly frayed, which could worsen over time. This condition may require professional cleaning or possible replacement to restore its original appearance and ensure longevity.

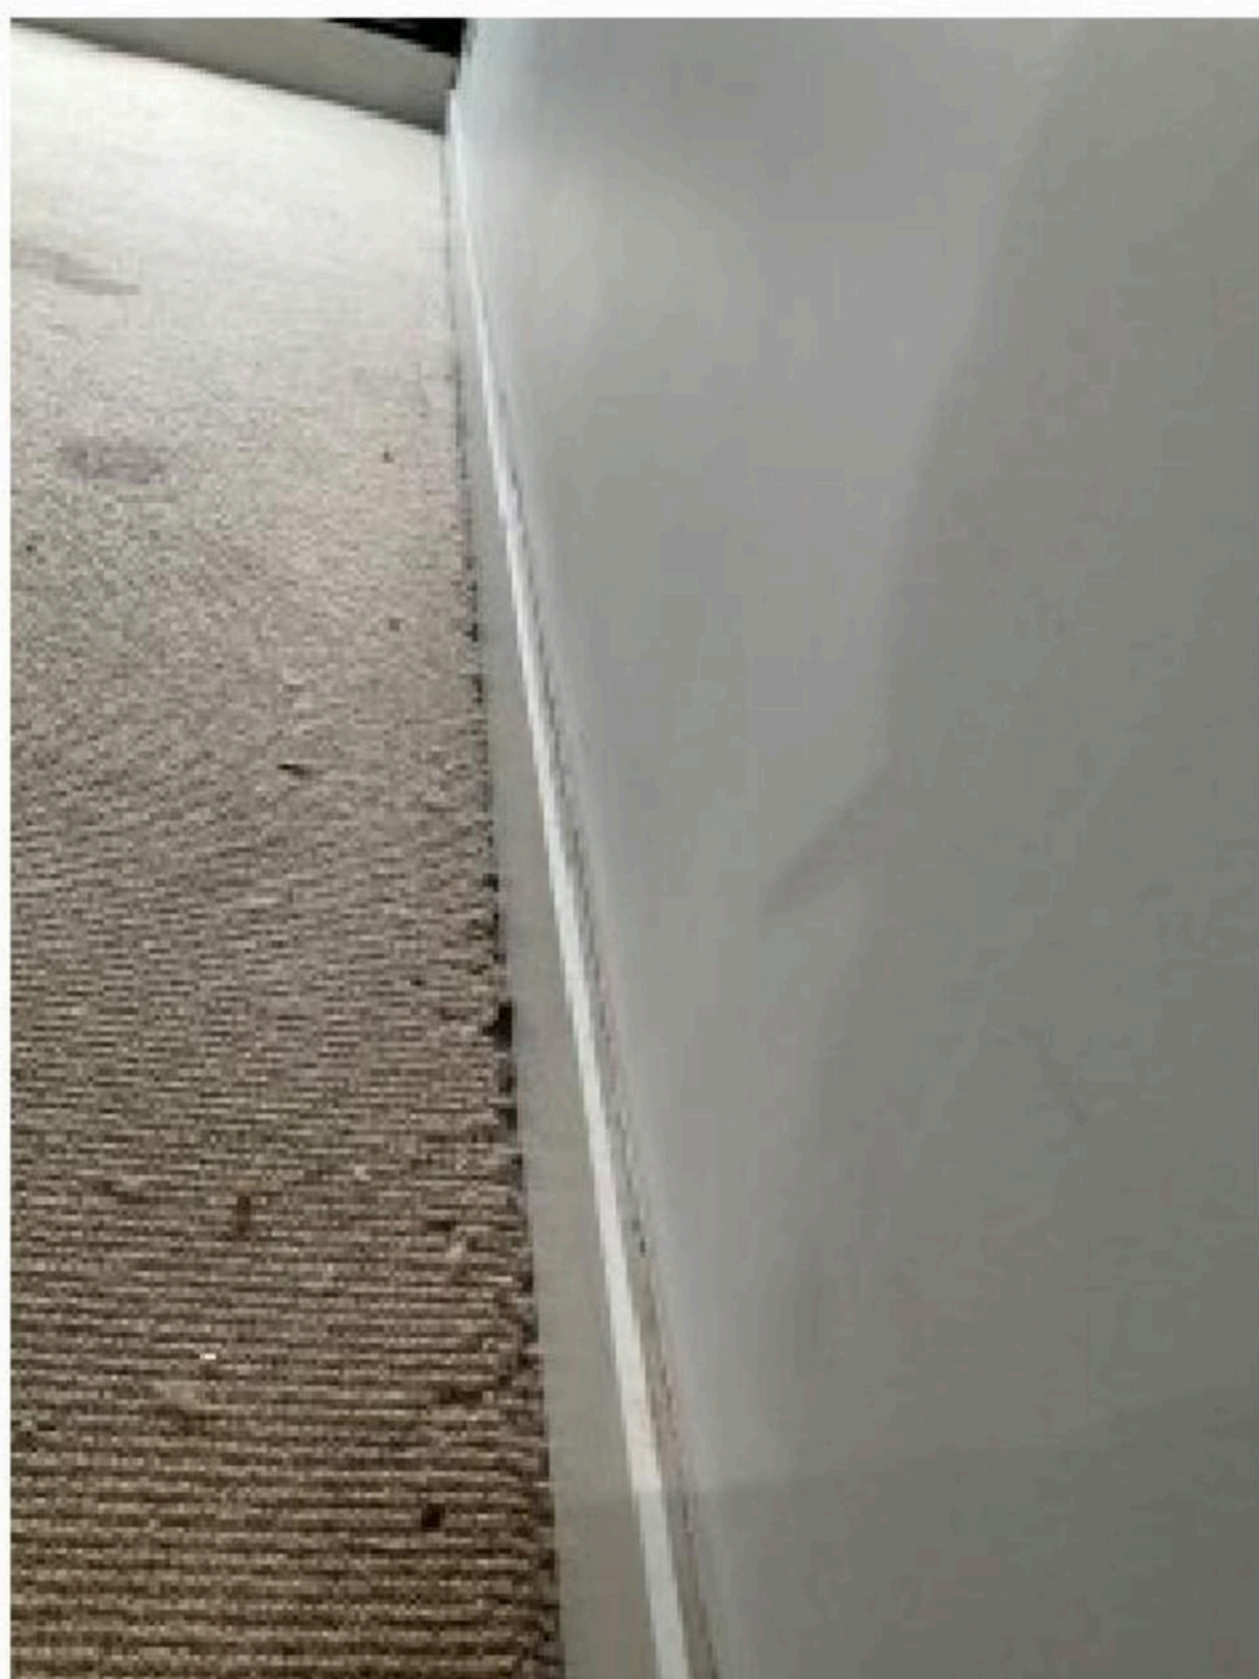
The carpet is shrinking away from the skirting. Consider consulting a professional for evaluation and potential corrective measures or replacement.

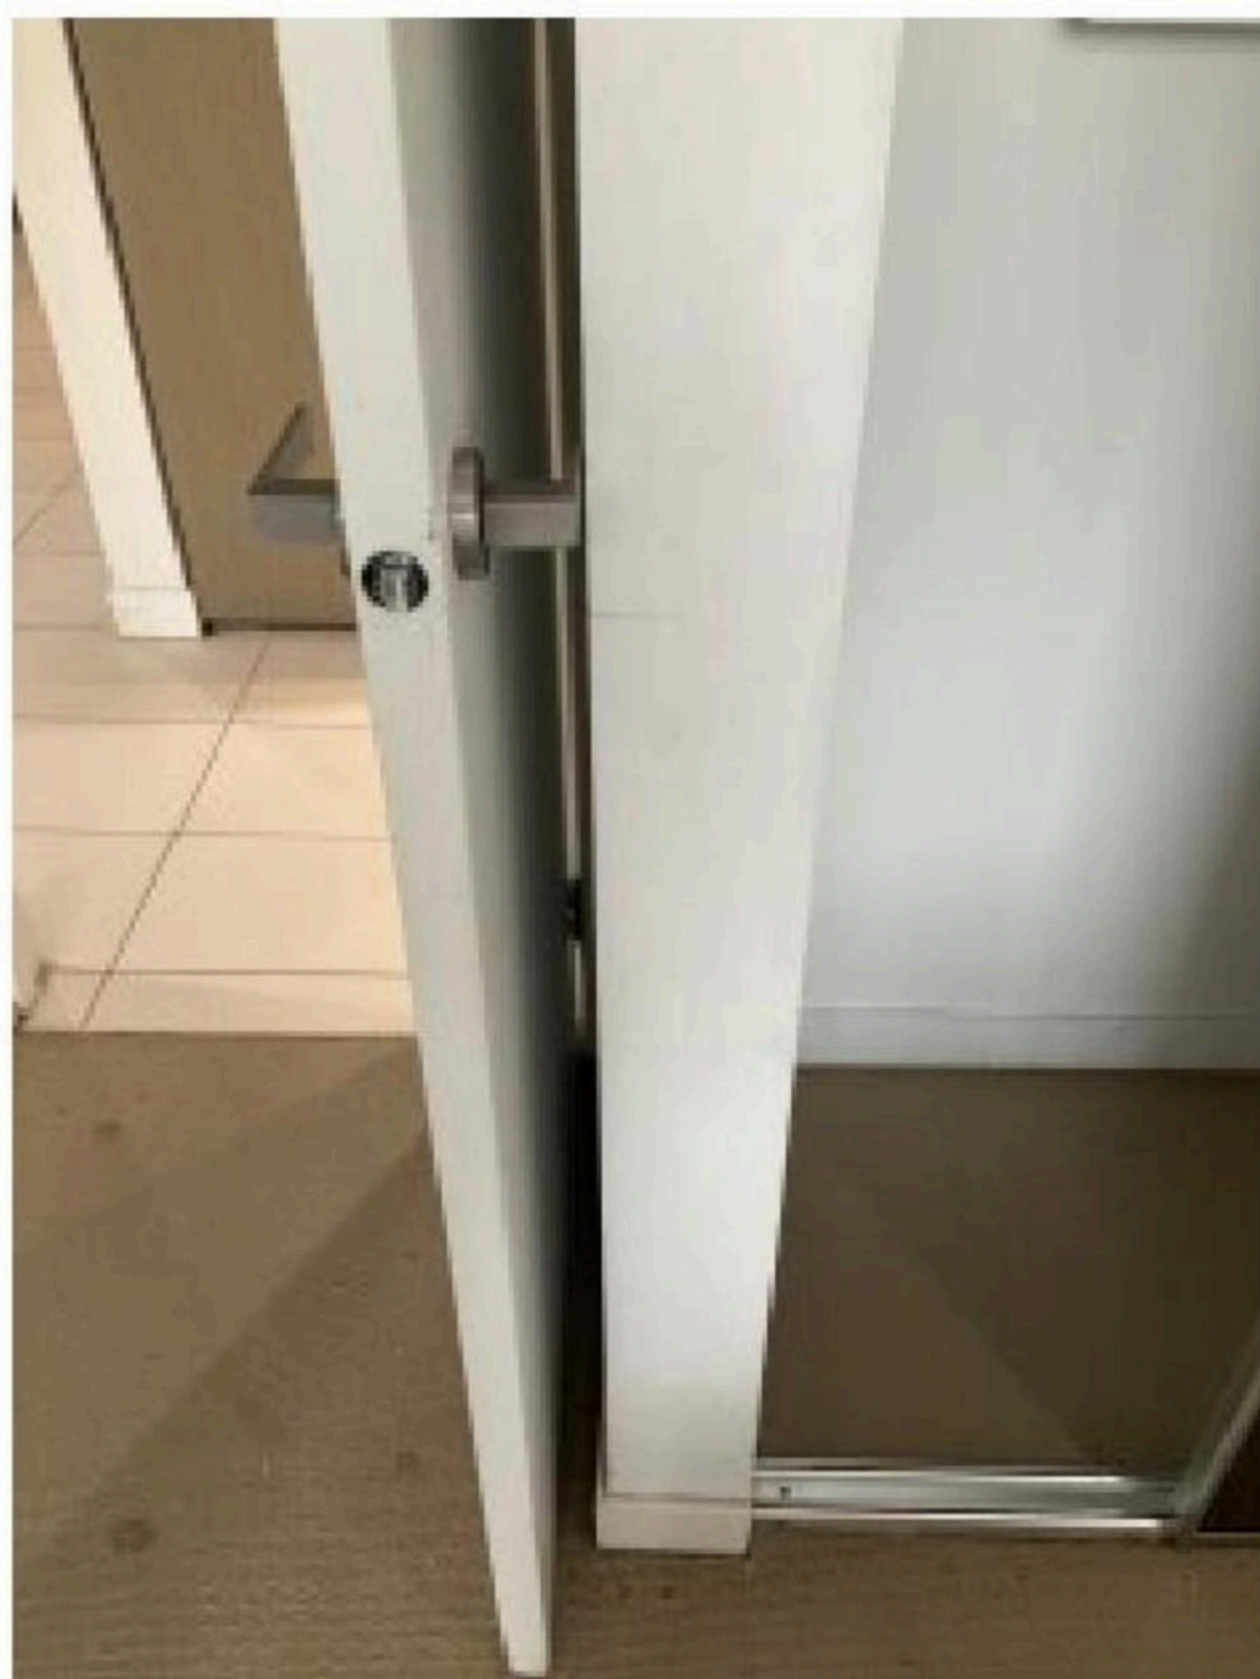
No door stop fitted at the time of inspection

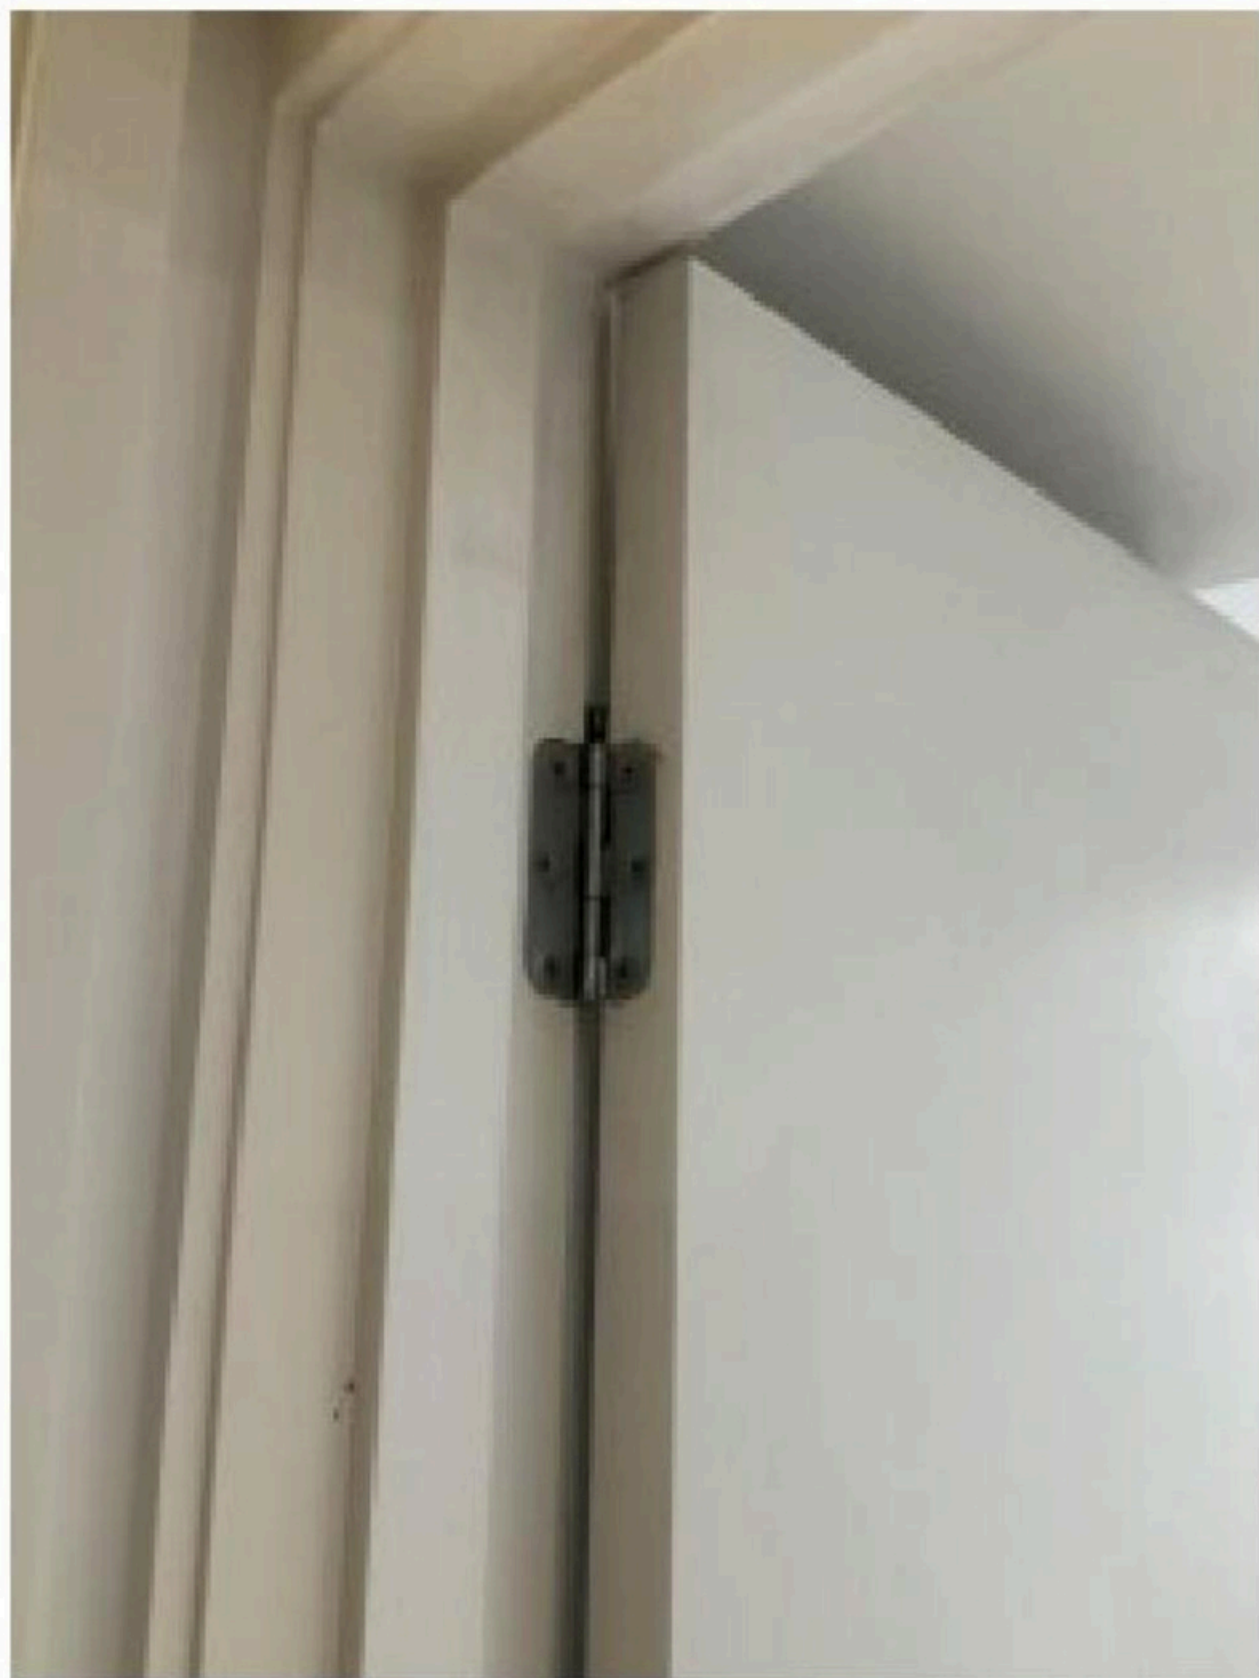
It appears the one of the door hinges pin is popping up from the fixing position. Recommended to fix the hinges to ensure smooth operation and proper alignment.
