## Just Inspections

## Building Inspection Report

AS4349.1- 2007

| <b>Appointment Date</b> | Mon 29 Jun 2026 2:00PM - 3:00PM |

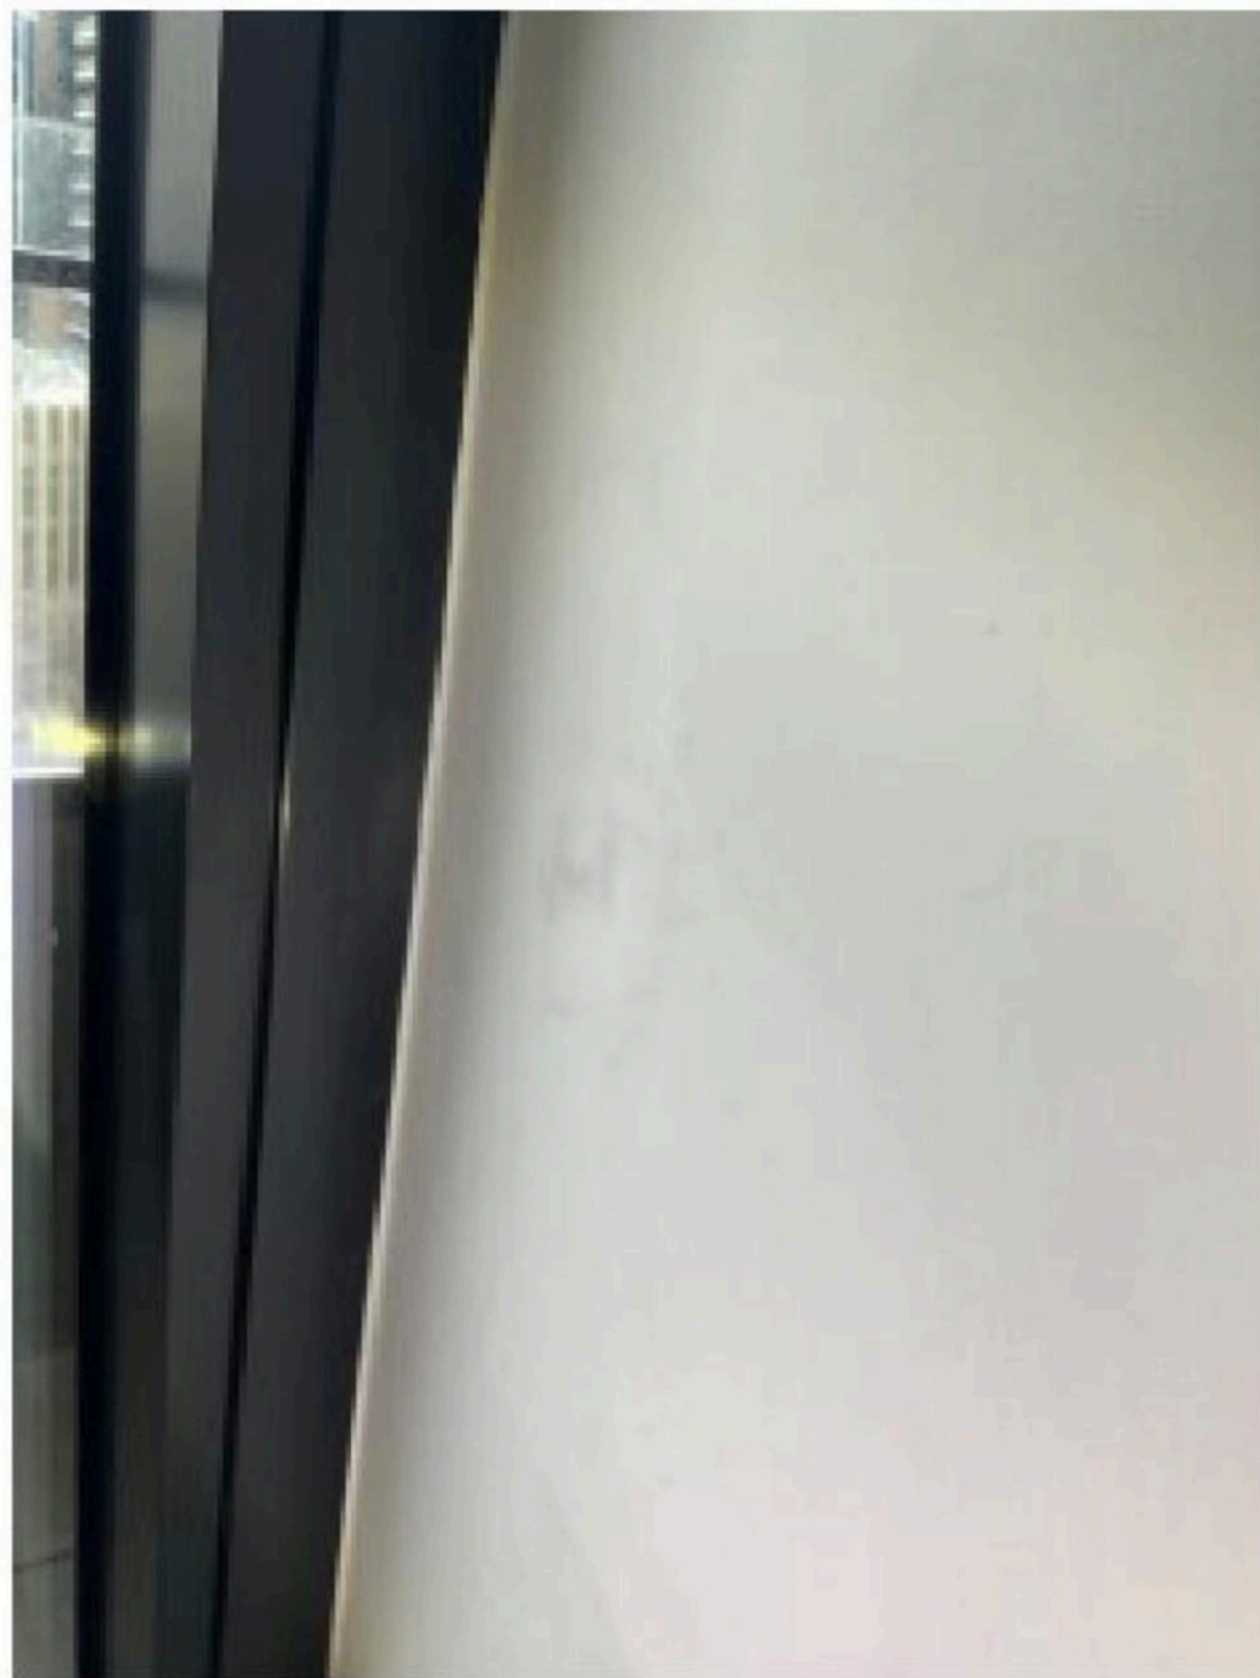
A patched section of the wall was observed. The repair appears visible and may indicate previous damage or repair work.

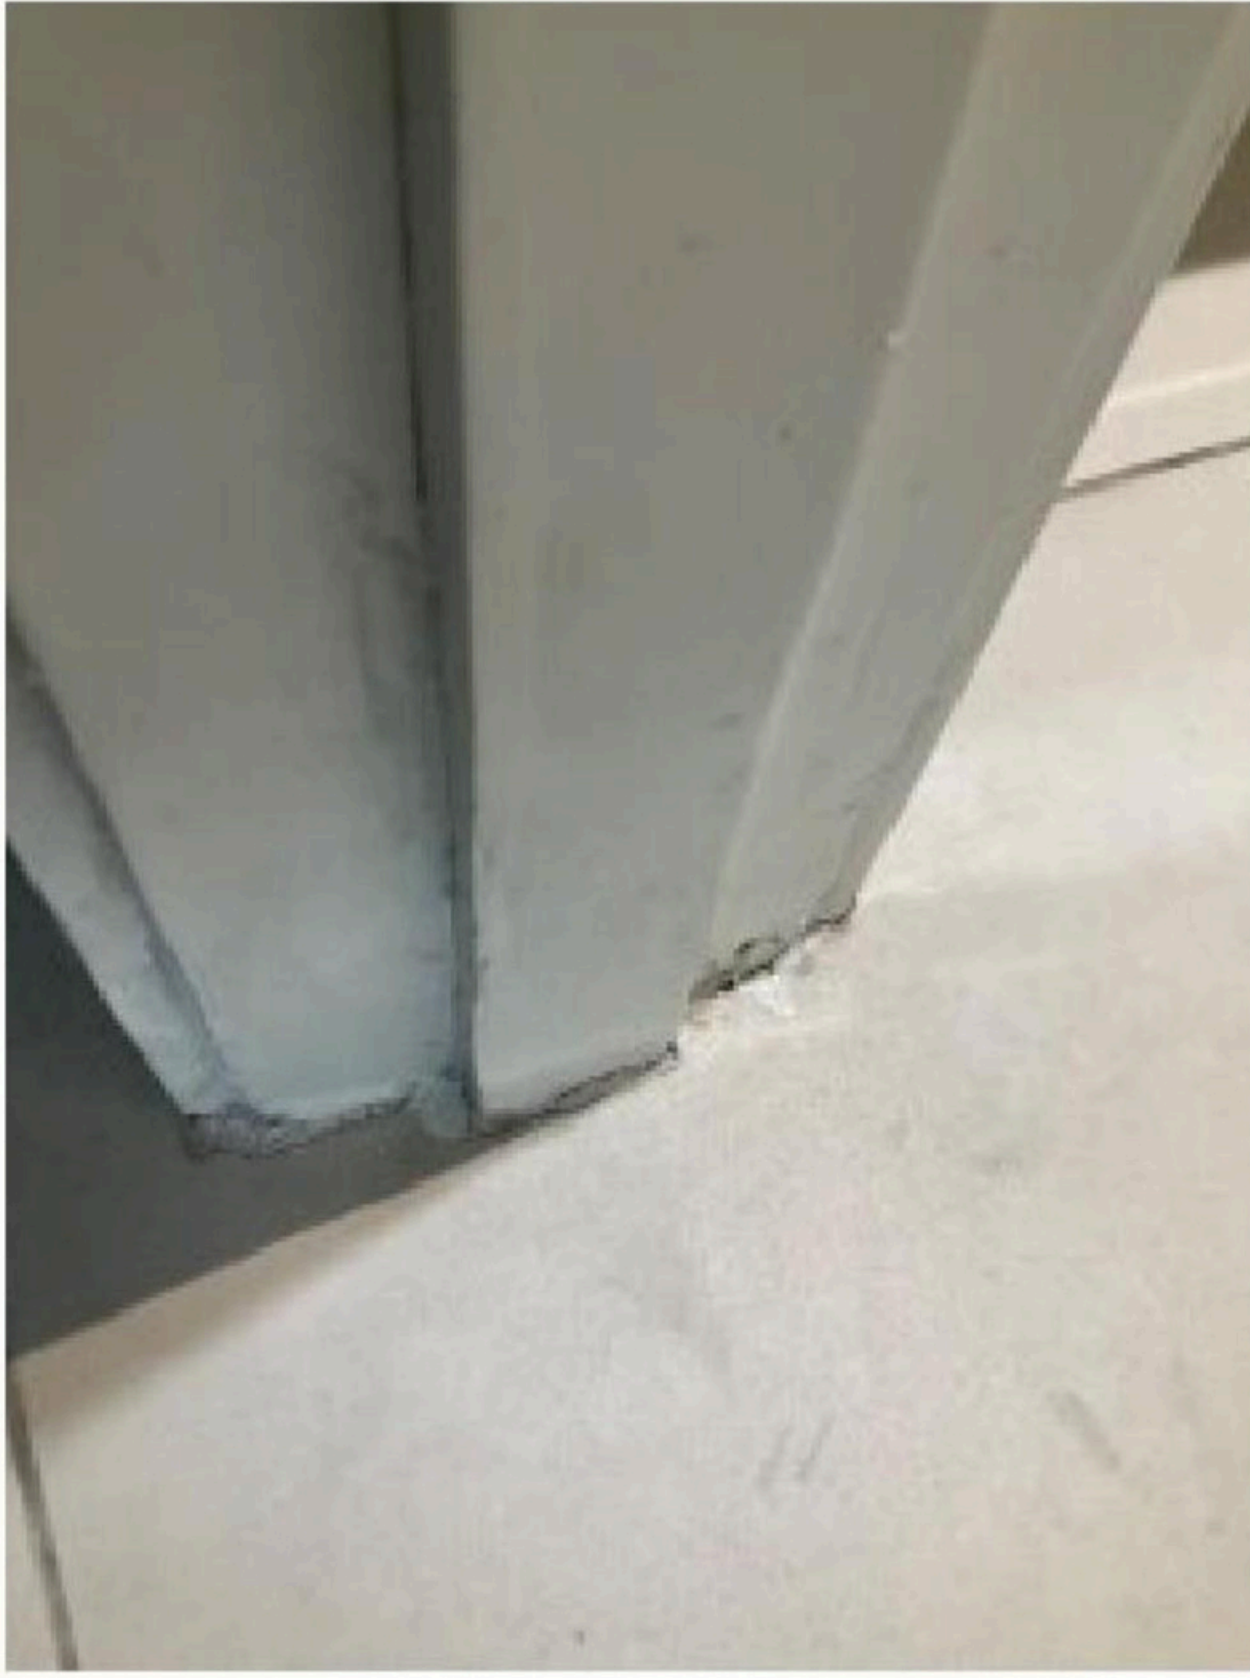
The image indicates an issue with the base of a door frame where signs of moisture ingress are evident. There is visible deterioration of the paint and slight expansion of the frame material, suggesting possible water damage. Consider evaluation and repair by a professional to prevent escalation of the defect.

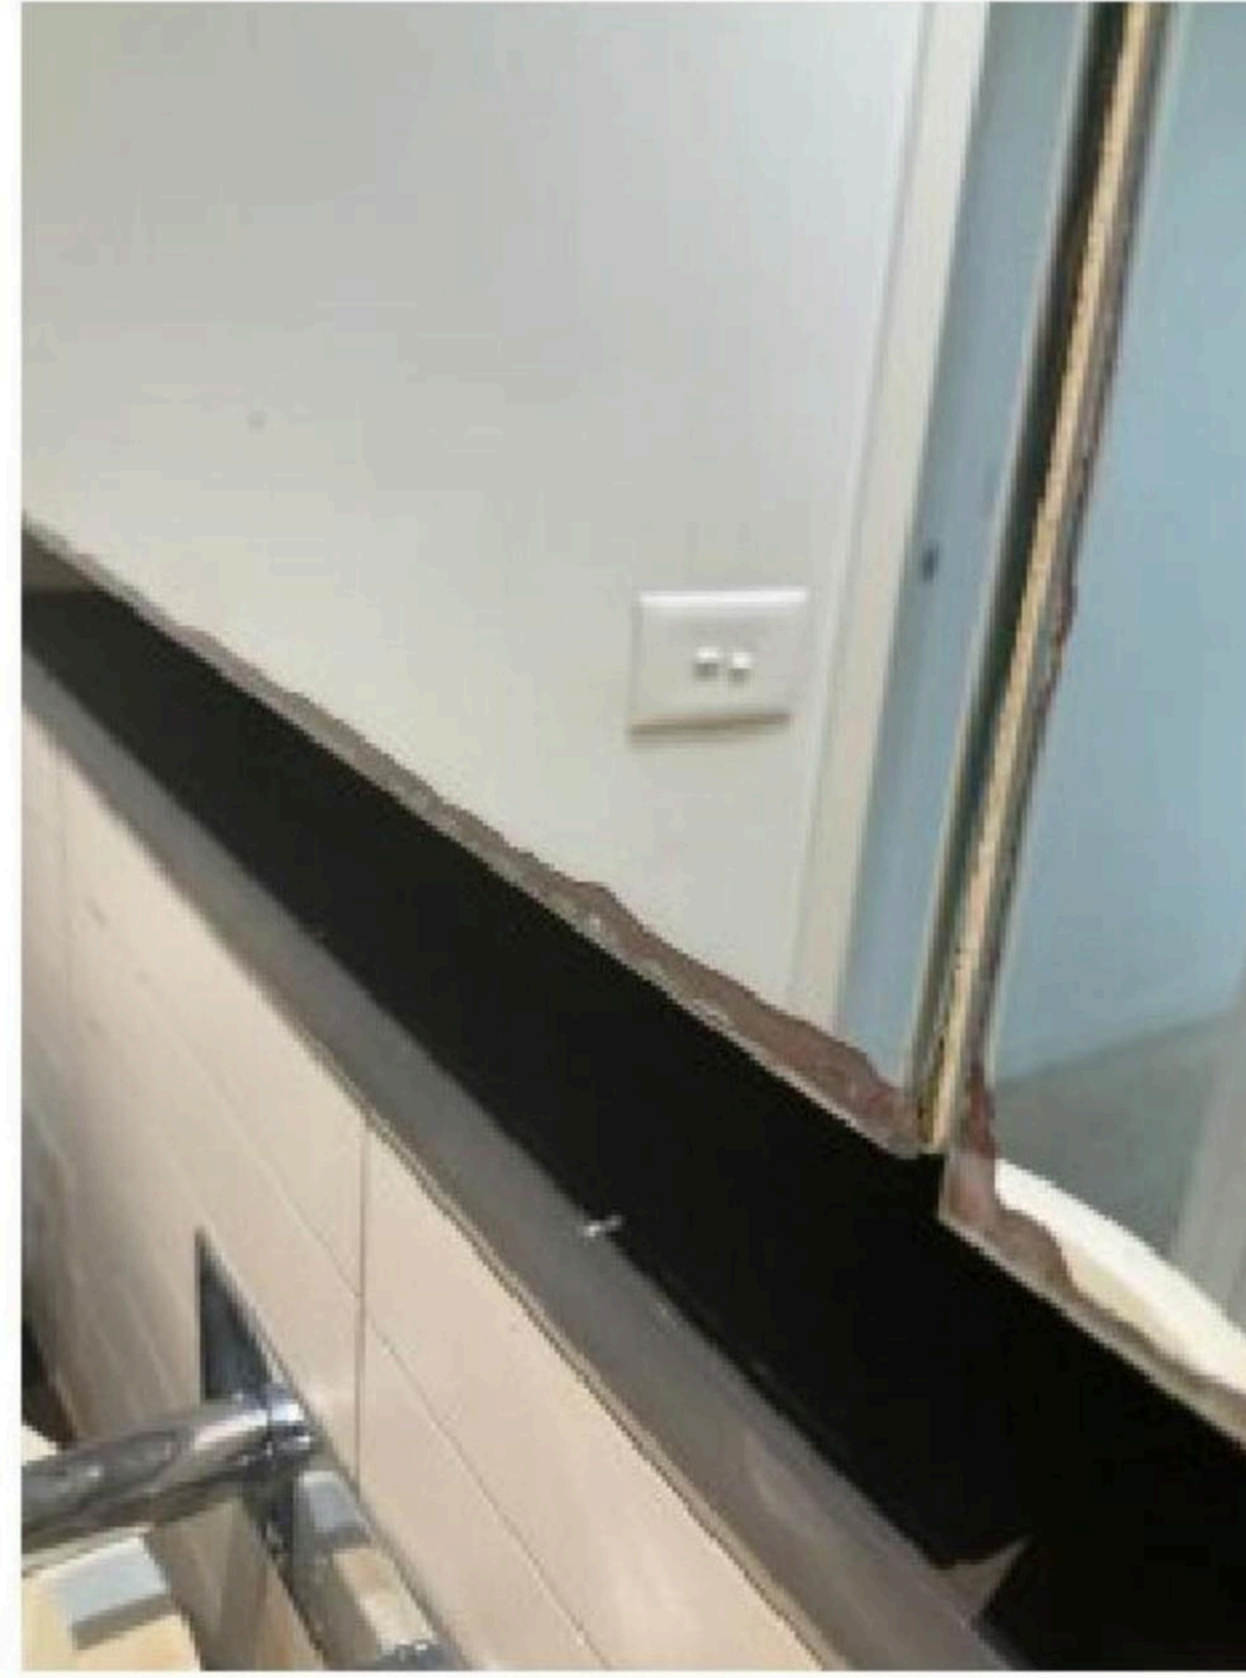
The mirror exhibits signs of deterioration, with noticeable DE silvering along the edges. This condition is typically caused by prolonged exposure to moisture, potentially compromising the visual appeal and functionality of the mirror. While not a structural concern, this defect may necessitate replacement to restore aesthetic quality. Attention to ventilation and moisture control in the surrounding area is advisable to prevent further damage.

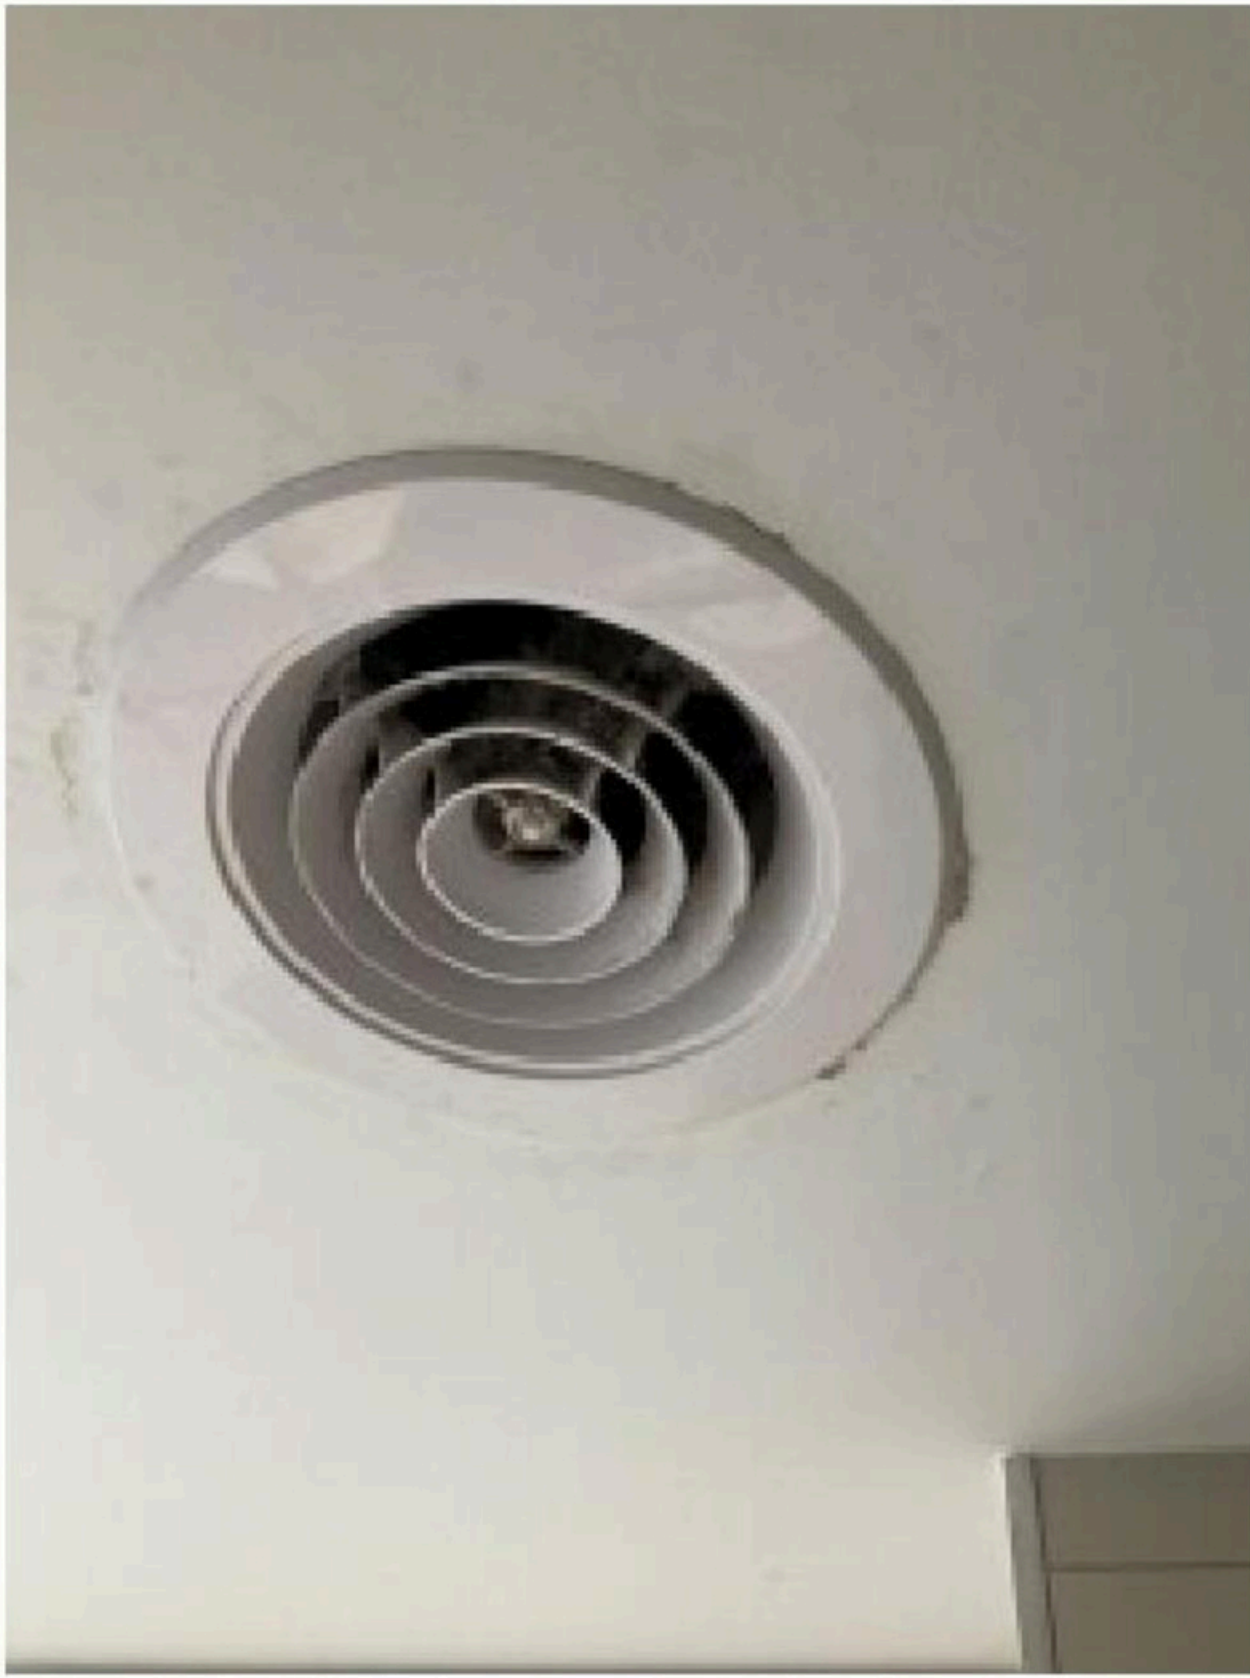
The ceiling shows signs of moisture damage around the ventilation duct, likely due to ventilation unoperational at the time of inspection, which can lead to mould growth if not addressed. The surrounding paint is starting to bubble and peel, suggesting that moisture is consistently accumulating. It is advisable to investigate the source of the moisture and ensure the area is sealed and ventilated properly to prevent further deterioration. Regular maintenance and assessment could prevent potential long-term issues related to air quality.

There is a possible ventilation issue in the bathroom.  
Recommend a plumber be engaged to investigate issues.

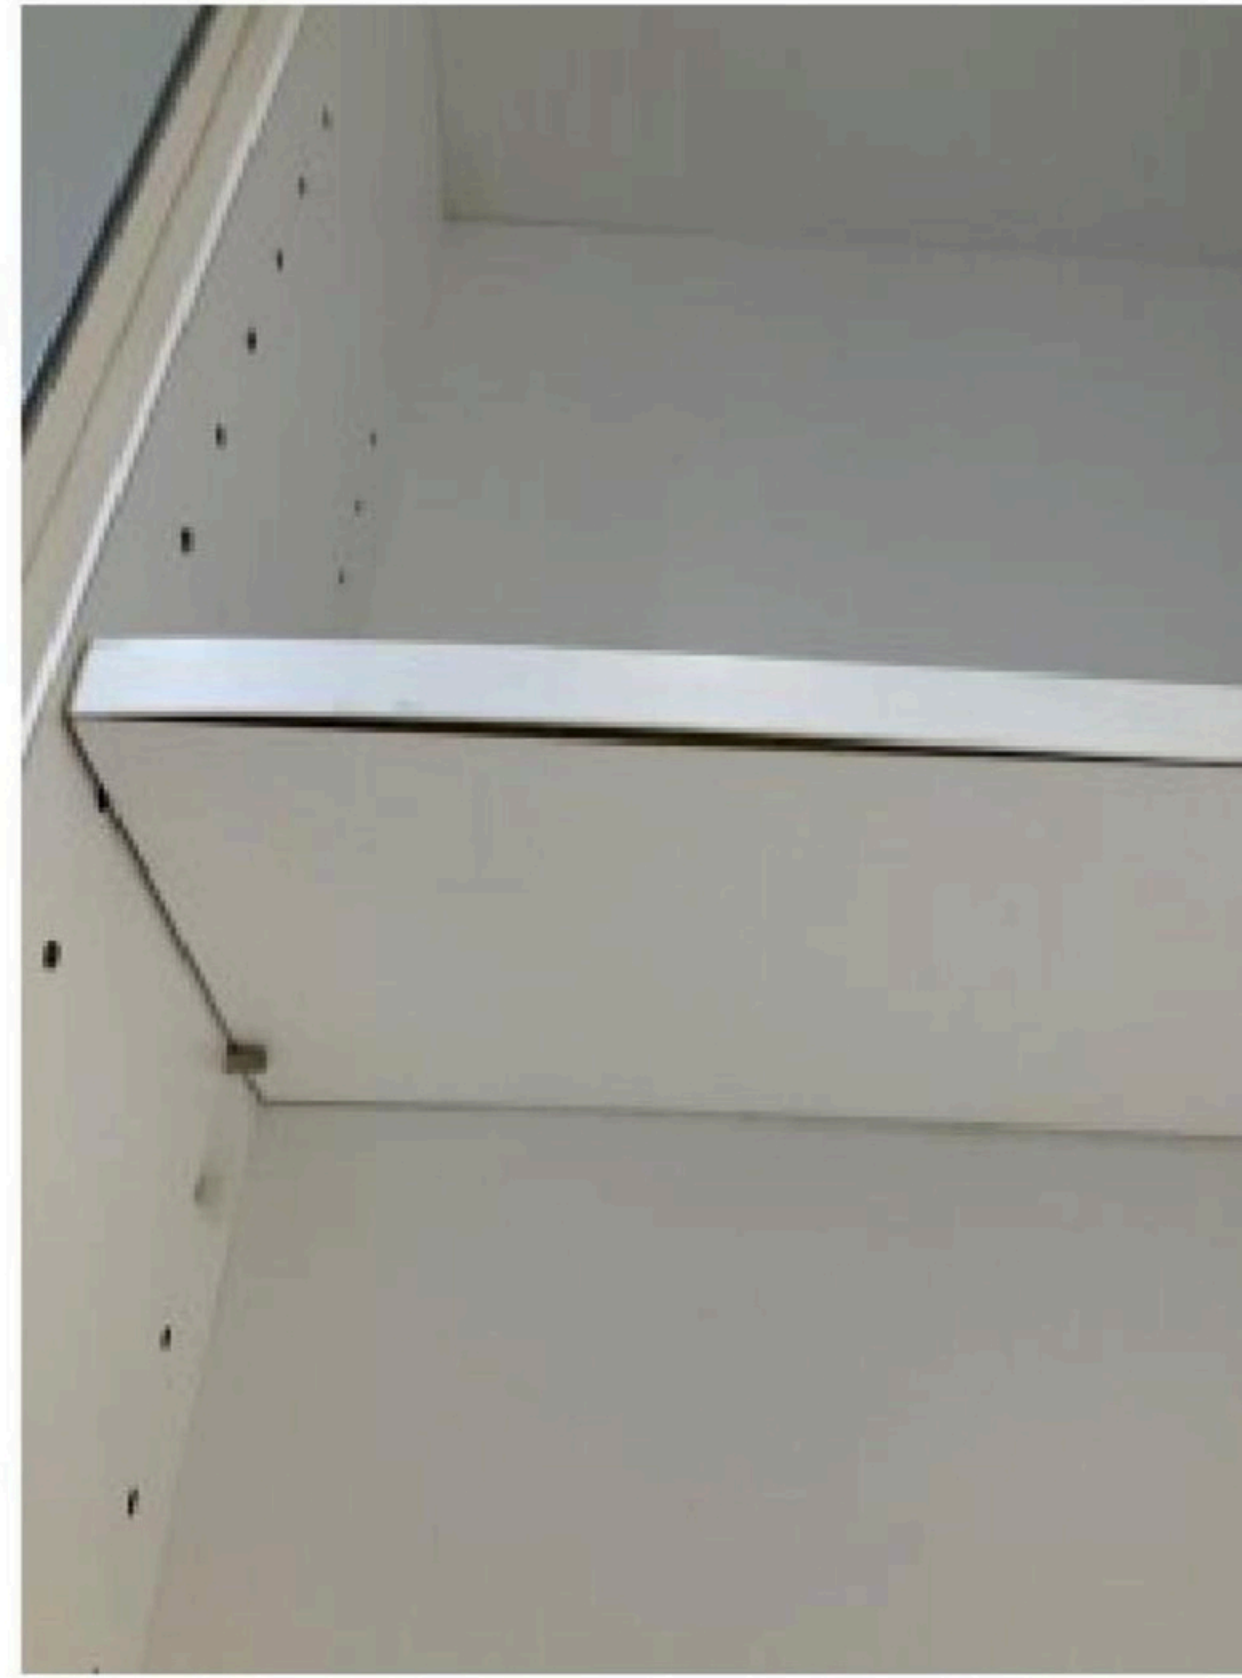
The interior shelf displays a noticeably chipped edge. Consider repair or replacement to maintain the unit's functionality and appearance.

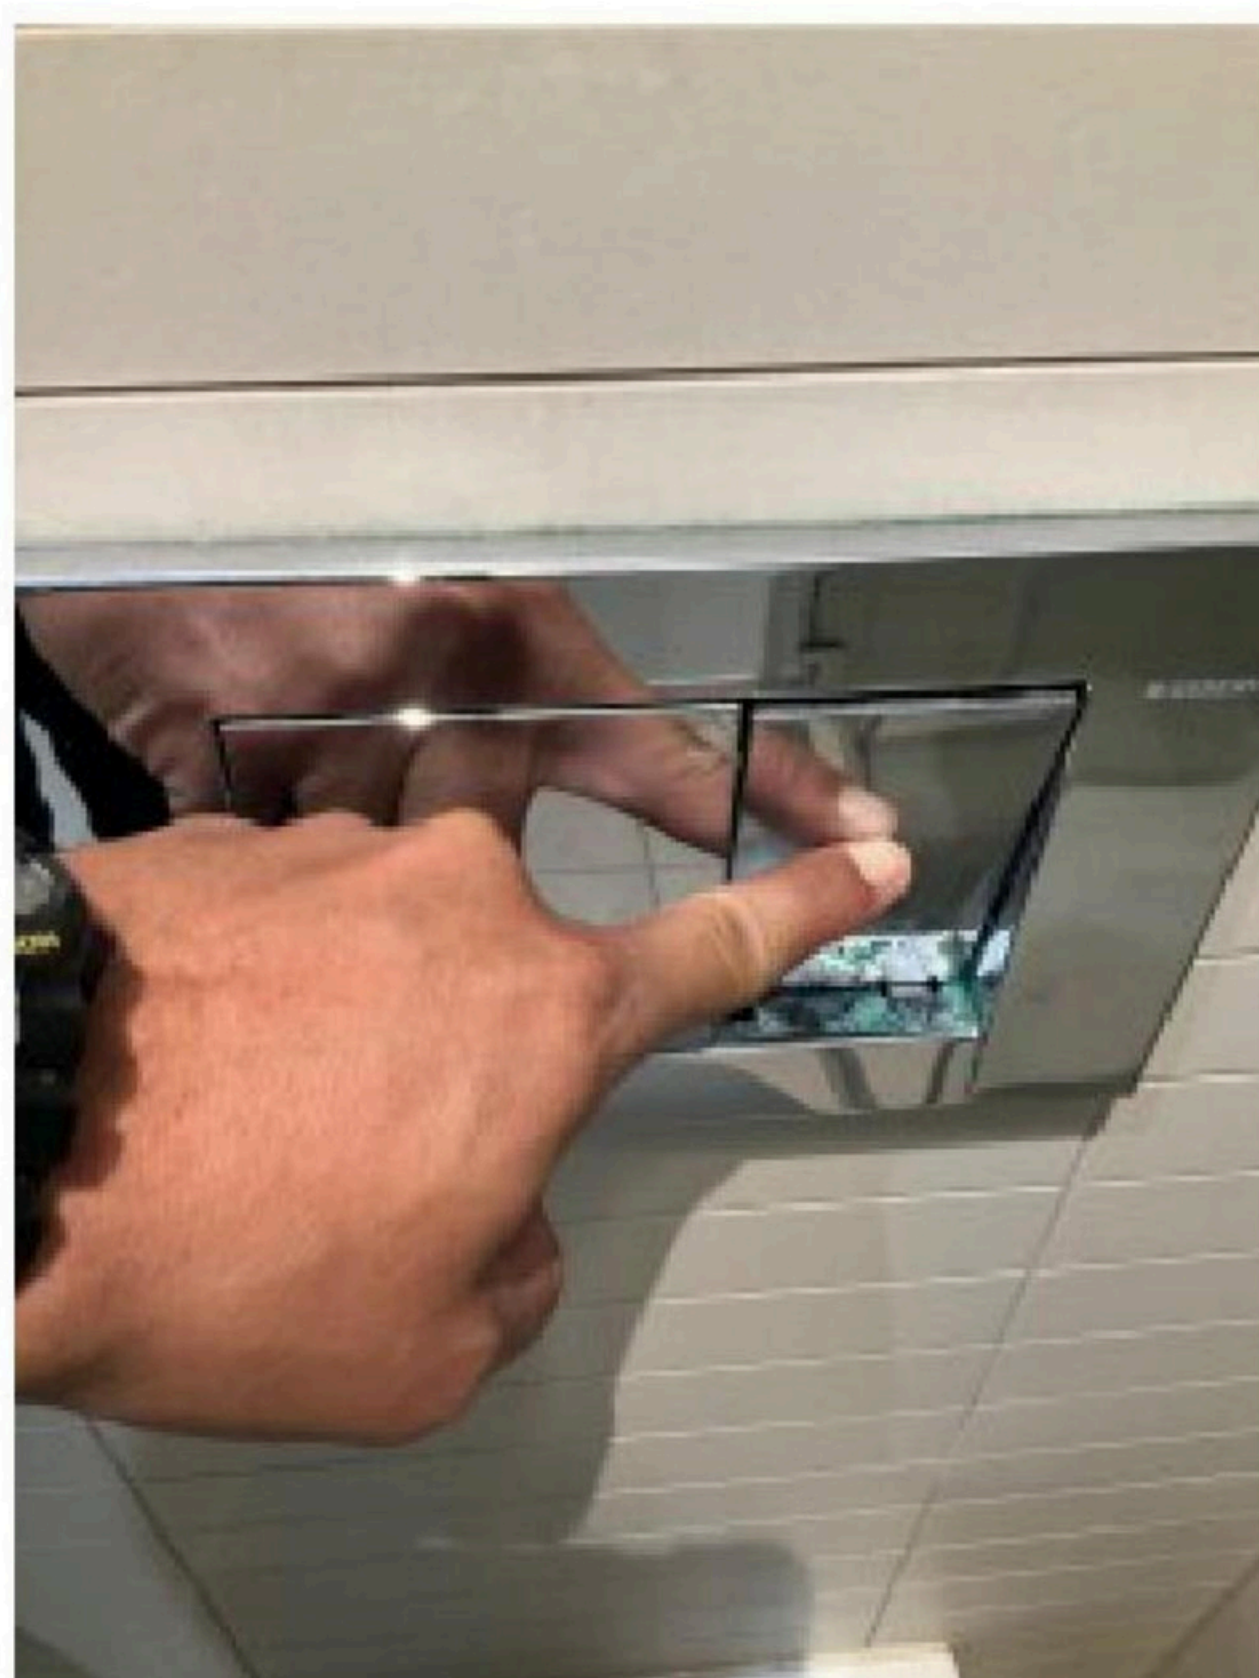
The flush plate on the toilet shows signs of deterioration and is not working, with visible corrosion and mineral buildup around the edges. This likely results from prolonged exposure to moisture, or inadequate ventilation in the bathroom. It is recommended that the issue be addressed promptly to prevent further damage and ensure proper operation of the toilet system.

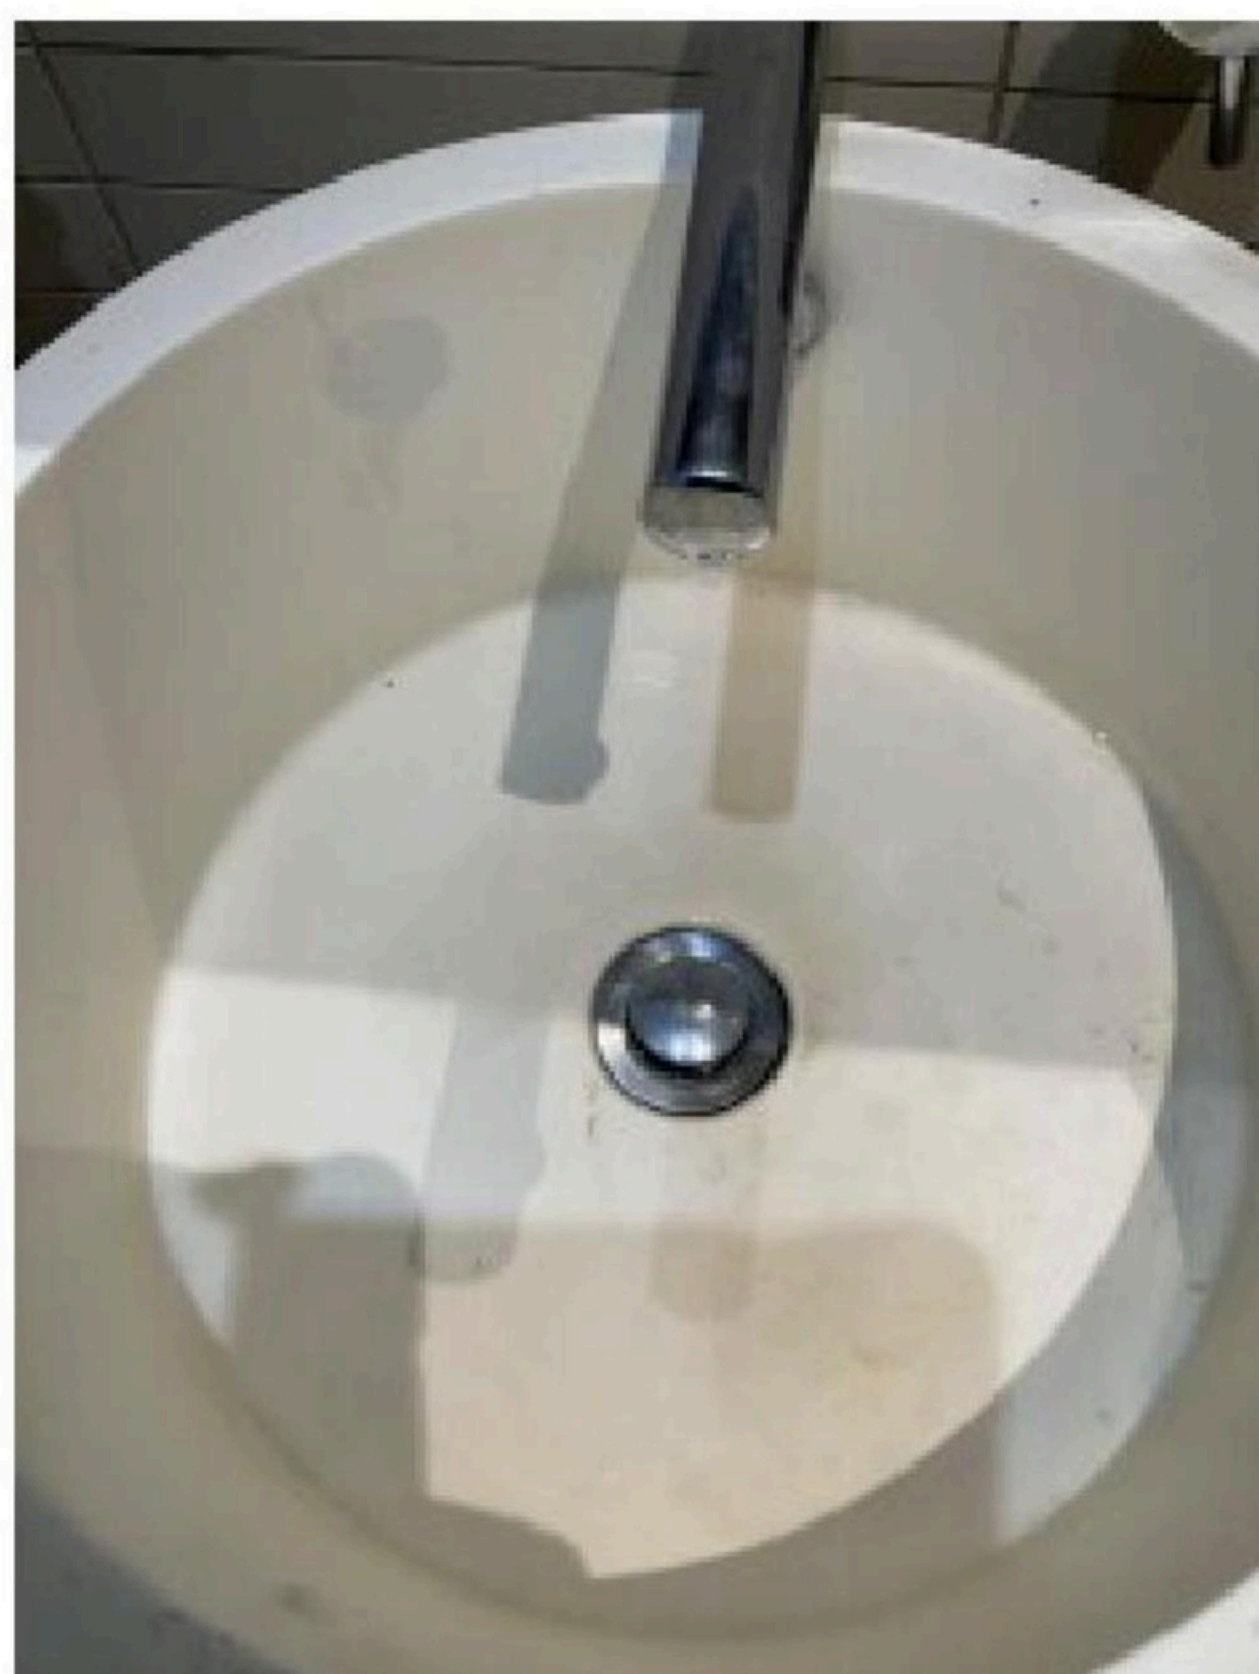
The sink basin shows signs of wear, including discoloration and surface staining. The tap is functional, but the finish is slightly worn, suggesting age and use. Regular cleaning and maintenance are advisable to prevent further deterioration, although the sink is currently operational.

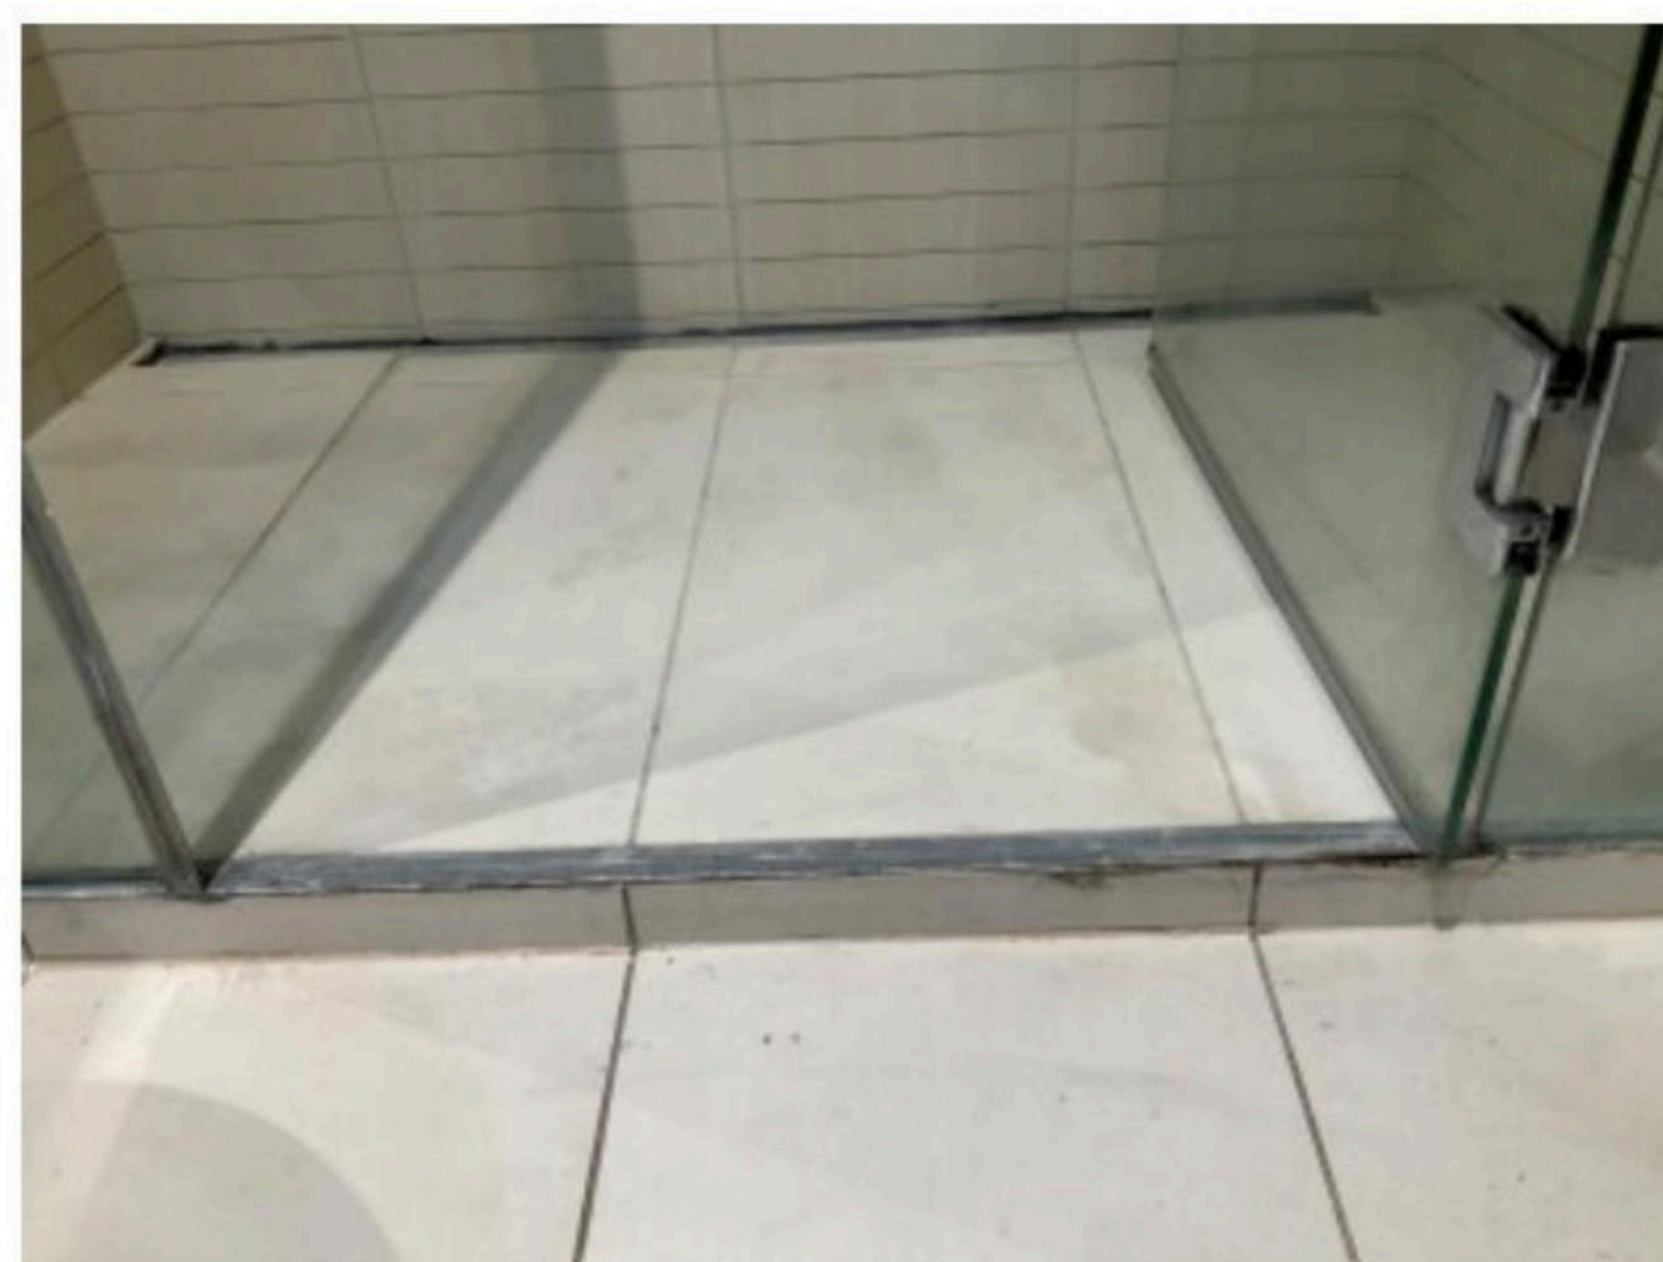
The shower area exhibits signs of moisture seepage, as evidenced by discoloured and stained tile grout, which may indicate insufficient sealing or improper drainage. The metal frame shows visible corrosion, suggesting prolonged exposure to moisture. These conditions could potentially lead to further deterioration and might require professional evaluation to prevent escalation. It is recommended to assess the sealing and ensure proper maintenance to enhance longevity and functionality.

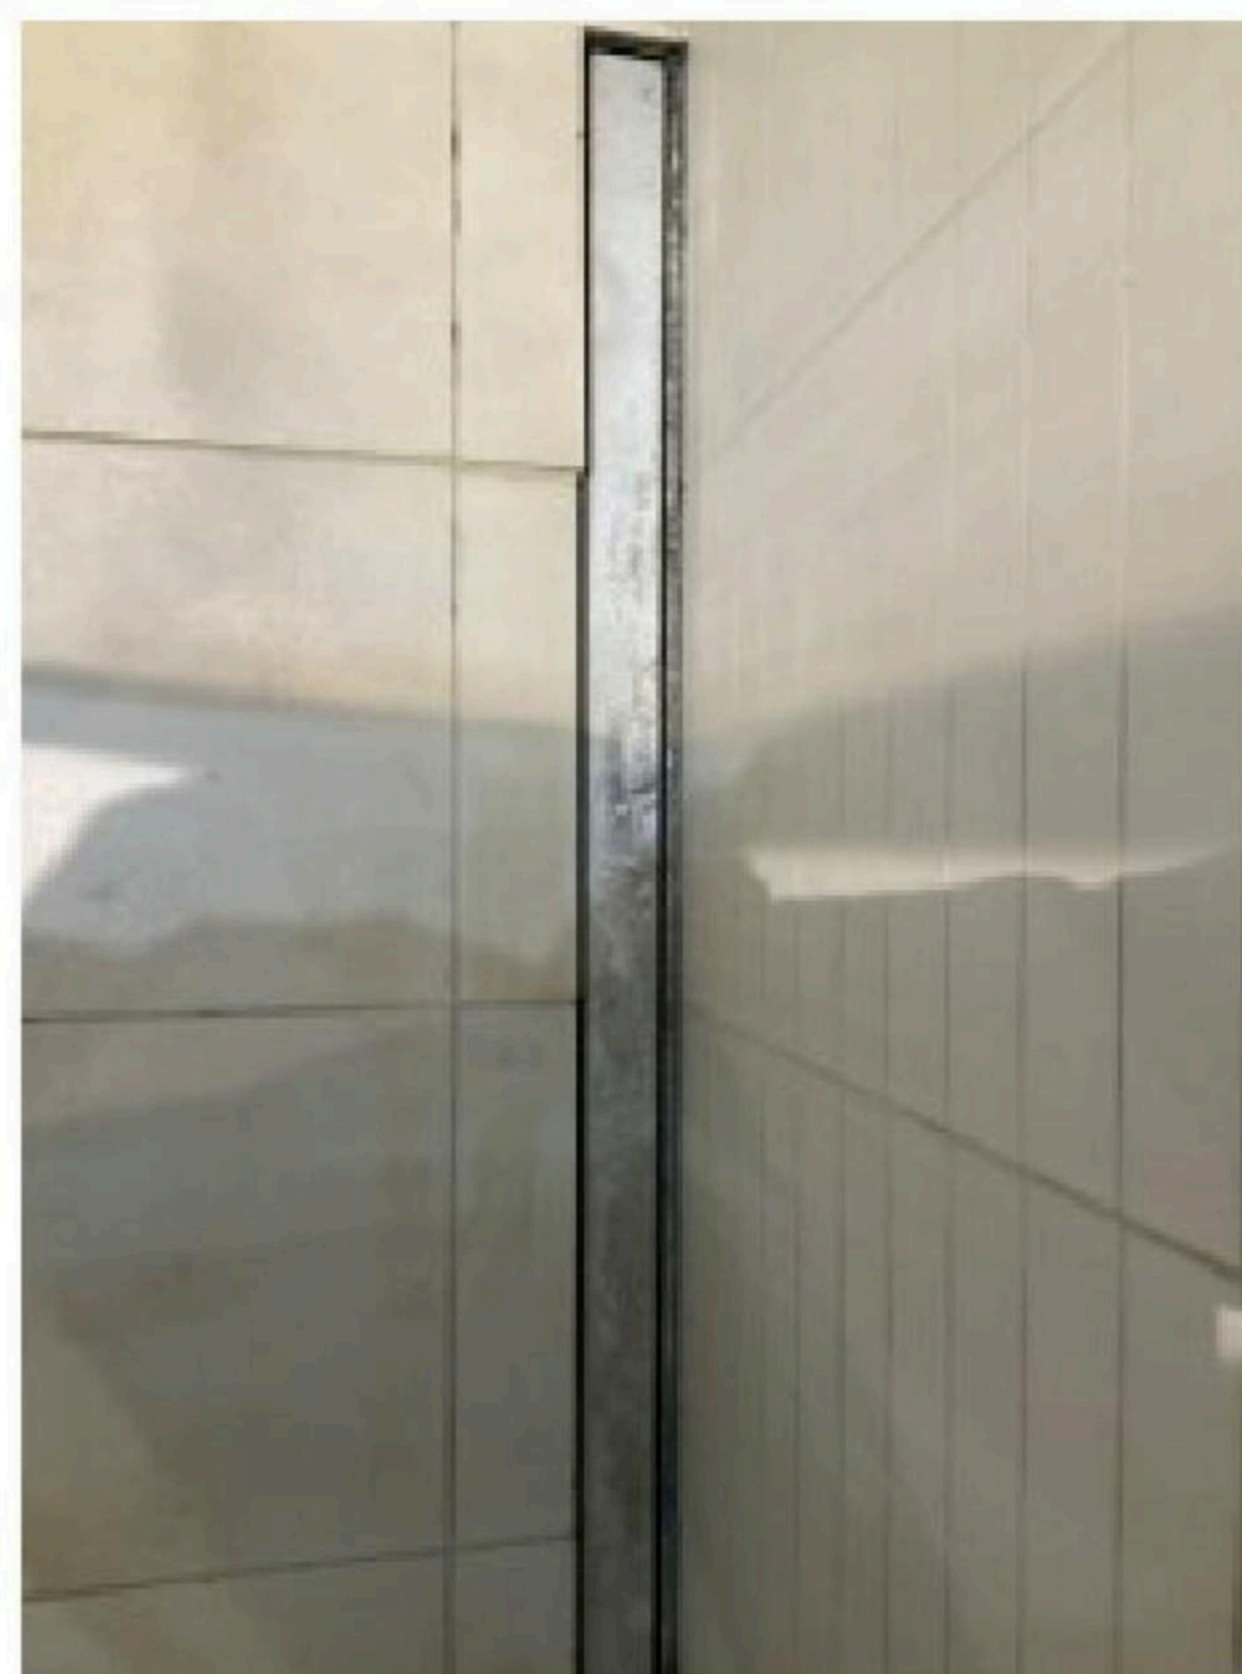
The tile grout and metal strip at the base of the wall exhibit signs of deterioration, likely due to prolonged exposure to moisture. There is visible discoloration and potential mould growth along the grout lines, suggesting insufficient sealing. The metal strip also shows signs of rust. It is advisable to clean, reseal, and possibly replace the affected materials to prevent further damage and maintain a healthy environment.

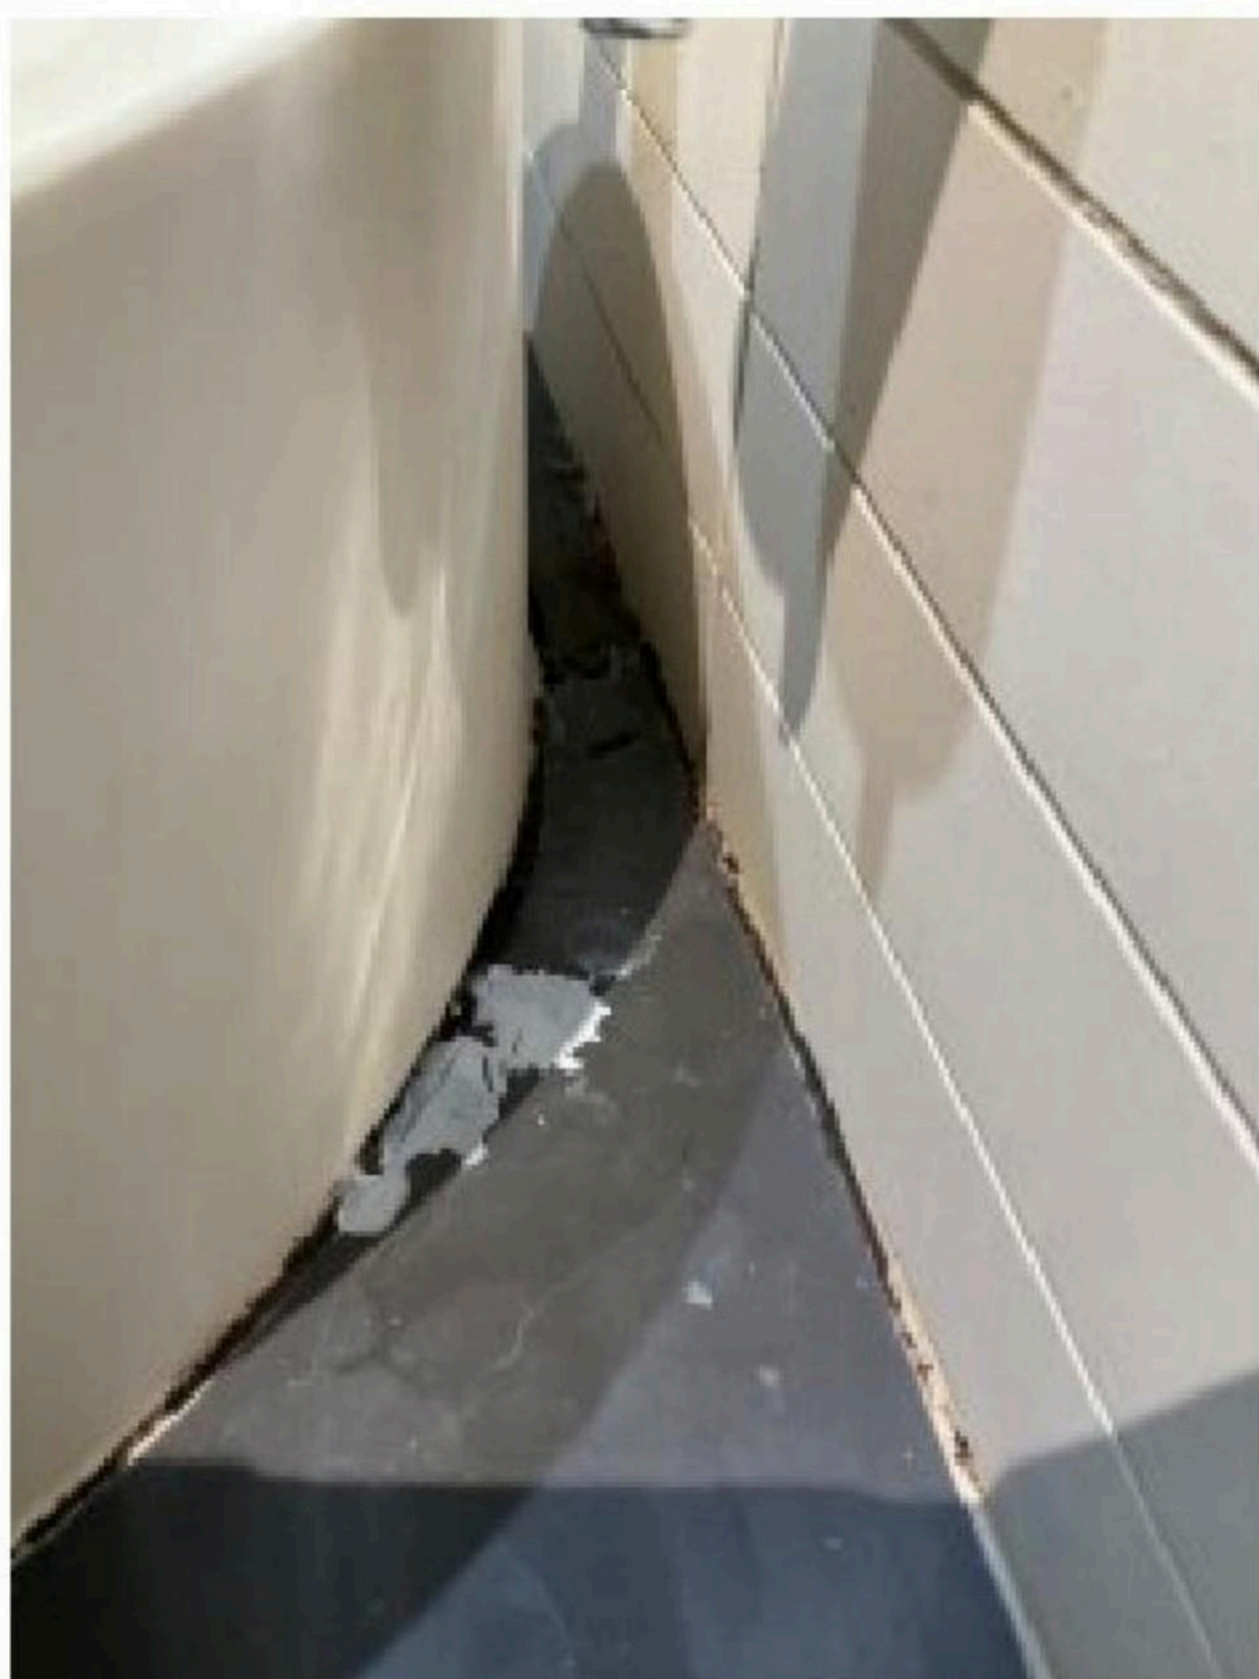
The inspection revealed evidence of mould growth along the joint between the wall tiles and the countertop . This appears to be due to inadequate sealing, which may allow moisture to penetrate and accumulate. To prevent further damage, it is recommended that the existing sealant be removed and replaced with a high-quality, waterproof sealant to inhibit moisture ingress and mould development. Regular maintenance will also be essential to ensure prolonged protection and durability of the area.
