## Just Inspections

## Building Inspection Report

AS4349.1- 2007

| <b>Appointment Date</b> | Mon 29 Jun 2026 2:00PM - 3:00PM |

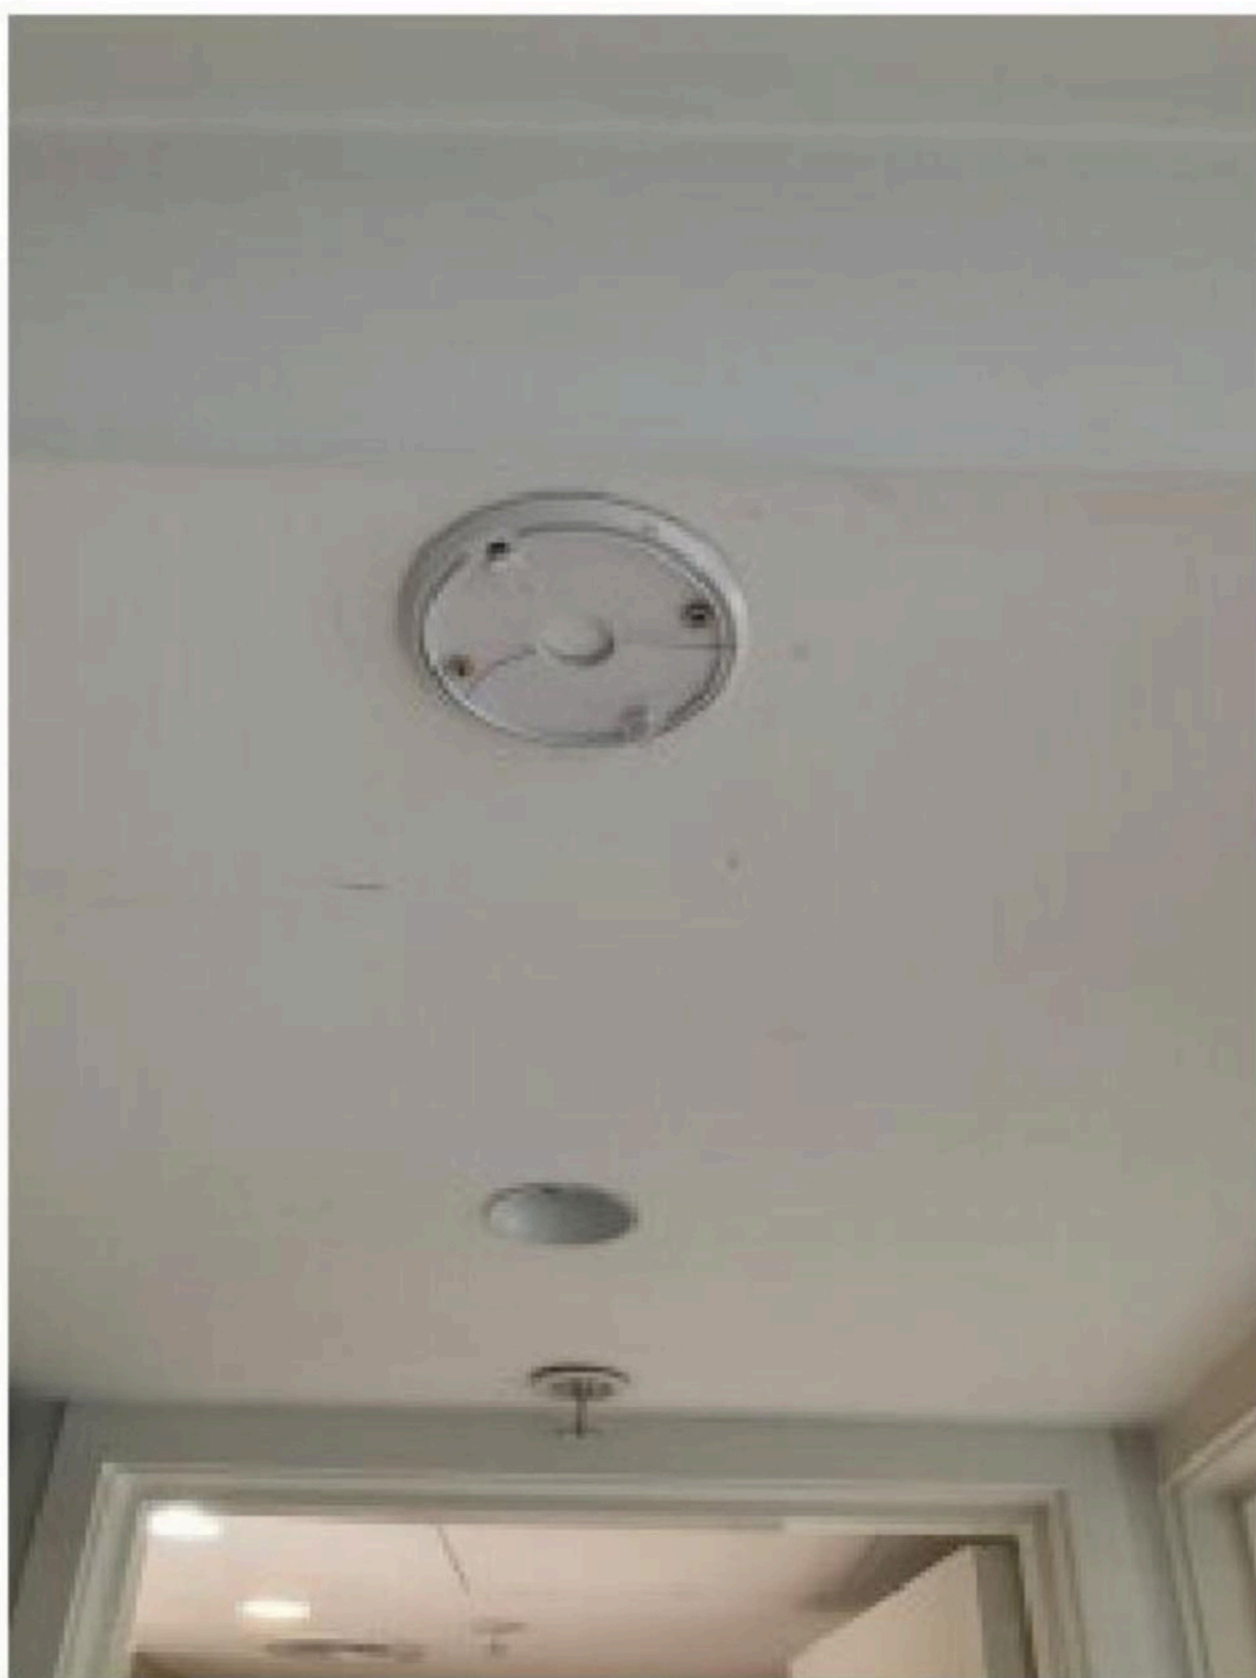
Smoke detector not in place at the time of inspection

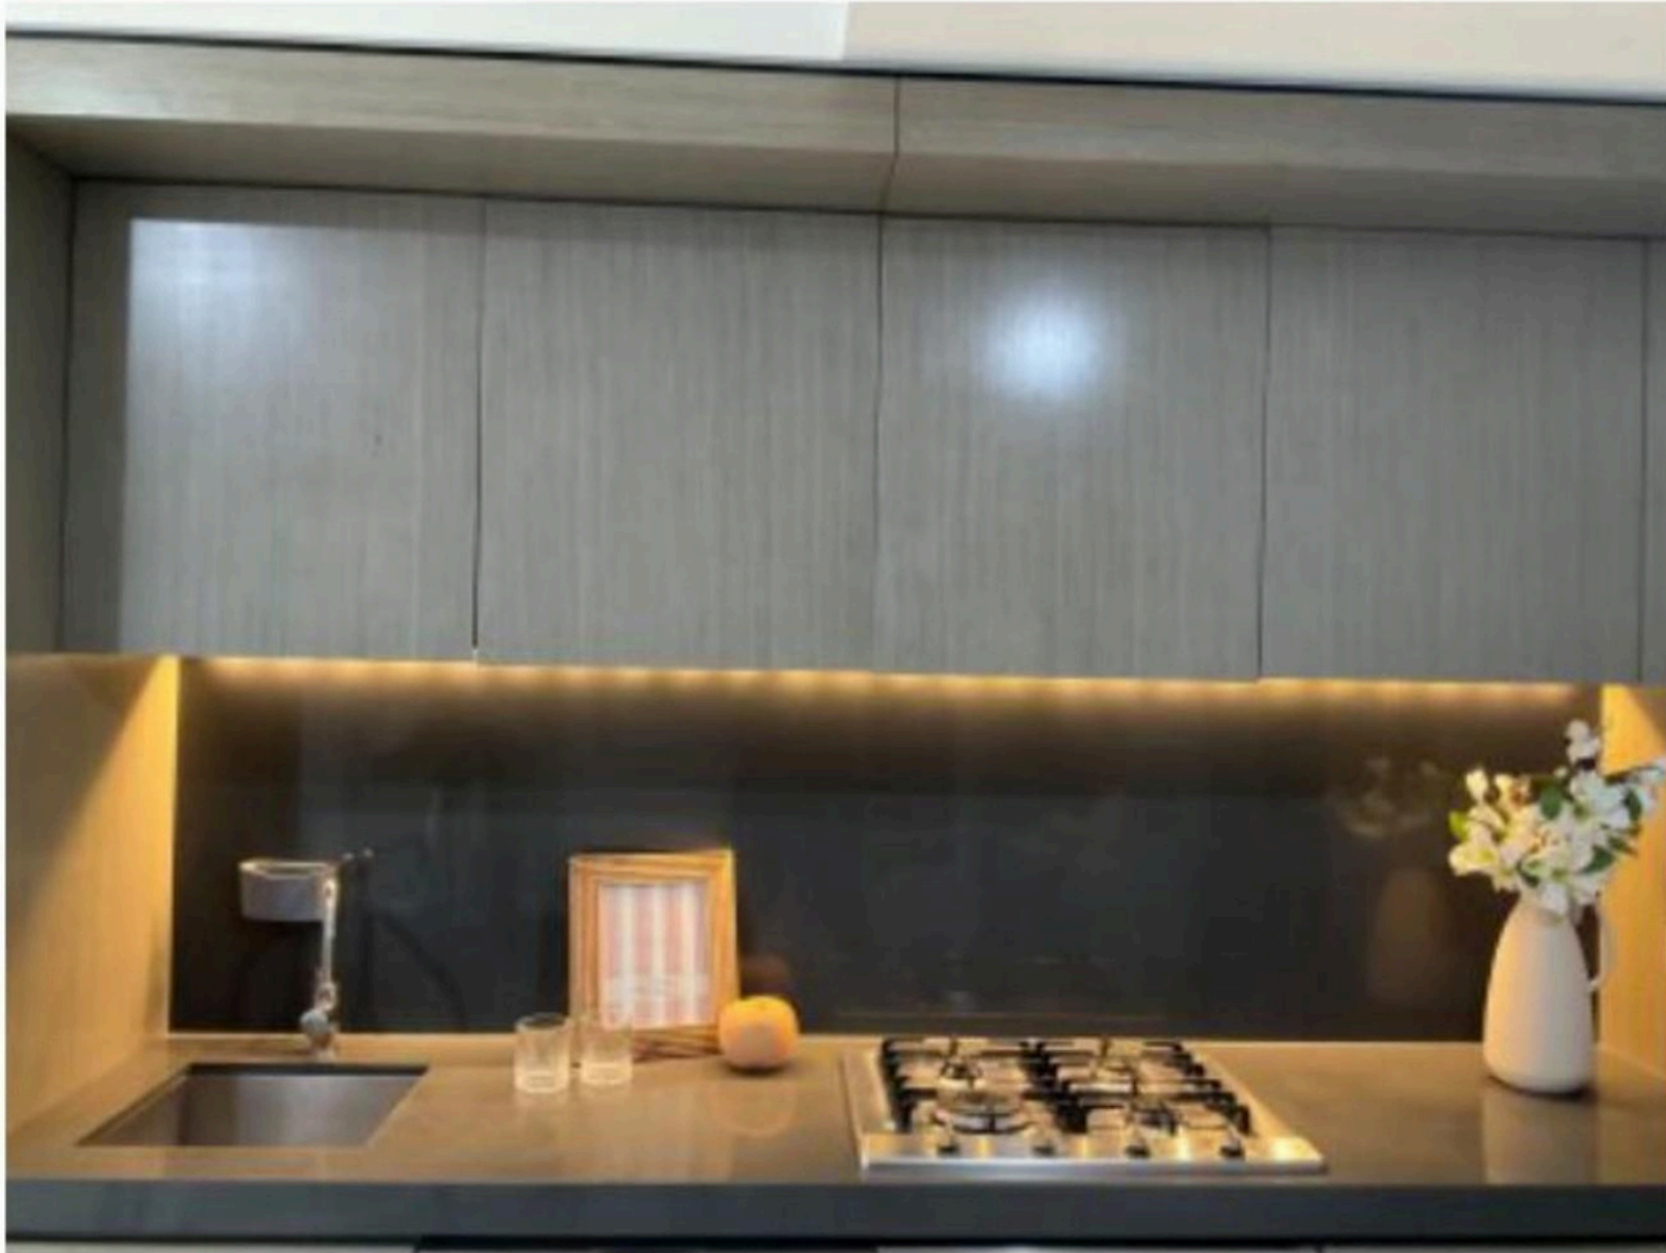
The kitchen door cabinet is misaligned. Recommended to adjust the cabinet hinges to realign the door, and replace any worn or damaged hardware if necessary.

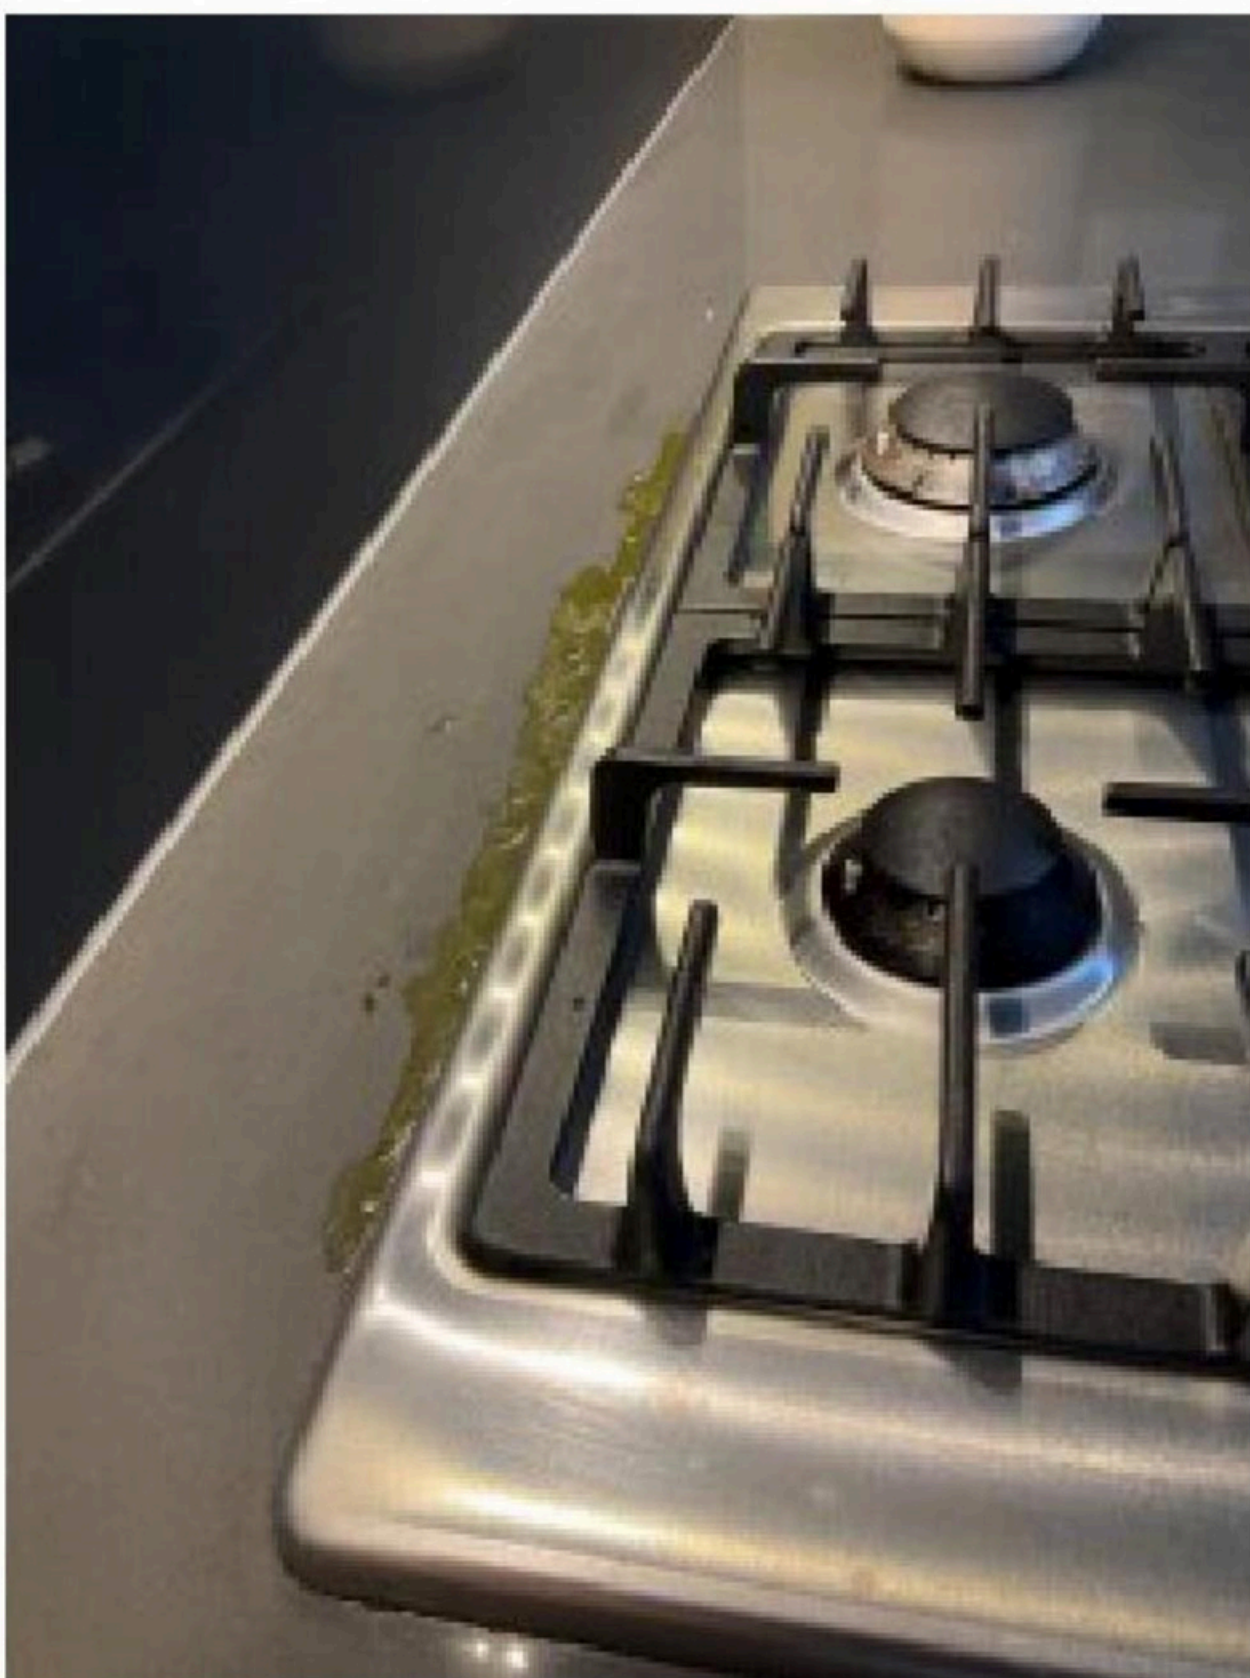
The cooktop is operational but exhibits signs of residue build-up. Regular maintenance should be considered to ensure the longevity and efficiency of the appliance.

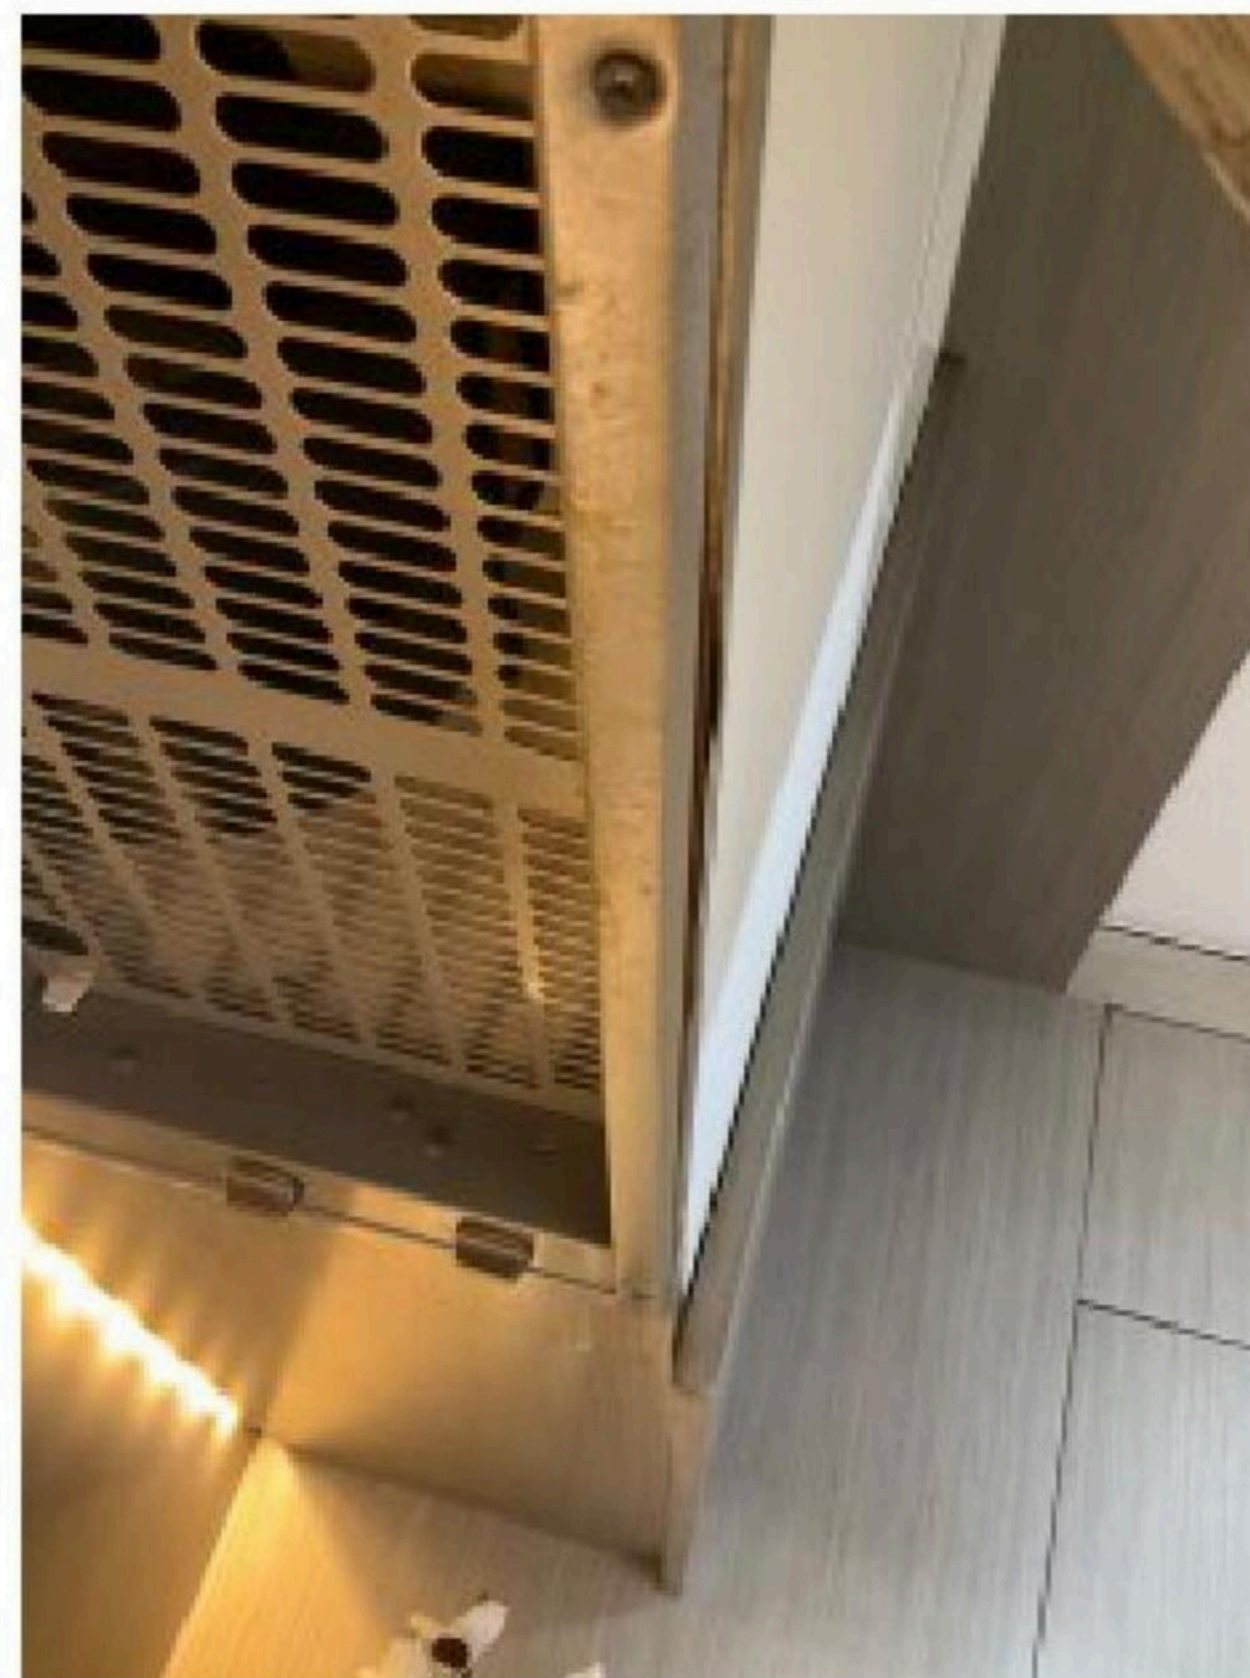
Veneer is peeling between edge of rangehood and panel of the cabinetry. Repair or replacement might be necessary to prevent further deterioration and maintain the integrity of the cabinetry and surrounding area.

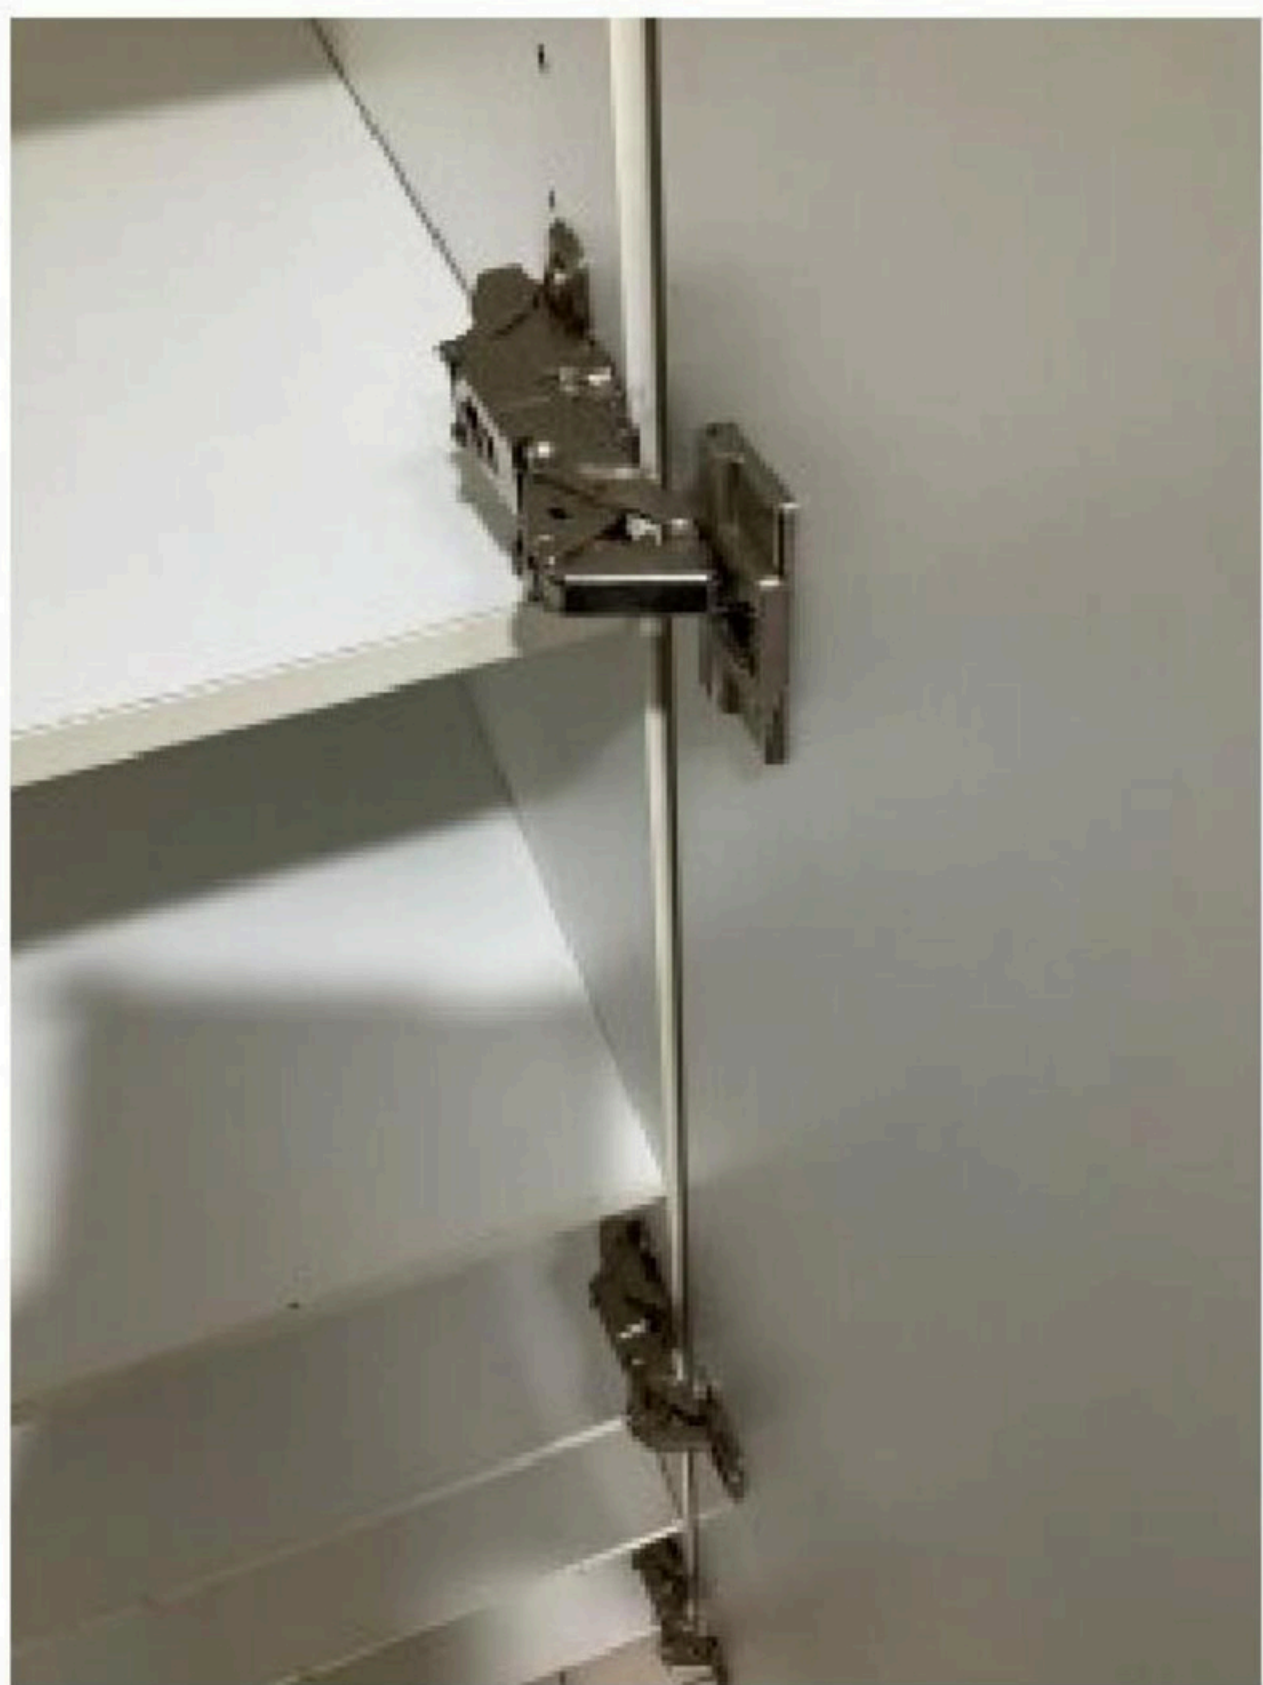
The image shows hinges with visible rust and corrosion, suggesting poor maintenance and potential exposure to moisture. The hinge's compromised condition could affect the kitchen door functionality, making it difficult to open or close smoothly. Repair or replacement is recommended to restore proper operation and prevent further deterioration.

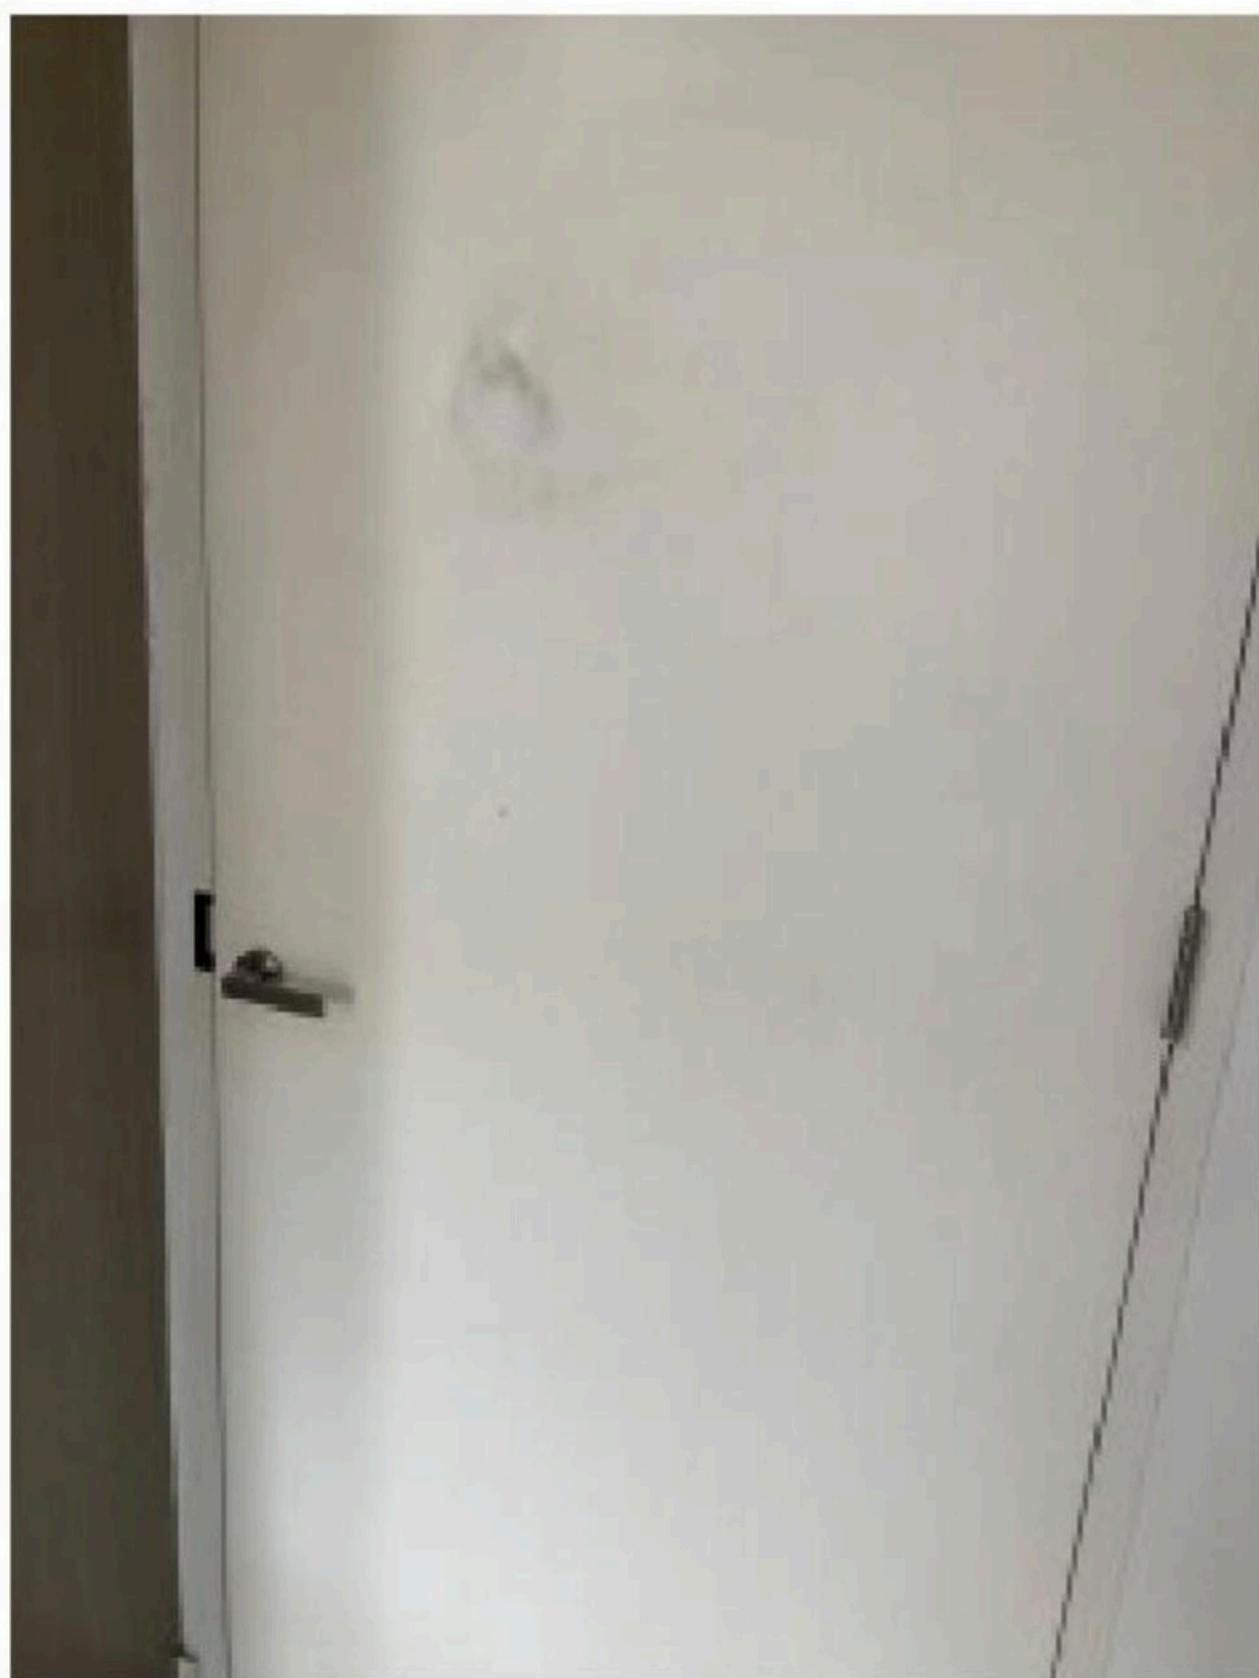
The inspected property shows a patch on the interior wall where the paint surface is uneven and appears to have undergone some repair work. The affected area may require additional smoothing and repainting to achieve a consistent finish with the surrounding wall. There is no immediate structural concern; however, addressing this cosmetic issue will improve the overall appearance.

The image shows visible wear and chipping on the door frame, which may indicate inadequate maintenance or general wear over time. This could potentially lead to further deterioration if not addressed. It is recommended to evaluate the need for repairs or repainting to prevent further damage and maintain the aesthetic appeal and functionality of the door. Regular maintenance will ensure the longevity of the fixture and preserve the overall quality of the property.

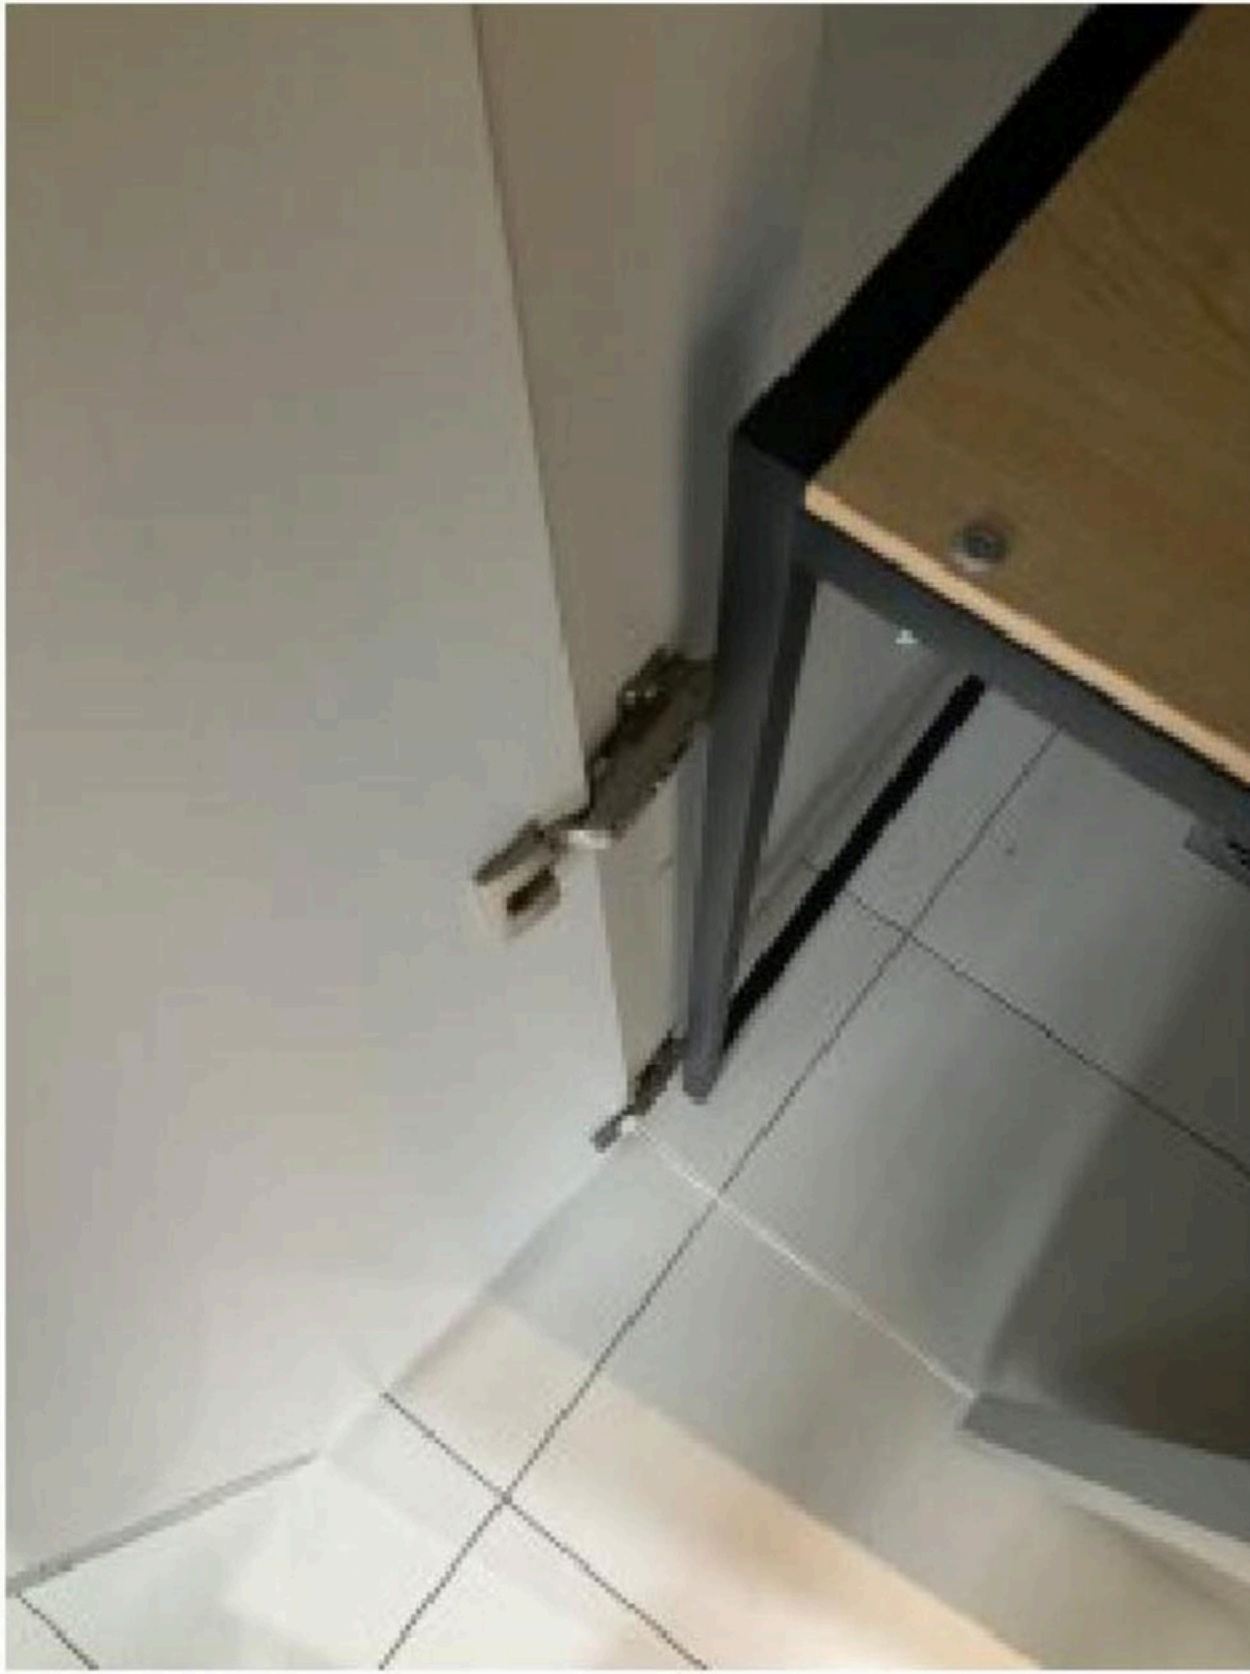
The image shows corrosion and rust on the metal hinge, which may impact the functionality and stability of the door or fixture it supports. The presence of rust suggests exposure to moisture and could potentially lead to further deterioration if not addressed. It is recommended to repair or replace the hardware.

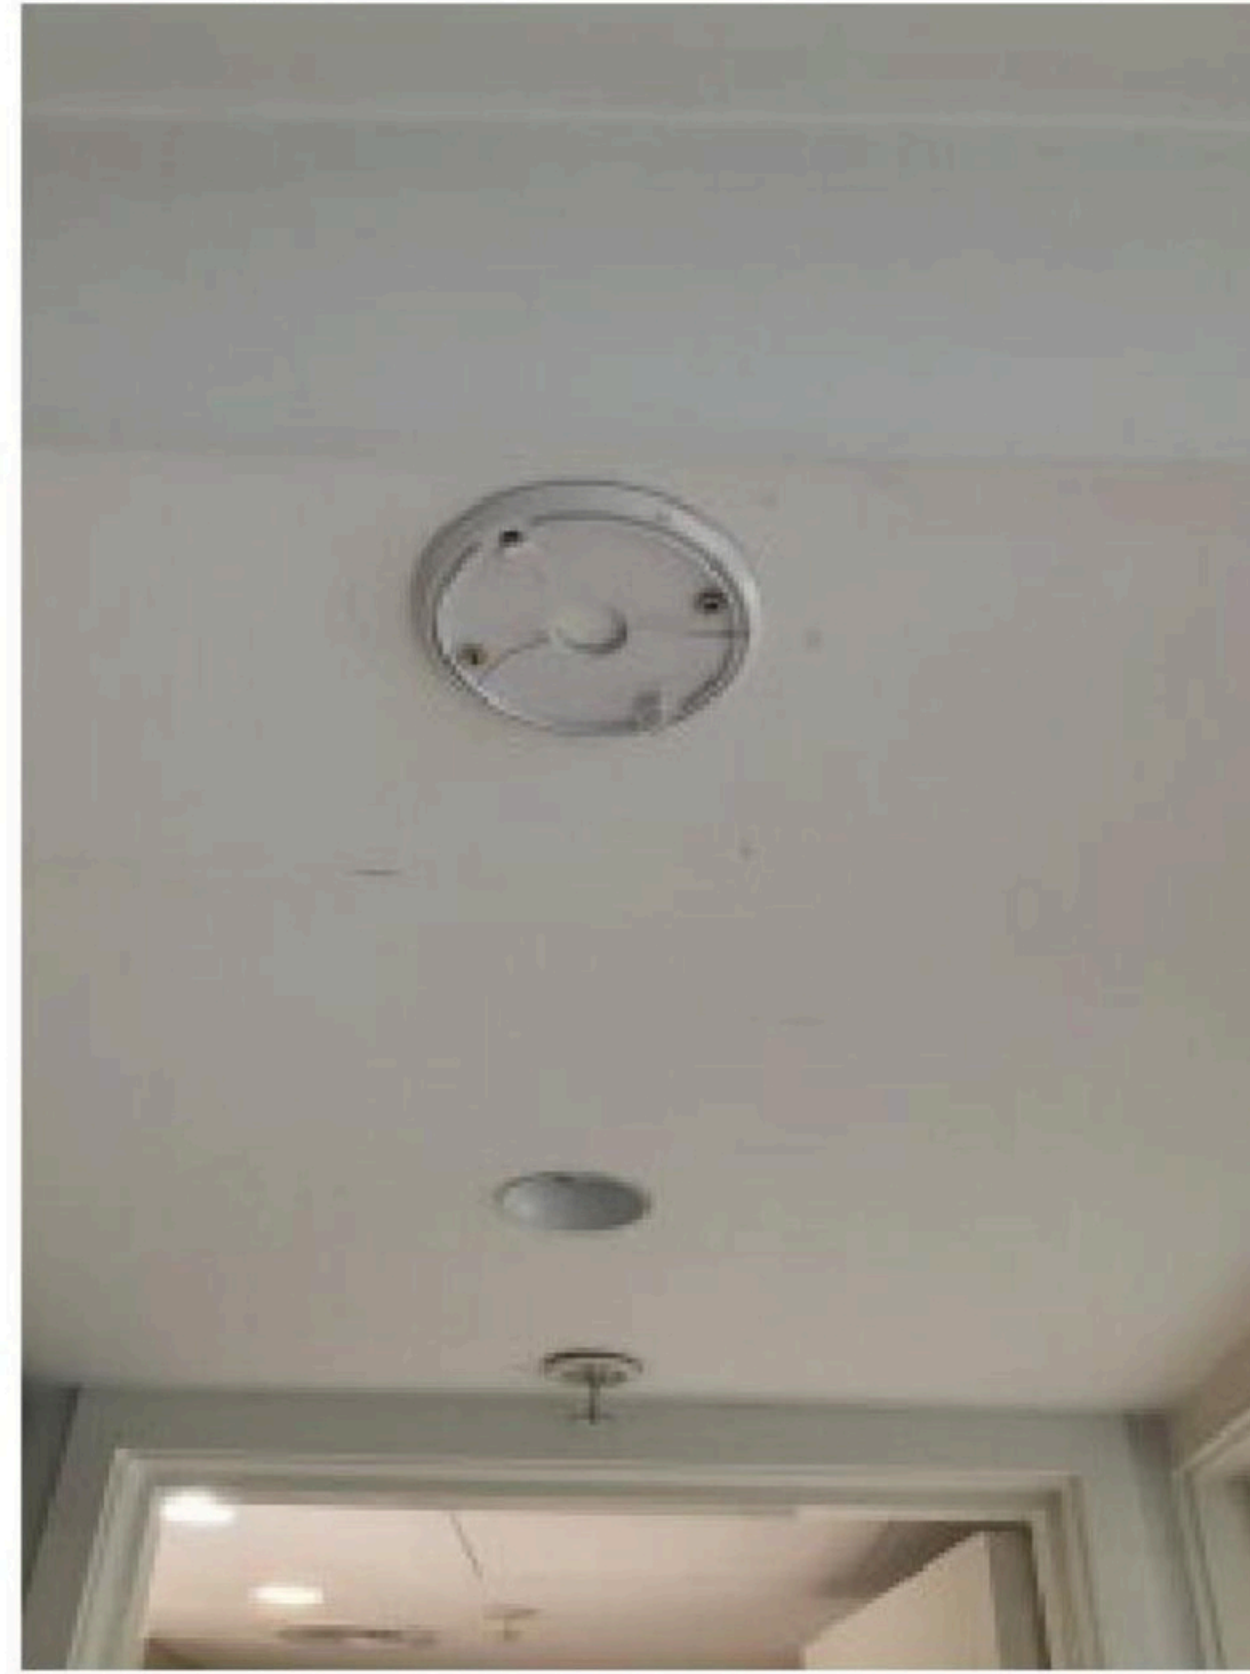
Smoke detector not in place at the time of inspection

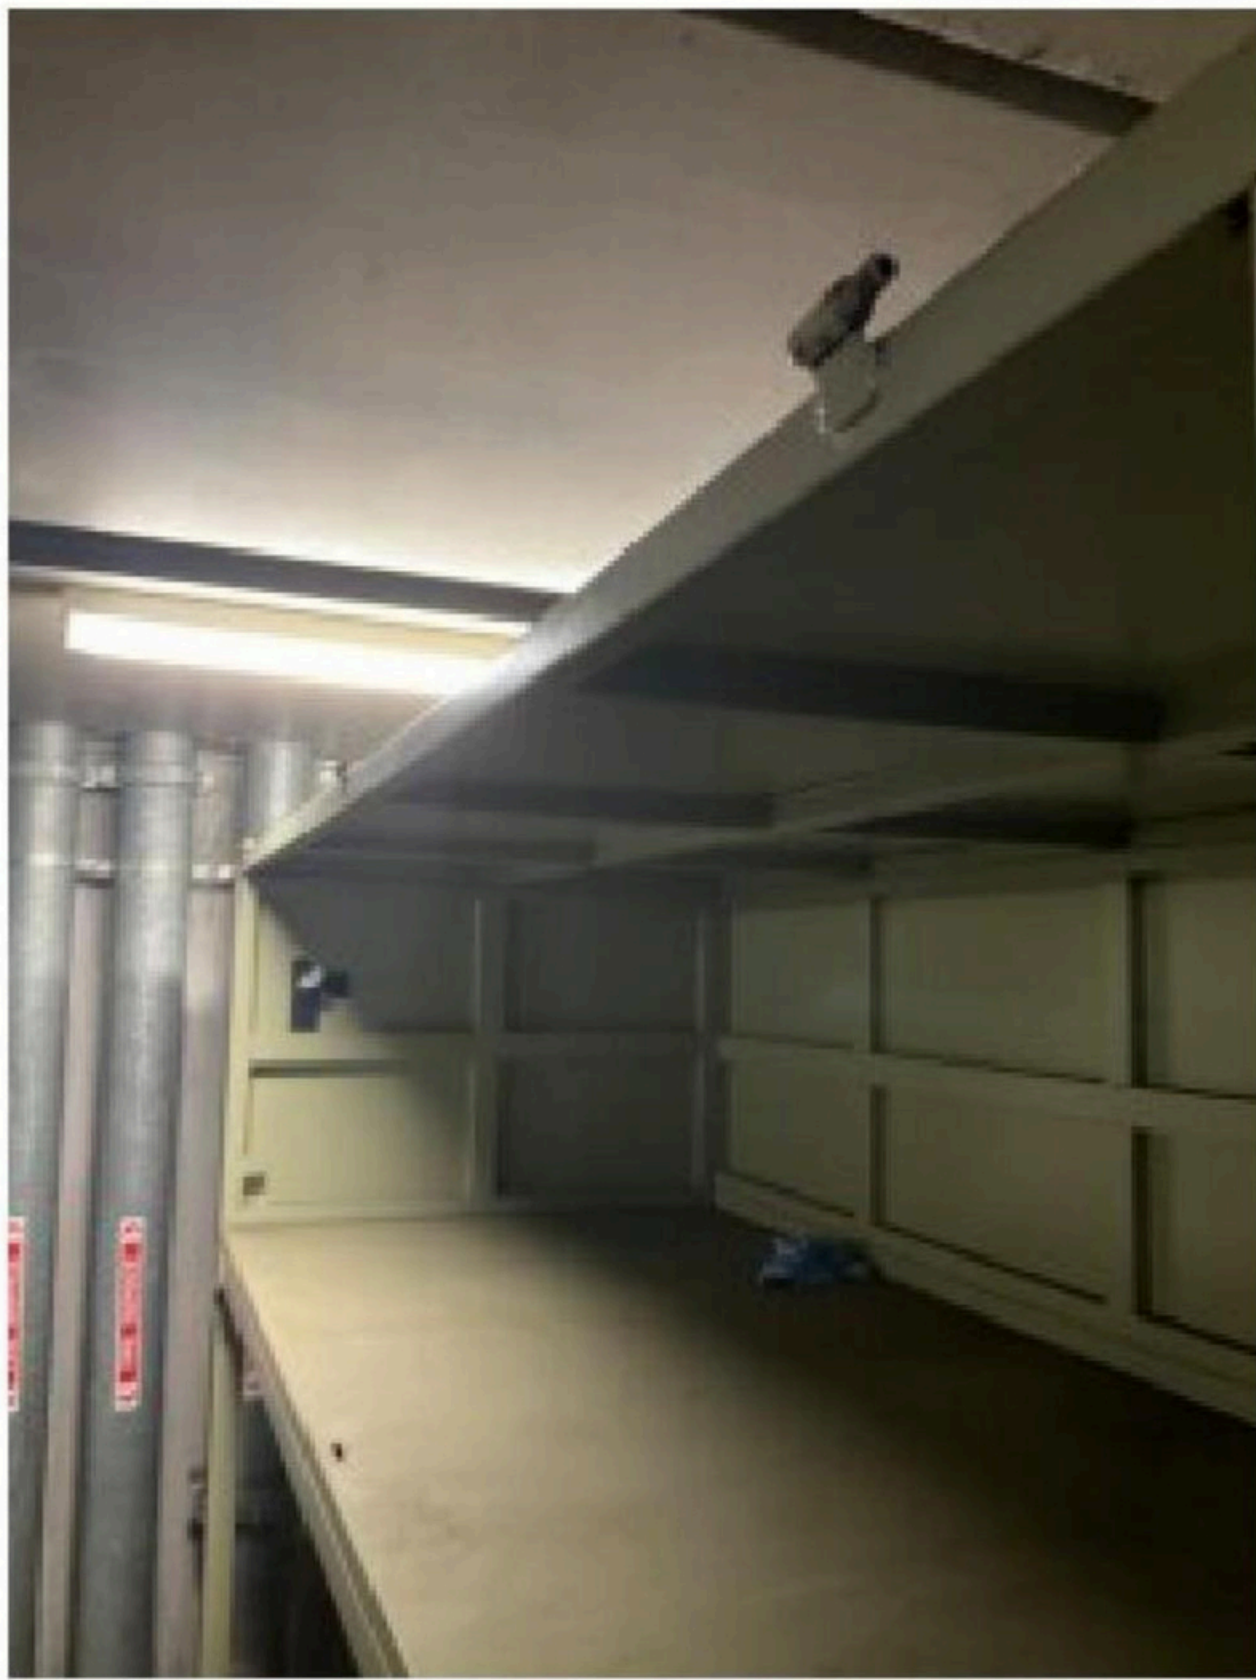
The storage room door in the car park is detached from its hinges. Recommended to repair the components and reattach and ensure it operates correctly and locks securely.
