## Just Inspections

## Building/Property & Timber Pest Inspection

**AS4349.1-2007 & AS4349.3-2010**

| Report Date | 22 Apr 2026 |

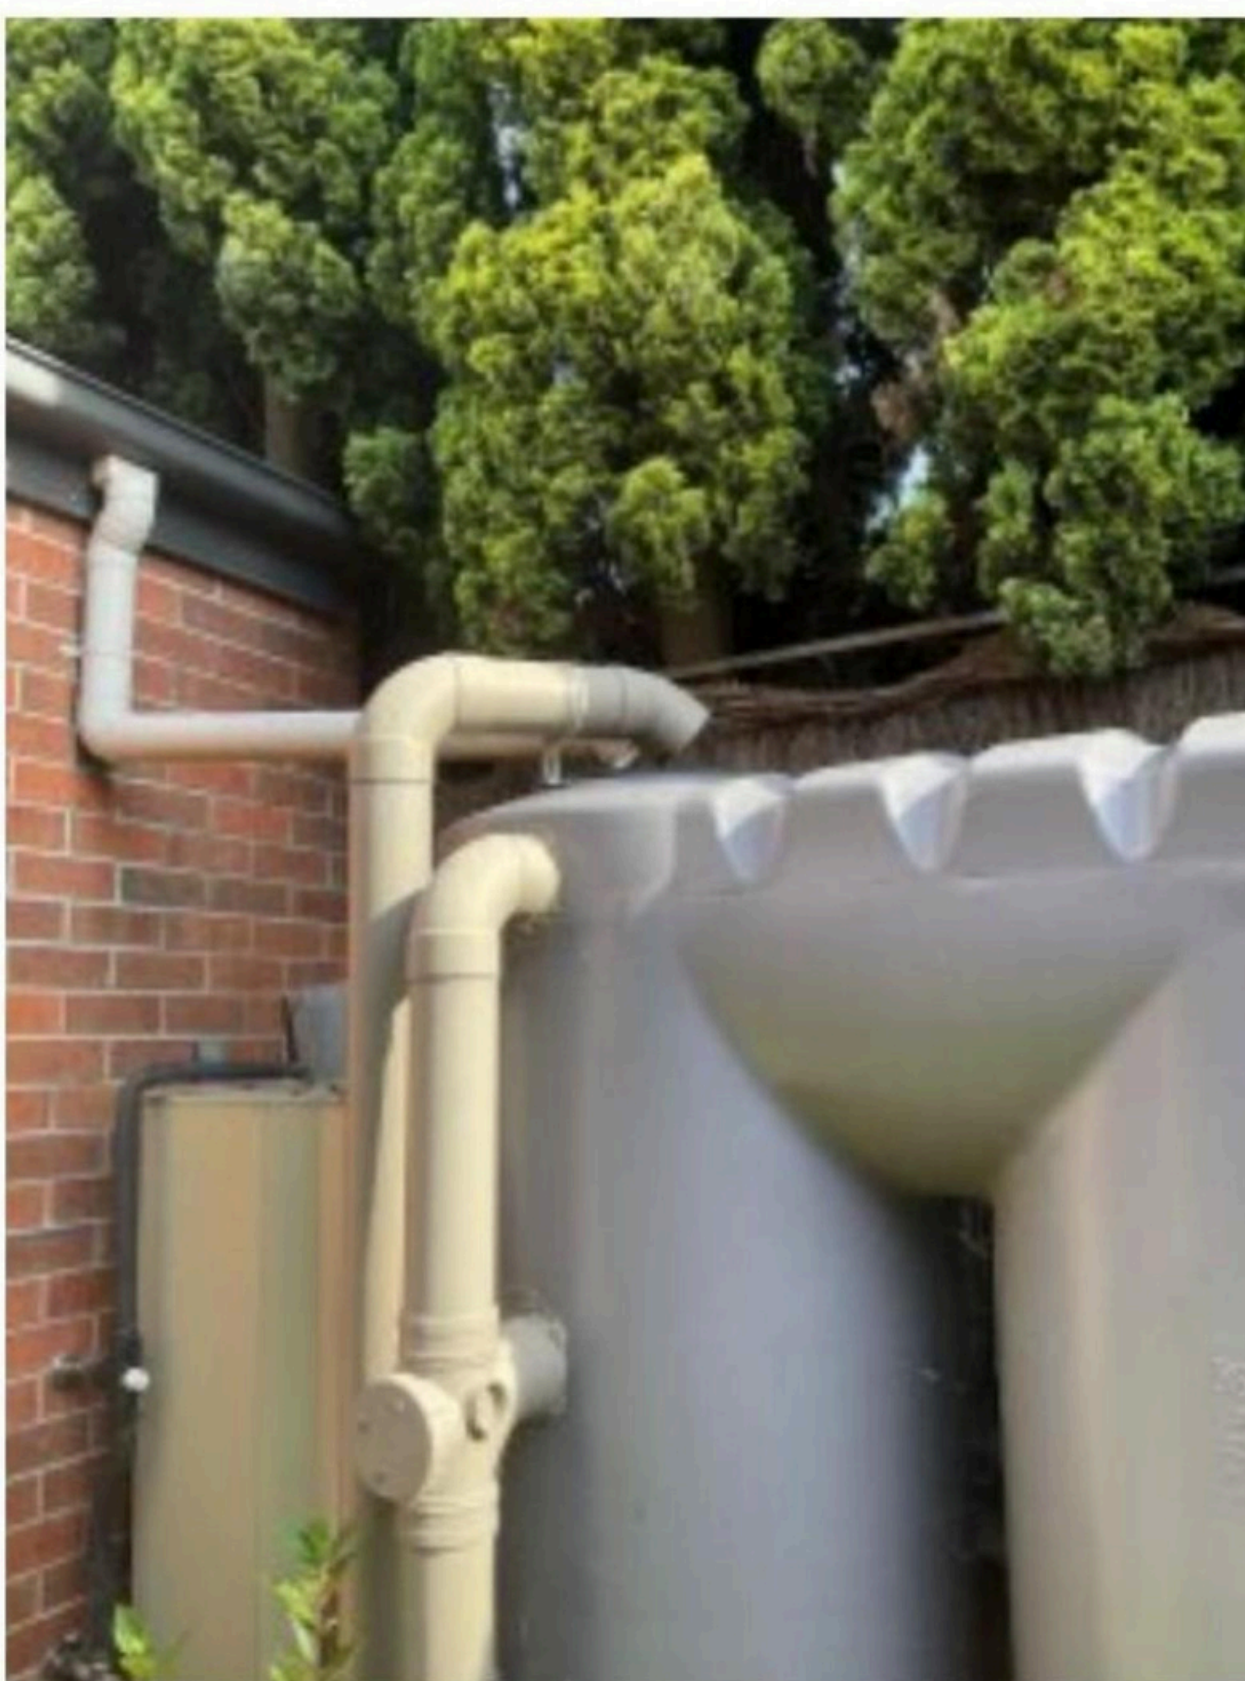
Down pipe connection not connecting directly to the water tank potentially leading to issues with water flow and leaks. It is recommended to assess and rectify by qualified plumber.

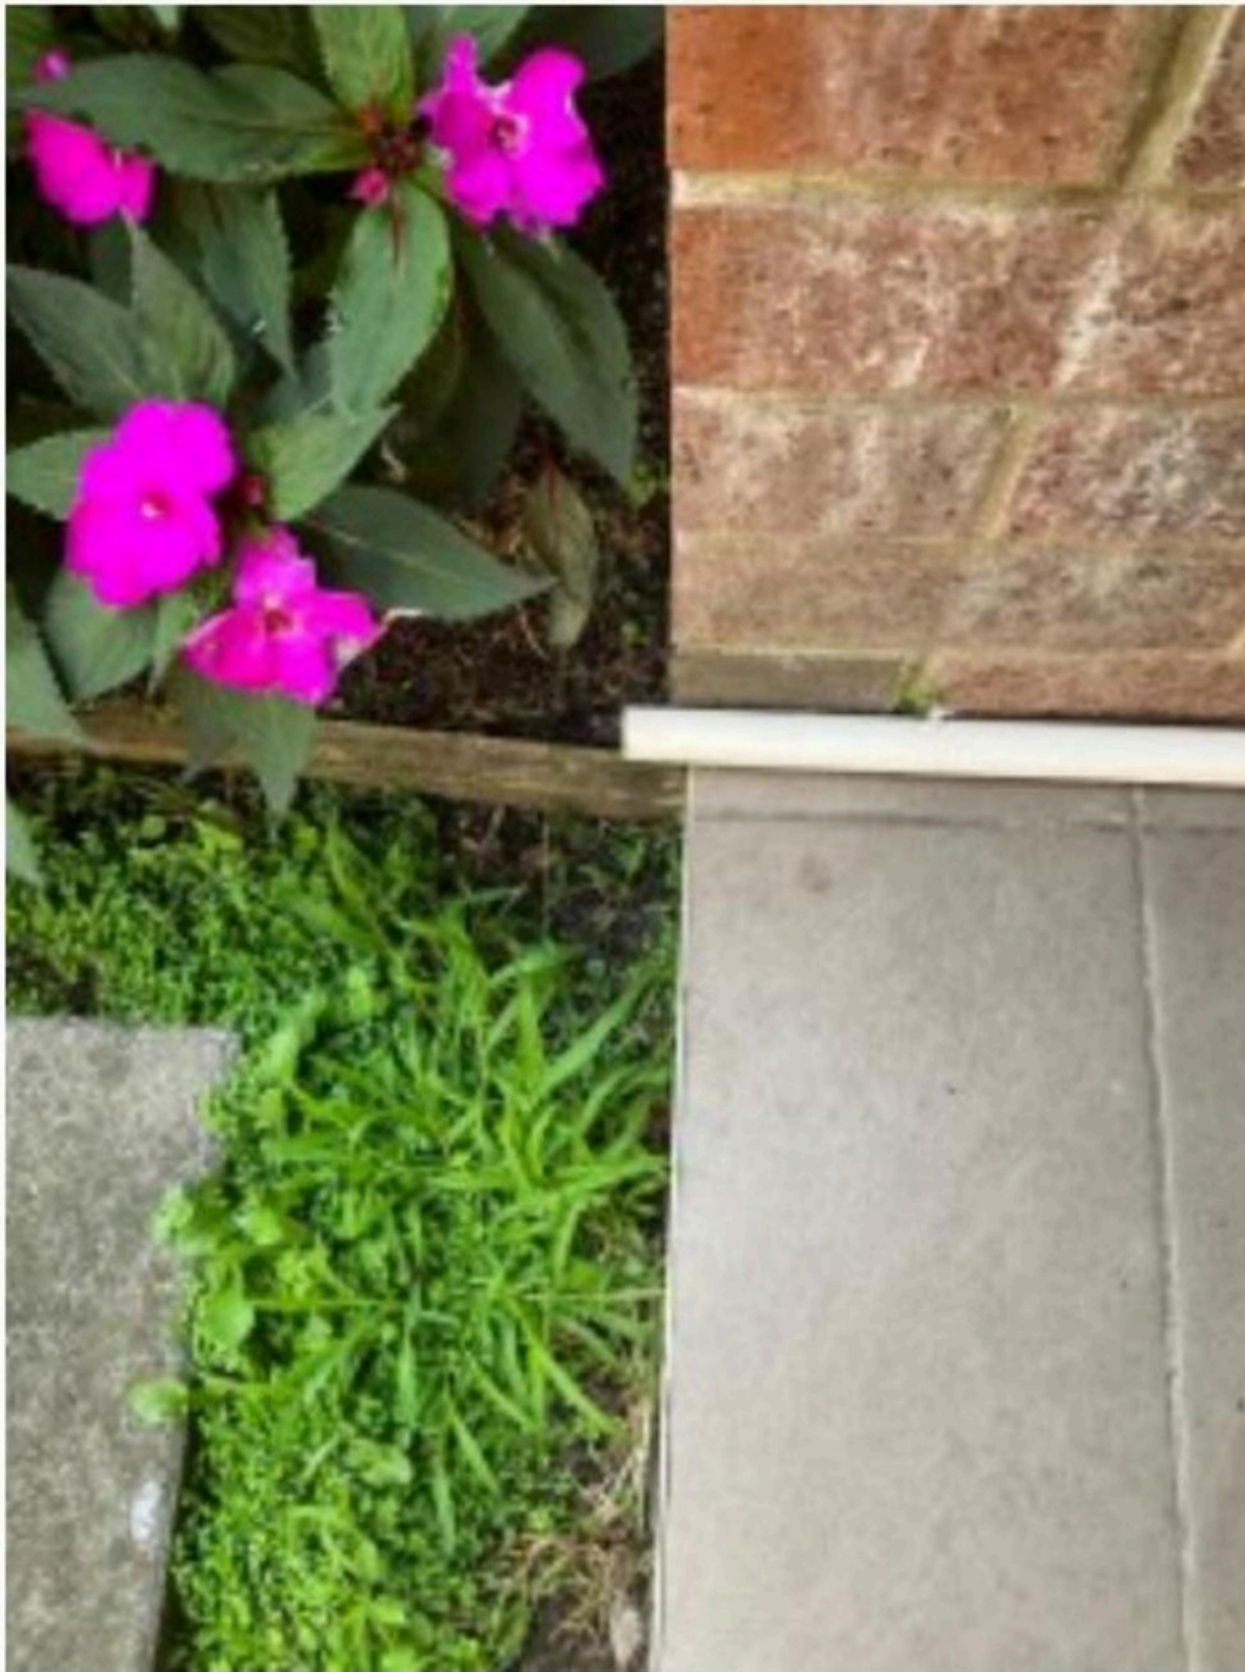
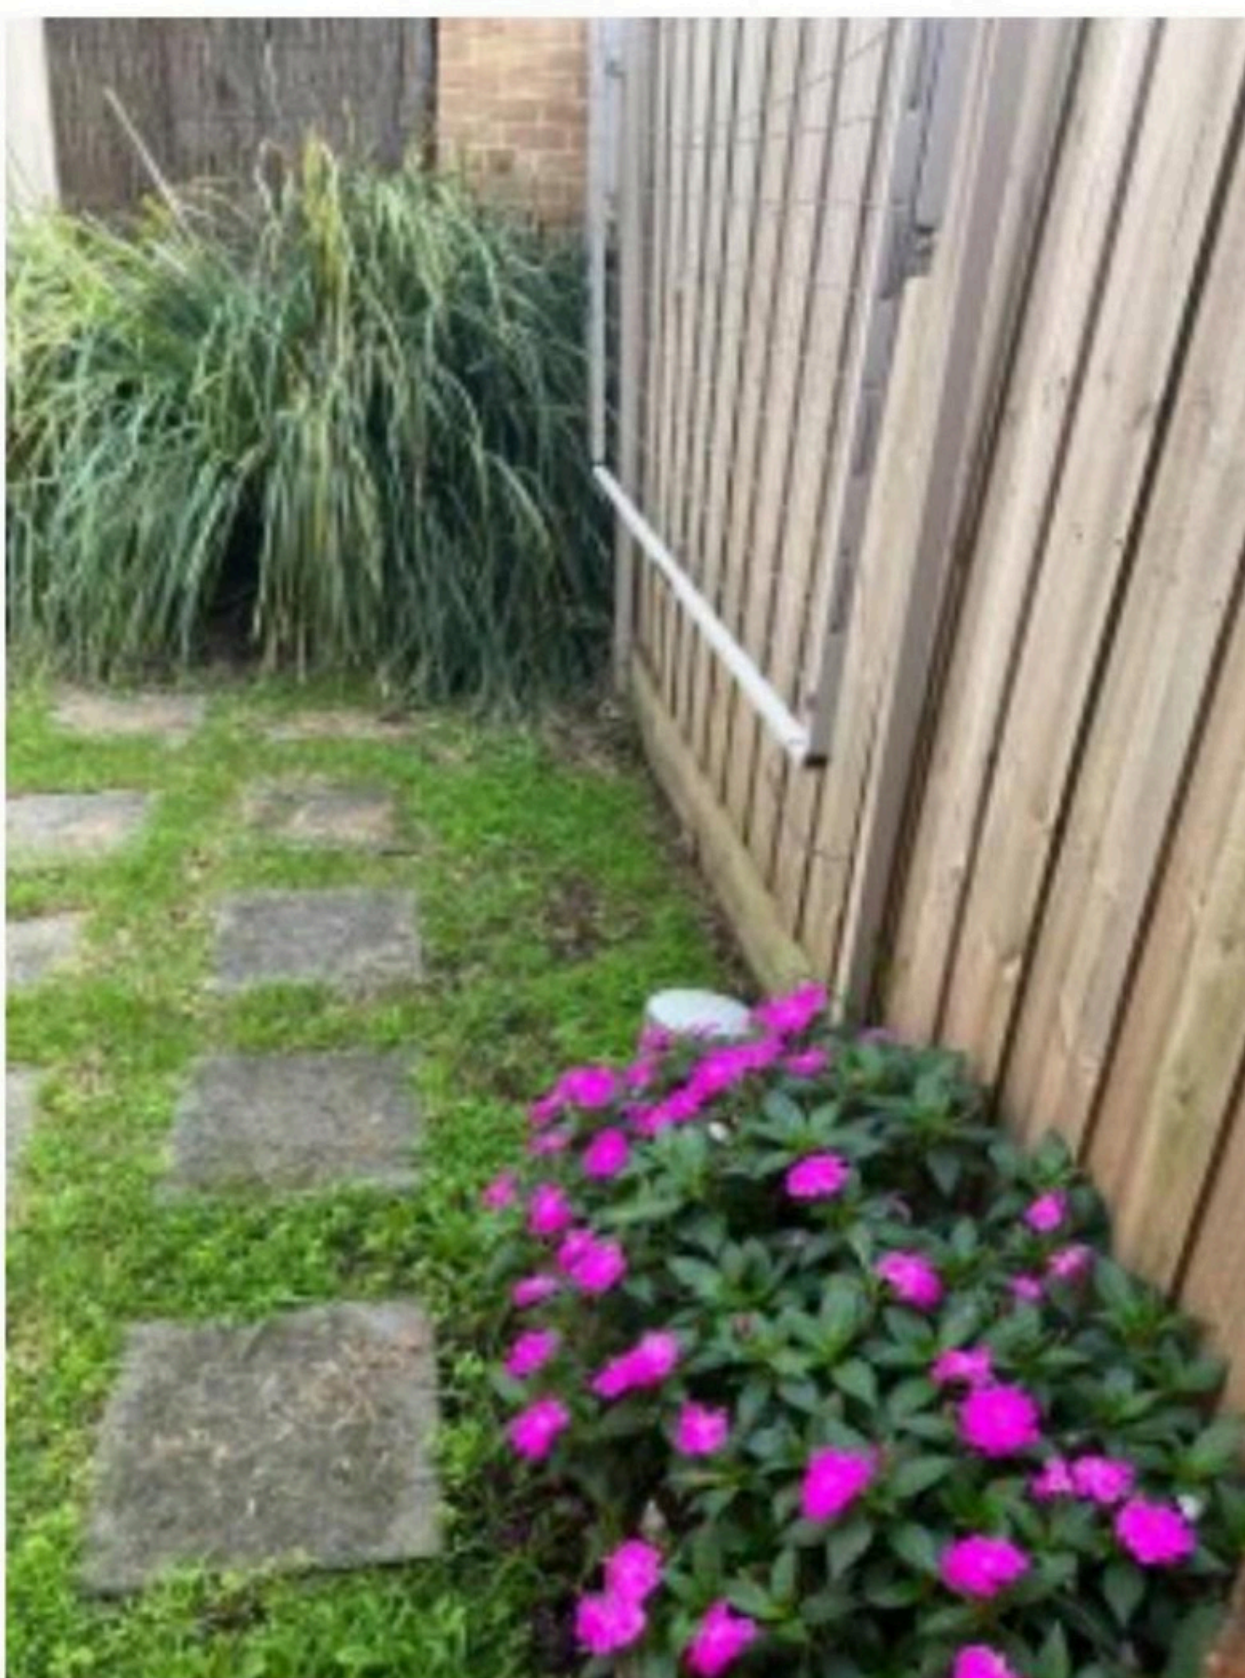
Vegetation is growing against the wall, potentially exacerbating moisture retention and contributing to decay or pest attraction. It is advisable to address these issues by improving drainage and managing vegetation to protect the building from potential damage.

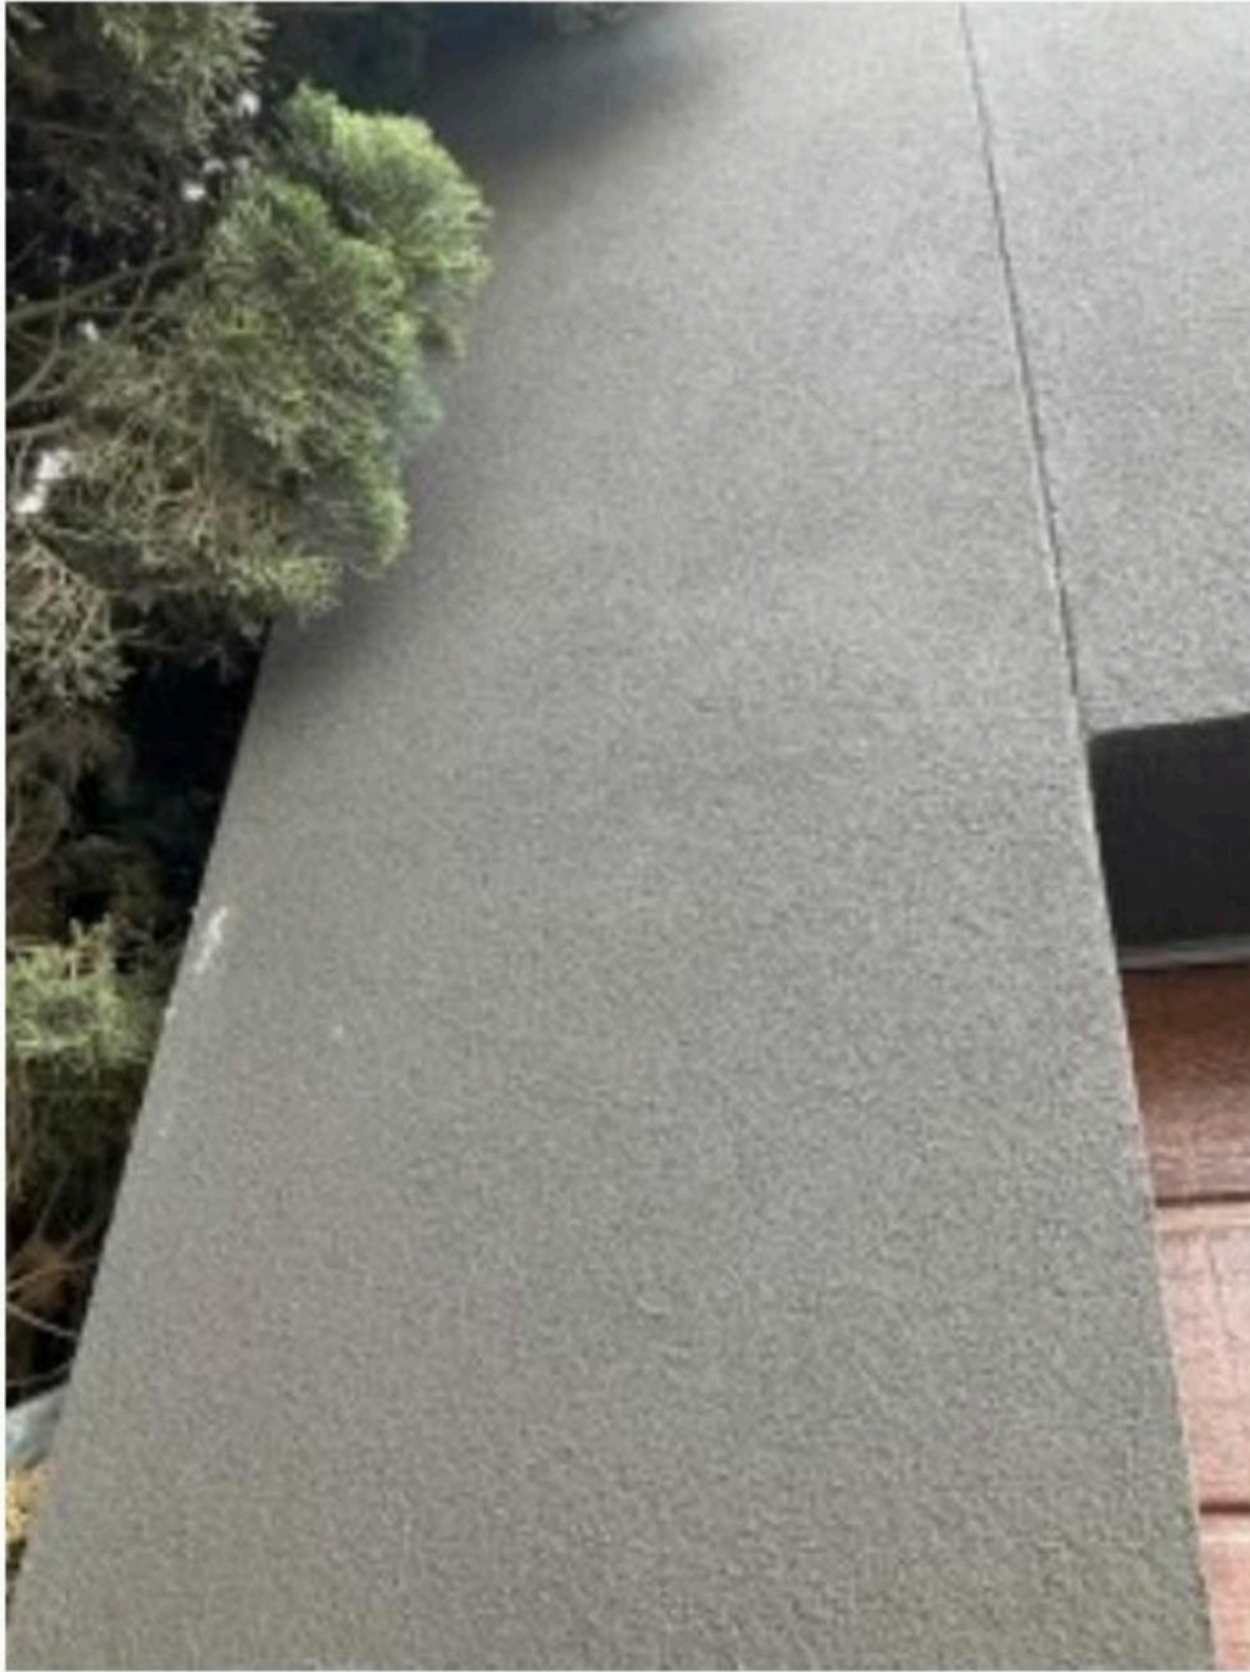
#### **Hairline crack on outside garage wall**

rendered wall surface shows signs of hairline cracking, with an evident horizontal crack and minor diagonal fissures. This issue may indicate underlying movement or stress in the structure, potentially from temperature fluctuations, settling, or moisture intrusion. It is recommended to continue monitoring to determine if there are any significant structural concerns and to prevent potential water ingress or further deterioration. Addressing the cause promptly will help maintain the wall's integrity and prevent escalation of damage.

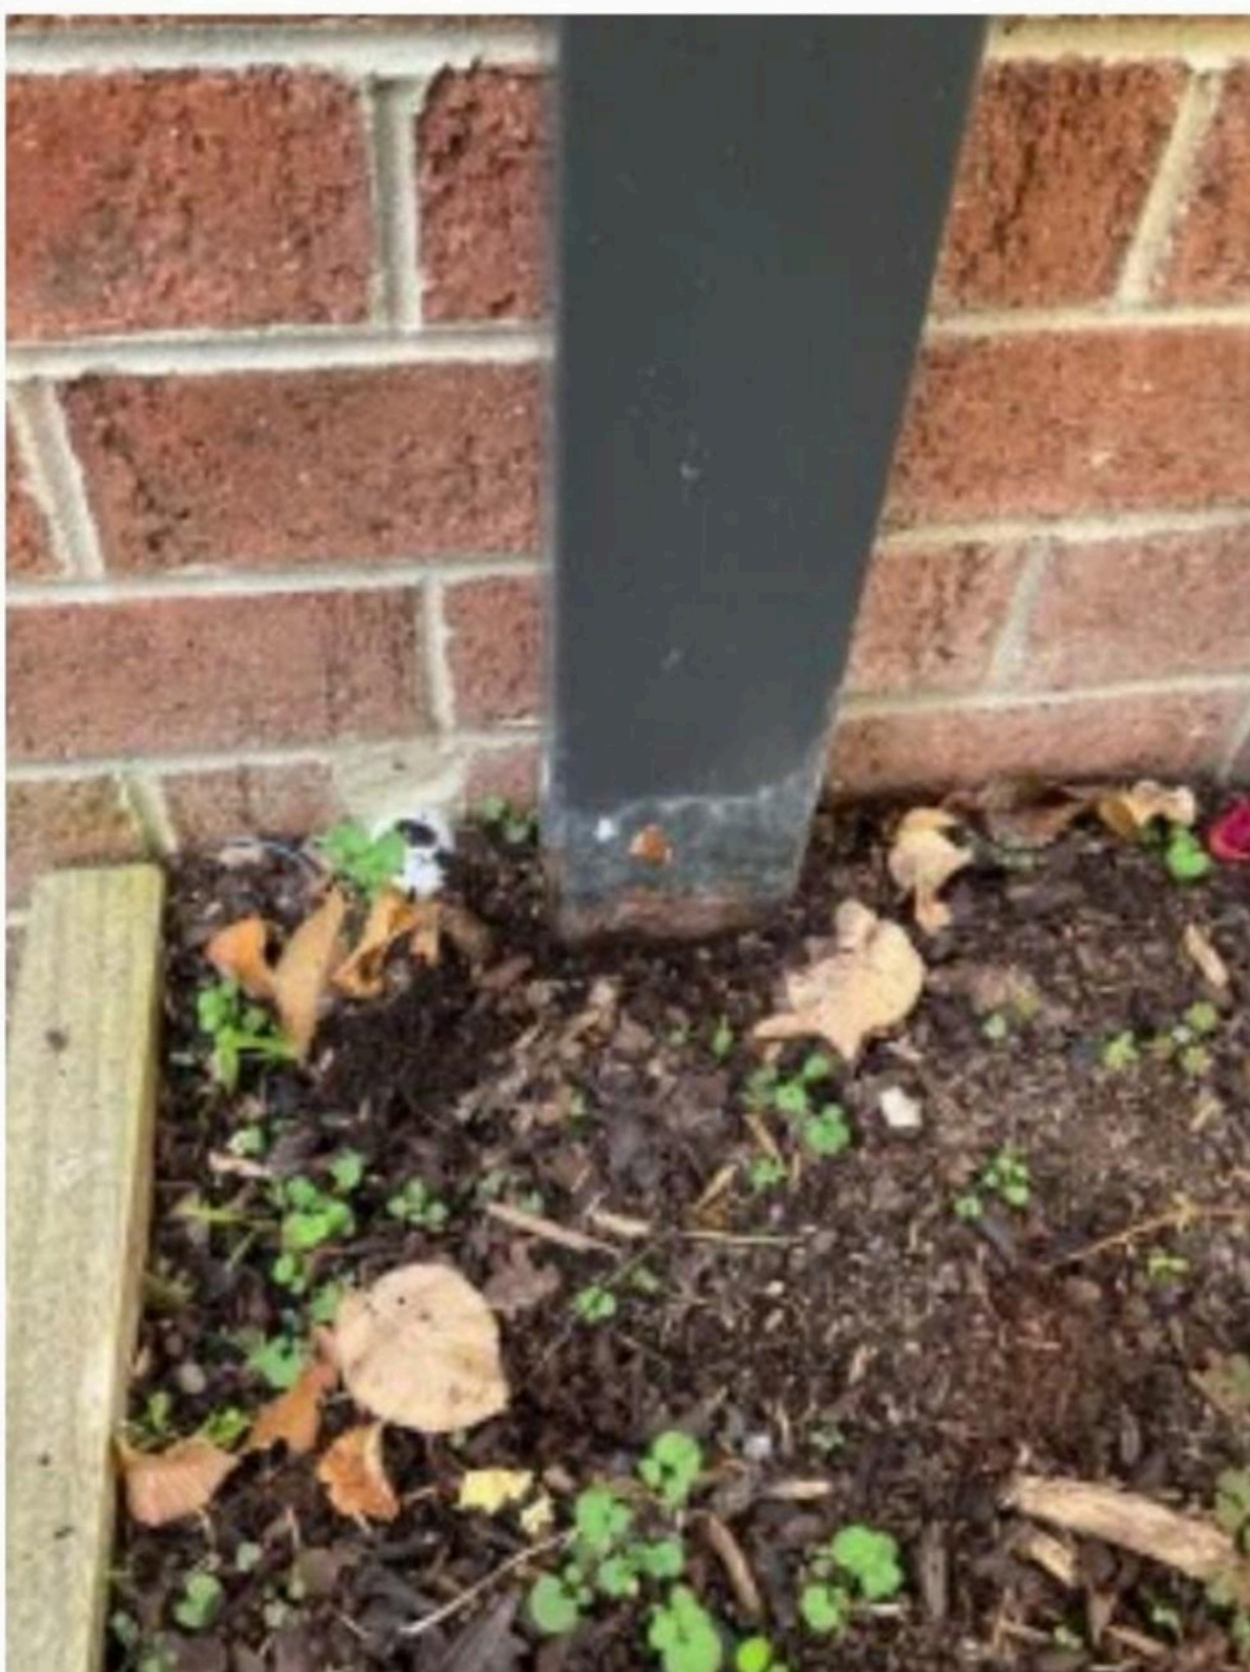
#### **Corroded downpipe at base**

Corrosion at the base of a downpipe in contact with soil. Prolonged exposure to moisture can exacerbate the leakage risk. It is recommended that the affected area be treated through rust removal and protective coating.

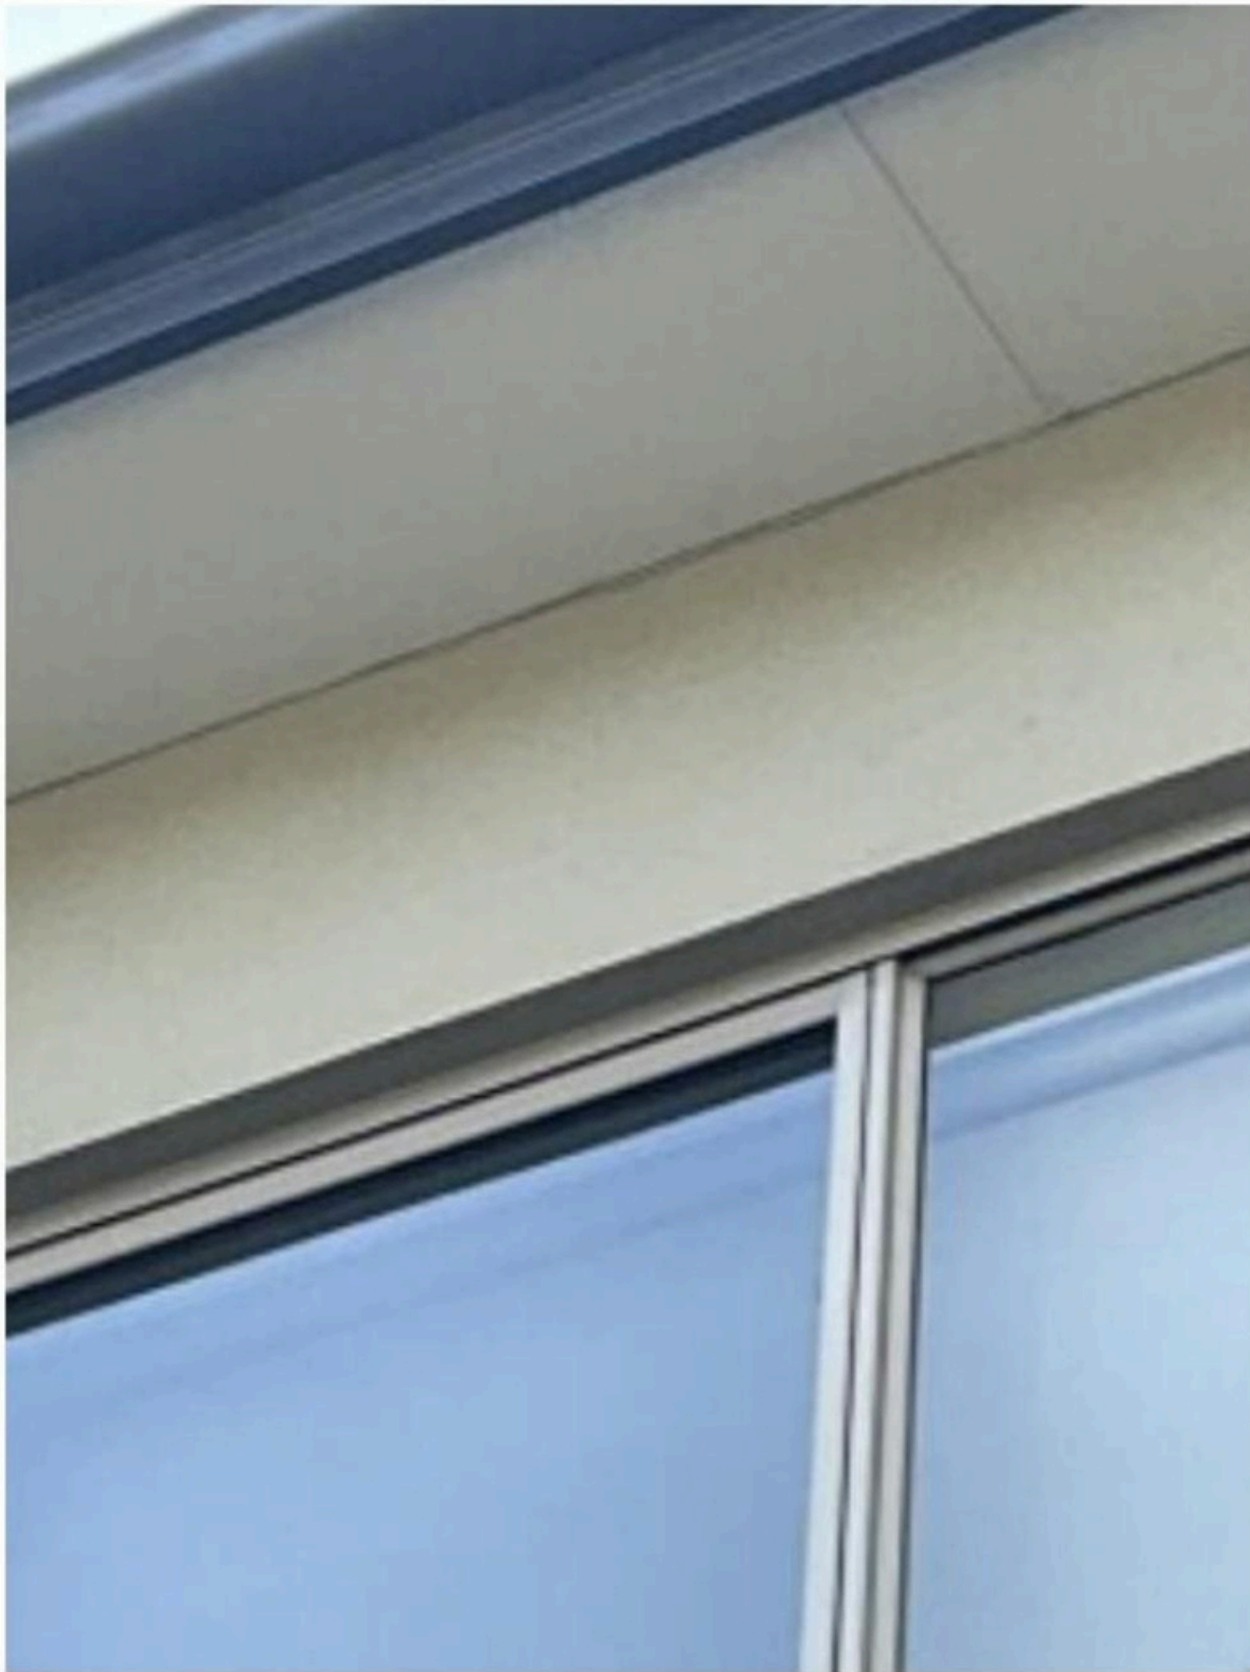
**Hairline crack between adjoining rendered wall and eaves**

Regular monitoring and potential repair work may be necessary to prevent further damage.

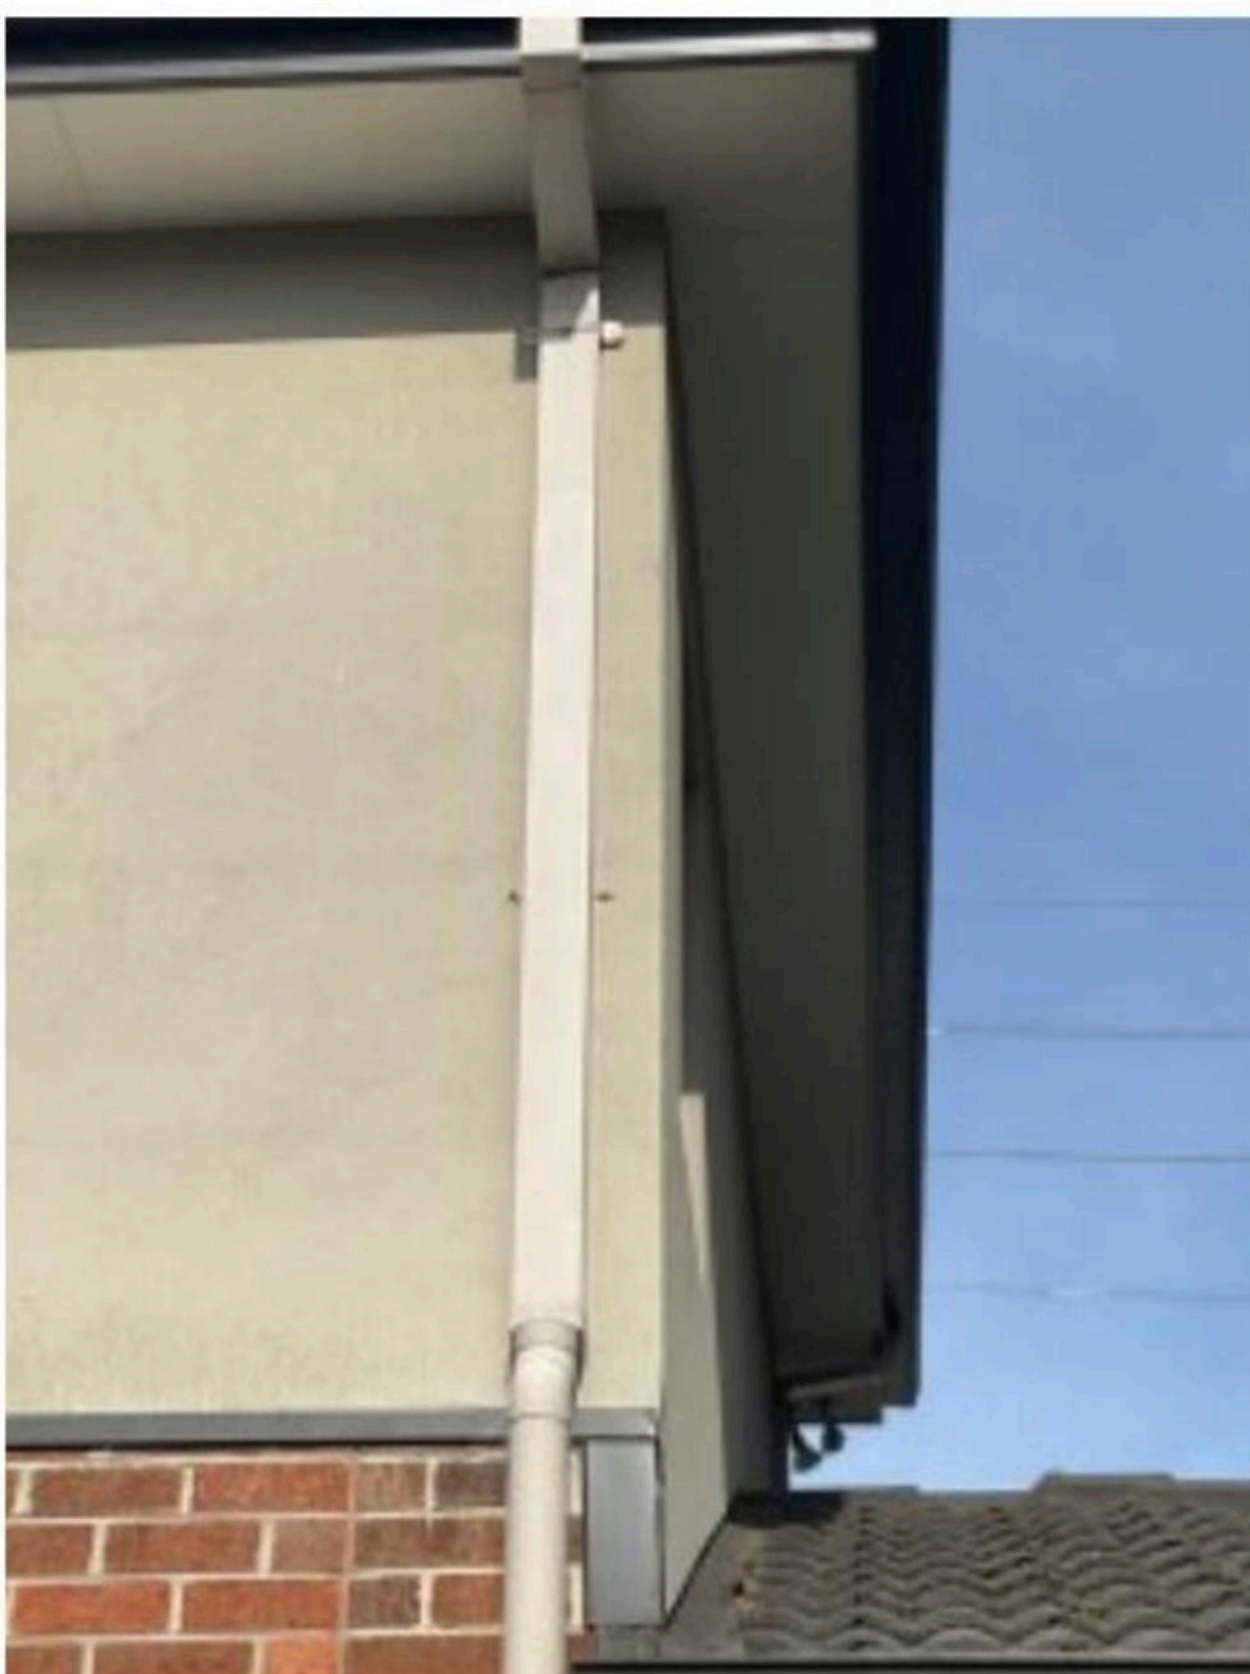
**Inadequate fastening**

The downpipe exhibits signs of inadequate fastening, with several missing or improperly secured screws. It is recommended to refasten the downpipe with appropriate fixtures, reducing the risk of damage and maintaining proper water drainage.

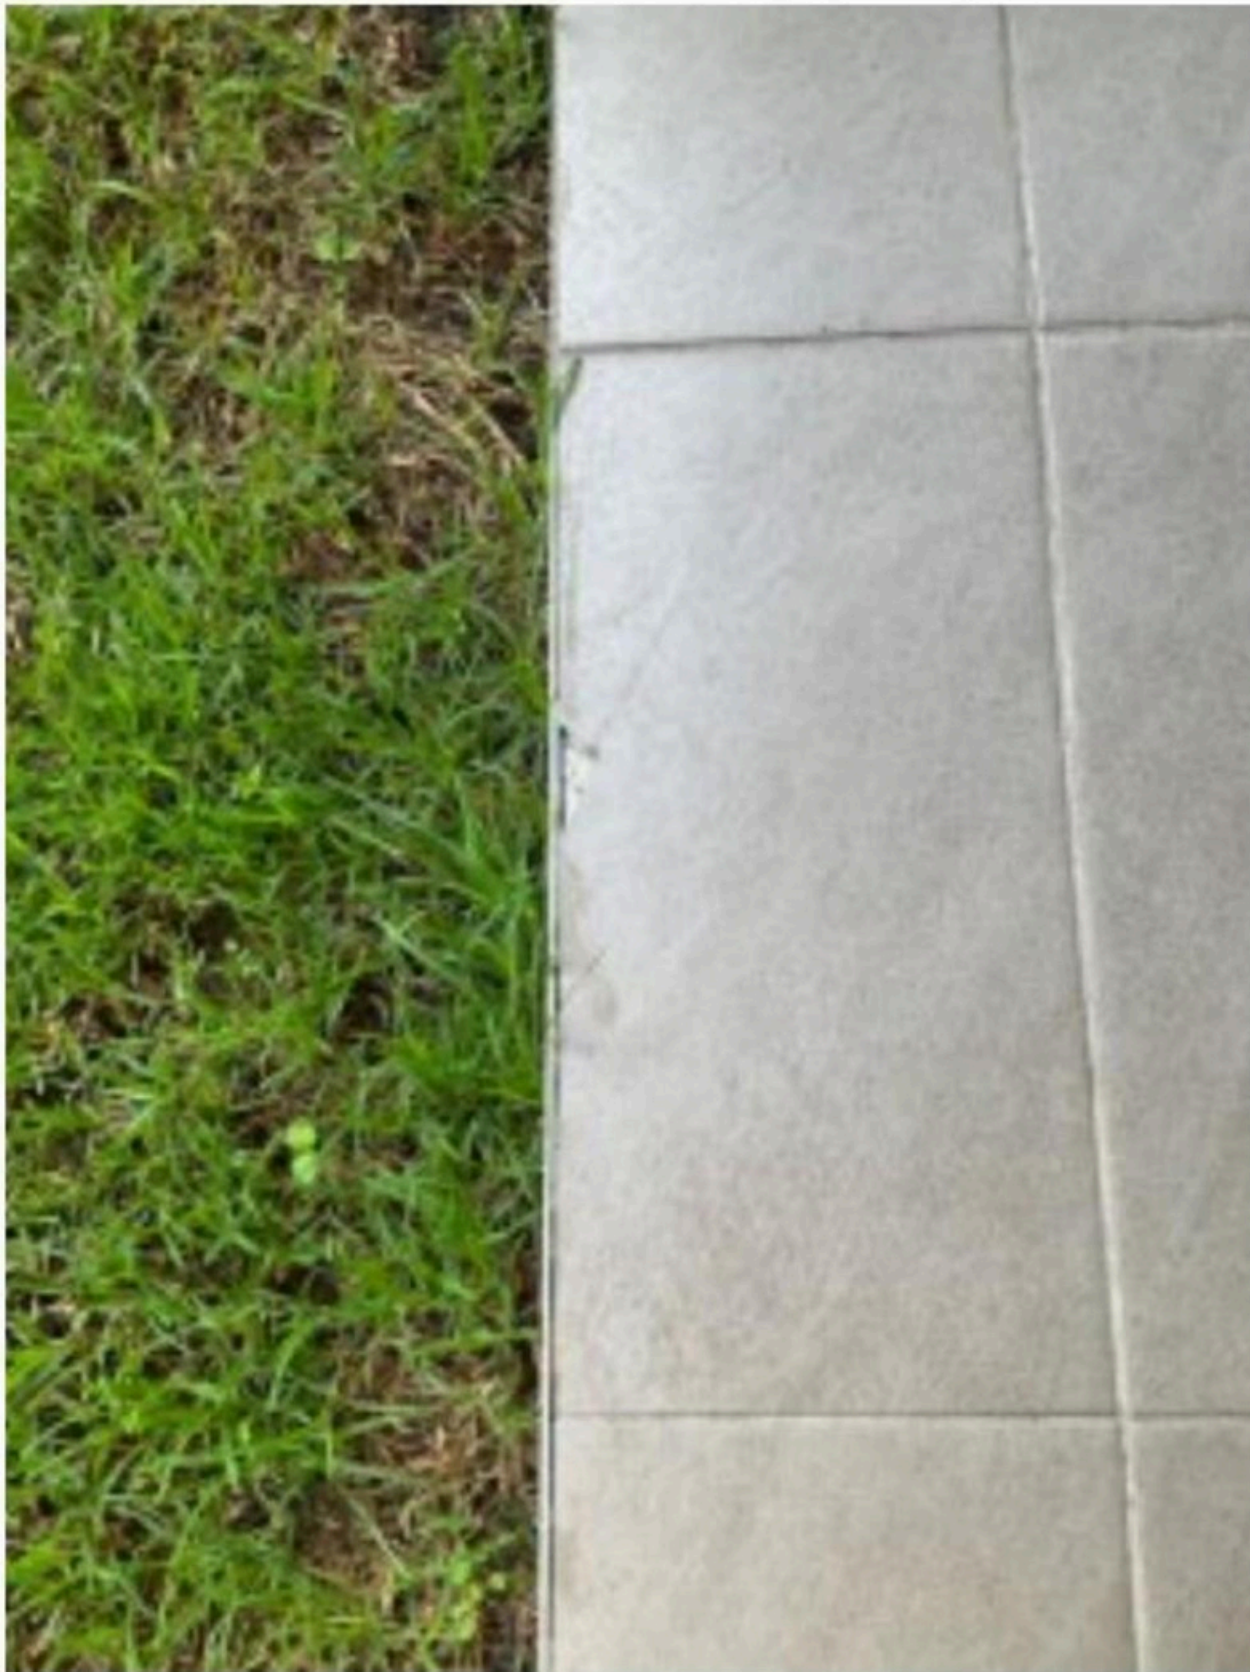
**Broken floor tile**

The inspection reveals a chipped corner in one of the exterior tiles. This defect exposes the underlying material, which may lead to further deterioration if not addressed. The damaged area could potentially allow water ingress, increasing the risk of further damage over time. Repair is recommended to maintain the durability and aesthetic appeal of the tiling.

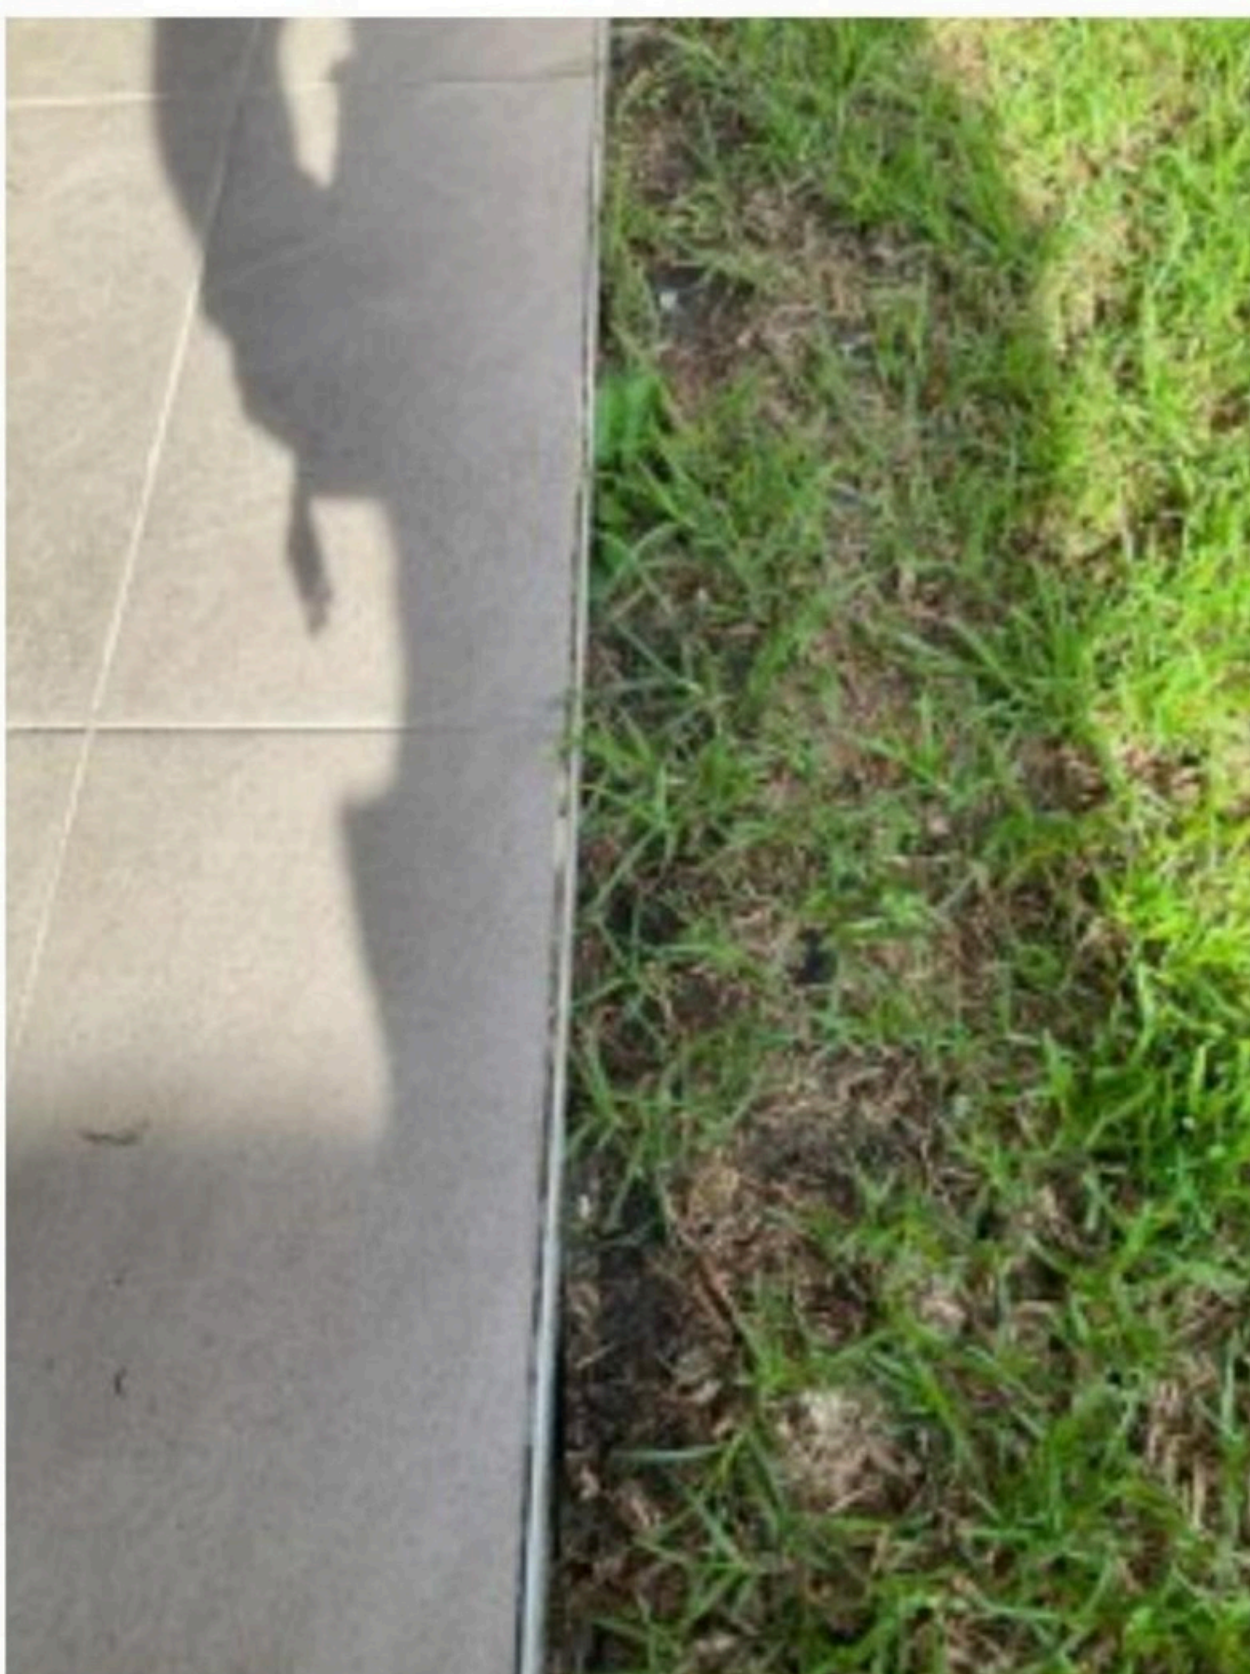
The inspection revealed that several outdoor tiles exhibit inadequate joint fill, creating visible gaps that might allow water to penetrate beneath the tiles. This could potentially lead to loosening of the tiles or water pooling. It's recommended that these joints are properly sealed to prevent potential moisture damage and ensure durability of the tiling installation. Proper sealing would also help maintain the structural integrity and aesthetics of the area.

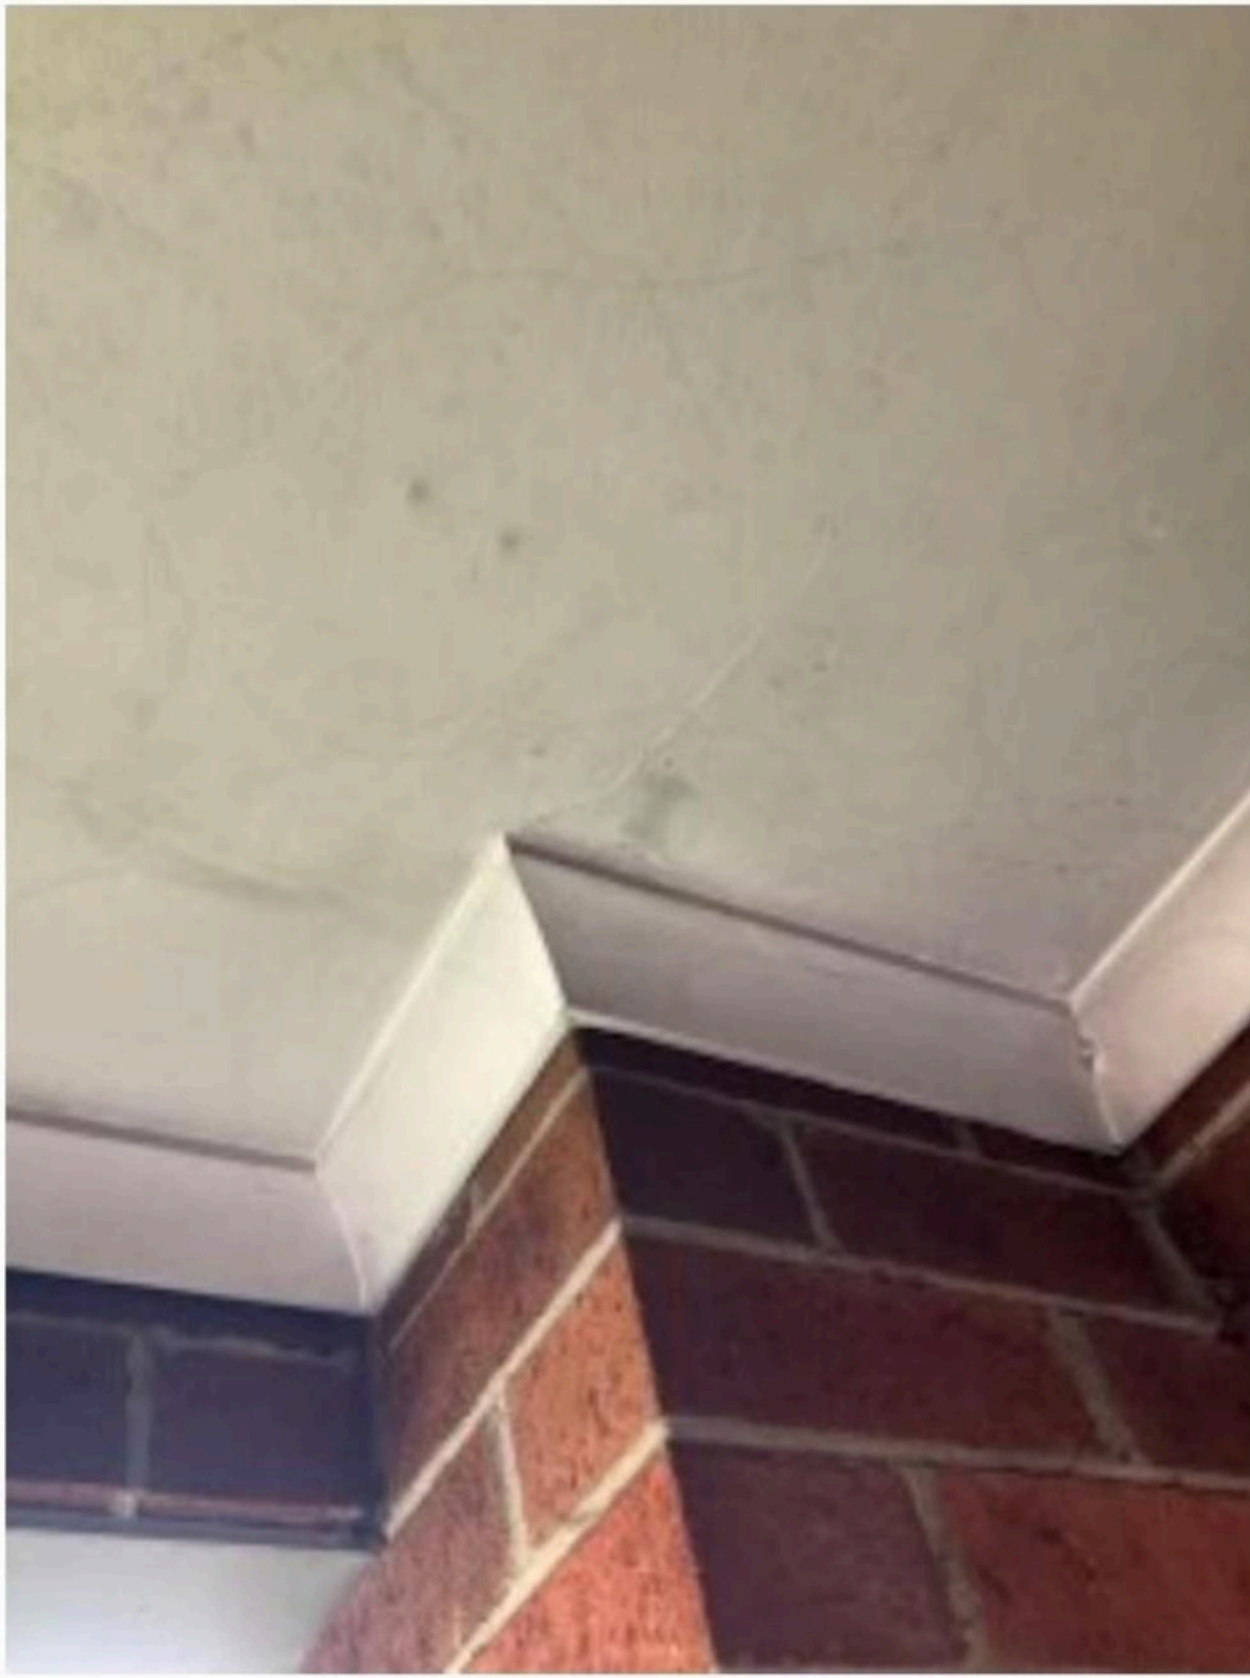
**Hairline crack on eaves porch area**

A noticeable crack along the interior ceiling. This defect suggests possible structural movement or settling over time. Regular monitoring and potential repair work may be necessary to prevent further damage.
