## Just Inspections

## Building/Property & Timber Pest Inspection

**AS4349.1-2007 & AS4349.3-2010**

| Report Date | 22 Apr 2026 |

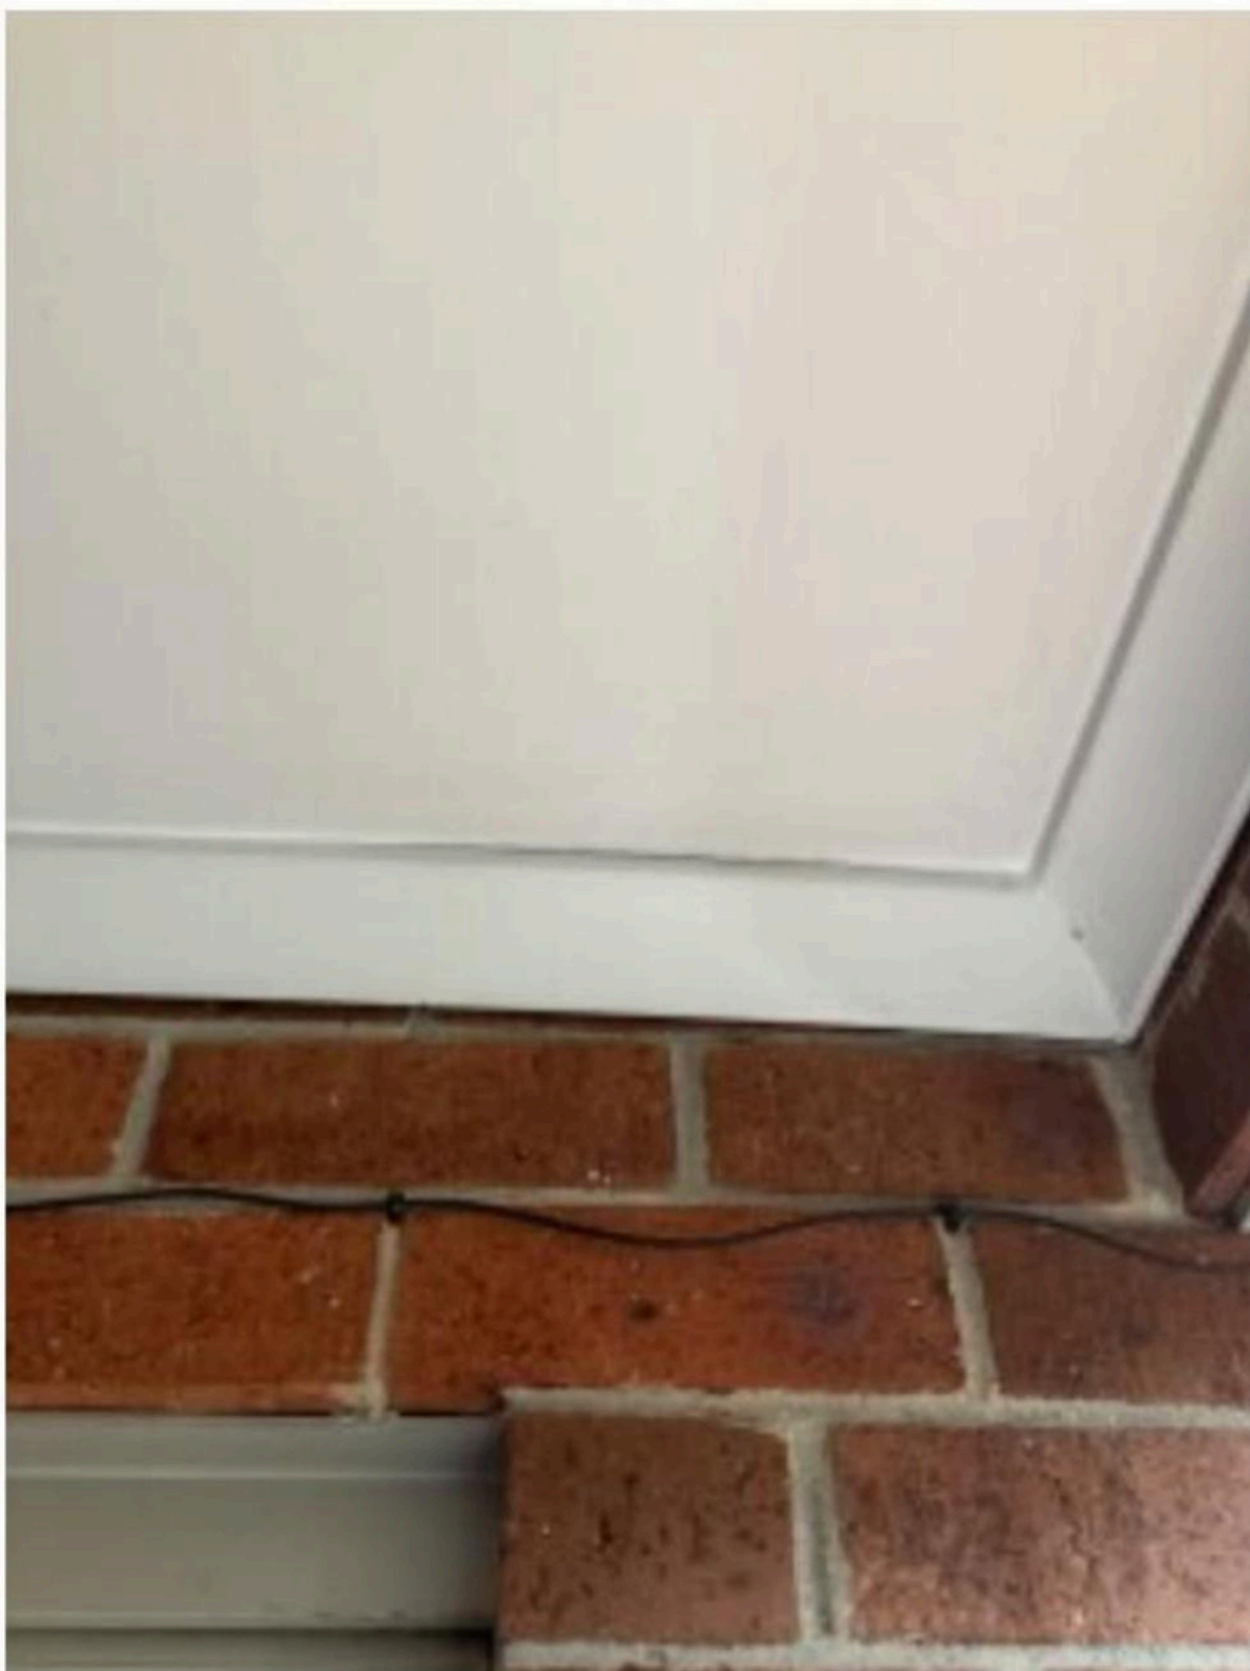
Hairline crack on corner between ceiling and cornice this defect suggests possible movement over time. Regular monitoring and potential repair work may be necessary to prevent further damage.

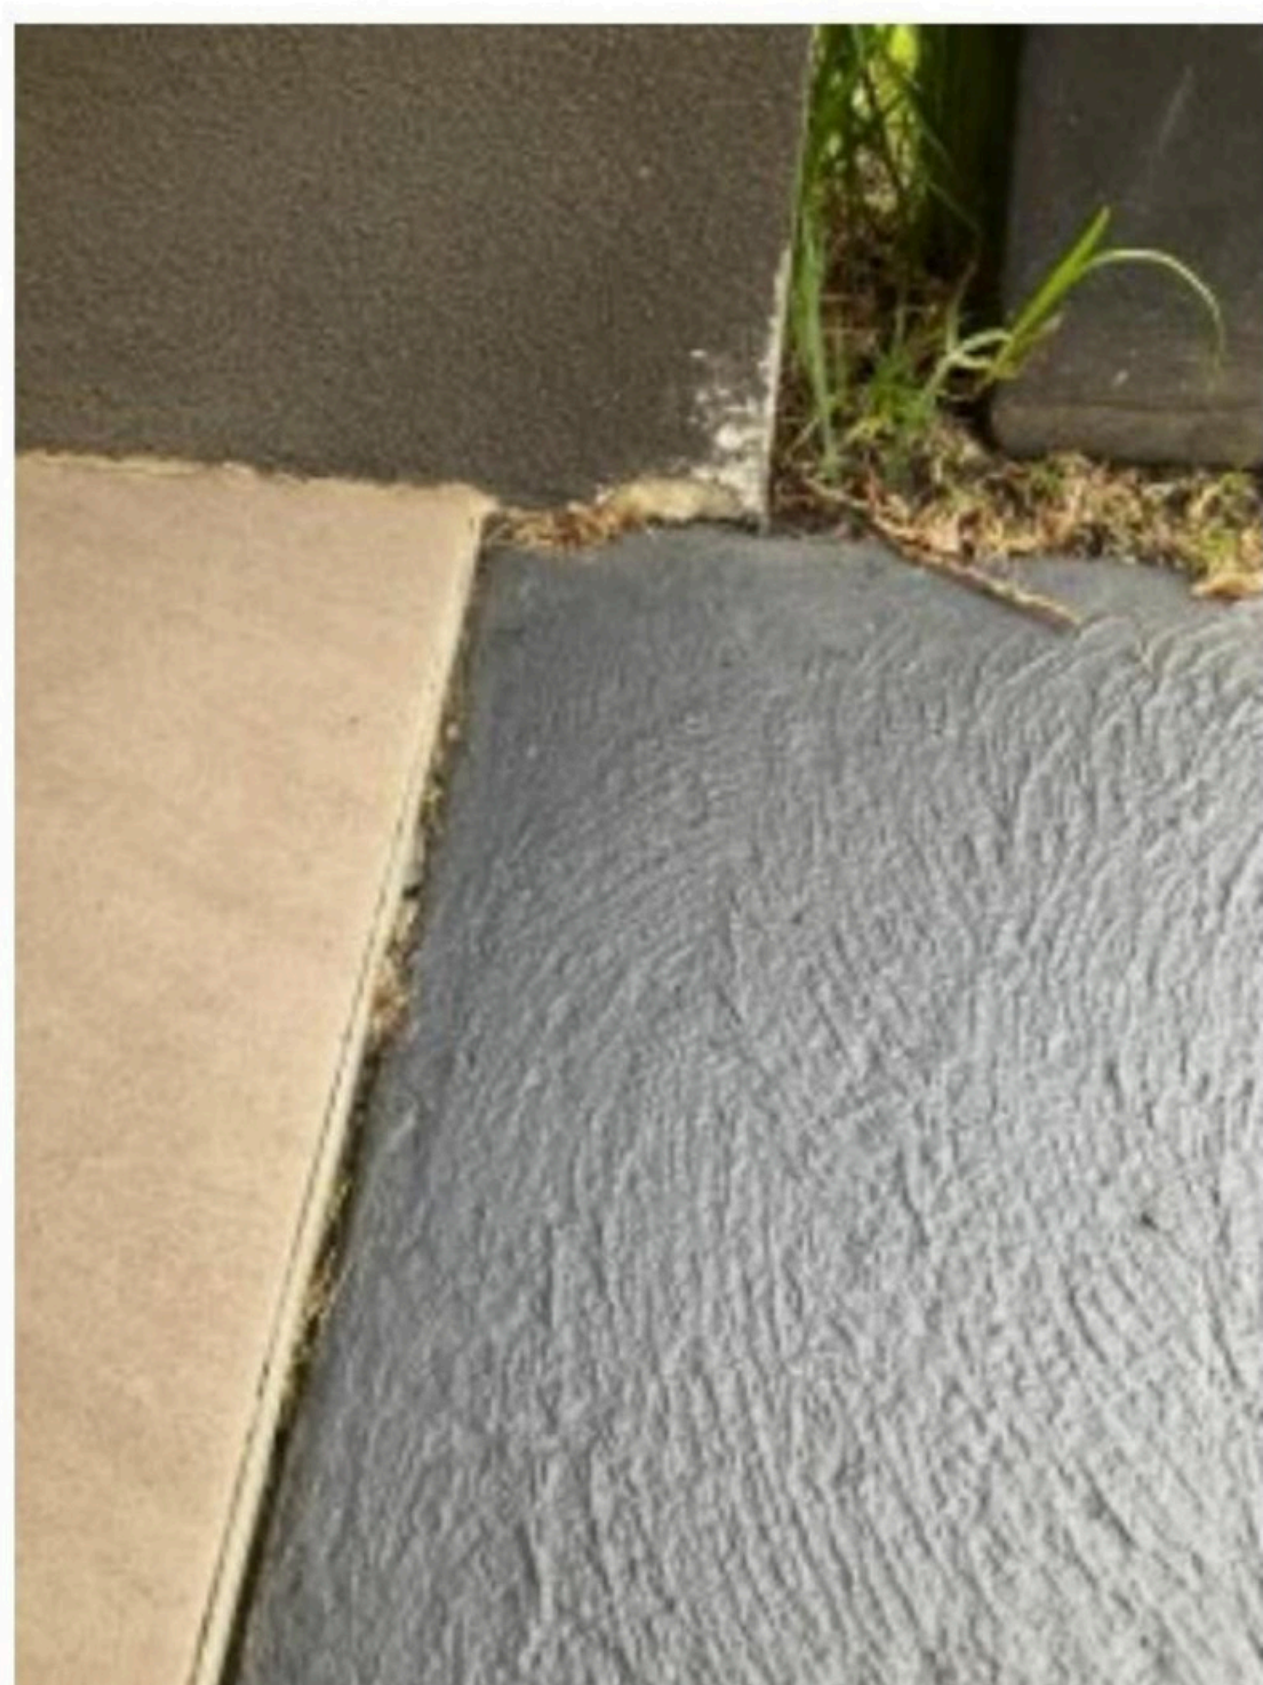
Chip at the bottom of rendered wall and a gap likely resulting from wear and tear, ground movement or settling over time. Repair by tradesman.

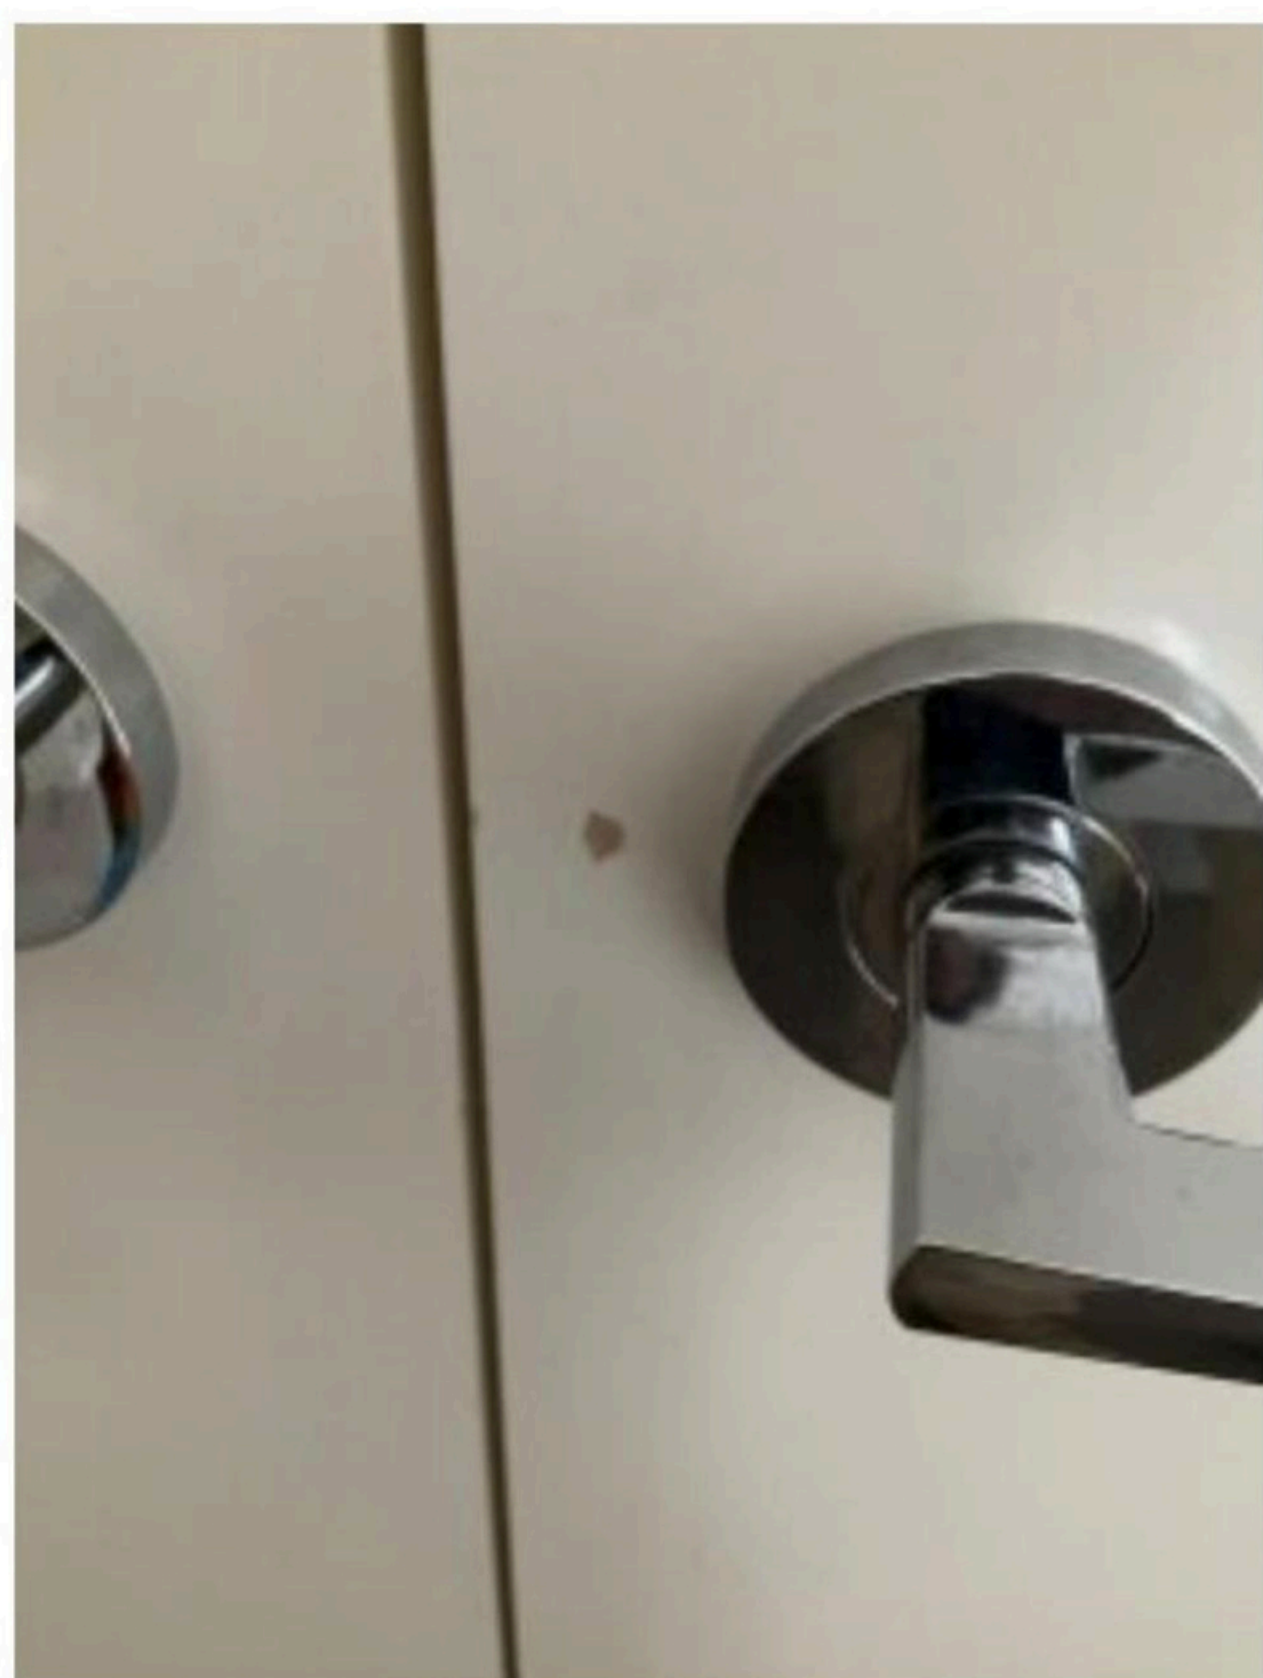
Bedroom

Minor damage to bedroom door. Handyman can repair.

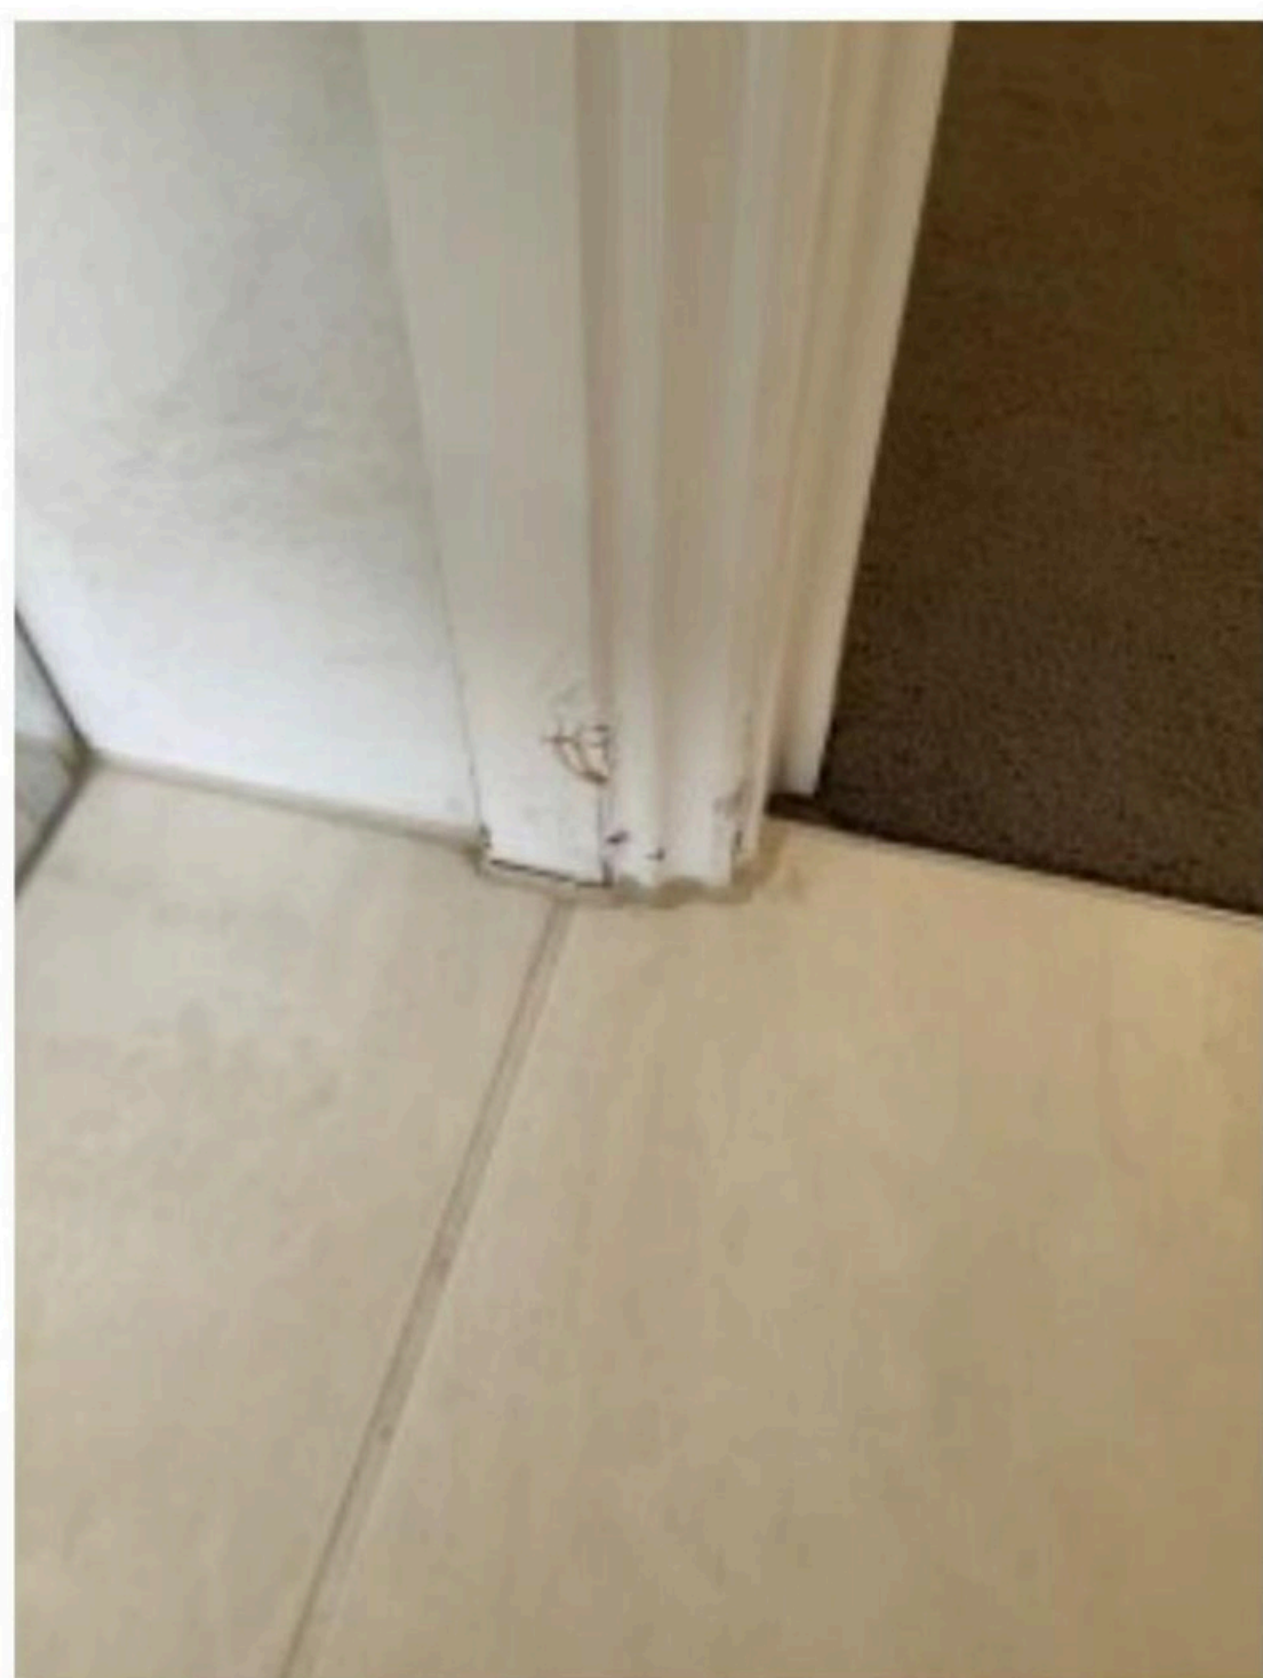
Bathroom

The door frame shows visible signs of damage, with peeling paint and a section of chipped wood at the base. This may be the result of wear and tear or potential water exposure. It is recommended to assess the extent of the damage and carry out necessary repairs to maintain. Regular maintenance and sealing may prevent further deterioration in the future.

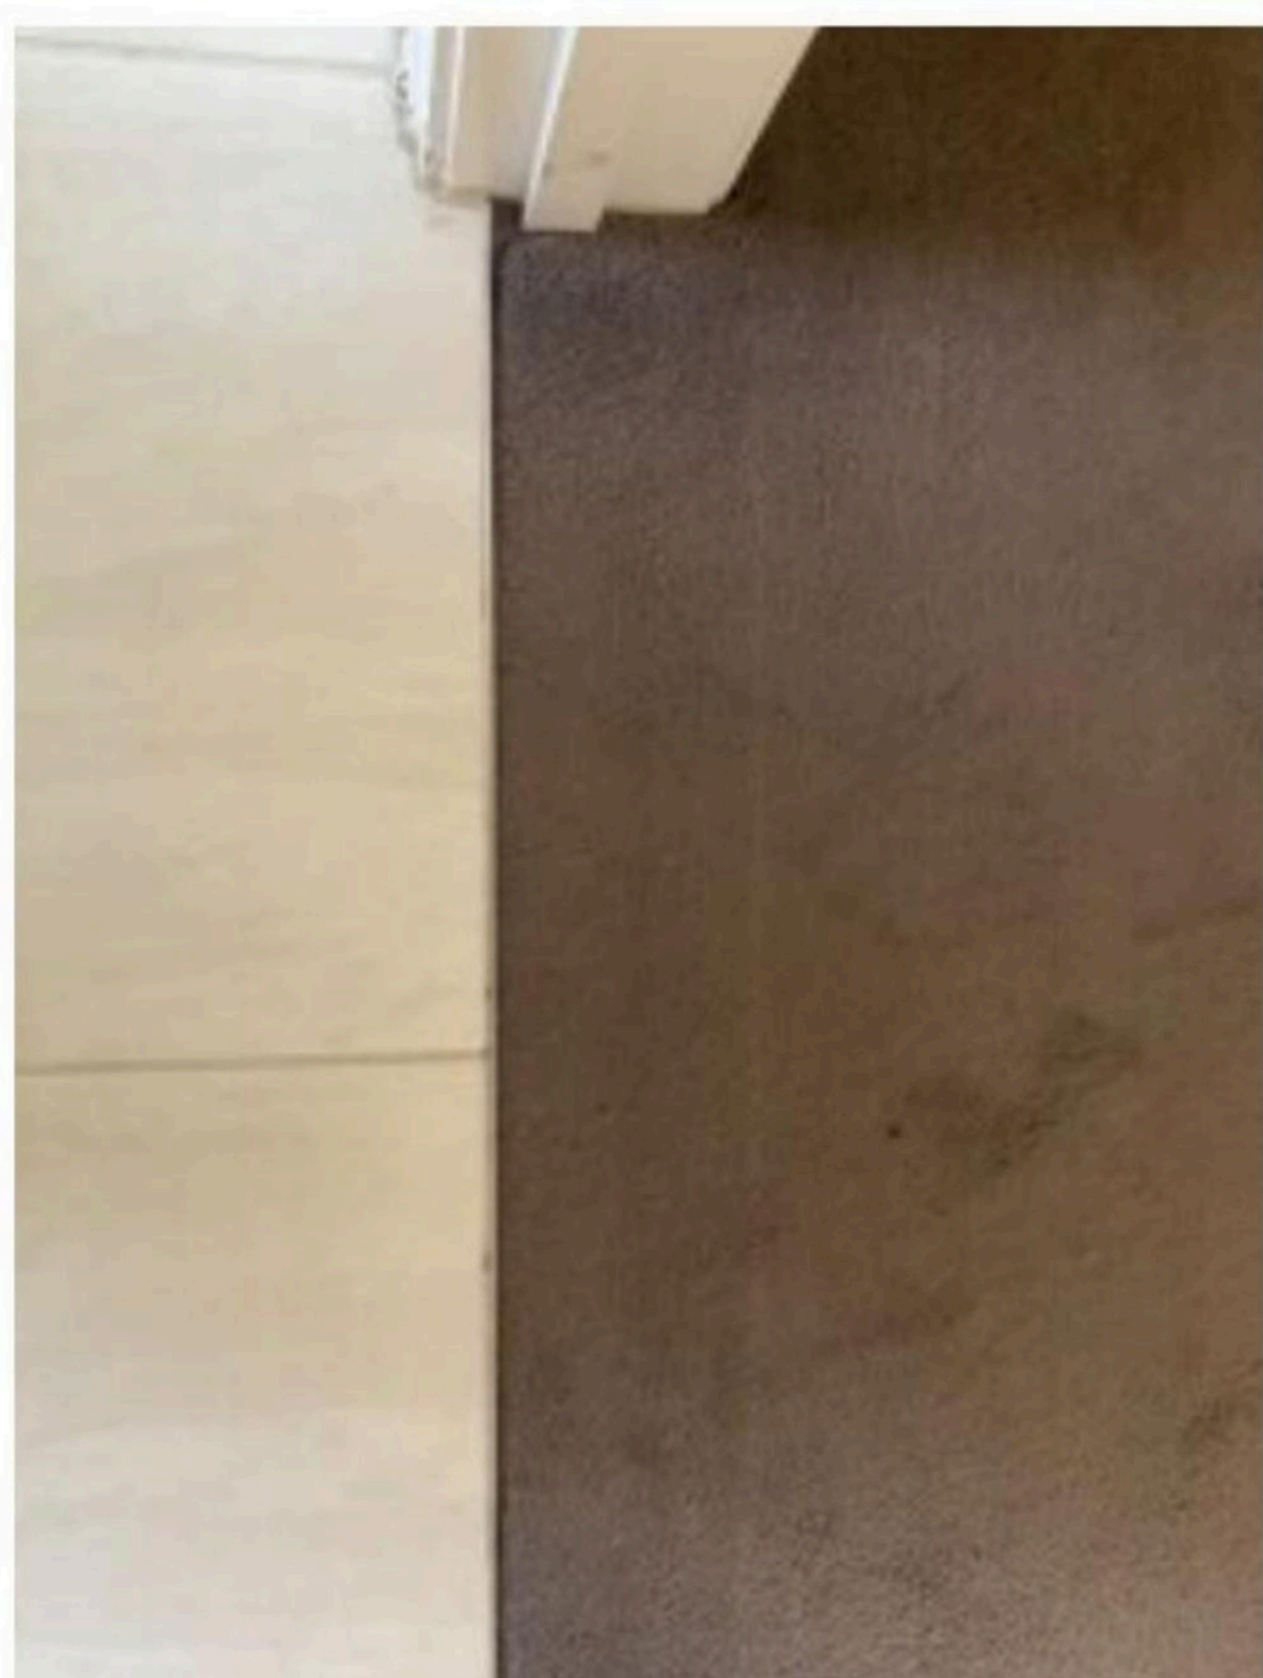
Missing grout this may lead to potential water ingress and compromise the integrity of the surrounding tiles. It is recommended to re grout to prevent further damage and ensure the longevity and stability of the floor surface in this area.

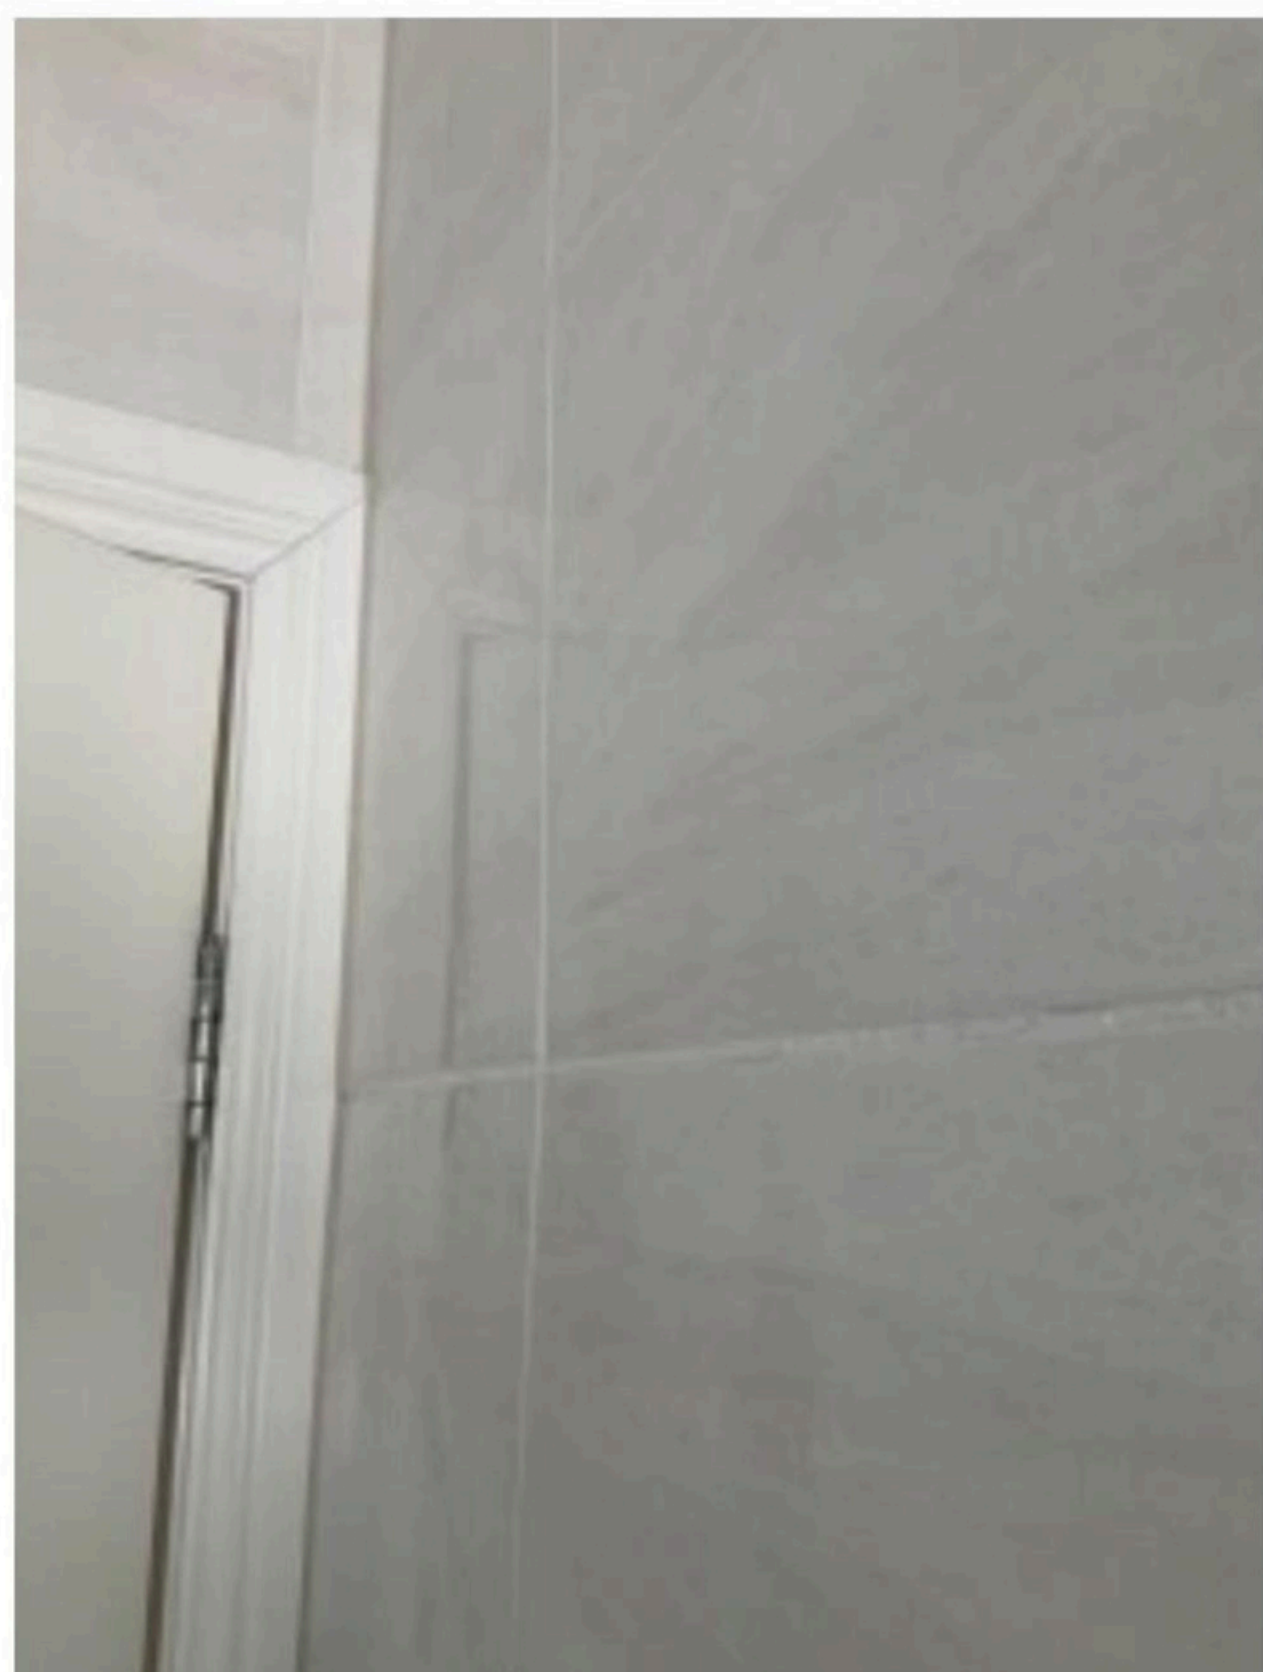
Visible signs of grout deterioration. It is recommended to re grout to prevent further damage and ensure the longevity and stability of the wall tile surface in this area.

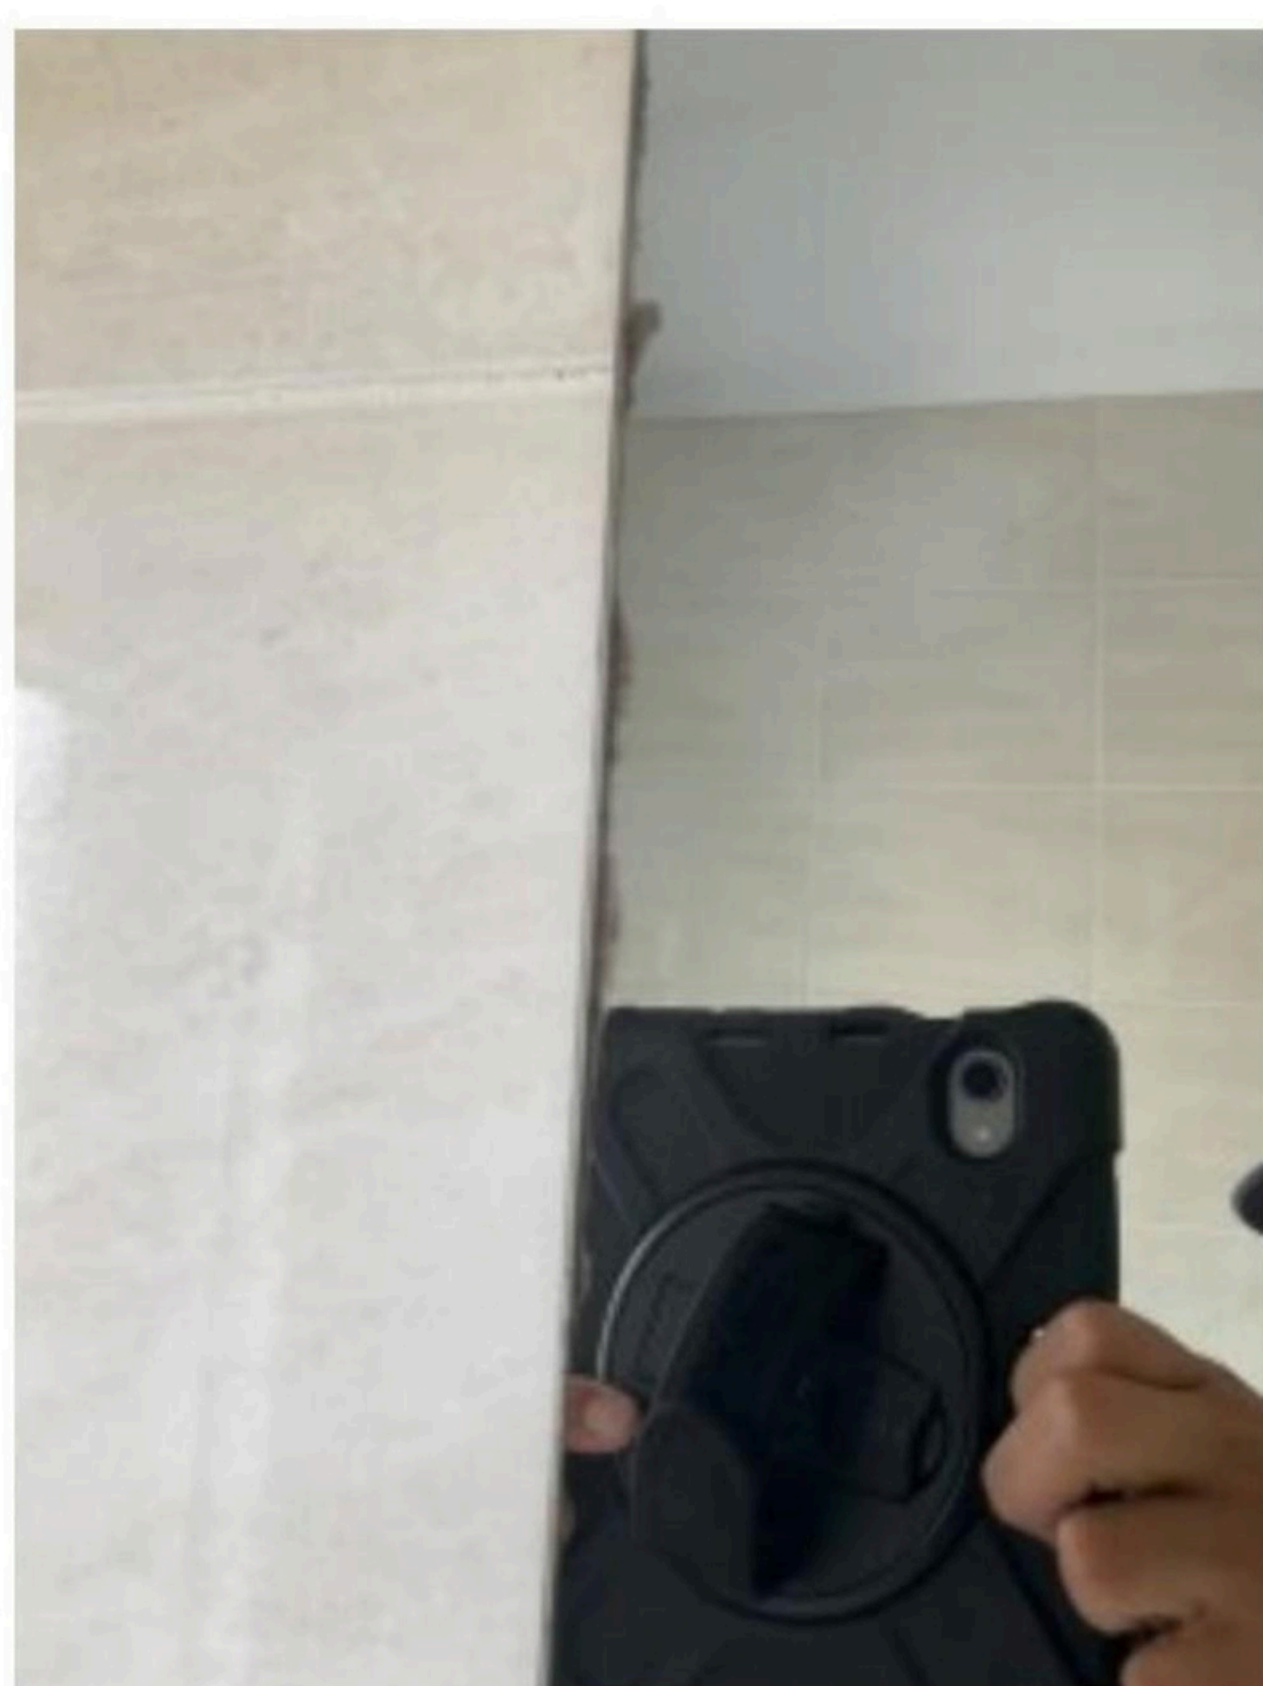
The mirror in the bathroom shows visible deterioration. Repairing or replacing are recommended.

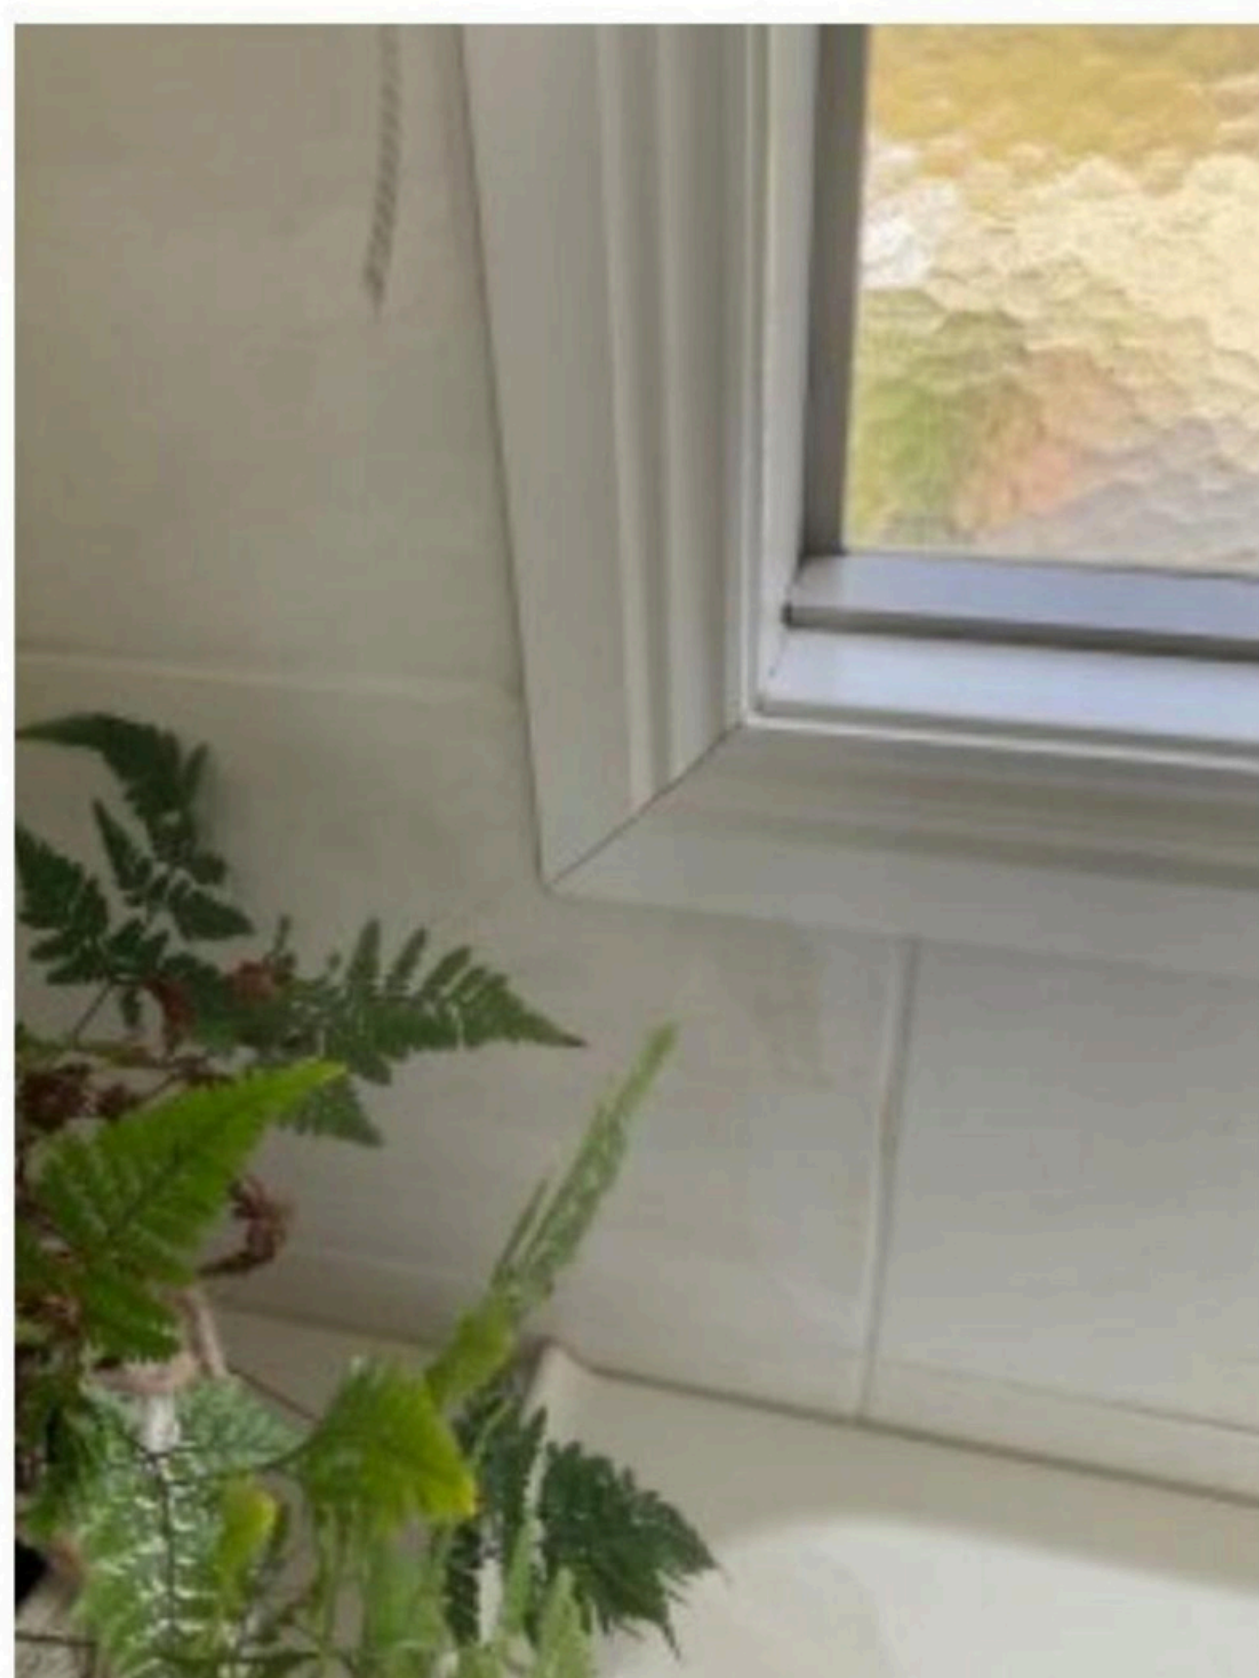
The window frame exhibits noticeable cracking at the corners. This could indicate potential movement or settlement. Rectification may involve repairing or resealing affected sections to ensure durability and effective sealing. If cracking worsens over time, it is recommended to engage a suitably qualified specialist for further investigation.

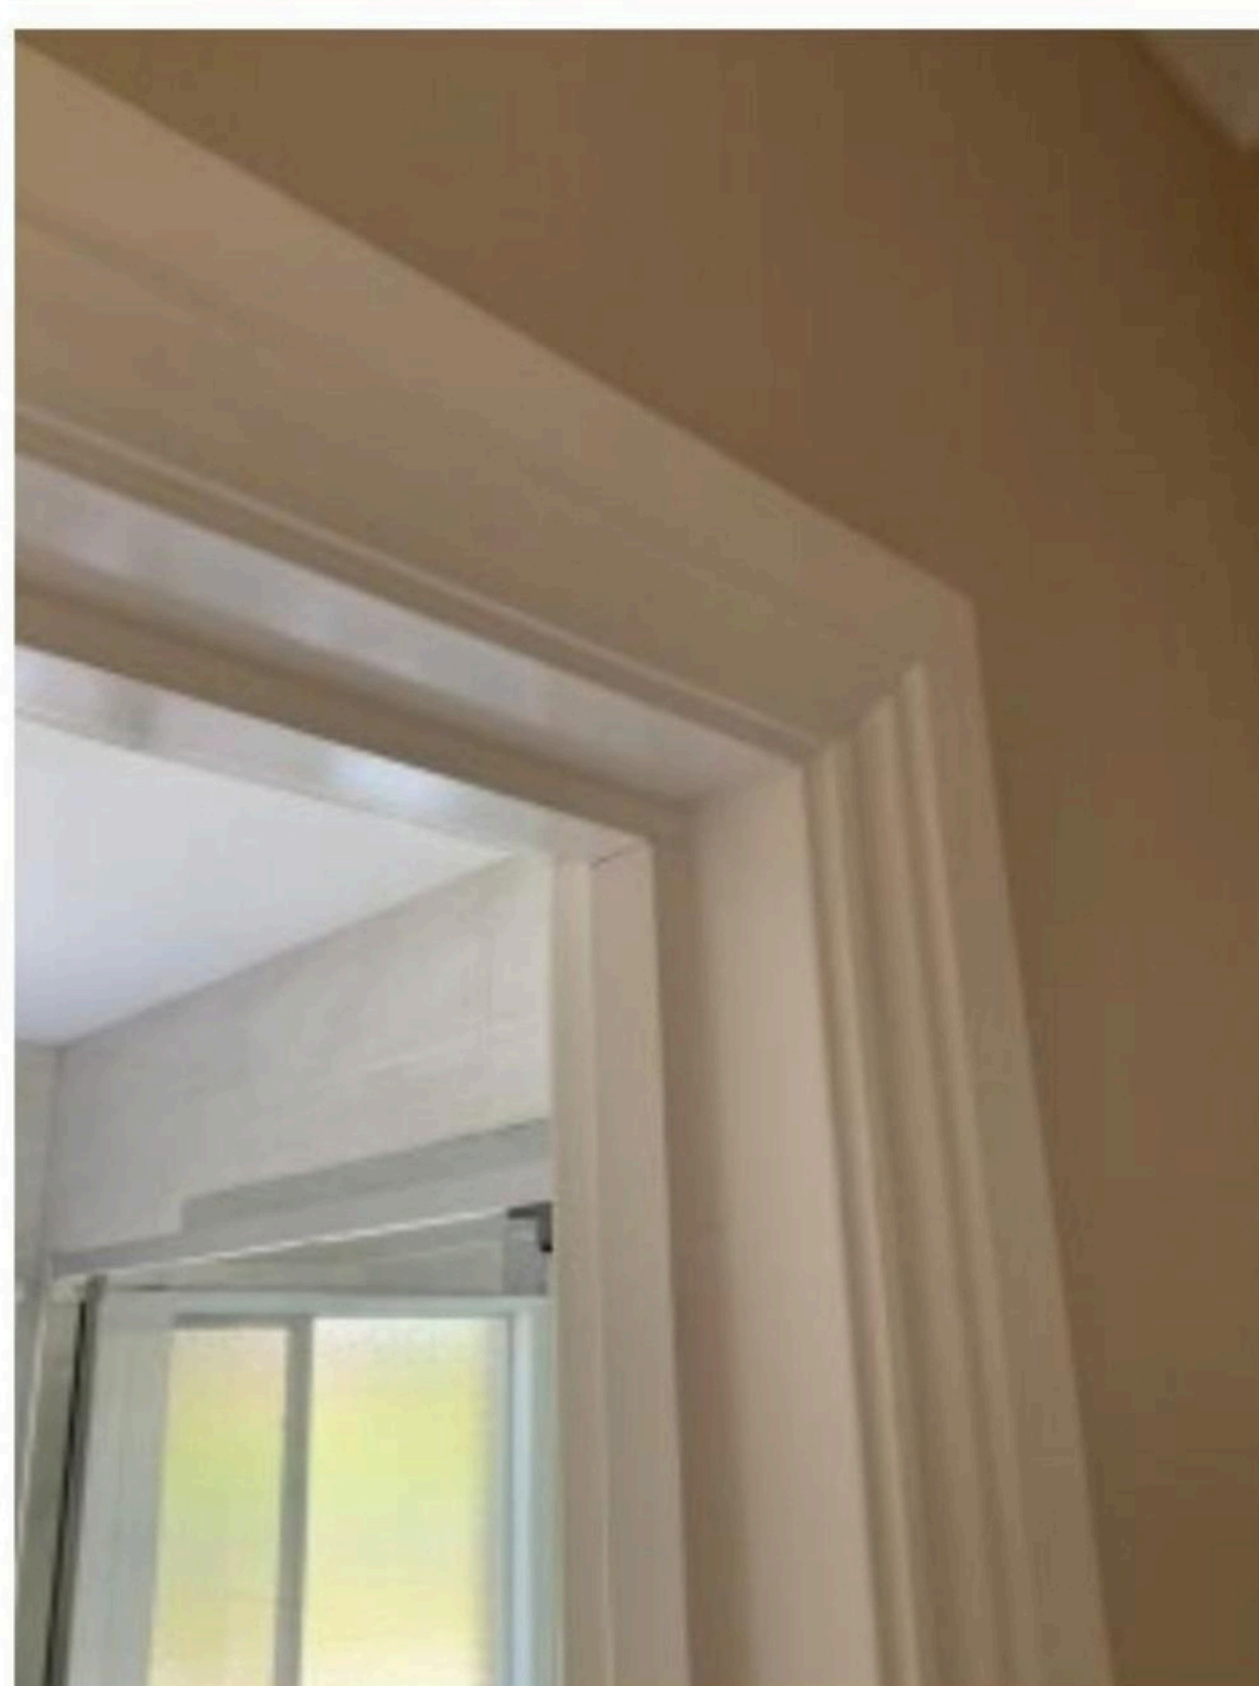
Door frame visible crack at the corner. This could indicate potential movement. Rectification by qualified tradesperson.
