## Just Inspections

## Building/Property & Timber Pest Inspection

**AS4349.1-2007 & AS4349.3-2010**

| Report Date | 22 Apr 2026 |

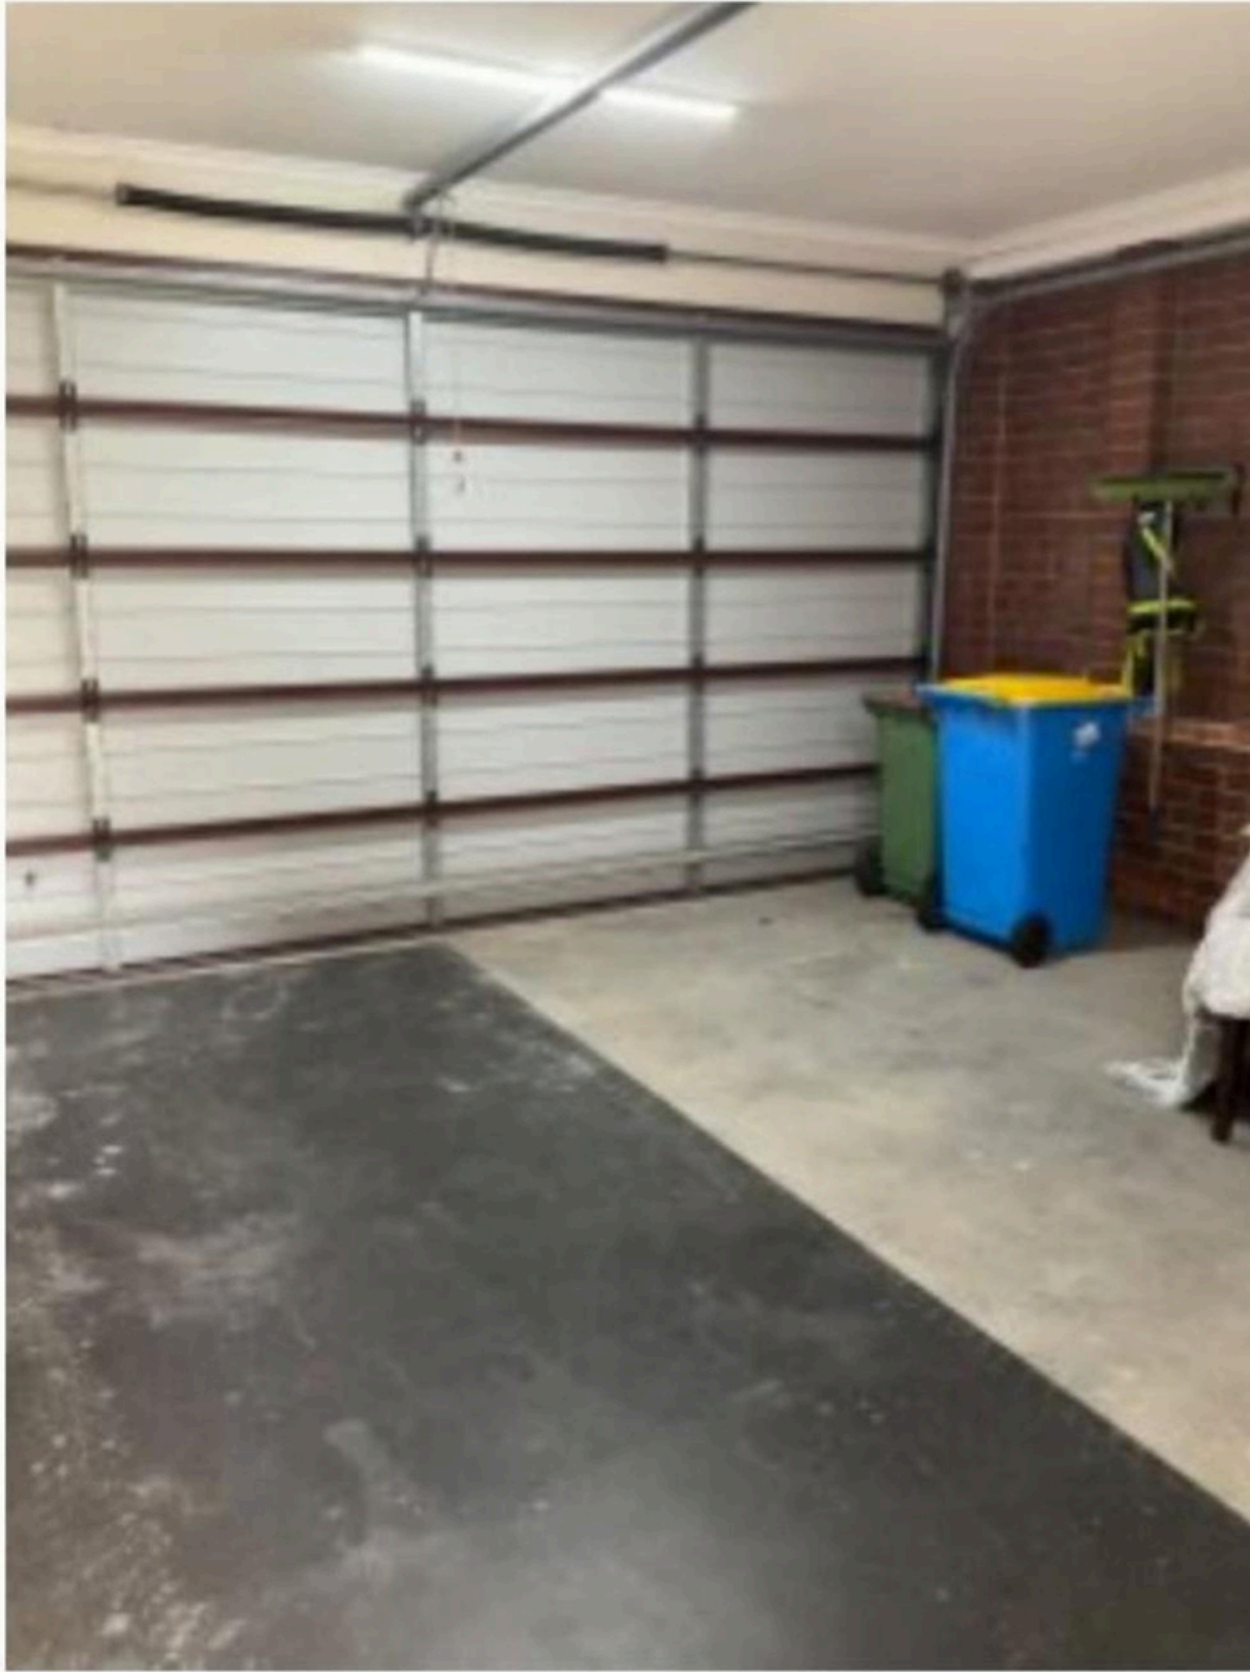
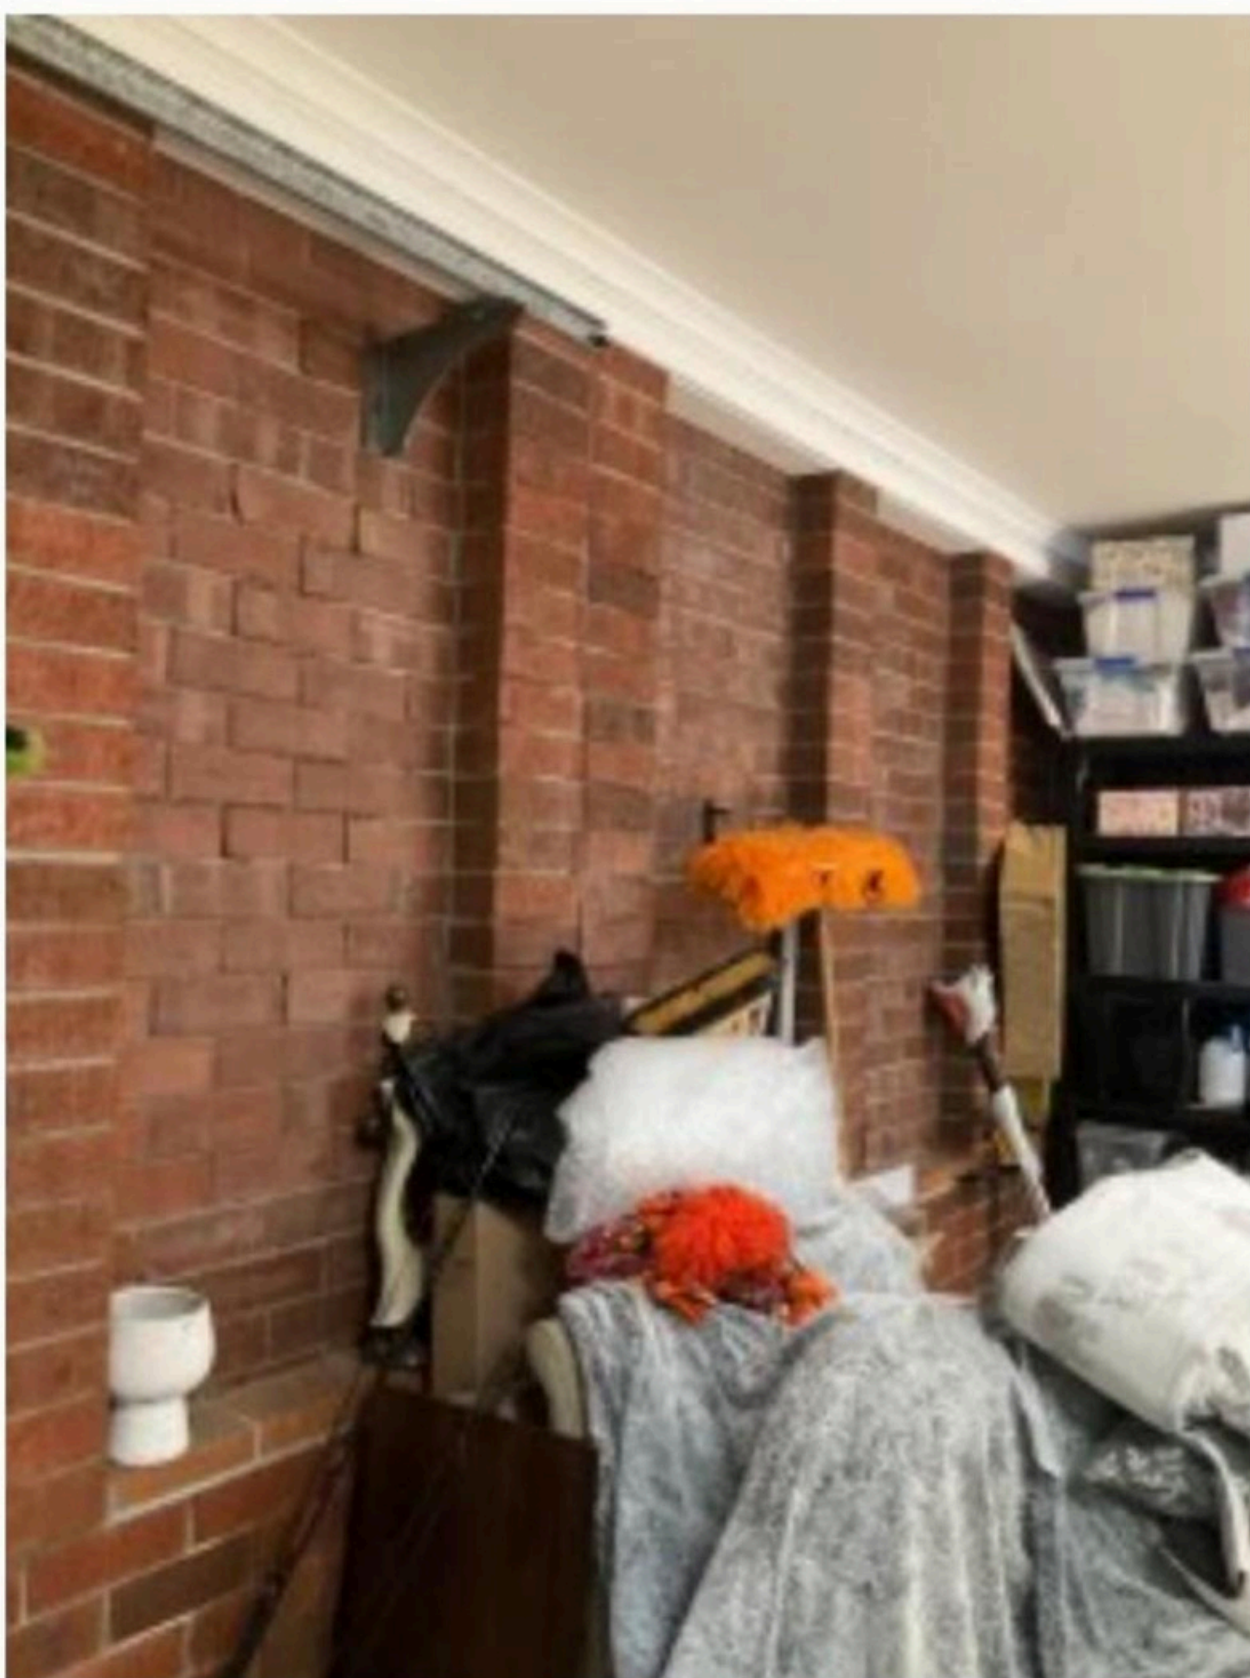
Other: Garage

The brick wall showing visible moisture. This condition can allow moisture ingress and weaken the integrity of the wall. It is recommended to have the affected sections repointed by a qualified professional to restore the wall's stability and prevent potential damage. Regular maintenance should be considered to ensure the longevity of the masonry work.

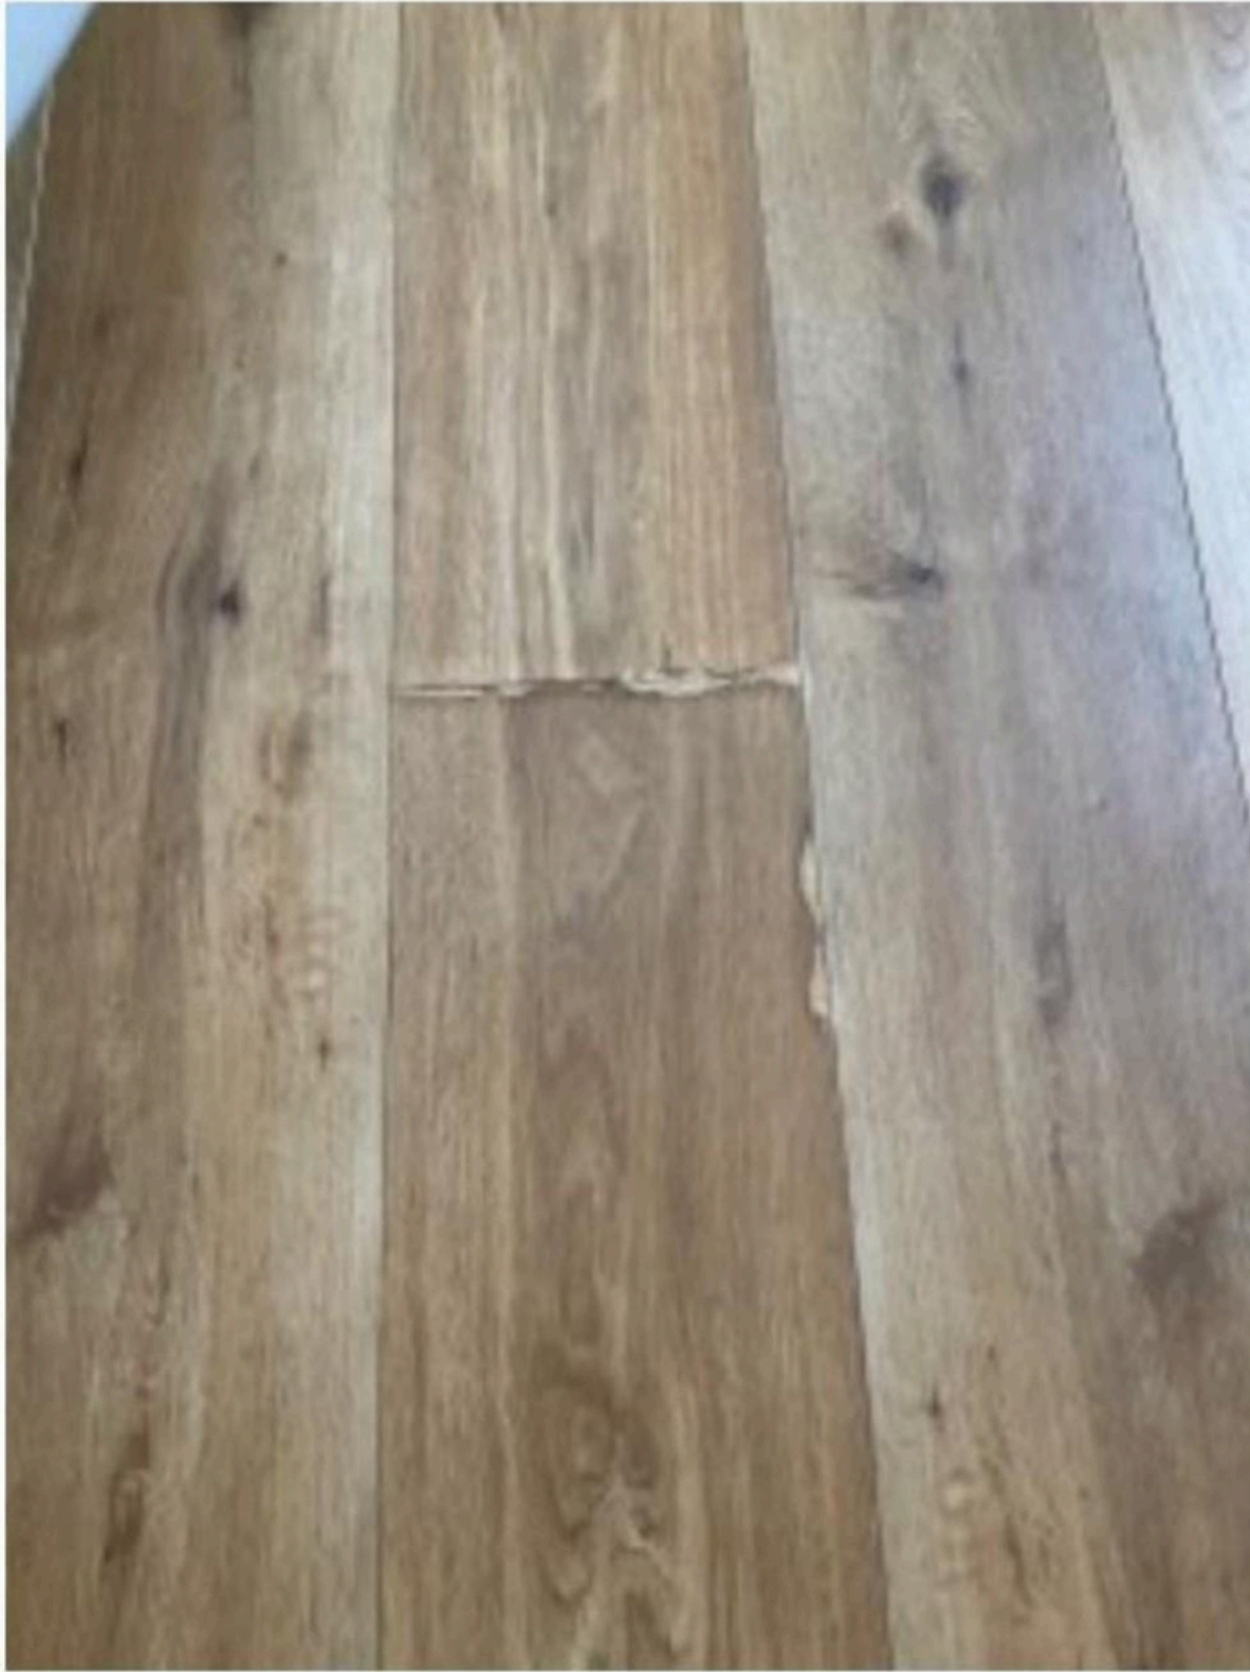
Other: Living area

The flooring shows signs of damage, with visible peeling and separation at the seams of the wood panels. This condition may lead to further deterioration if left unaddressed, potentially compromising the flooring's structural integrity. Timely repair or replacement of the affected areas might be necessary to prevent further issues and maintain the quality and appearance of the floor.

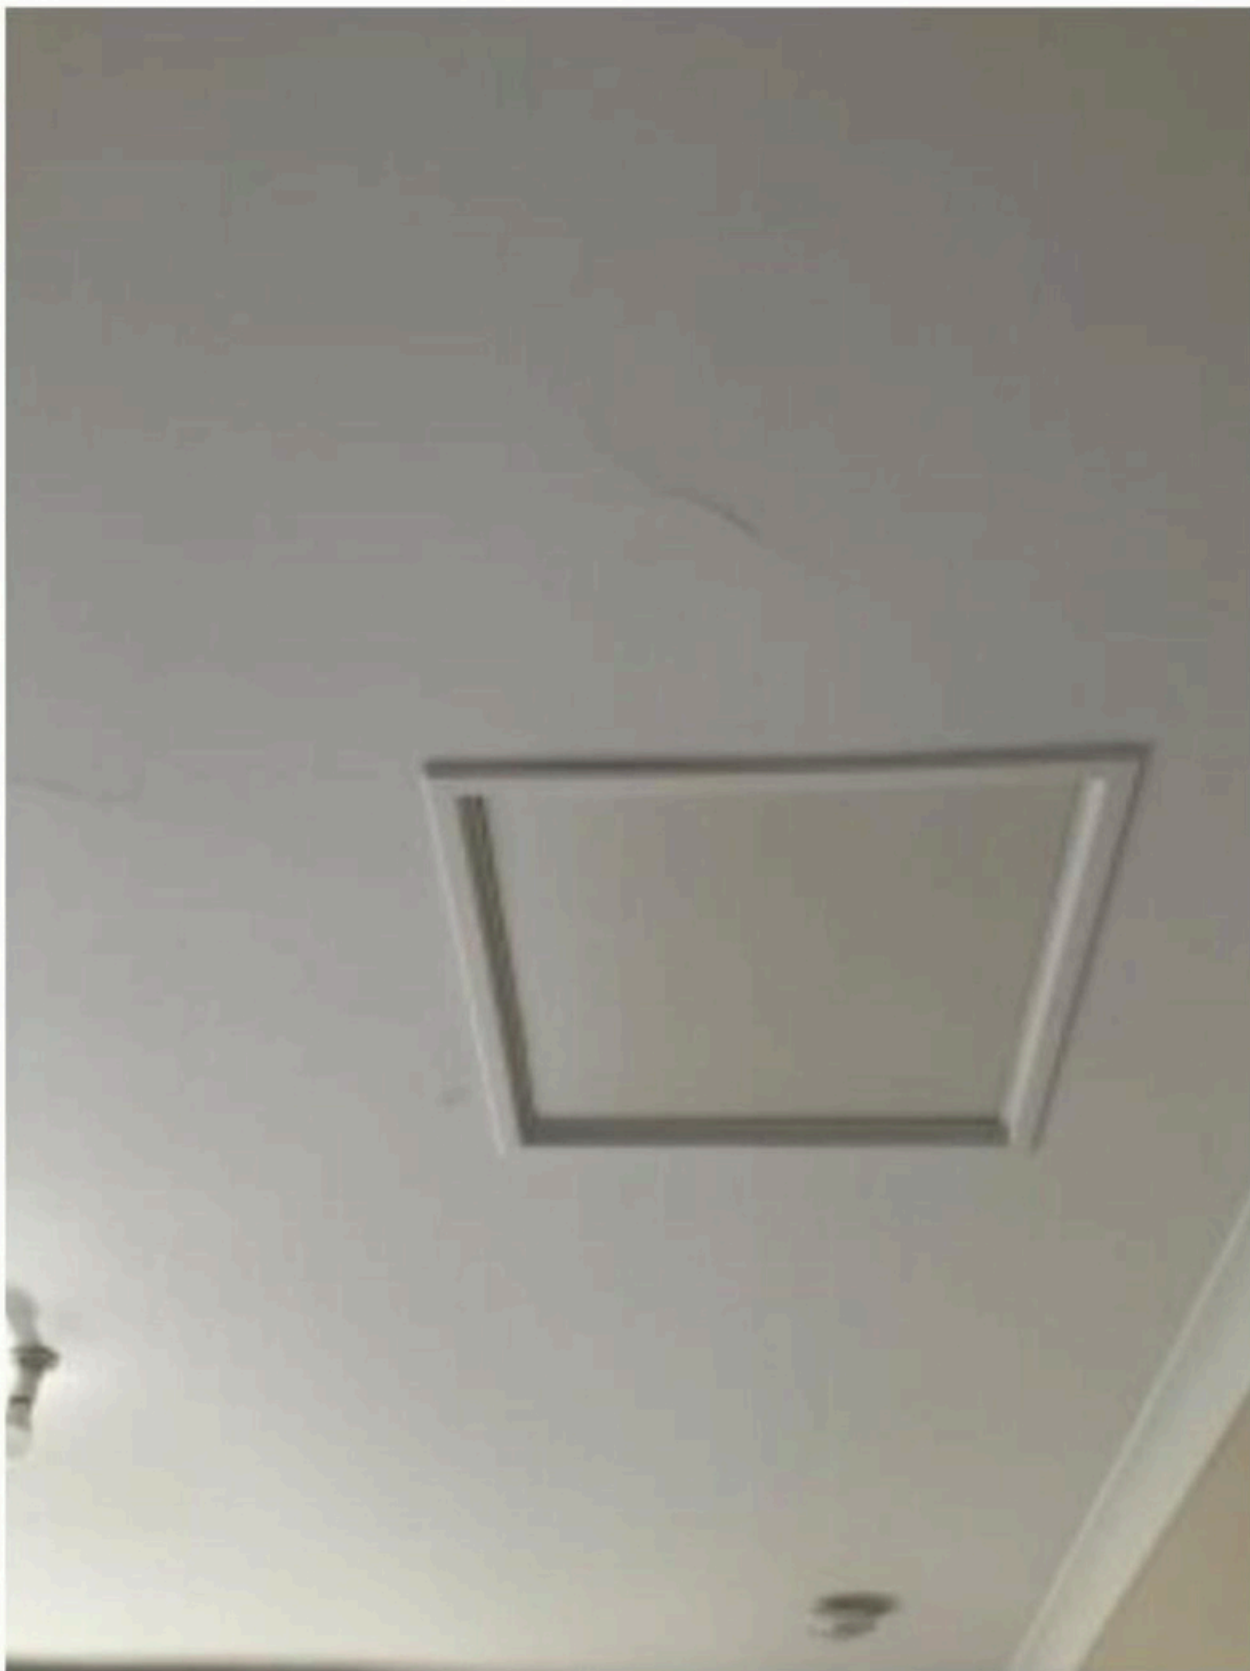
Other: 2nd level ceiling

The ceiling exhibits a noticeable crack adjacent to an access panel. This crack may suggest minor movement or settling of the ceiling materials. While the integrity of the overall structure does not seem compromised, it is recommended to monitor the crack for any progression. Minor repairs may be required to prevent further damage and ensure aesthetic appeal is maintained. Regular inspection by a qualified professional is advised to assess any underlying issues.

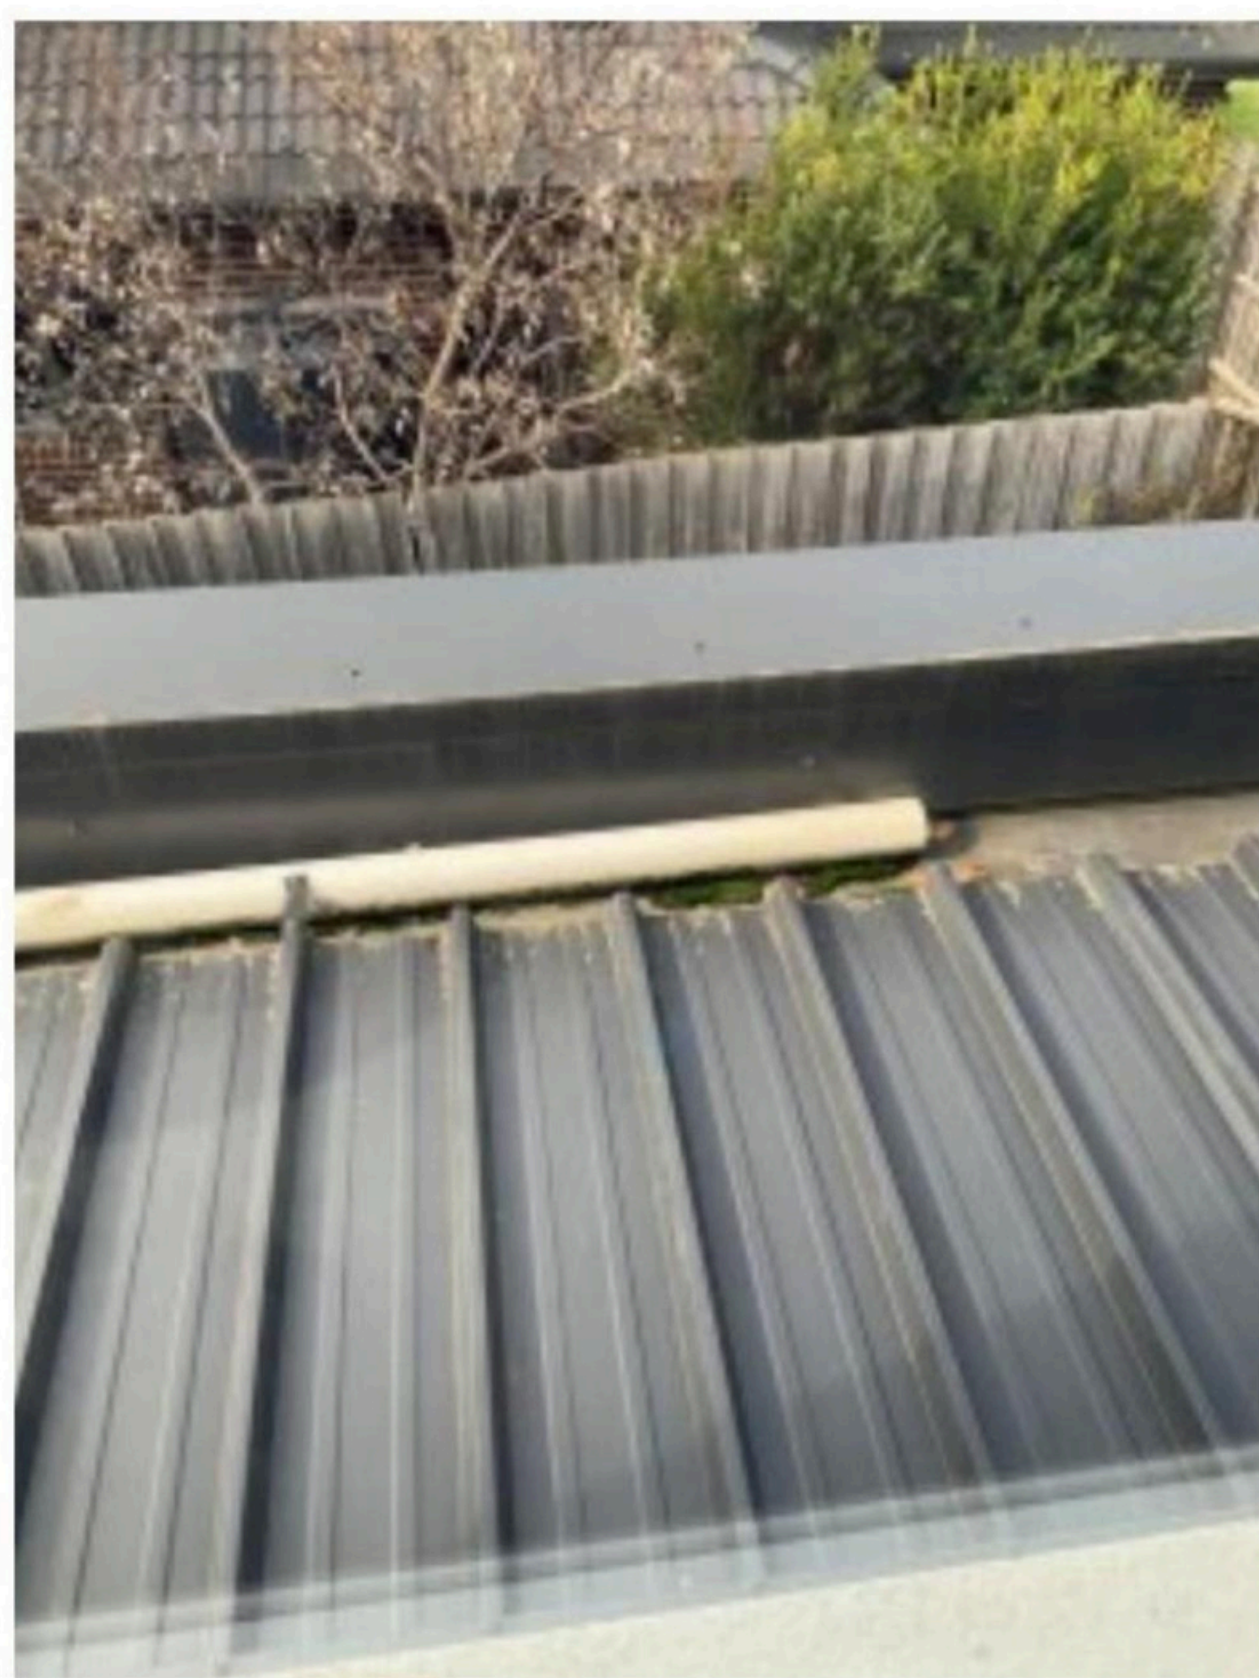
### **Roof space exterior**

Visible signs of moss a growth along the edge of the roof gutter . This can potentially lead to water pooling and subsequent roof deterioration, affecting its integrity. Regular maintenance and possibly enhancing the drainage system would be advisable to prevent further issues and ensure roof longevity.

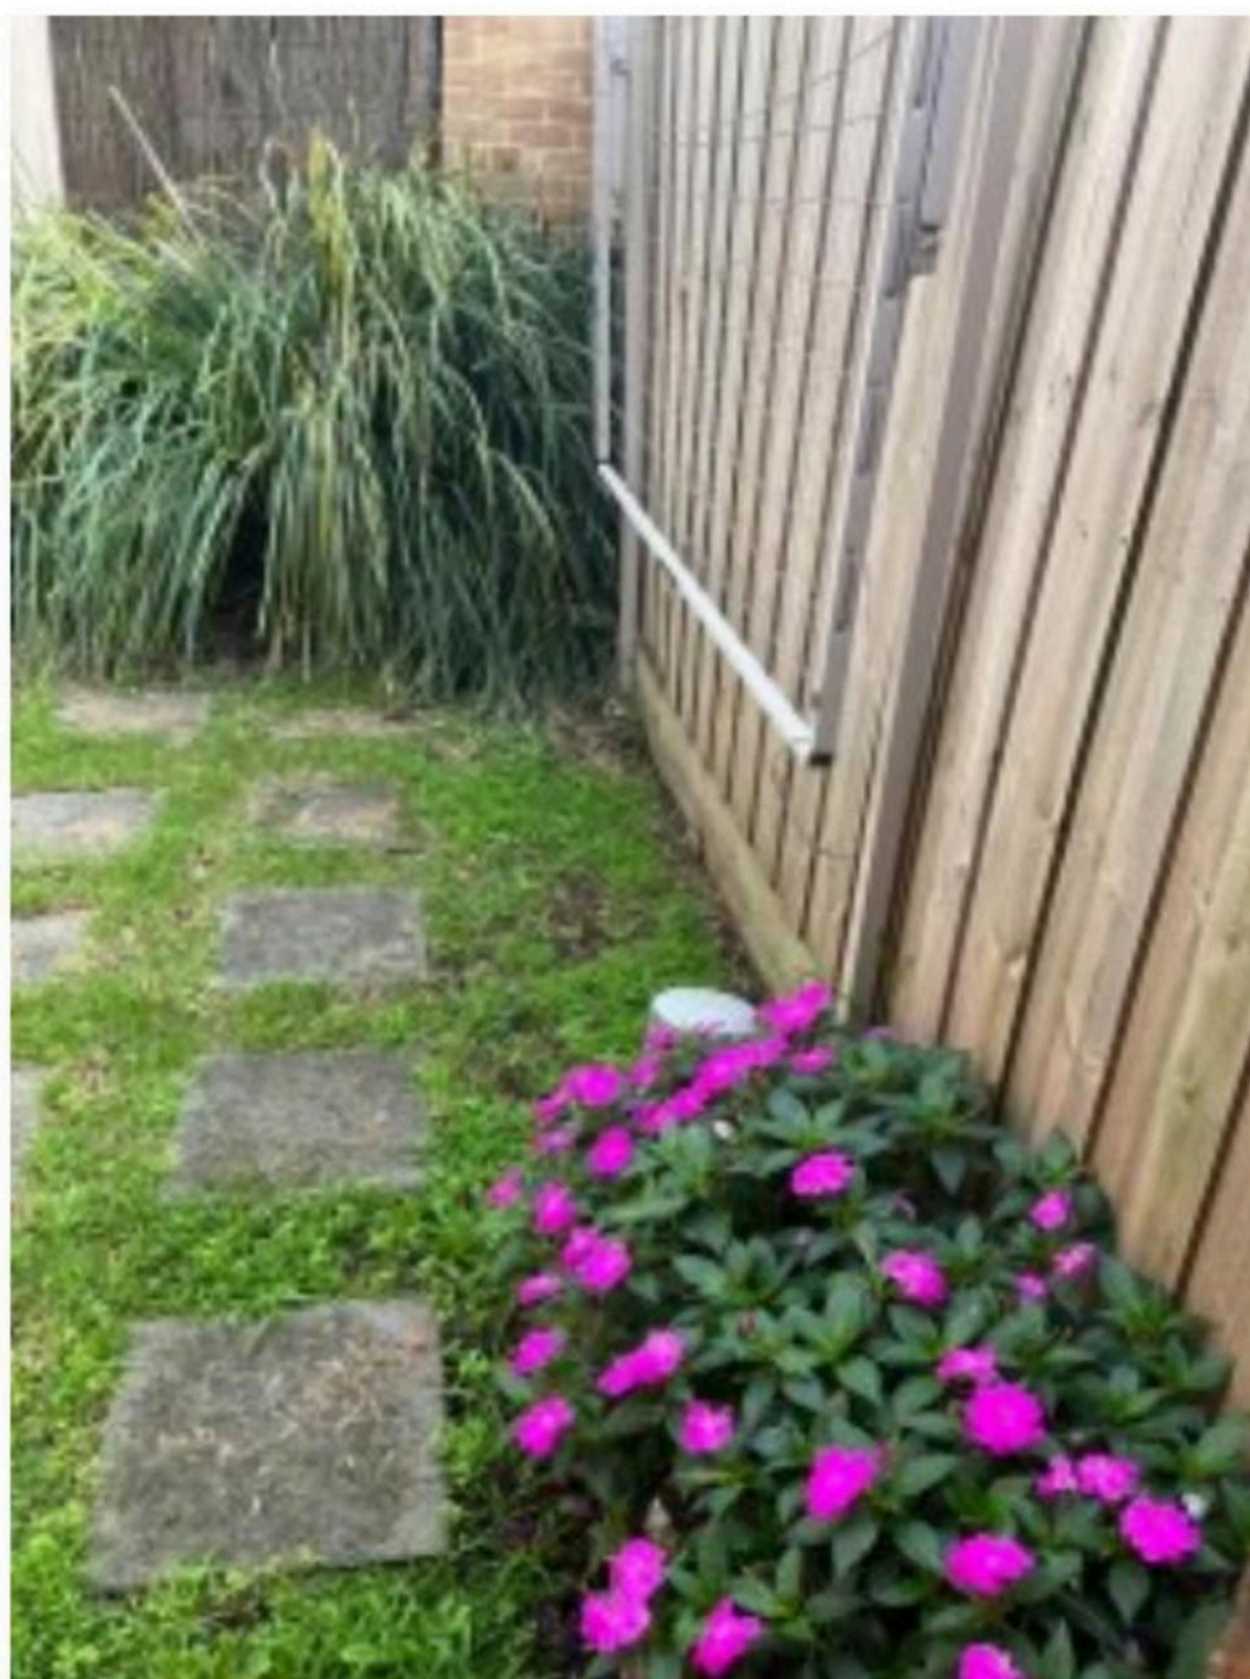
Vegetation is growing against the wall, potentially exacerbating moisture retention and contributing to decay or pest attraction. It is advisable to address these issues by improving drainage and managing vegetation to protect the building from potential damage.

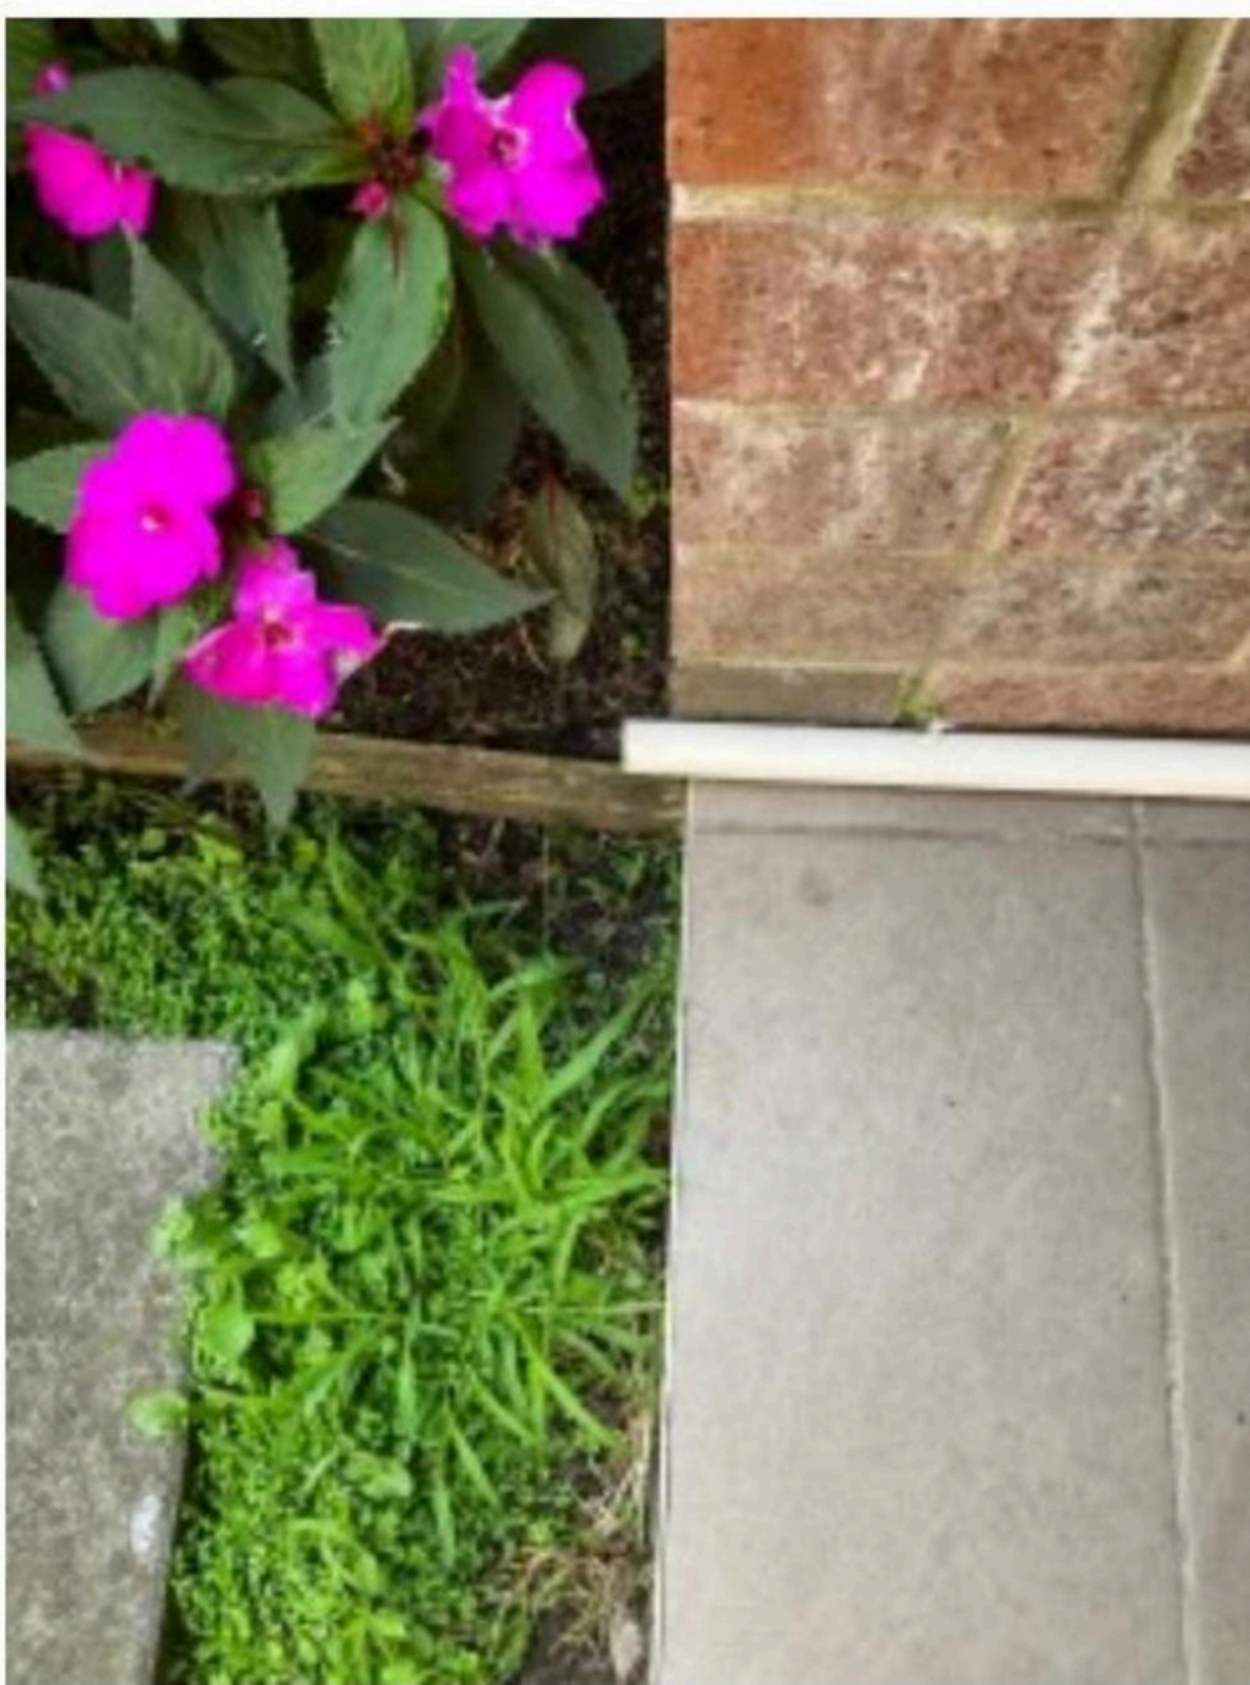
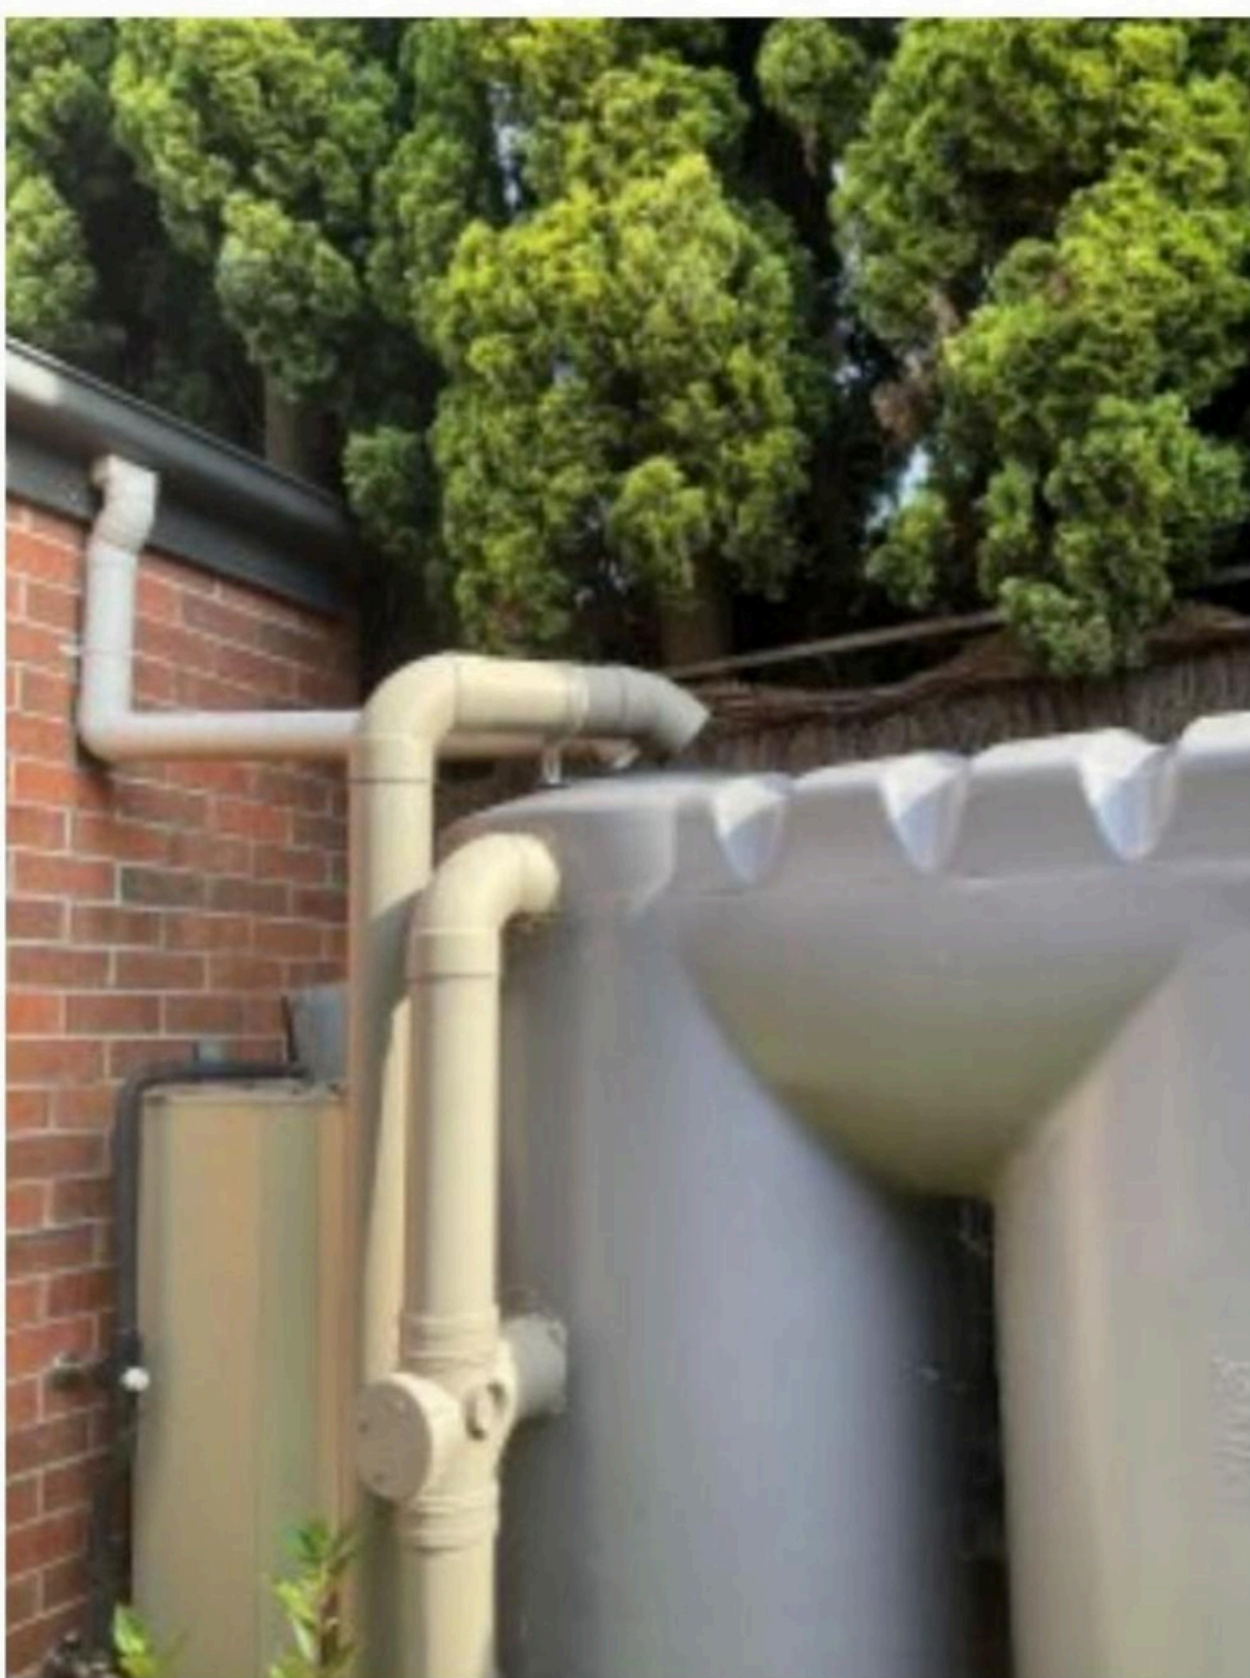
Down pipe connection not connecting directly to the water tank potentially leading to issues with water flow and leaks. It is recommended to assess and rectify by qualified plumber.

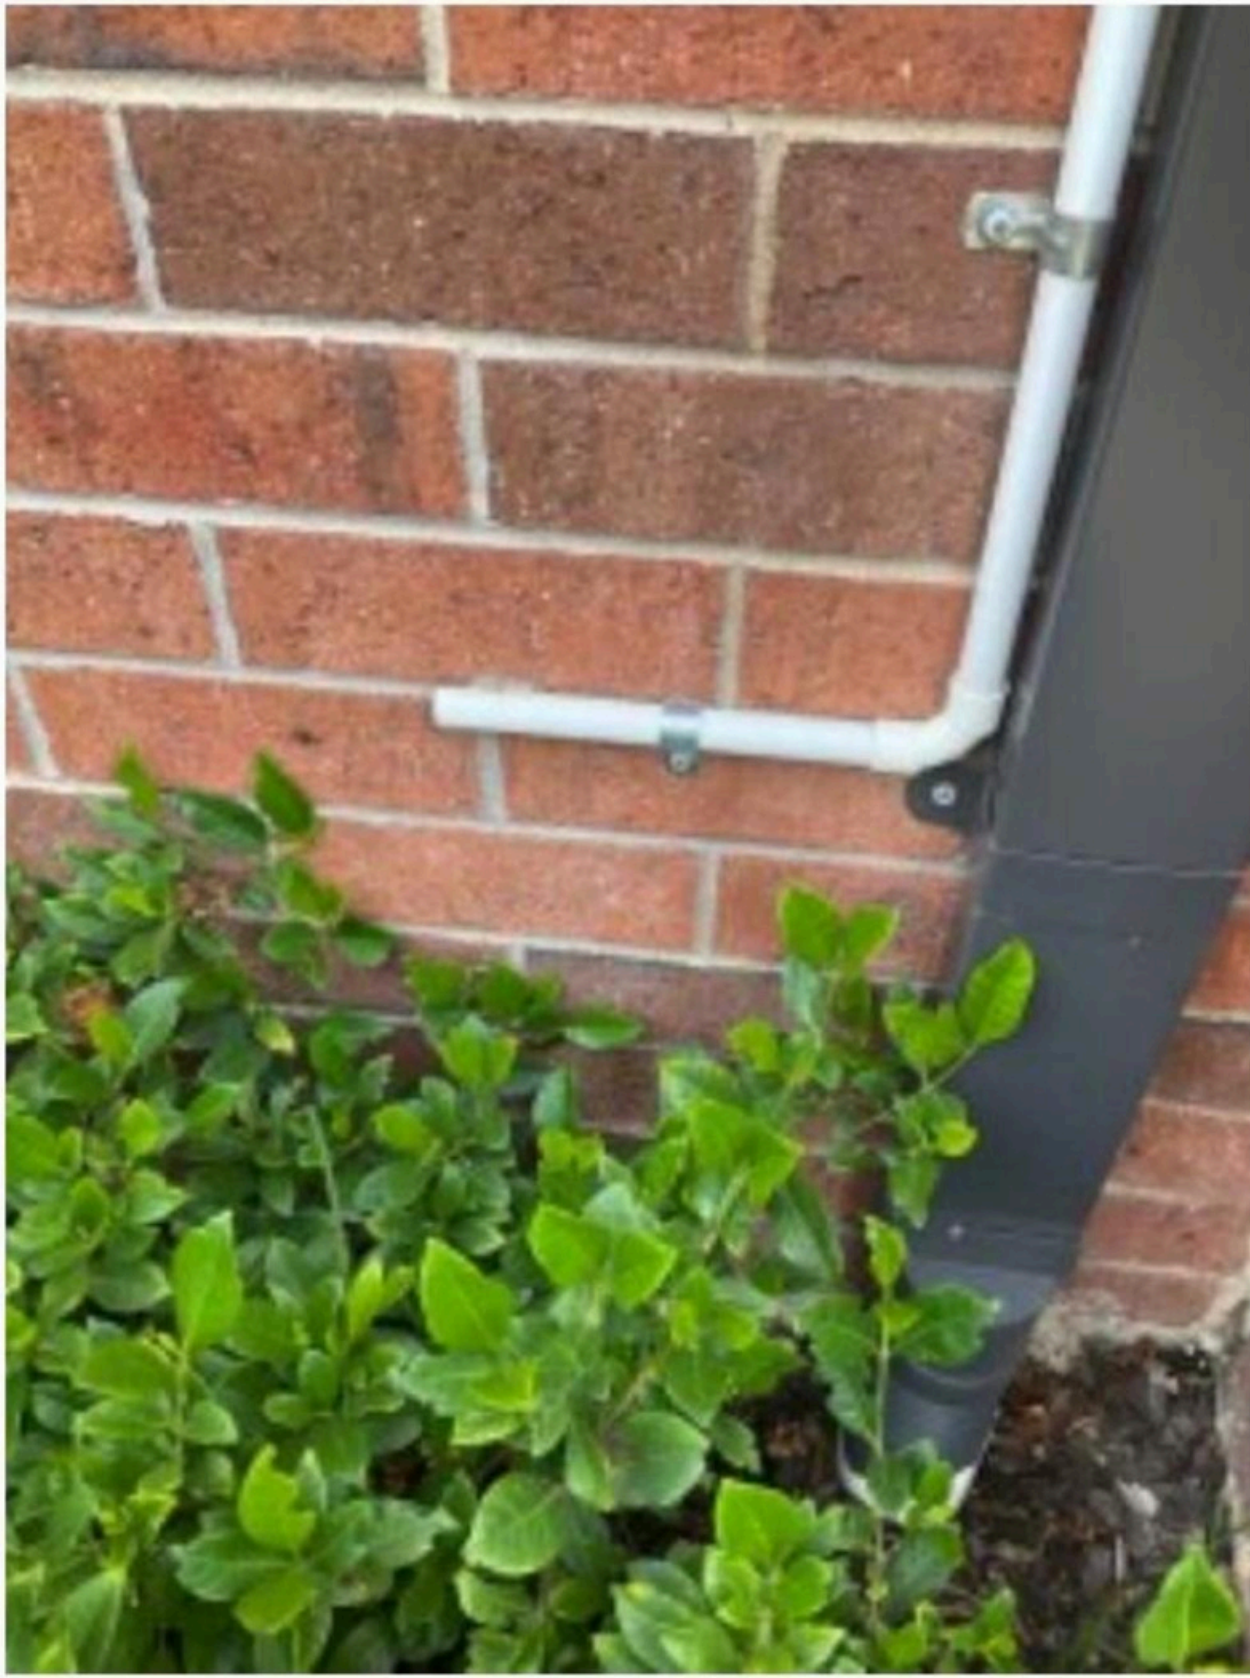
Drainpipe not connected to storm drainage system. This can lead to potential issues such as moisture retention against the wall, which might cause damage over time. It is recommended to engage a qualified plumber to connect.
