Thank you for the opportunity to inspect the preparation and application of paintwork of your home under construction. We attended the site on Wednesday, 27 November, 2024 and make the following comment on the quality and compliance of the works to date;

# Quality Assurance Inspection

Preparation and application of paintwork and workmanship only.

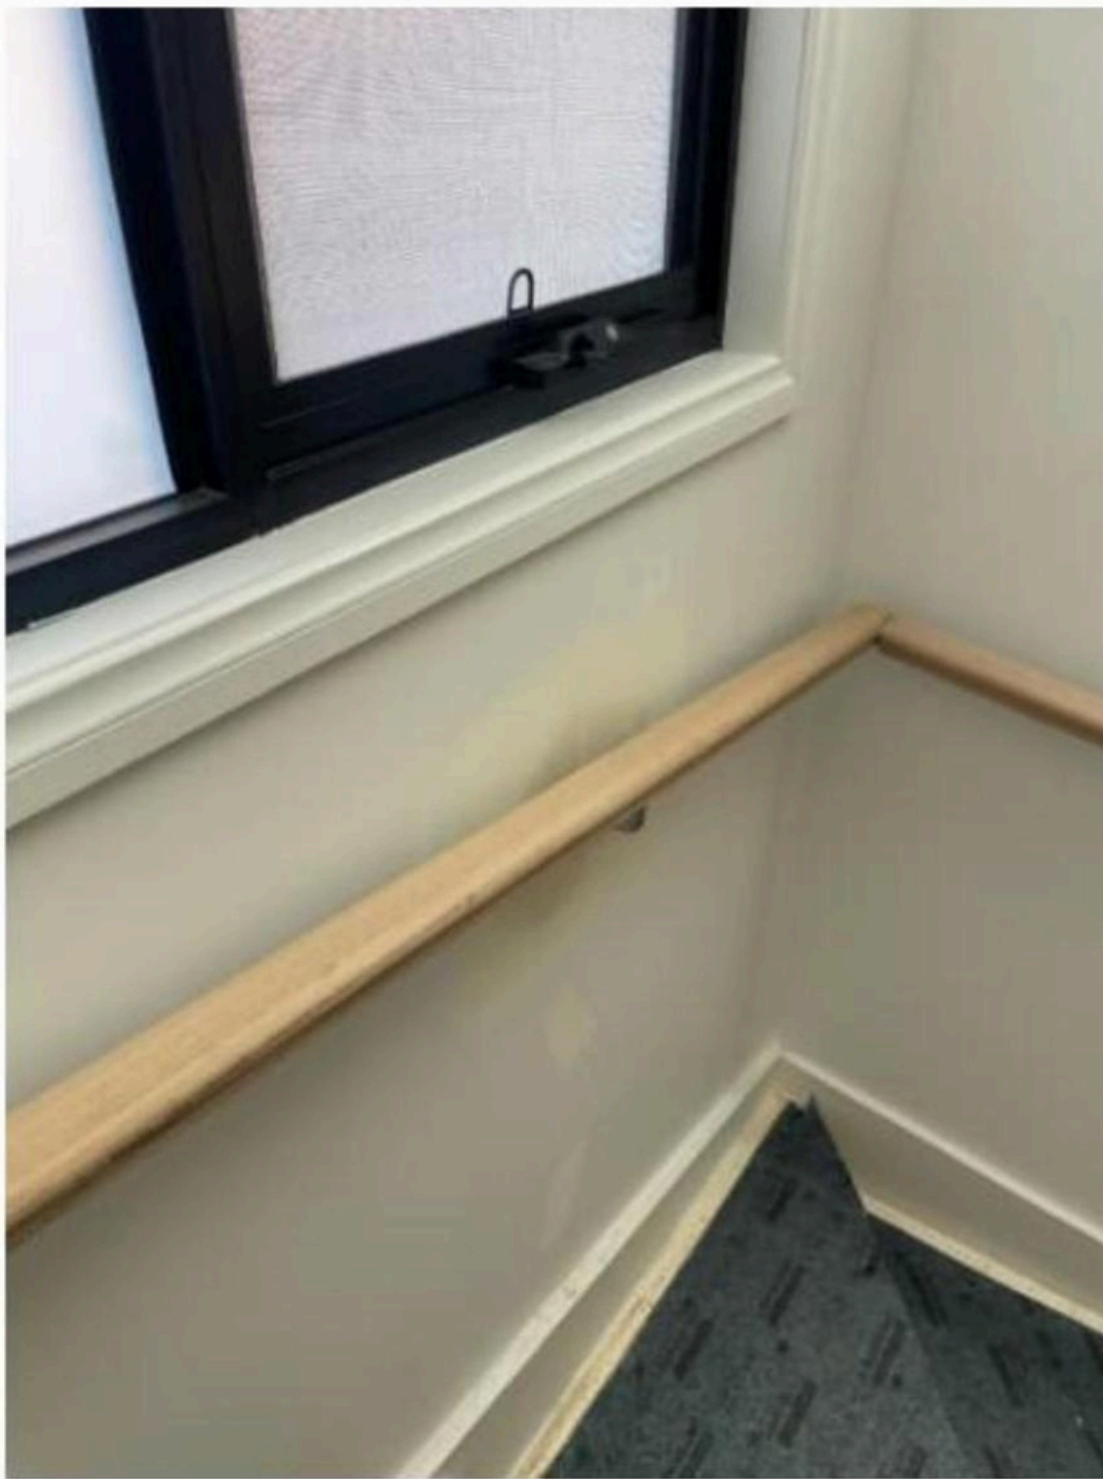
Stairwell areas painting is incomplete.

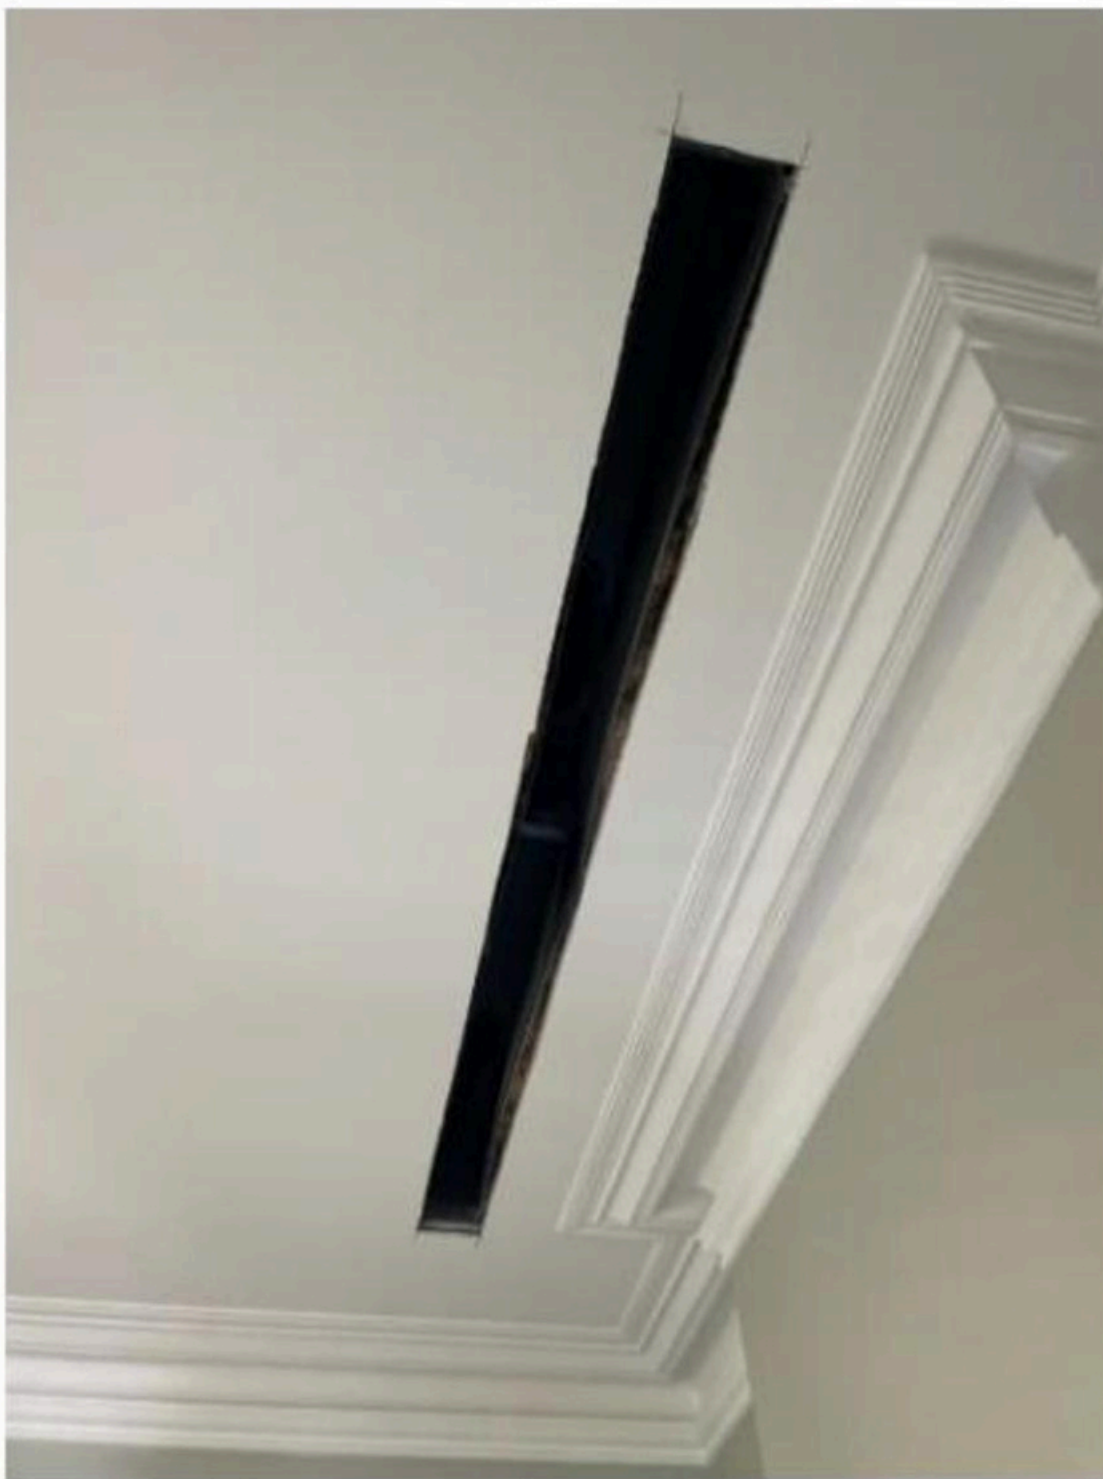
HVAC grille not installed yet.
