Thank you for the opportunity to carry out a dilapidation inspection at the above property in order to document existing cracking prior to the commencement of construction works at your property.

The two-storey property is of single skin brick and timber frame construction with brick veneer exterior walls, internal brick walls and timber ceilings, timber windows and a pitched roof clad with concrete tiles.

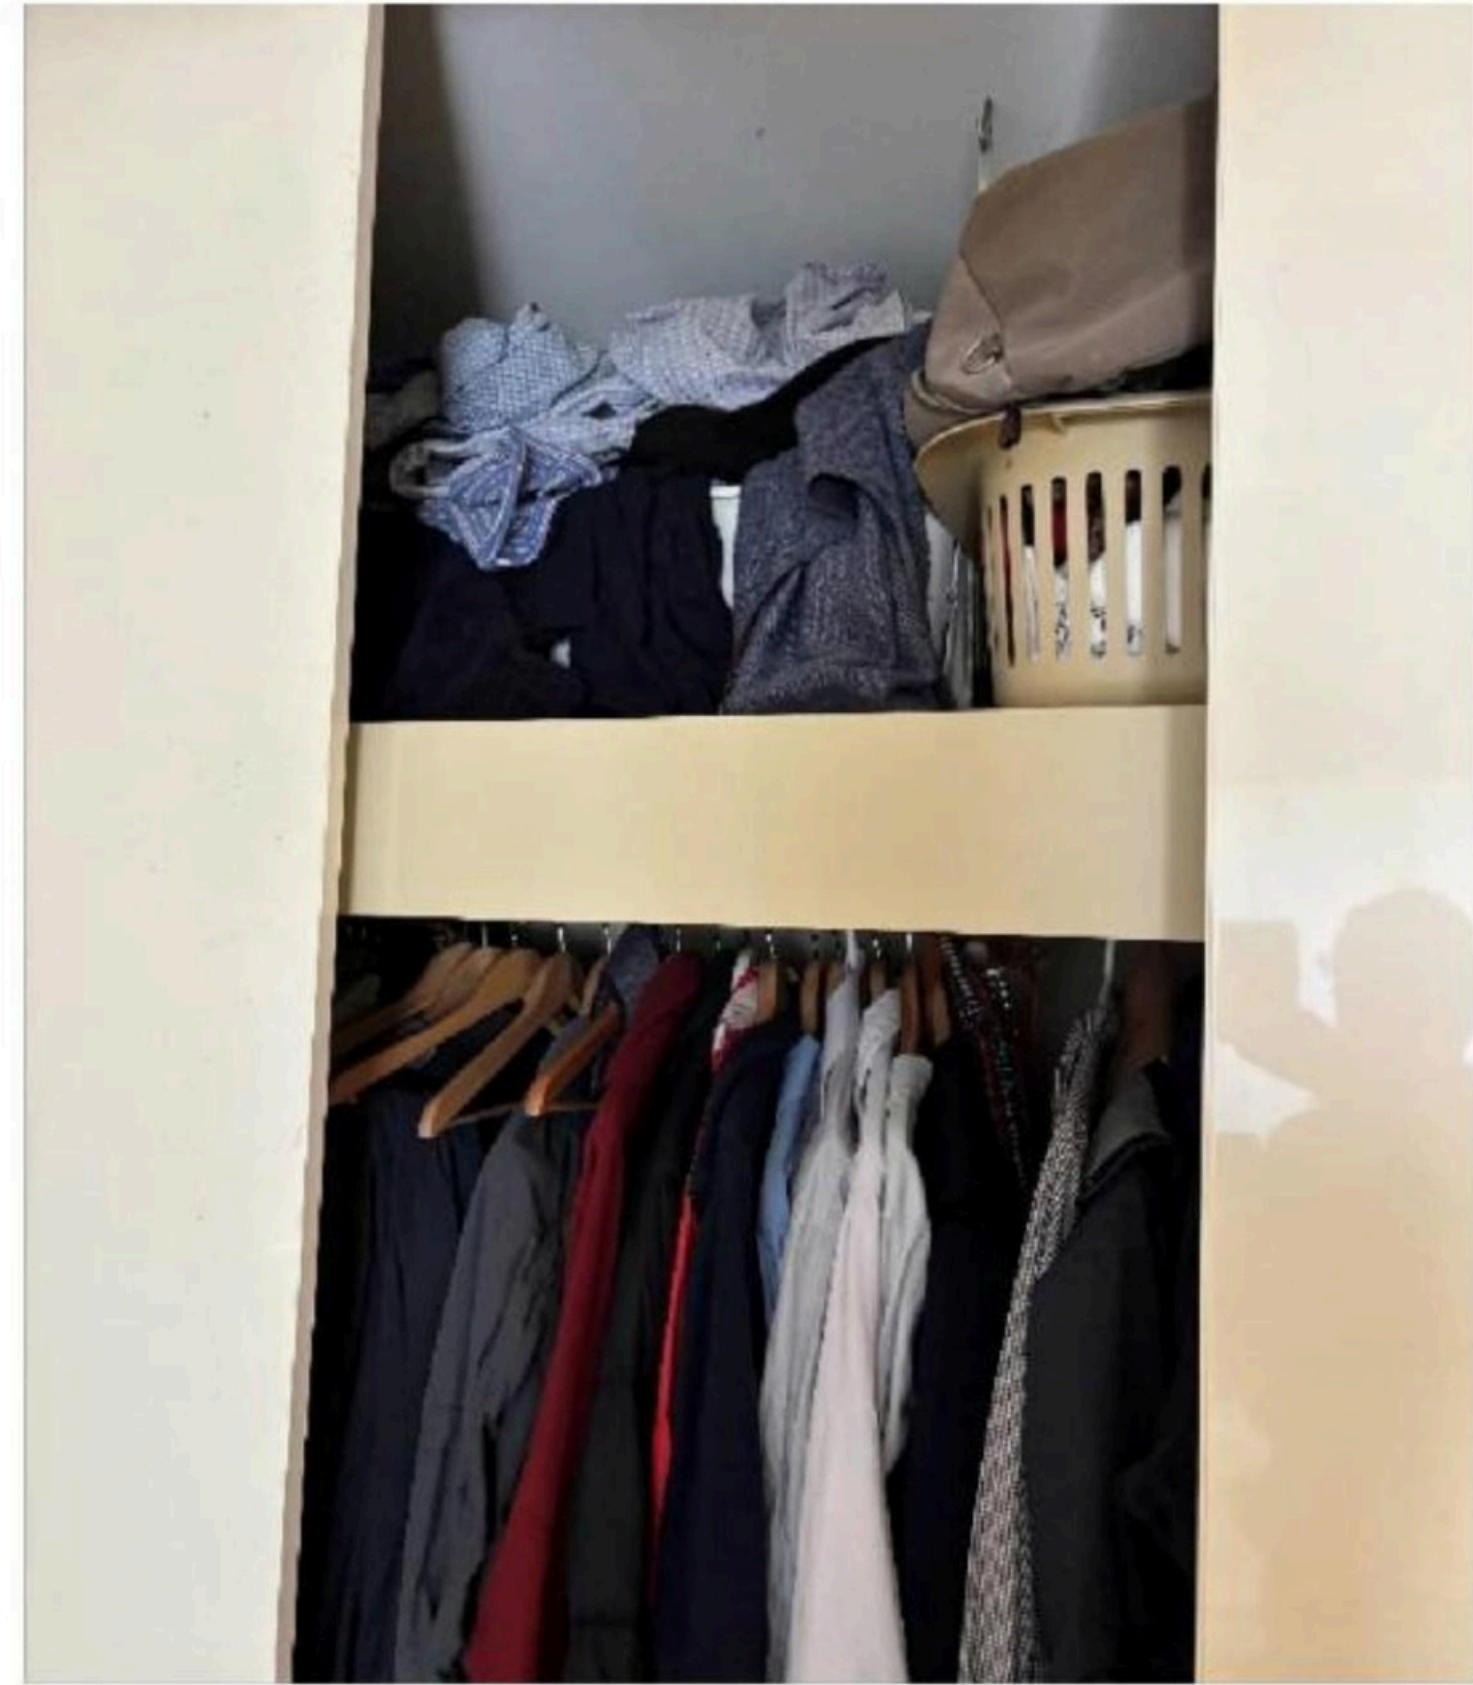
| Bedroom 1 | Fine cracking evident on western wall. |

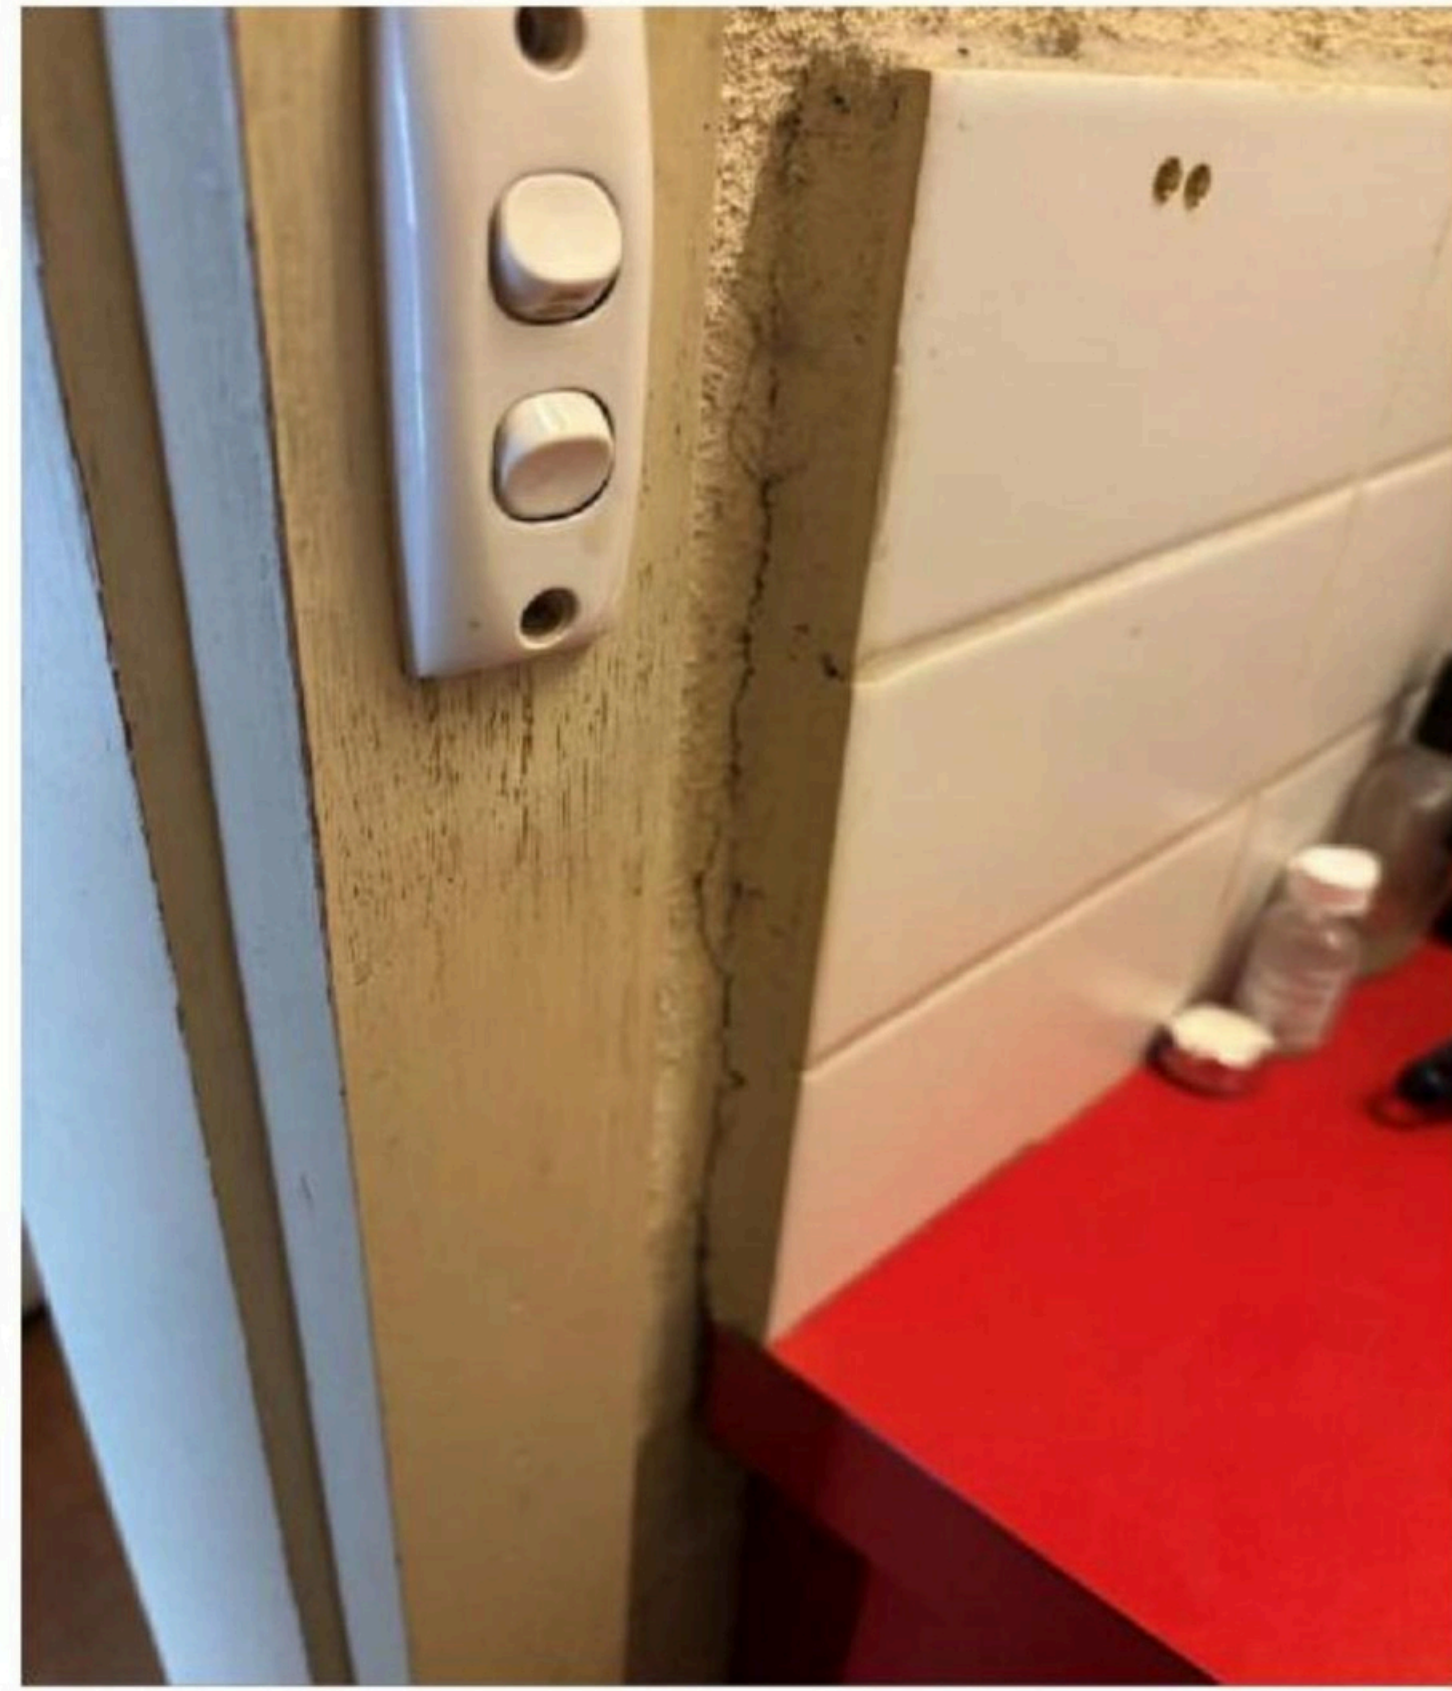
| Shower | Evidence of water ingress on western wall.<br>Fine cracking evident on eastern wall. |

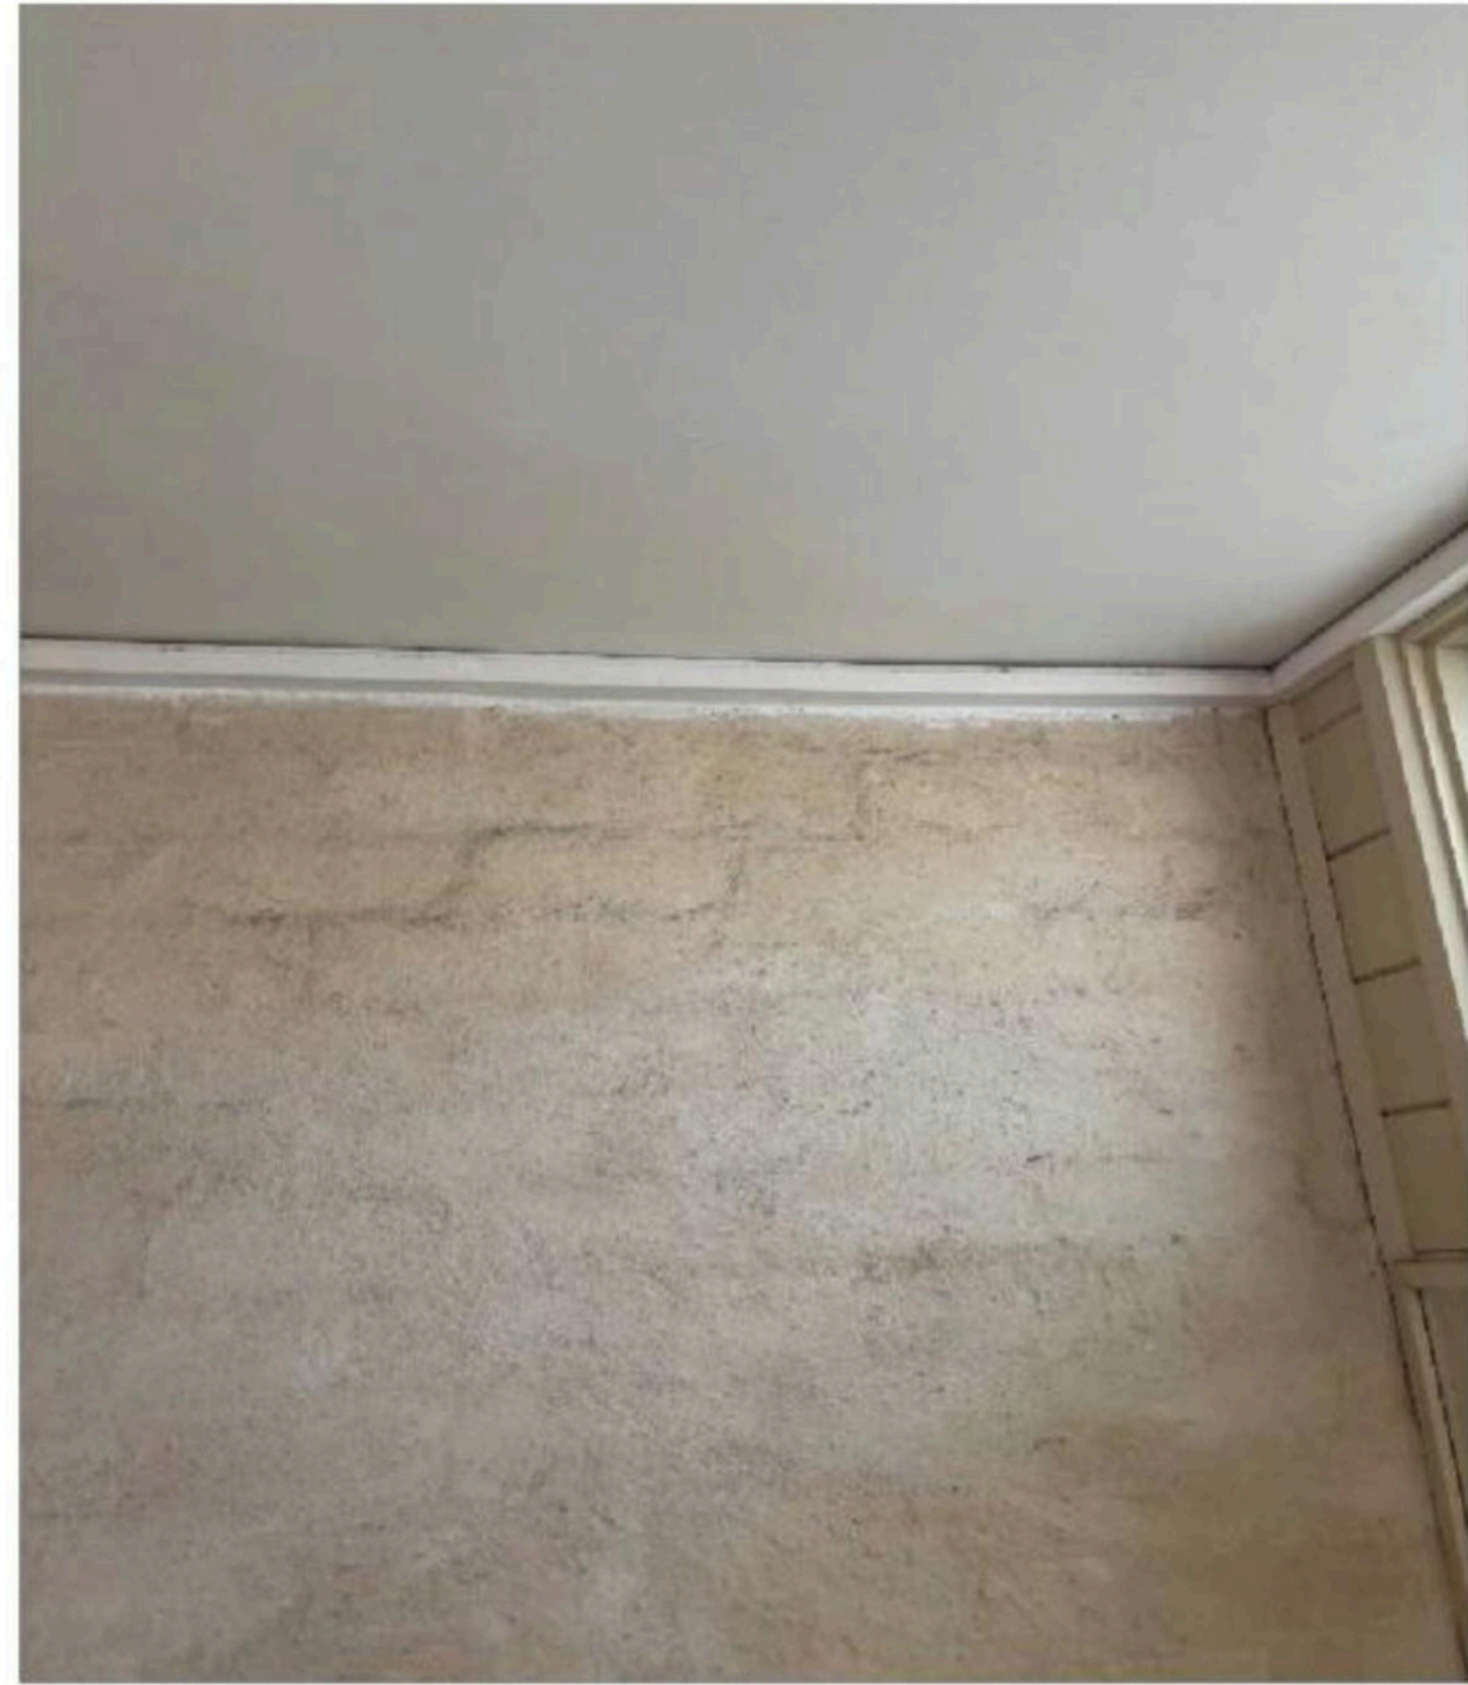
| Bathroom | Tiles have fallen off from bathtub.<br>Evidence of water damage on ceiling around exhaust fan.<br>Evidence of cracked tiles on walls (all sides).<br>Evidence of cracked tiles on walls in the shower.<br>Evidence of fine cracking on ceiling cornices.<br>Evidence of cracked walls (repairs conducted). |

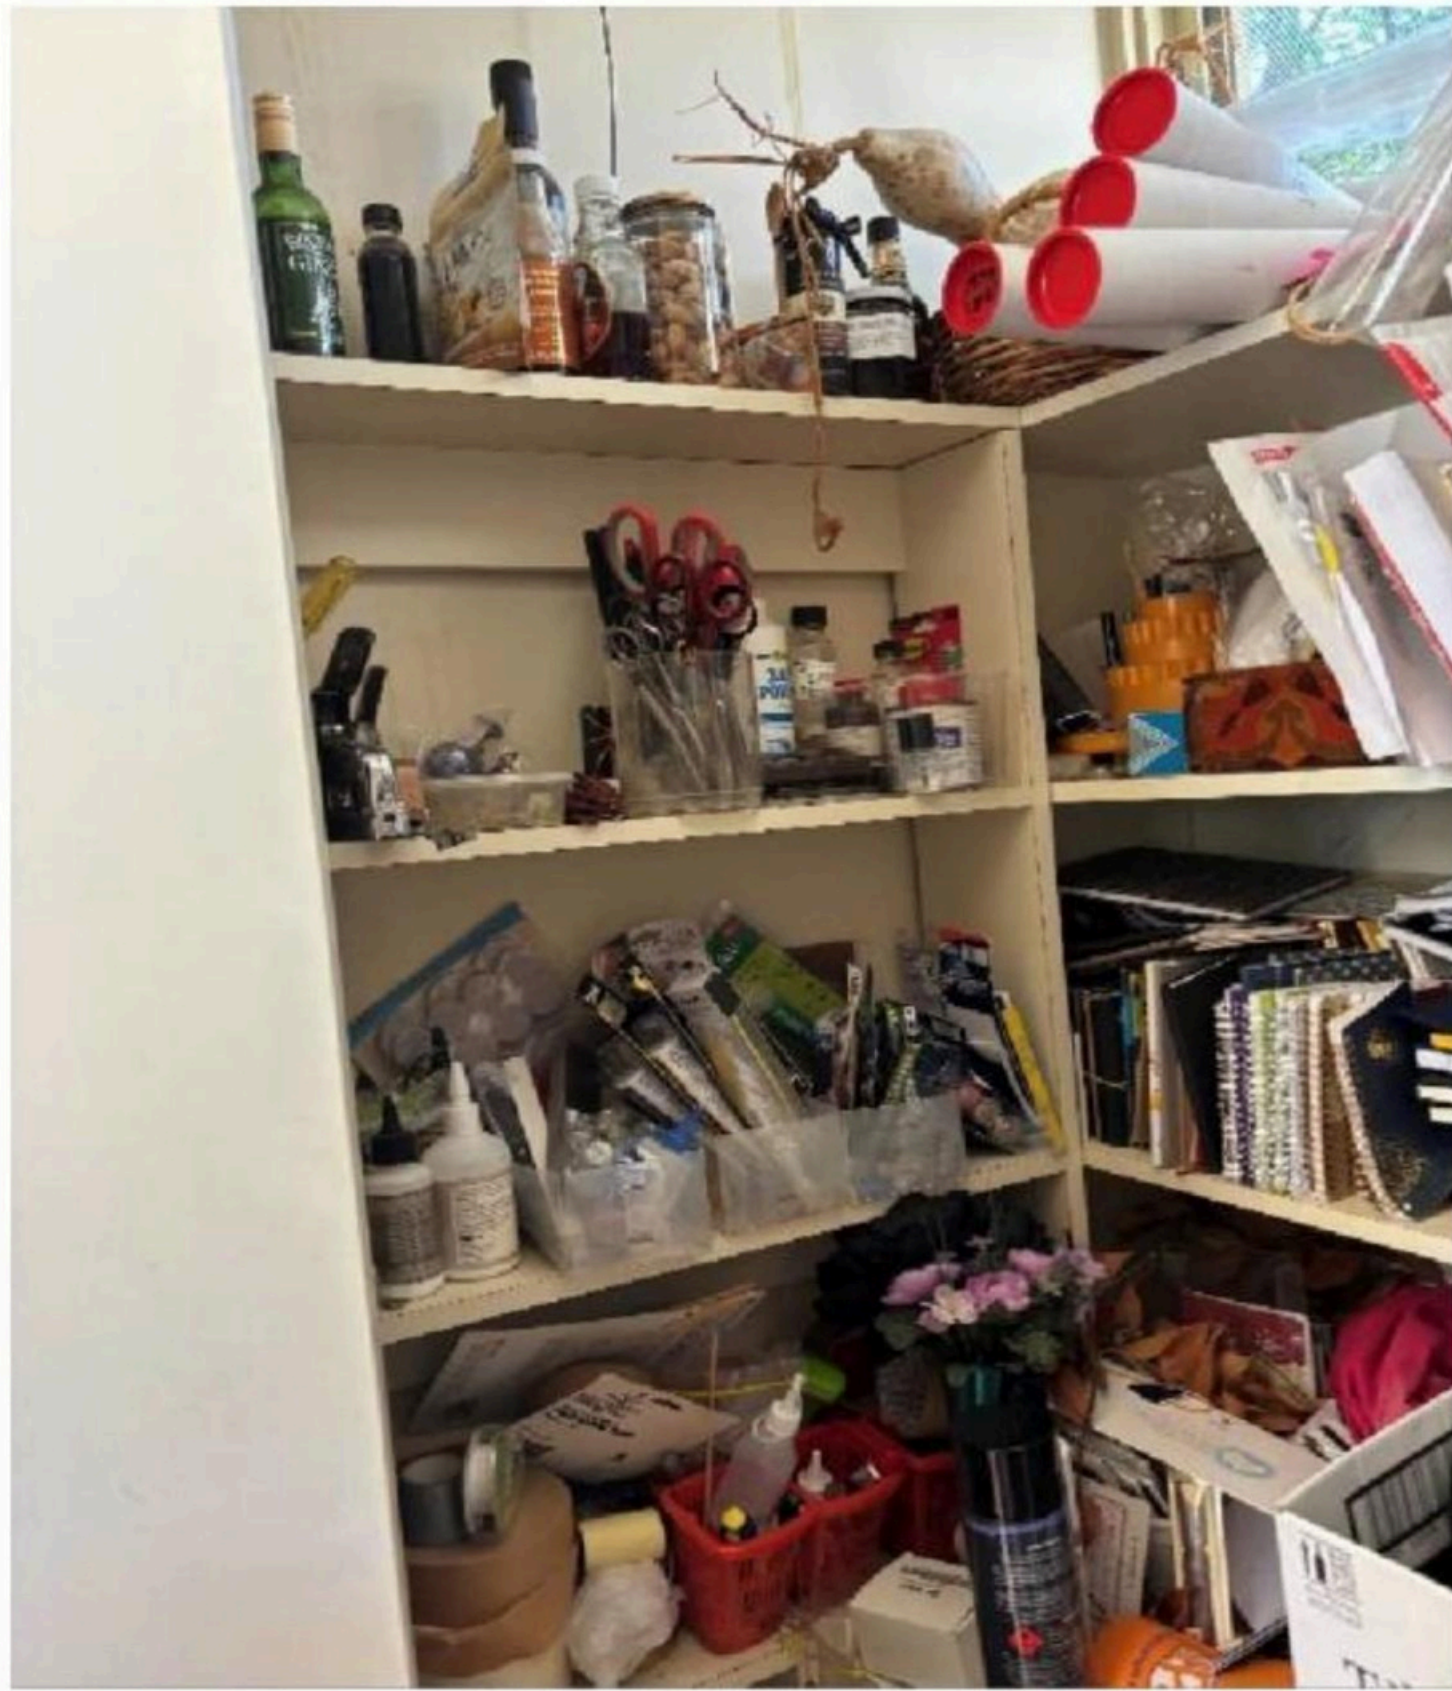
| Office | Evidence of water ingress and water stains on western and Eastern side walls. |

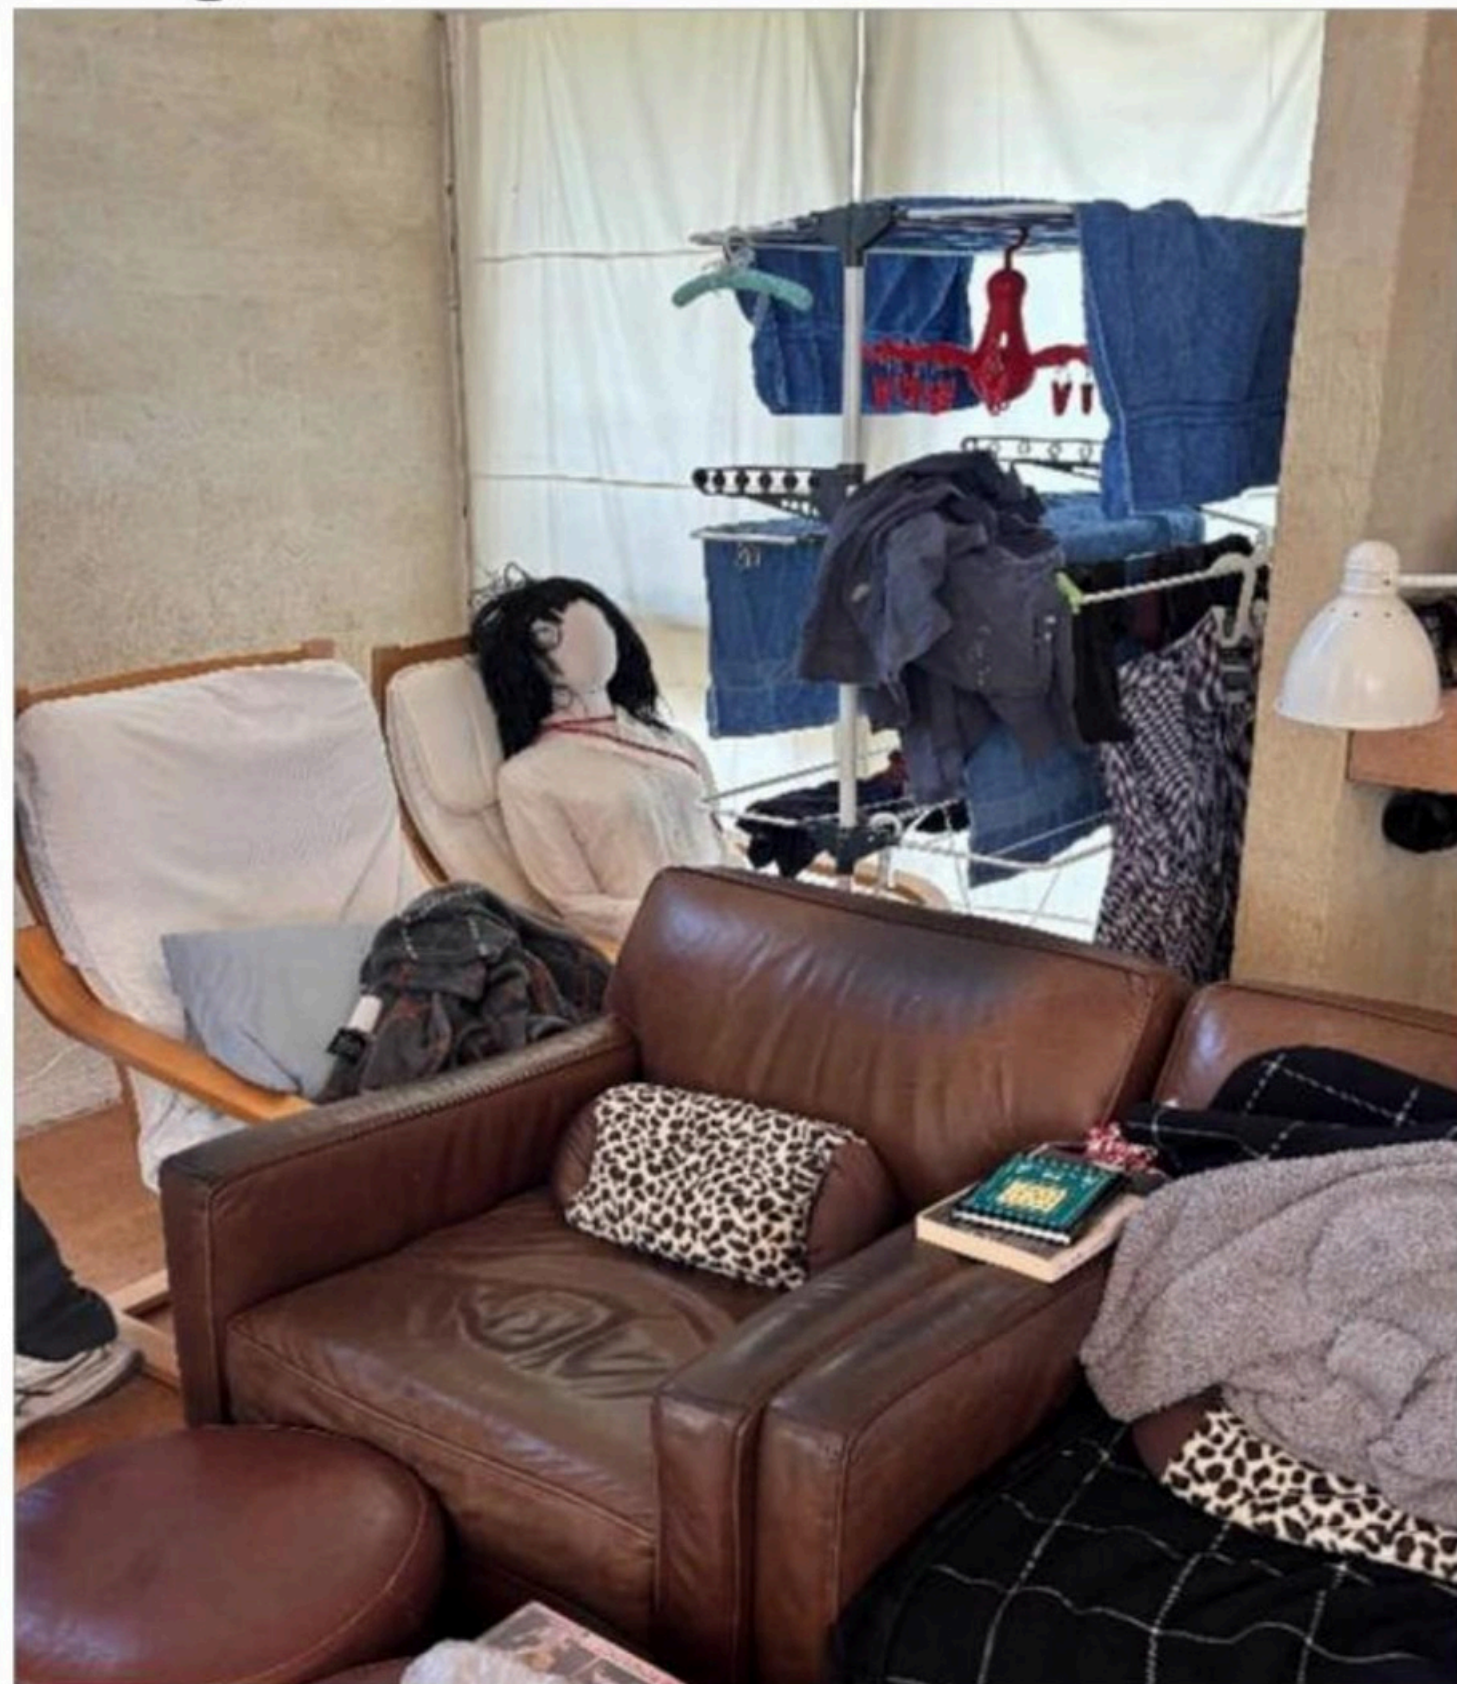
| Living Room | Evidence of water ingress and water stains on western and Eastern side walls.<br>Evidence of fine cracking (step cracking) to southern wall (2 locations).<br>Evidence of fine cracking to western wall at the bottom. |

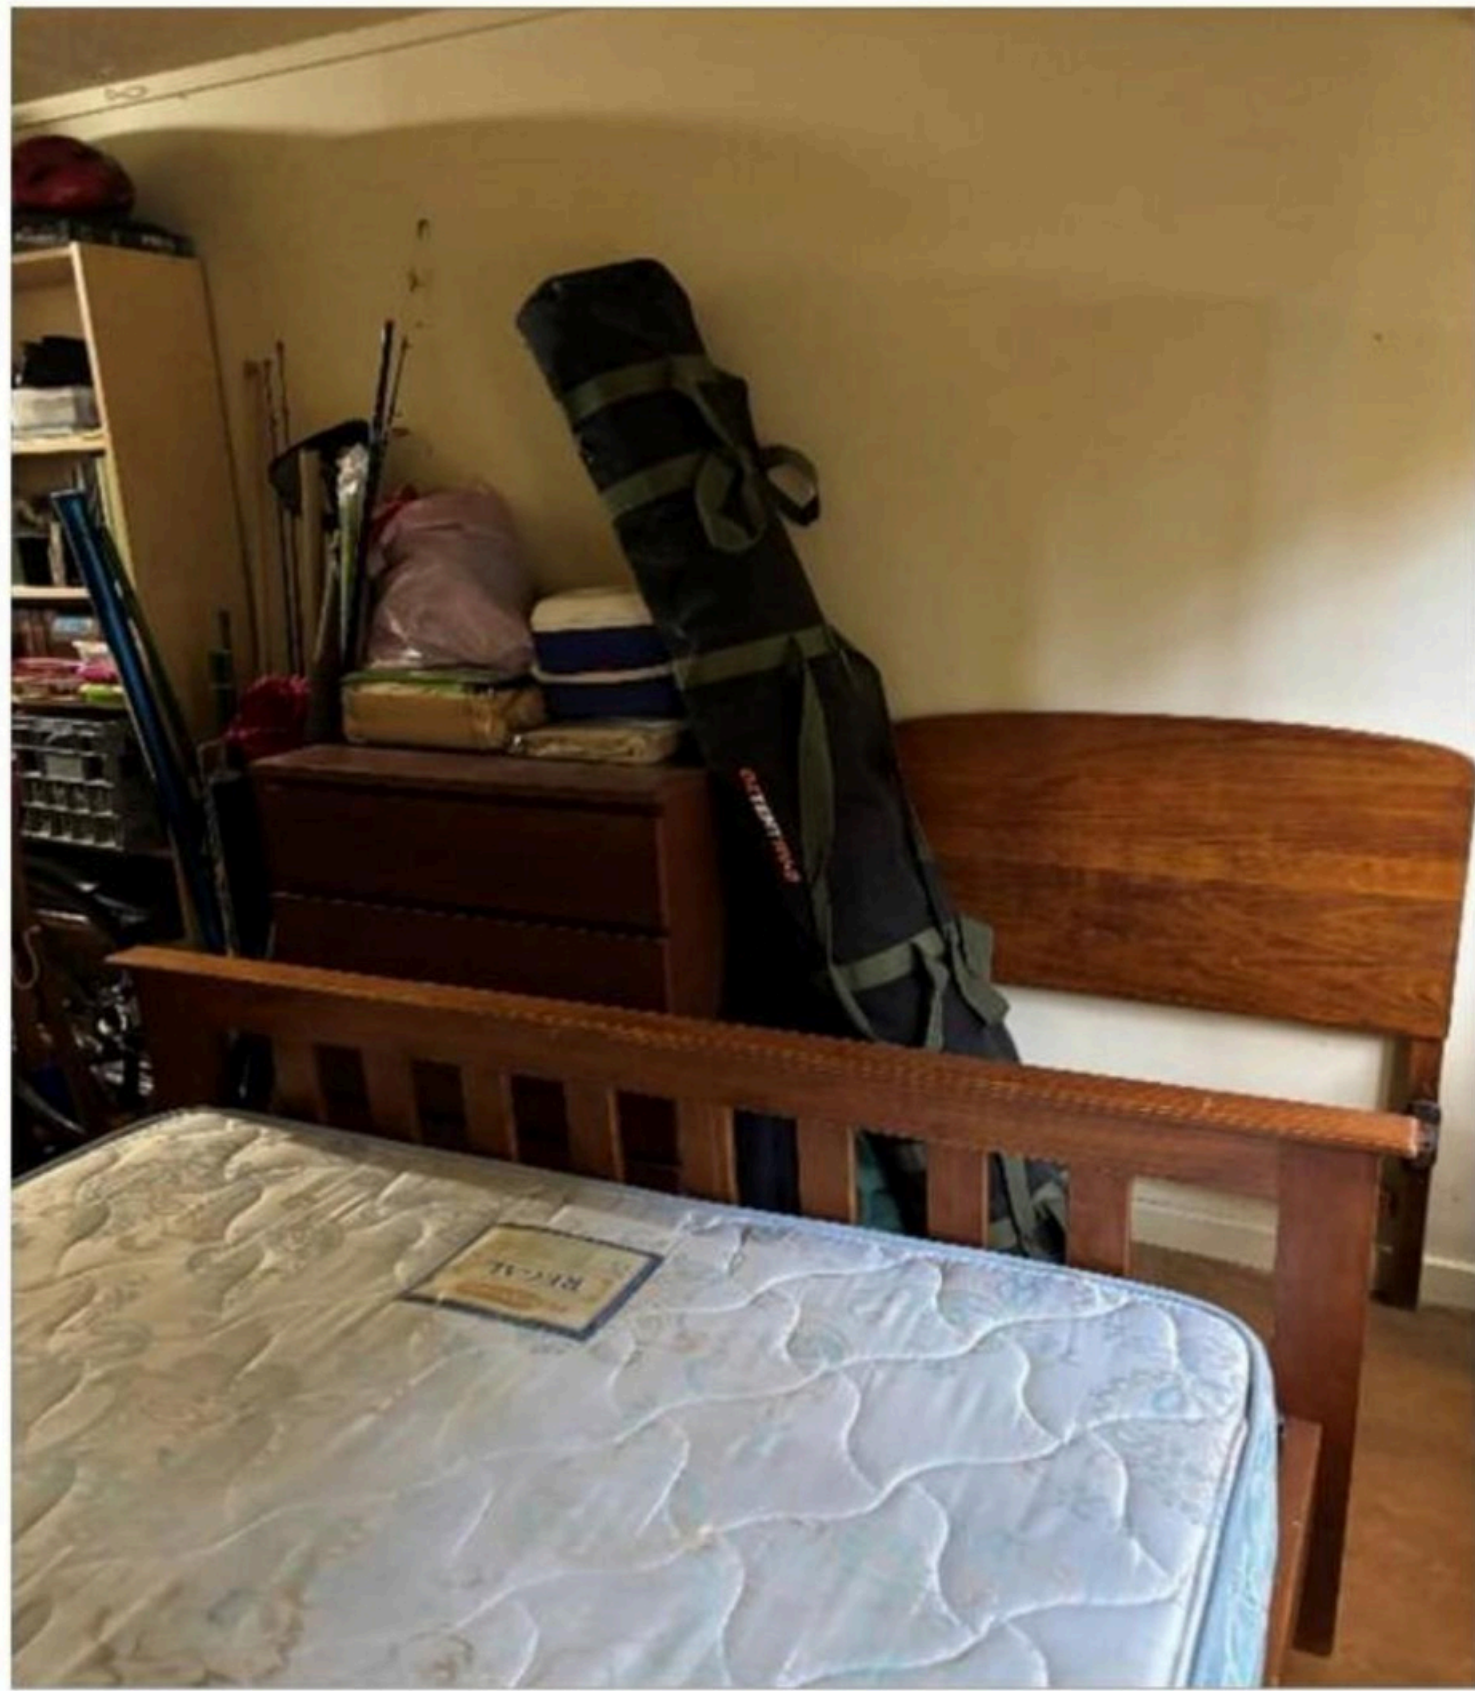
| Bedroom 4 | Evidence of water ingress on western wall.<br>Evidence of efflorescence on ceiling (concrete). |

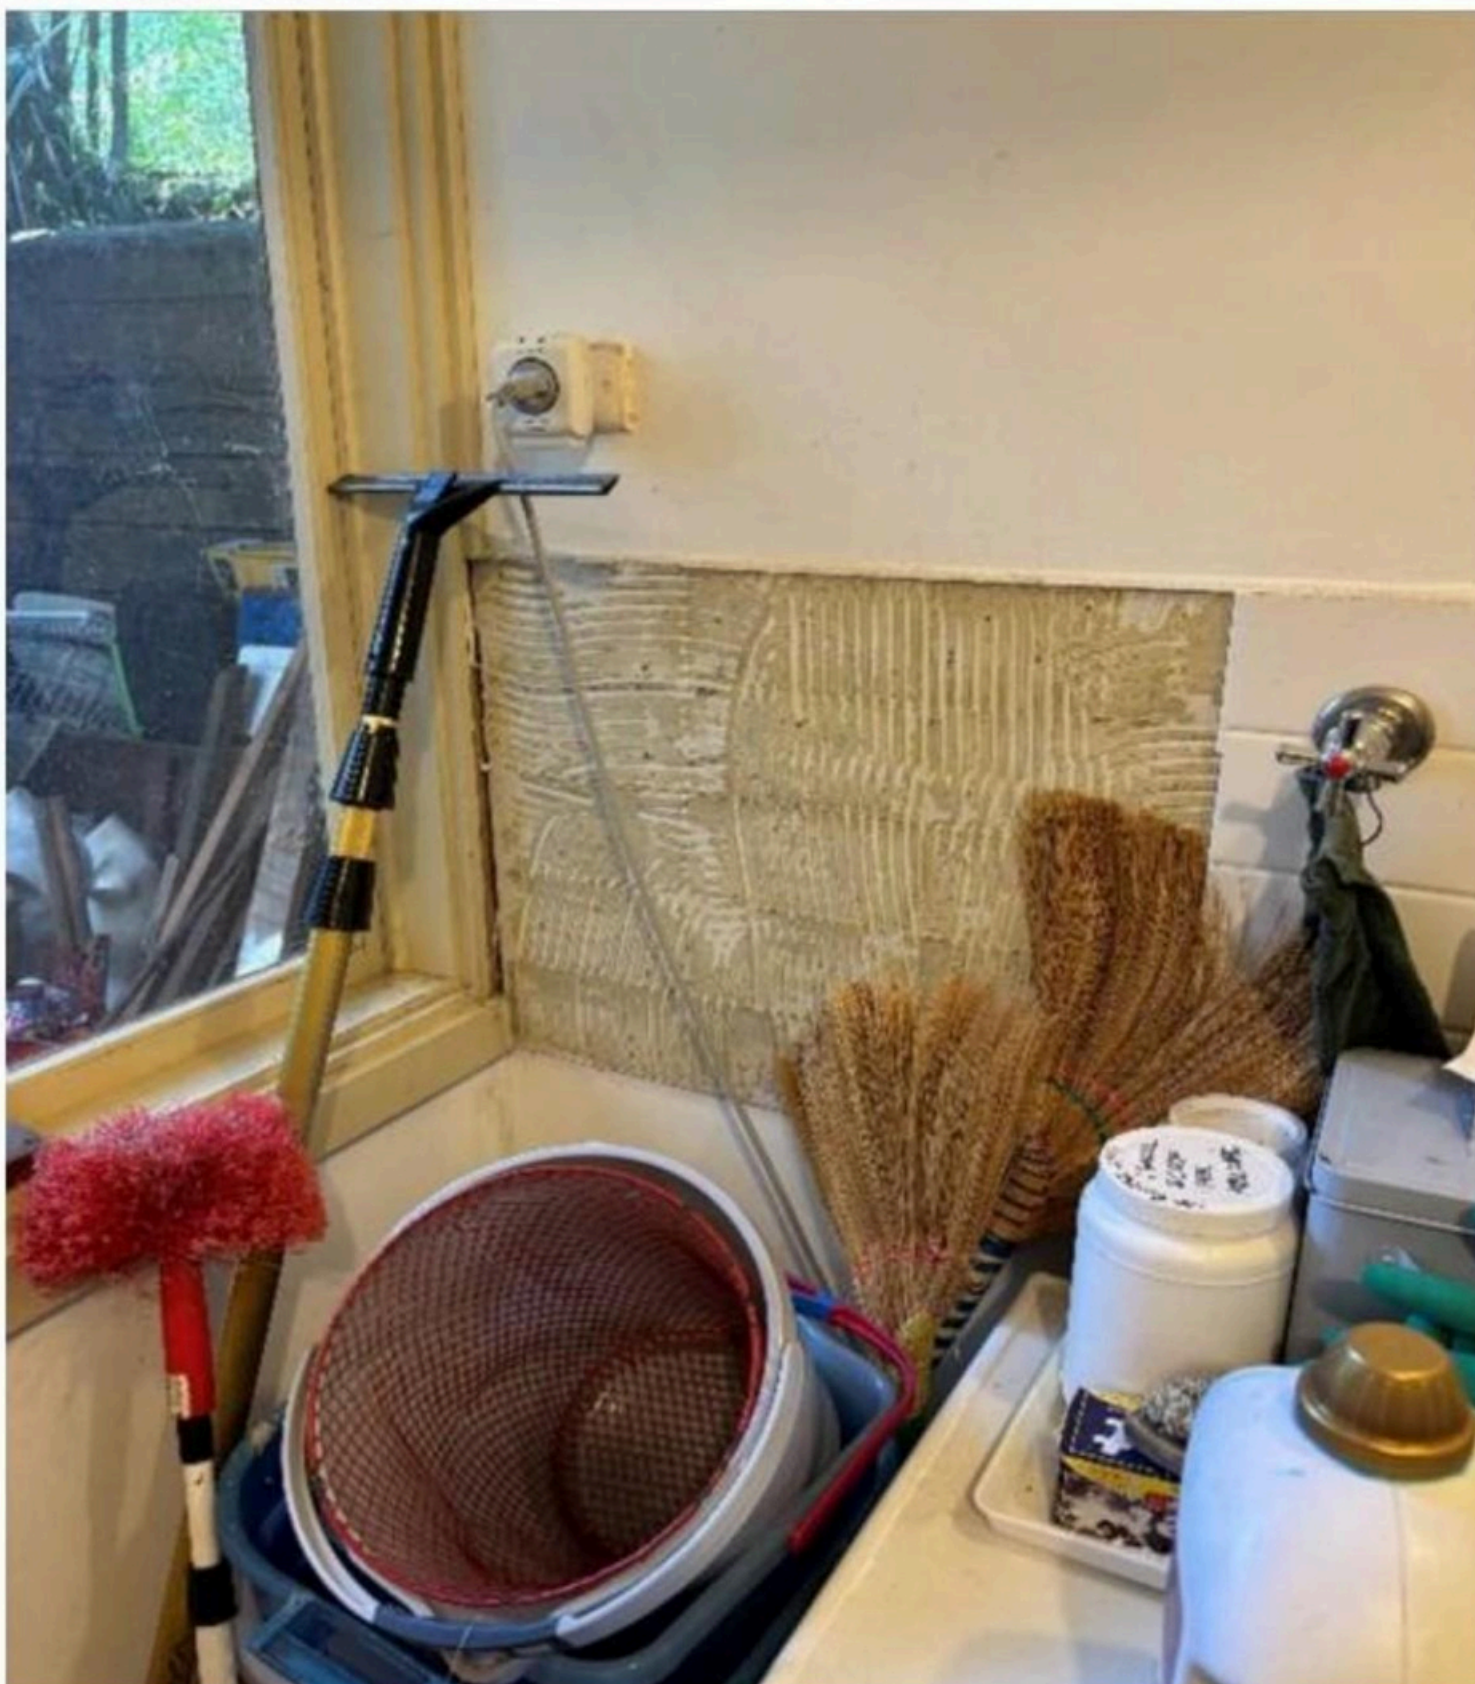
| Laundry | Tiles have fallen off from the laundry wall.<br>Evidence of fine cracking to northern wall adjacent to door. |

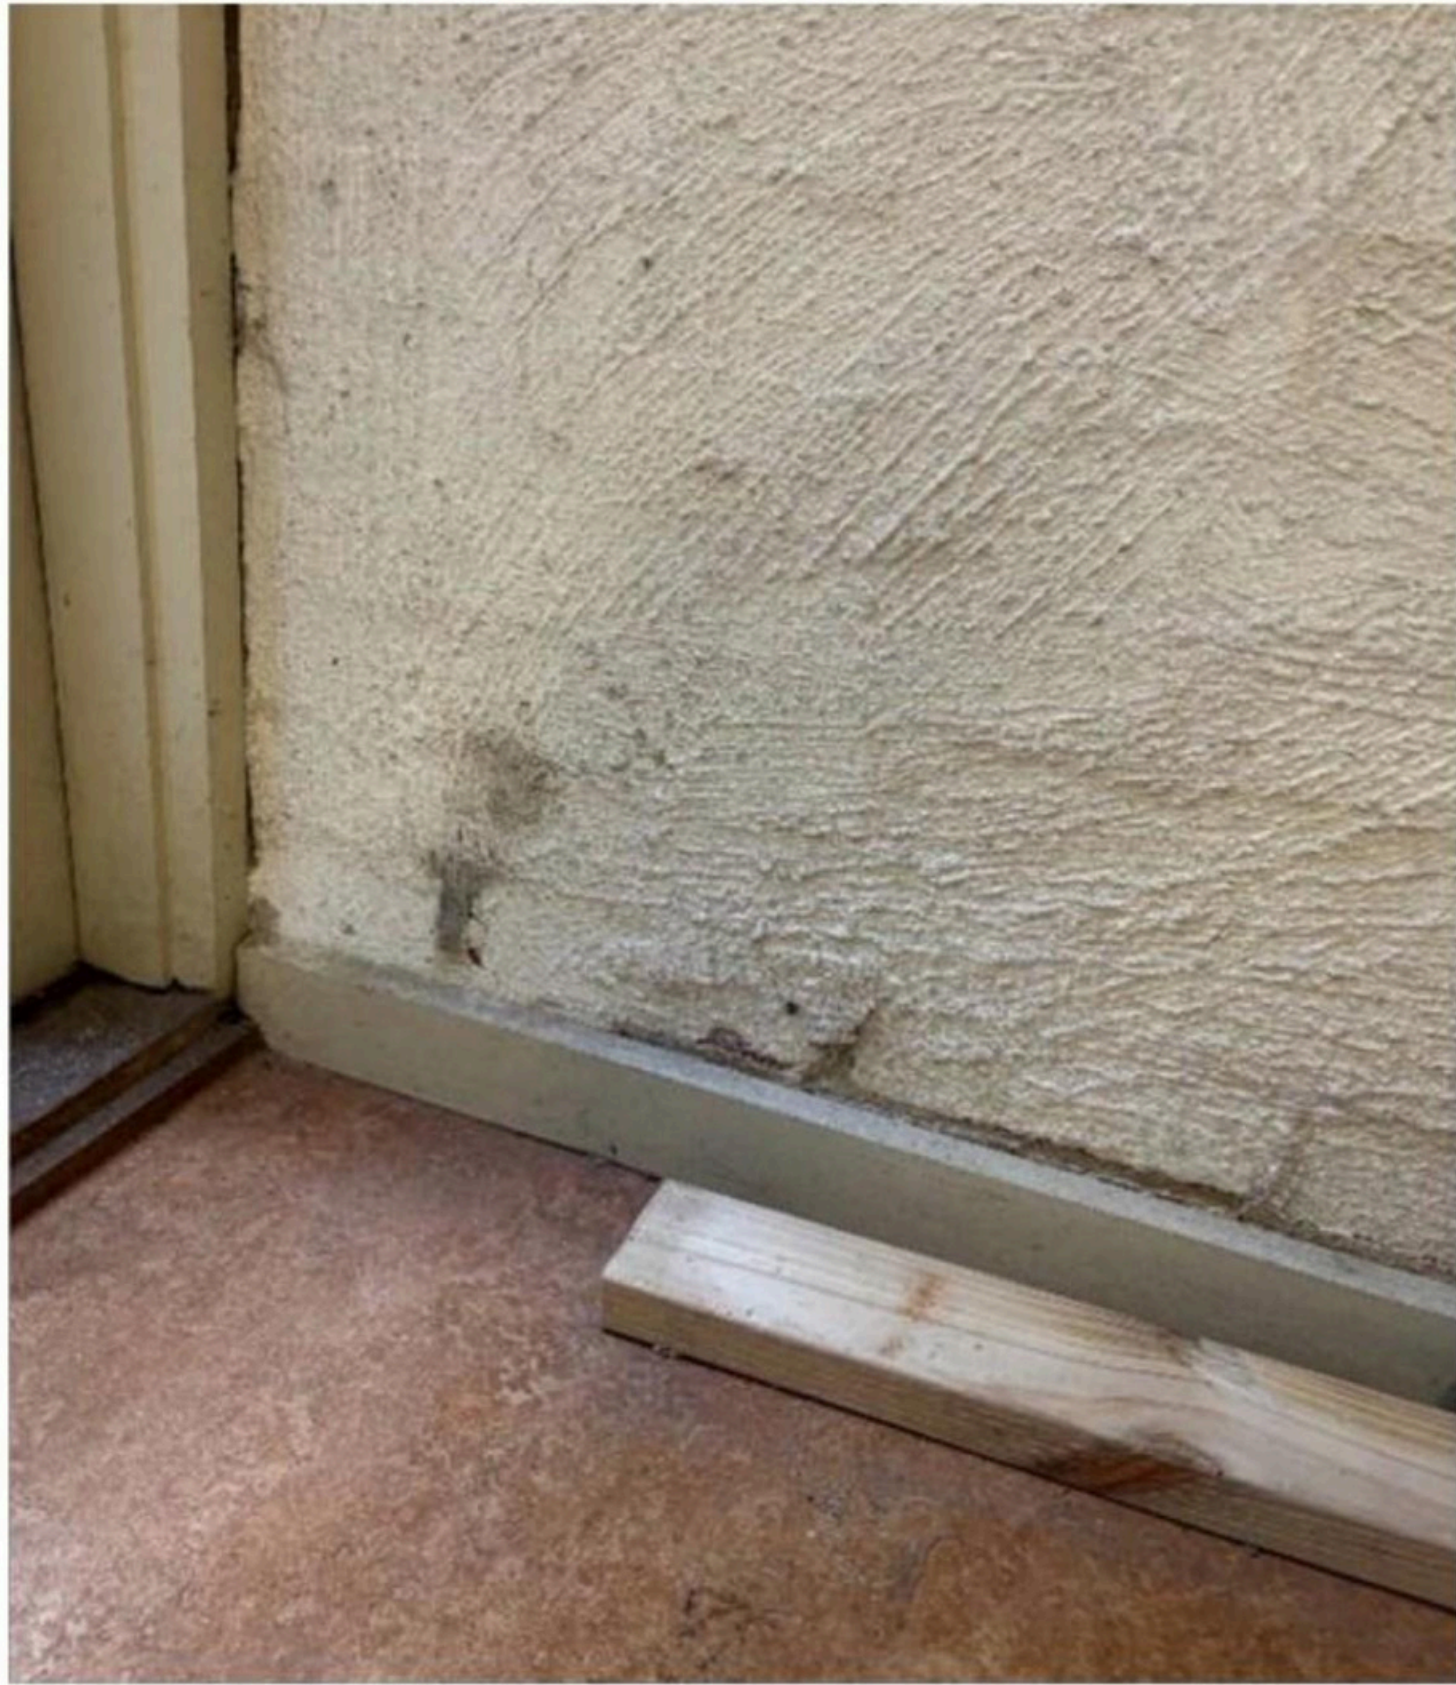
| Downstairs office | Evidence of fine cracking to northern wall adjacent to door.<br>Evidence of water ingress and water damage on south wall. |

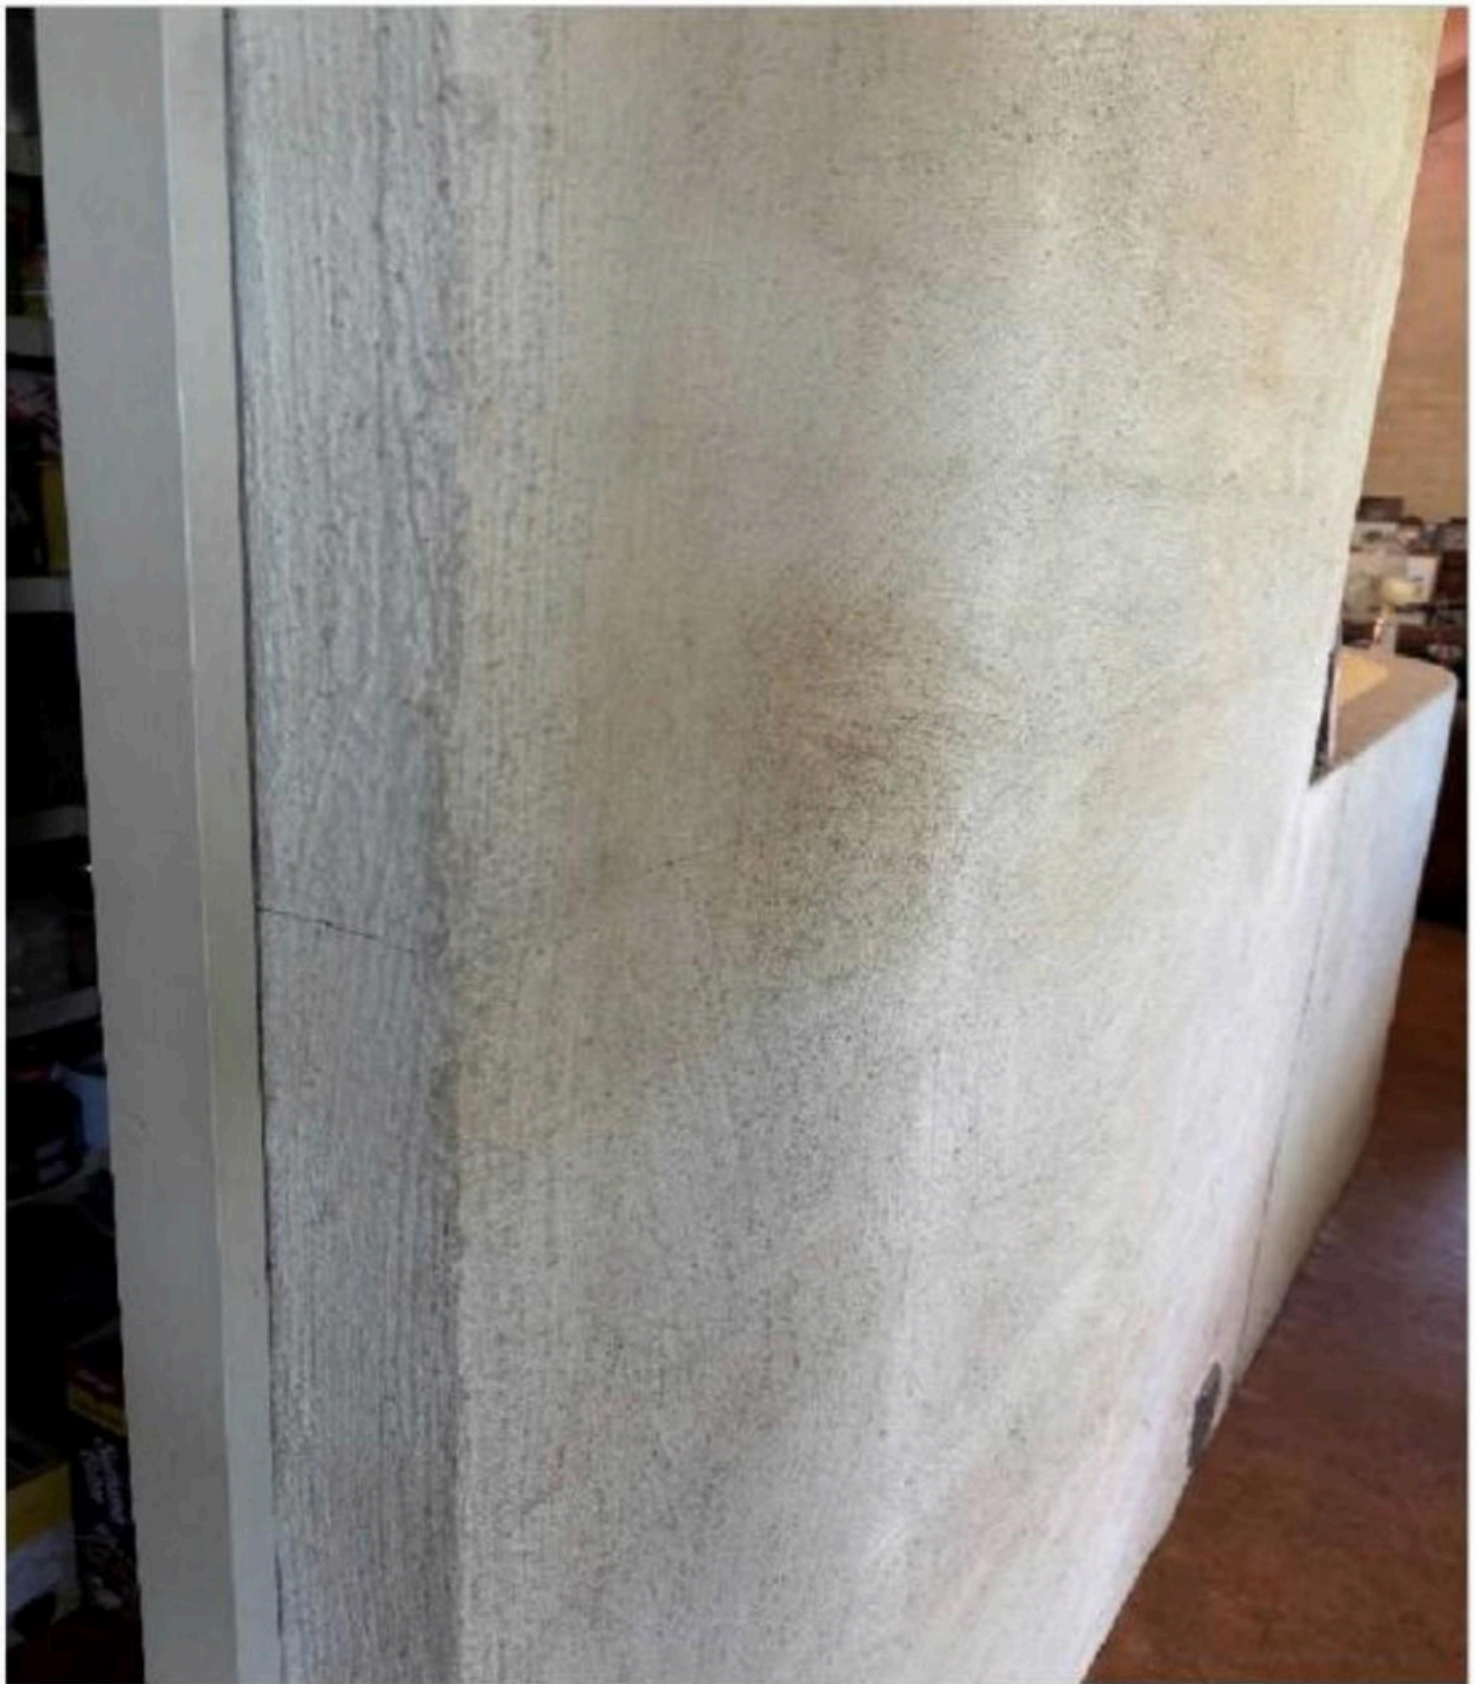
Kitchen Evidence of fine cracking to northern wall.  
Evidence of water damage (severe) to ceiling & water ingress.
