## Just Inspections

## Building Inspection Report

AS4349.1- 2007

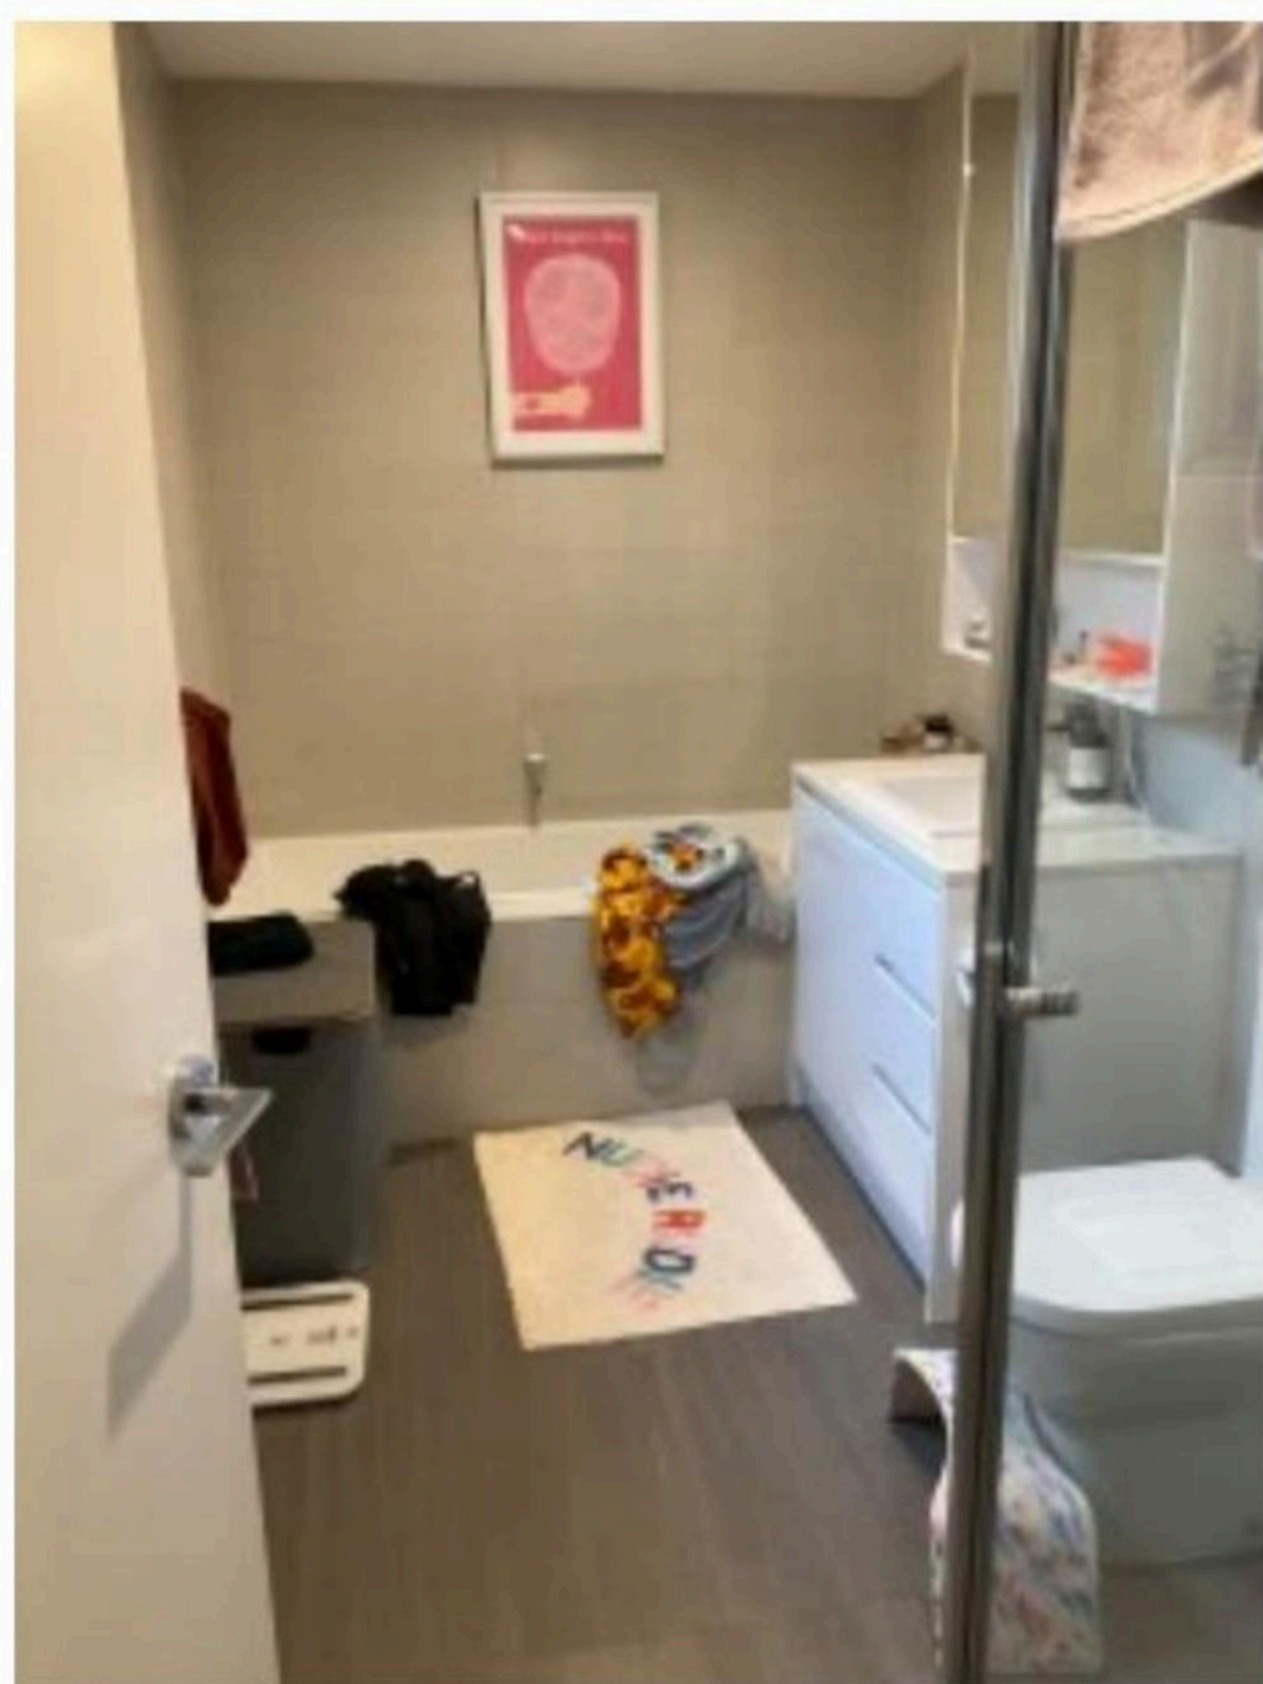
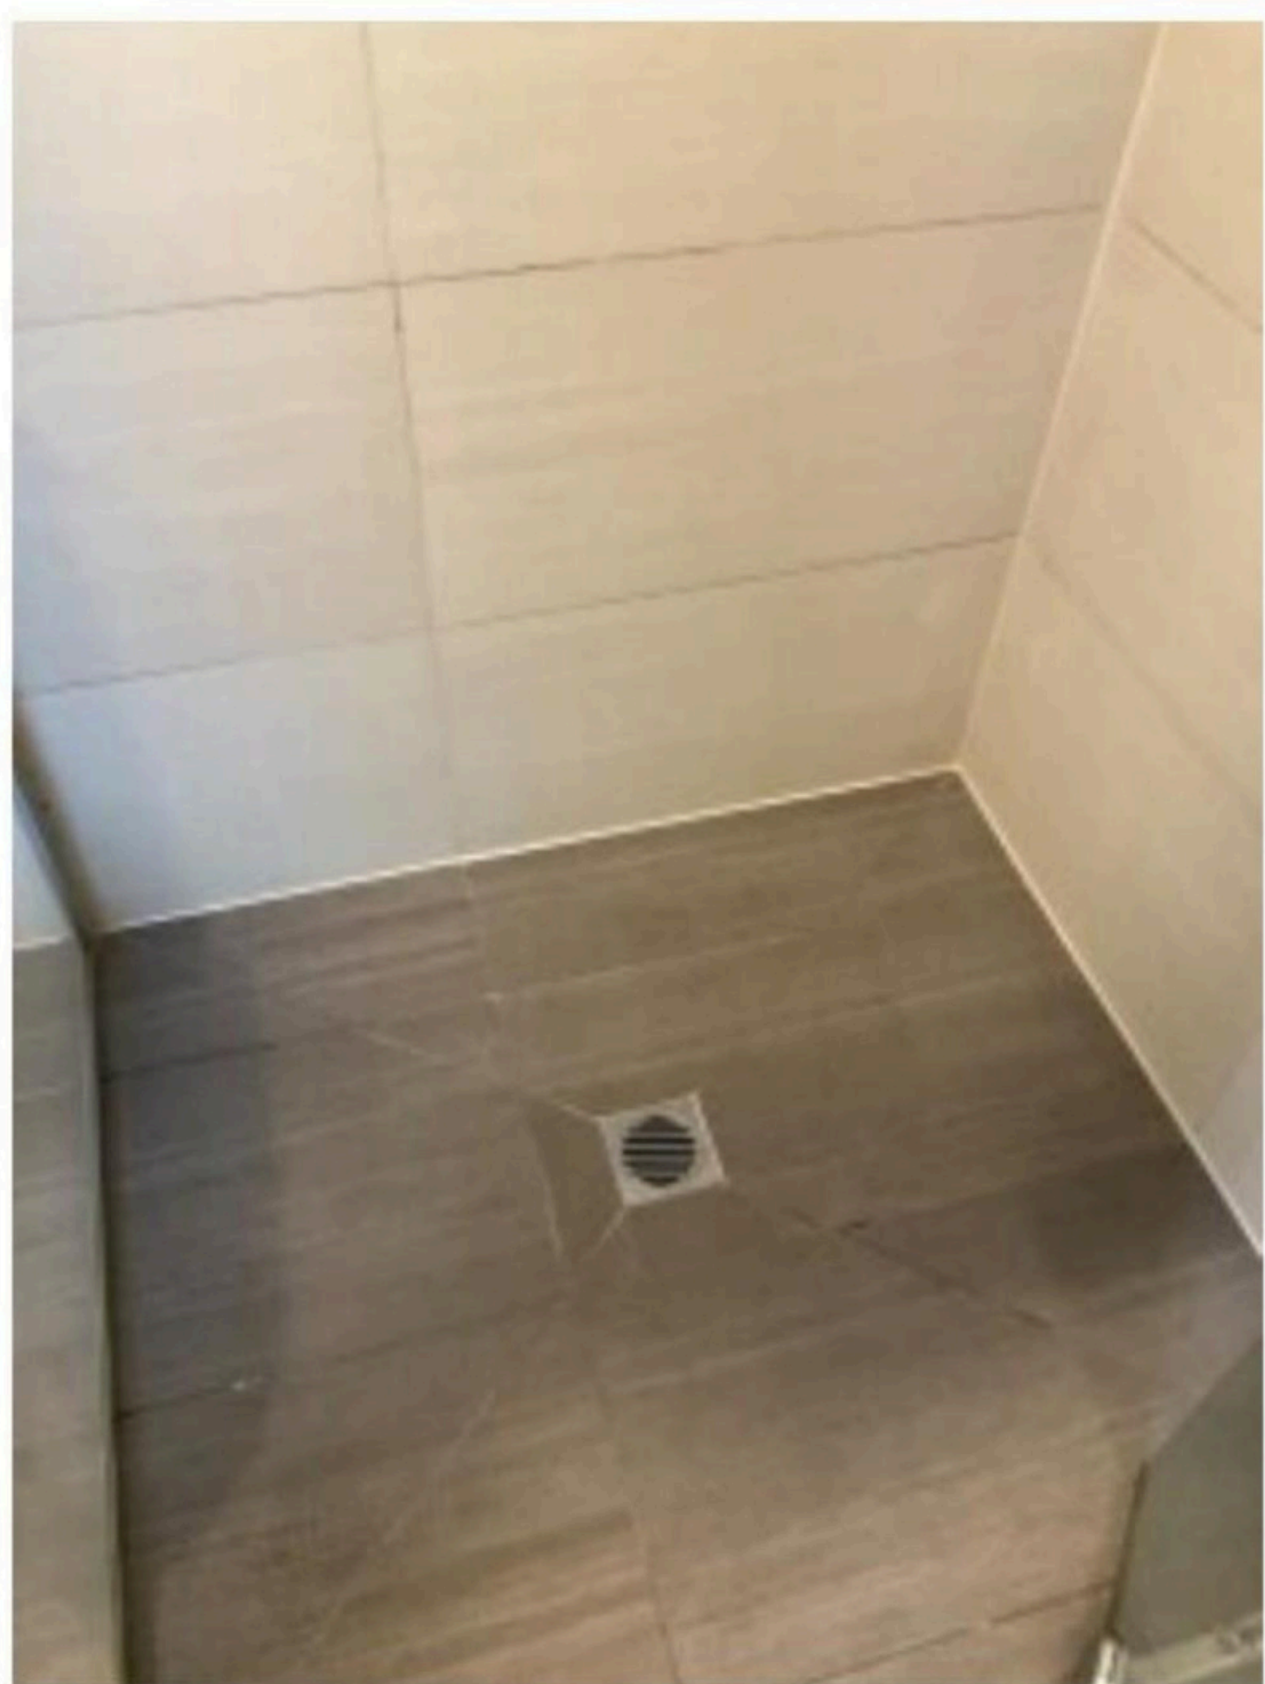
Visible signs of mould growth on the wall tiles and shower base in the bathroom. Recommend regular cleaning to prevent grout deterioration

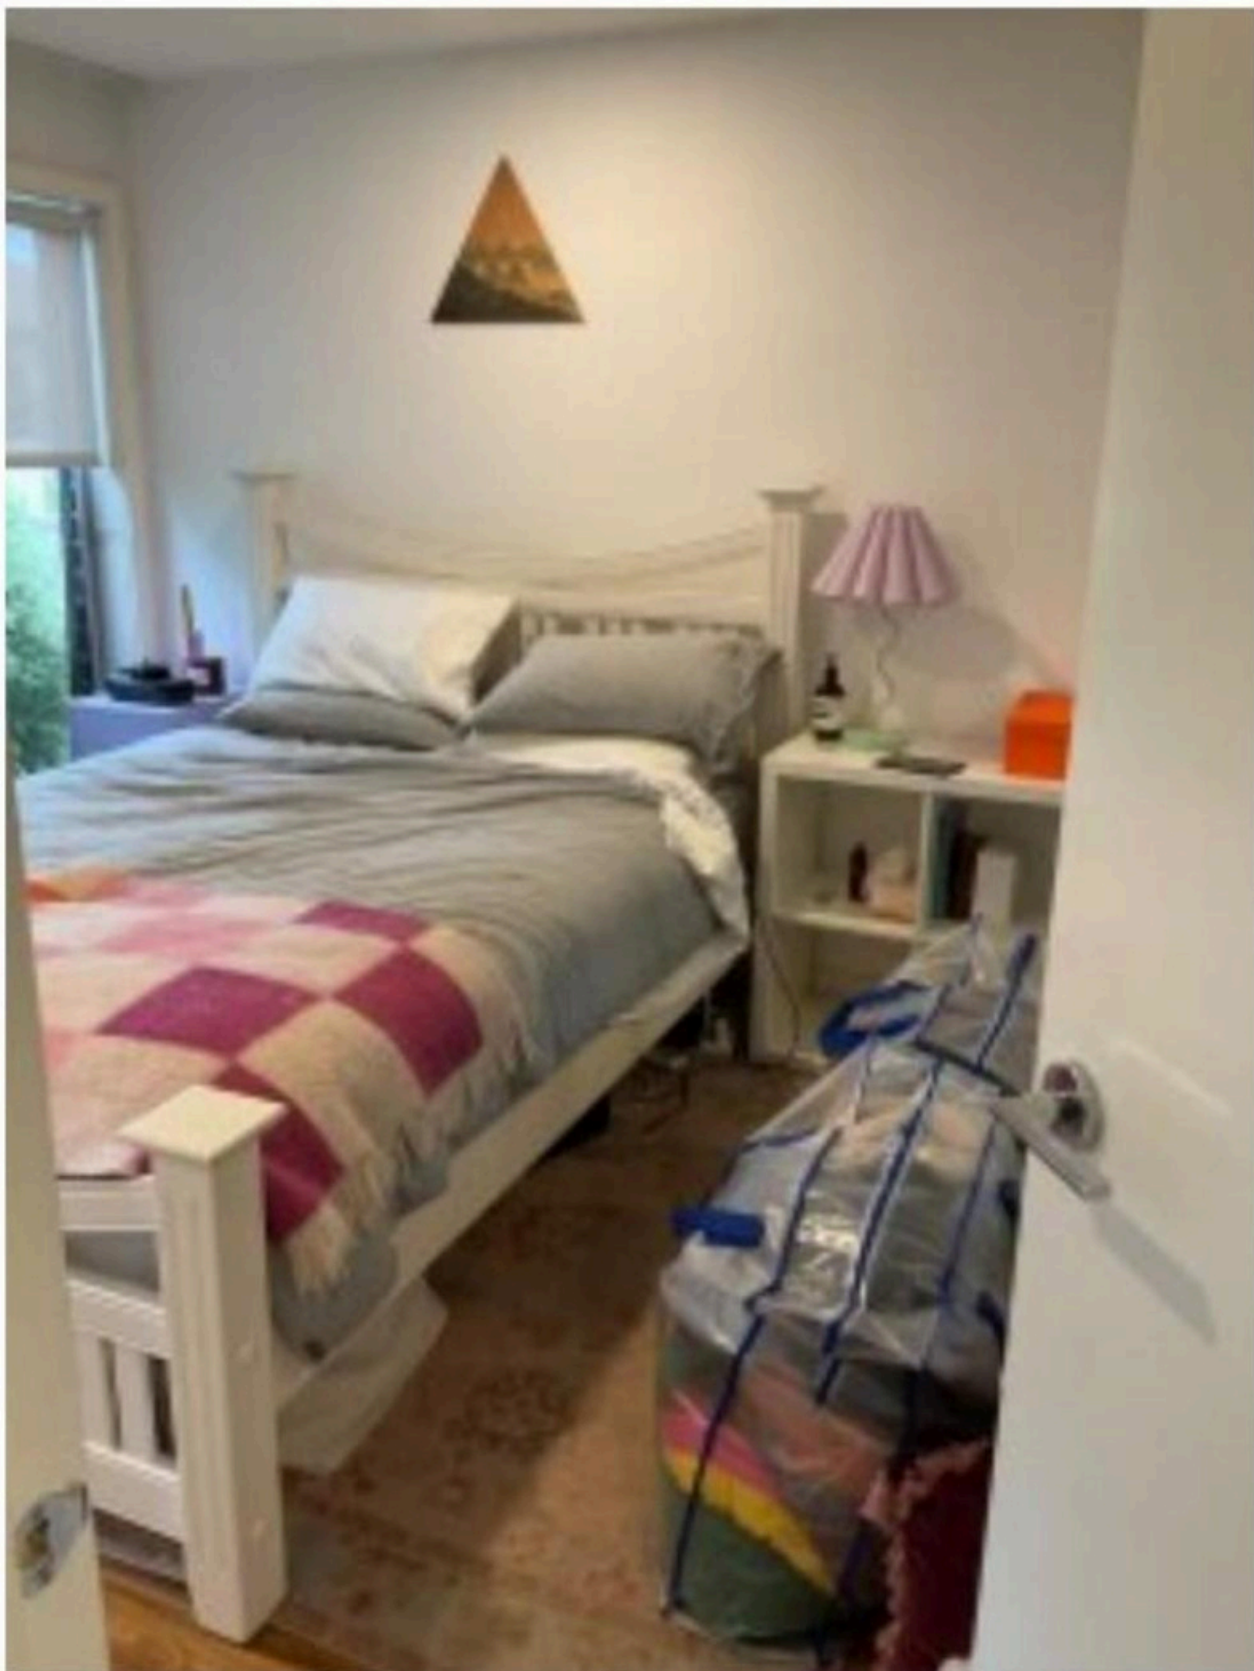
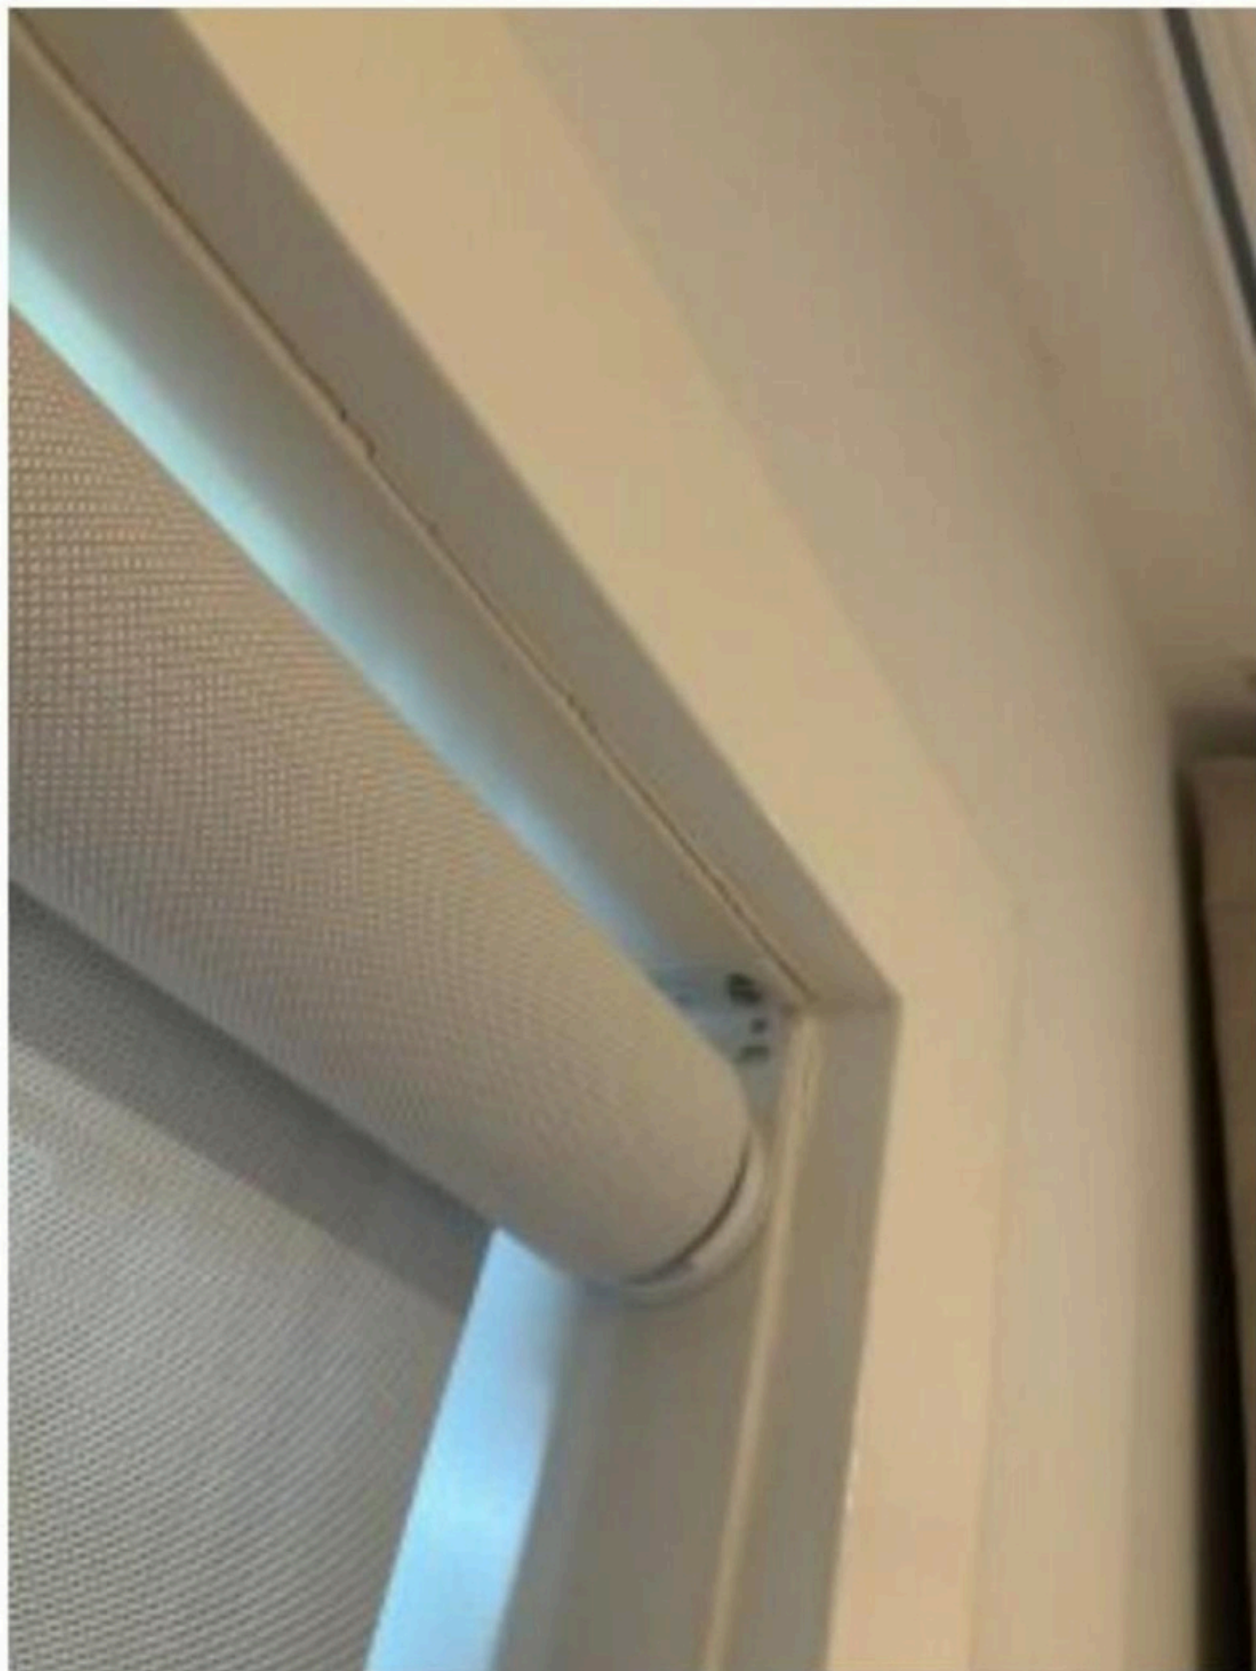
The window frame exhibits noticeable cracking along the inner edges, which could indicate minor structural movement or settling. Though currently superficial, these cracks may allow moisture ingress over time if not promptly sealed and maintained. Regular monitoring and timely repairs are recommended to prevent potential deterioration.

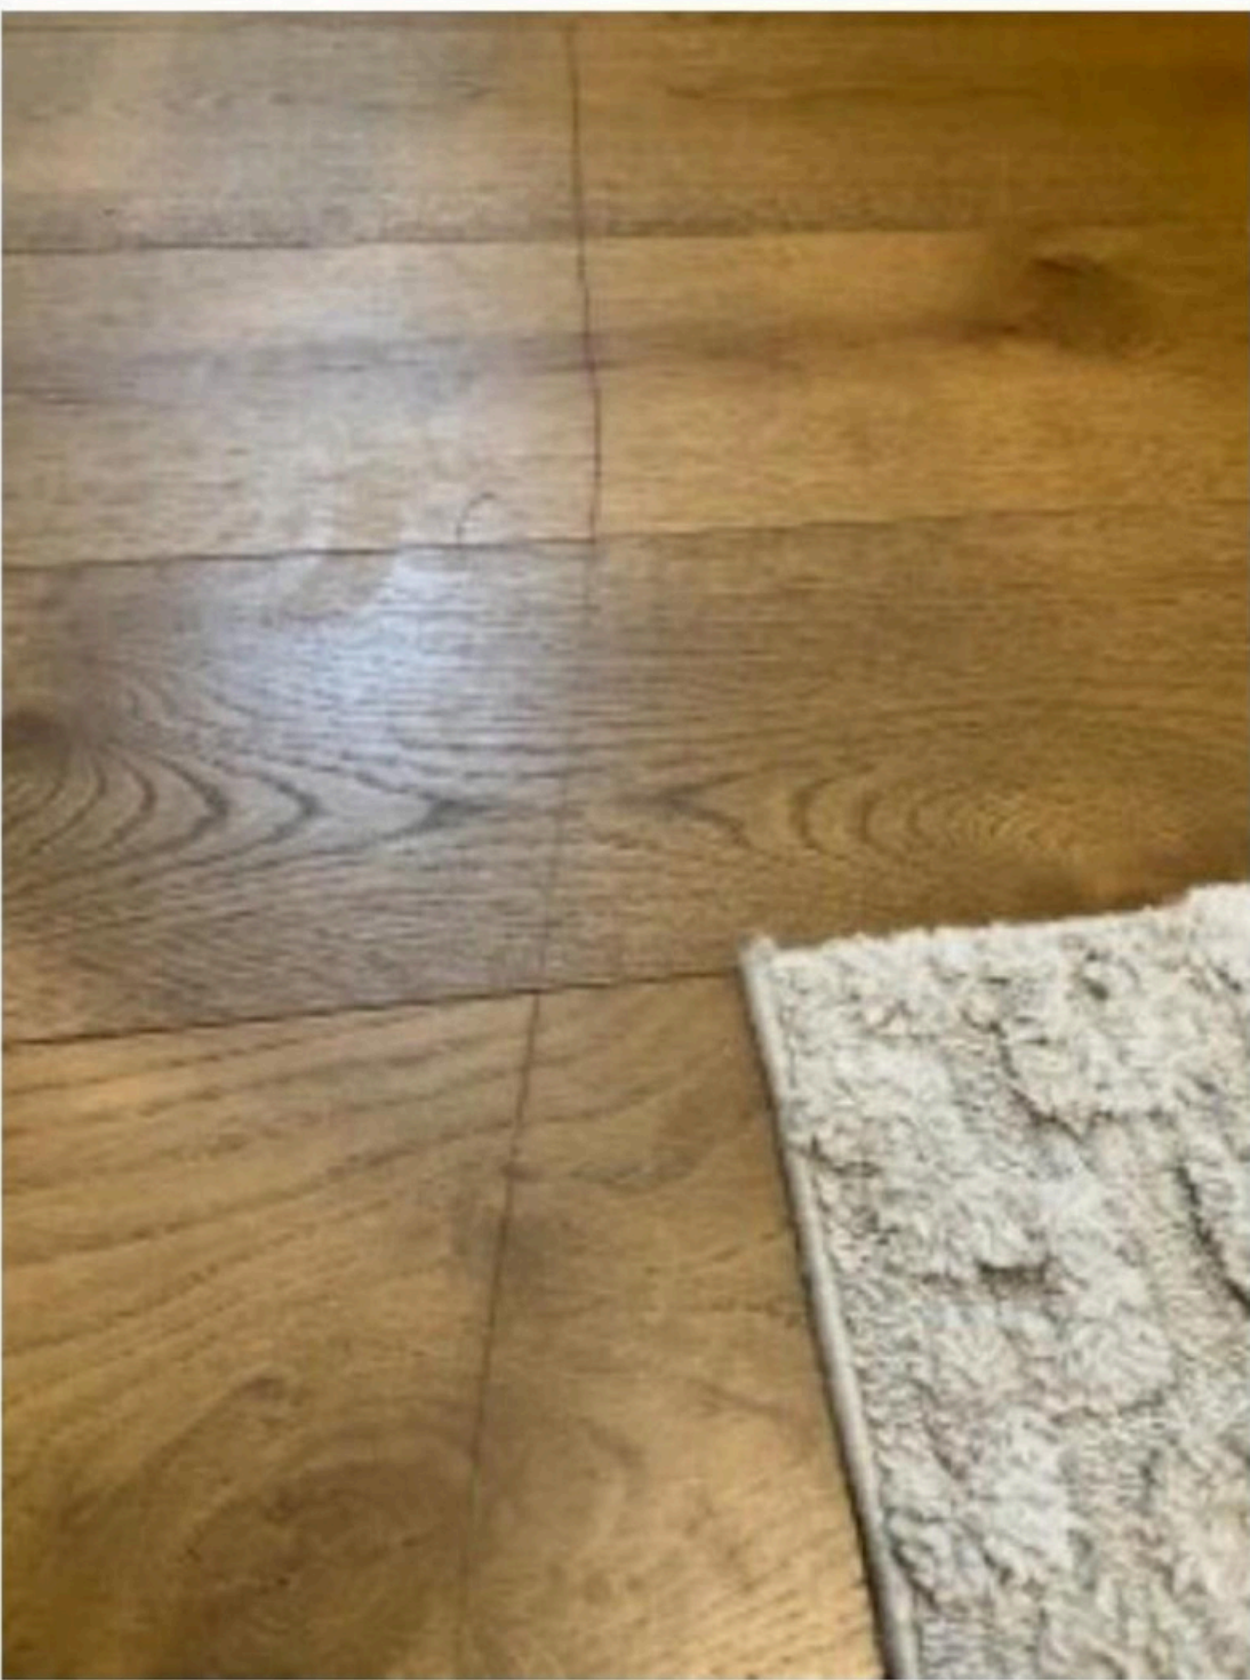
The image indicates a scratch on a timber floorboard. This defect could compromise the aesthetic appeal. Further inspection is recommended to determine the cause and assess whether repairs or replacements are necessary.

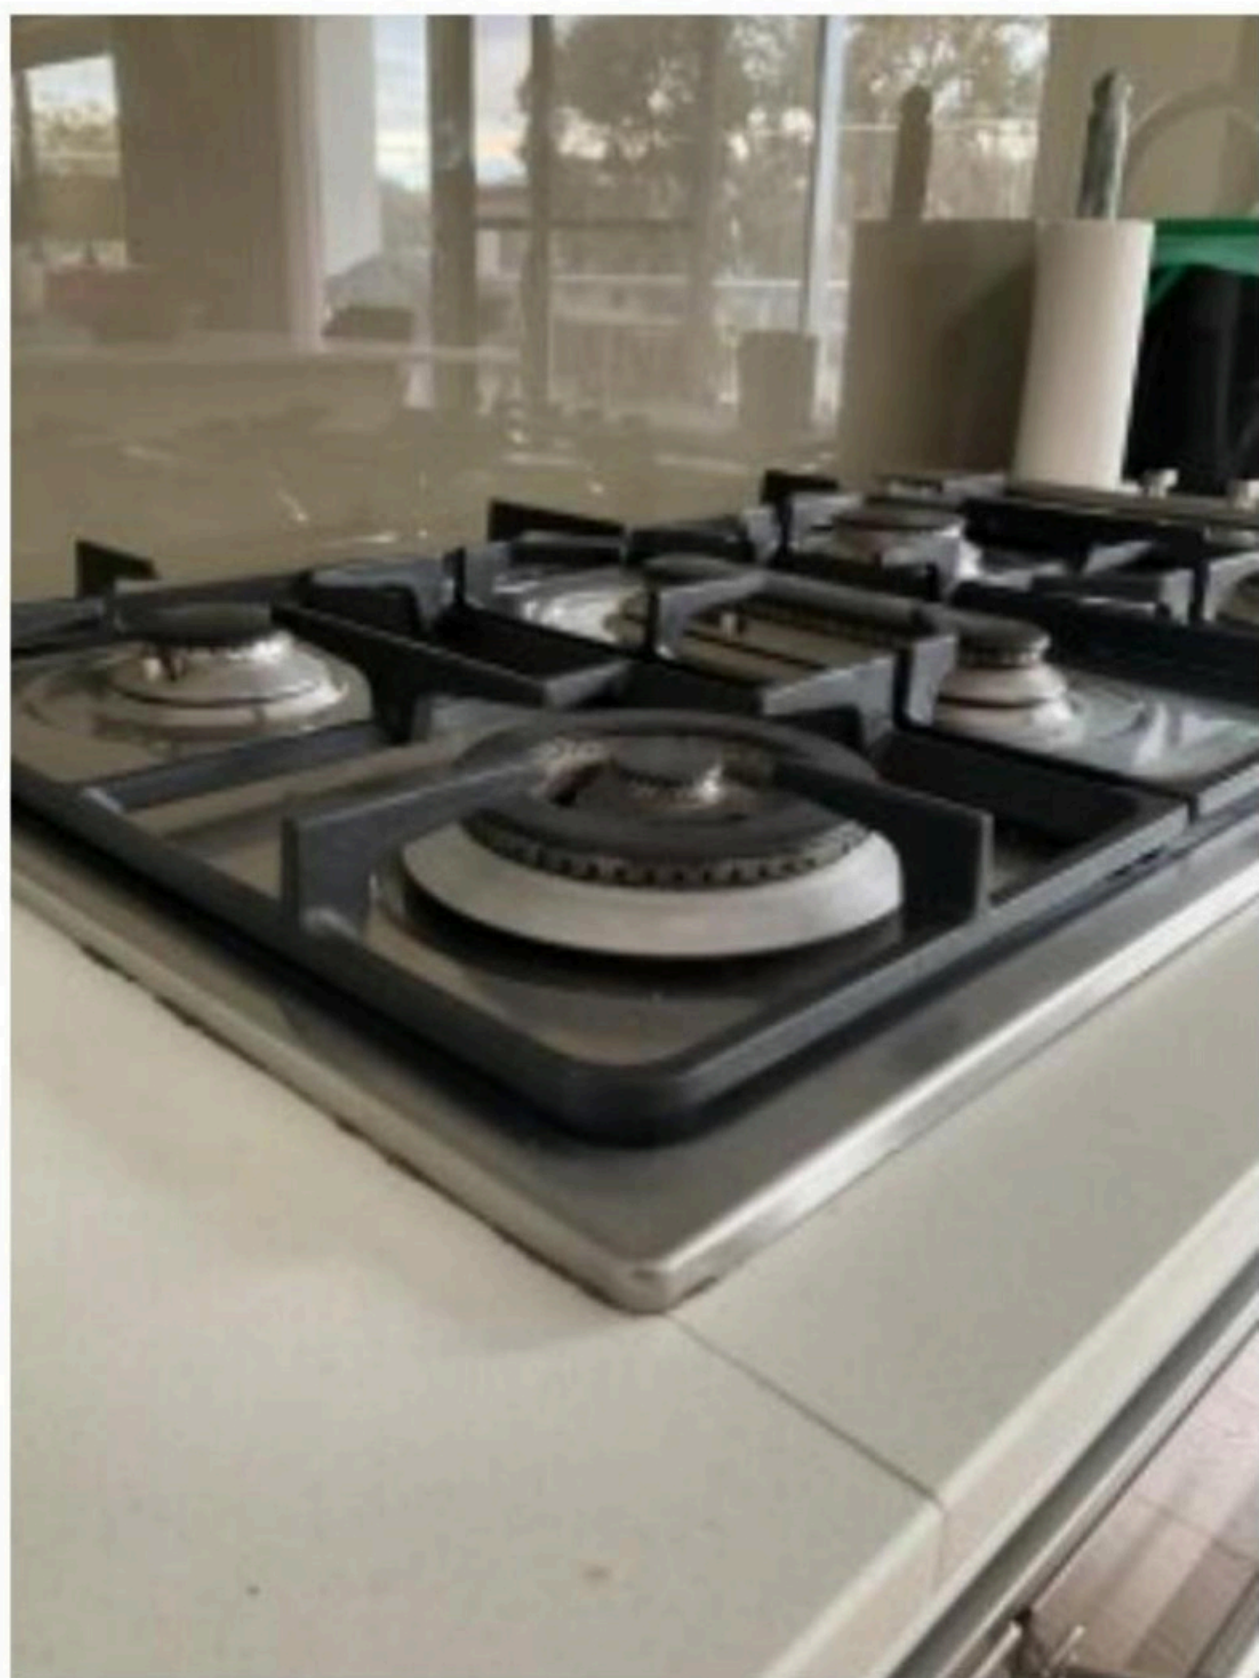
The gas cooktop installation shows sealant deterioration between the appliance and the surrounding countertop, which may result in moisture entry and accumulation. The lack of a proper seal may also compromise the countertop’s integrity over time. It is recommended to have a qualified tradesperson address this issue by ensuring a secure and well-sealed fit to prevent potential deterioration and maintain the kitchen’s overall functionality and appearance.

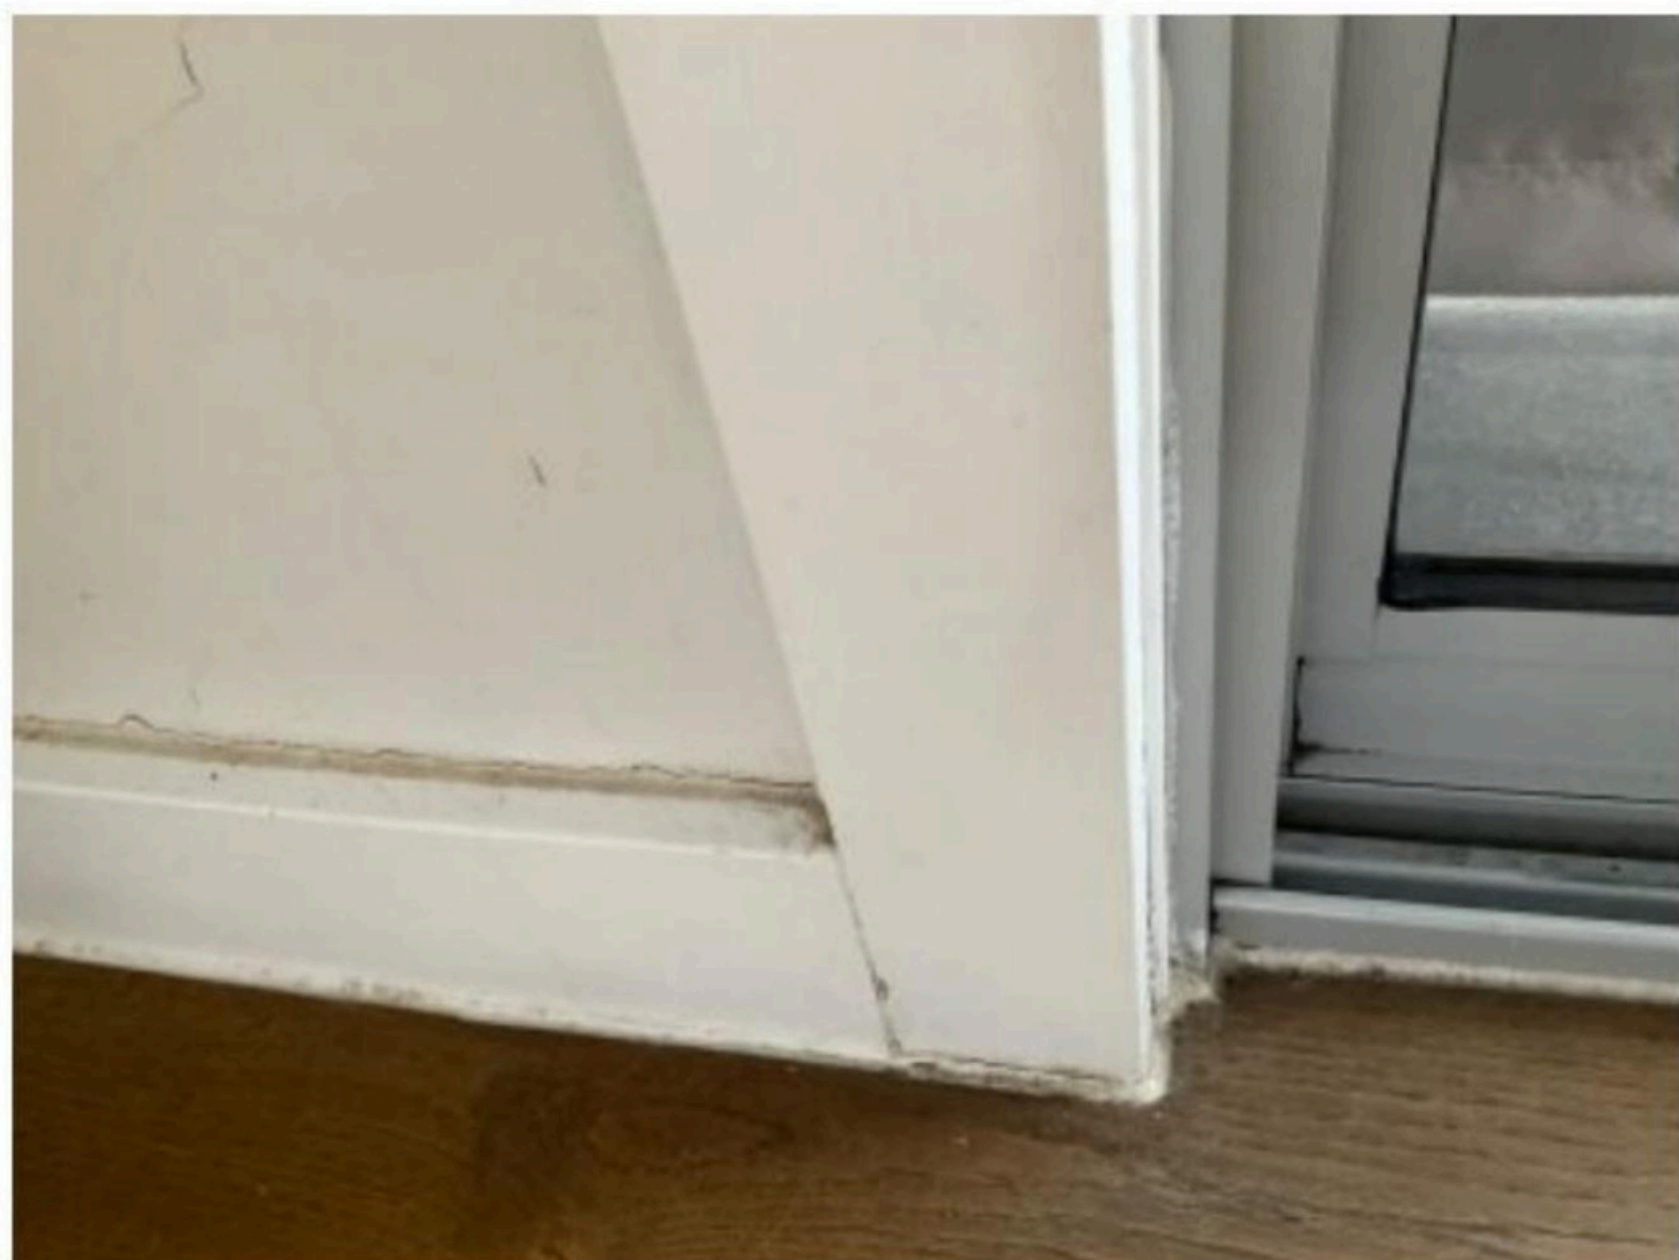
The image presents evidence of minor cracks and gaps in the wall near the door frame. The separation between the wall and floor potentially allowing moisture ingress. It is advisable to repair the gaps to ensure the integrity of the structure is maintained and to prevent future complications.

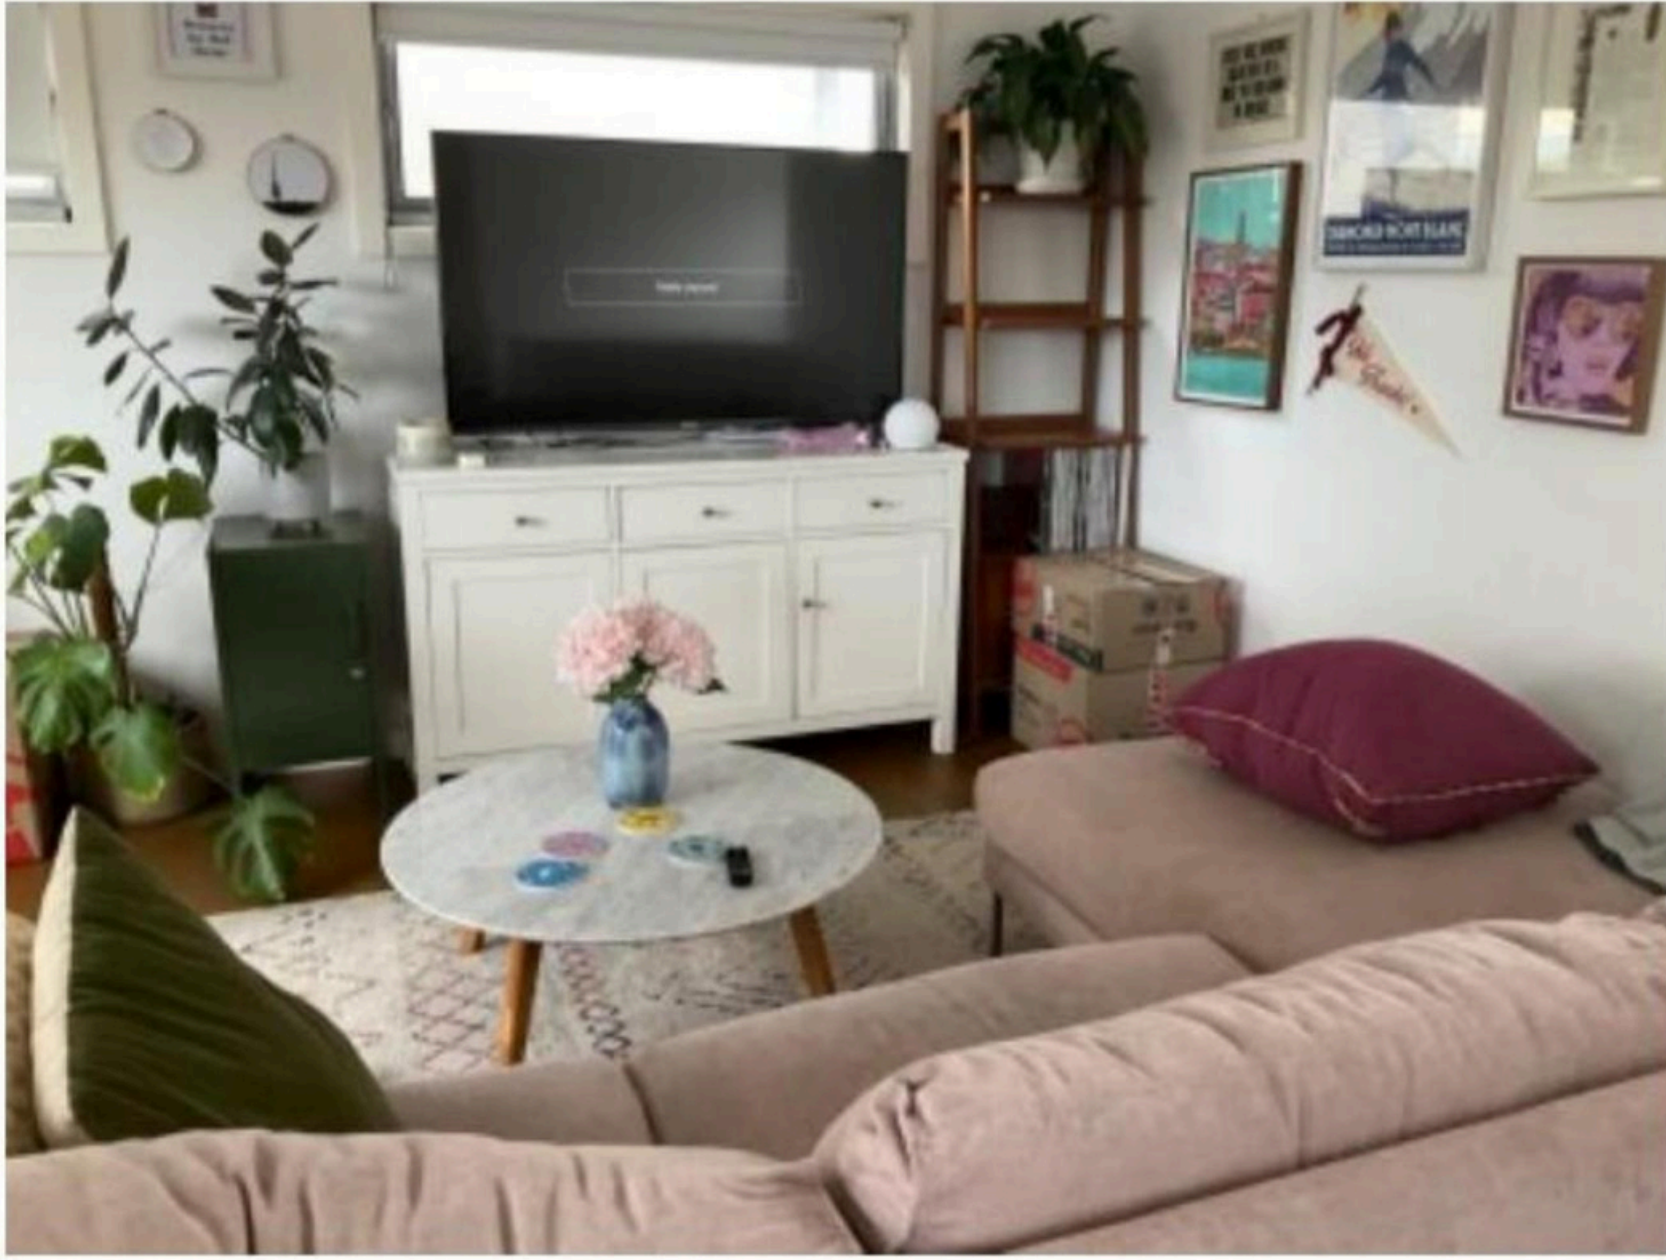
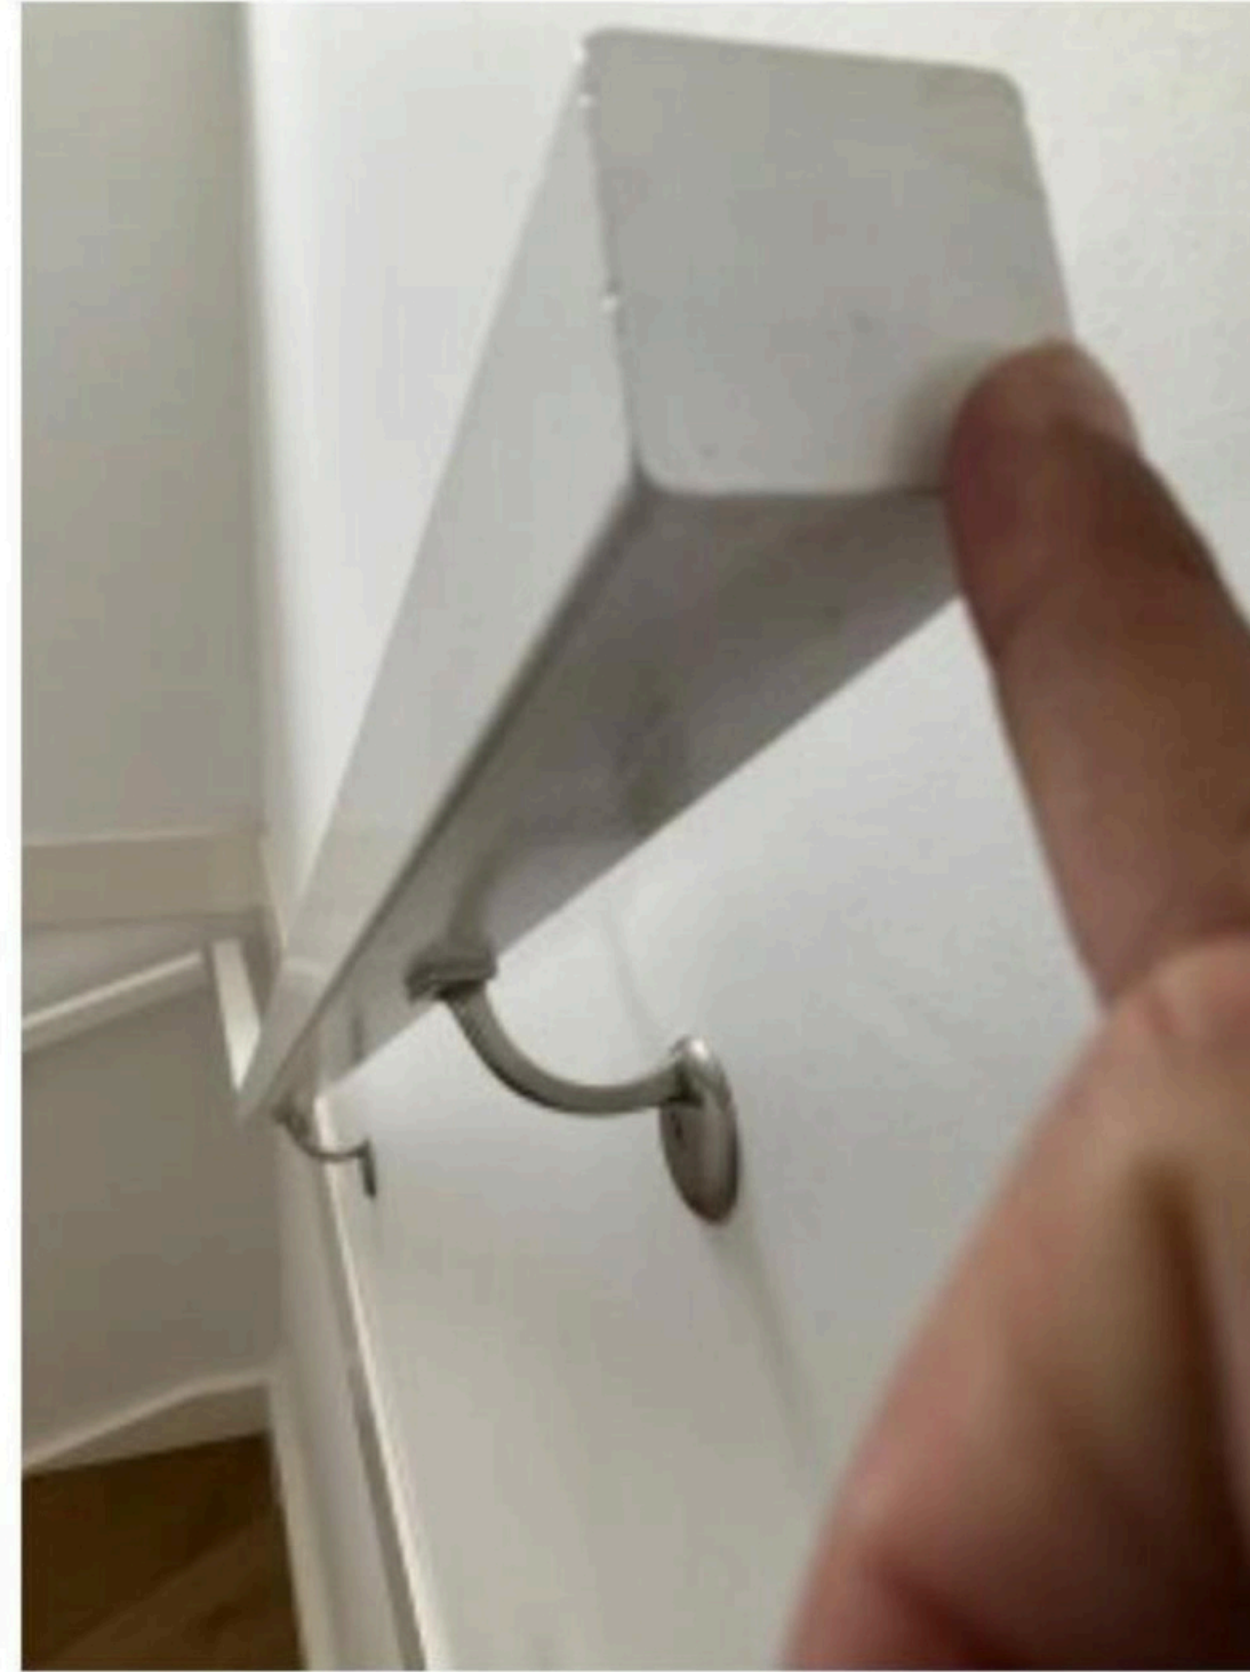
The handrail was found to be loose at the time of inspection, excessive movement was noted, which reduce its effectiveness and could pose a safety risk to occupants. It is recommended to be secured by a qualified tradesperson to ensure stability.

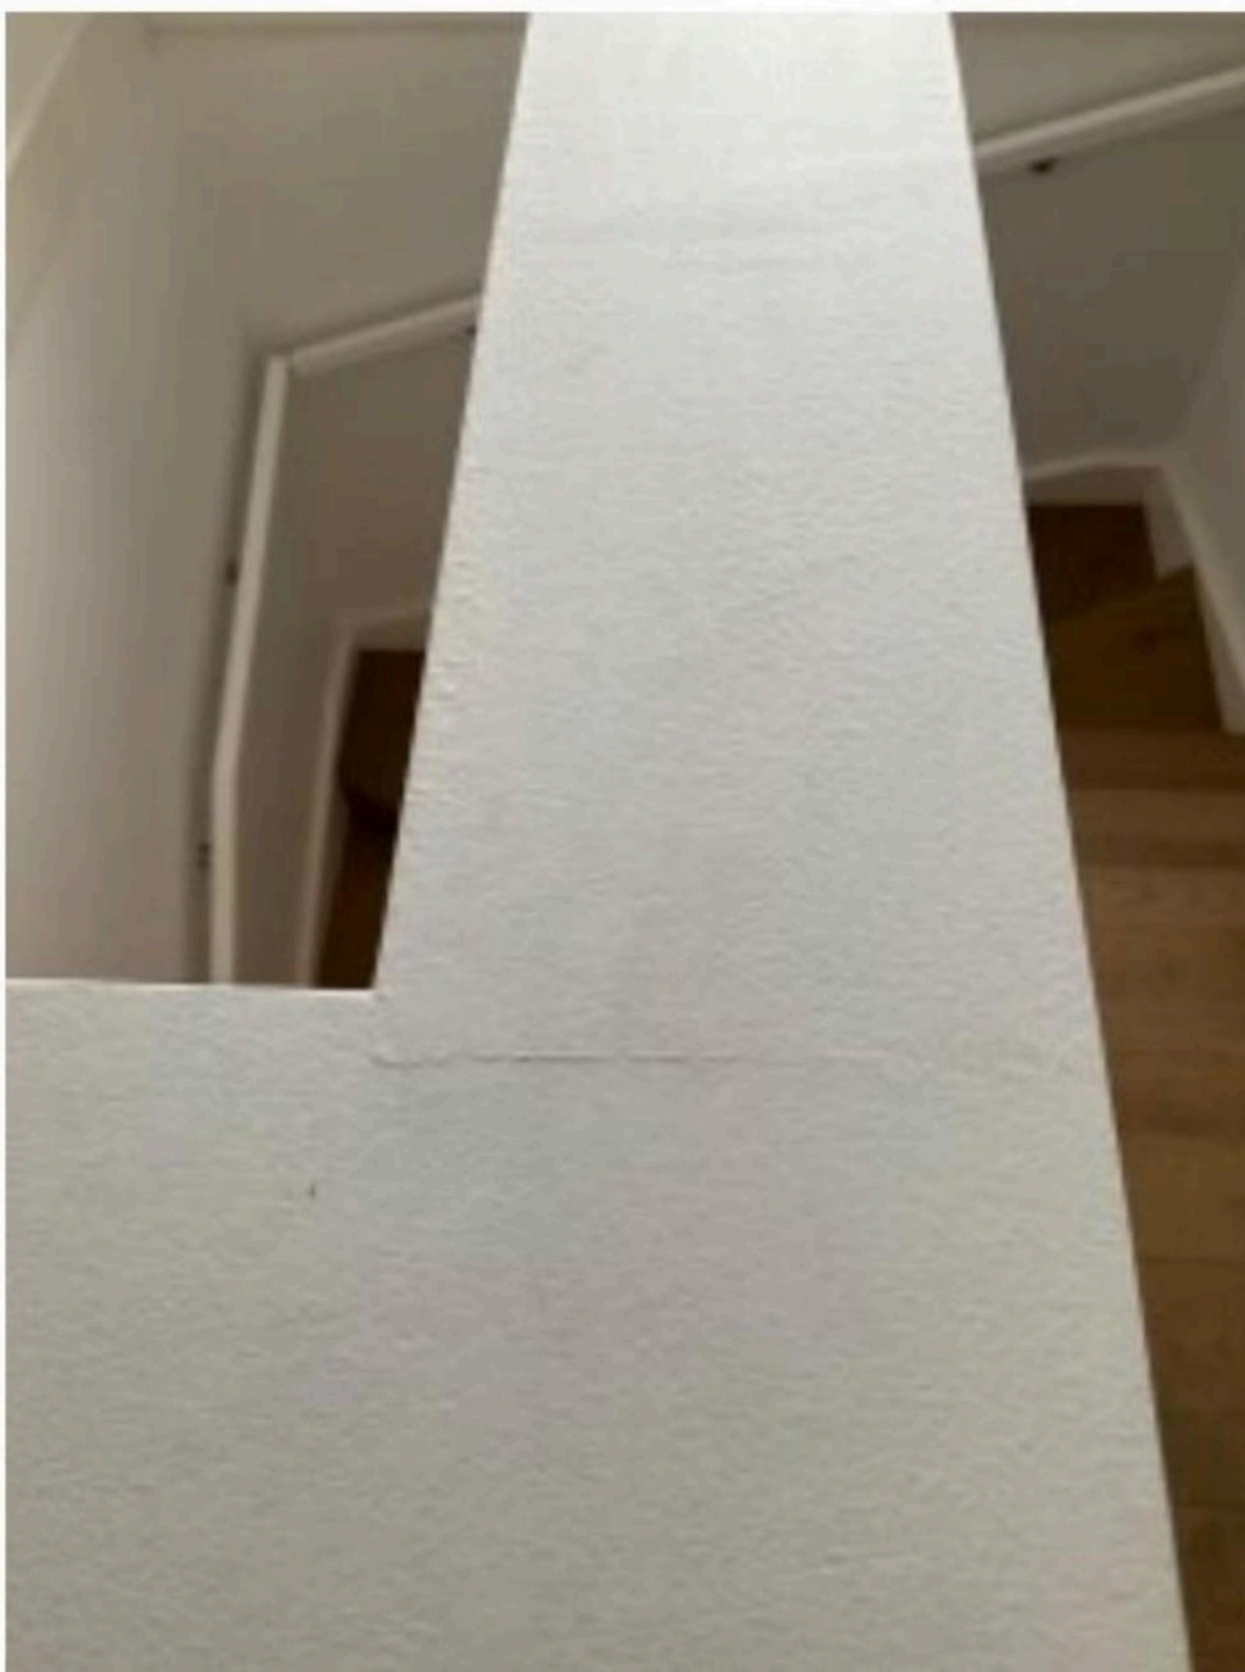
The image shows a minor crack line along the painted surface. The defect appears to be a minor cosmetic issue. Requires simple repair and repainting to restore the aesthetic appeal of the area.
