## Just Inspections

## REPORT ON DOMESTIC BUILDING WORK

SECTION 137B OF THE BUILDING ACT 1993 (OWNER BUILDER CONSTRUCTION)

| Report Date | 07 Aug 2026 |

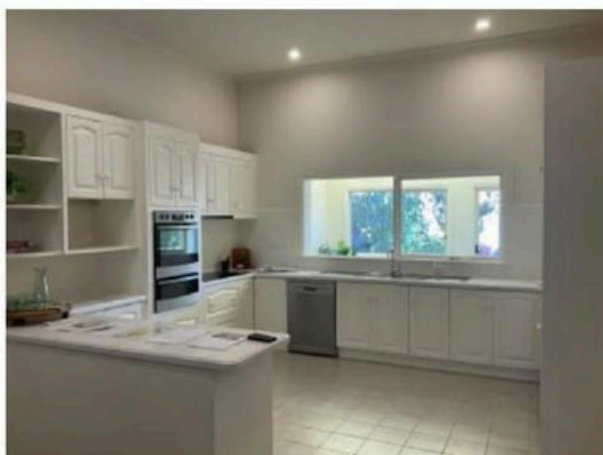
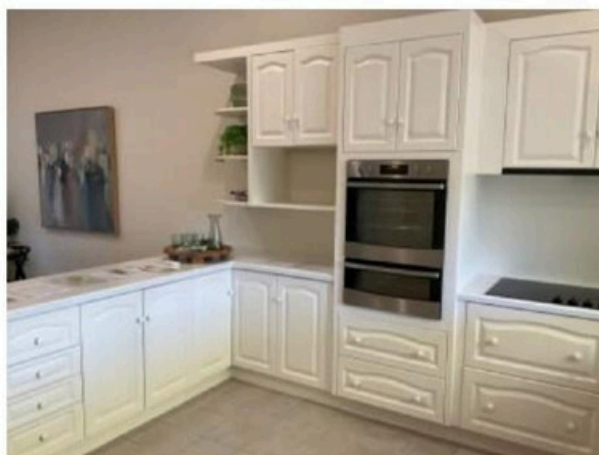
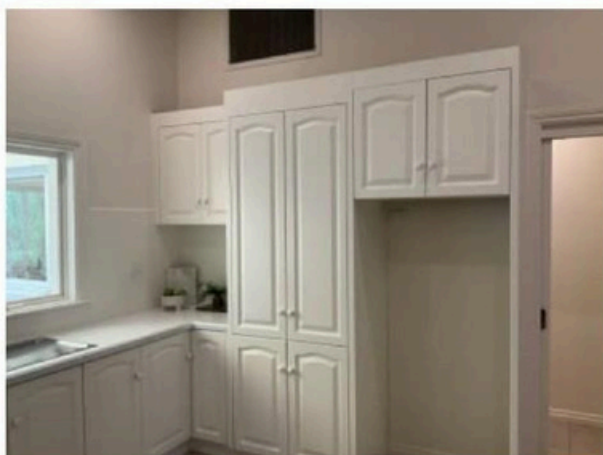
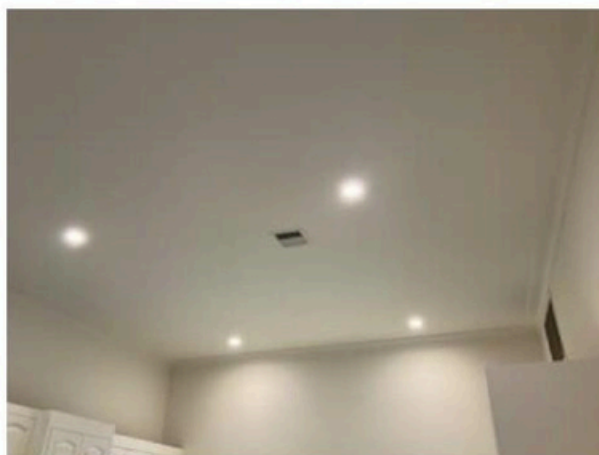
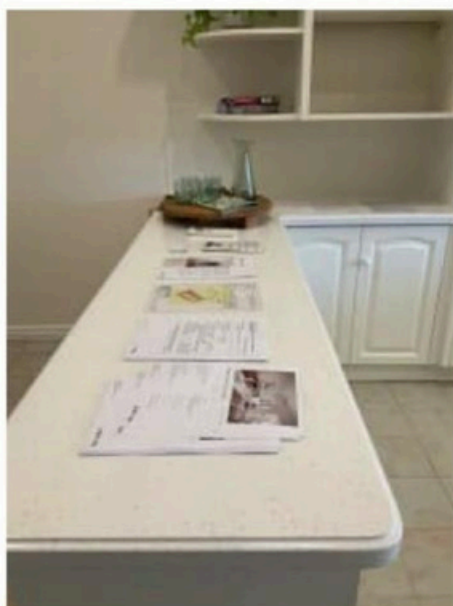
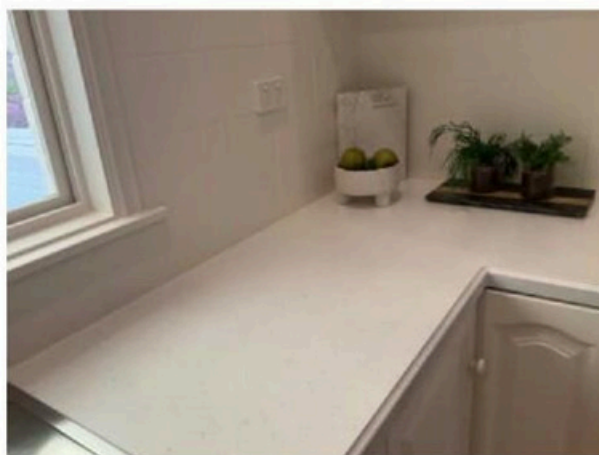
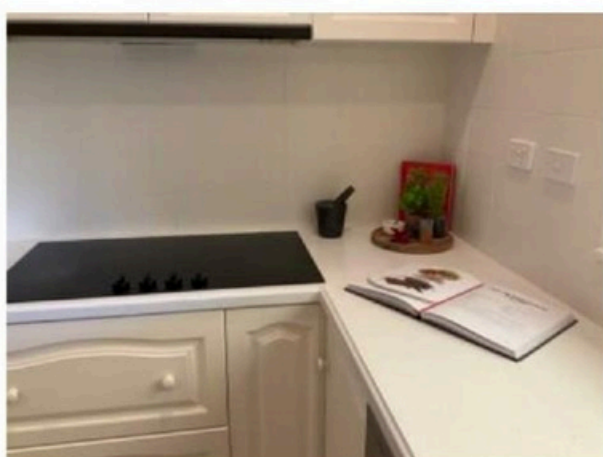
Kitchen

**Floor** There are no defects visible or evident in the floor

**Floor tiles** There are no defects visible or evident in the floor tiles

**Walls** There are no defects visible or evident in the walls

**Wall tiles** There are no defects visible or evident in the wall-tiles

**Ceiling** There are no defects visible or evident in the ceiling

**Windows (Internal)** There are no defects visible or evident internally. See also windows (external)

**Joinery** There are no defects visible or evident in the joinery

**Plumbing fixtures** There are no defects visible or evident in the plumbing fixtures

**Electrical** • Lighting installed adequately.

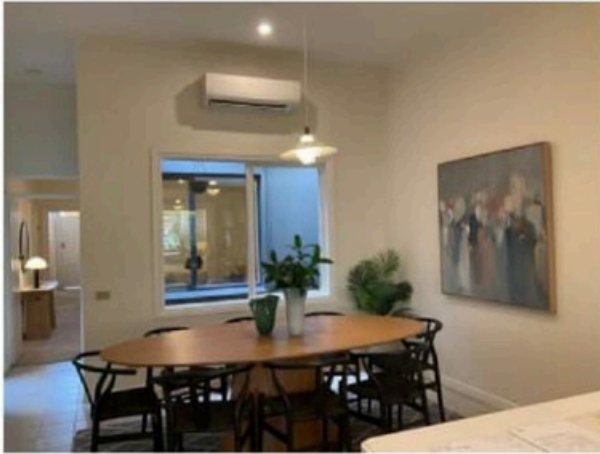
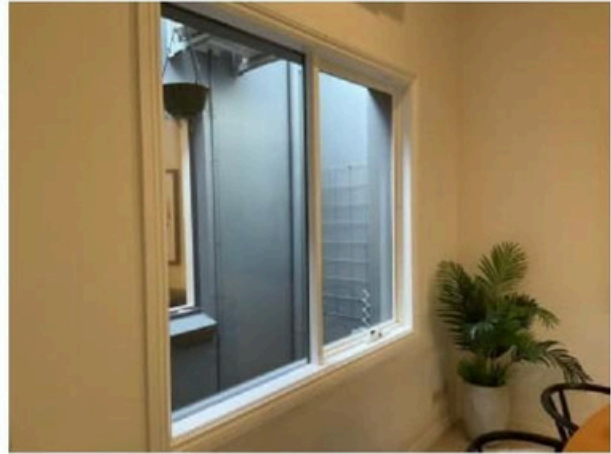
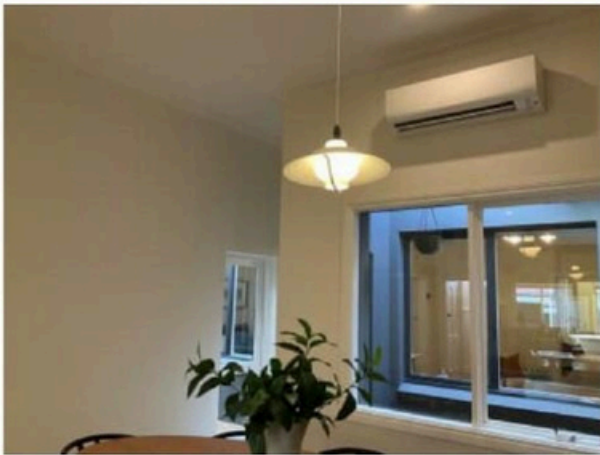
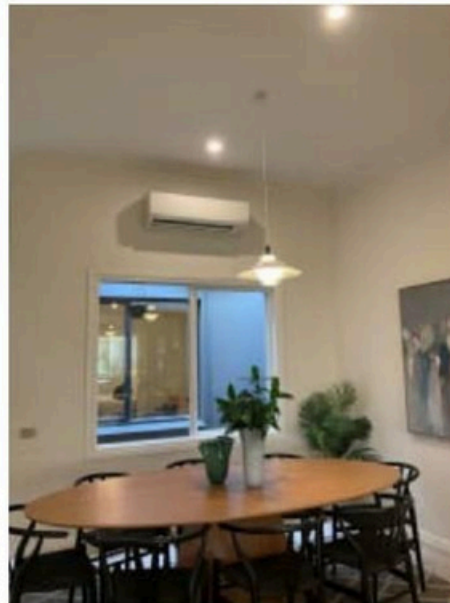
Dining room

**Floor** There are no defects visible or evident in the floor

**Floor tiles** There are no defects visible or evident in the floor tiles

**Walls** There are no defects visible or evident in the walls

**Ceiling** There are no defects visible or evident in the ceiling

**Windows (Internal)** There are no defects visible or evident internally. See also windows (external)

**Doors (Internal)** There are no defects visible or evident in the door(s)

**Electrical** • Installed adequately.

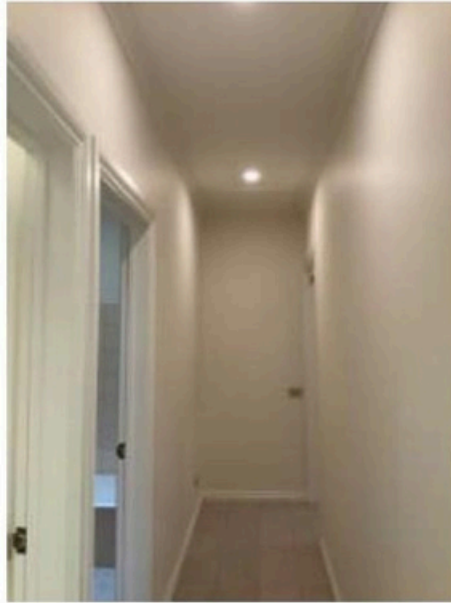
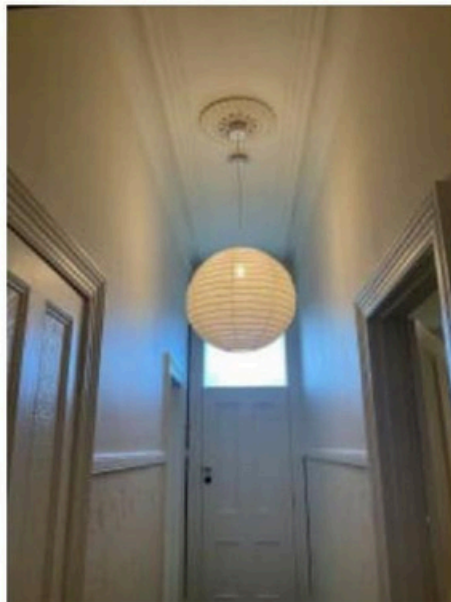
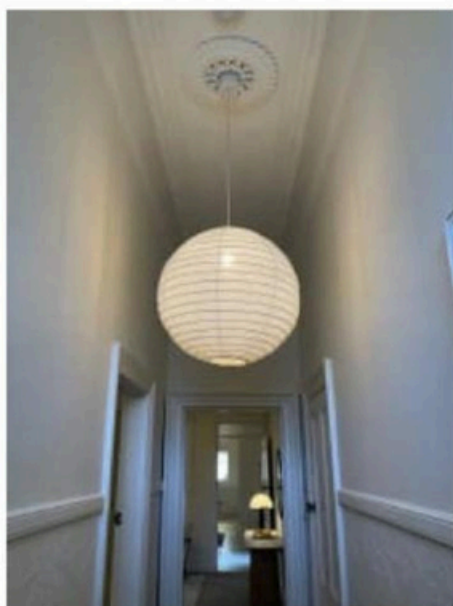
**Inspected Area** Hallway

**Floor** There are no defects visible or evident in the floor

**Floor tiles** There are no defects visible or evident in the floor tiles

**Walls** There are no defects visible or evident in the walls

**Ceiling** There are no defects visible or evident in the ceiling

**Windows (Internal)** There are no defects visible or evident internally. See also windows (external)

**Doors (Internal)** There are no defects visible or evident in the door(s)

**Electrical** • Installed adequately

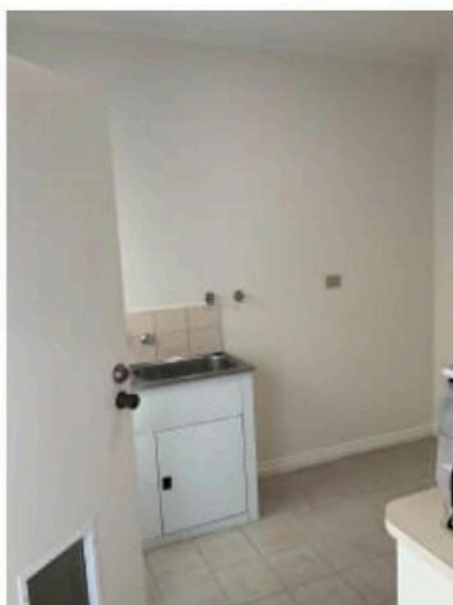
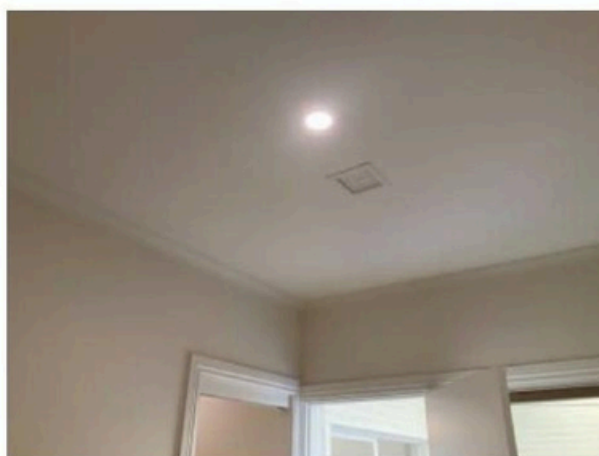
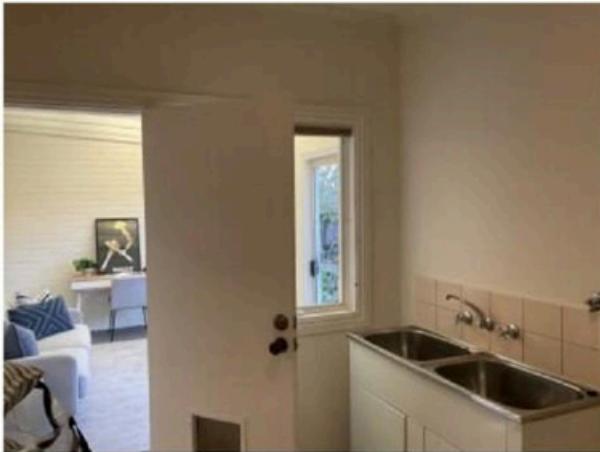
Laundry

**Floor** There are no defects visible or evident in the floor

**Floor tiles** There are no defects visible or evident in the floor tiles

**Walls** There are no defects visible or evident in the walls

**Wall tiles** There are no defects visible or evident in the wall-tiles

**Ceiling** There are no defects visible or evident in the ceiling

**Windows (Internal)** There are no defects visible or evident internally. See also windows (external)

**Doors (Internal)** There are no defects visible or evident in the door(s)

**Joinery** There are no defects visible or evident in the joinery

**Plumbing fixtures** There are no defects visible or evident in the plumbing fixtures

**Electrical** • Installed adequately.

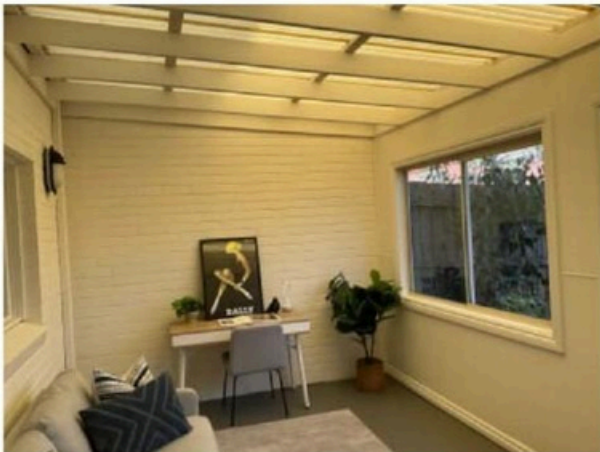
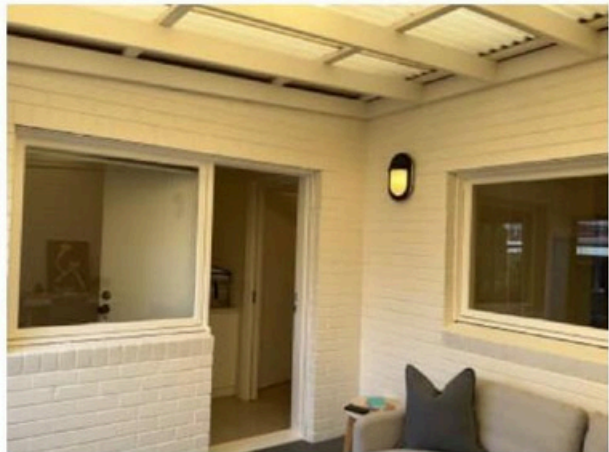
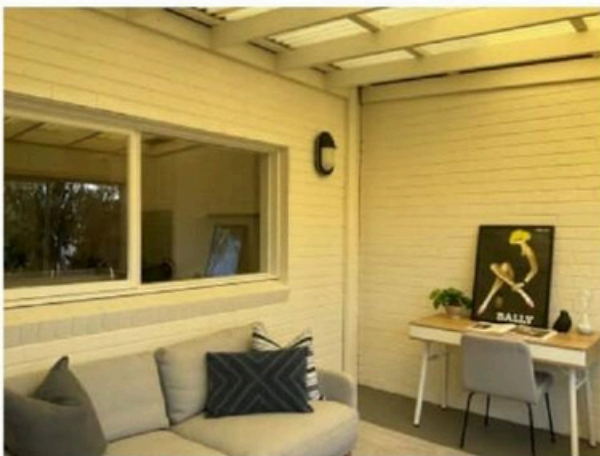
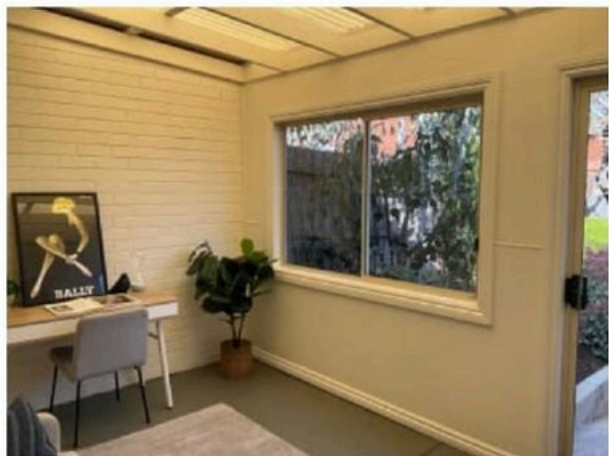
**Inspected Area** Alfresco

**Floor** There are no defects visible or evident in the floor

**Walls** There are no defects visible or evident in the walls

**Ceiling** There are no defects visible or evident in the ceiling

**Windows (Internal)** There are no defects visible or evident internally. See also windows (external)

**Doors (Internal)** There are no defects visible or evident in the door(s)

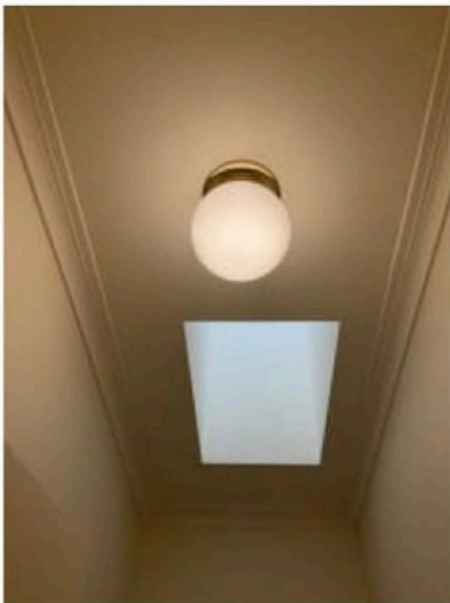
**Inspected Area** Toilet

**Floor** There are no defects visible or evident in the floor

**Floor tiles** There are no defects visible or evident in the floor tiles

**Walls** There are no defects visible or evident in the walls

**Doors (Internal)** There are no defects visible or evident in the door(s)

**Plumbing fixtures** There are no defects visible or evident in the plumbing fixtures

**Electrical** • Installed adequately

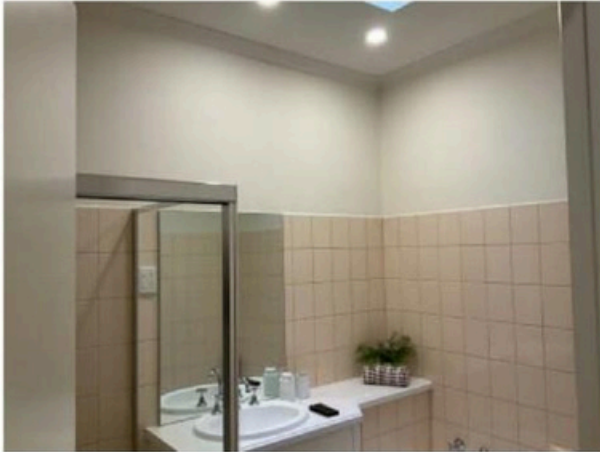
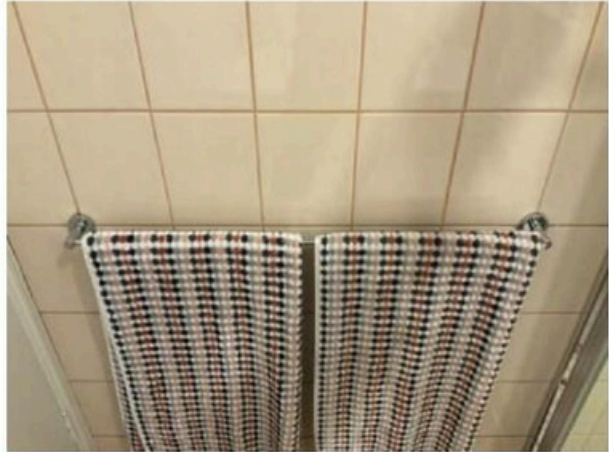
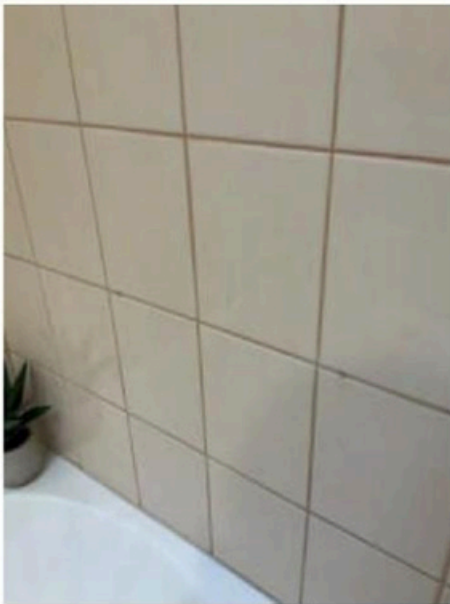
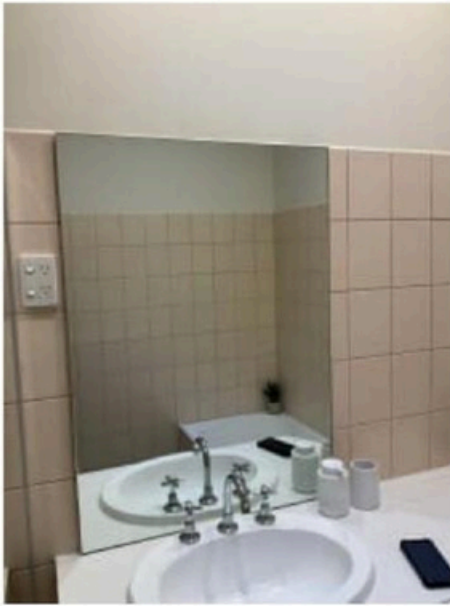
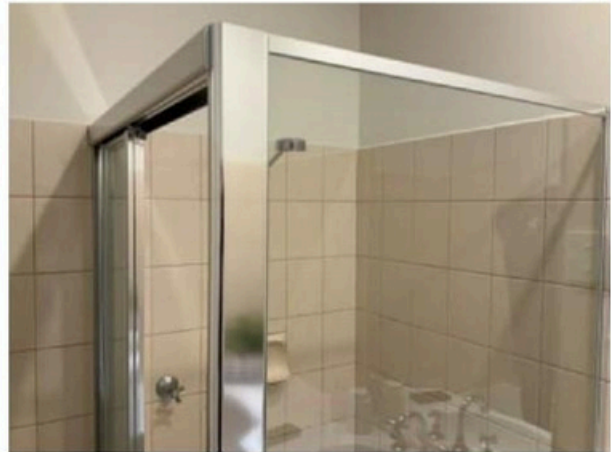
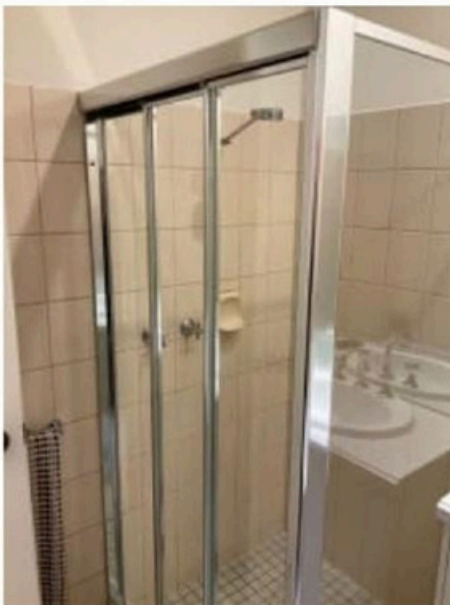
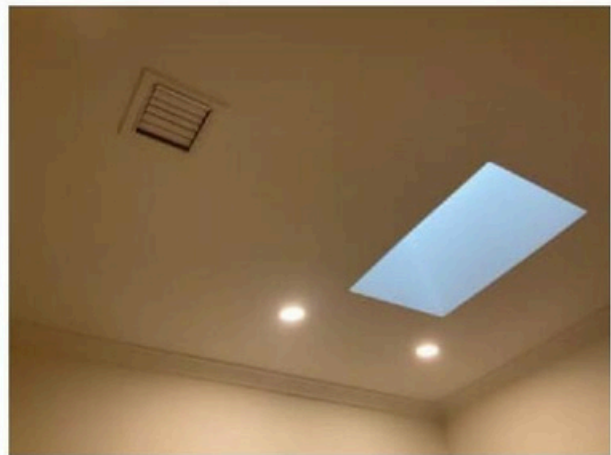
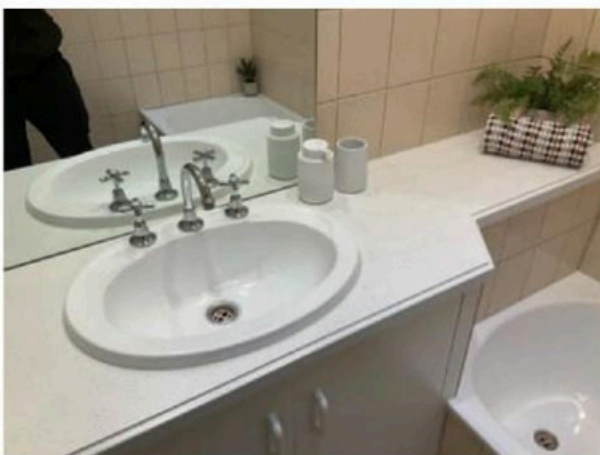
Bathroom

**Floor** There are no defects visible or evident in the floor

**Floor tiles** There are no defects visible or evident in the floor tiles

**Walls** There are no defects visible or evident in the walls

**Wall tiles** Pre-existing. Not included in this report

**Ceiling** There are no defects visible or evident in the ceiling

**Doors (Internal)** There are no defects visible or evident in the door(s)

**Joinery** There are no defects visible or evident in the joinery

**Plumbing fixtures** There are no defects visible or evident in the plumbing fixtures

**Electrical** • Installed adequately

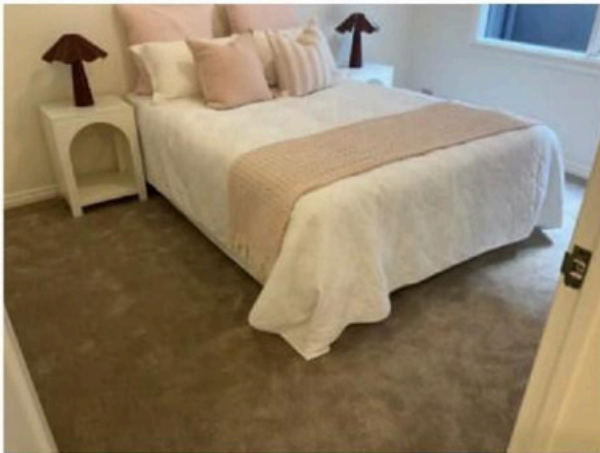
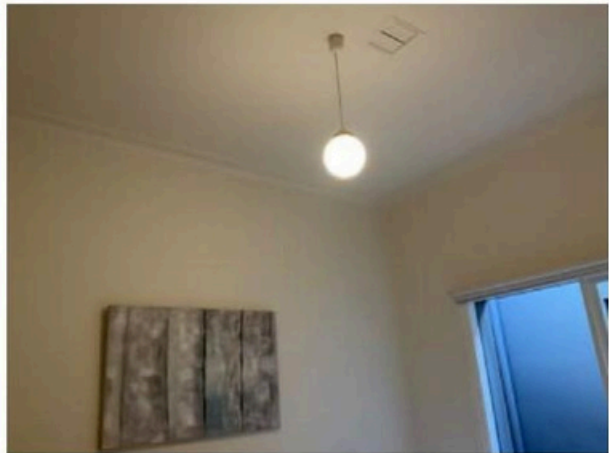
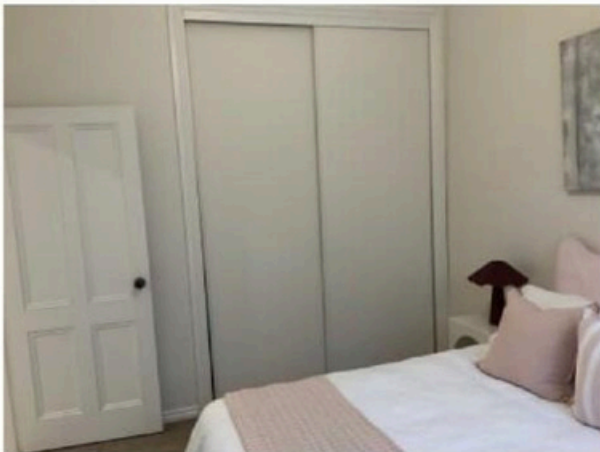
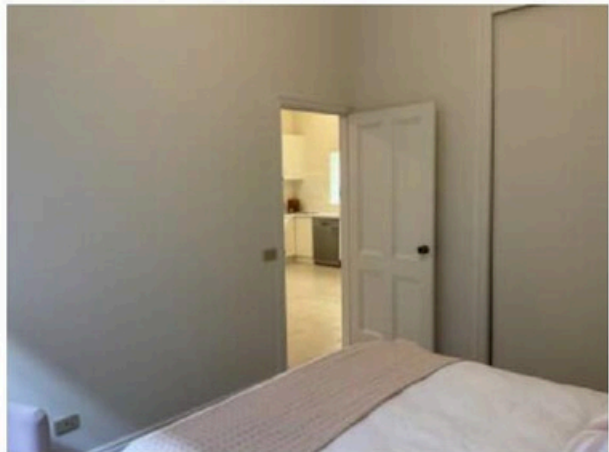
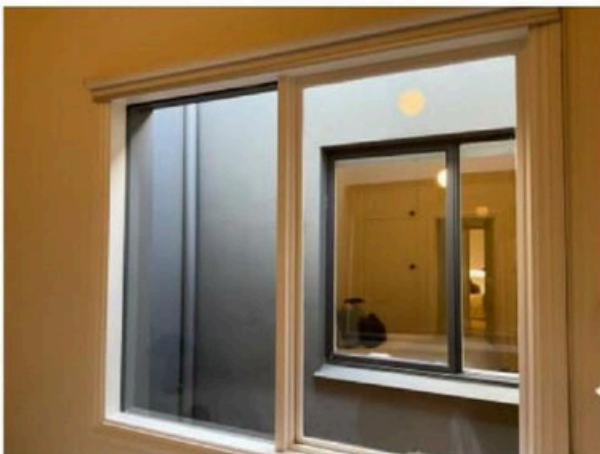
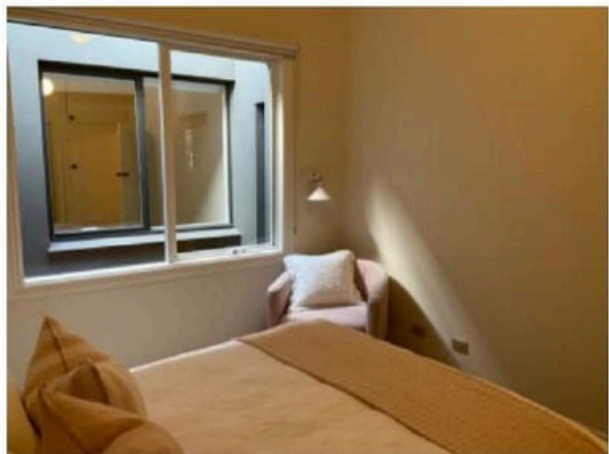
Bedroom 2

**Walls** There are no defects visible or evident in the walls

**Ceiling** There are no defects visible or evident in the ceiling

**Windows (Internal)** There are no defects visible or evident internally. See also windows (external)

**Doors (Internal)** Pre-existing. Not included in this report

**Joinery** There are no defects visible or evident in the joinery

**Electrical** • Installed adequately.

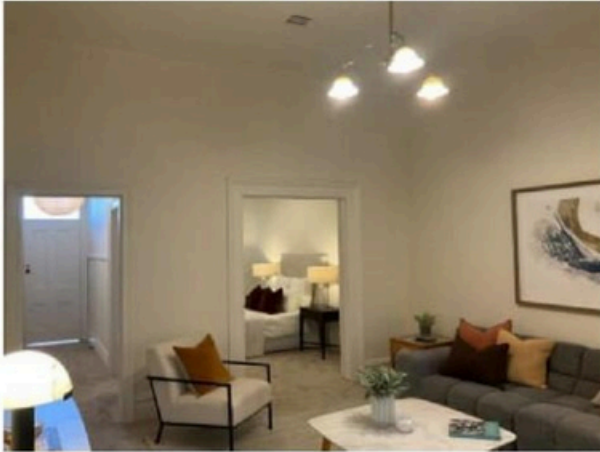
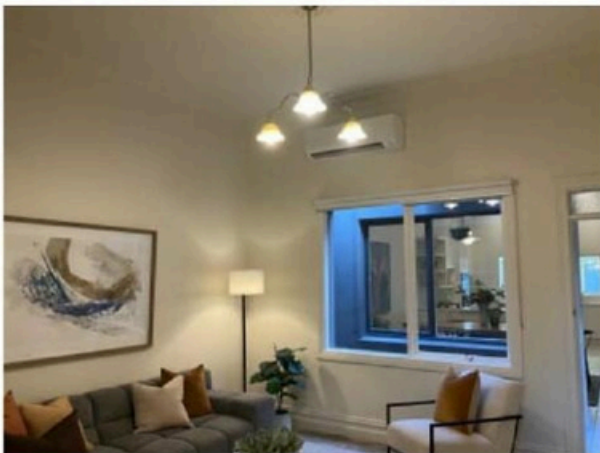
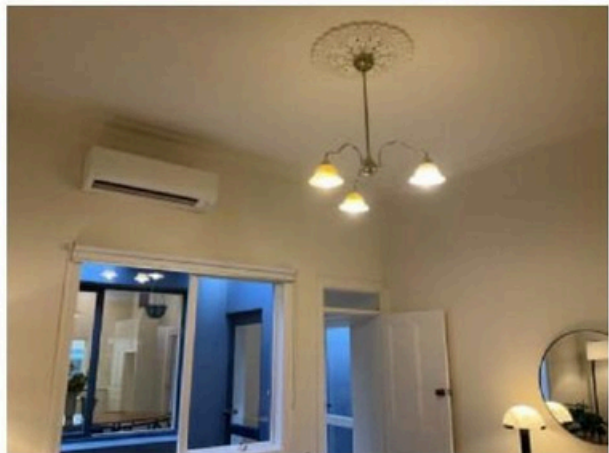
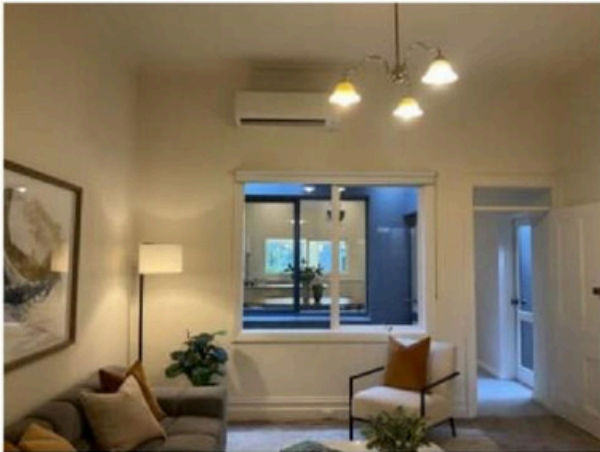
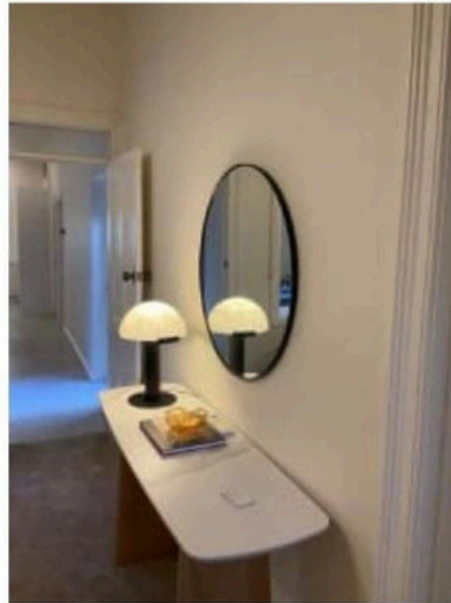
Living room

**Floor** There are no defects visible or evident in the floor

**Walls** There are no defects visible or evident in the walls

**Ceiling** There are no defects visible or evident in the ceiling

**Windows (Internal)** There are no defects visible or evident internally. See also windows (external)

**Doors (Internal)** Pre-existing. Not included in this report

**Electrical** • Installed adequately.

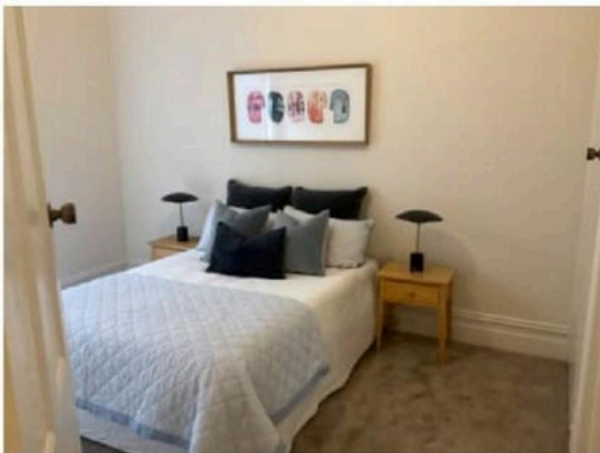
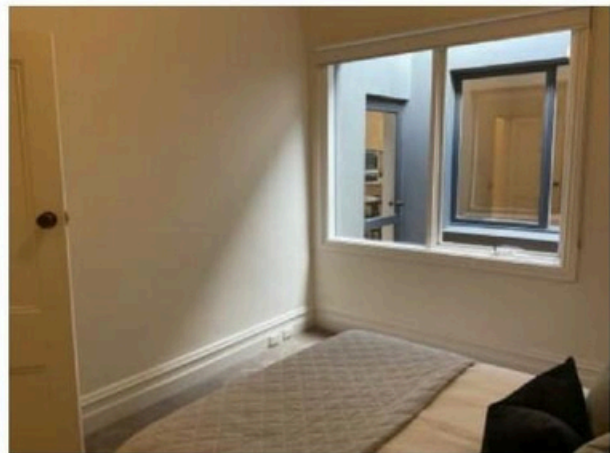
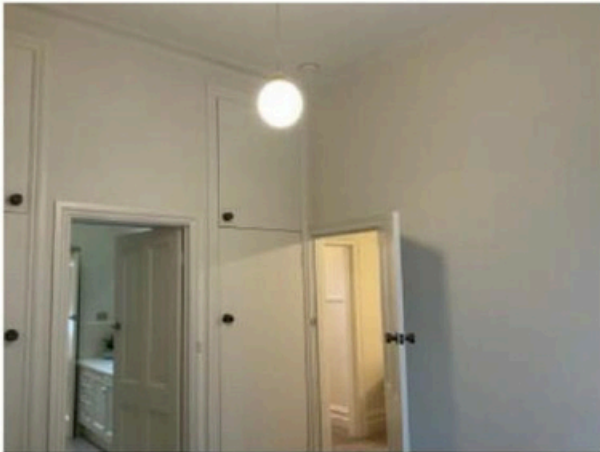
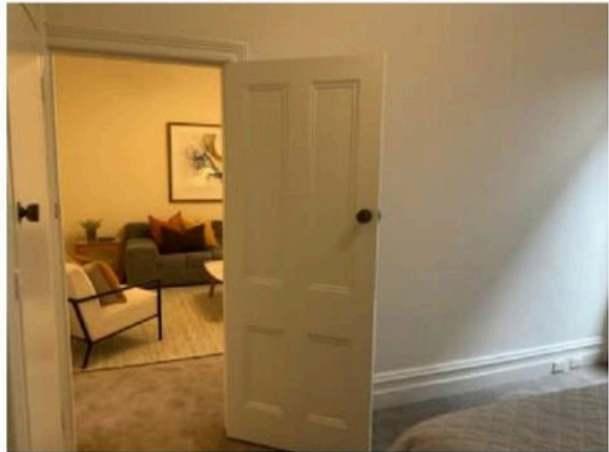
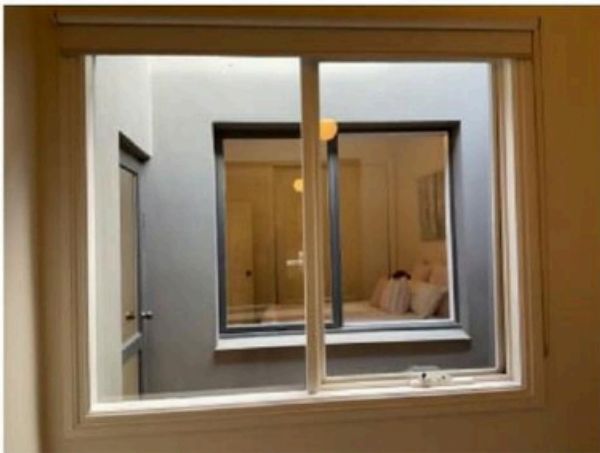
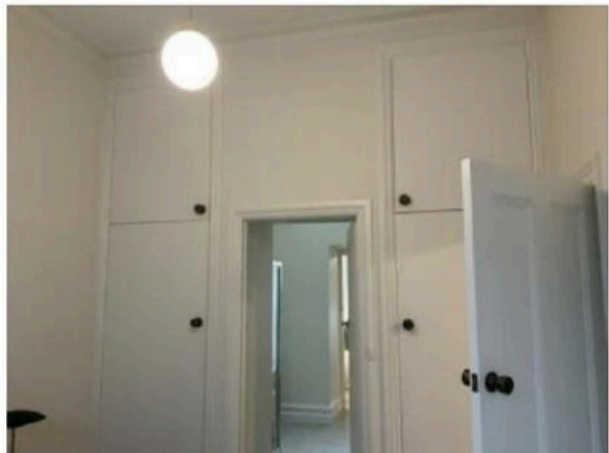
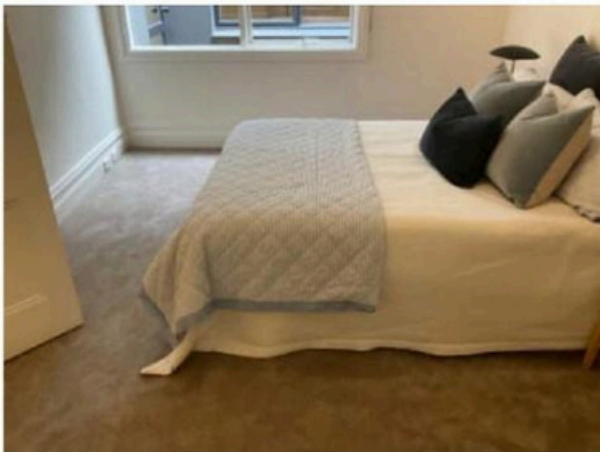
Bedroom 1

**Floor** There are no defects visible or evident in the floor

**Walls** There are no defects visible or evident in the walls

**Ceiling** There are no defects visible or evident in the ceiling

**Windows (Internal)** There are no defects visible or evident internally. See also windows (external)

**Joinery** There are no defects visible or evident in the joinery

**Electrical** • Installed adequately.

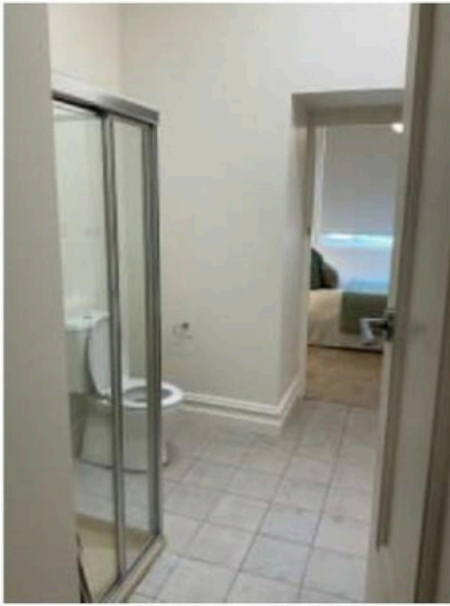
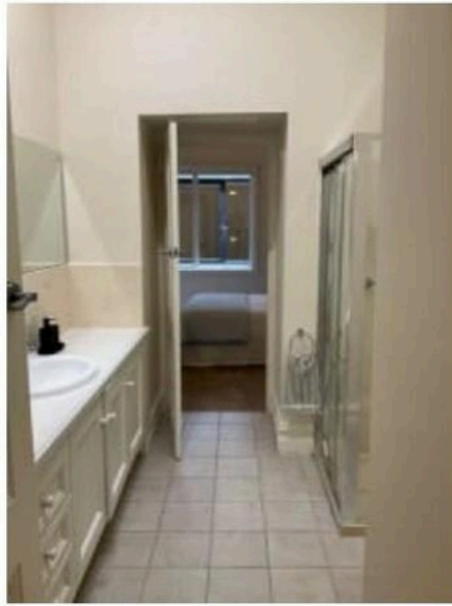
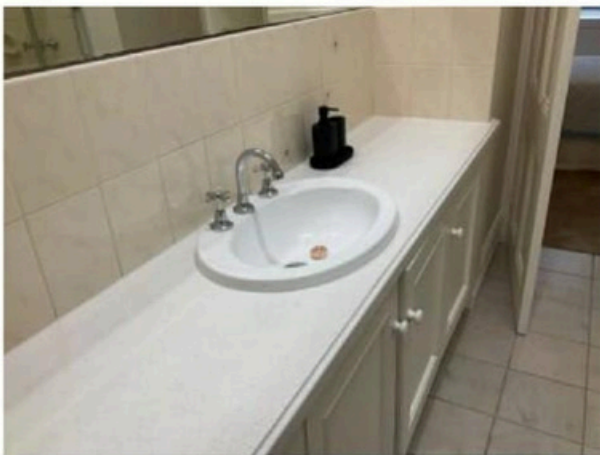
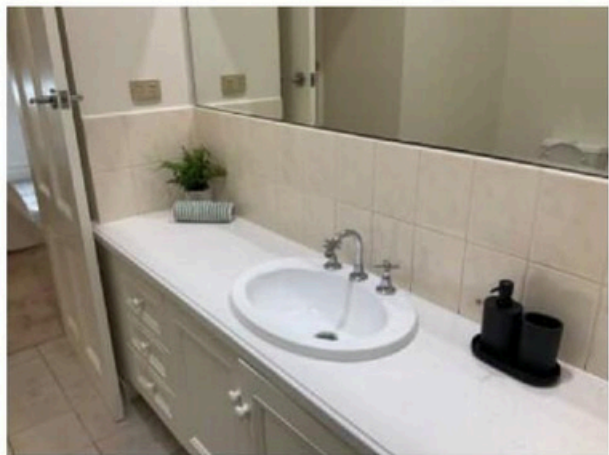
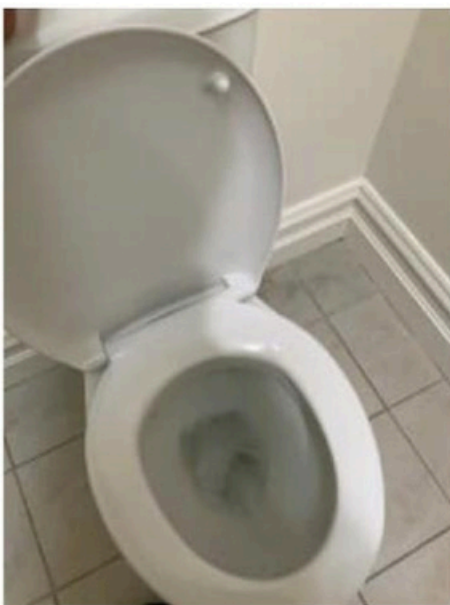
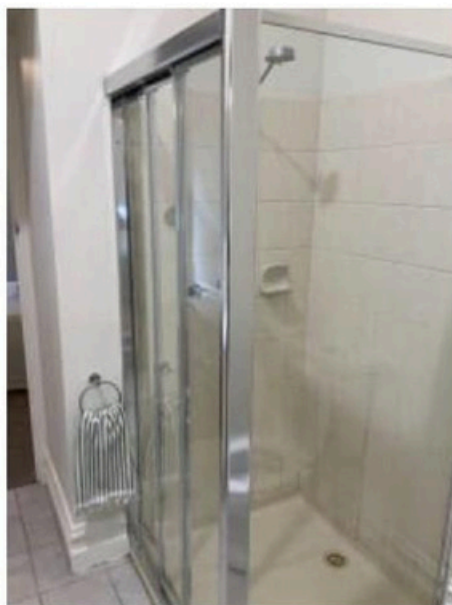
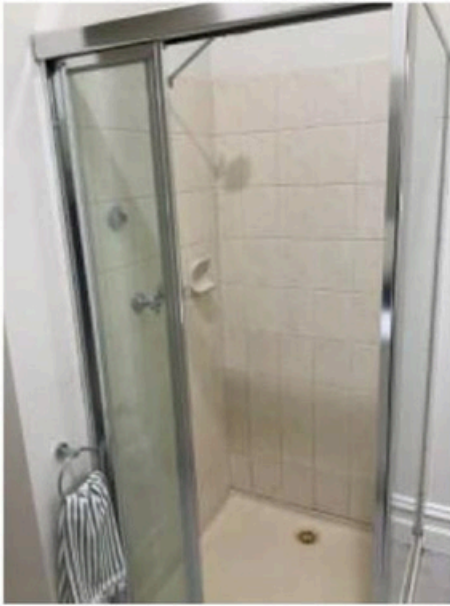
En-suite

**Floor tiles** There are no defects visible or evident in the floor tiles

**Walls** There are no defects visible or evident in the walls

**Wall tiles** There are no defects visible or evident in the wall-tiles

**Ceiling** There are no defects visible or evident in the ceiling

**Doors (Internal)** There are no defects visible or evident in the door(s)

**Joinery** There are no defects visible or evident in the joinery

**Plumbing fixtures** There are no defects visible or evident in the plumbing fixtures

**Electrical** • Installed adequately.

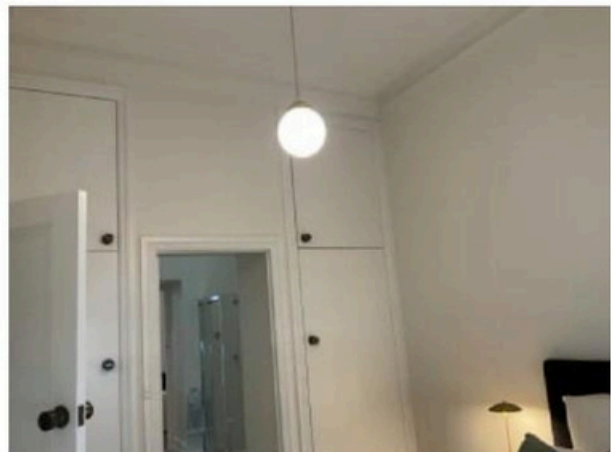
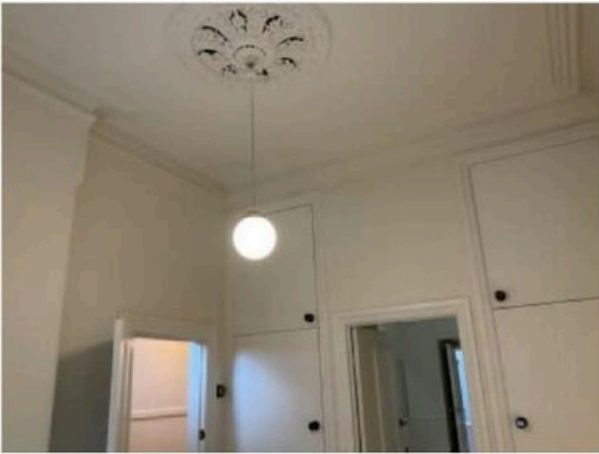
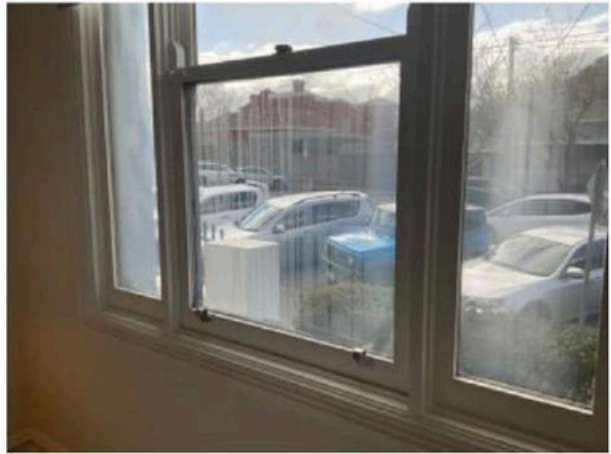
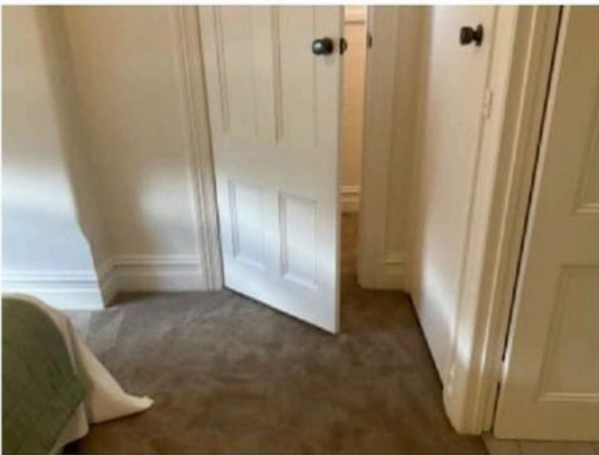
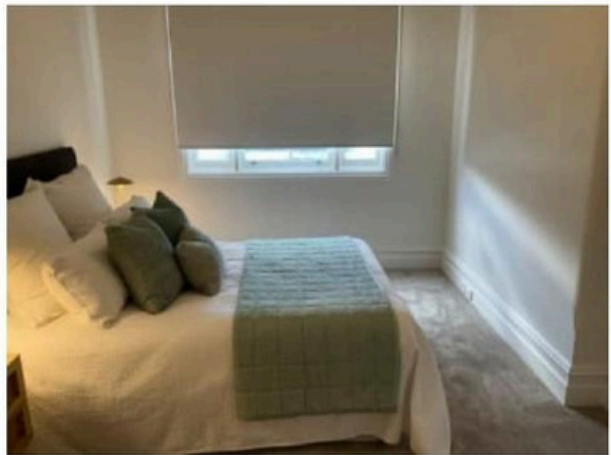
Bedroom 3

**Floor** There are no defects visible or evident in the floor

**Walls** There are no defects visible or evident in the walls

**Ceiling** There are no defects visible or evident in the ceiling

**Windows (Internal)** There are no defects visible or evident internally. See also windows (external)

**Doors (Internal)** There are no defects visible or evident in the door(s)

**Joinery** There are no defects visible or evident in the joinery

**Electrical** • Installed adequately.
