7 SAMPLE STREET
CITY

PRE-PURCHASE INSPECTION REPORT

PRE-PURCHASE INSPECTION REPORT		
<i>Subject to 'Conditions Assumptions and Limitations' attached</i>		
Purchaser;	R. Paul	Telephone; 9762-0382
Purchaser address;	84 Boronia Road, Boronia.	
Property address;	7 Sample Street, City.	
Date of report;	03/04/2007	
Date of inspection;	02/04/2007	
DESCRIPTION OF THE BUILDING AND MATERIALS USED IN CONSTRUCTION:		
The single storey dwelling is of timber frame construction with brick veneer exterior walls, internal plasterboard wall and ceiling lining, timber floor, aluminium windows and conventional roof covered with concrete tiles. The thermal ceiling insulation is in place. The fixed appliances appear to be in a well used condition. The required smoke alarm is in place.		
SERVICES CONNECTED TO THE PROPERTY:		
Electricity;	Mains supply.	
Gas;	Mains supply.	
Water;	Mains supply.	
Sewerage;	Septic system.	
SITE DETAILS:		
The building site is located on the East side of the street with a moderate slope. Site drainage would appear to be adequate. The paving is satisfactory. The boundary fence is adequate. A few trees are closer than mature height would allow. (As a general rule trees should

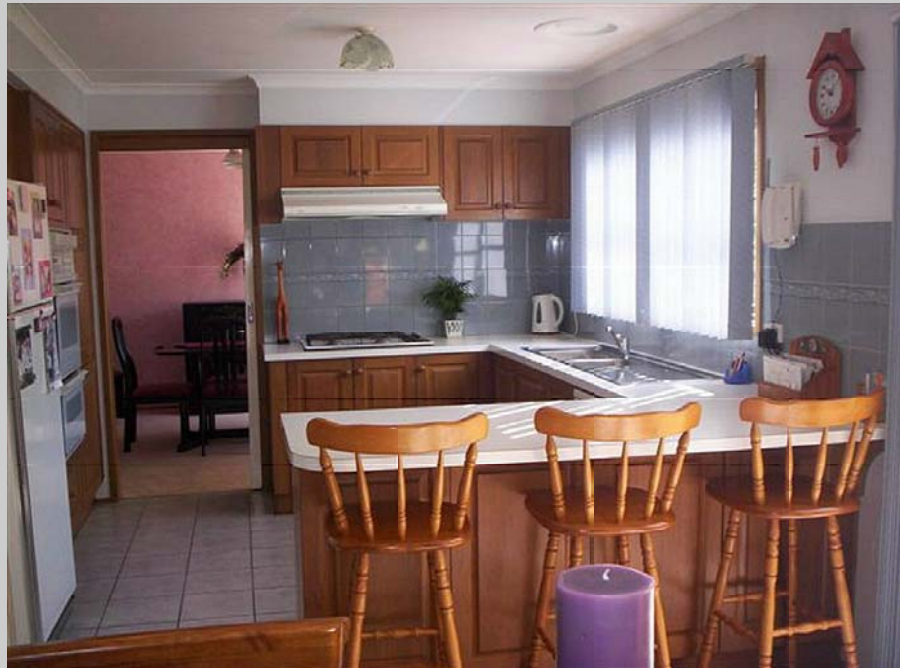
KITCHEN

Floor	There are no defects visible or evident in the floor.	61
Floortiles	There are no defects visible or evident in the floortiles.	62
Walls	There are no defects visible or evident in the walls.	63
Walltiles	The hard grout at the junction between walltiles and/or floortiles, benchtop, showerbase, bath, vanity unit, trough or similar wet area fixture should be re-sealed with silicone.	64
Ceiling	There are no defects visible or evident in the ceiling	65
Windows (internal)	There are no defects visible or evident internally. See also windows (external).	66
Joinery	There are no defects visible or evident in the joinery.	67
Plumbing fixtures	There are no defects visible or evident in the plumbing fixtures.	68
