## Just Inspections

## Building/Property & Timber Pest Inspection

**AS4349.1-2007 & AS4349.3-2010**

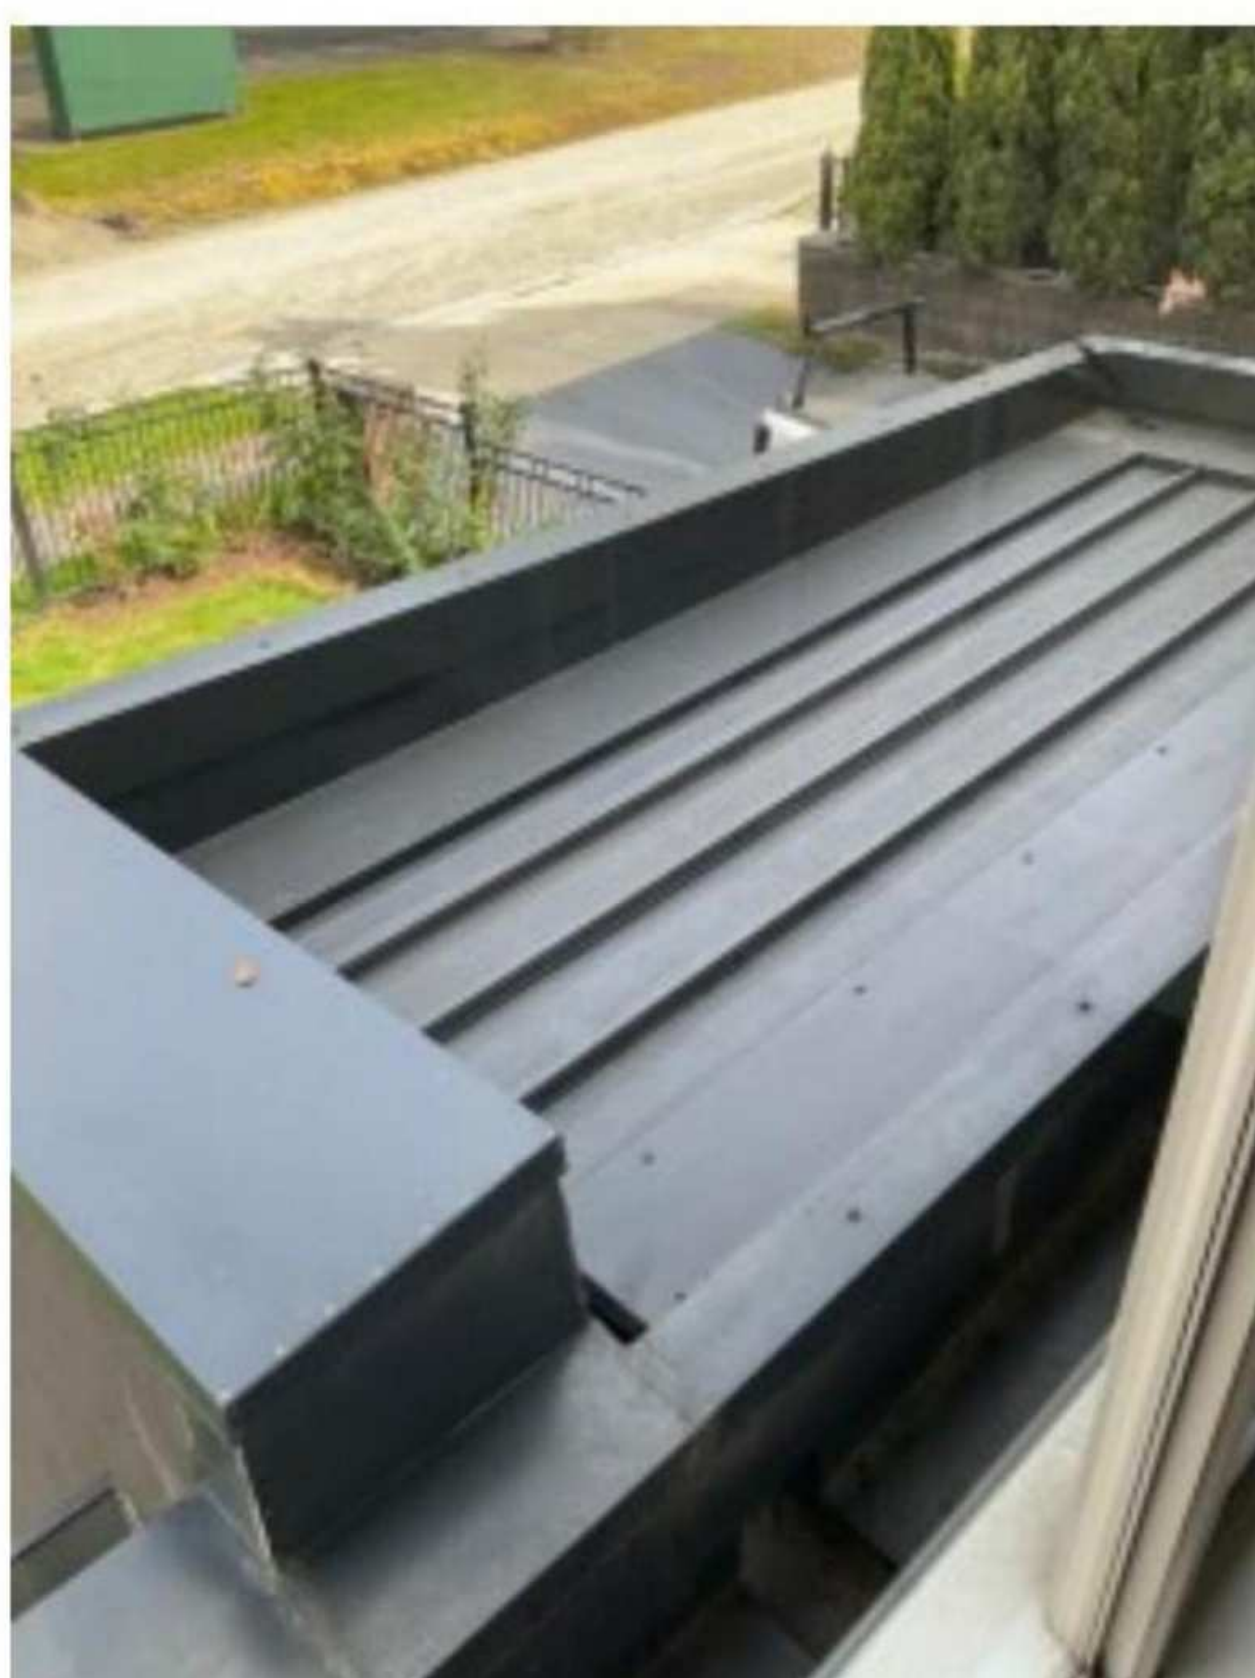
### **Roof space exterior**

Visible signs of moss a growth along the edge of the roof gutter . This can potentially lead to water pooling and subsequent roof deterioration, affecting its integrity. Regular maintenance and possibly enhancing the drainage system would be advisable to prevent further issues and ensure roof longevity.
