## Just Inspections

## Building/Property & Timber Pest Inspection

**AS4349.1-2007 & AS4349.3-2010**

| Report Date | 22 Apr 2026 |

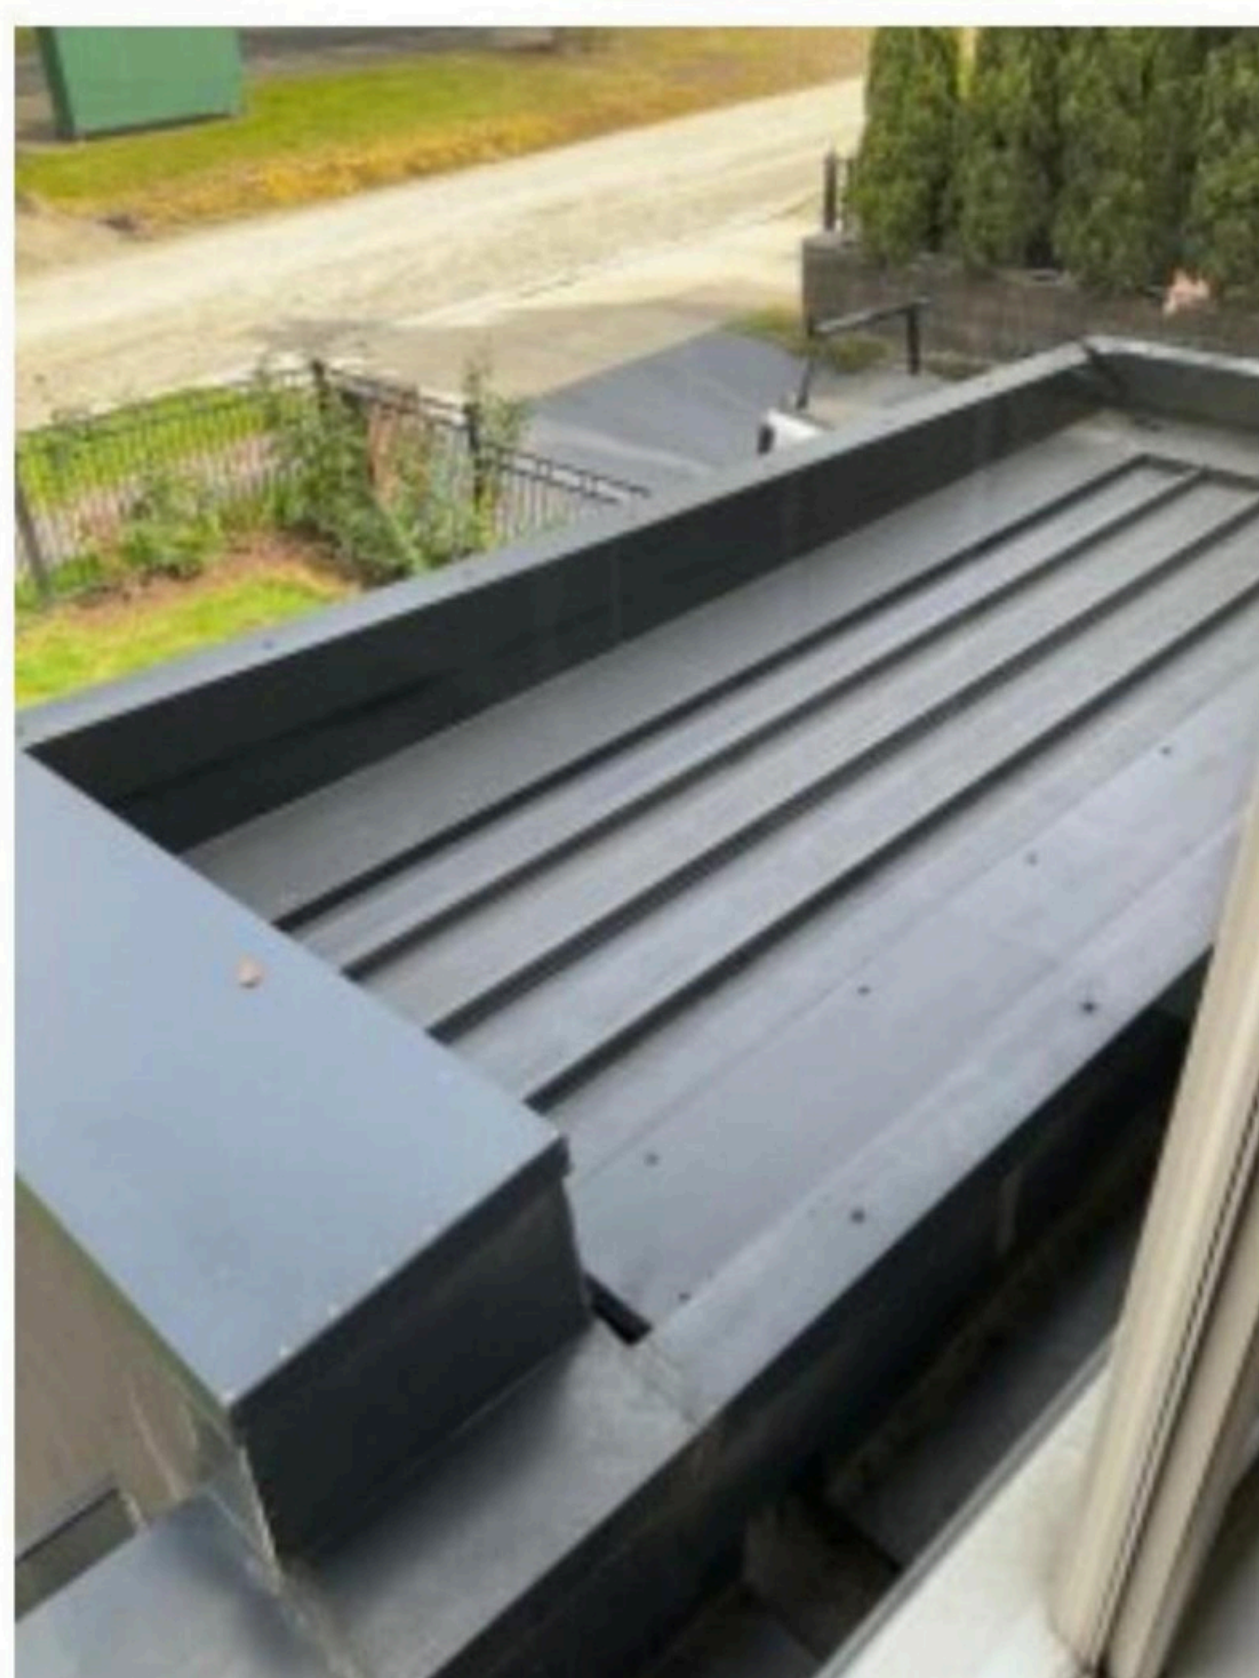
Roof space

Visible signs of moss a growth along the edge of the roof gutter . This can potentially lead to water pooling and subsequent roof deterioration, affecting its integrity. Regular maintenance and possibly enhancing the drainage system would be advisable to prevent further issues and ensure roof longevity.
