Thank you for the opportunity to carry out a dilapidation inspection at the above property in order to document existing cracking prior to the commencement of construction works at your property.

The two-storey property is of single skin brick and timber frame construction with brick veneer exterior walls, internal brick walls and timber ceilings, timber windows and a pitched roof clad with concrete tiles.

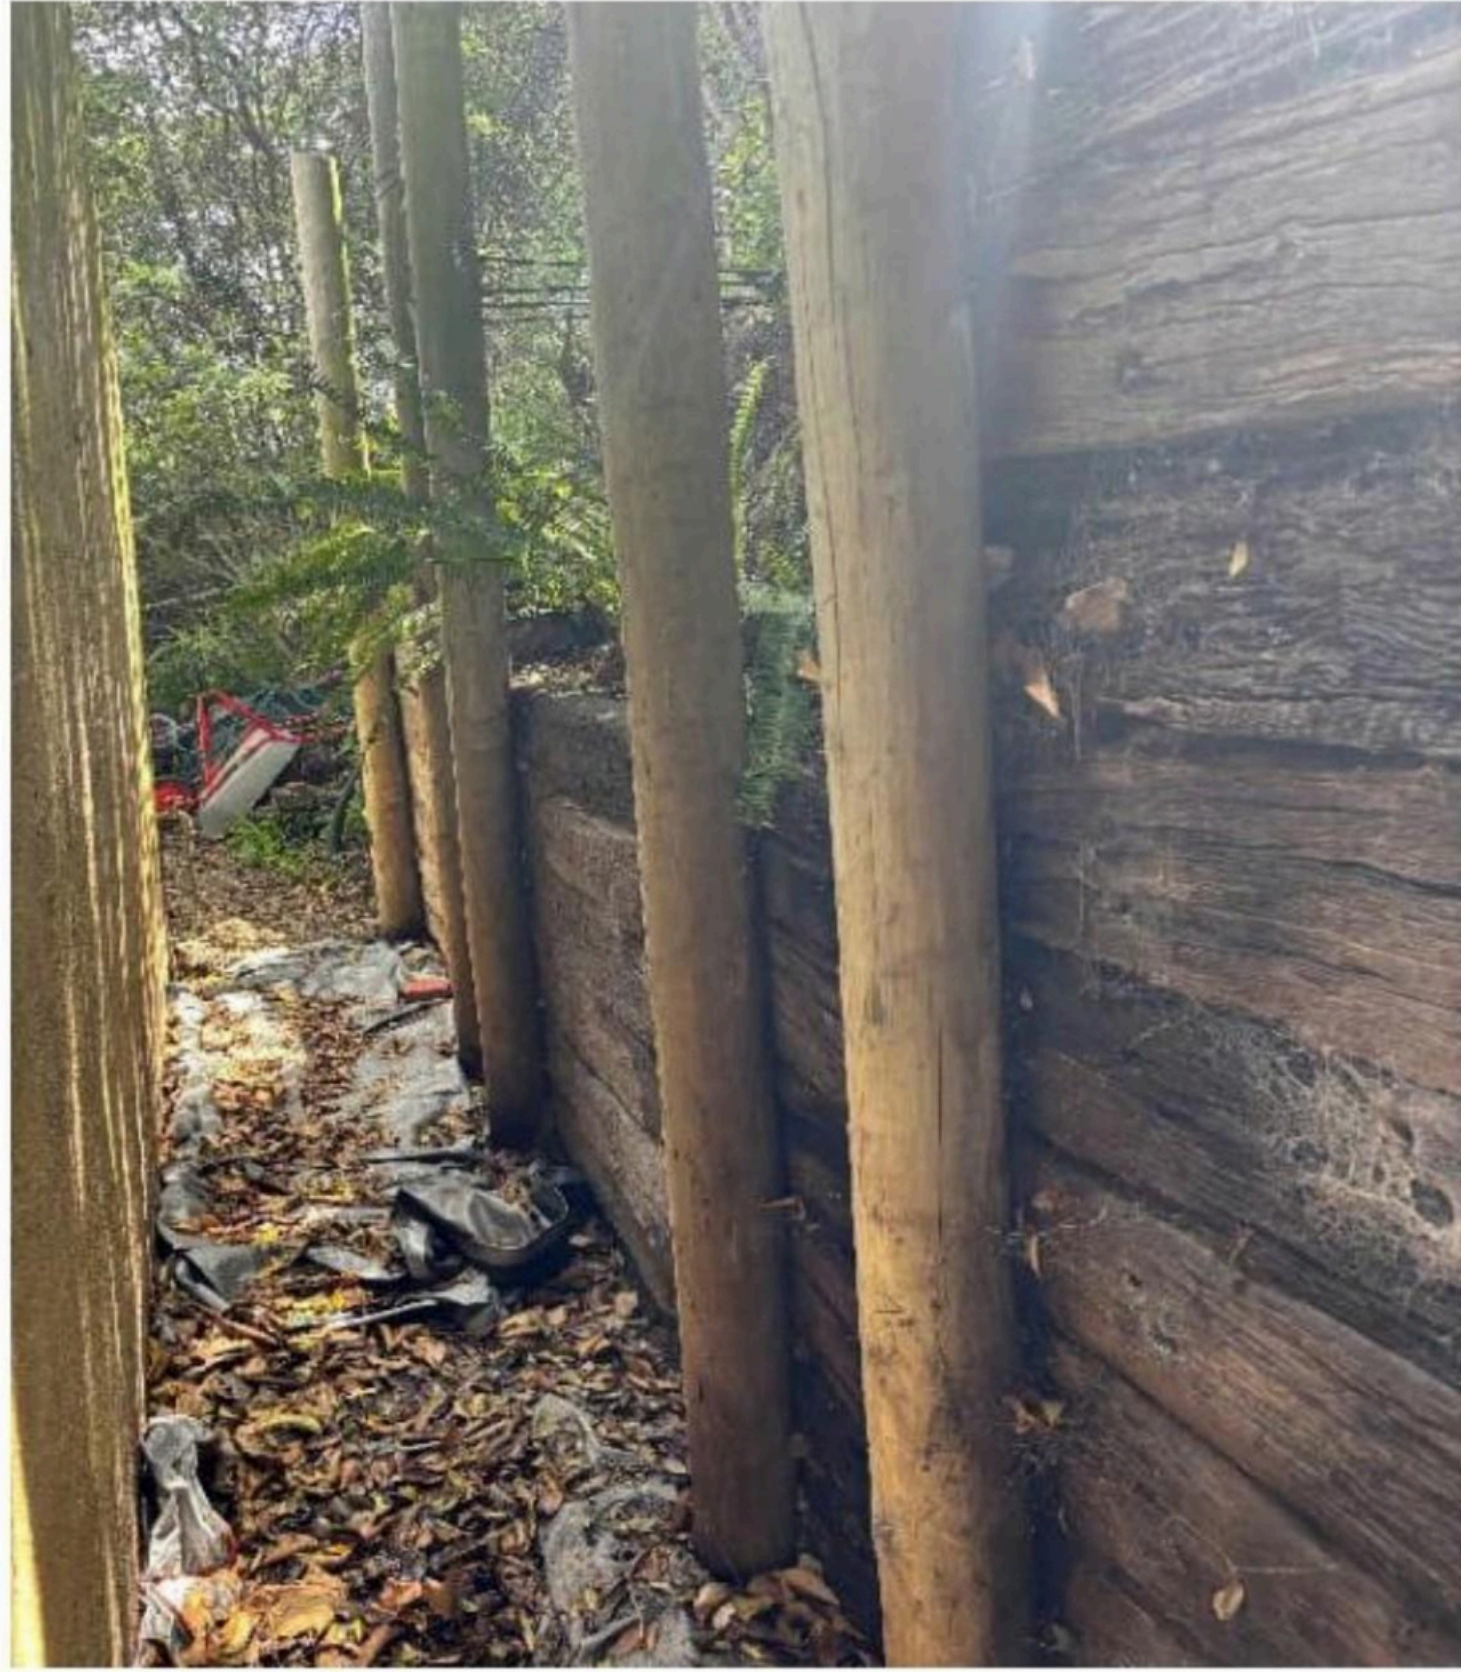
Dining Room No defect evident.
