Thank you for the opportunity to carry out a dilapidation inspection at the above property in order to document existing cracking prior to the commencement of construction works at your property.

The two-storey property is of single skin brick and timber frame construction with brick veneer exterior walls, internal brick walls and timber ceilings, timber windows and a pitched roof clad with concrete tiles.

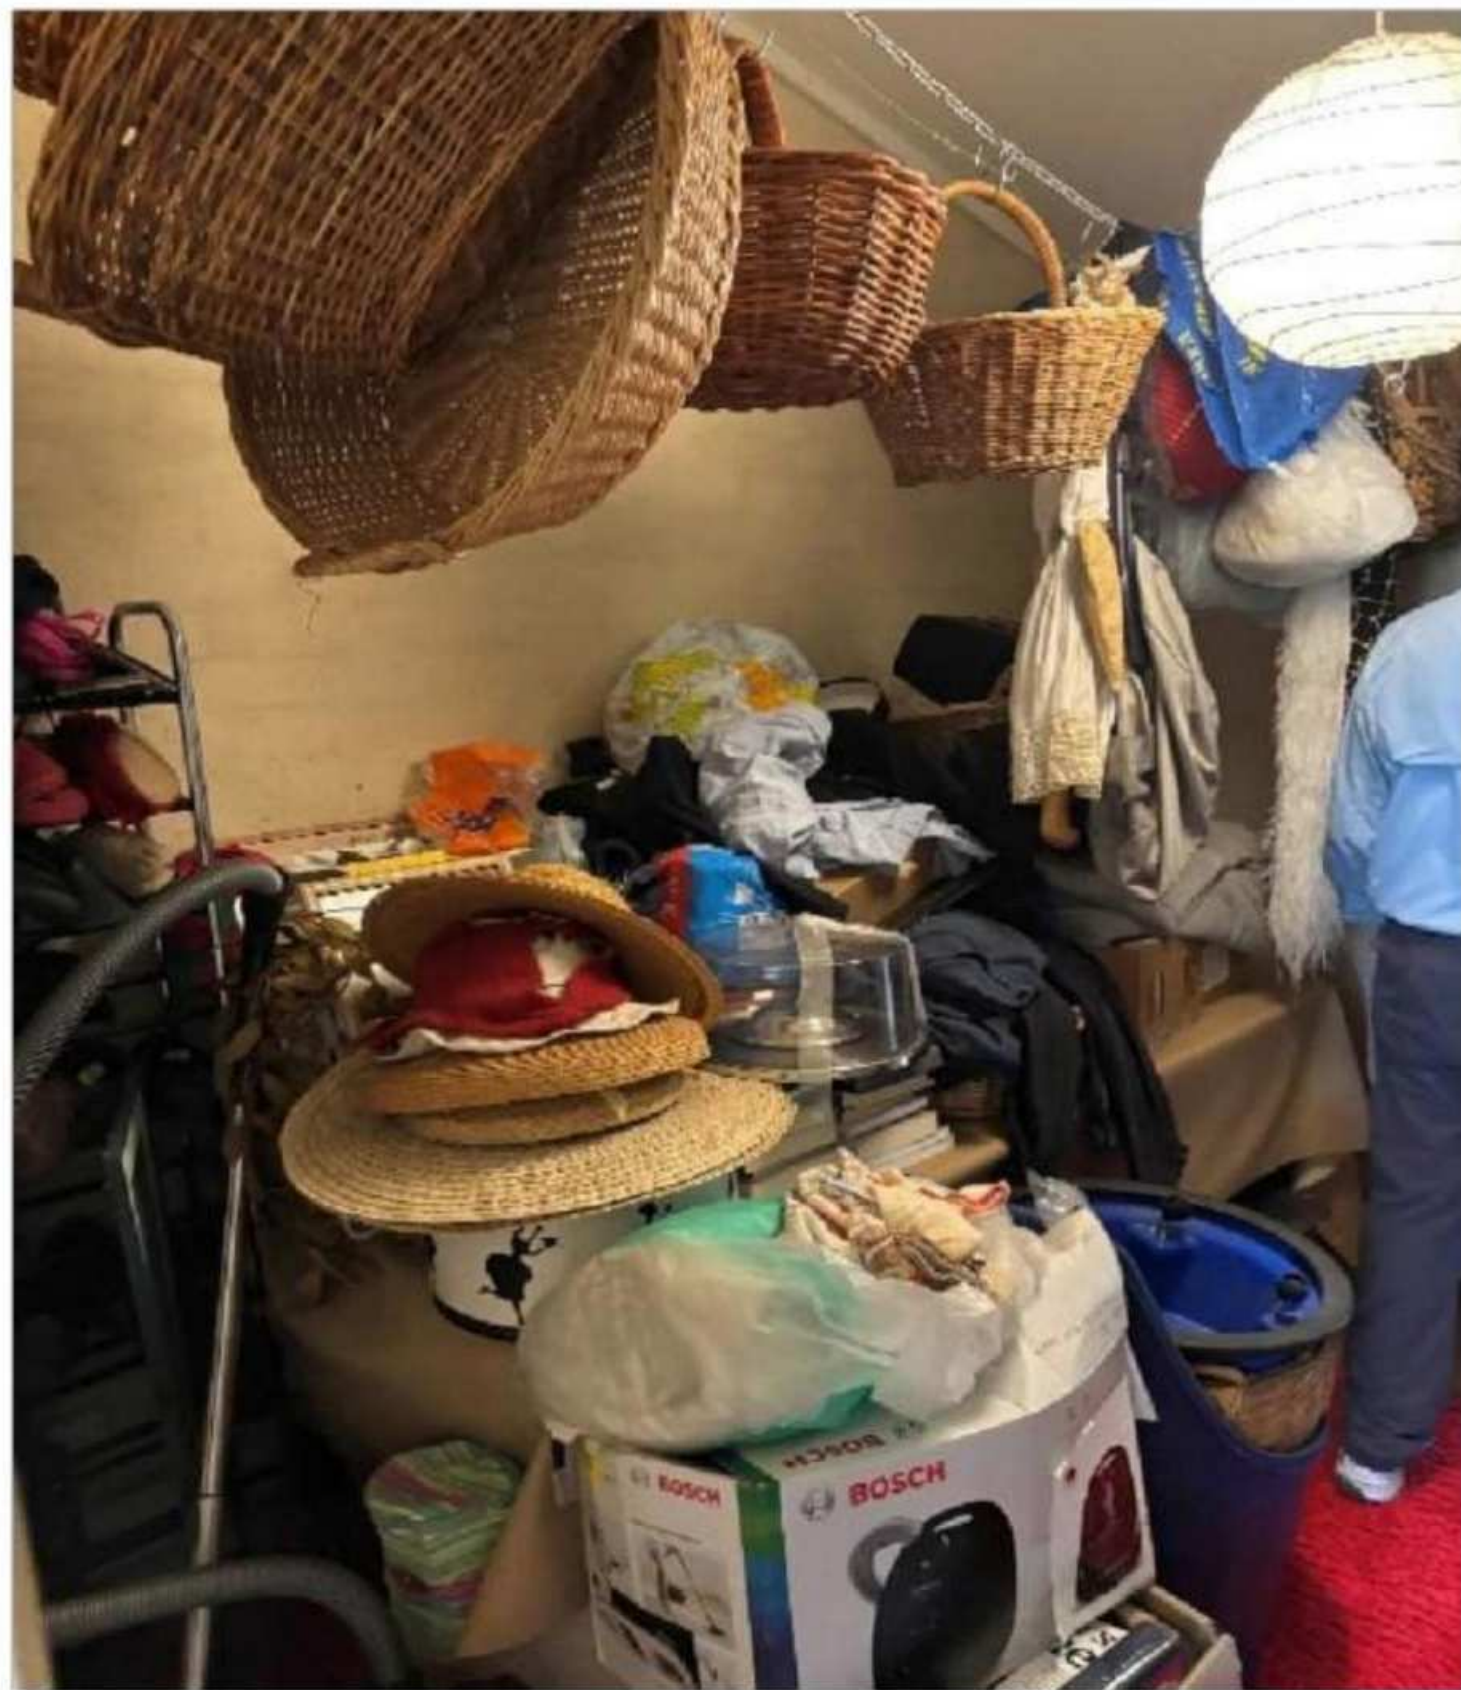
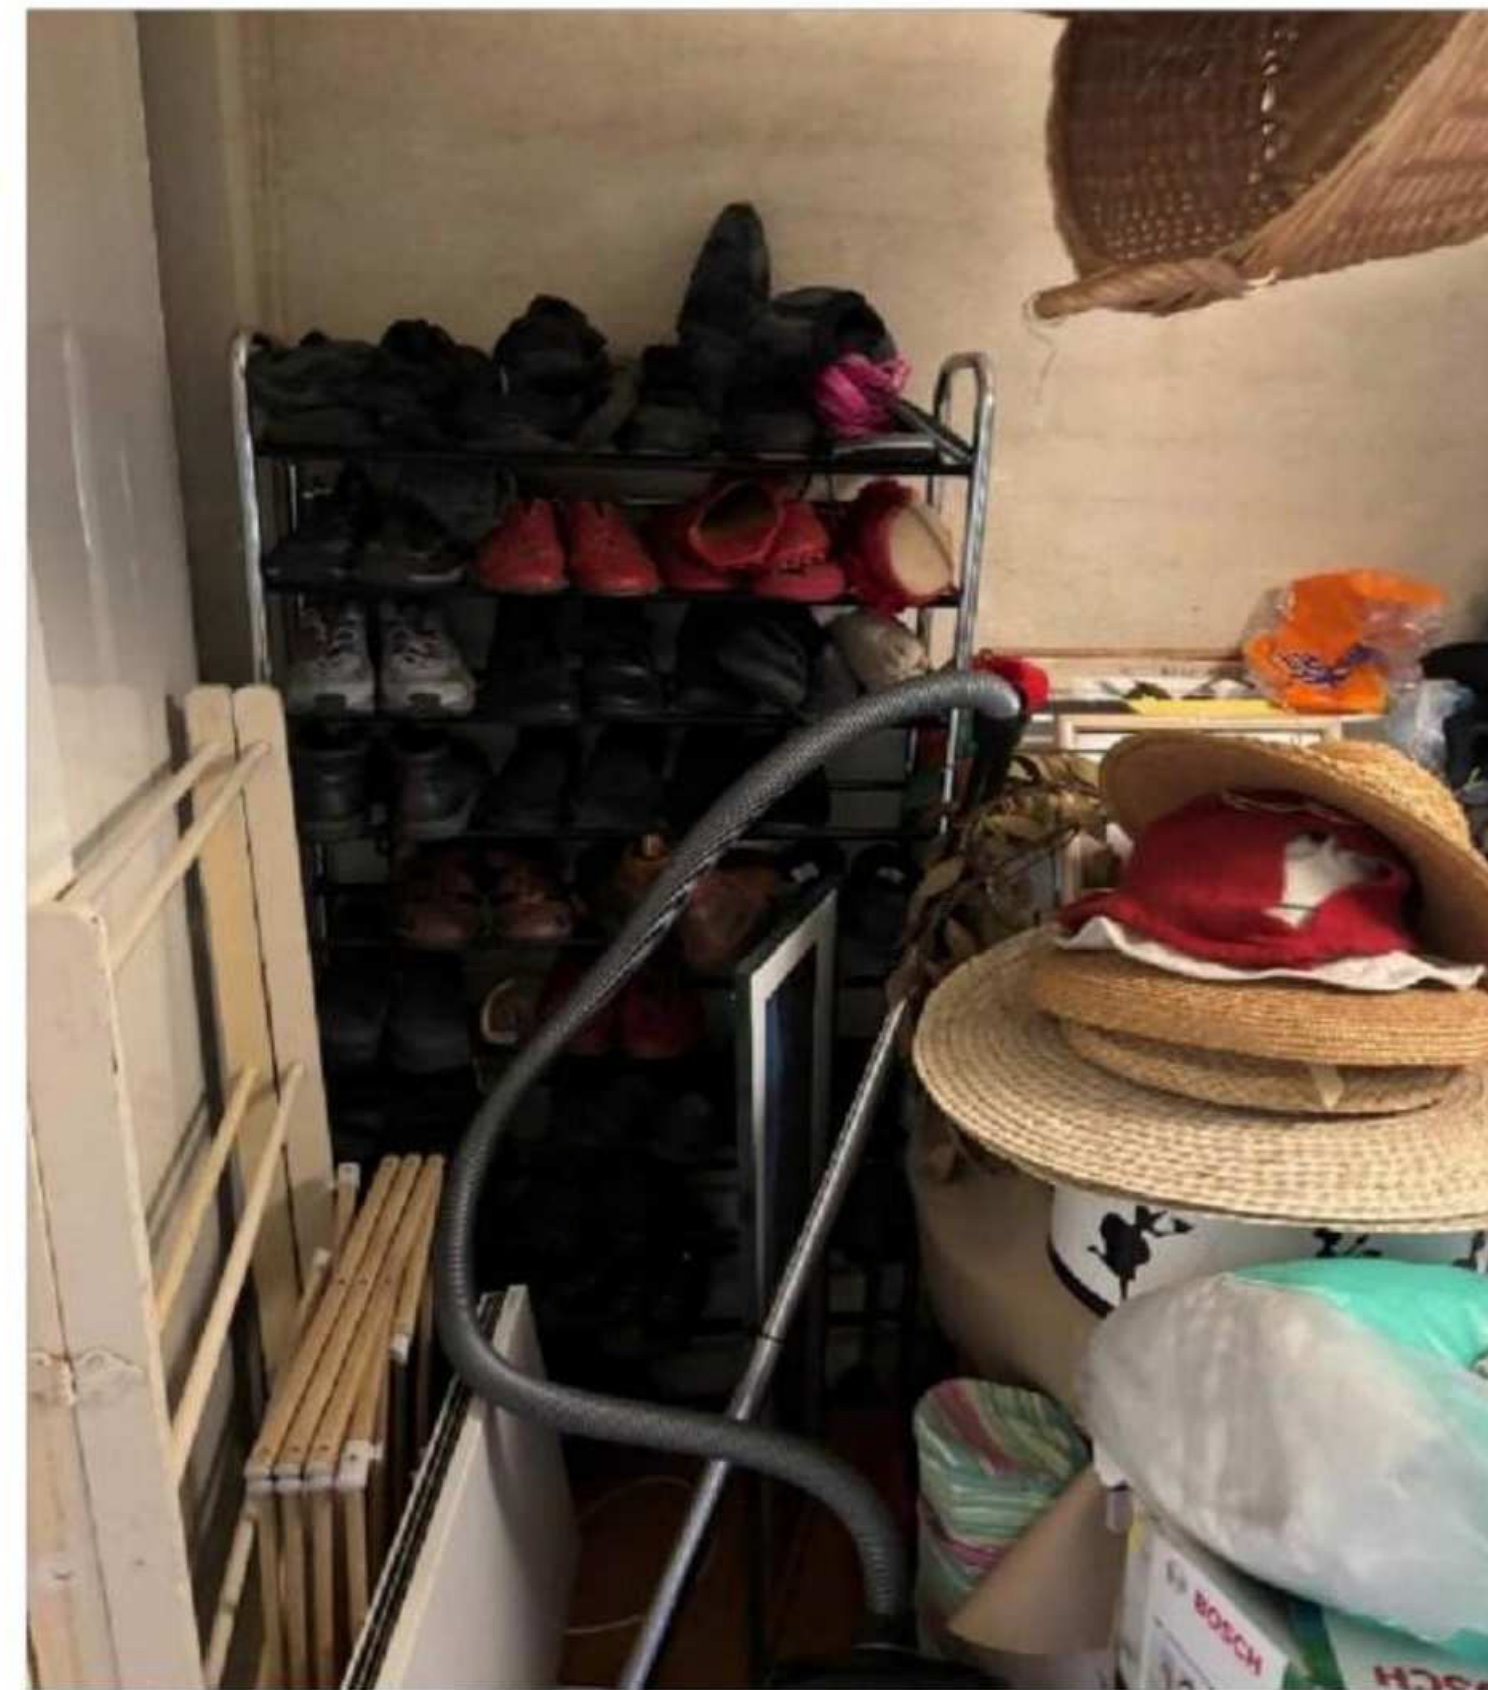
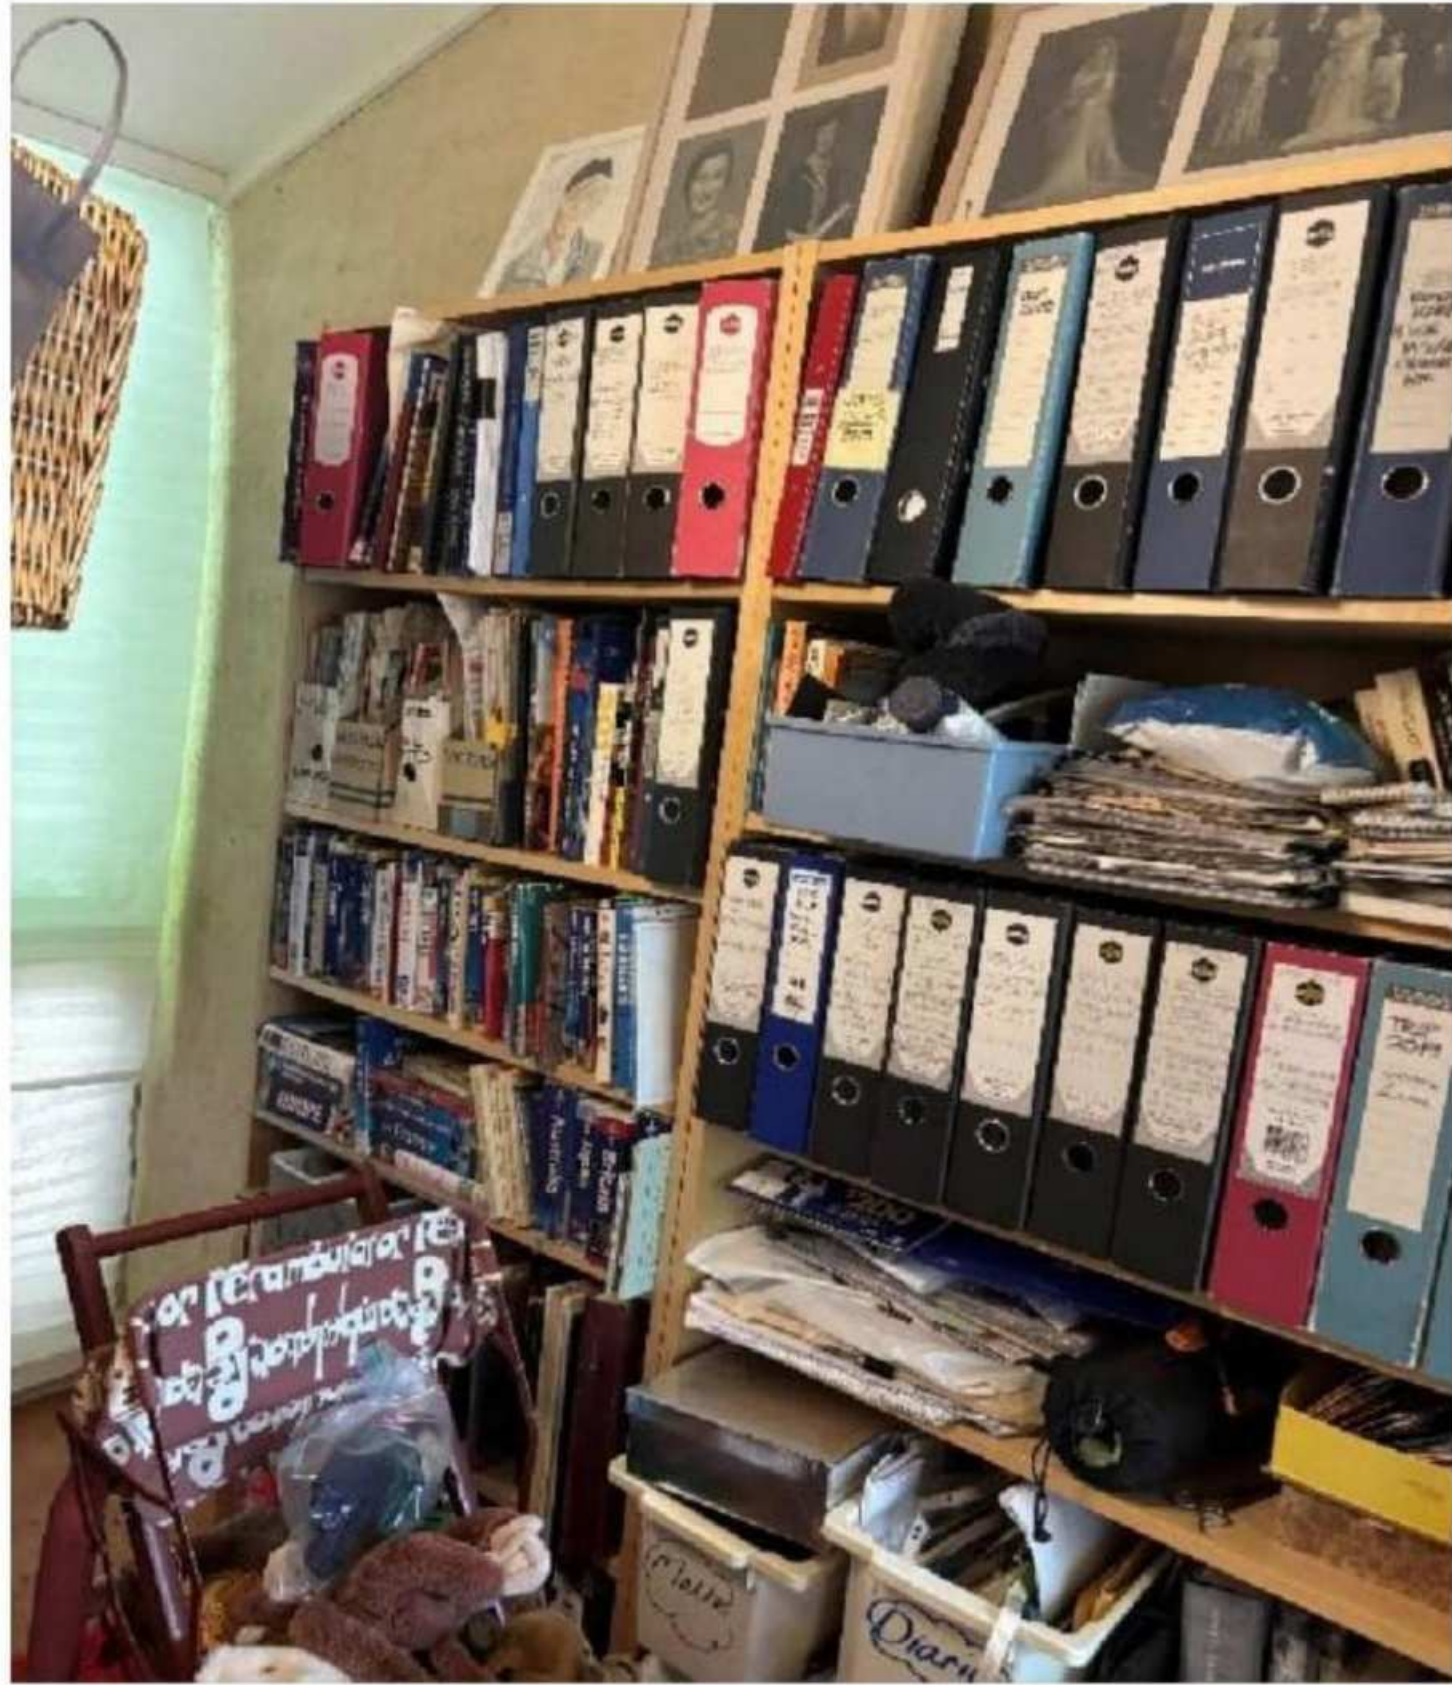
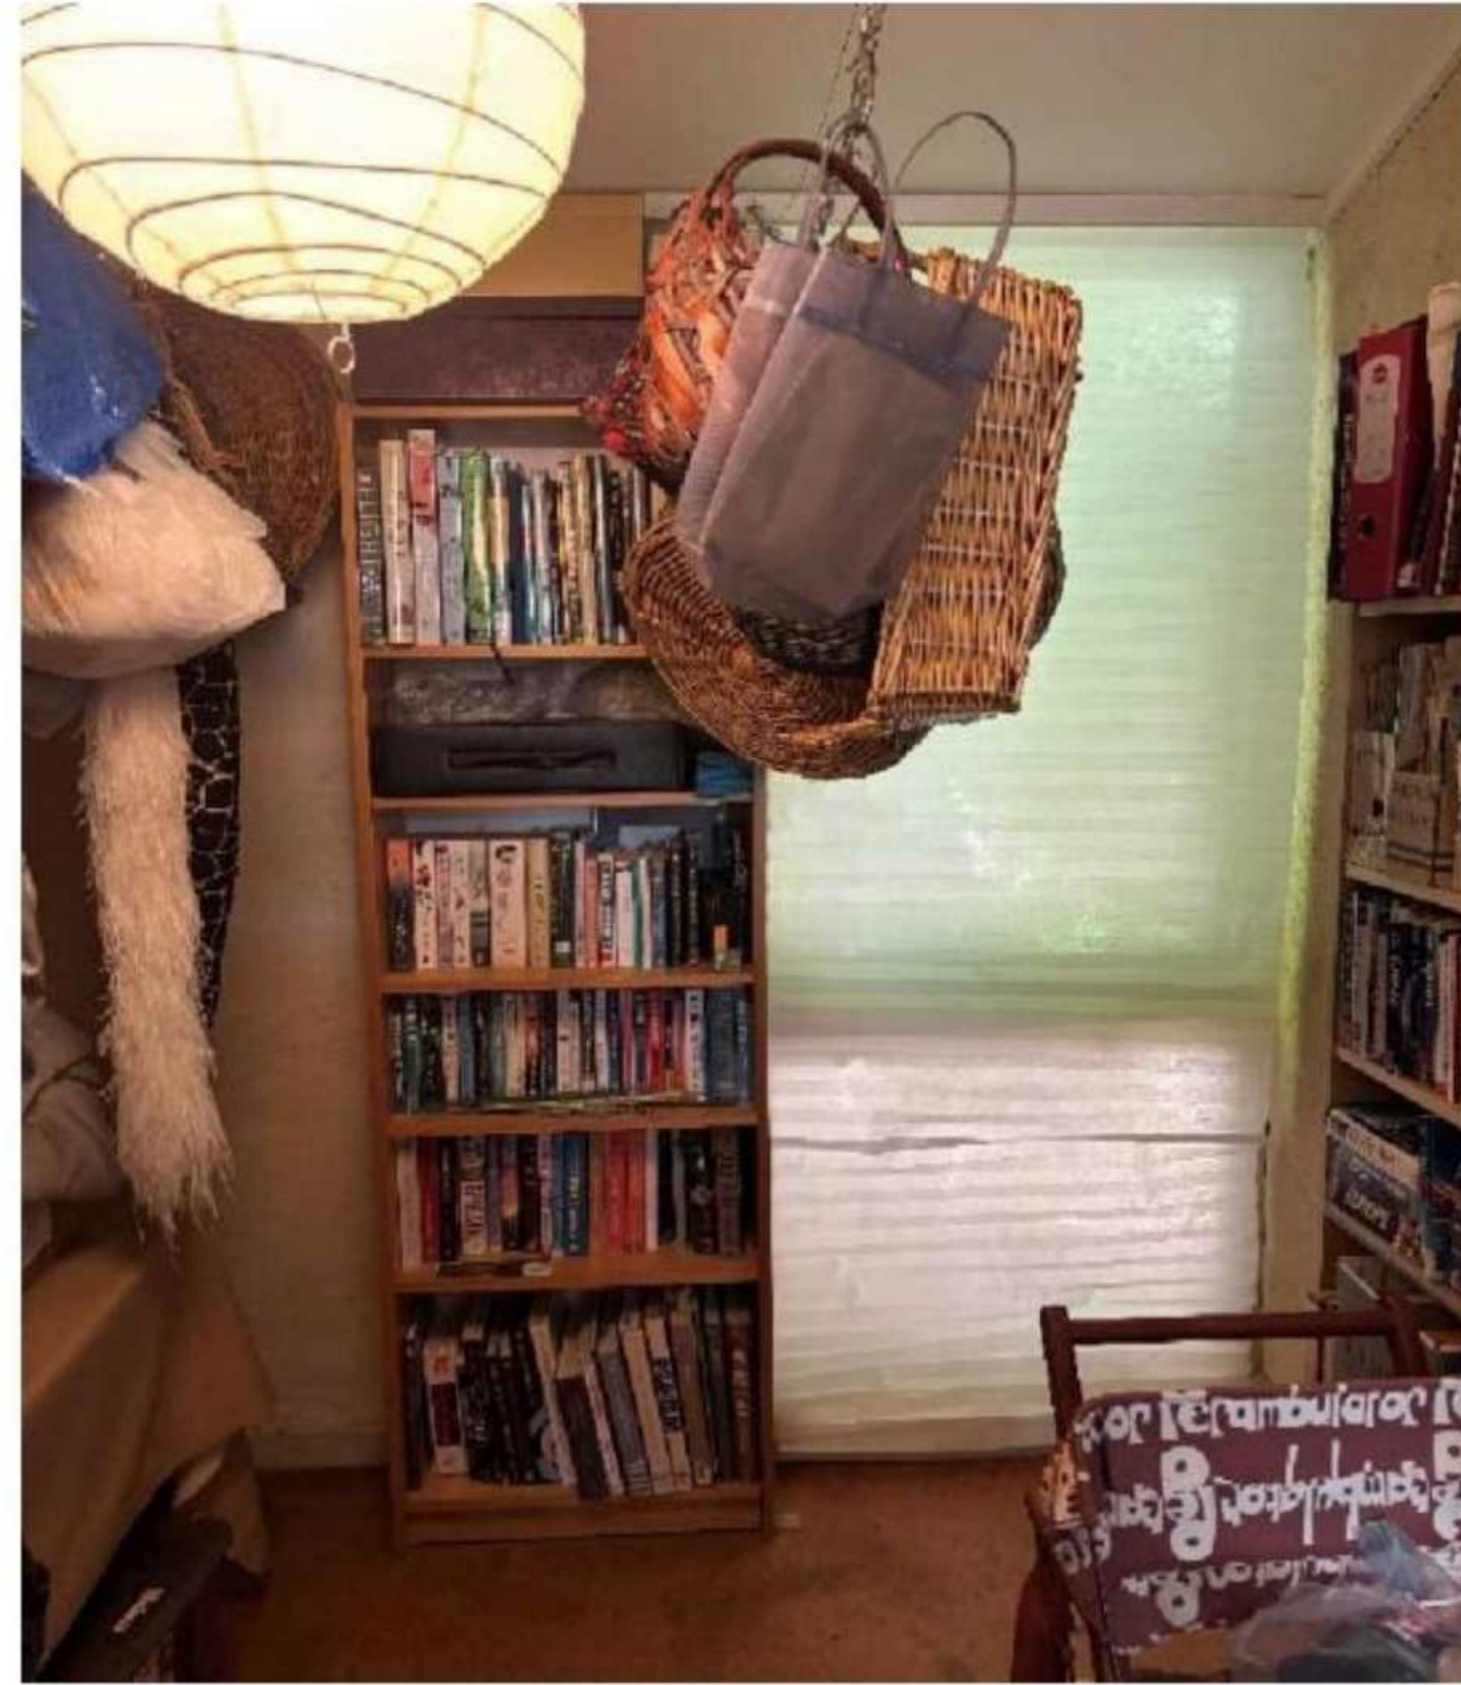
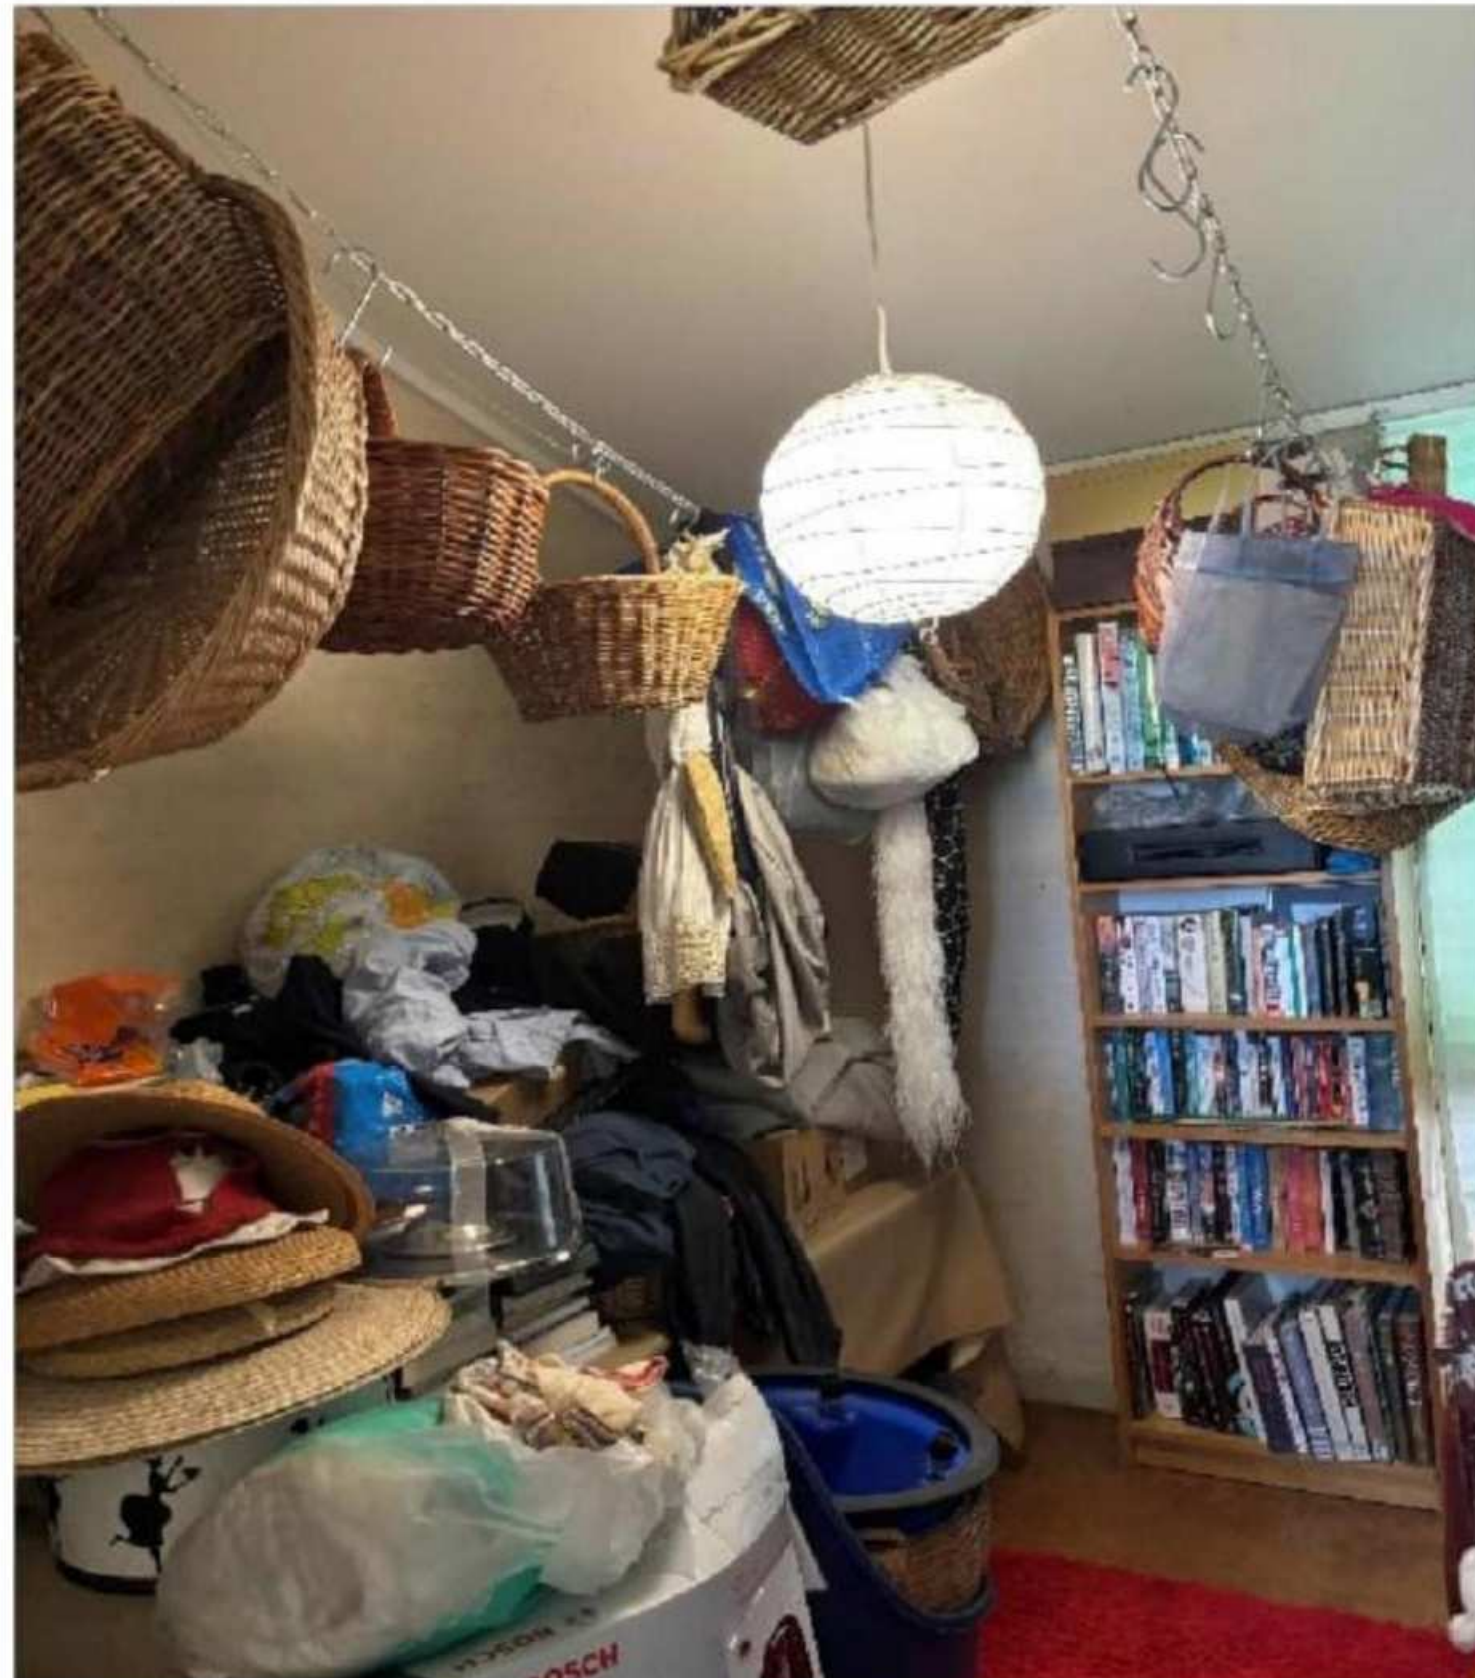
| Bedroom 2 | No defect evident. |

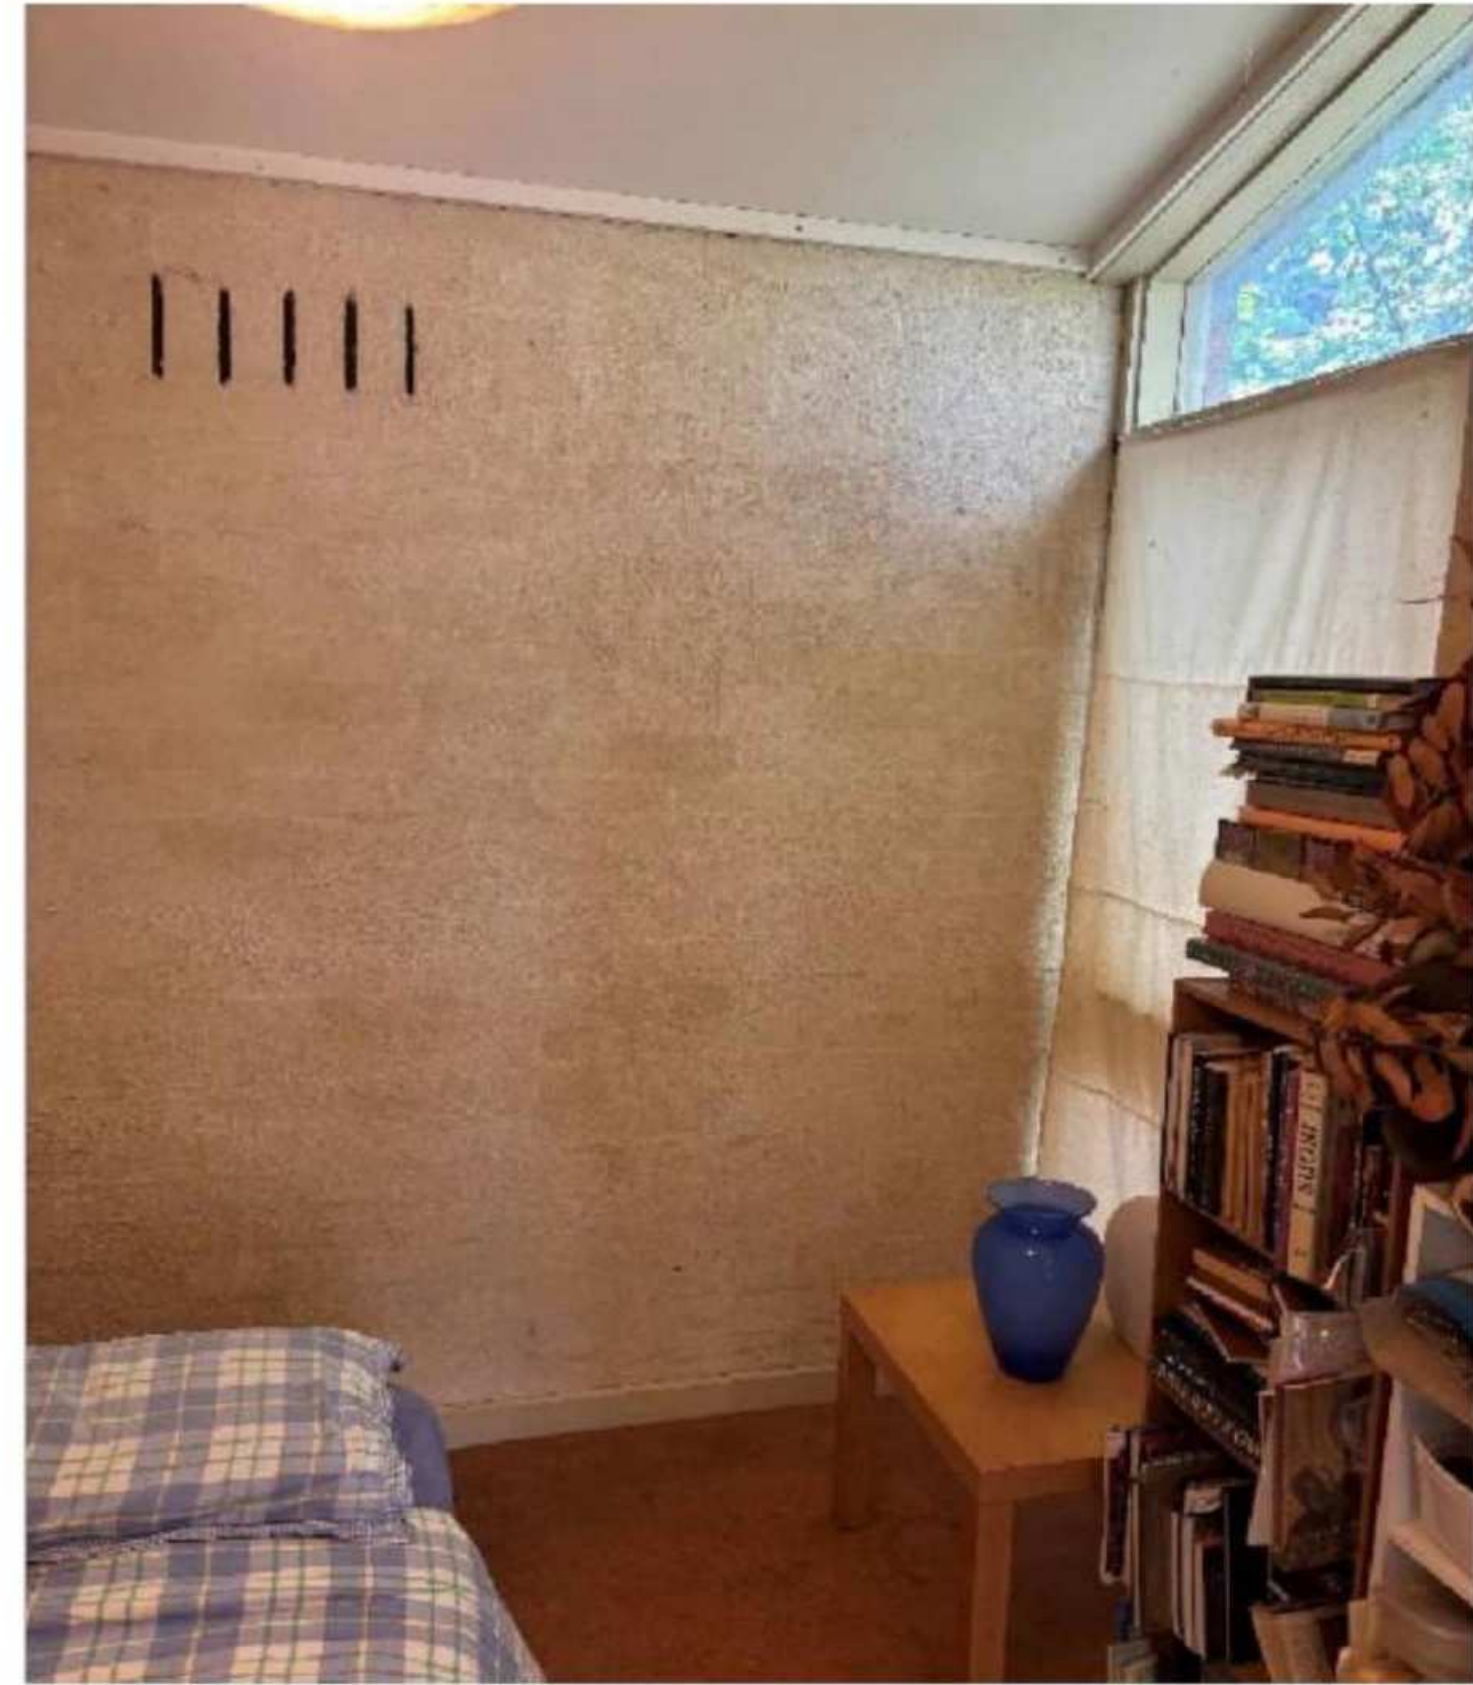
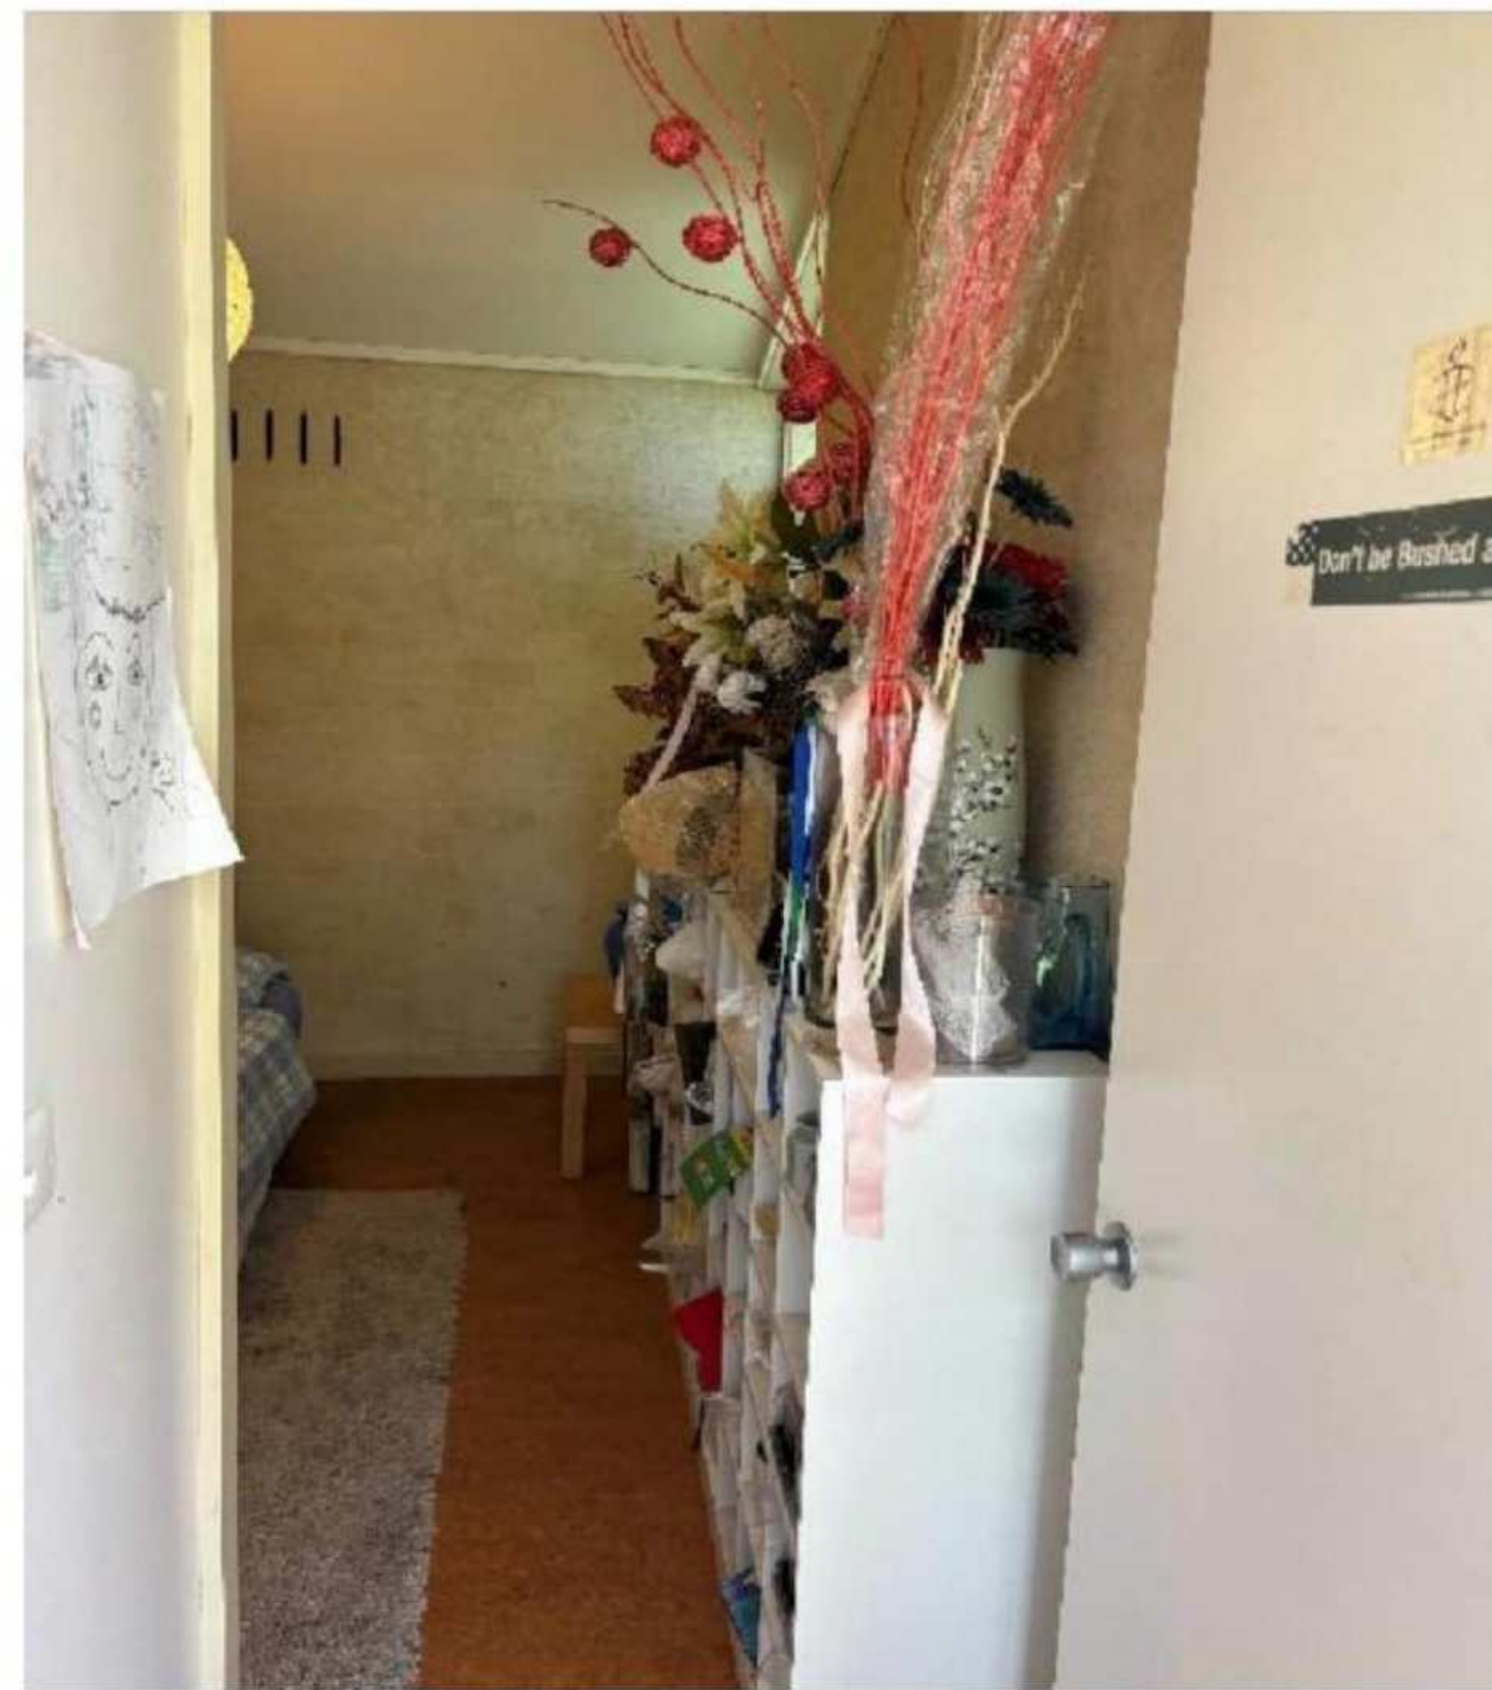
| Bedroom 3 | No defect evident. |

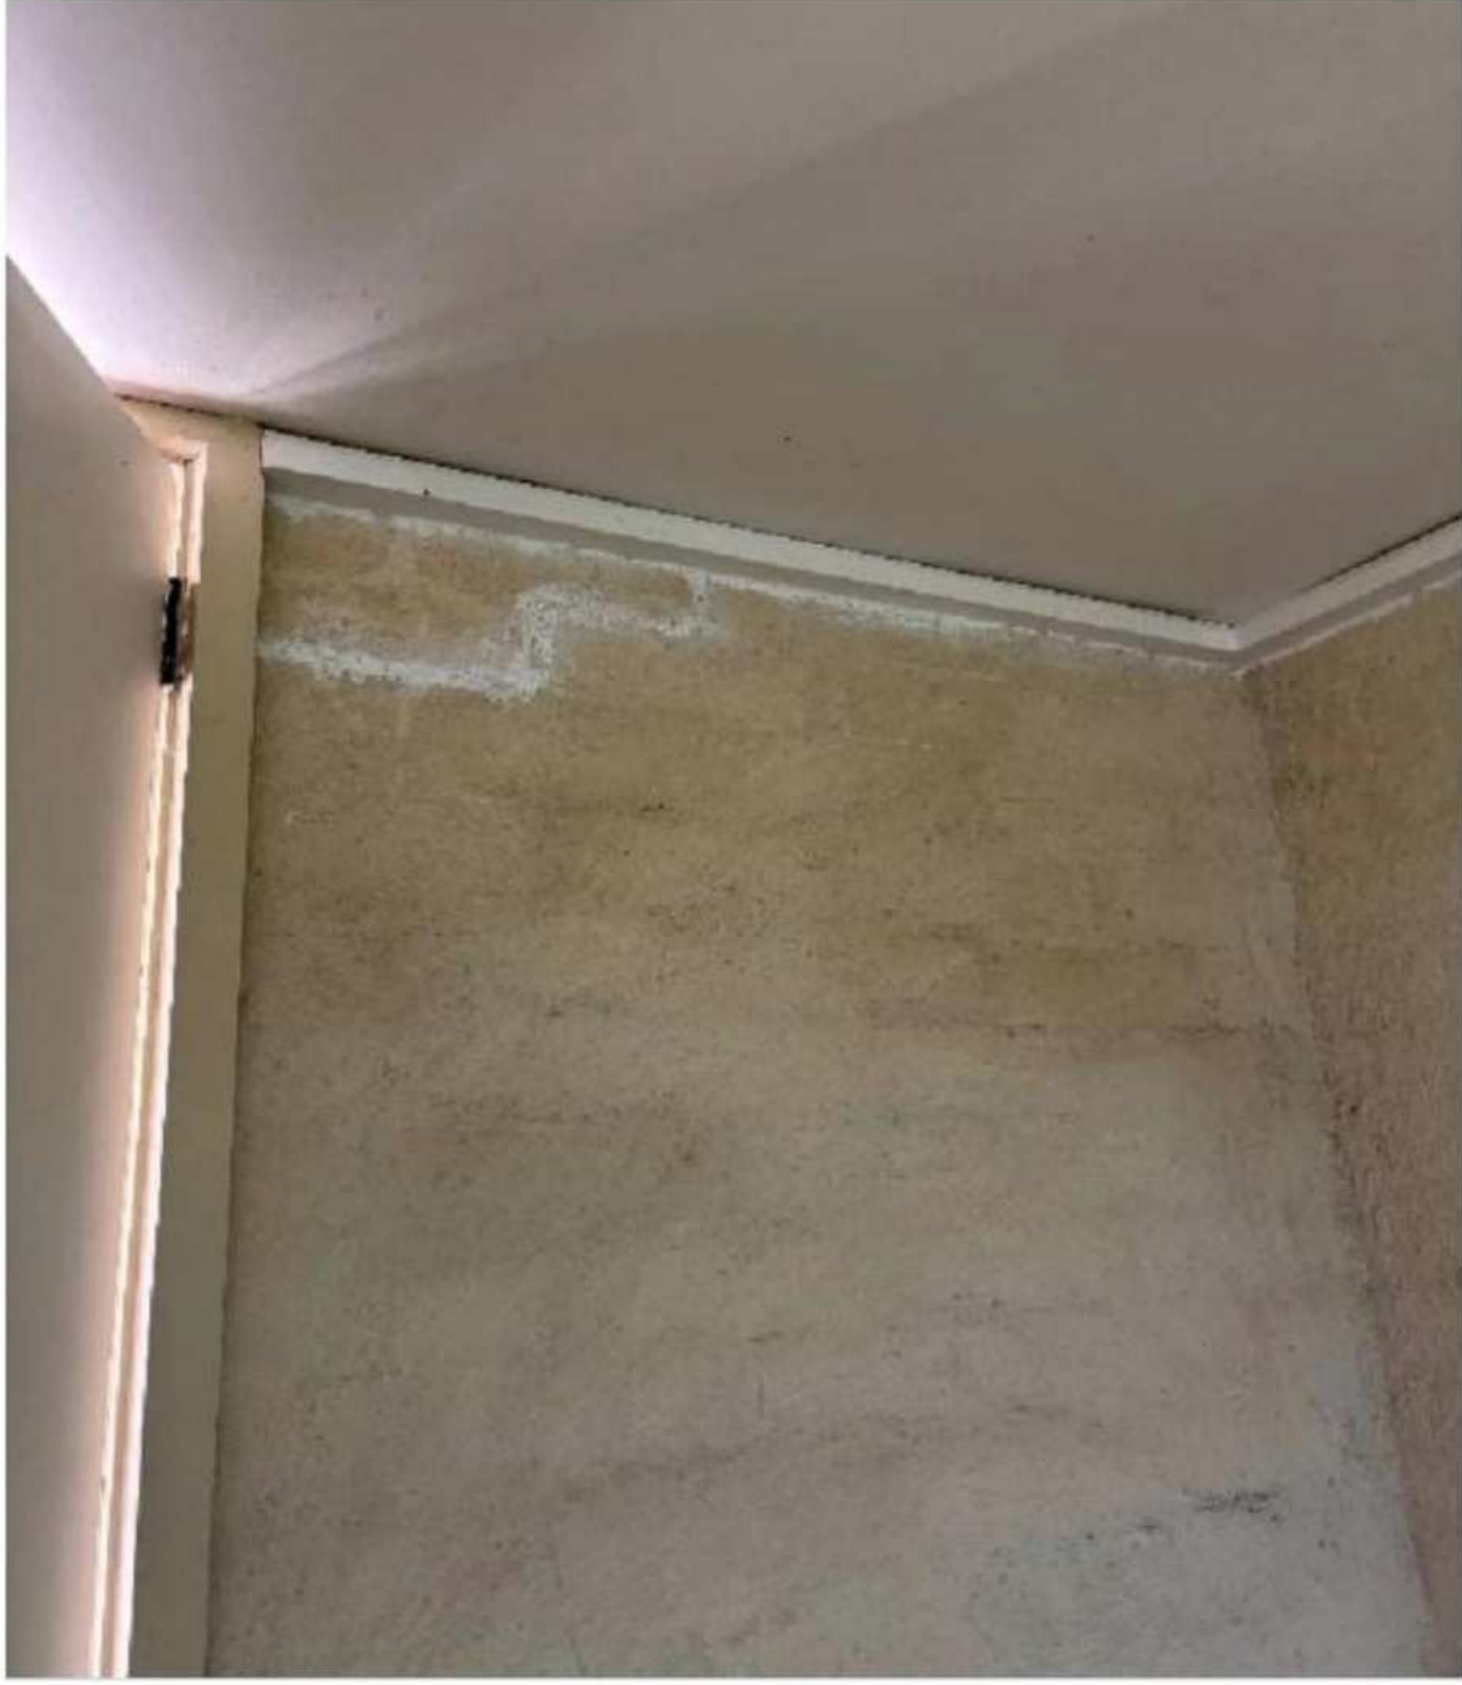
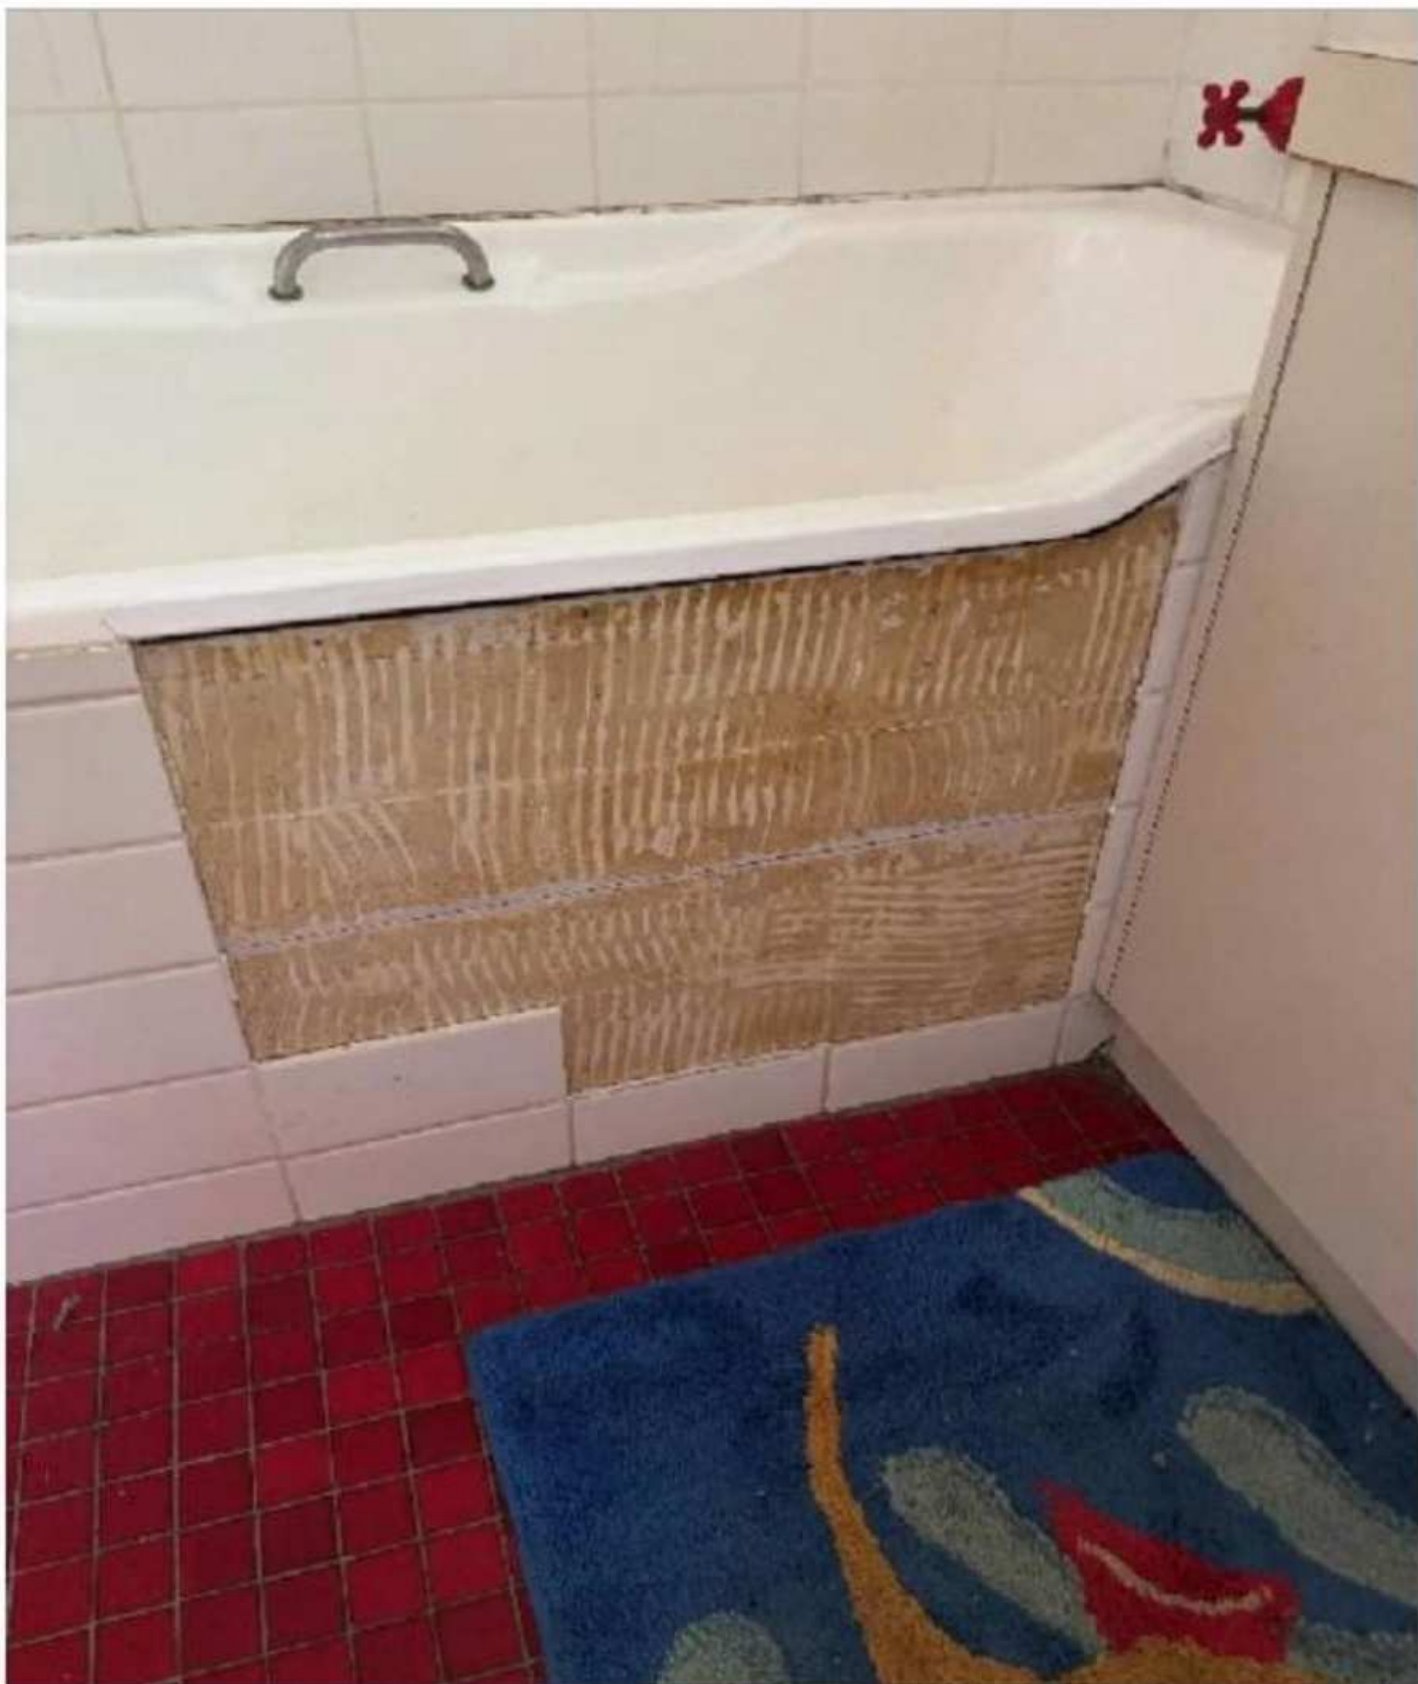
| Bathroom | Tiles have fallen off from bathtub.<br>Evidence of water damage on ceiling around exhaust fan.<br>Evidence of cracked tiles on walls (all sides).<br>Evidence of cracked tiles on walls in the shower.<br>Evidence of fine cracking on ceiling cornices.<br>Evidence of cracked walls (repairs conducted). |
