Thank you for the opportunity to carry out a dilapidation inspection at the above property in order to document existing cracking prior to the commencement of construction works at your property.

The two-storey property is of single skin brick and timber frame construction with brick veneer exterior walls, internal brick walls and timber ceilings, timber windows and a pitched roof clad with concrete tiles.

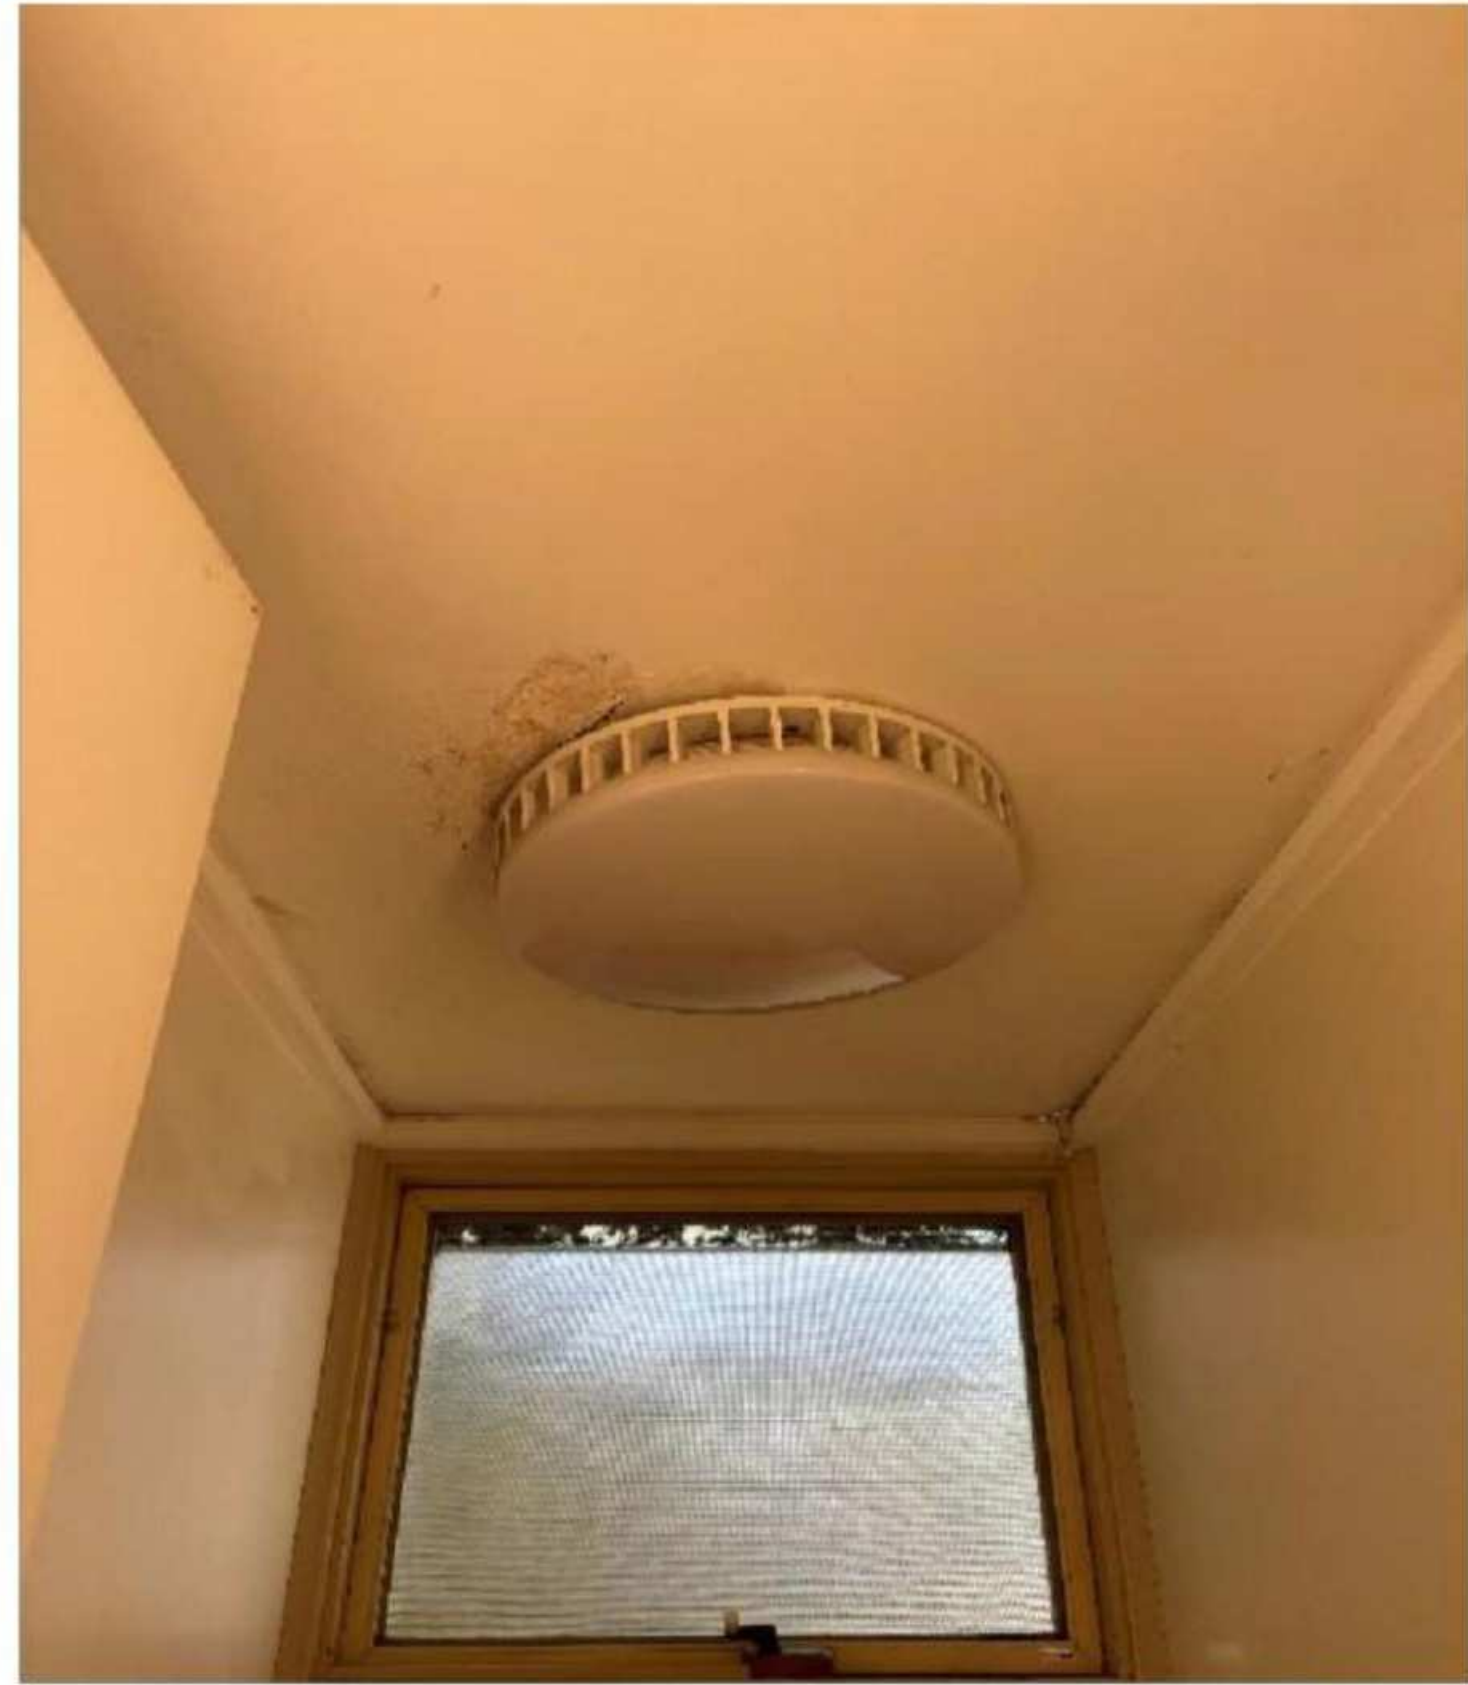
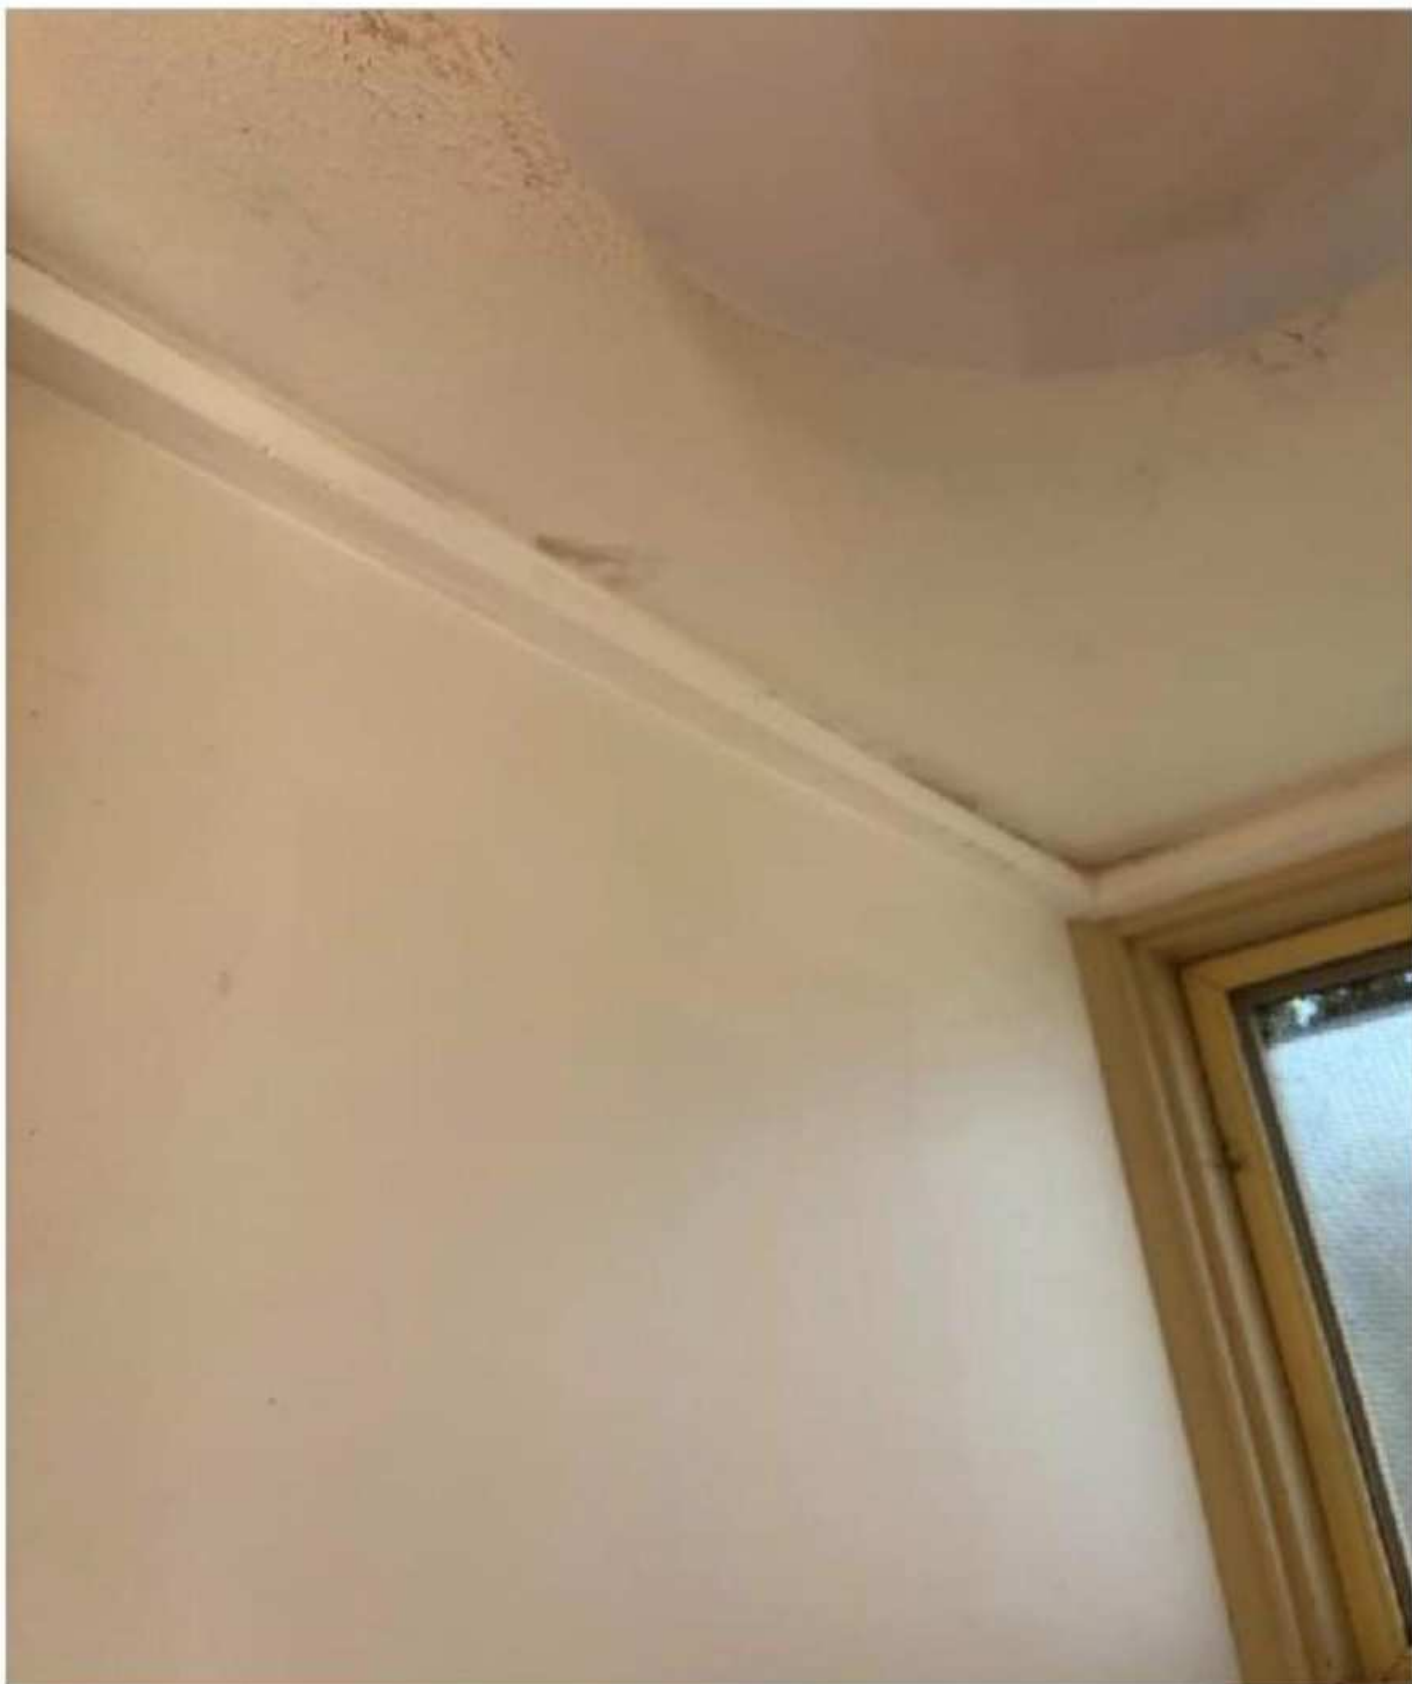
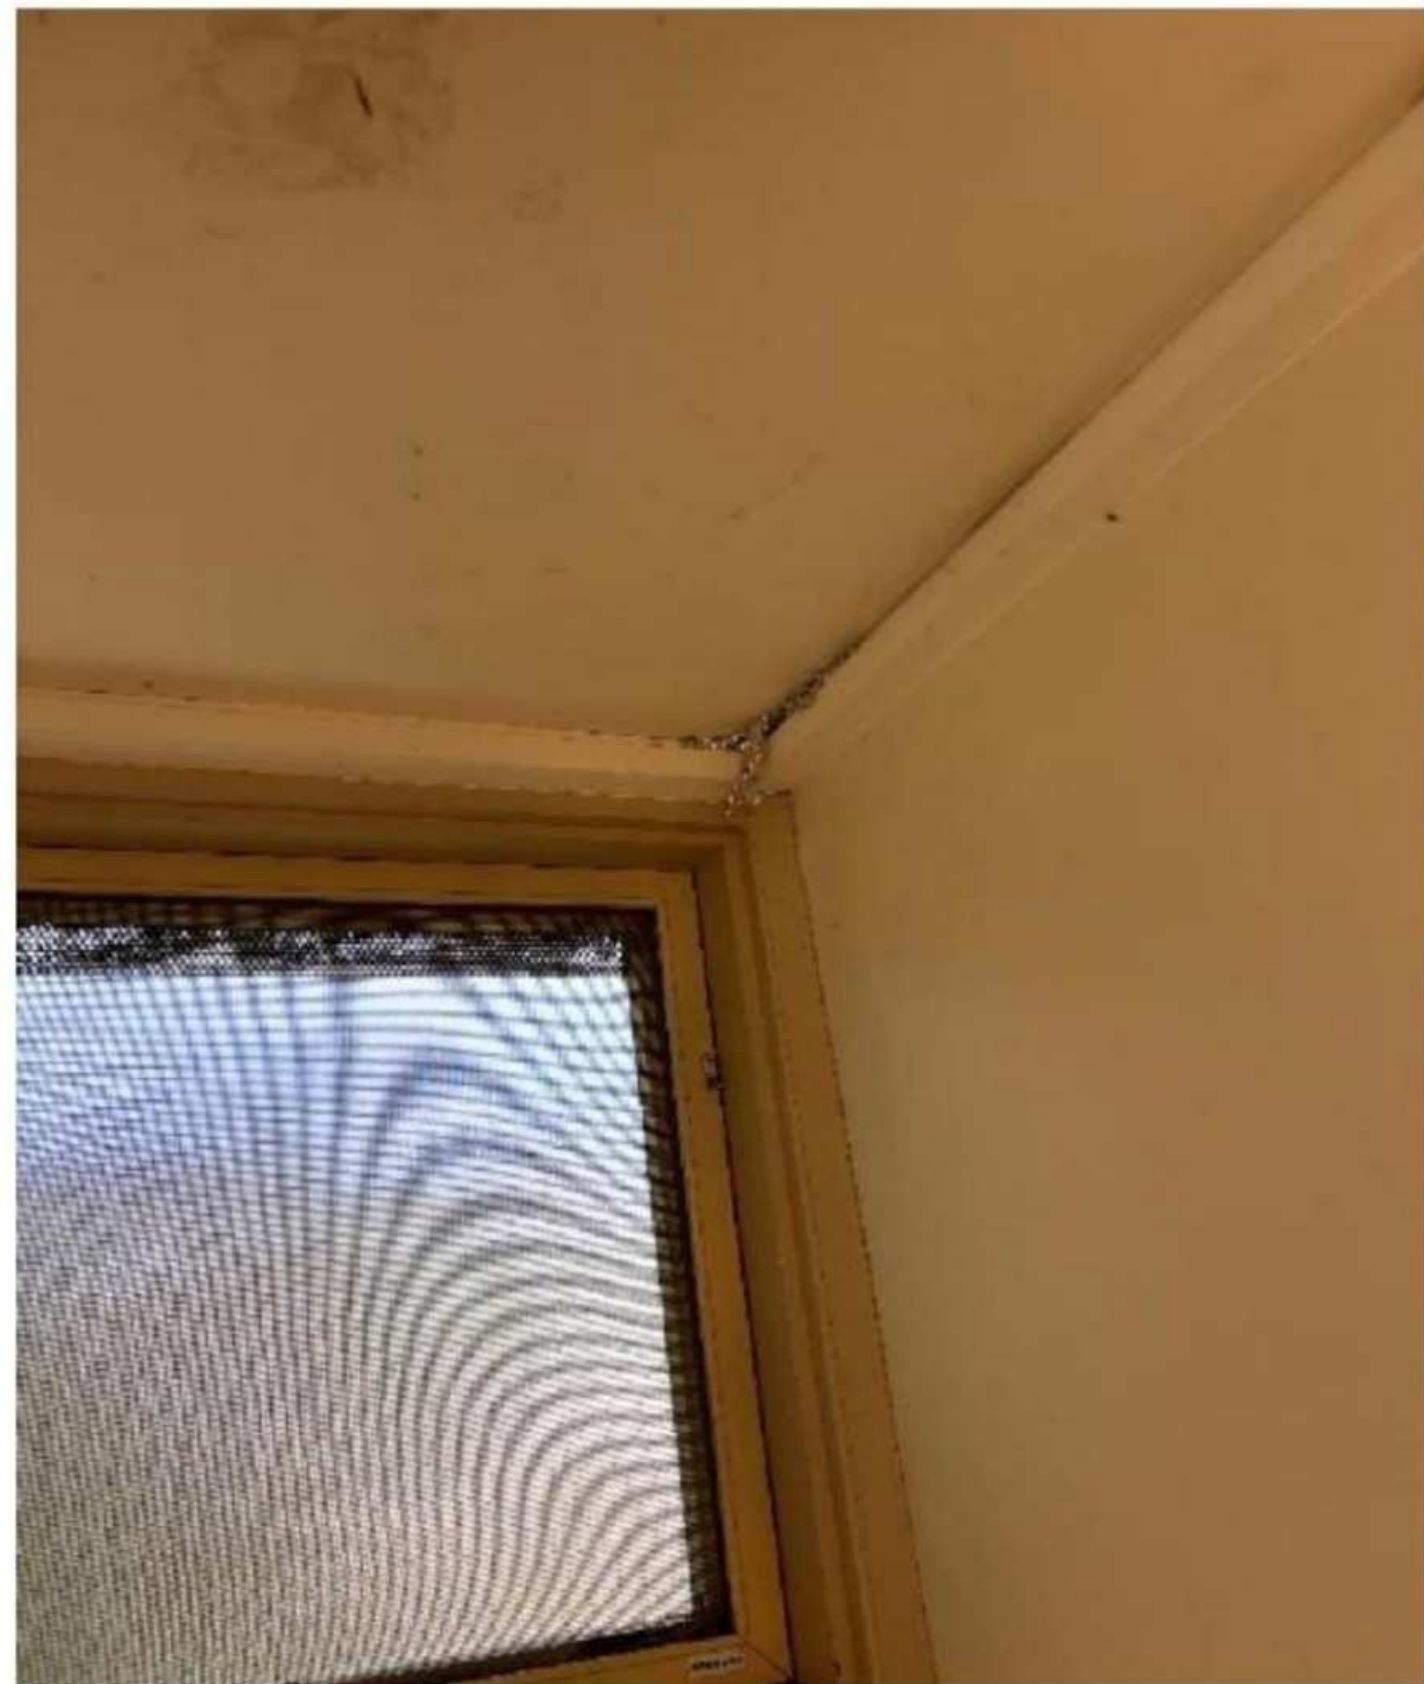
| Toilet (2) | Evidence of water damage on ceiling around exhaust fan, eastern wall, and western wall. |

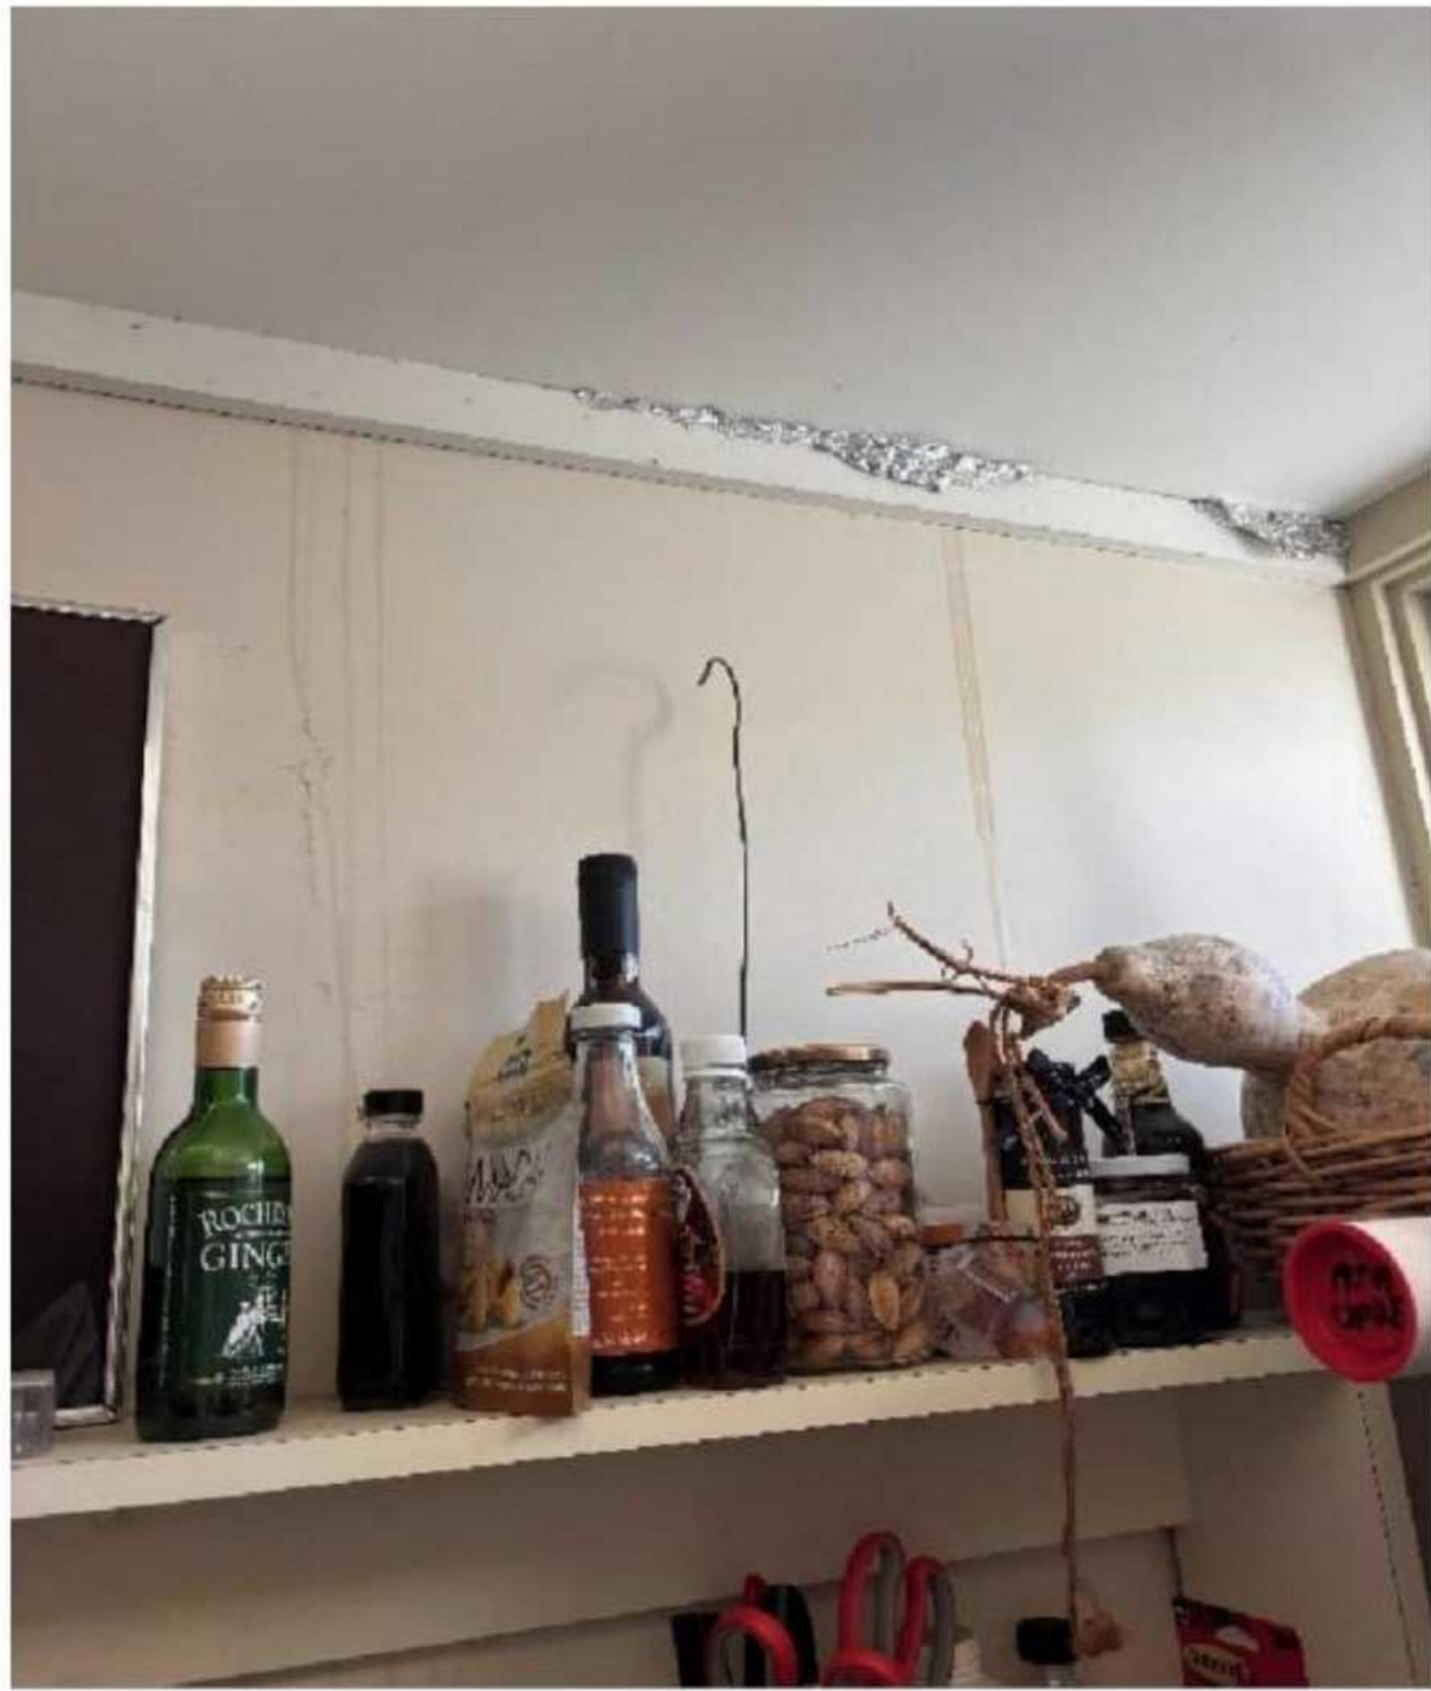
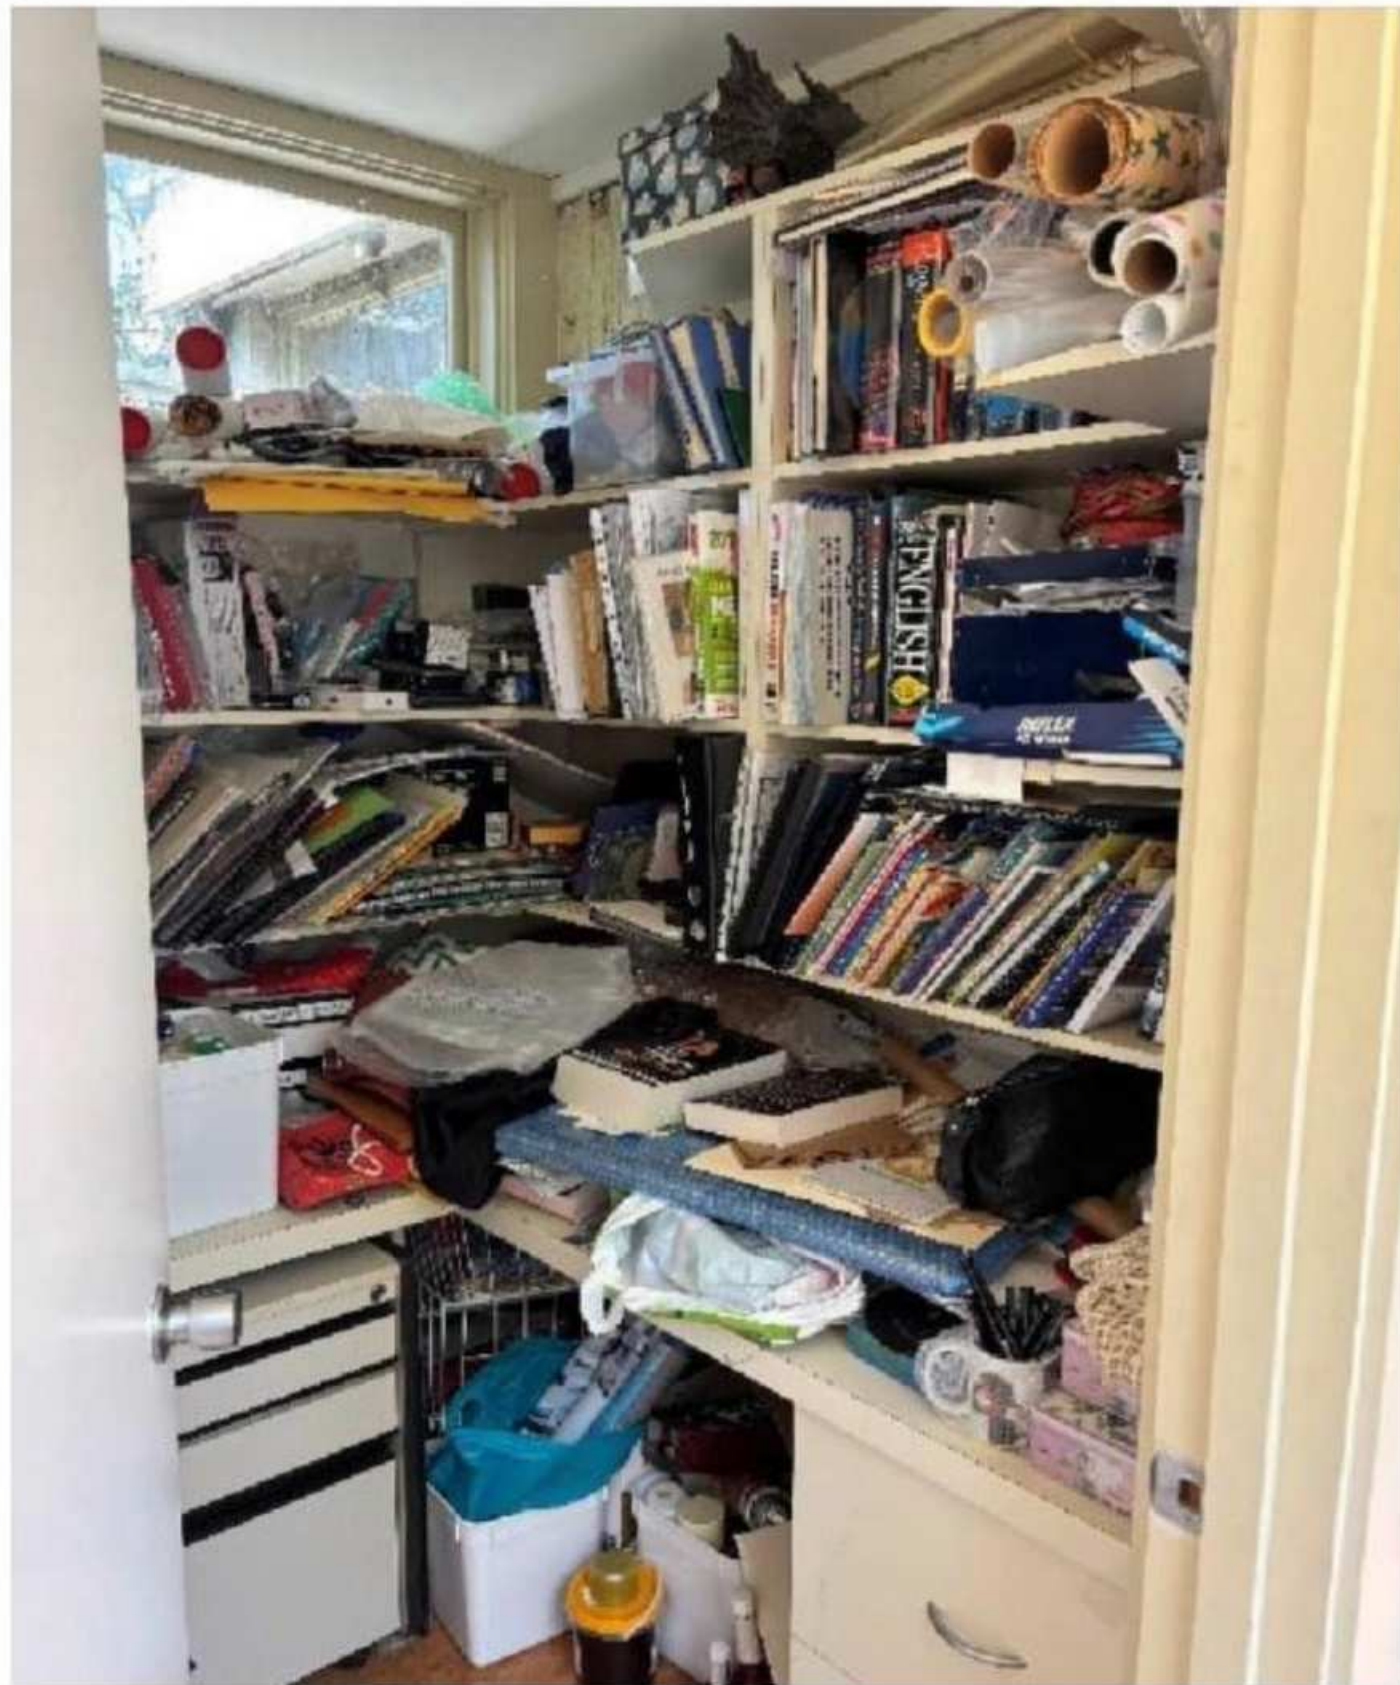
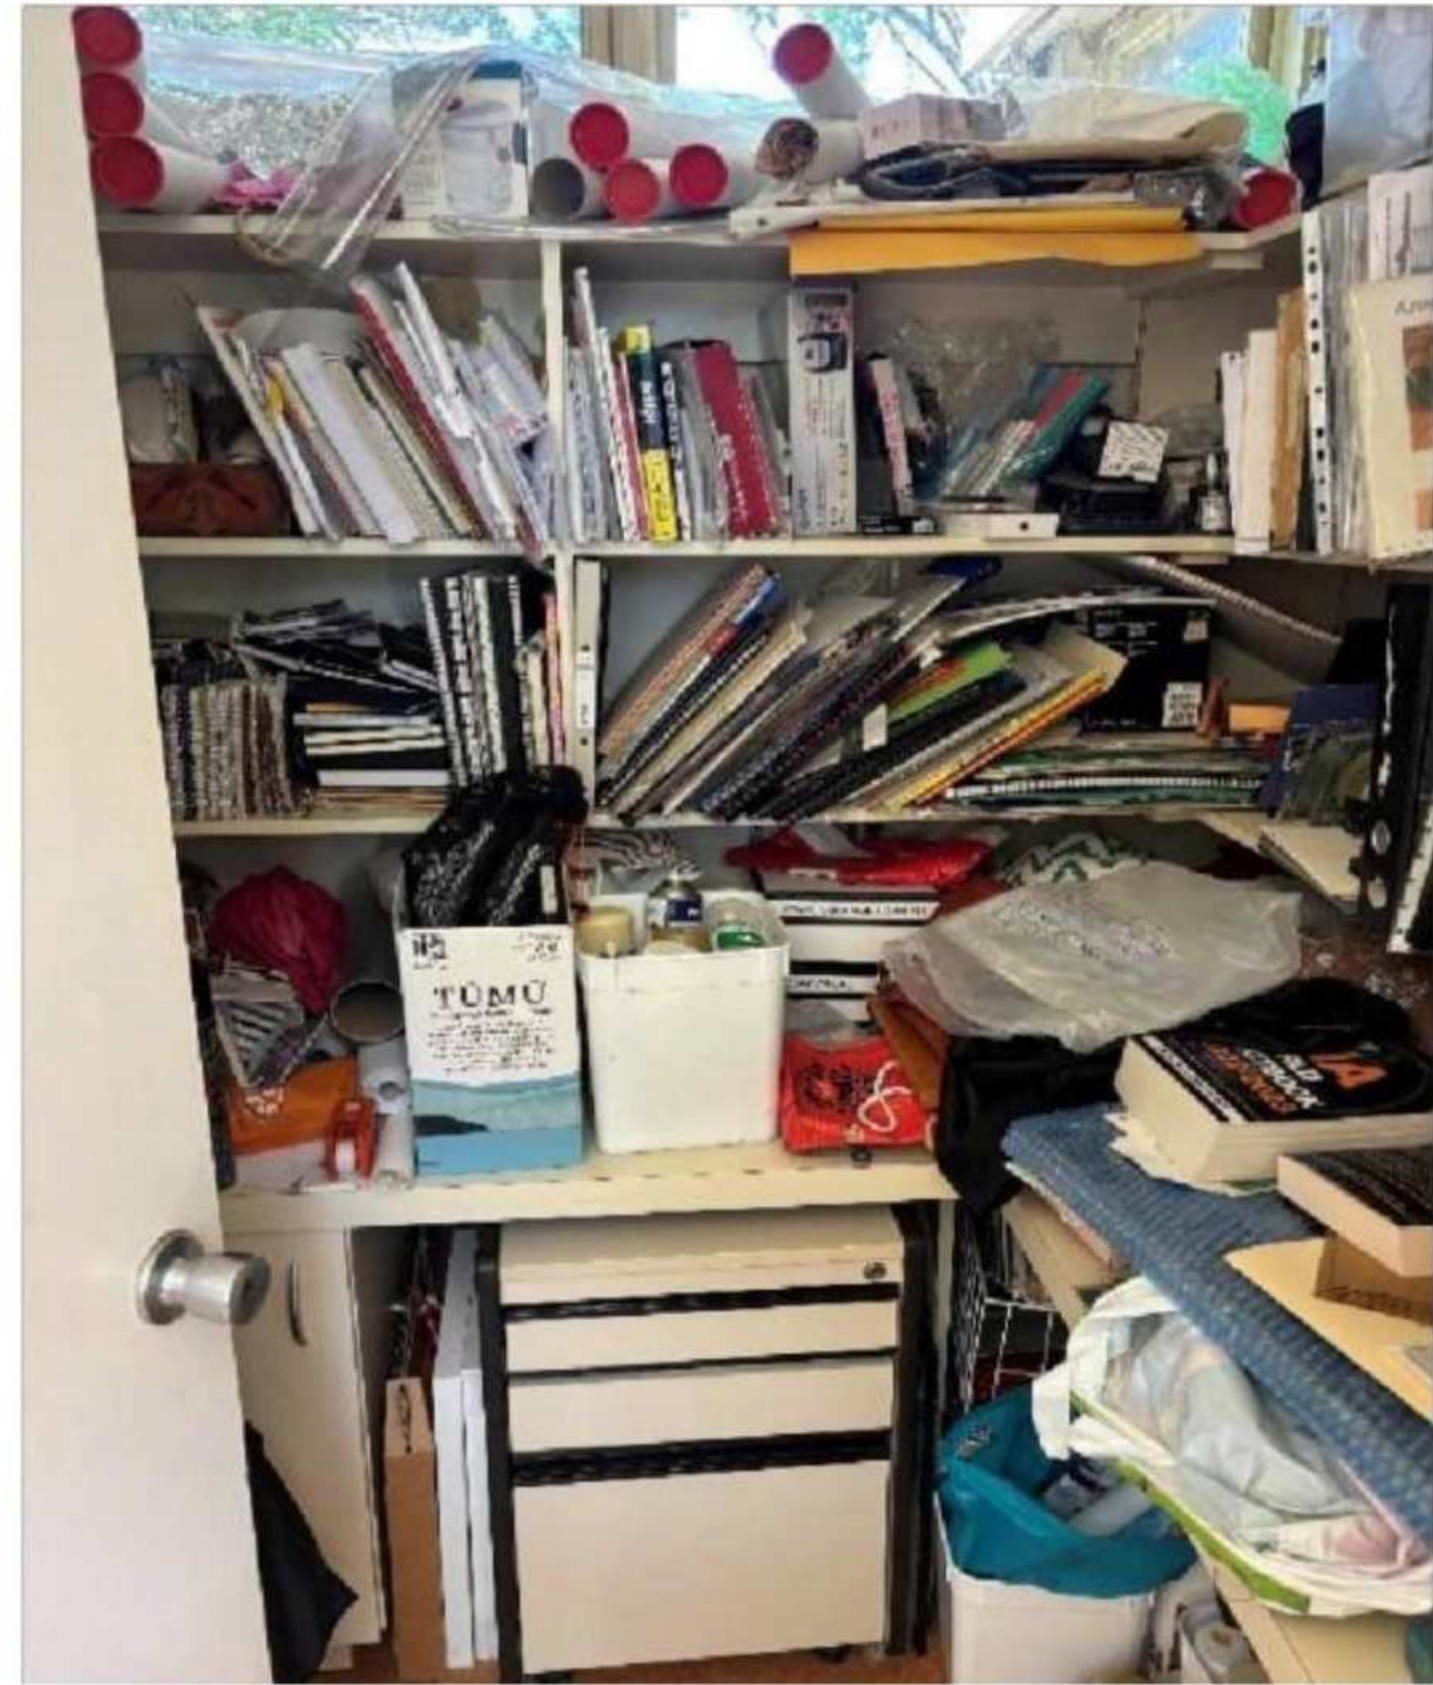
| Office | Evidence of water ingress and water stains on western and Eastern side walls. |

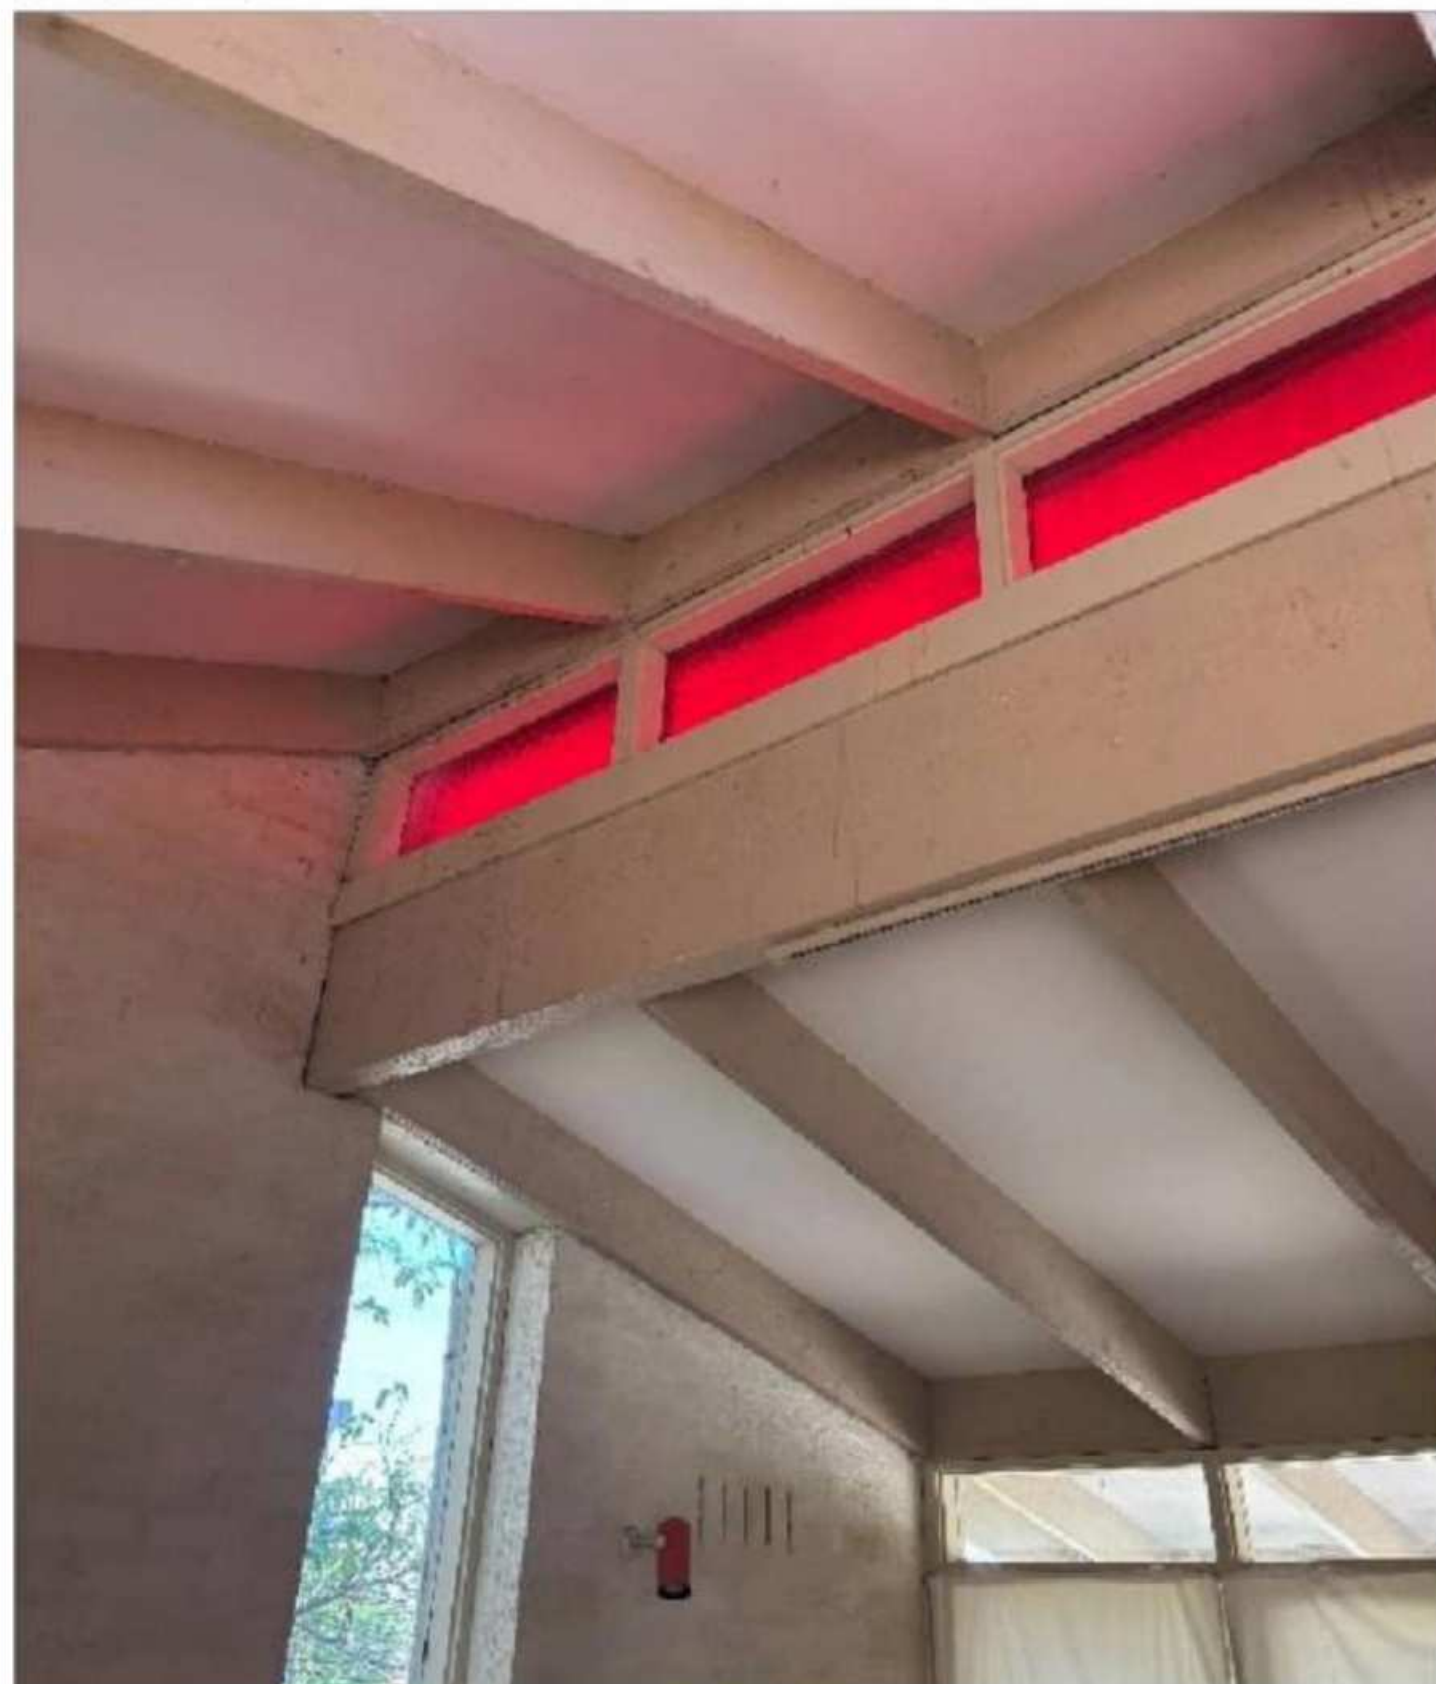
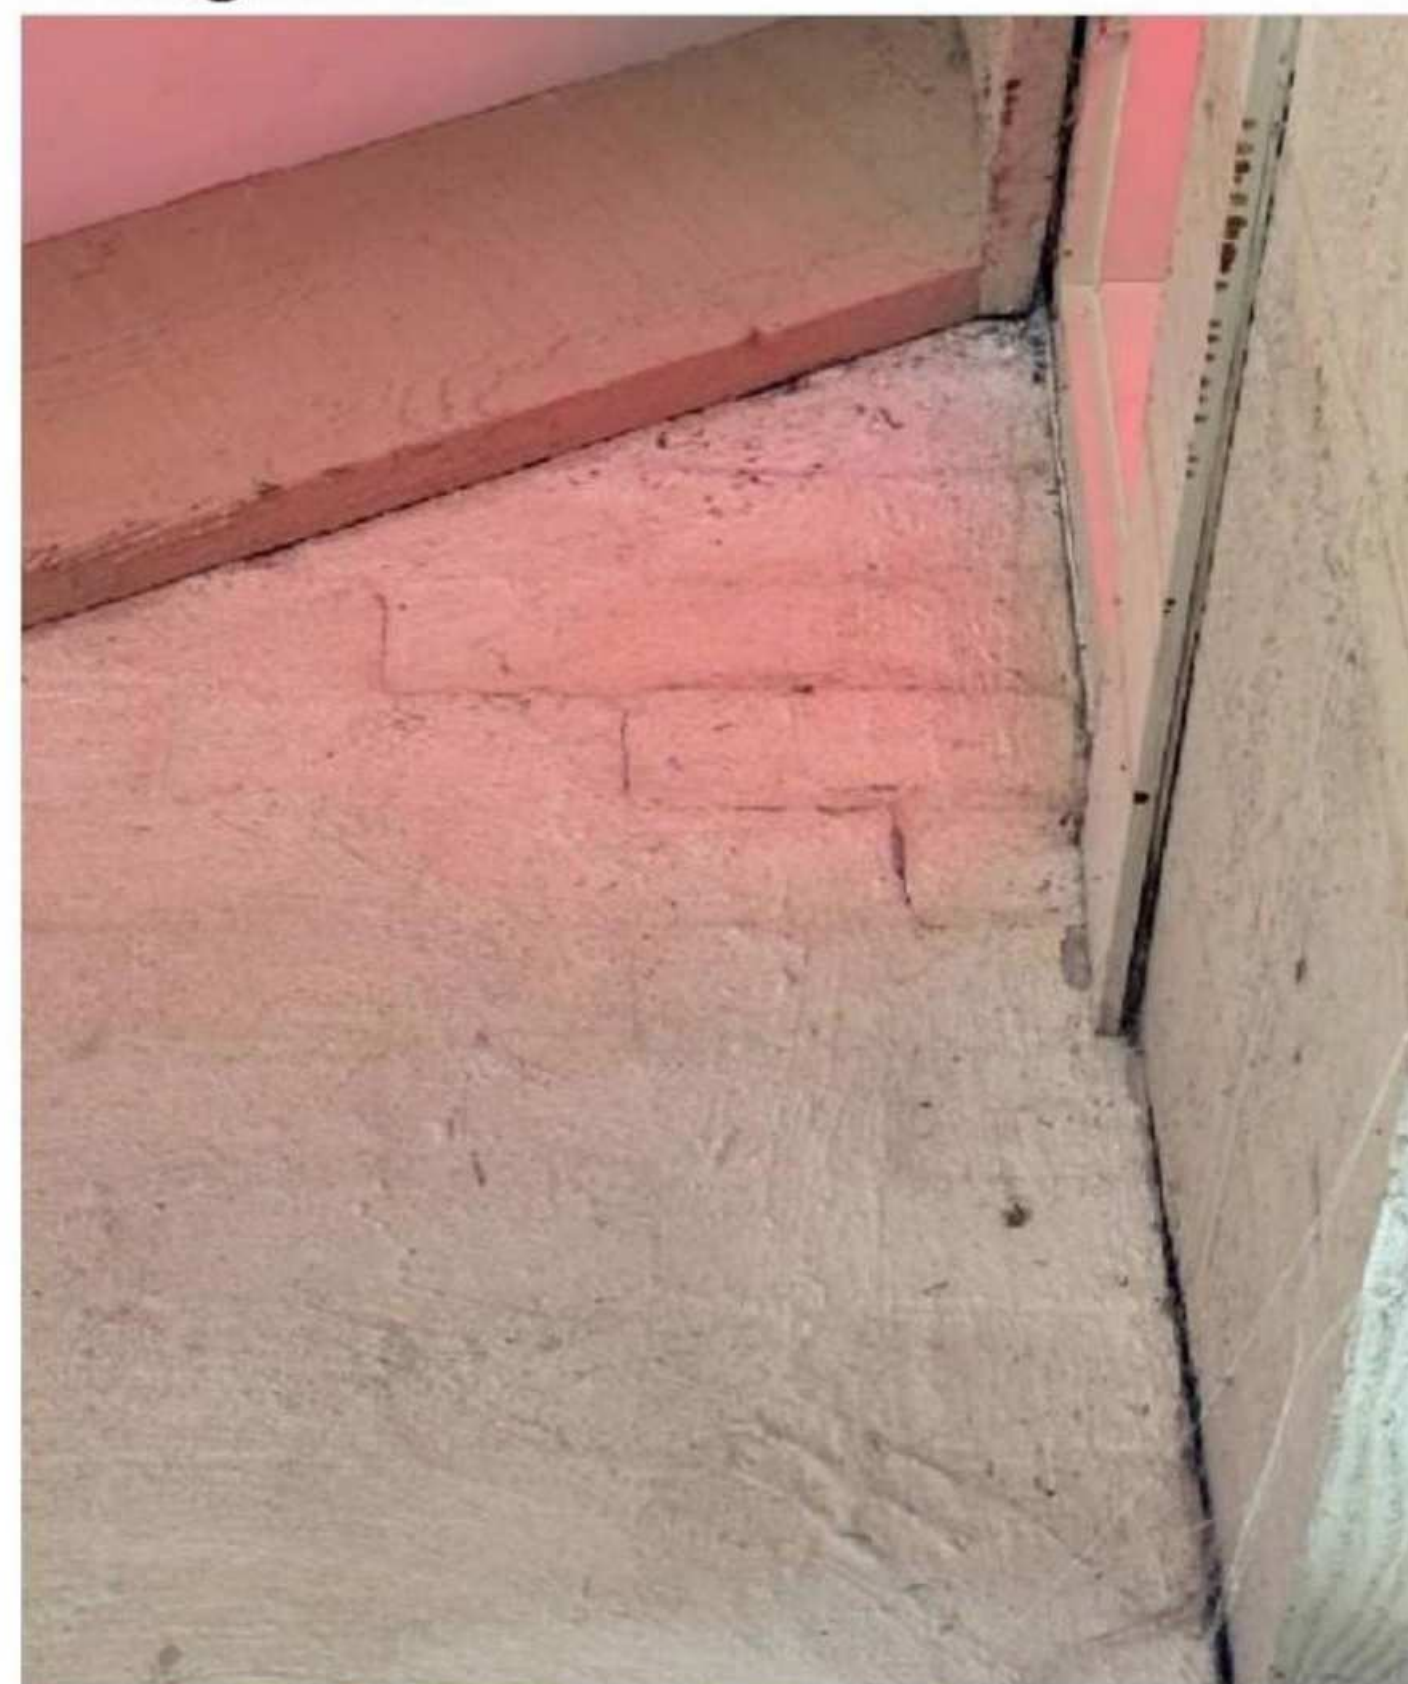
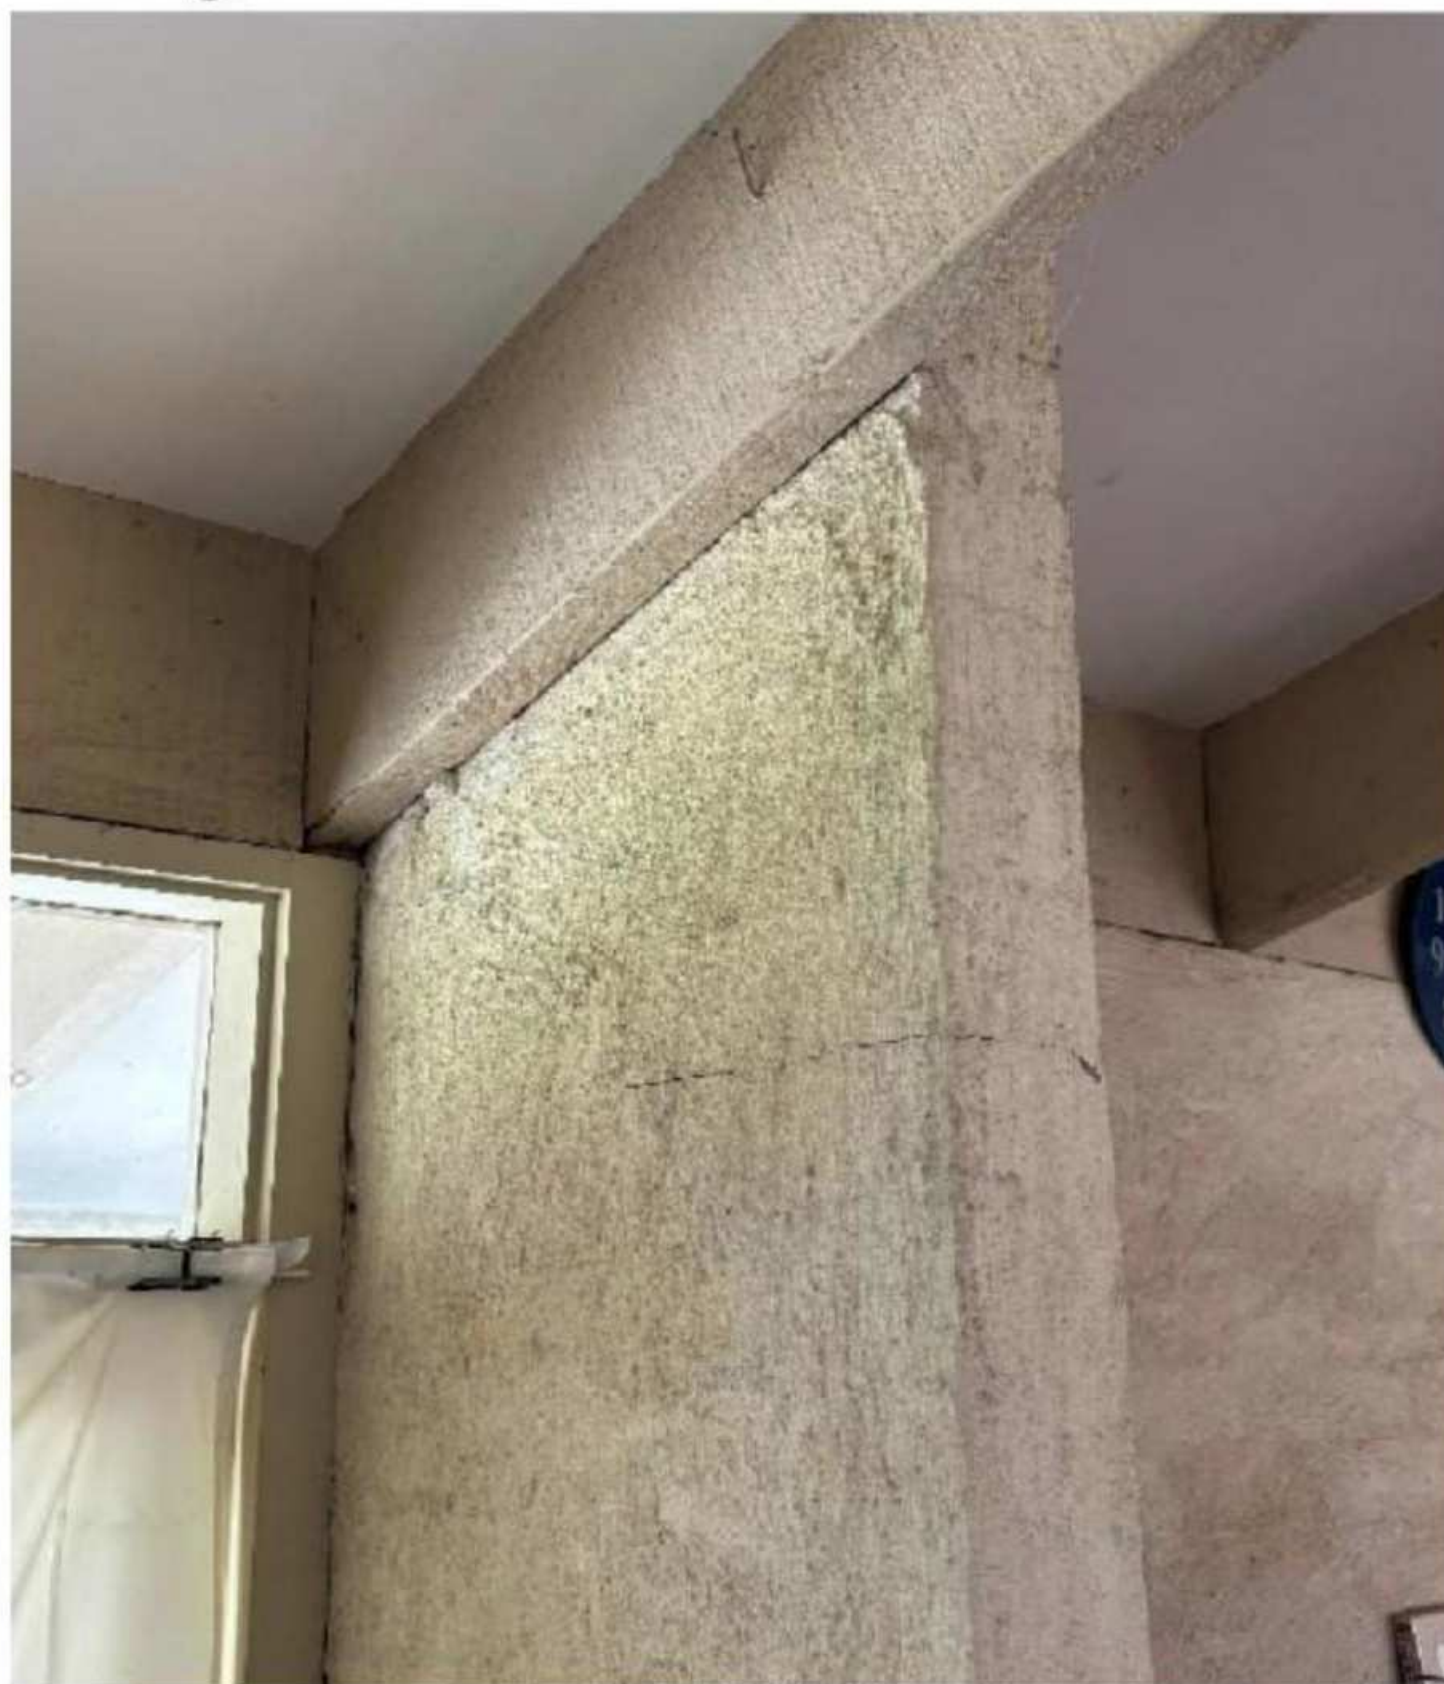
| Living Room | Evidence of water ingress and water stains on western and Eastern side walls.<br>Evidence of fine cracking (step cracking) to southern wall (2 locations).<br>Evidence of fine cracking to western wall at the bottom. |
