Thank you for the opportunity to carry out a dilapidation inspection at the above property in order to document existing cracking prior to the commencement of construction works at your property.

The two-storey property is of single skin brick and timber frame construction with brick veneer exterior walls, internal brick walls and timber ceilings, timber windows and a pitched roof clad with concrete tiles.

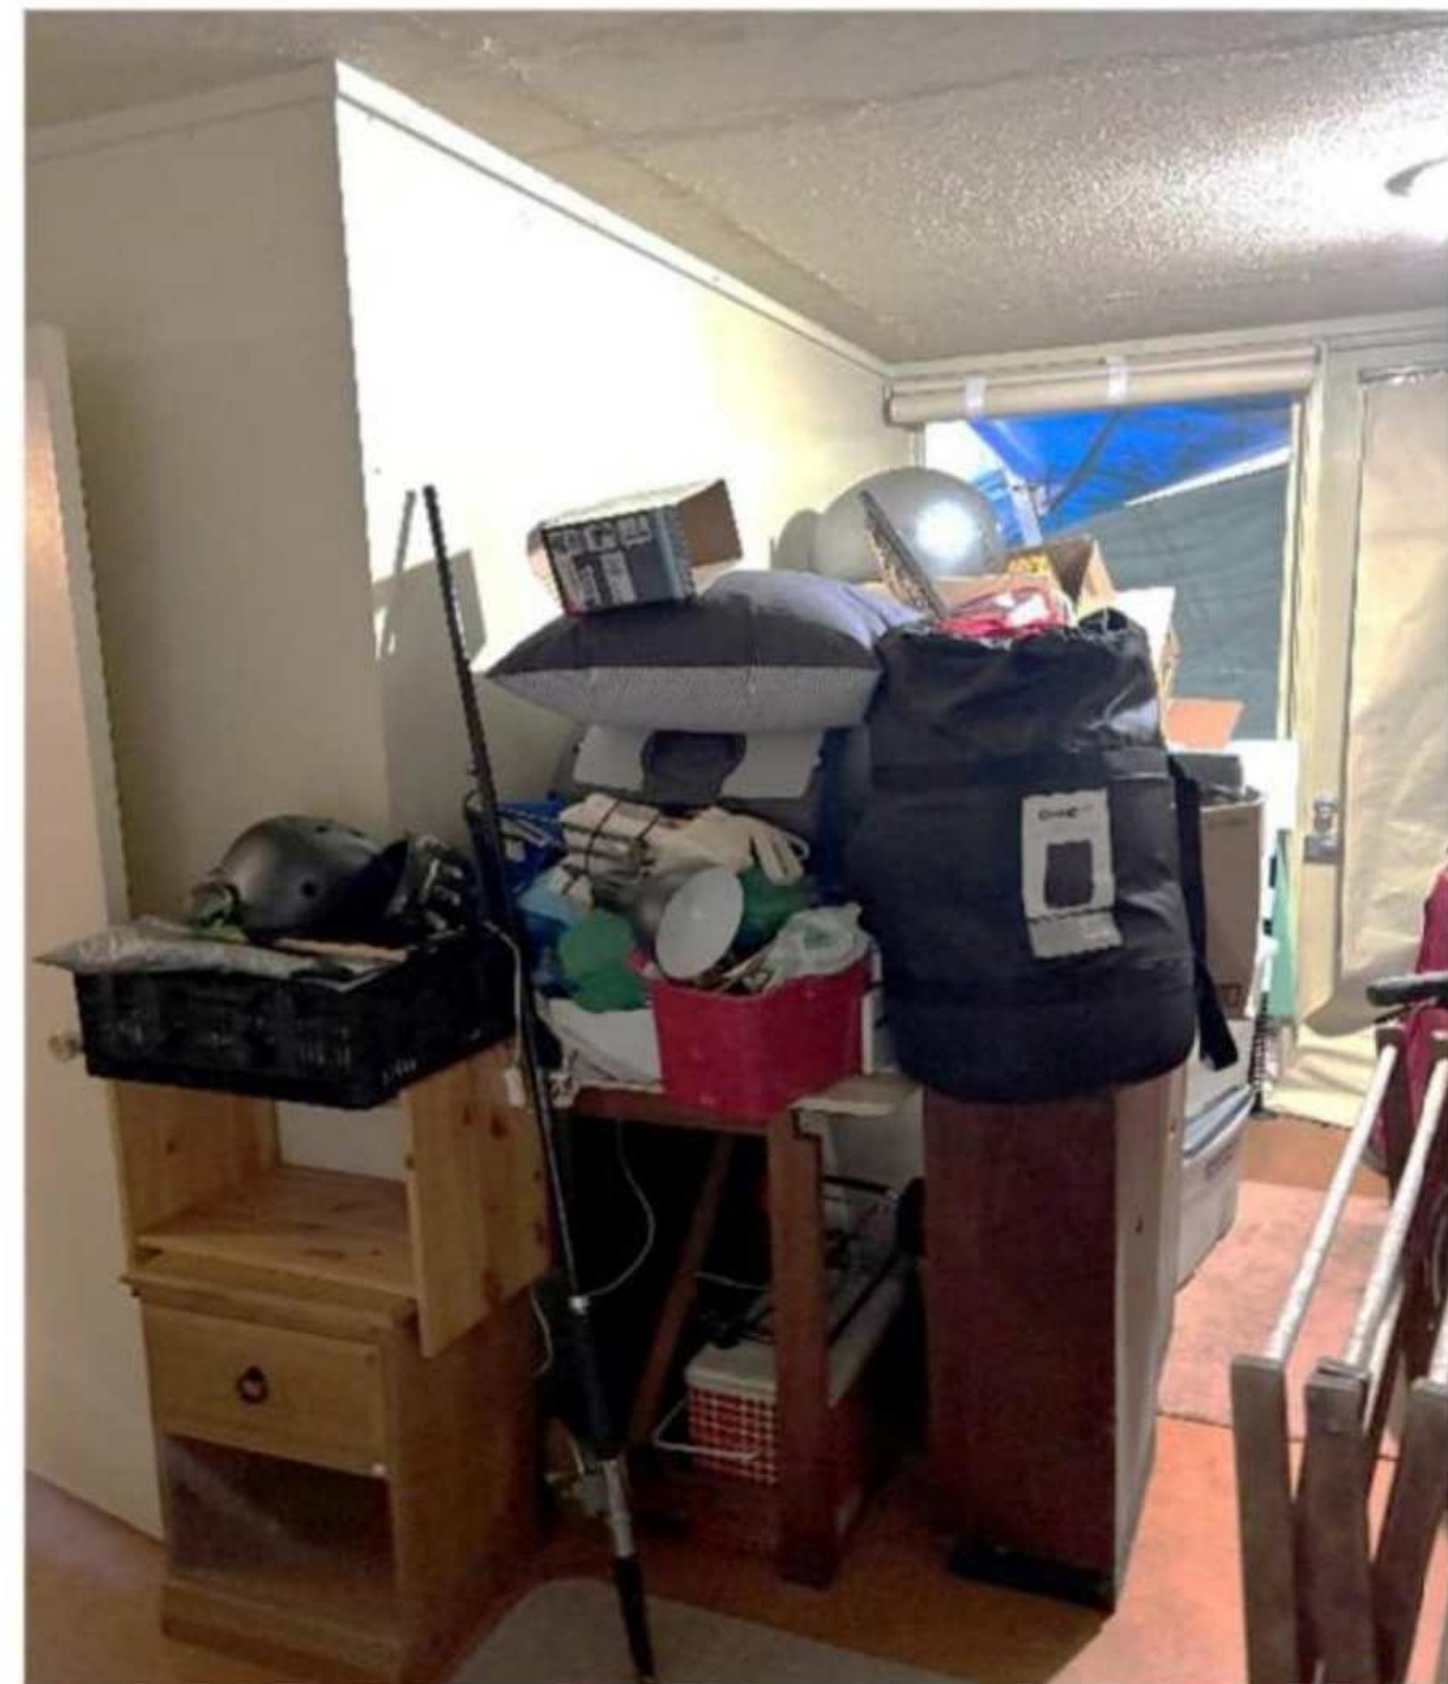
| Bedroom 4 | Evidence of water ingress on western wall.<br>Evidence of efflorescence on ceiling (concrete). |

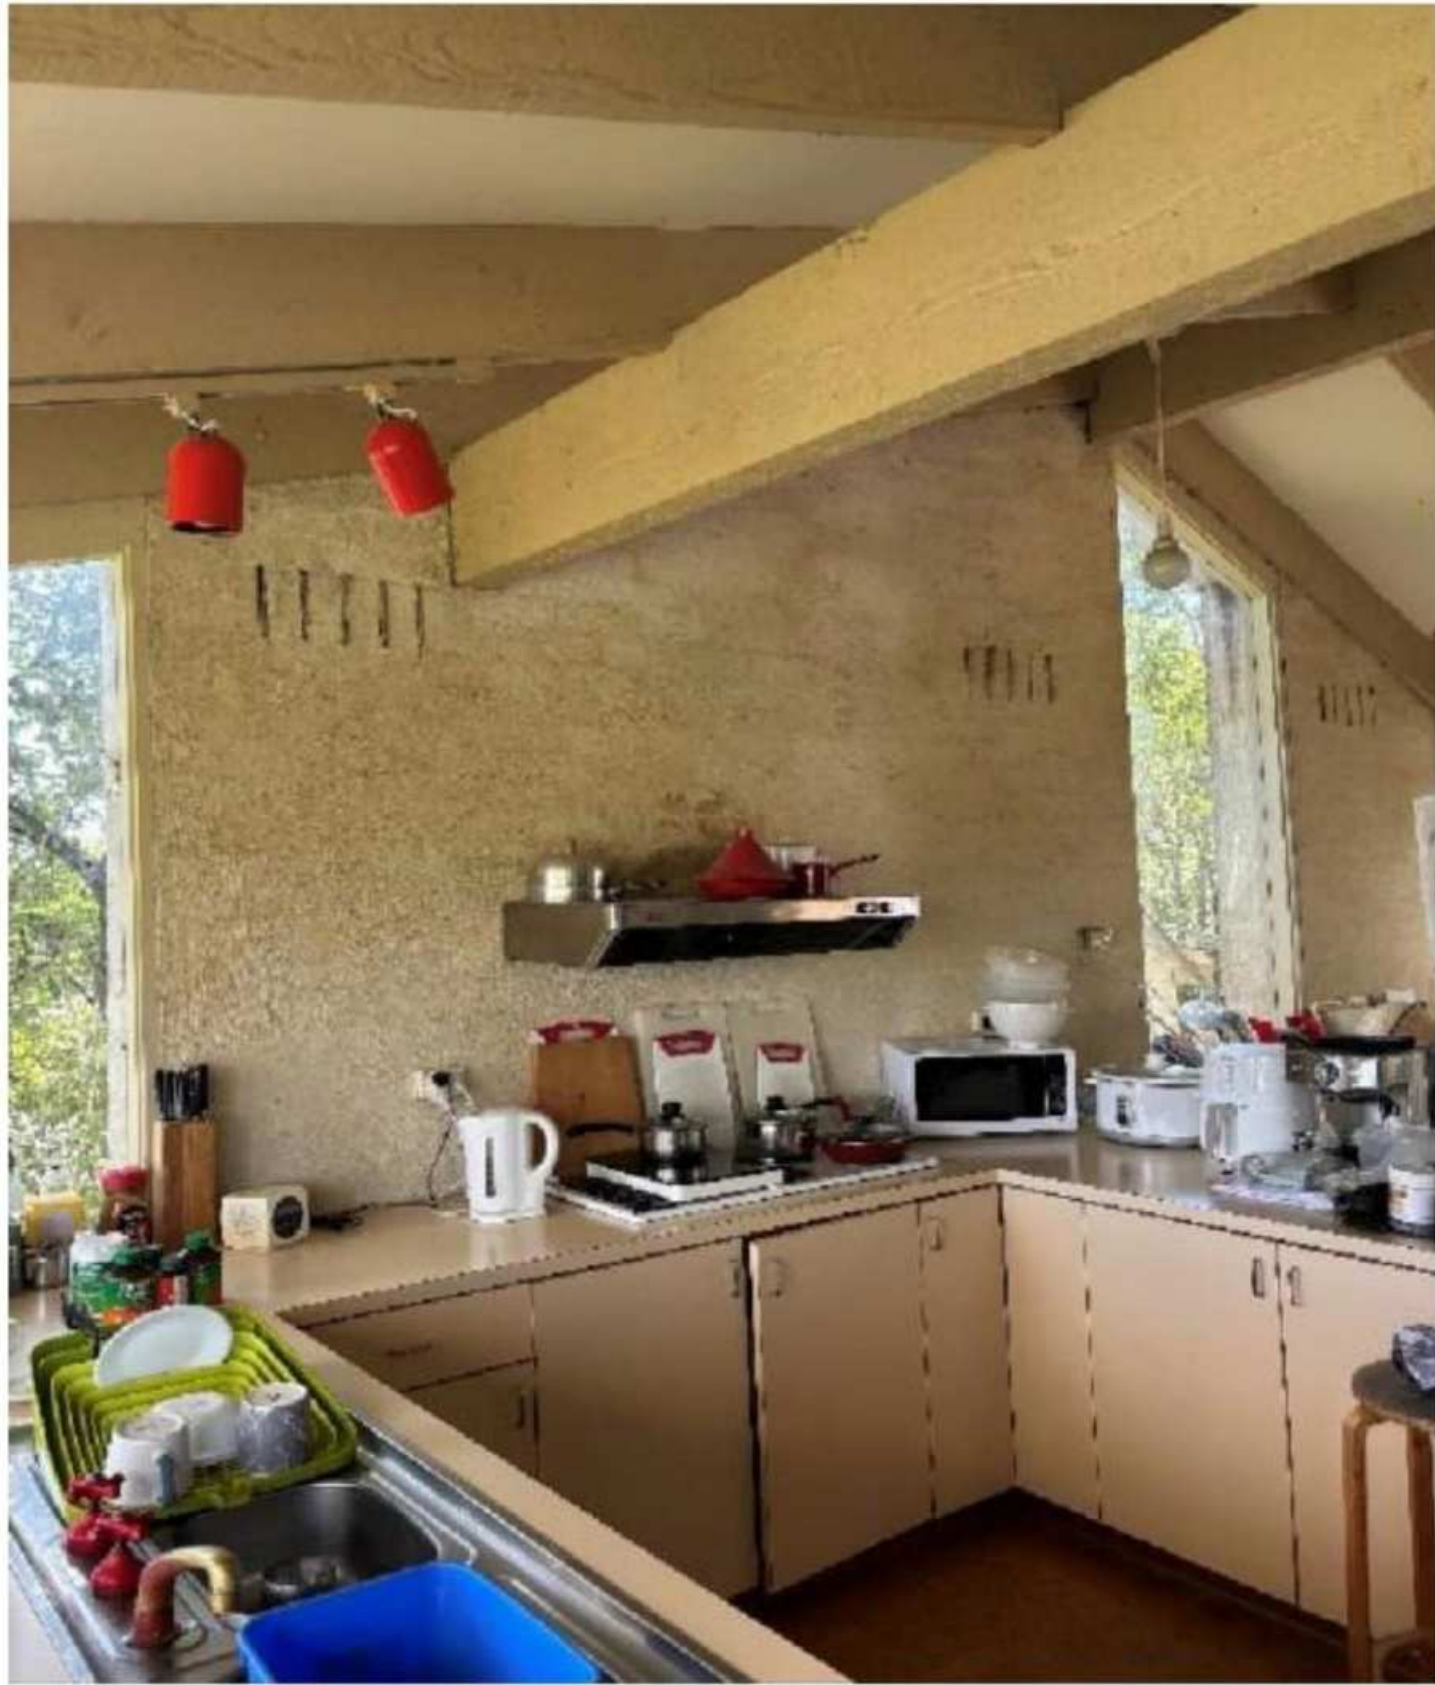
Kitchen Evidence of fine cracking to northern wall.  
Evidence of water damage (severe) to ceiling & water ingress.
