Thank you for the opportunity to inspect the preparation and application of paintwork of your home under construction. We attended the site on Wednesday, 27 November, 2024 and make the following comment on the quality and compliance of the works to date;

# Quality Assurance Inspection

Preparation and application of paintwork and workmanship only.

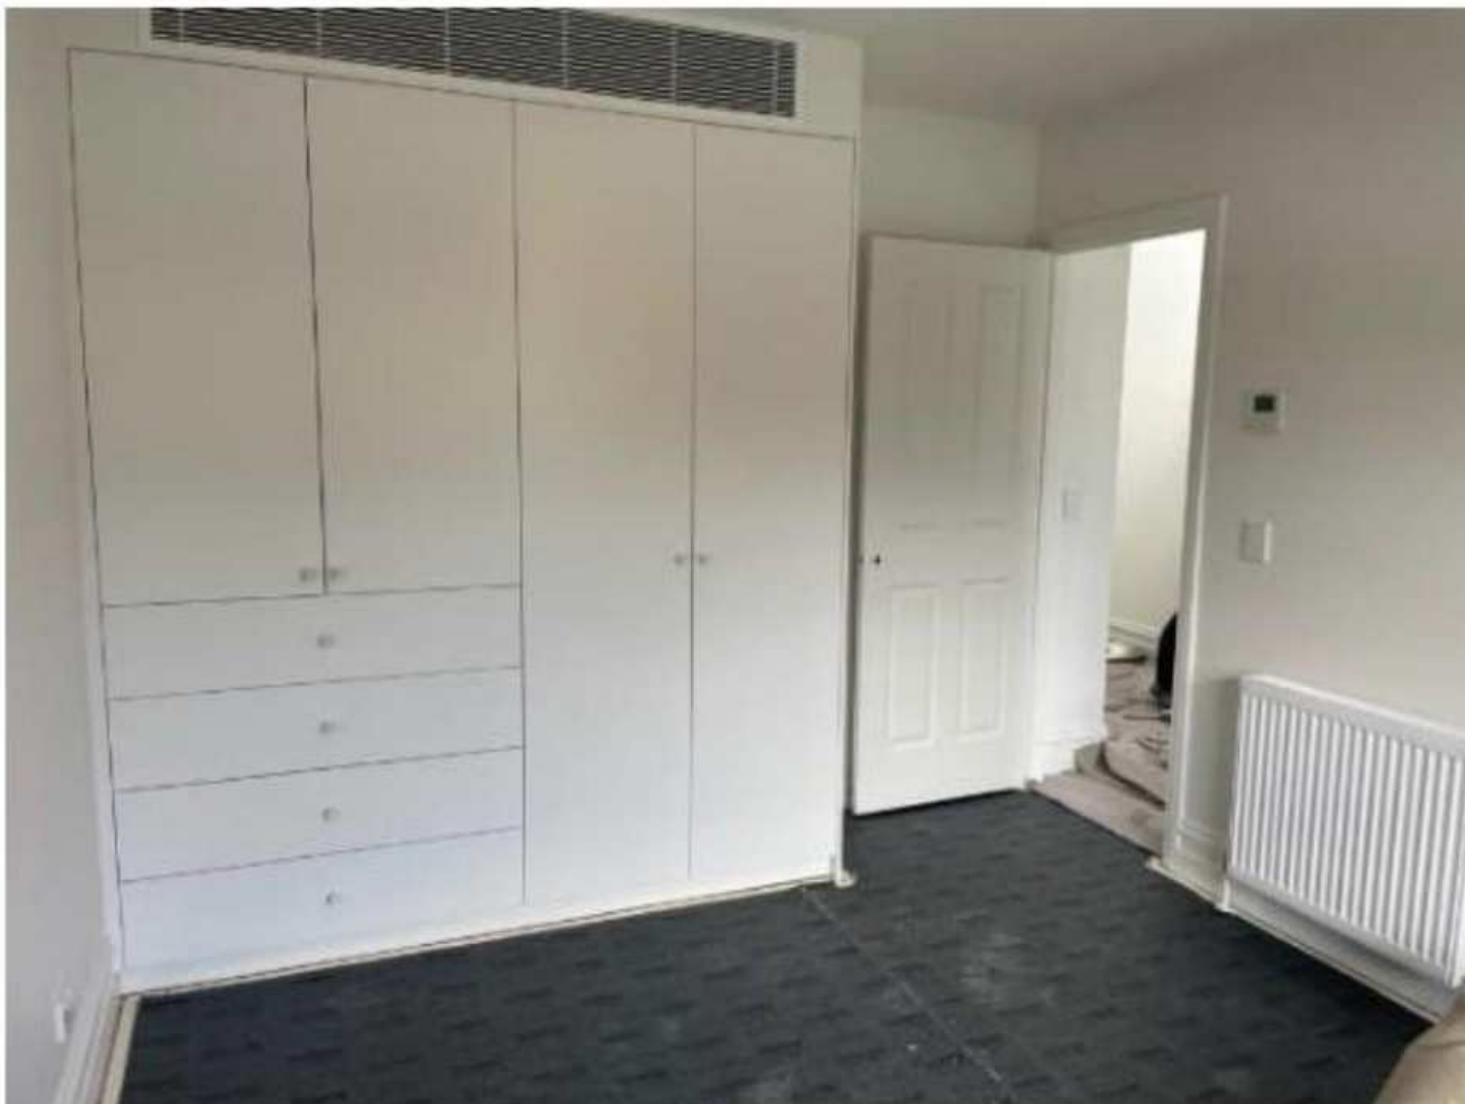
(2)

**Bedroom 3**

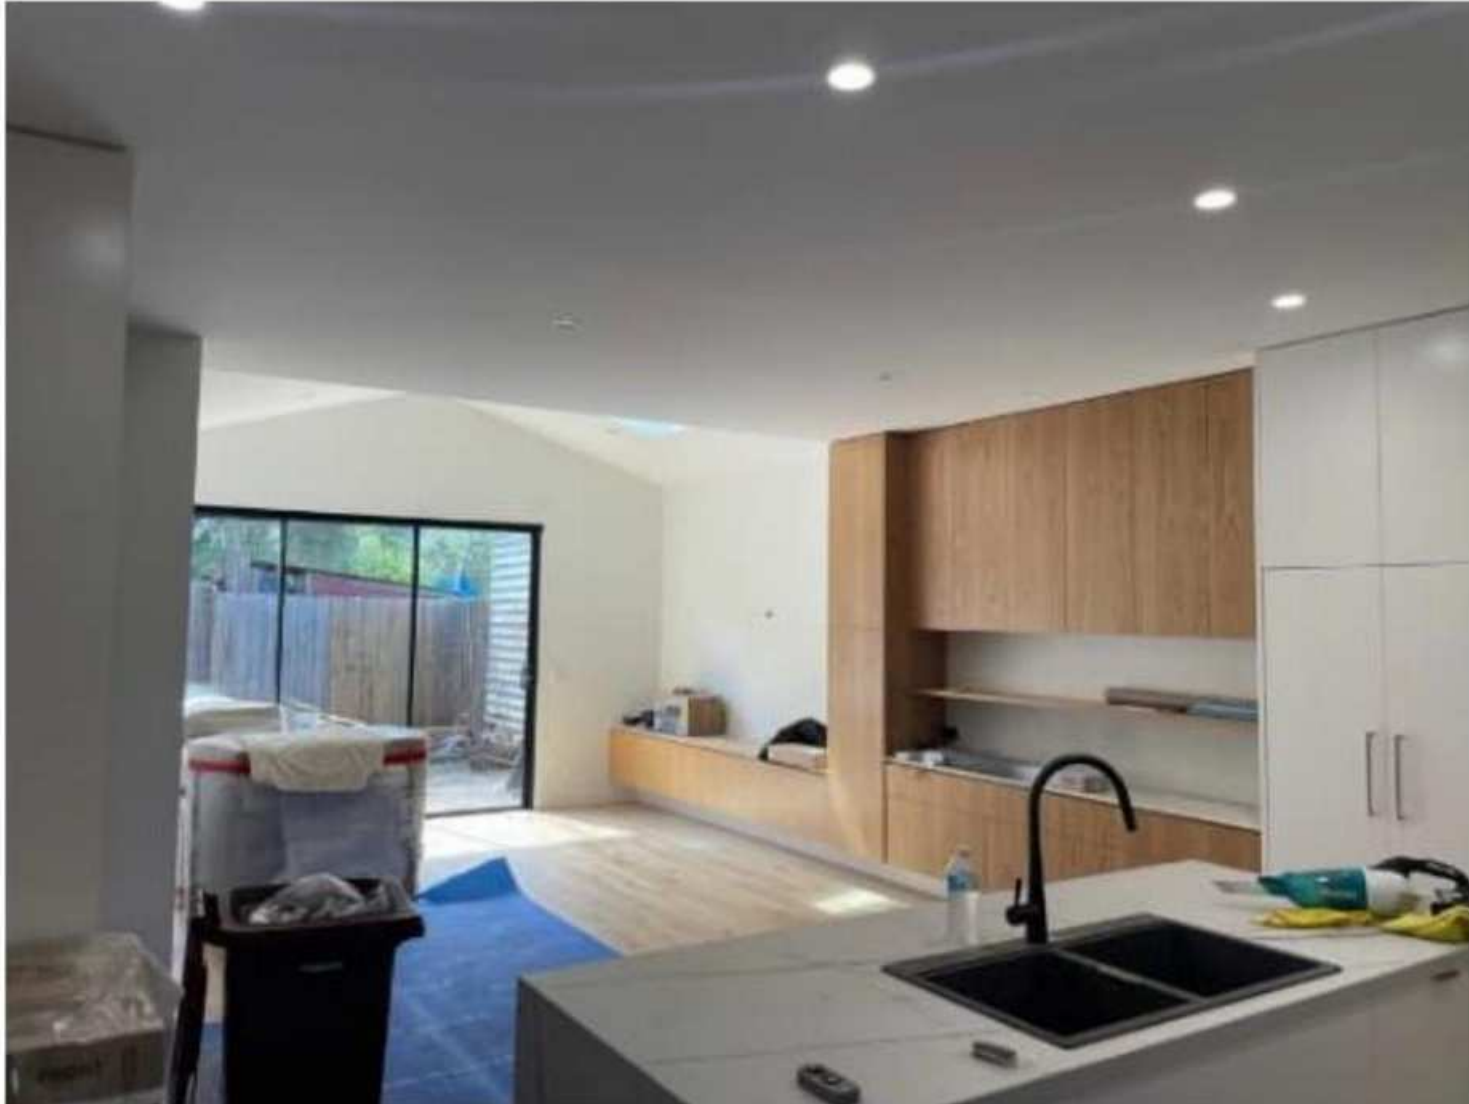
(12)

**Kitchen + Living**

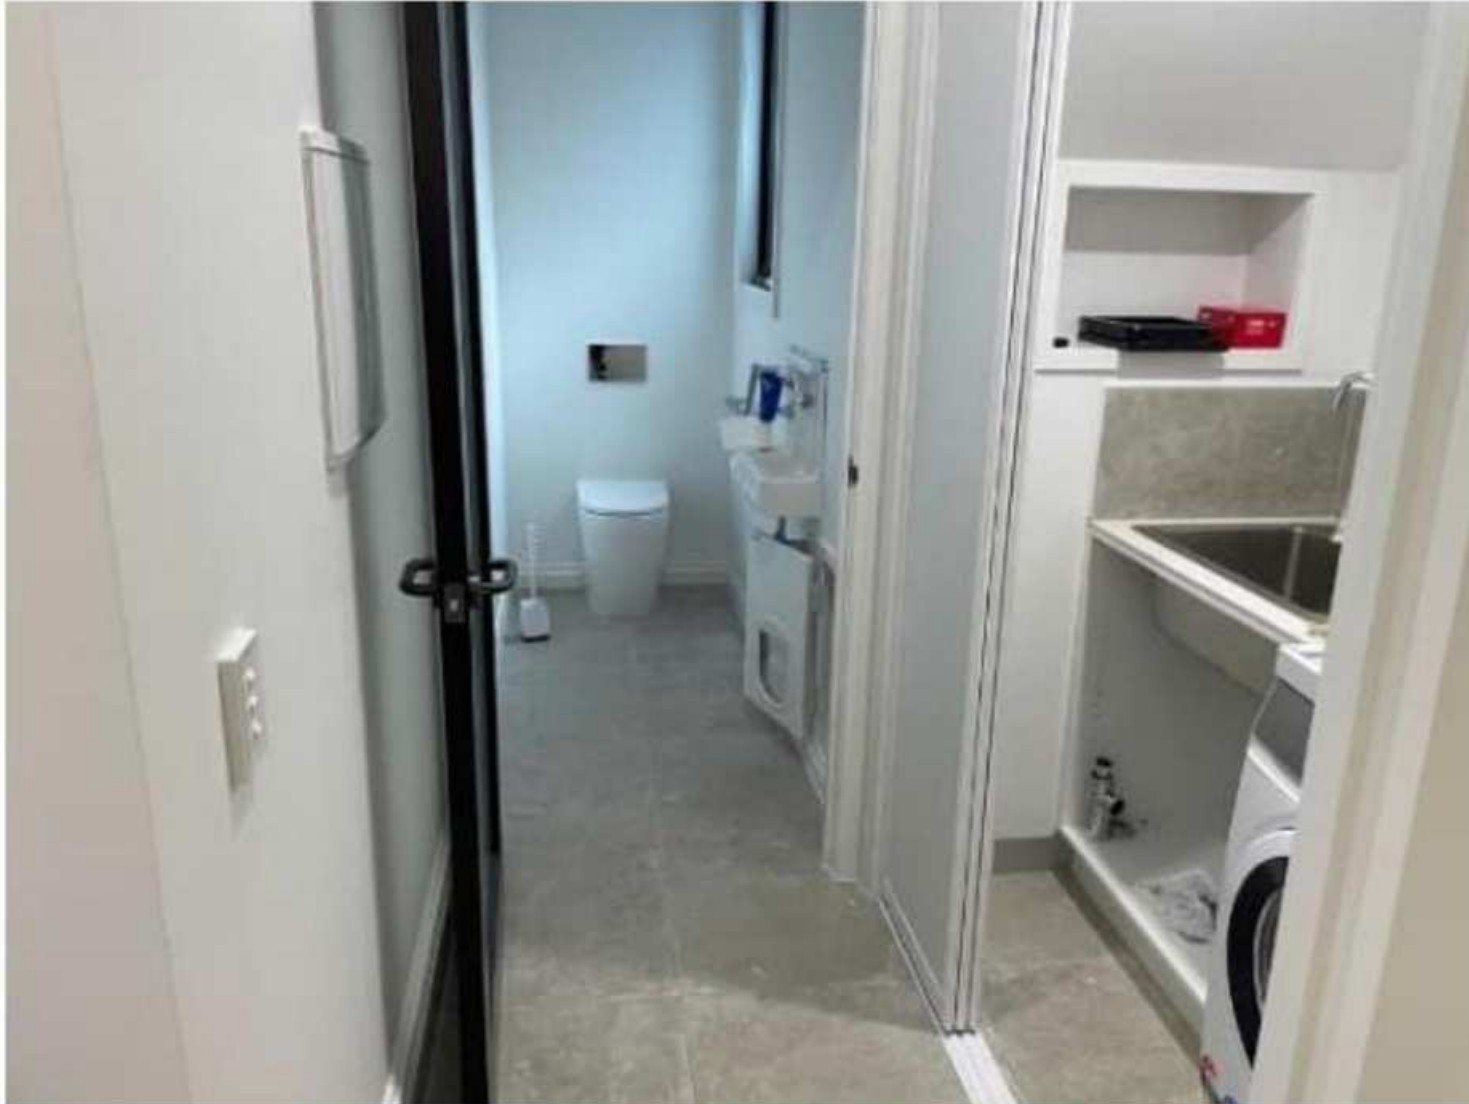
(13)

**Laundry + Powder Room**

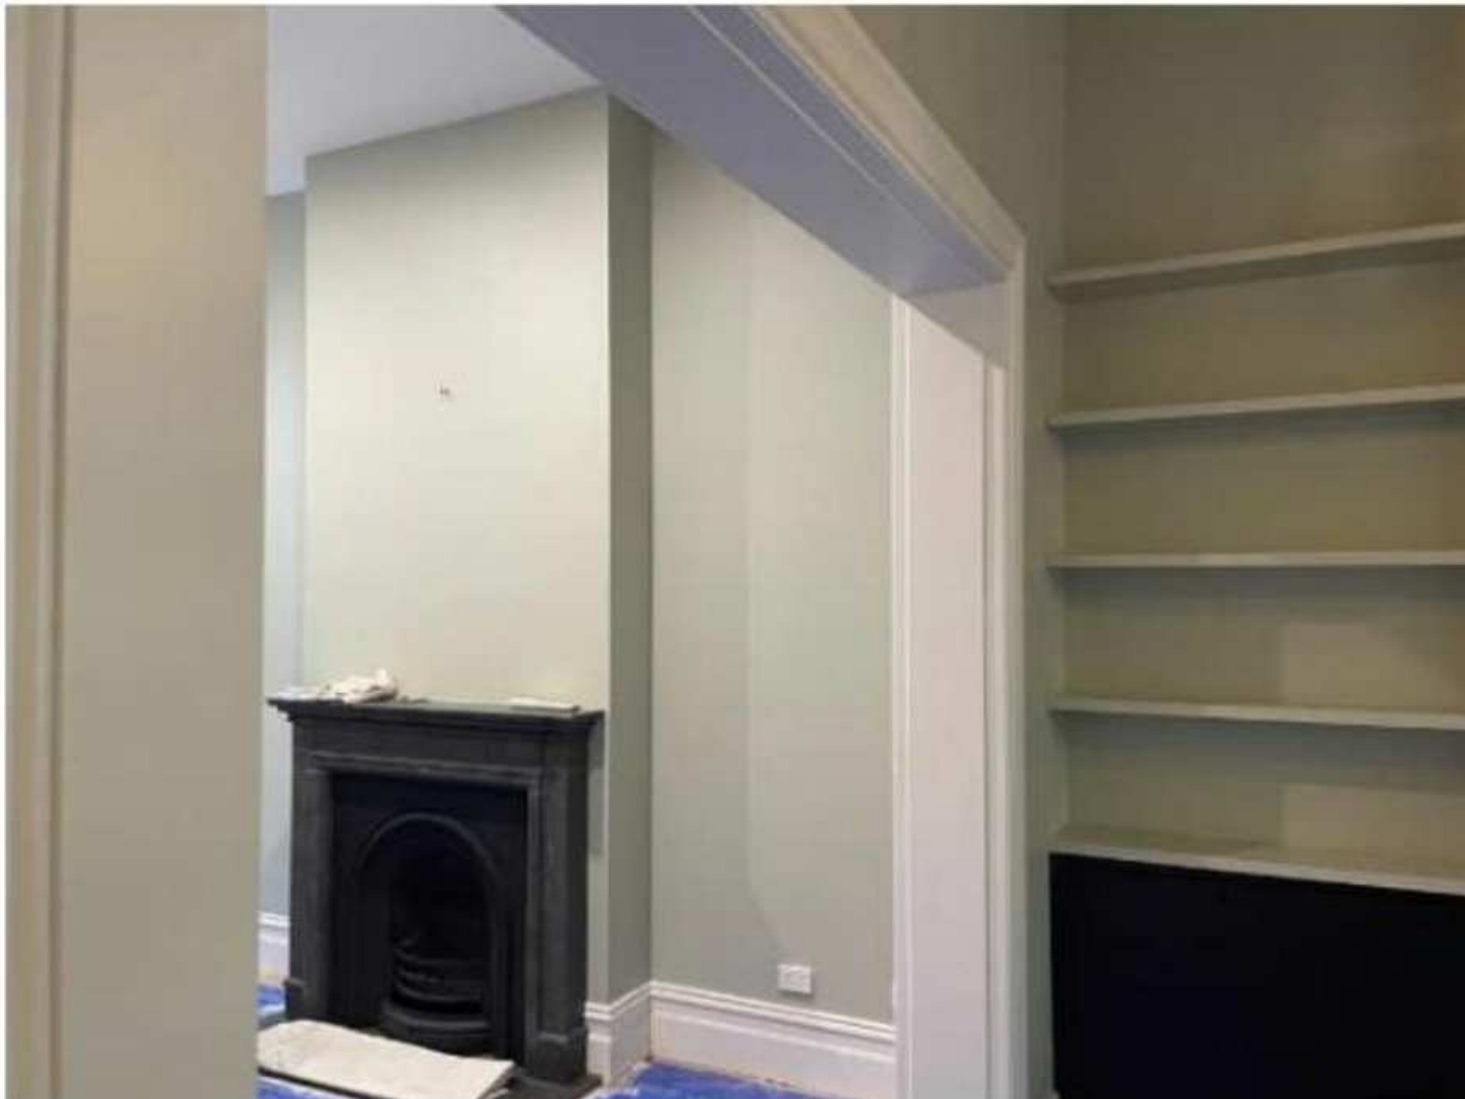
(16)

Study

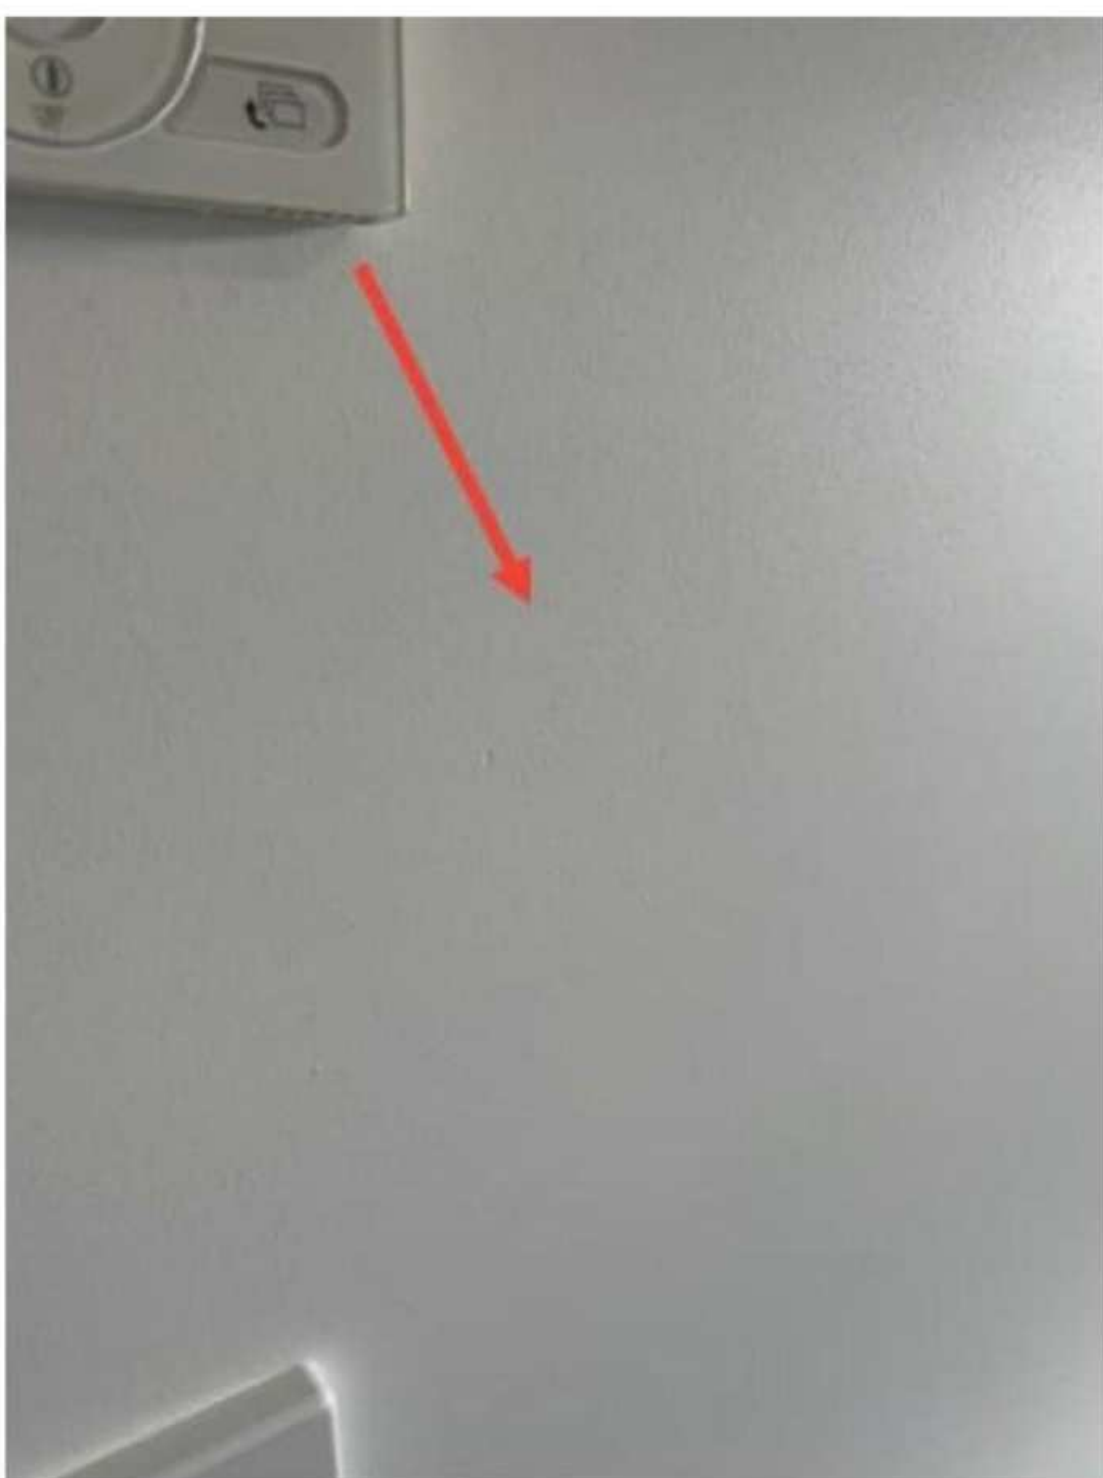
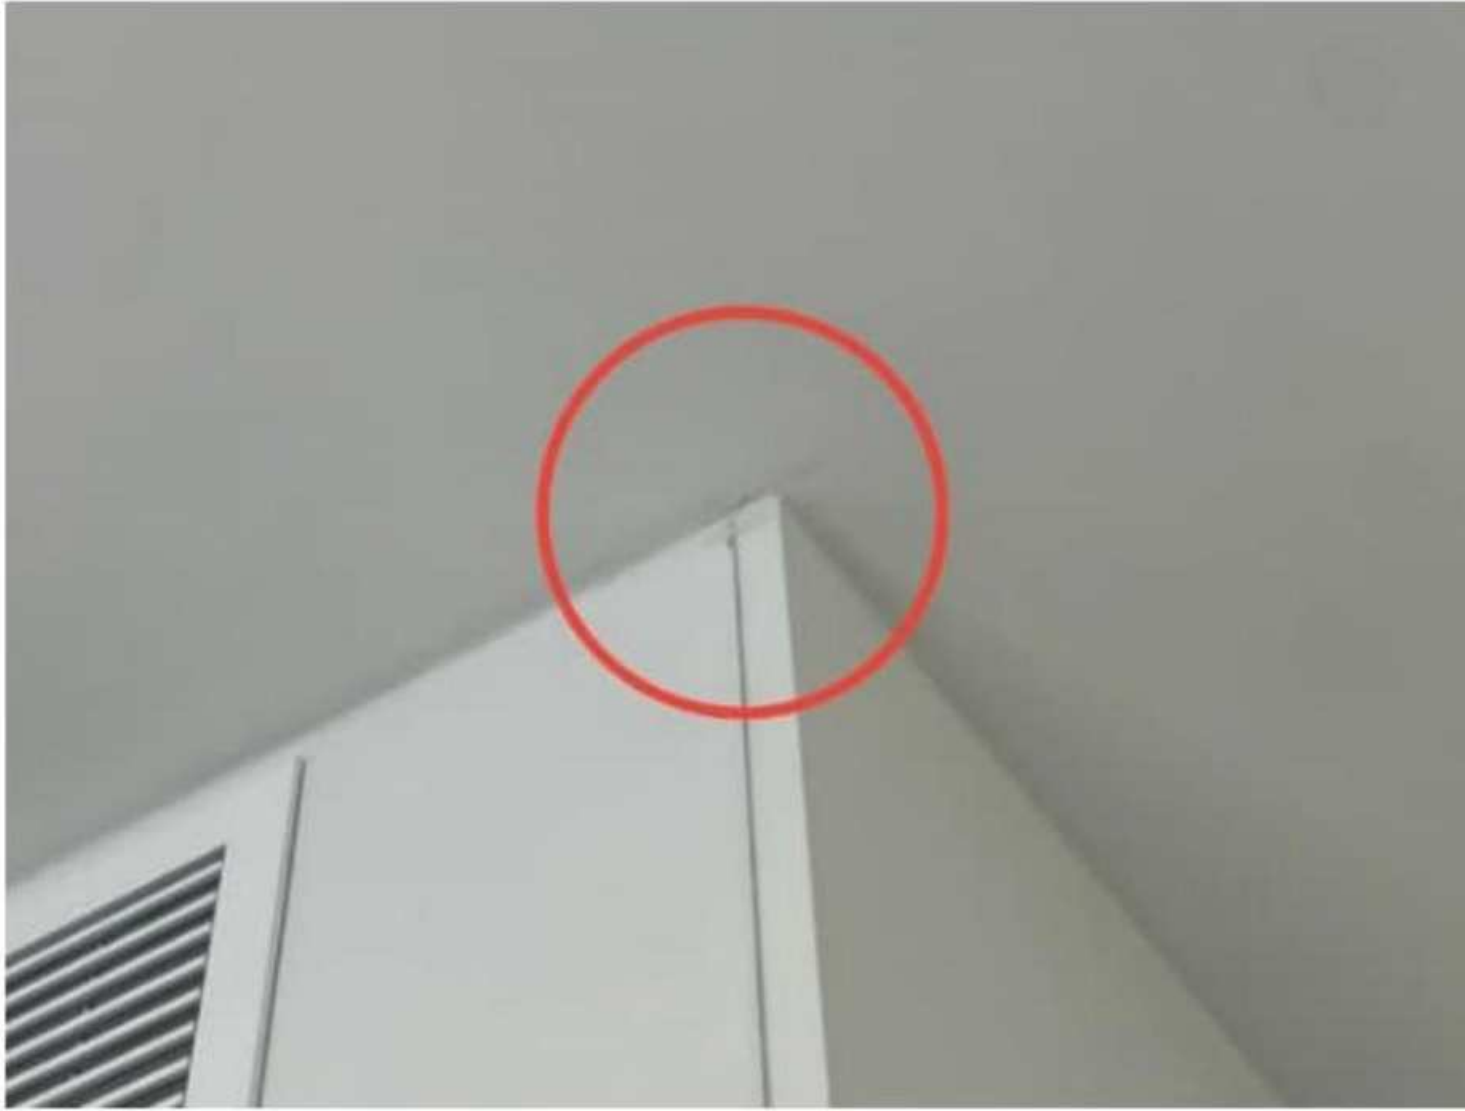
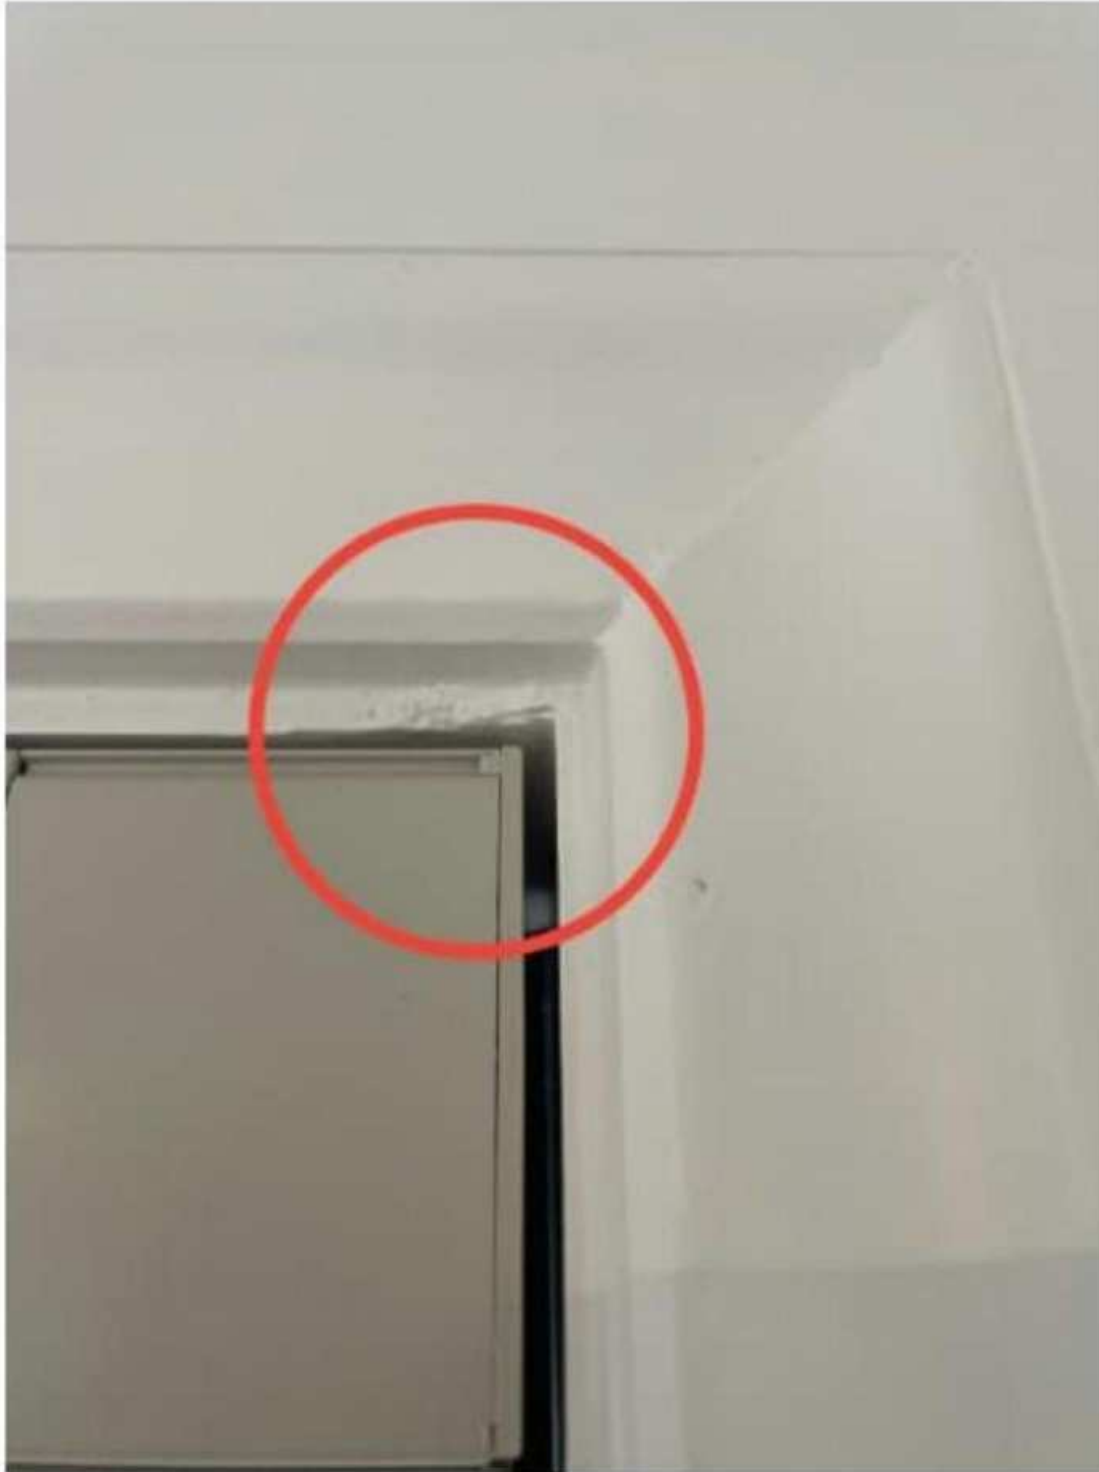
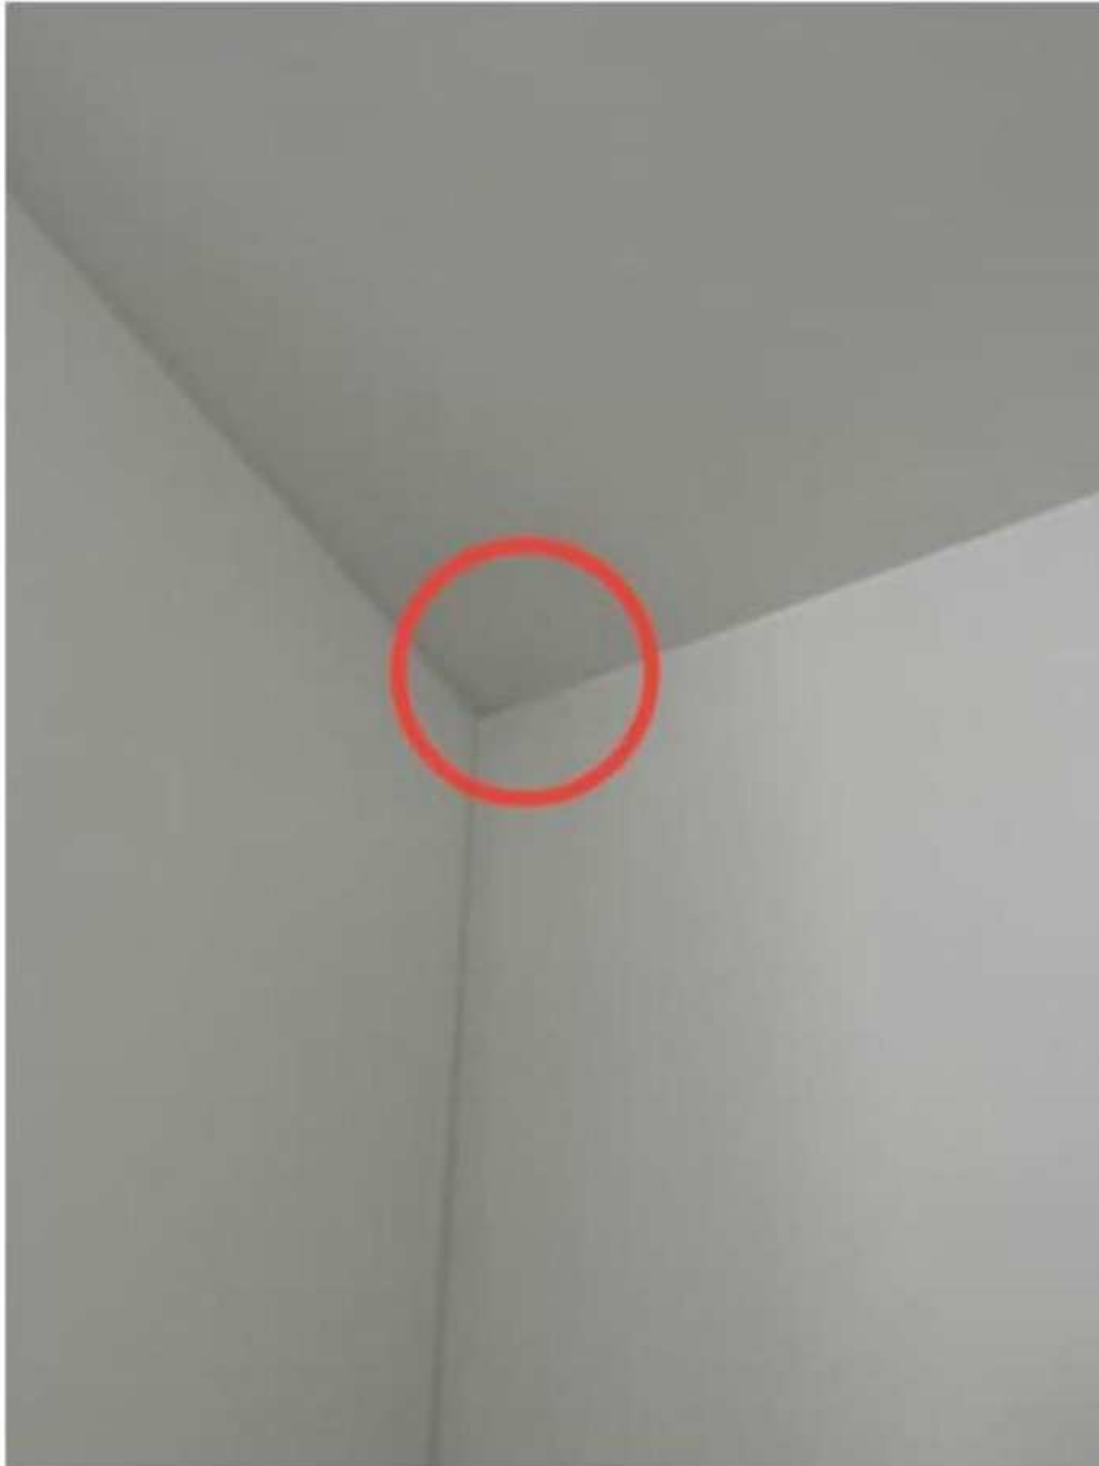
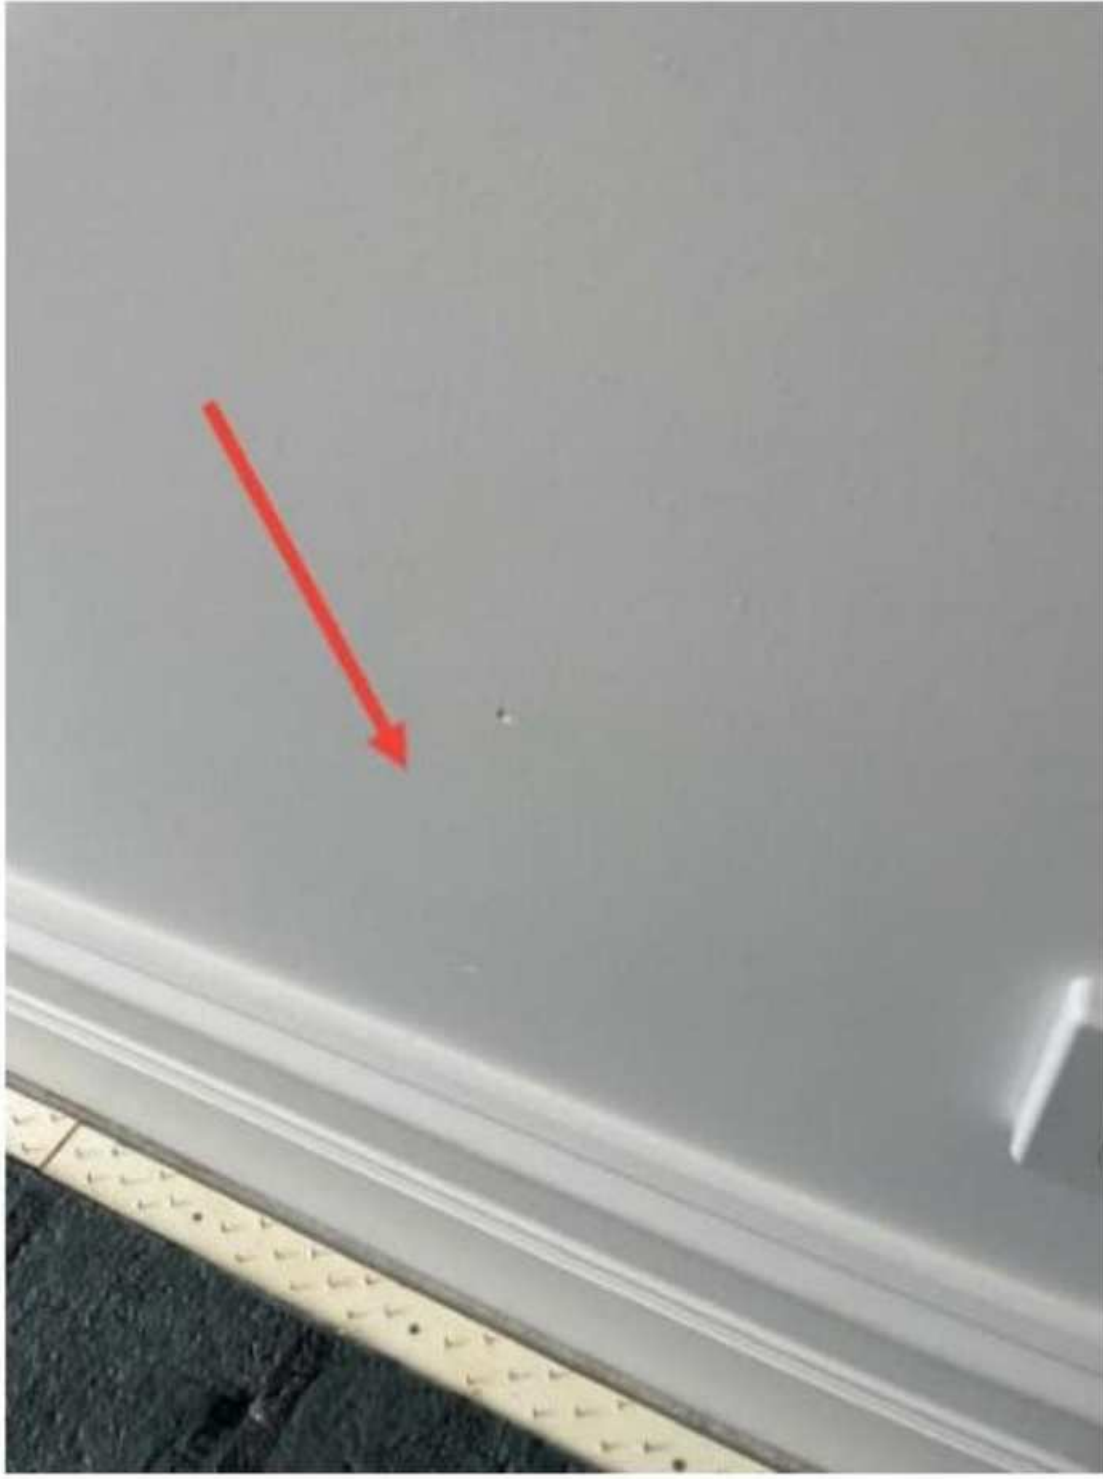
Damaged noted to plaster walls around window sills and architraves.

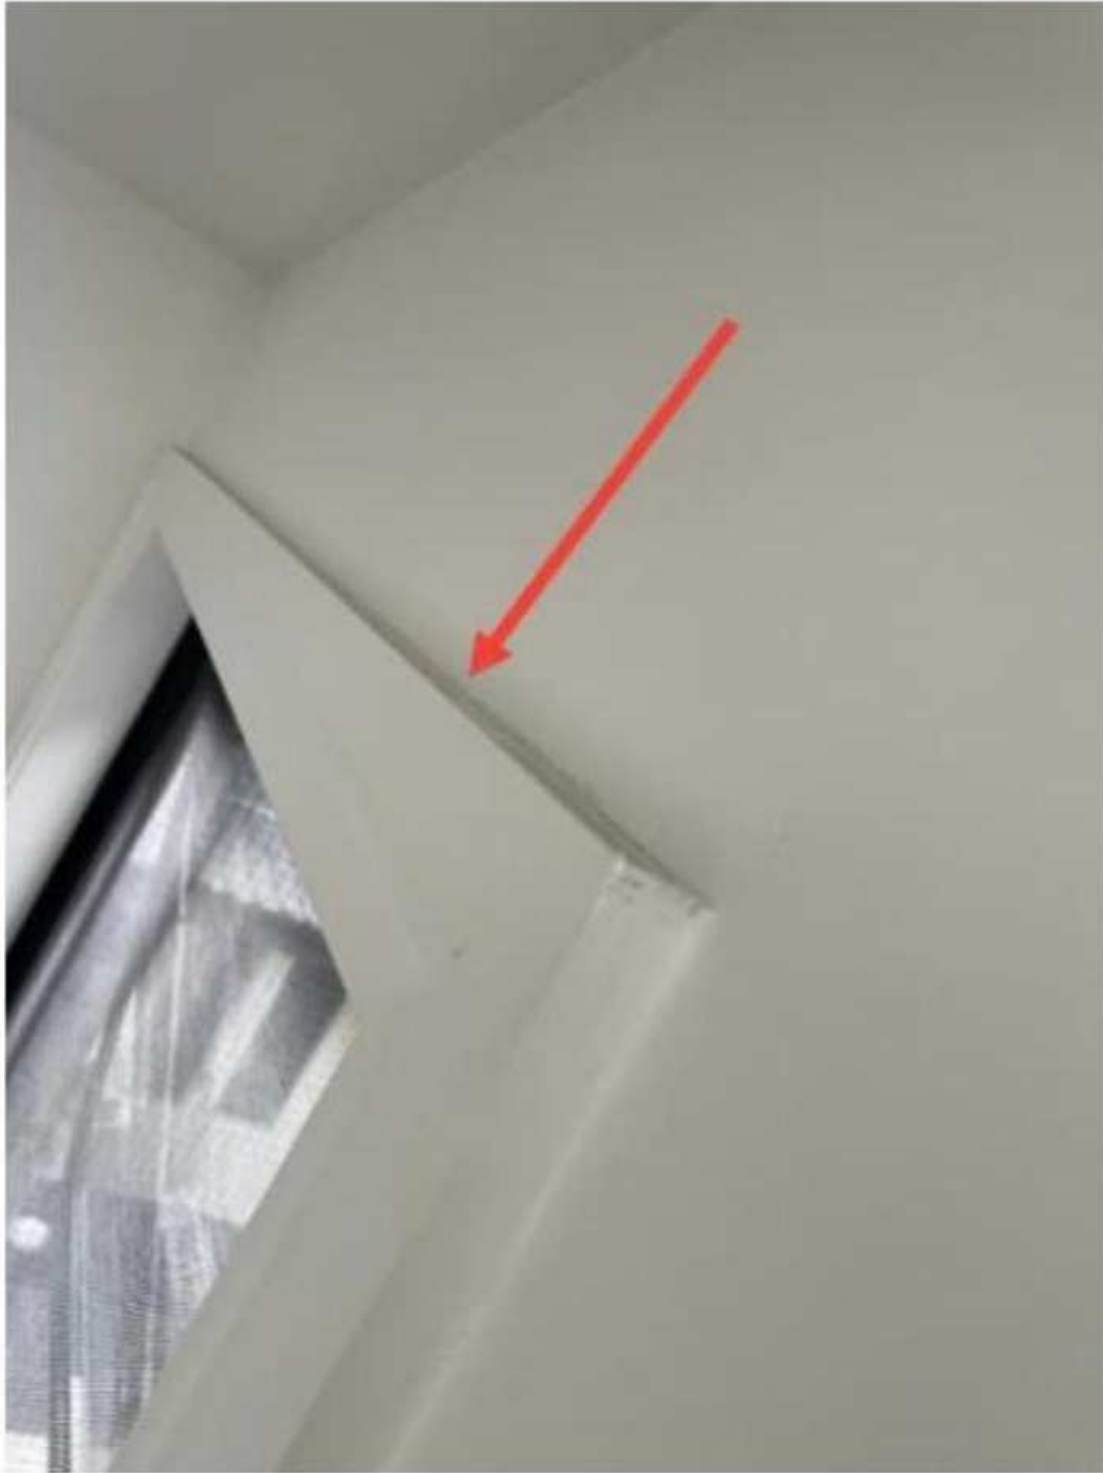
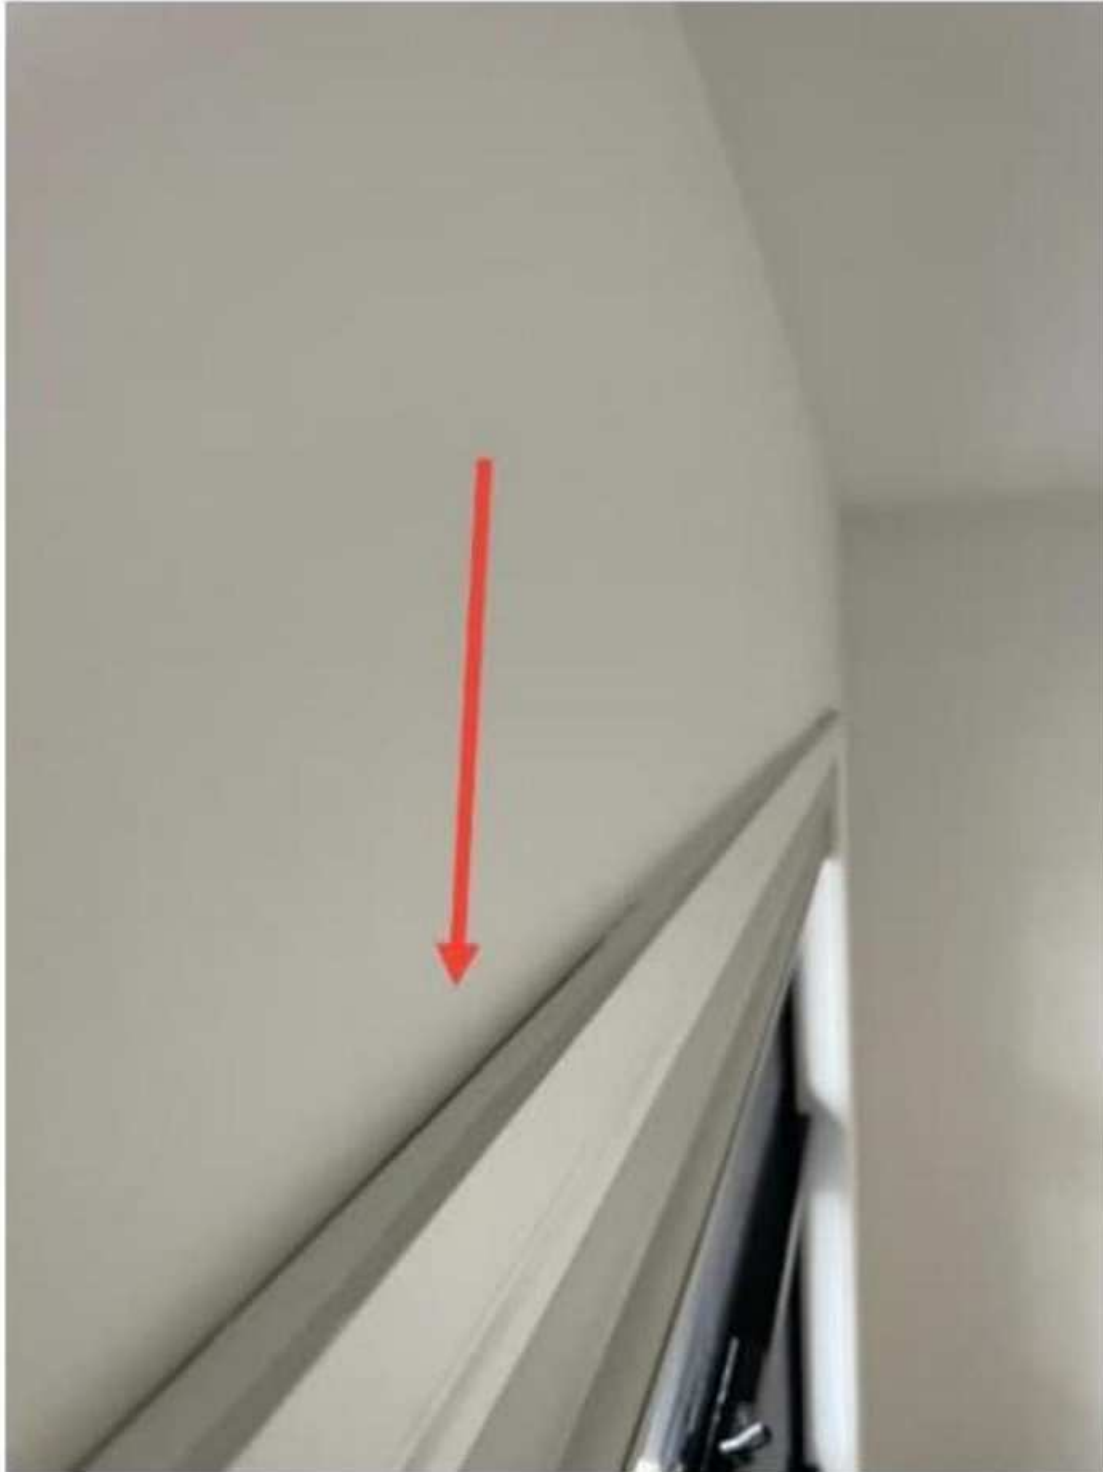
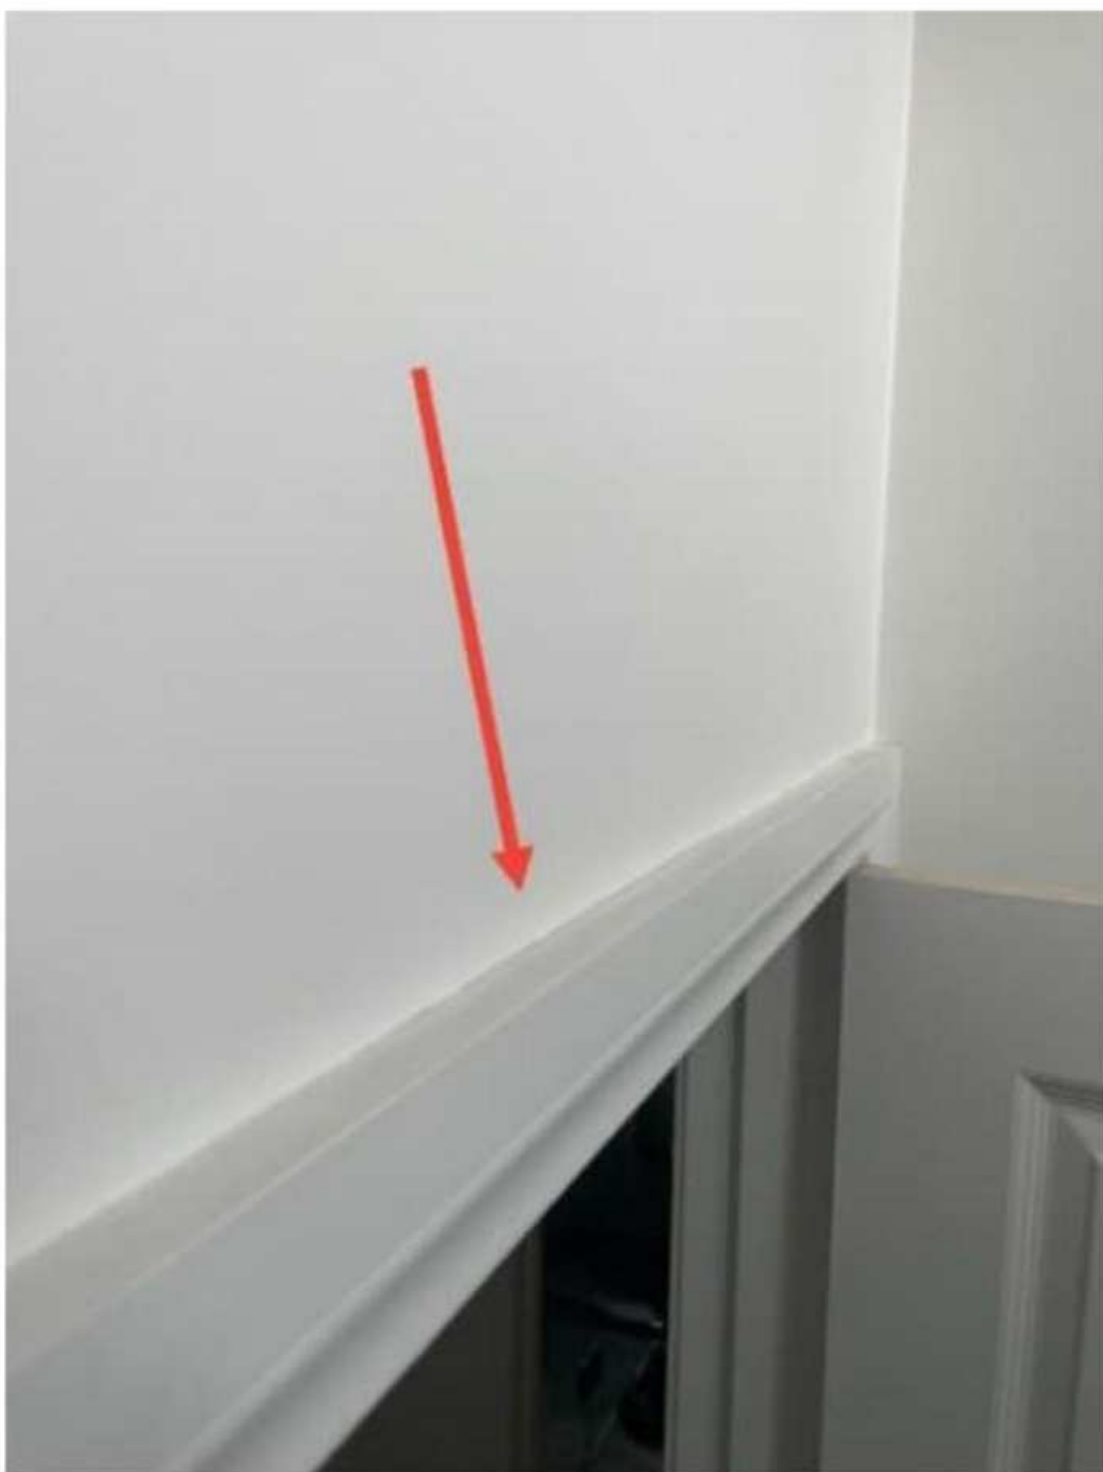
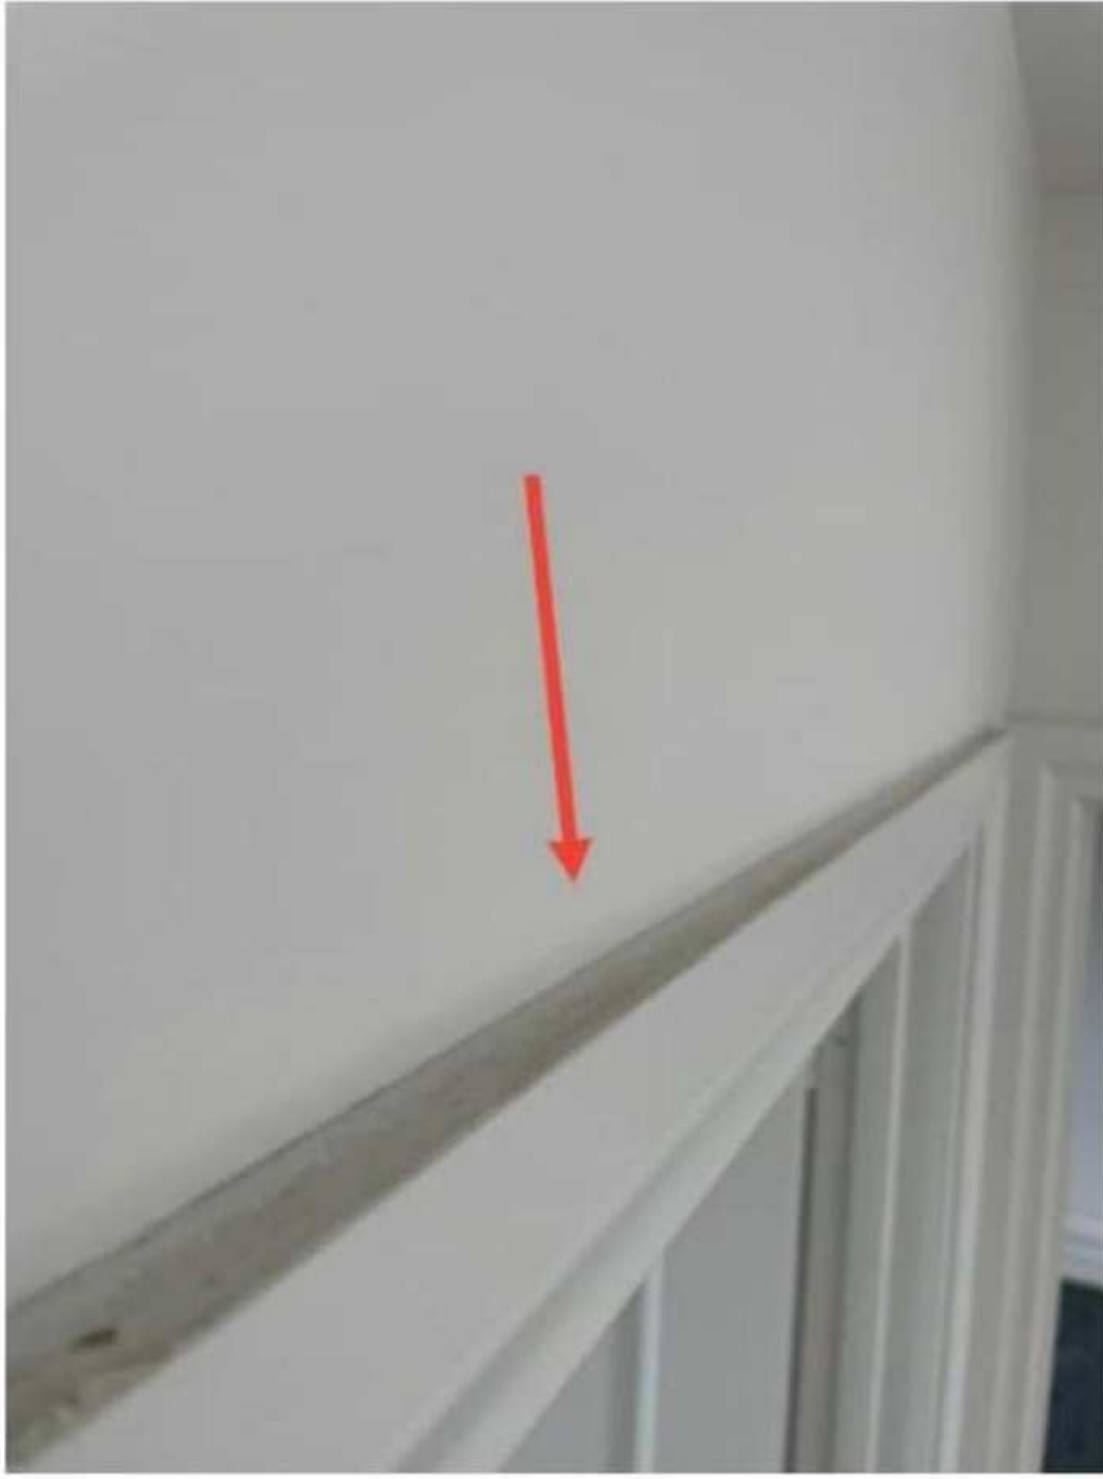
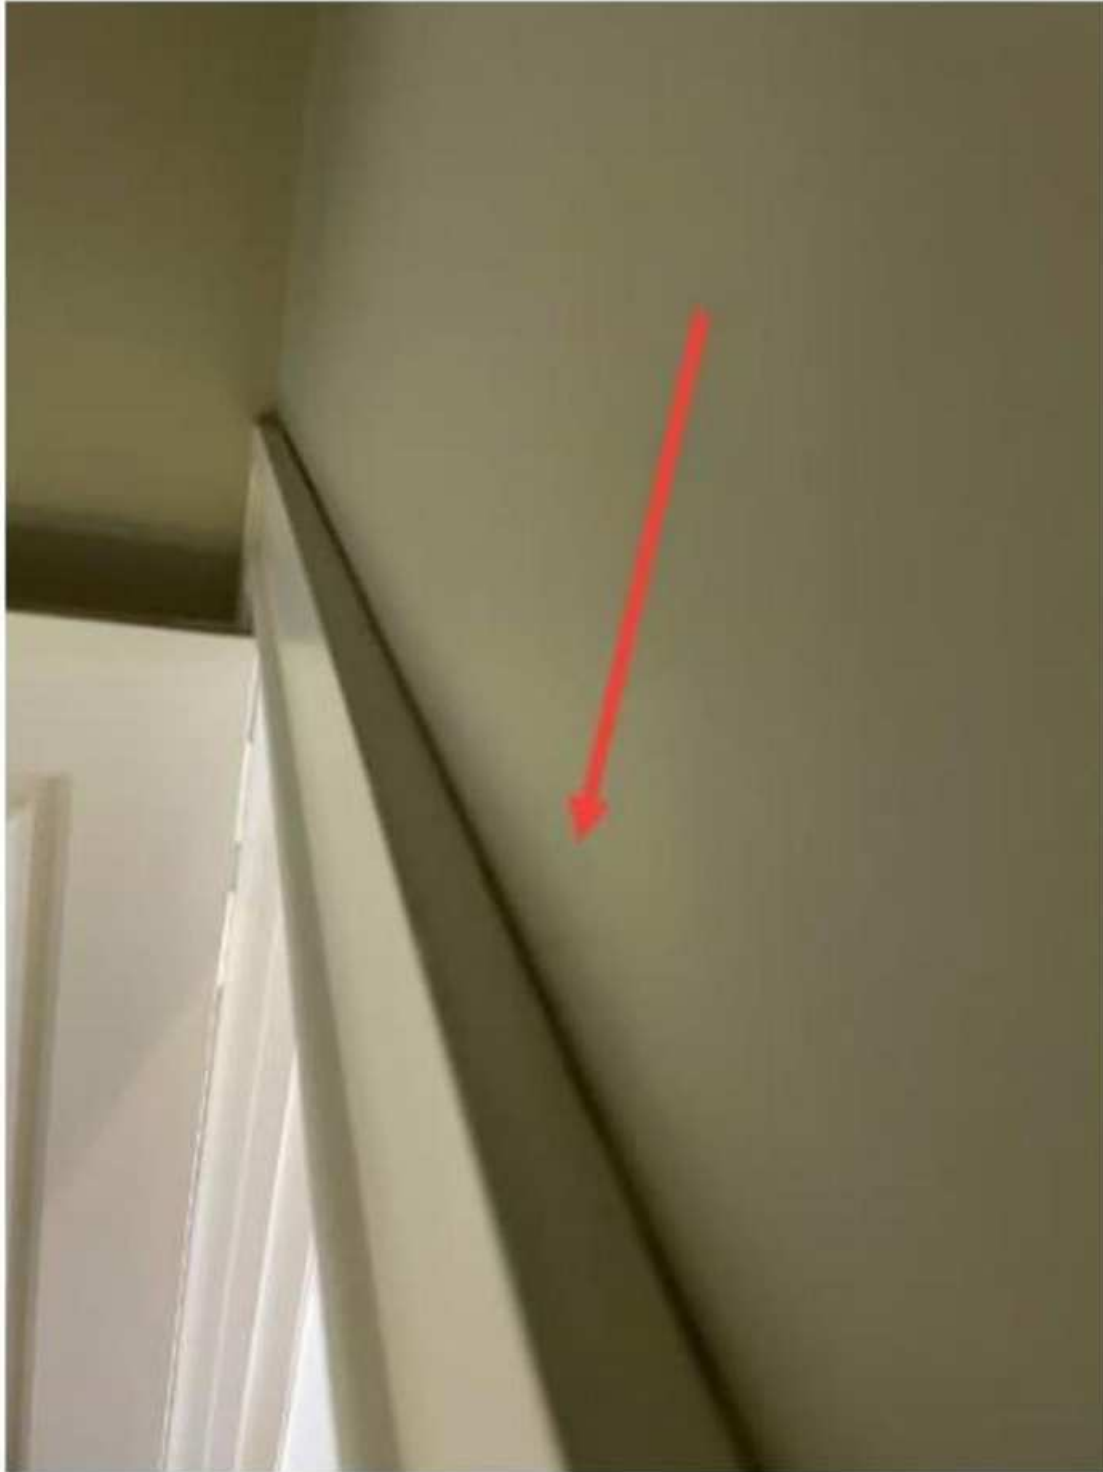
Top architraves around openings are not painted.
