Thank you for the opportunity to inspect the preparation and application of paintwork of your home under construction. We attended the site on Wednesday, 27 November, 2024 and make the following comment on the quality and compliance of the works to date;

# Quality Assurance Inspection

Preparation and application of paintwork and workmanship only.

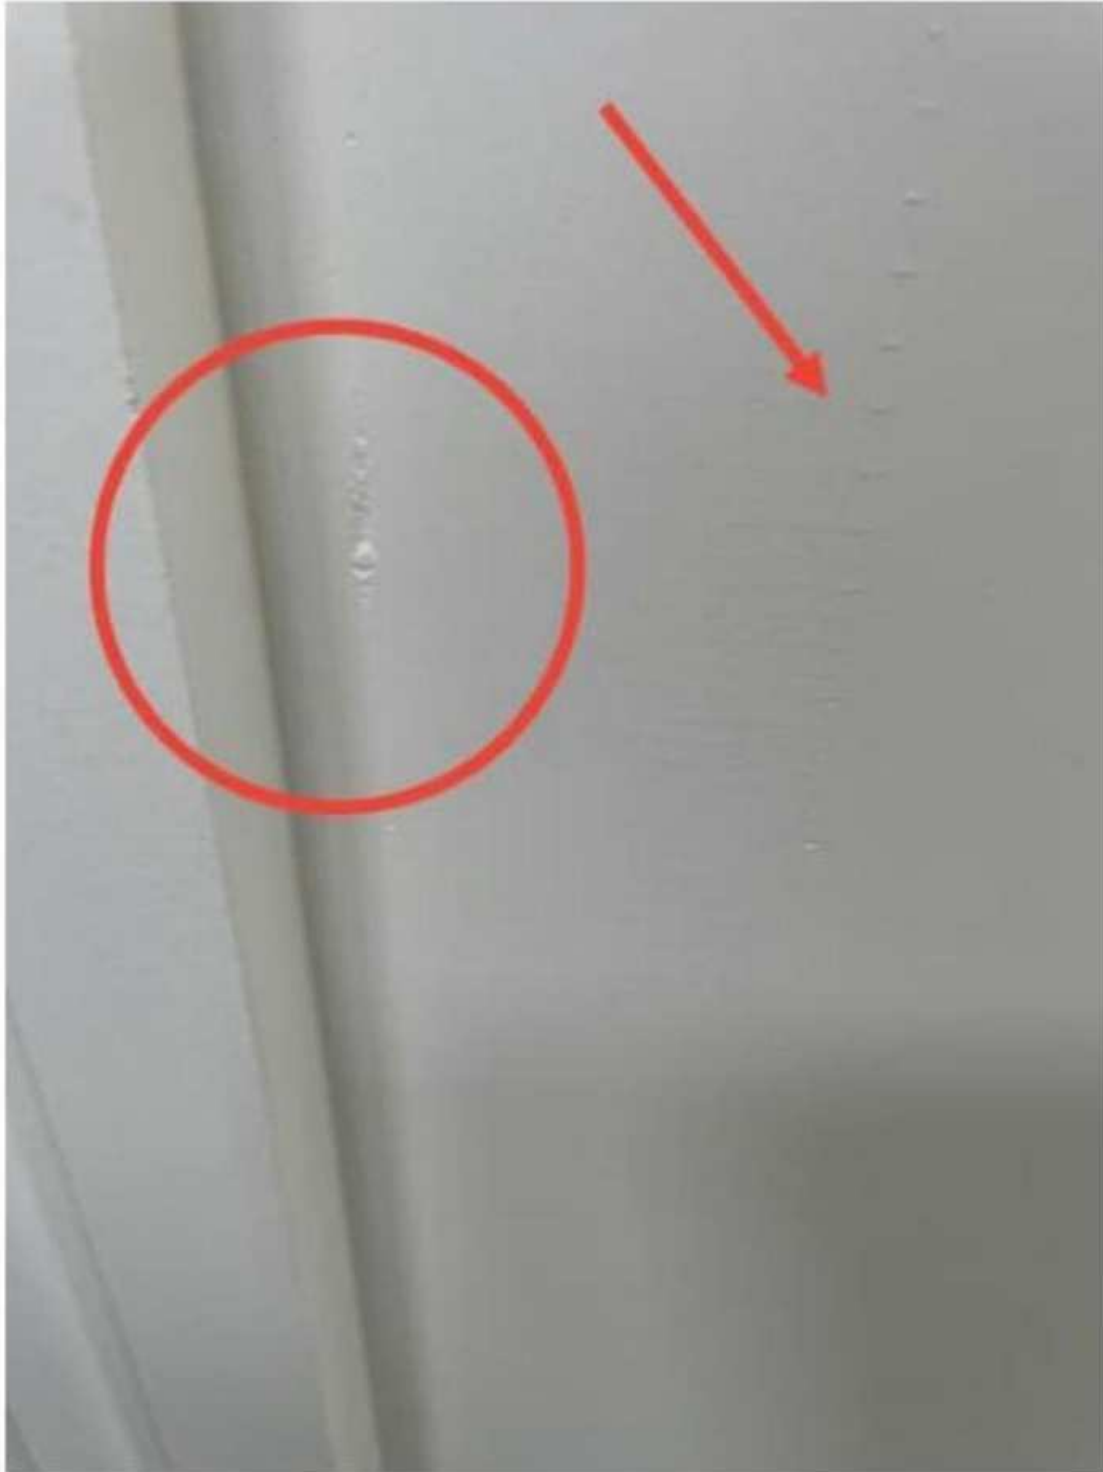
(33)

Poor workmanship finishes to skirting boards located around the dwelling.

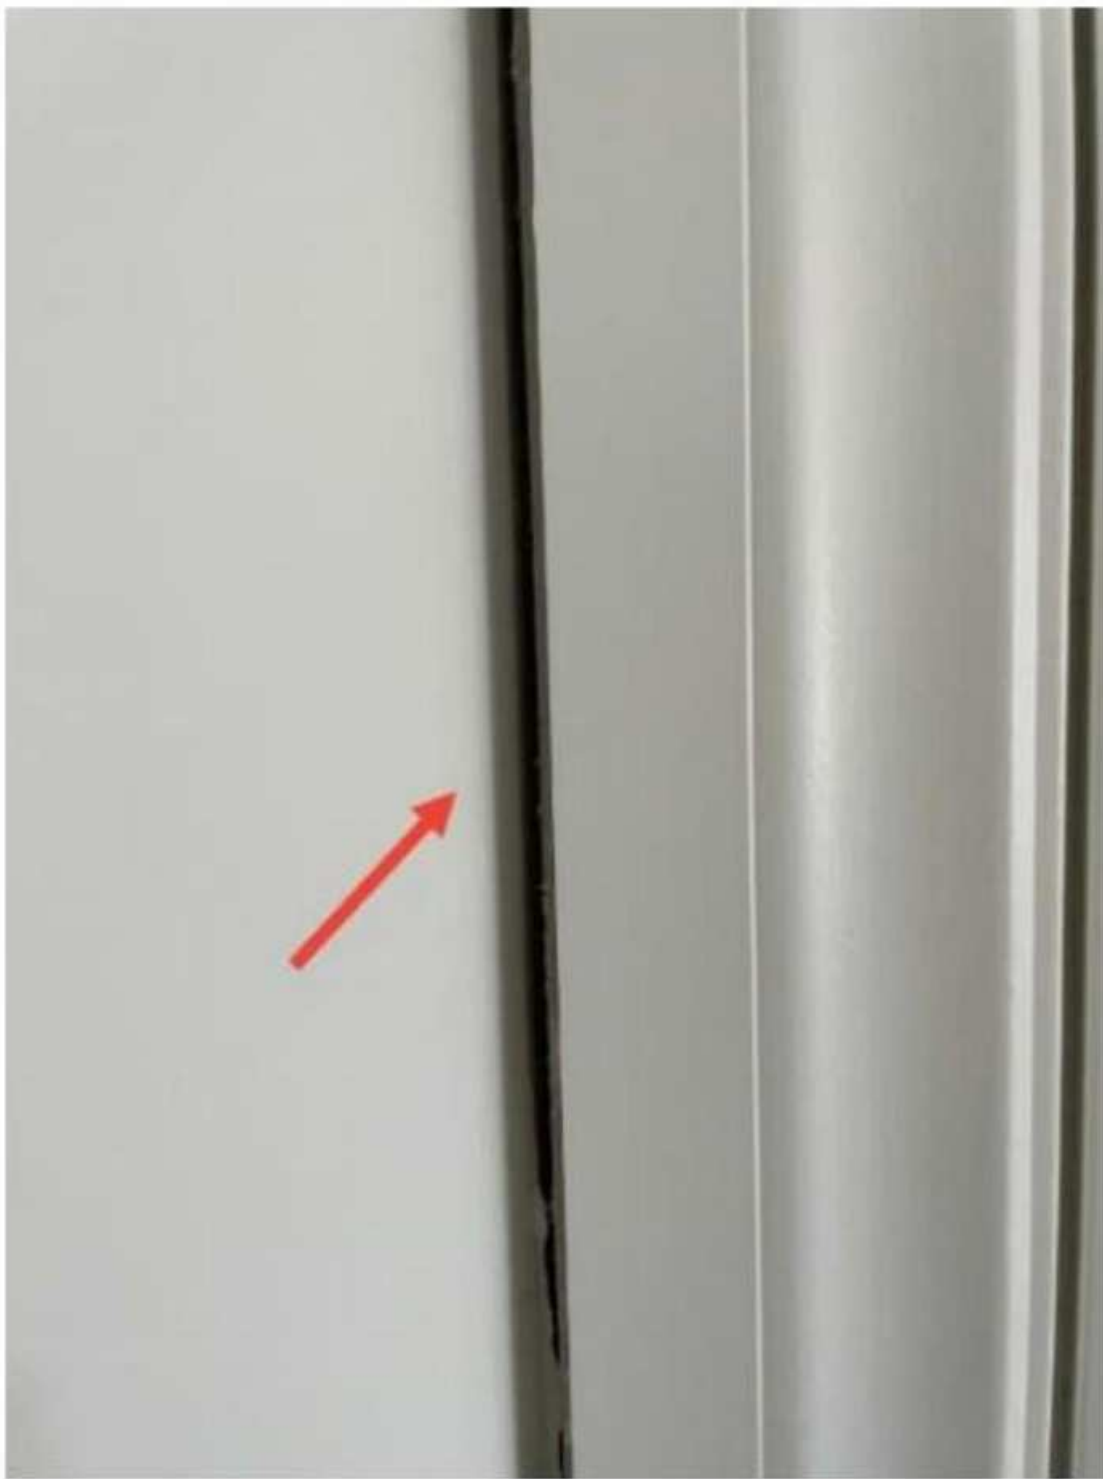
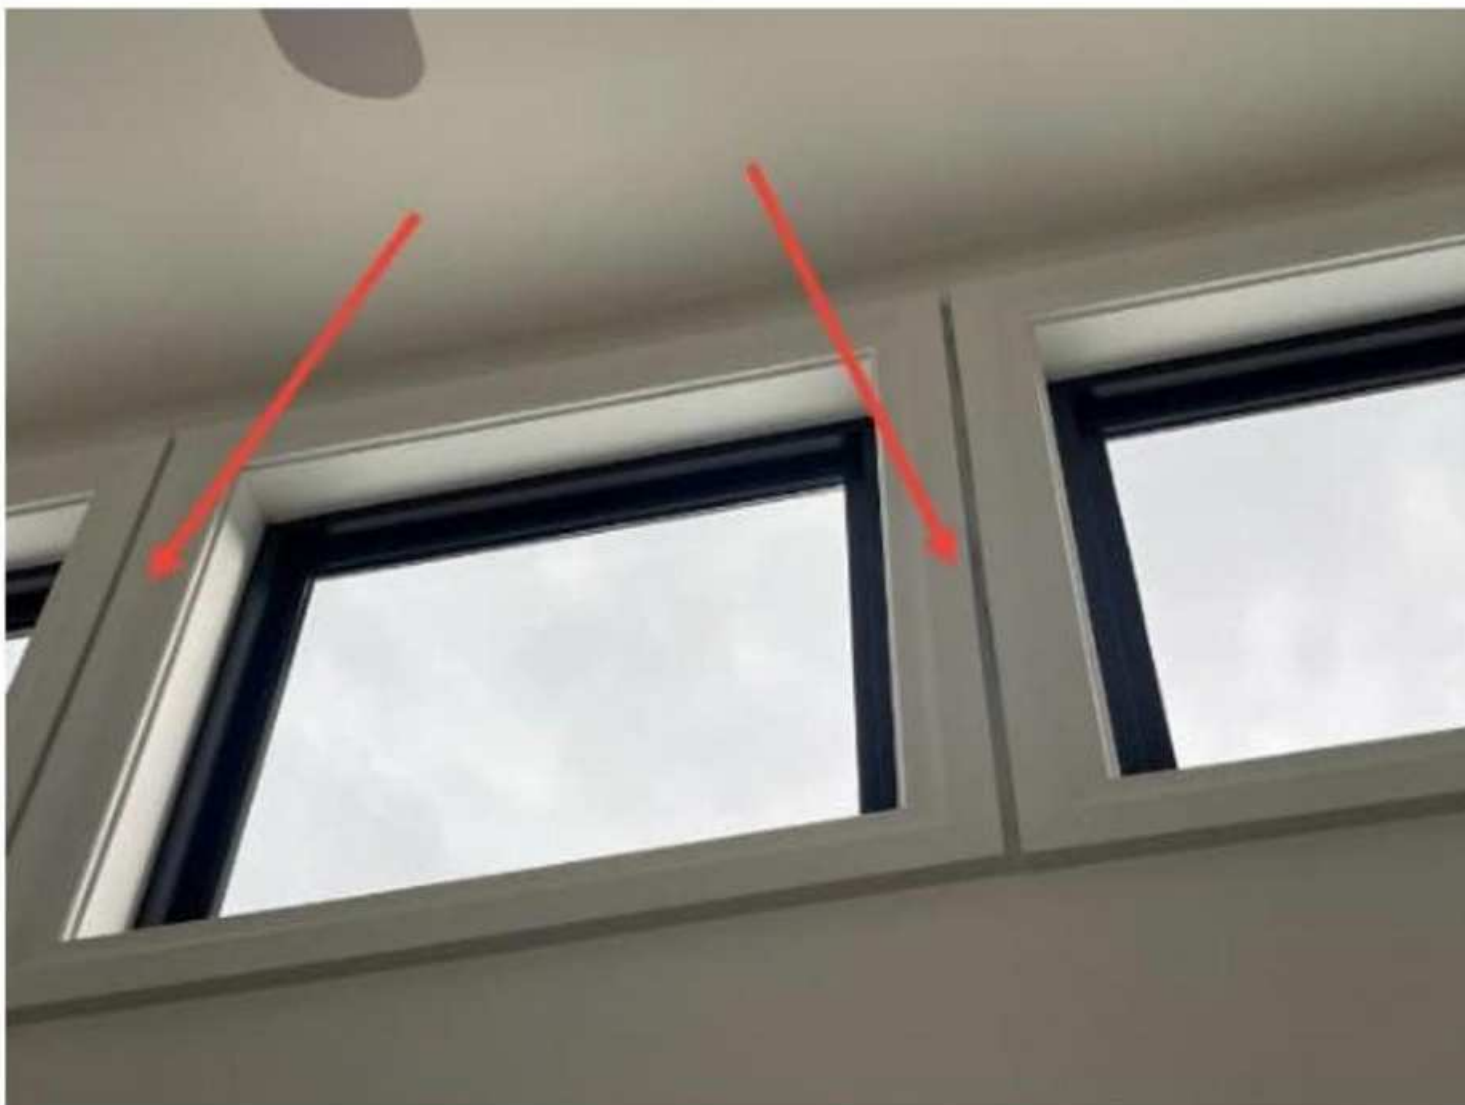
Gaps noted in parts around openings and wall to wall junctions and to do not appeared to be complete.

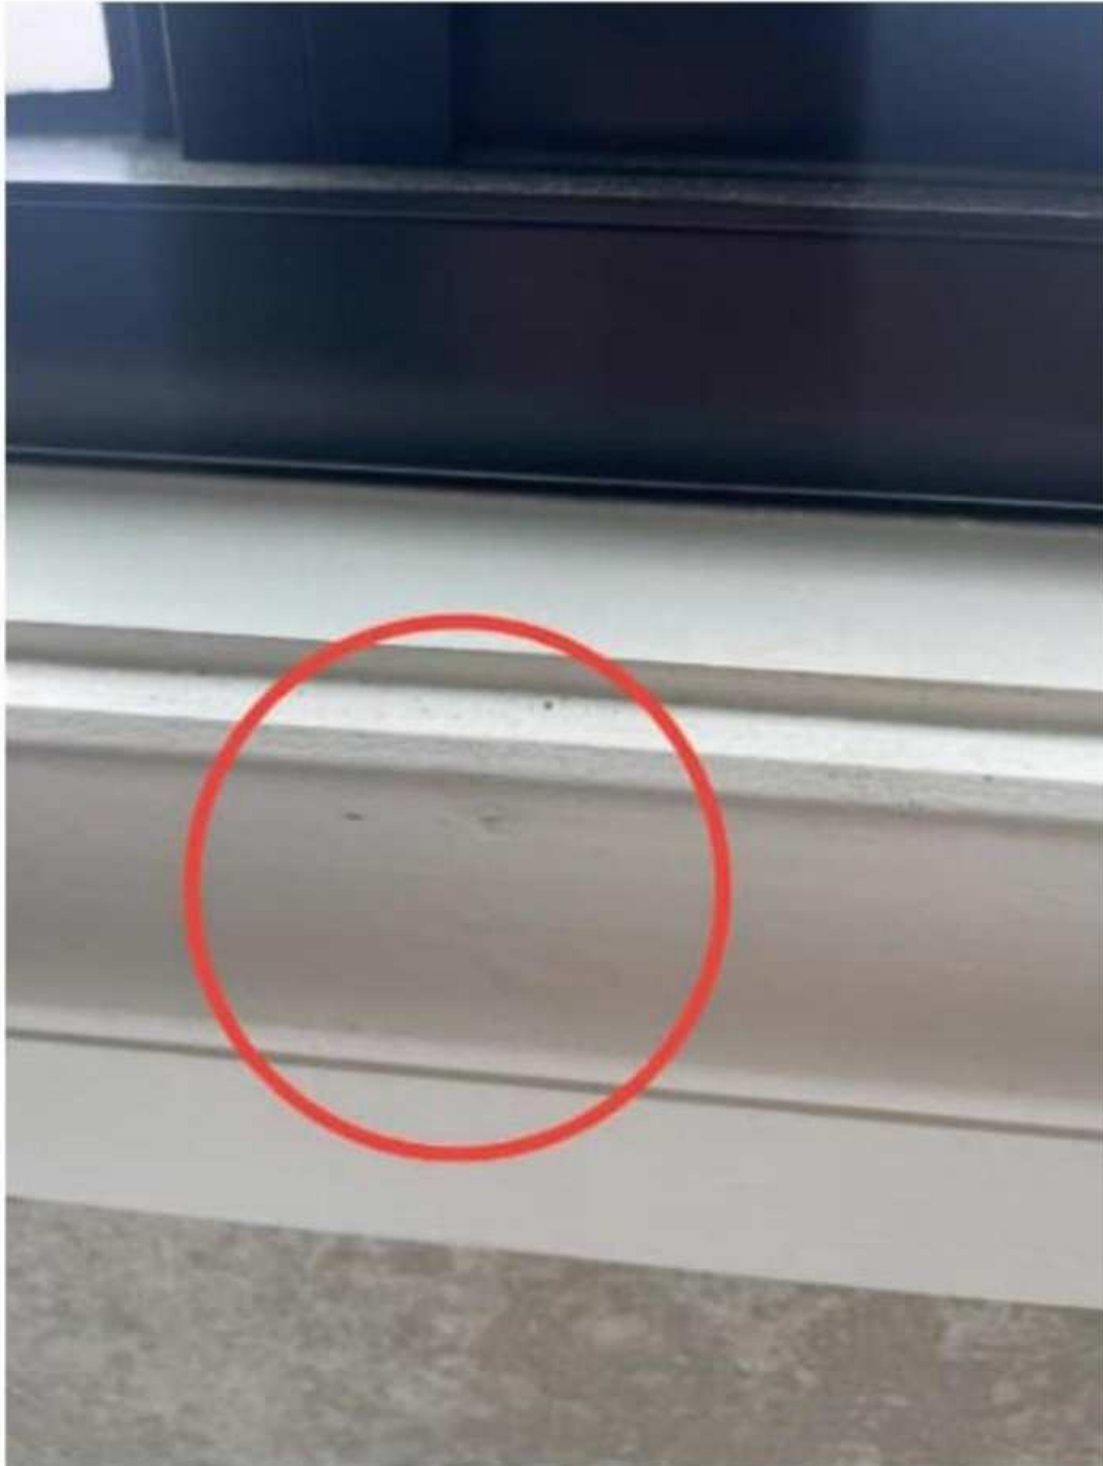
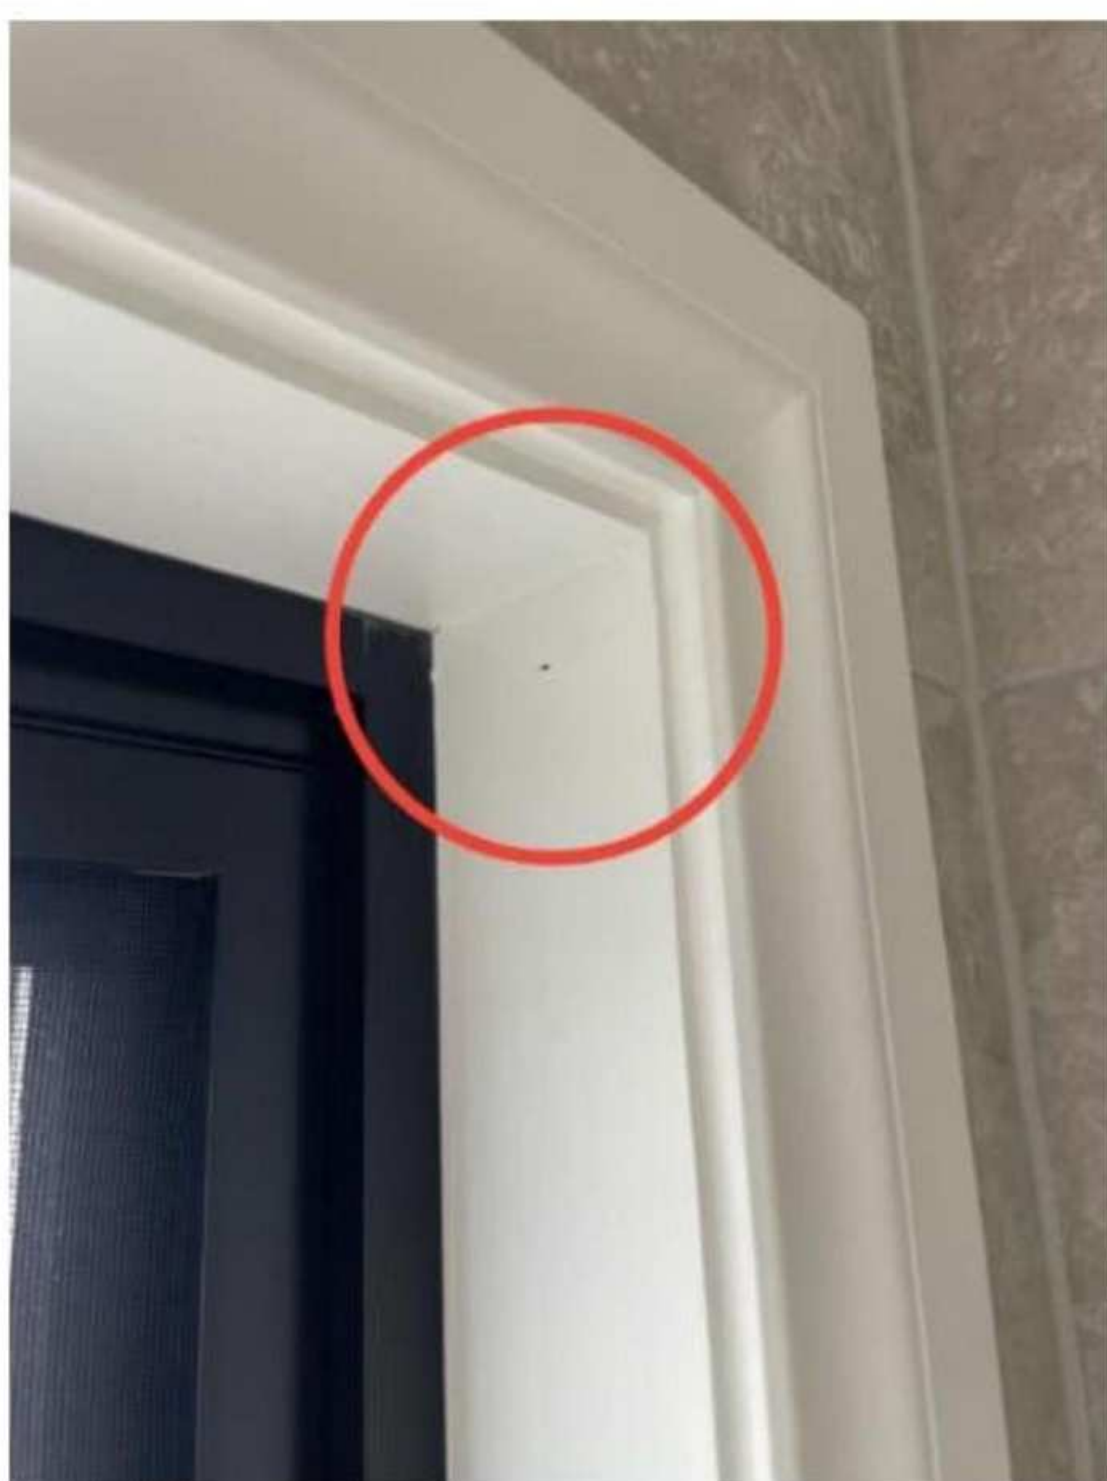
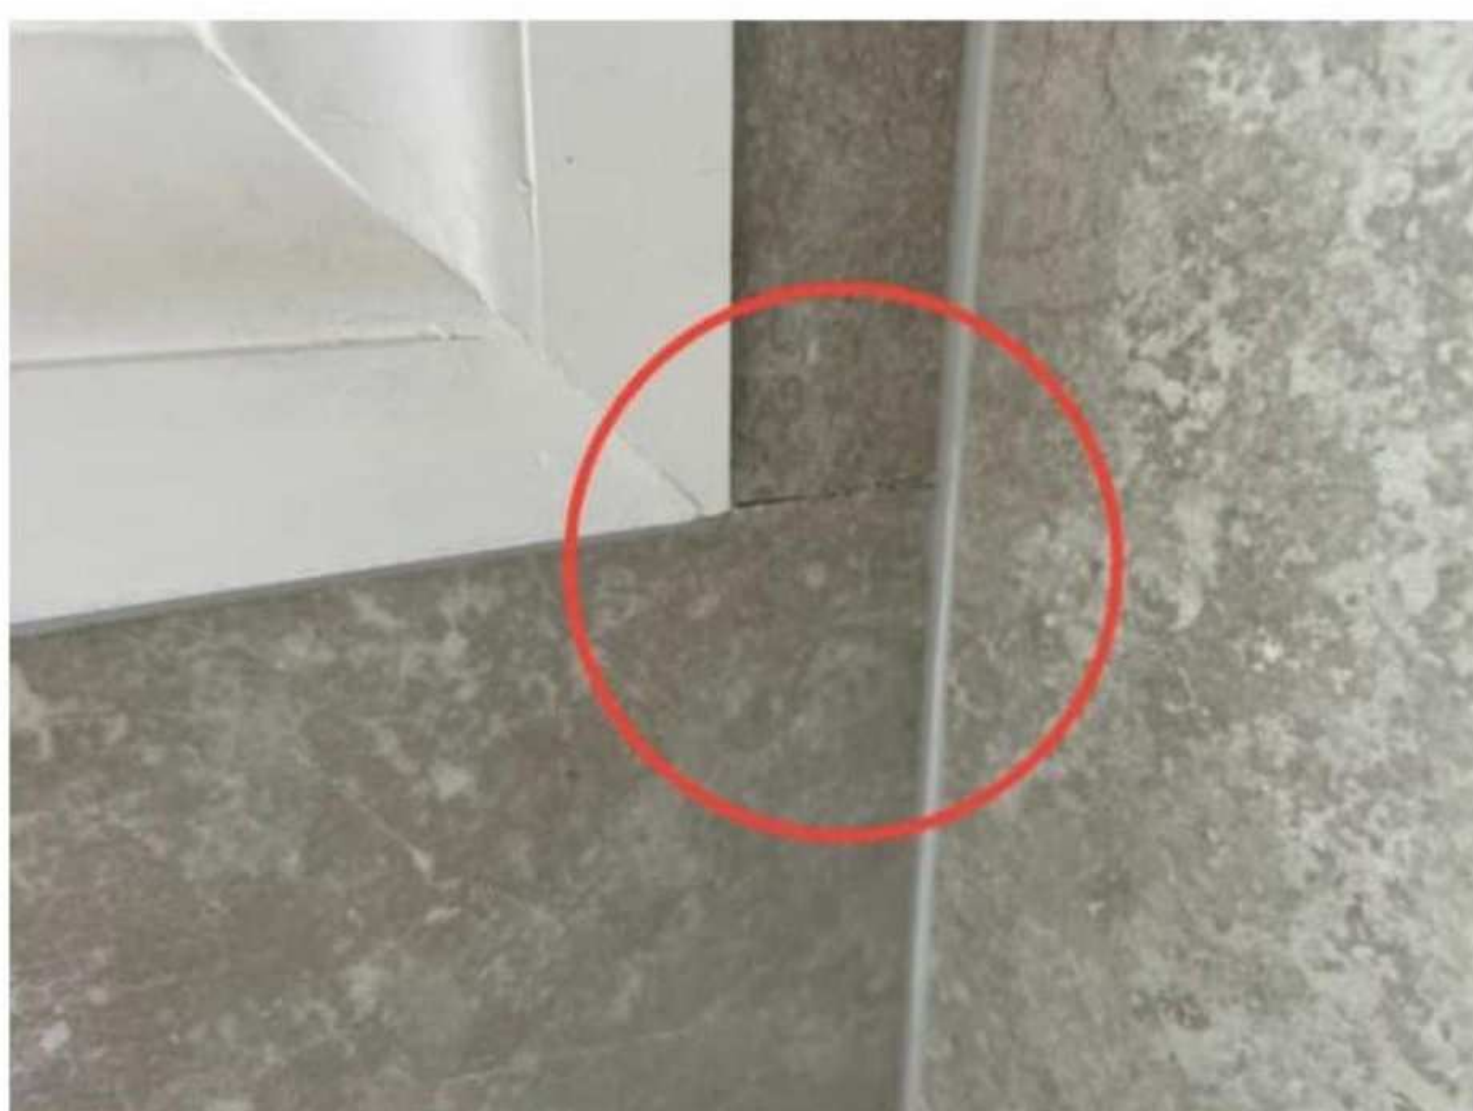
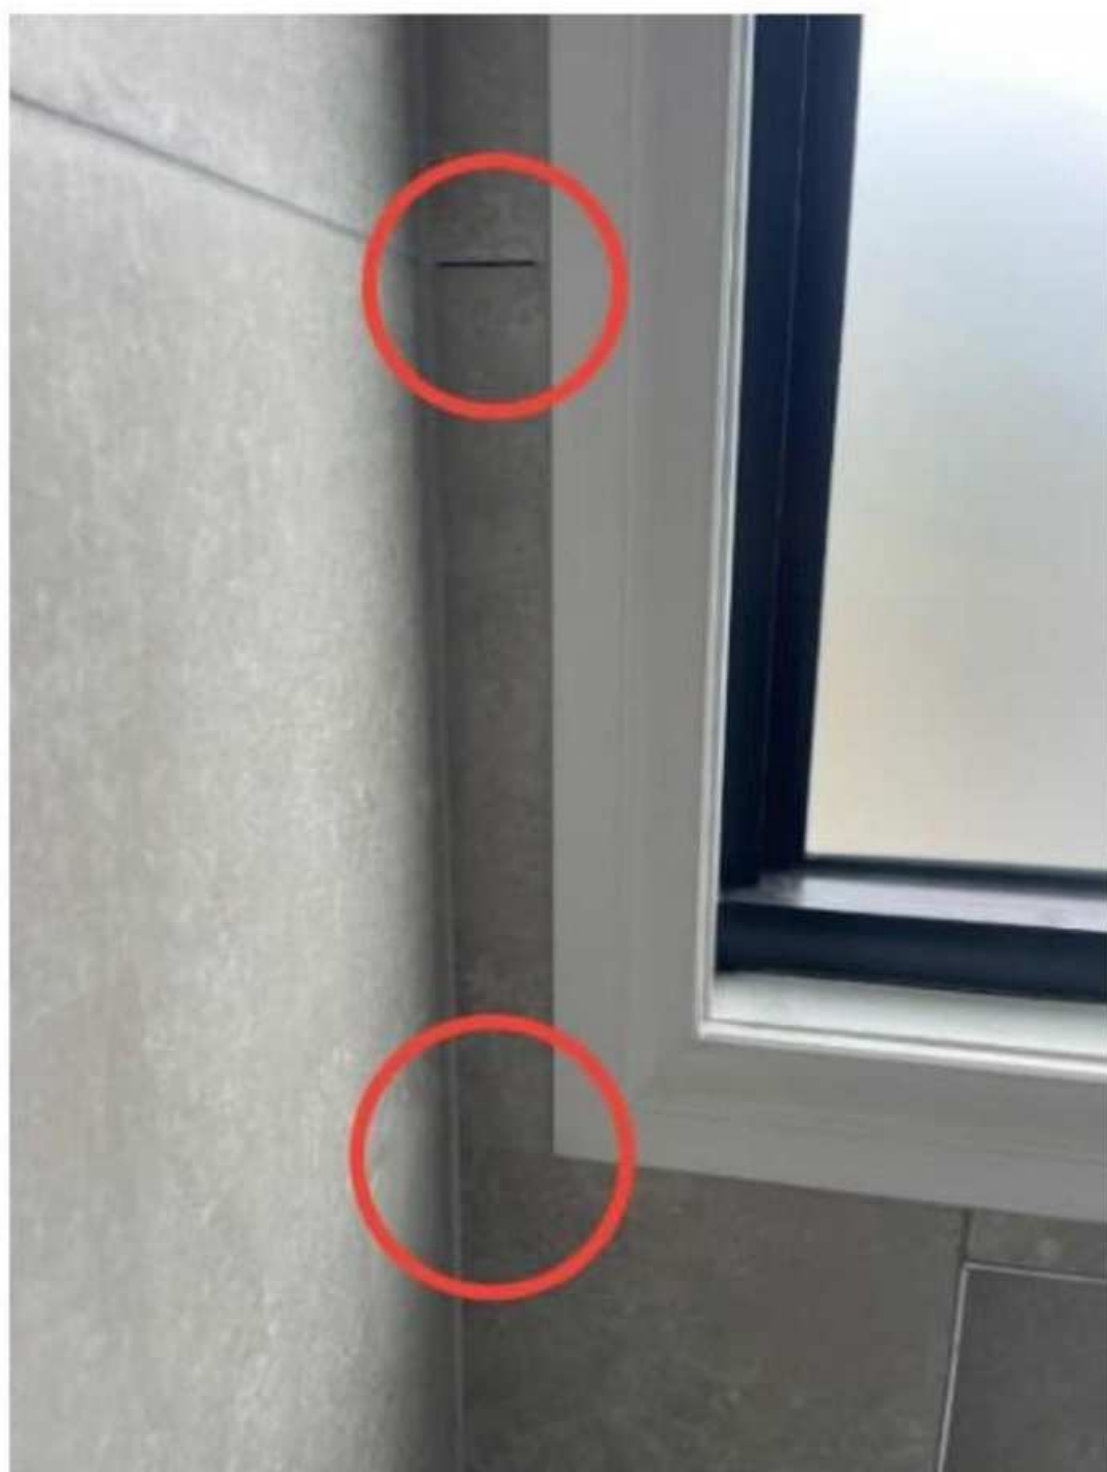
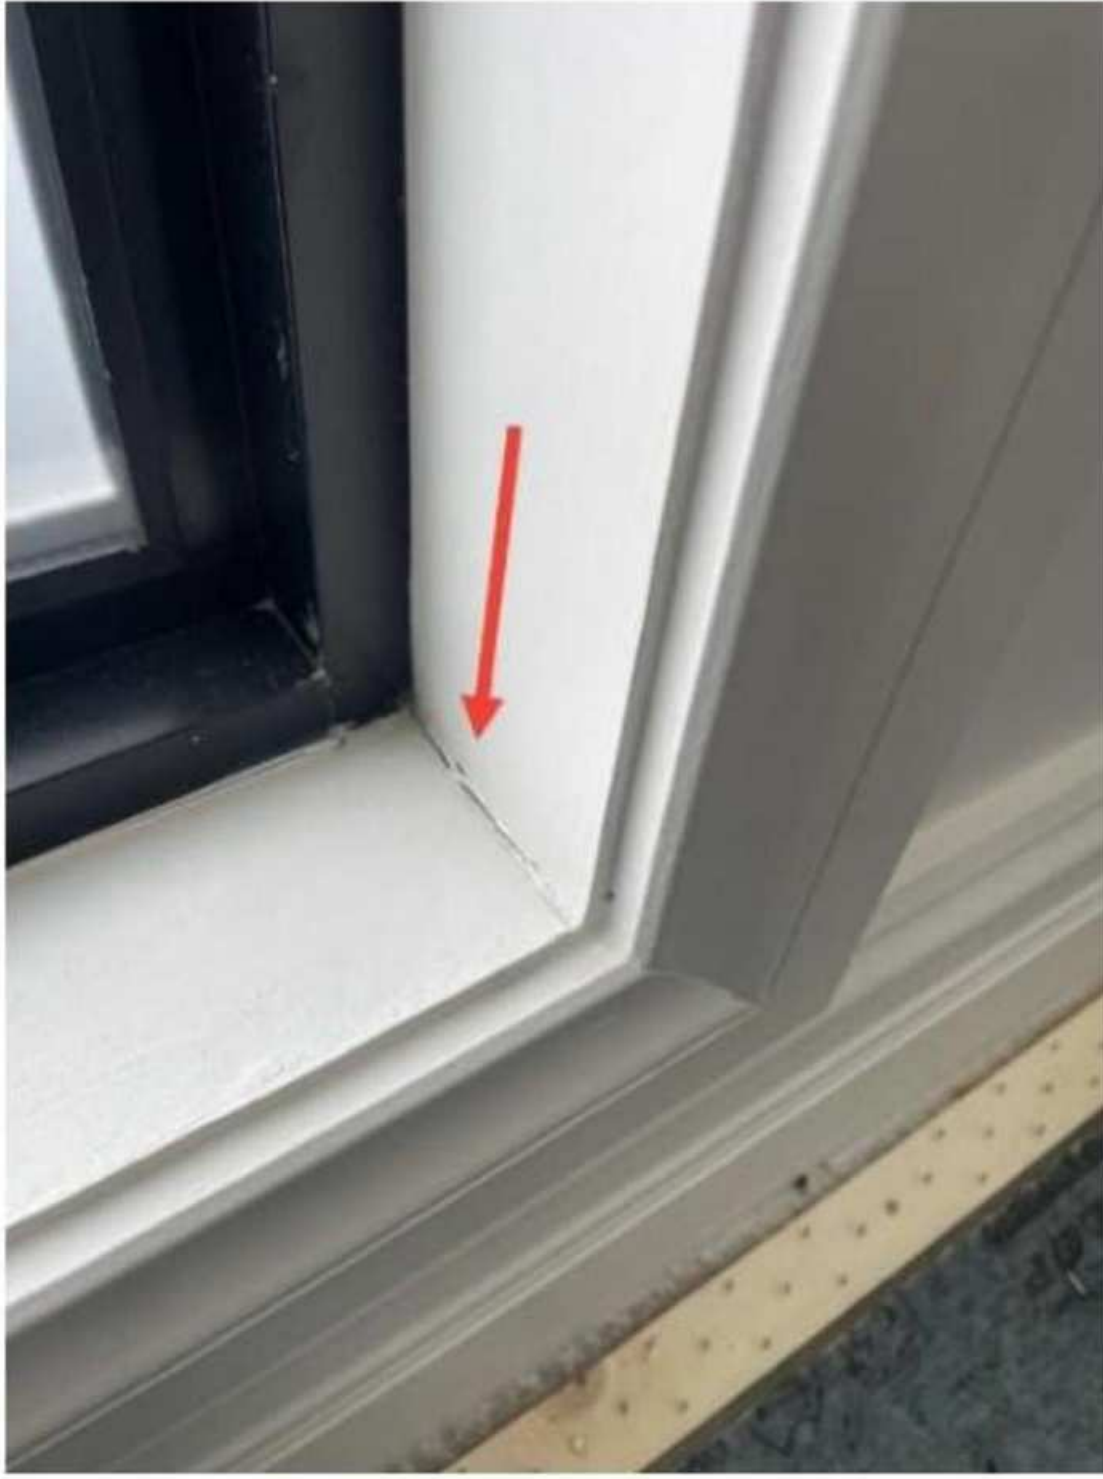
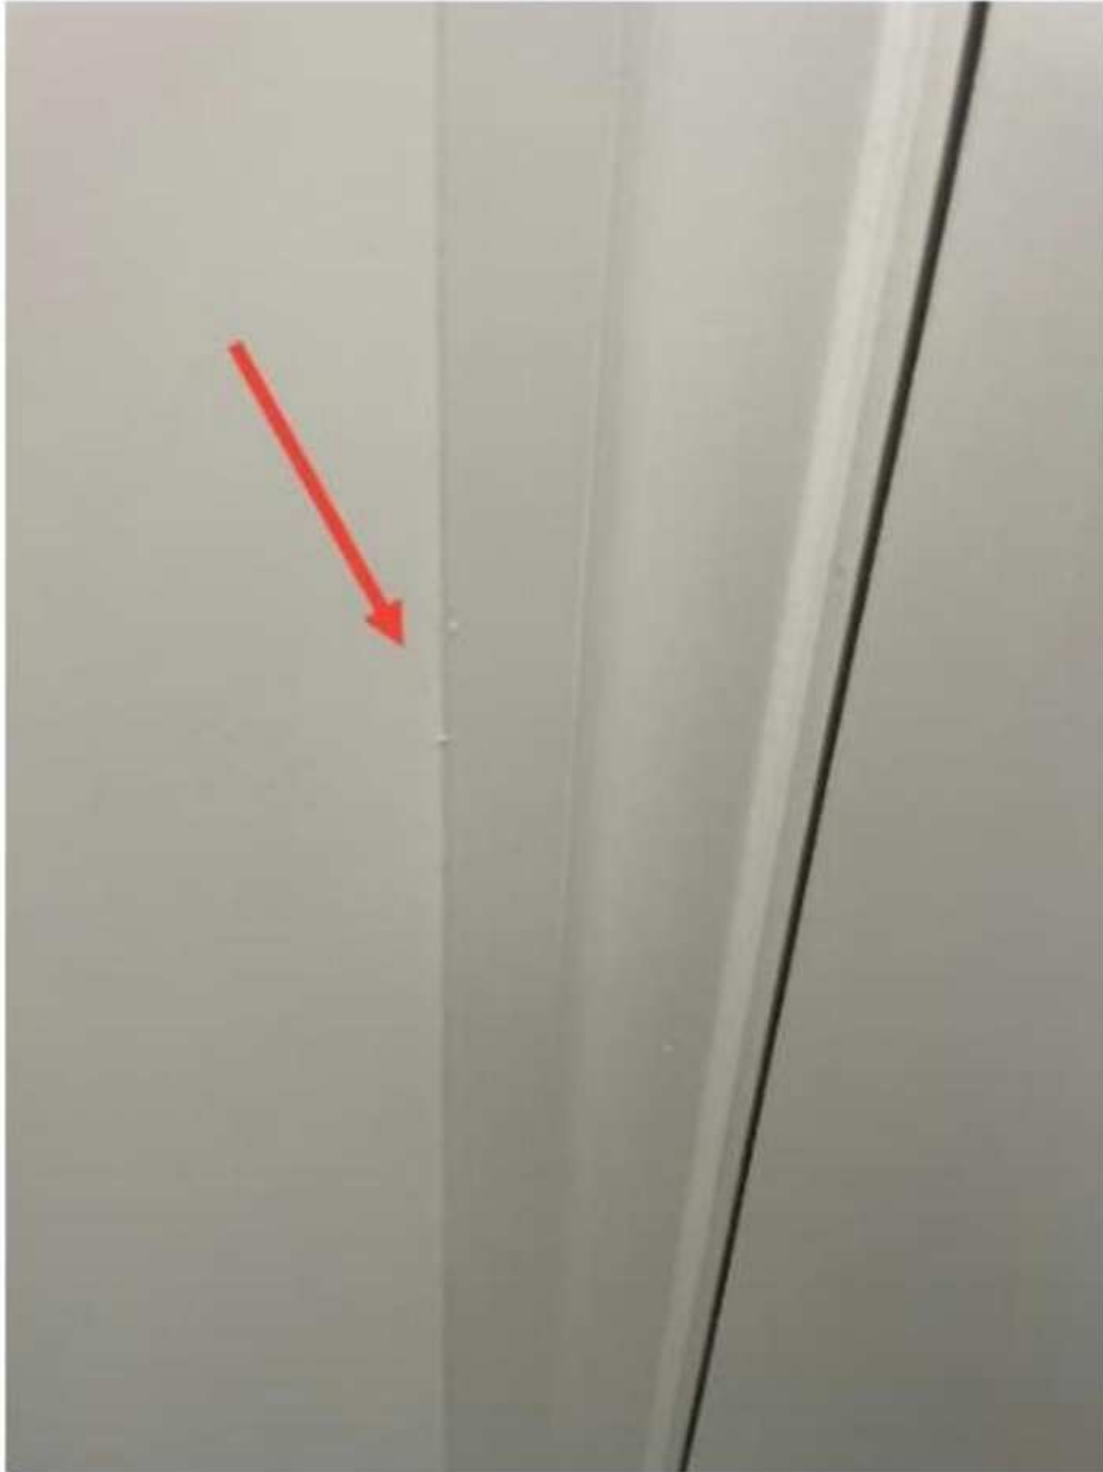
Damaged noted to the sills and architraves.

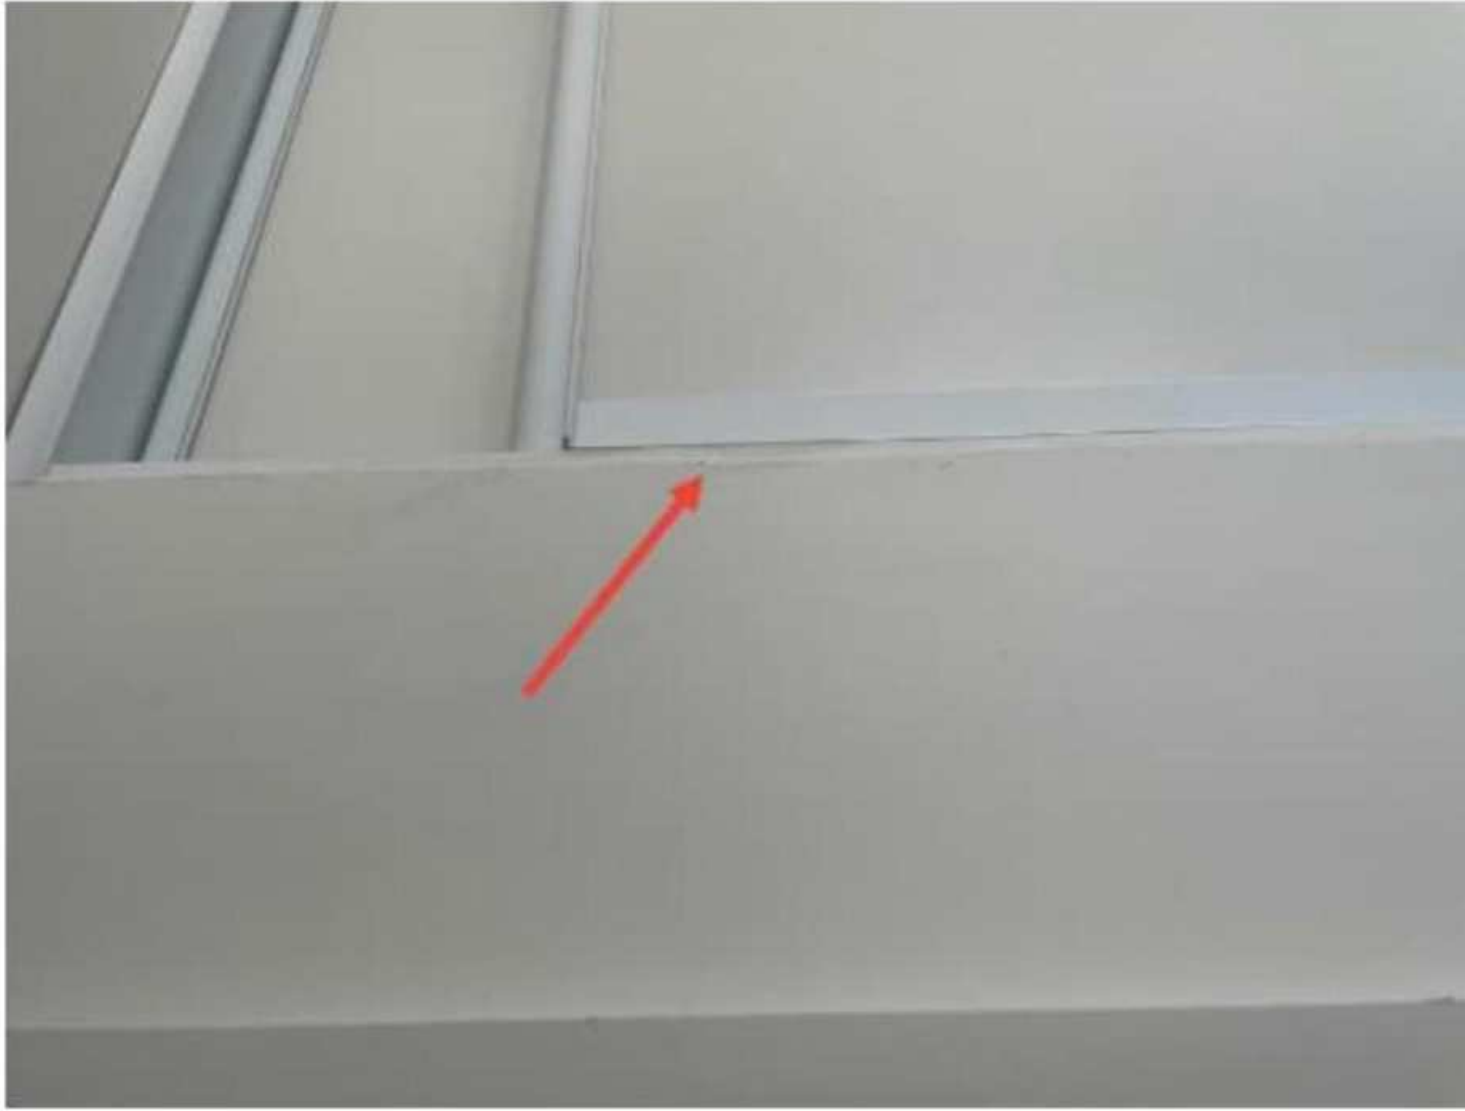
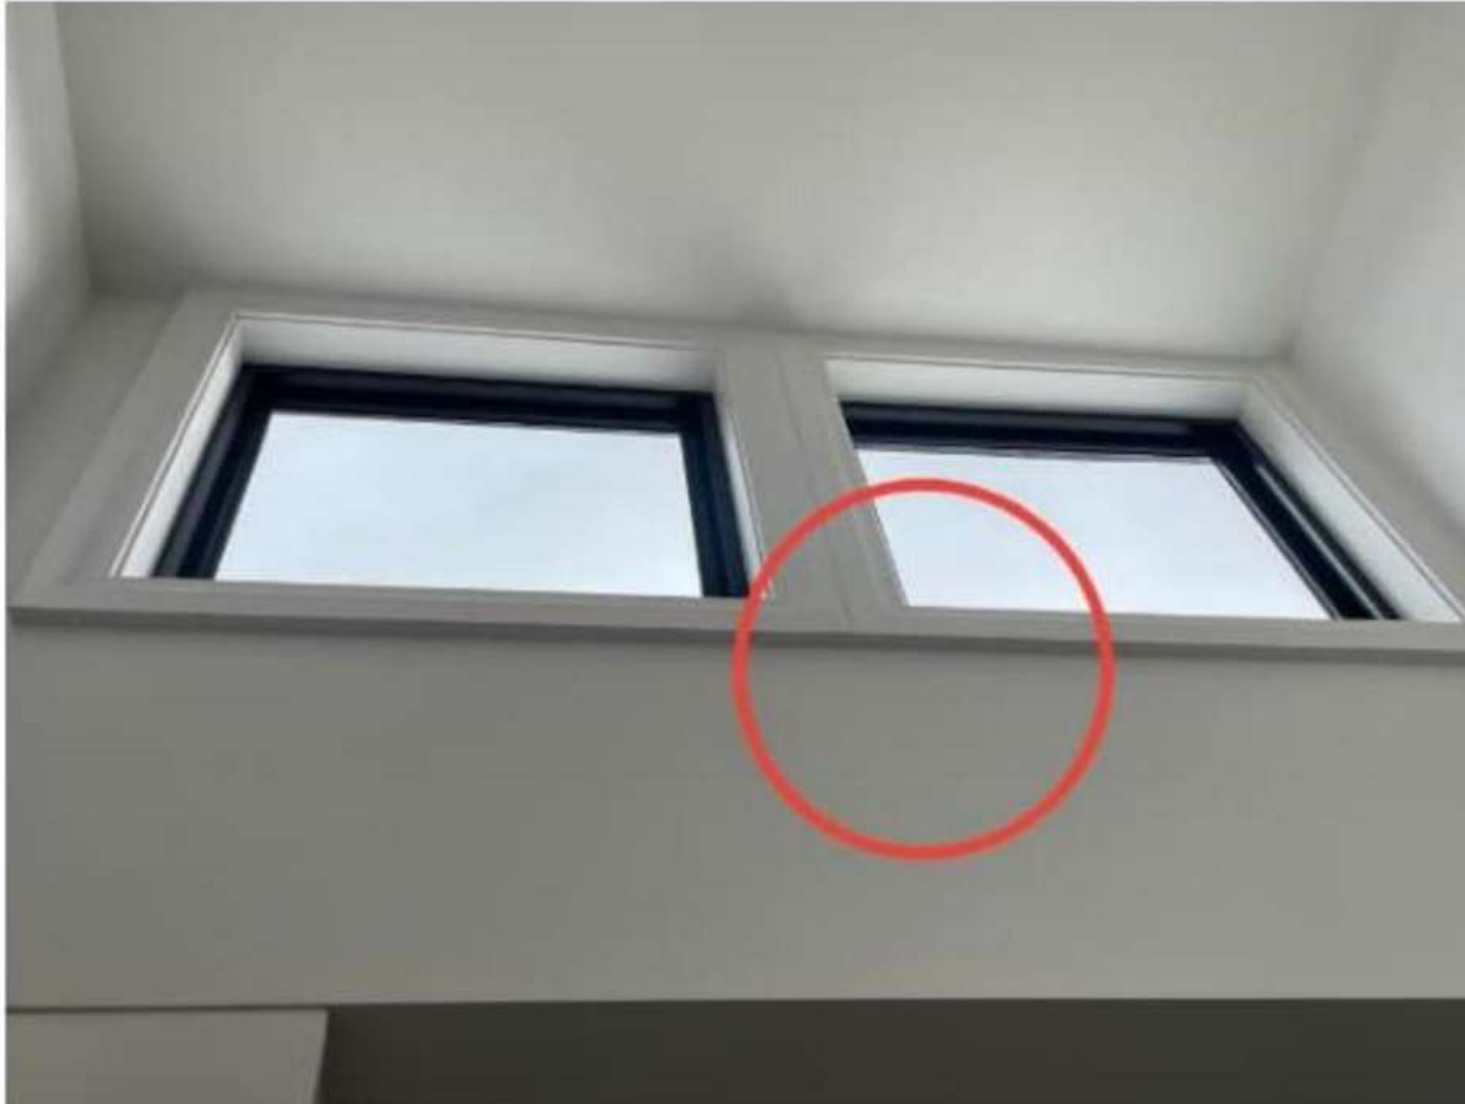
Damaged sections noted around bulk heads.

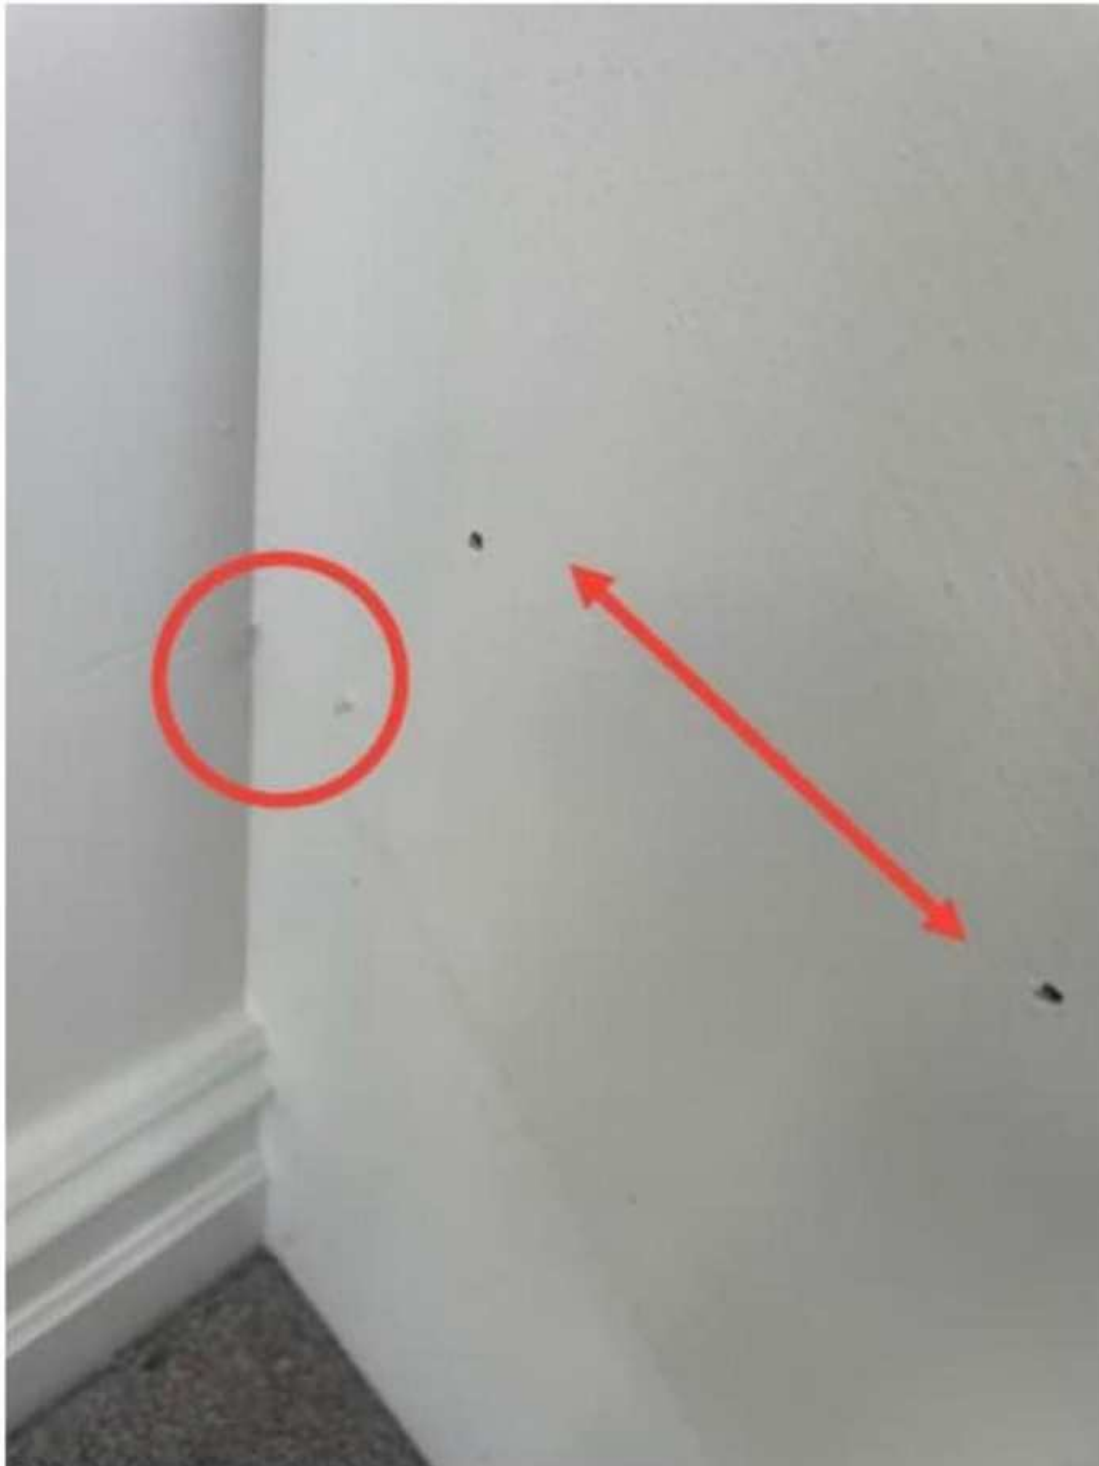
(49)

Nailhead holes not filled and painted around architraves.

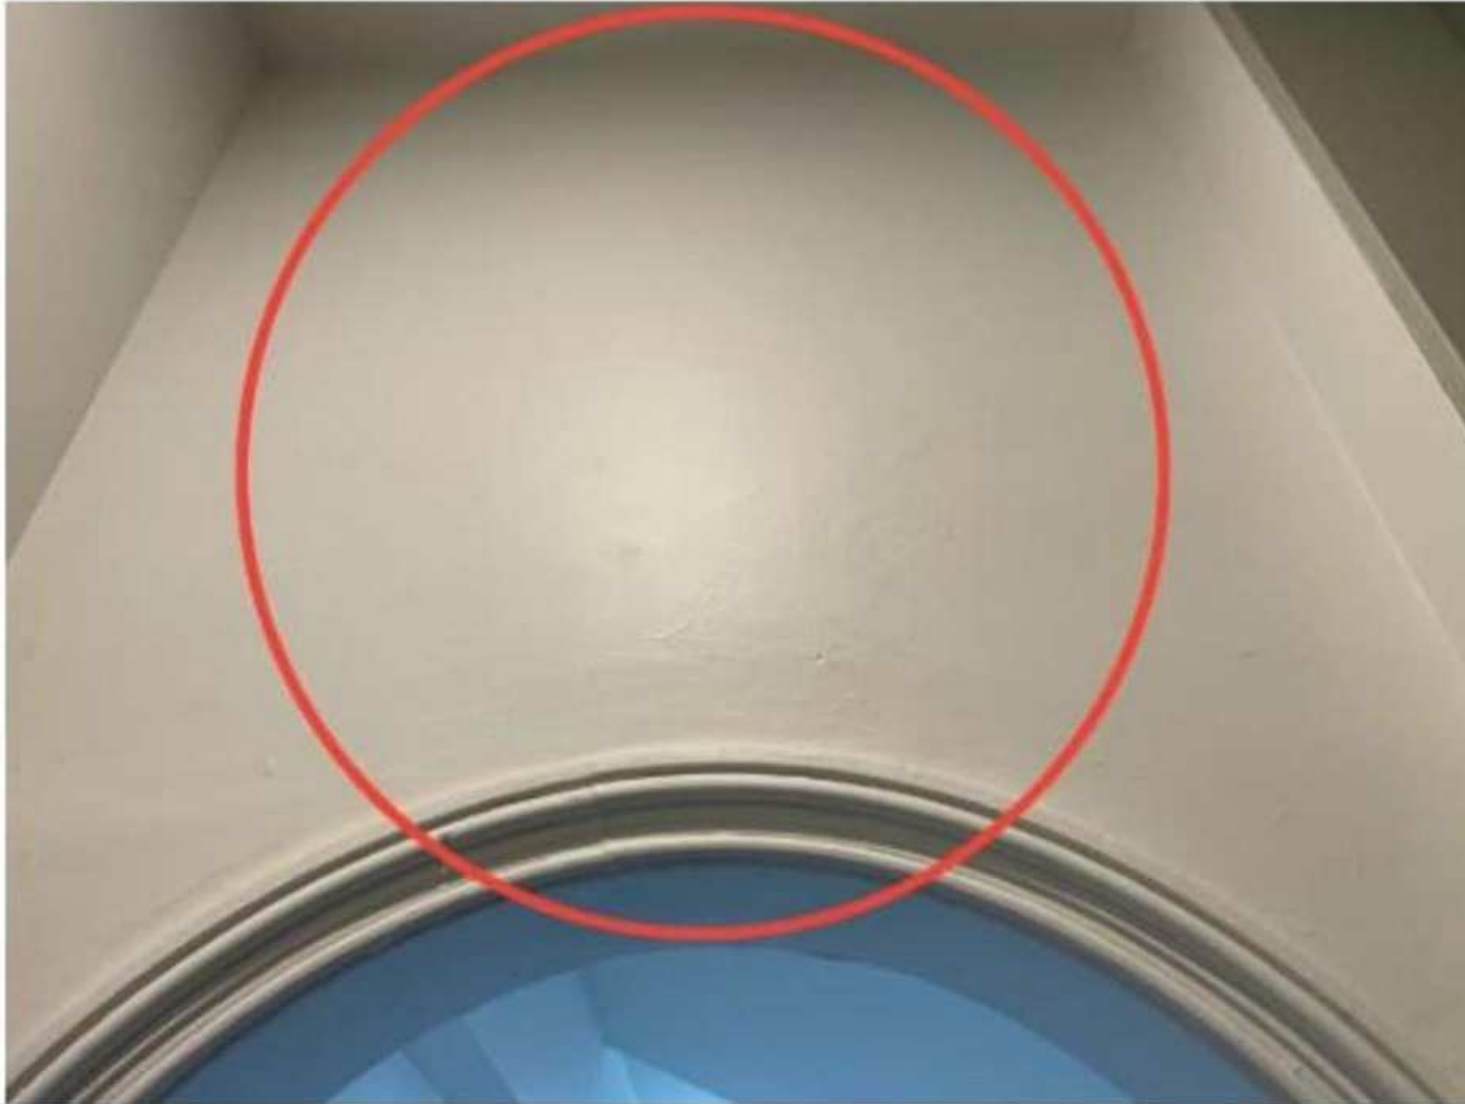
(51)

Preparation of existing walls and elements appeared to be defective.
