Thank you for the opportunity to inspect the preparation and application of paintwork of your home under construction. We attended the site on Wednesday, 27 November, 2024 and make the following comment on the quality and compliance of the works to date;

# Quality Assurance Inspection

Preparation and application of paintwork and workmanship only.

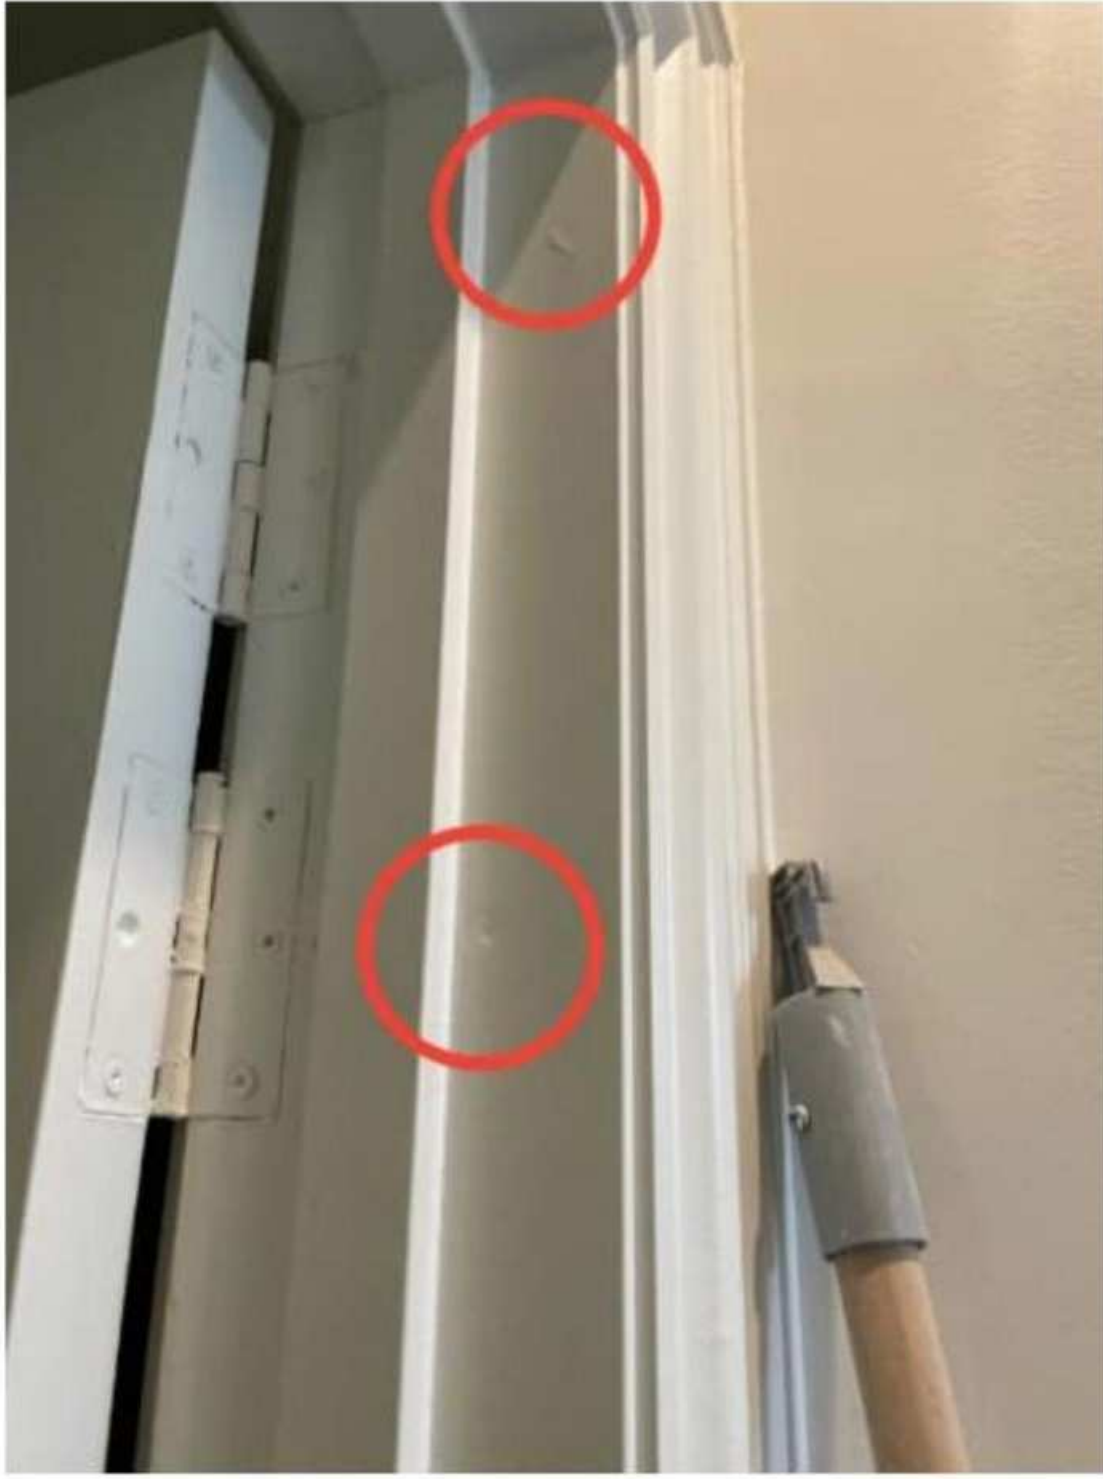
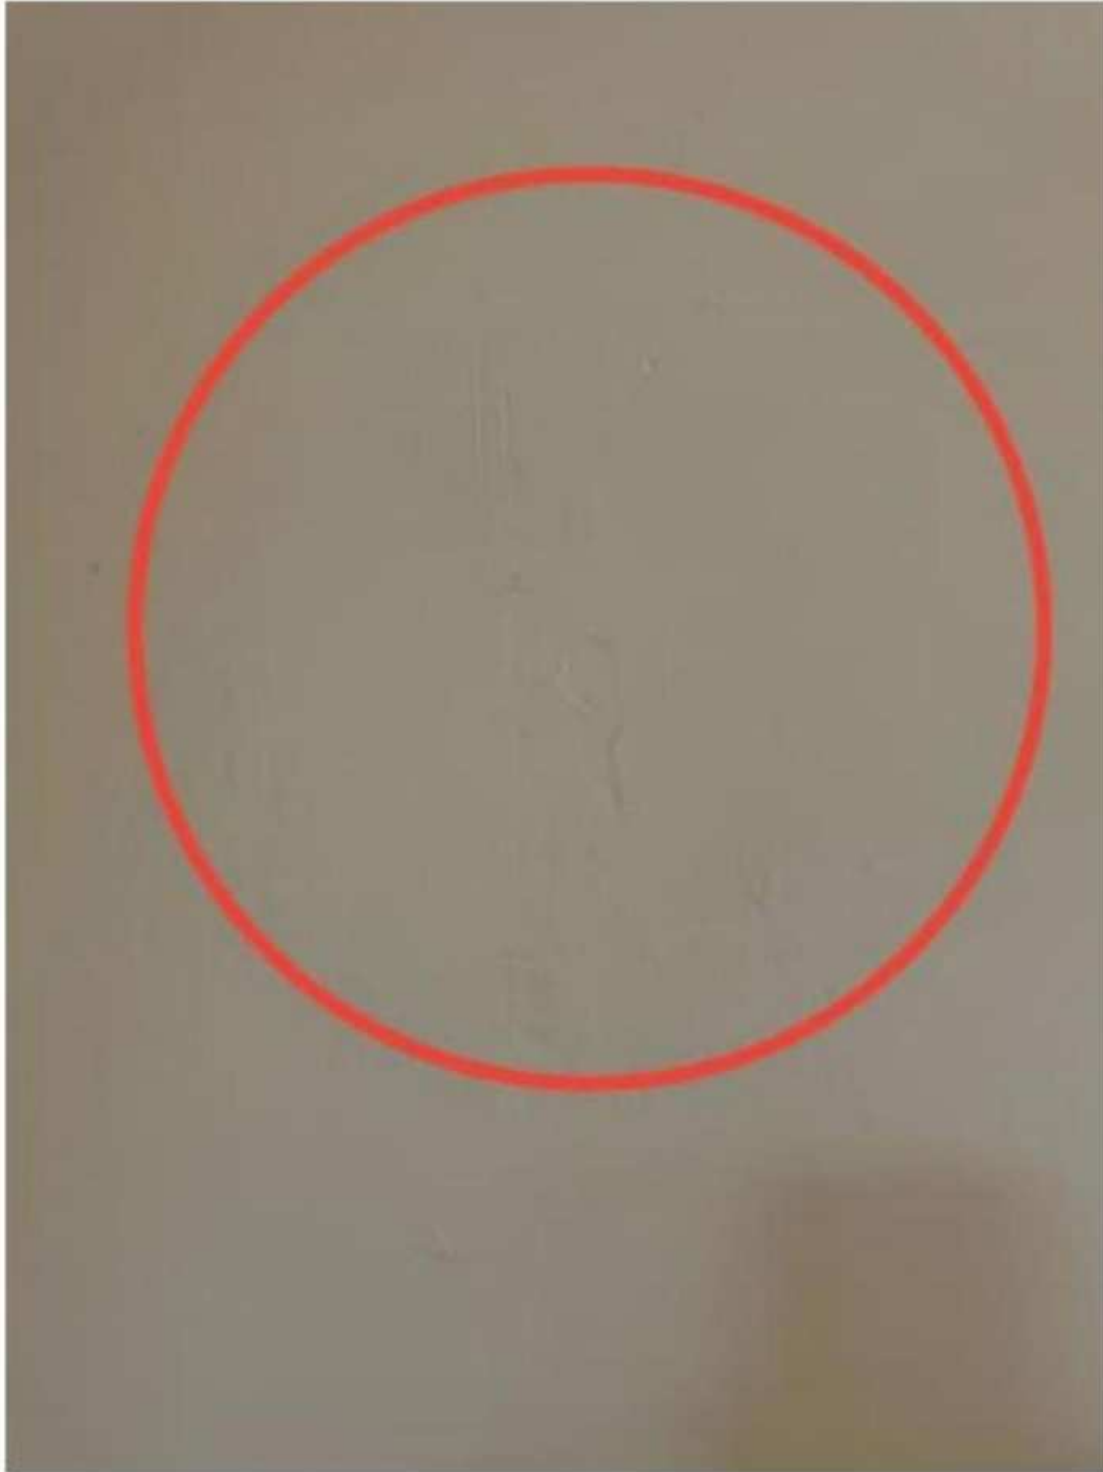
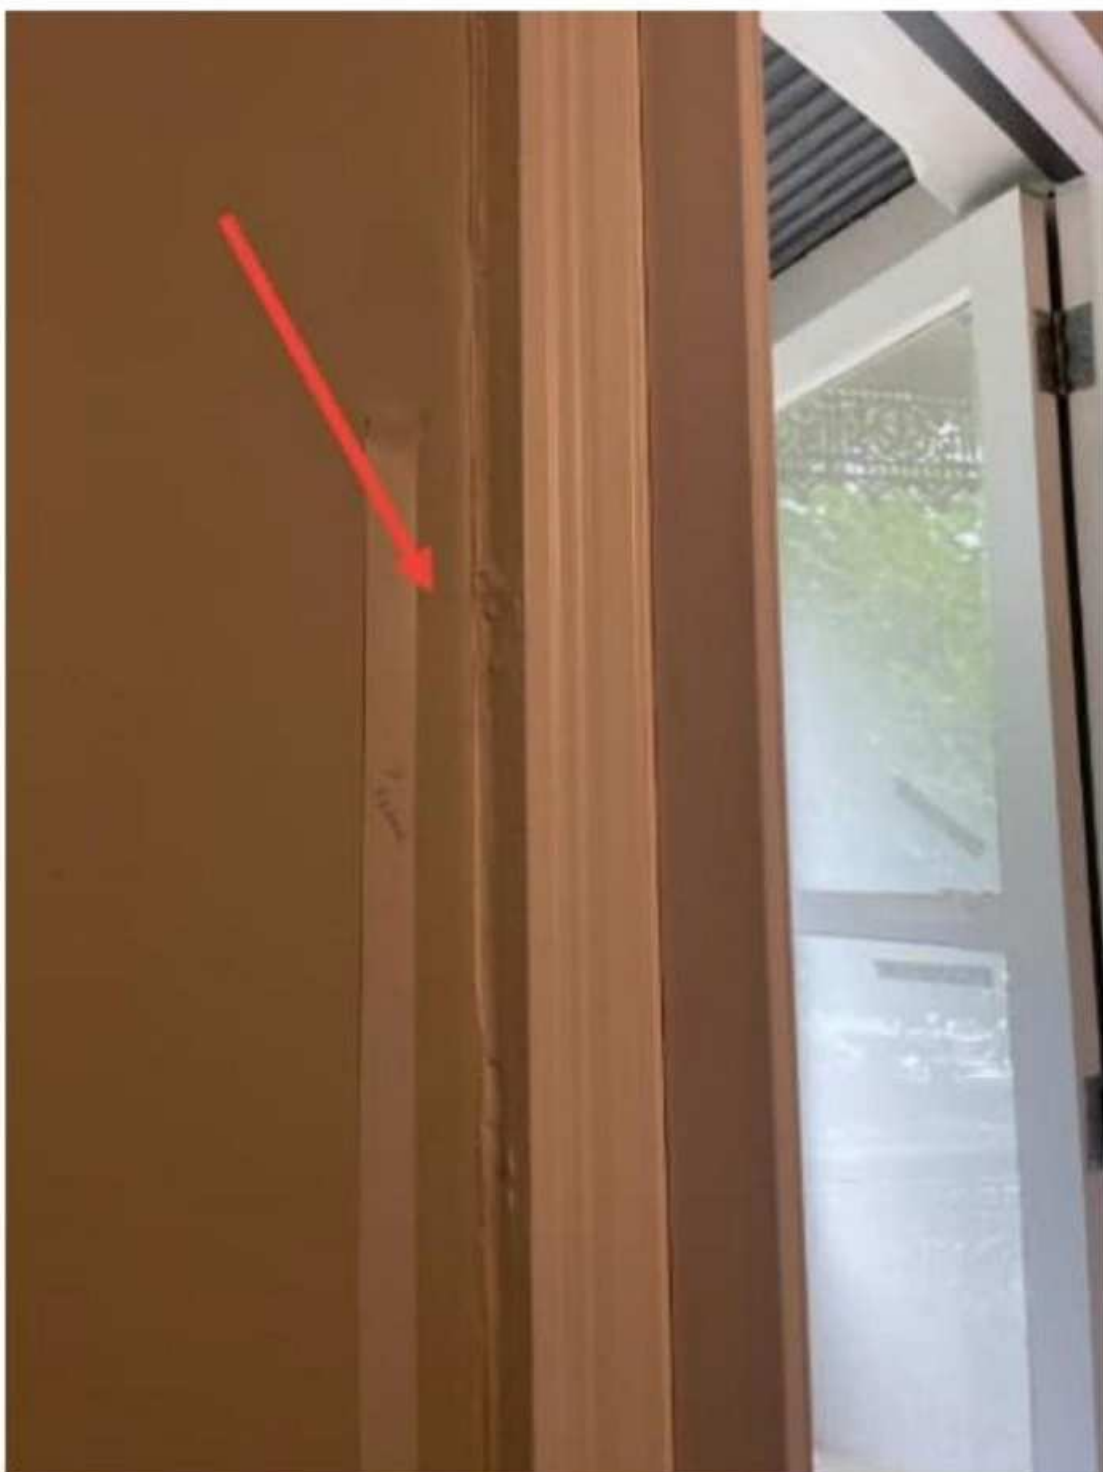
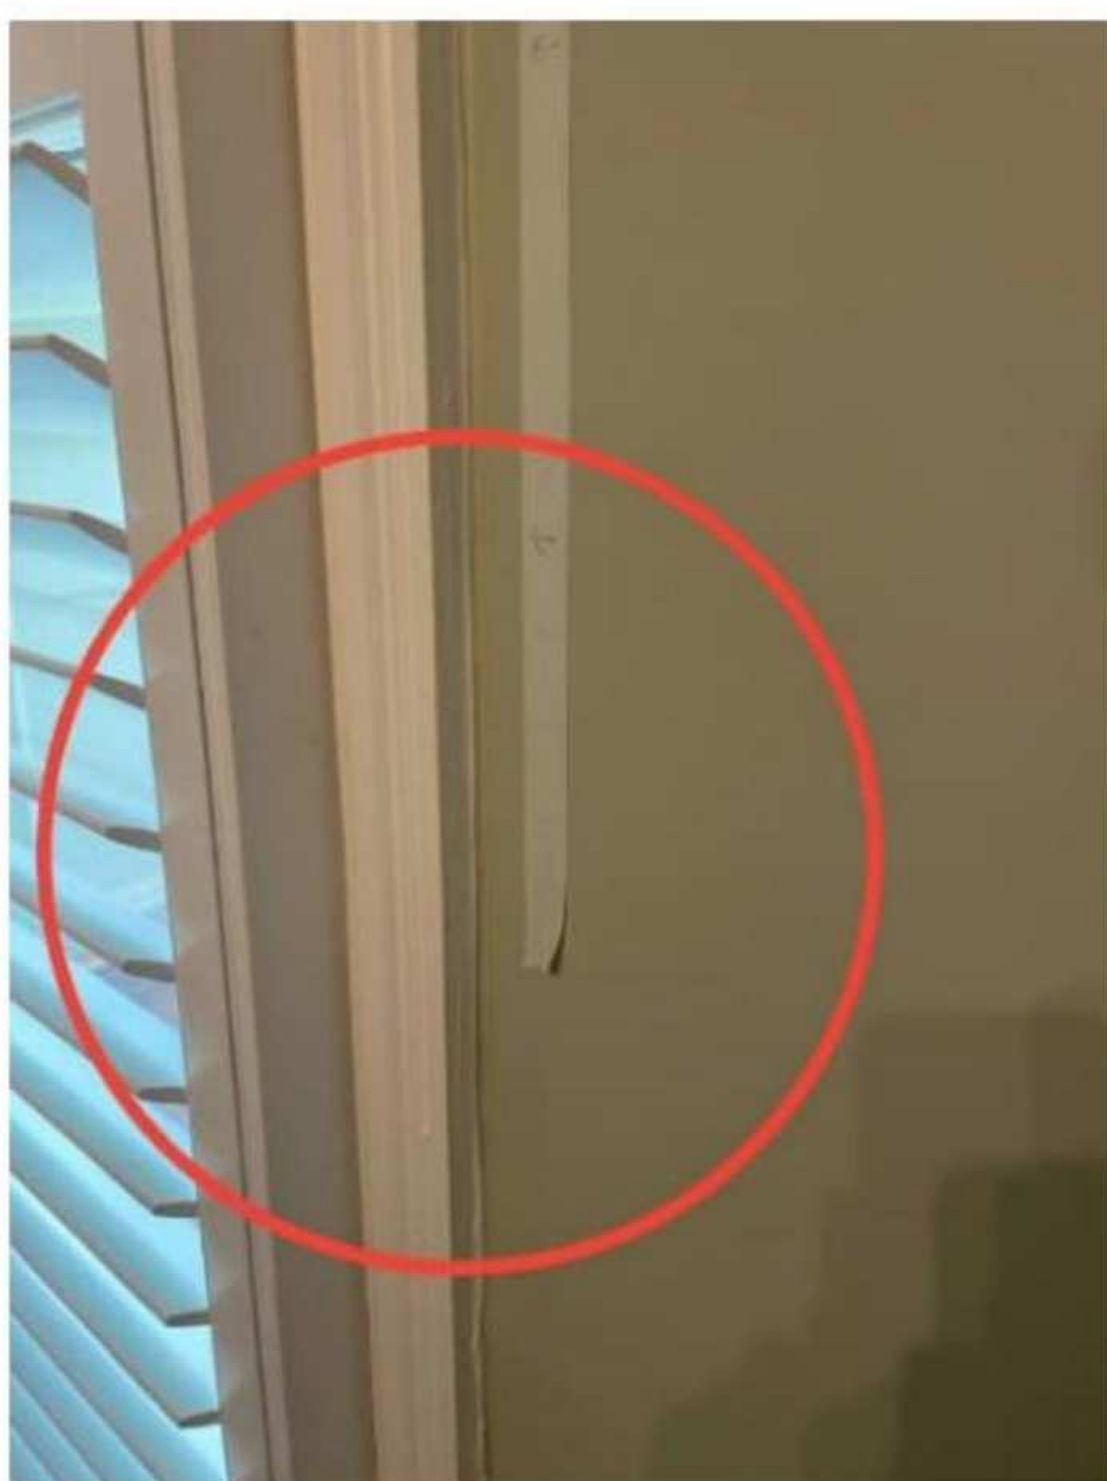
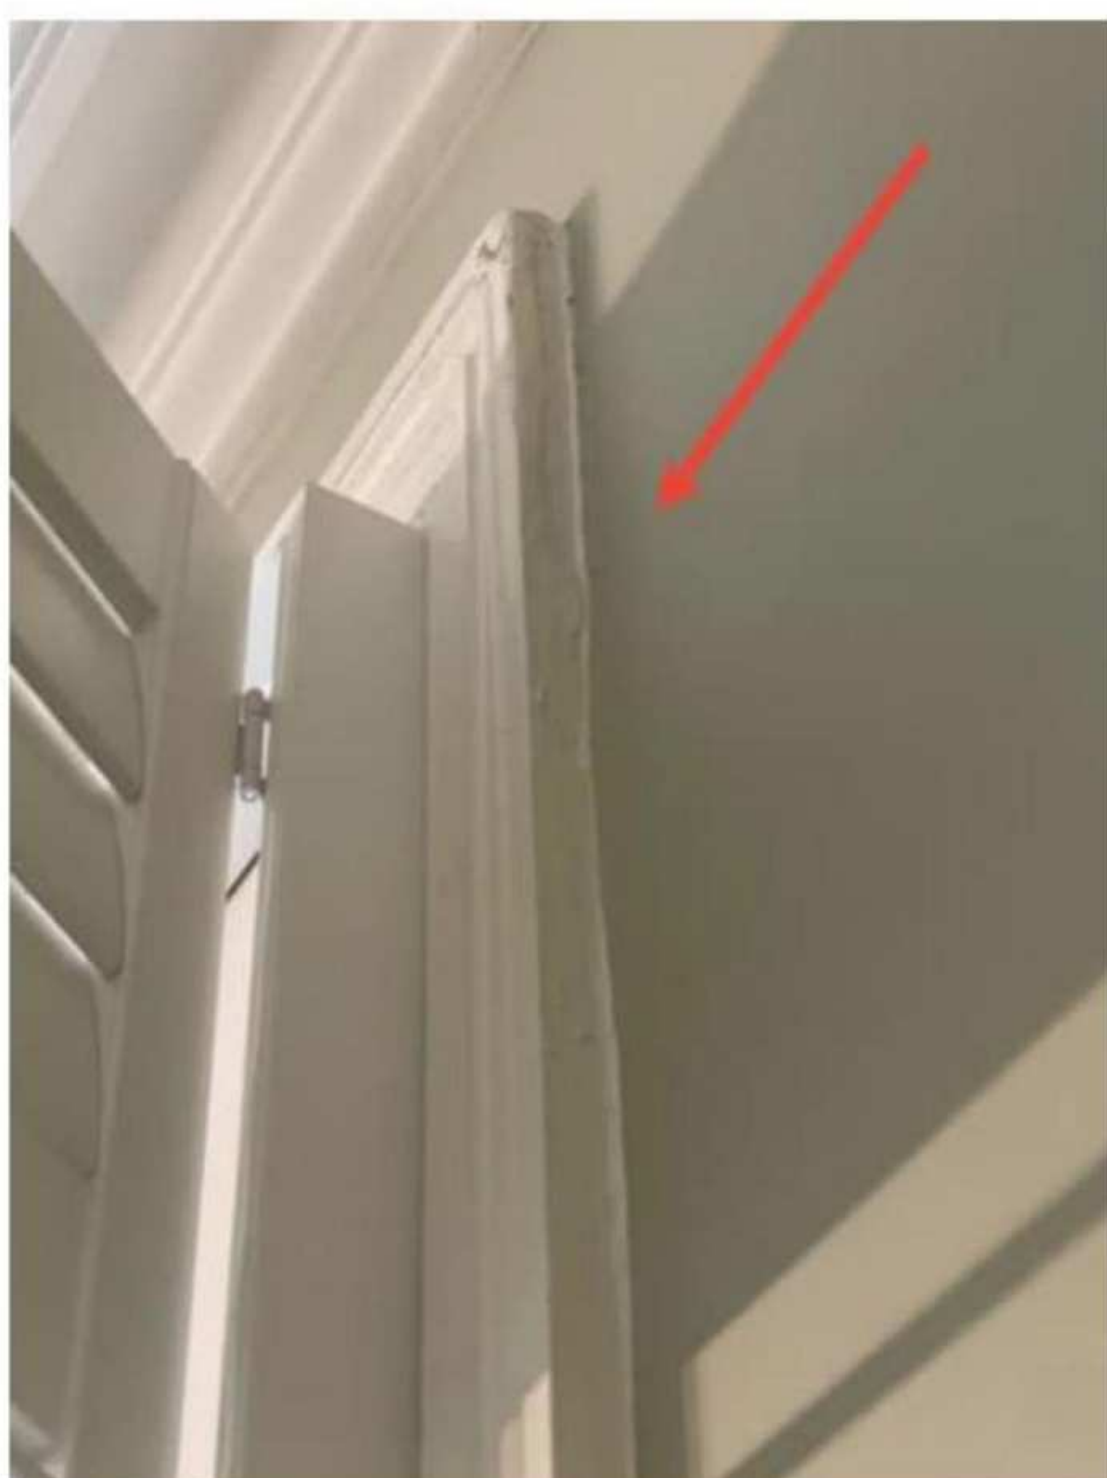
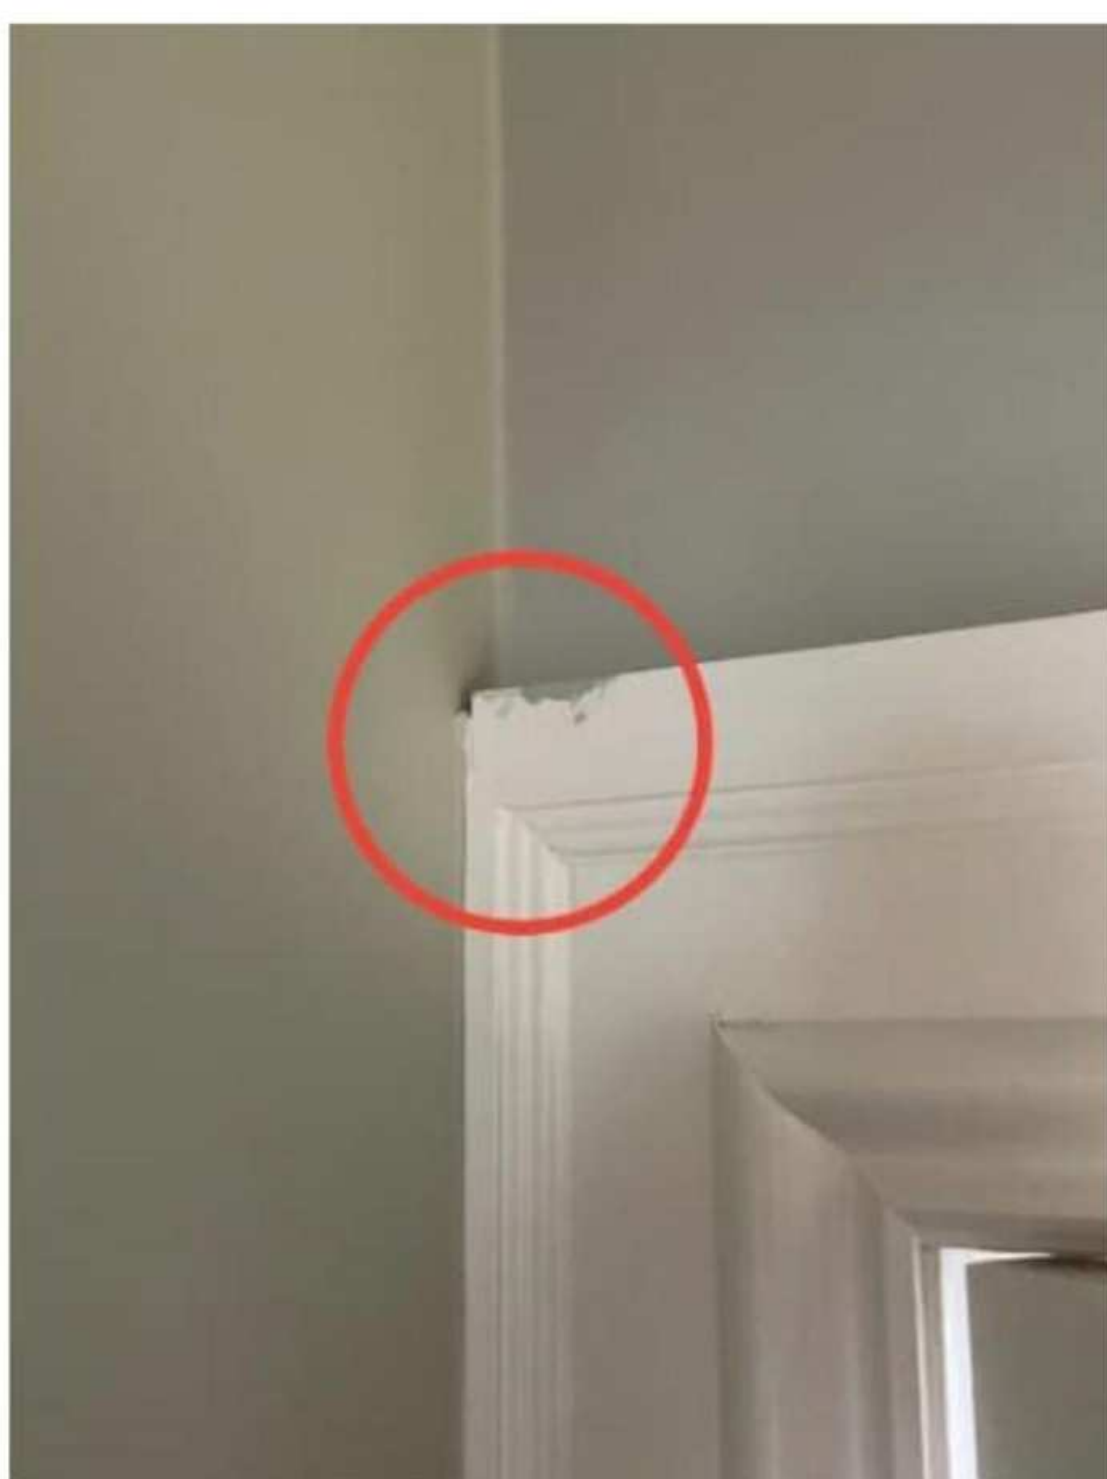
Multiple damage and nail popping, infilled holes found throughout and around the openings architraves.

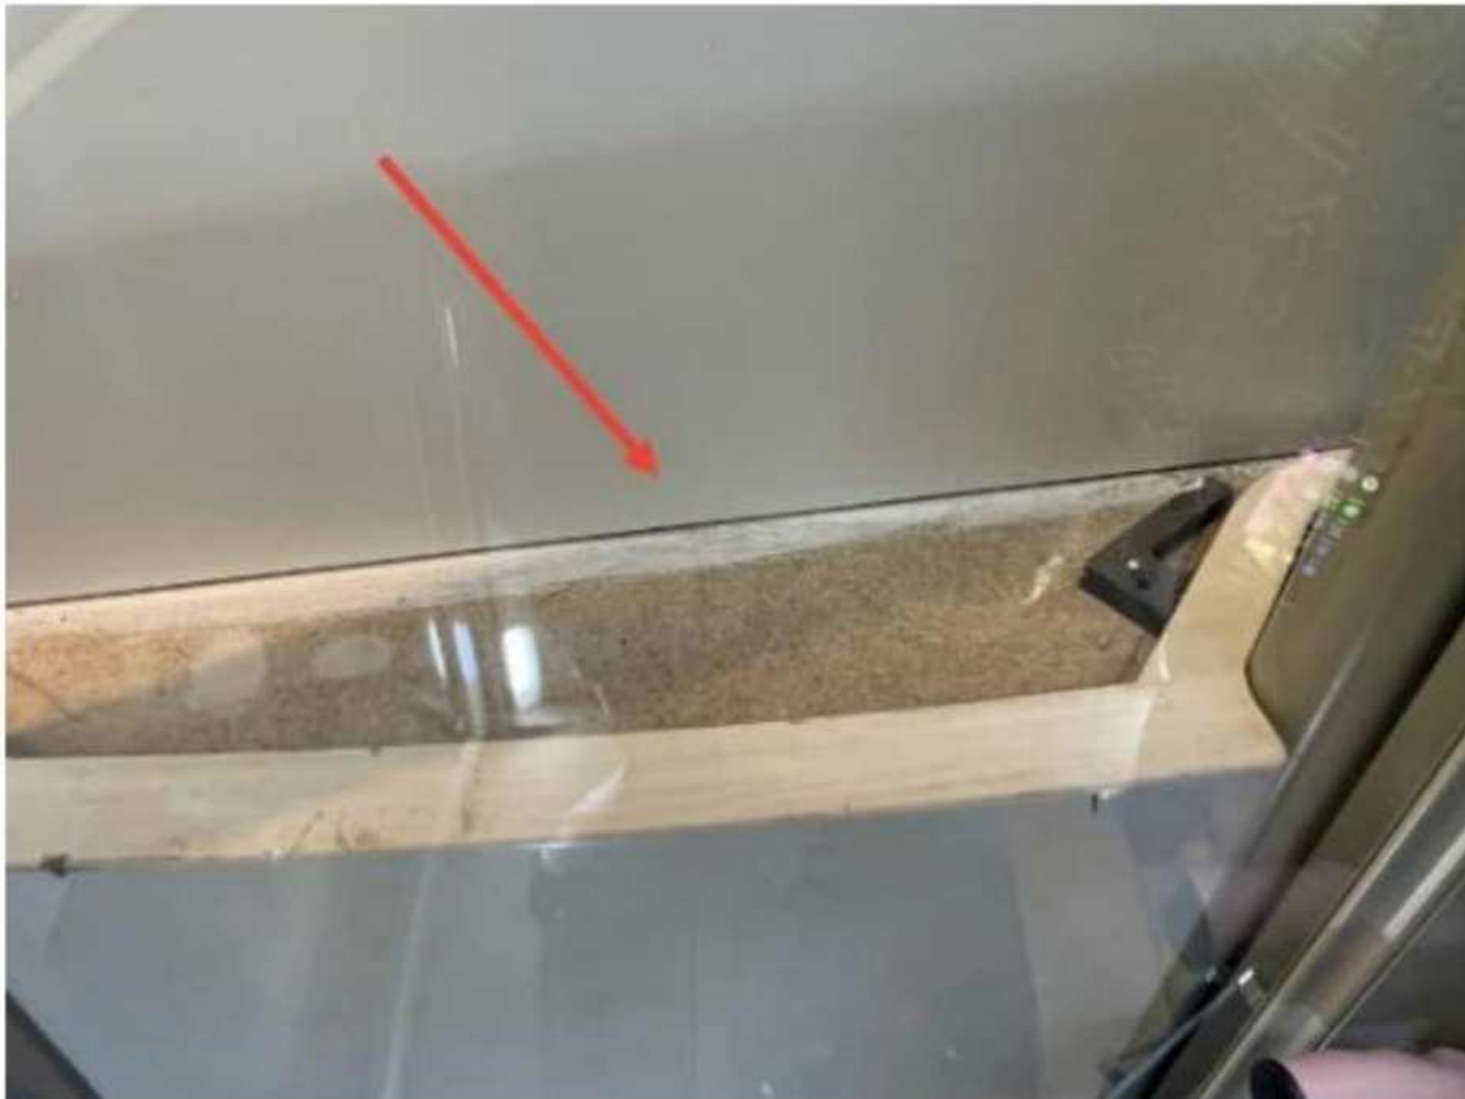
(67)

Damage and paint defects sighted to the lift well space as well as incomplected works.

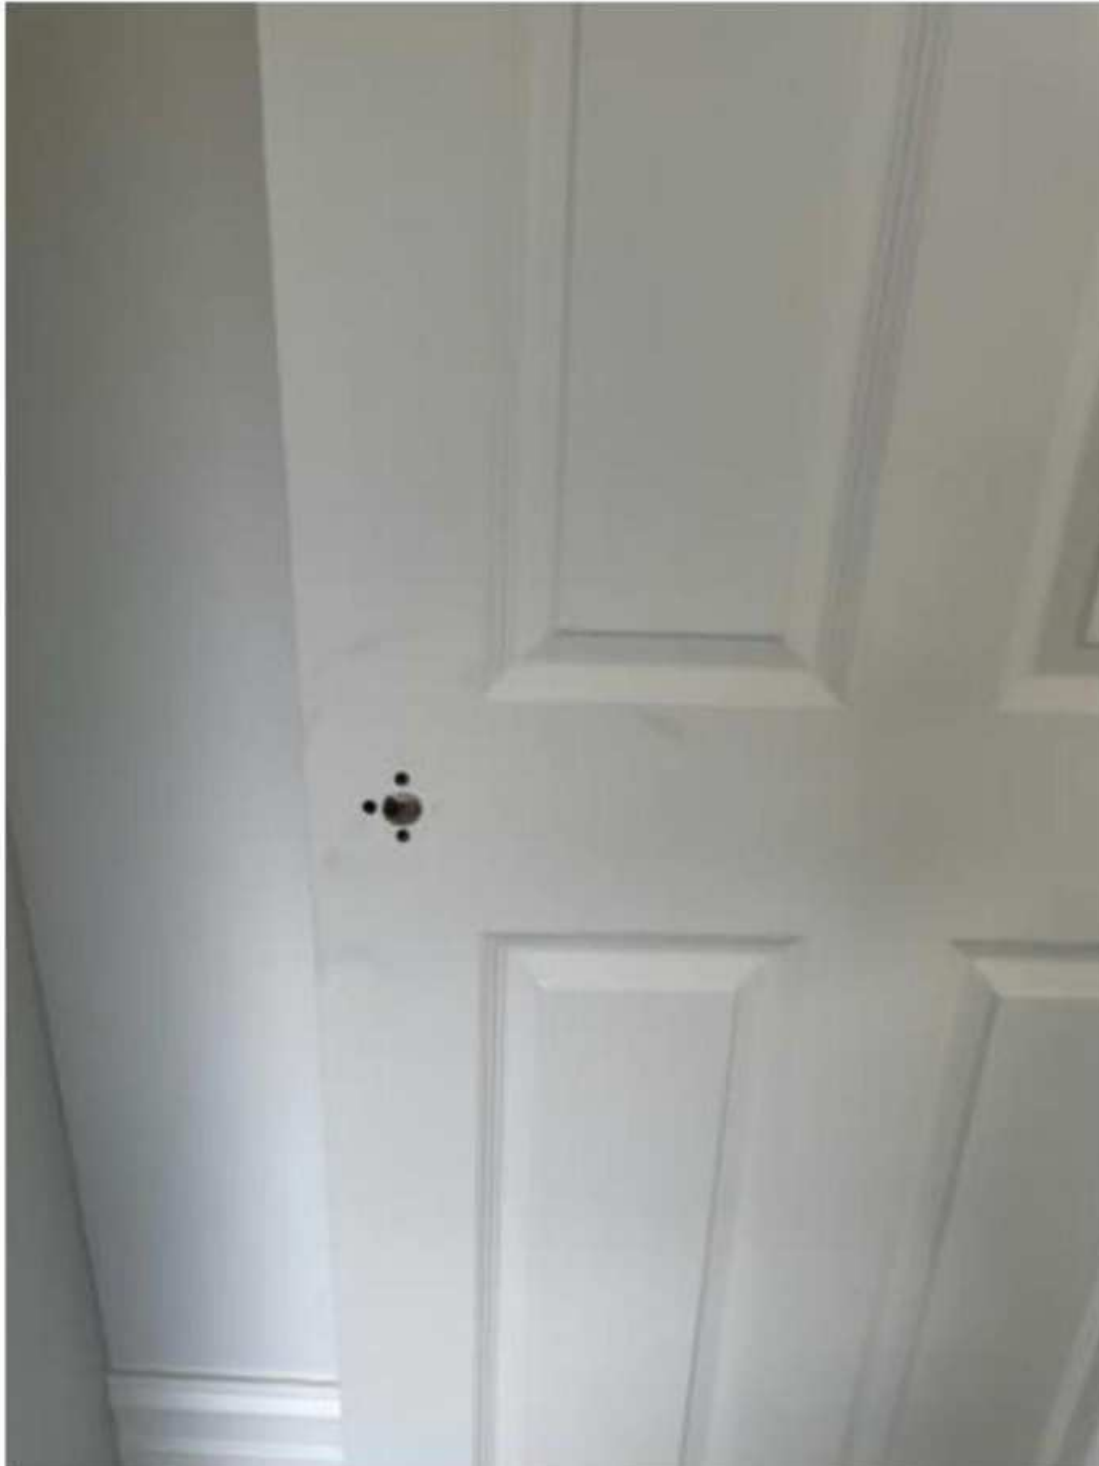
(97)

Strike plates and door handles not installed to the first floor.
