Thank you for the opportunity to inspect the preparation and application of paintwork of your home under construction. We attended the site on Wednesday, 27 November, 2024 and make the following comment on the quality and compliance of the works to date;

# Quality Assurance Inspection

Preparation and application of paintwork and workmanship only.

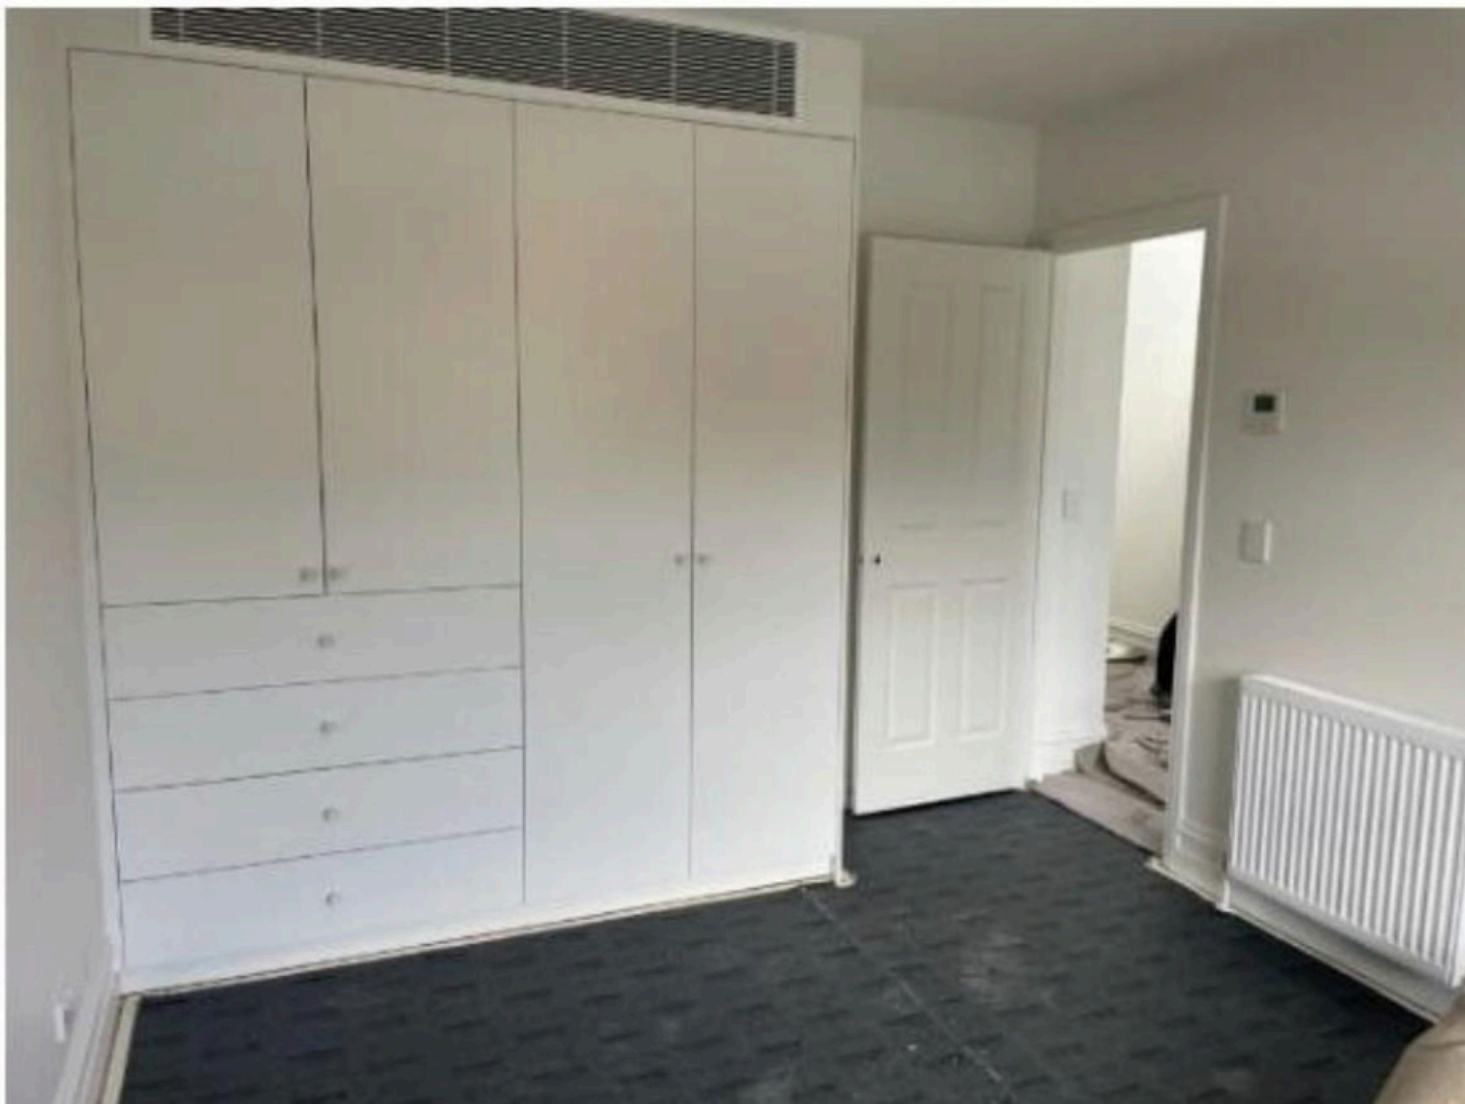
(2)

**Bedroom 3**

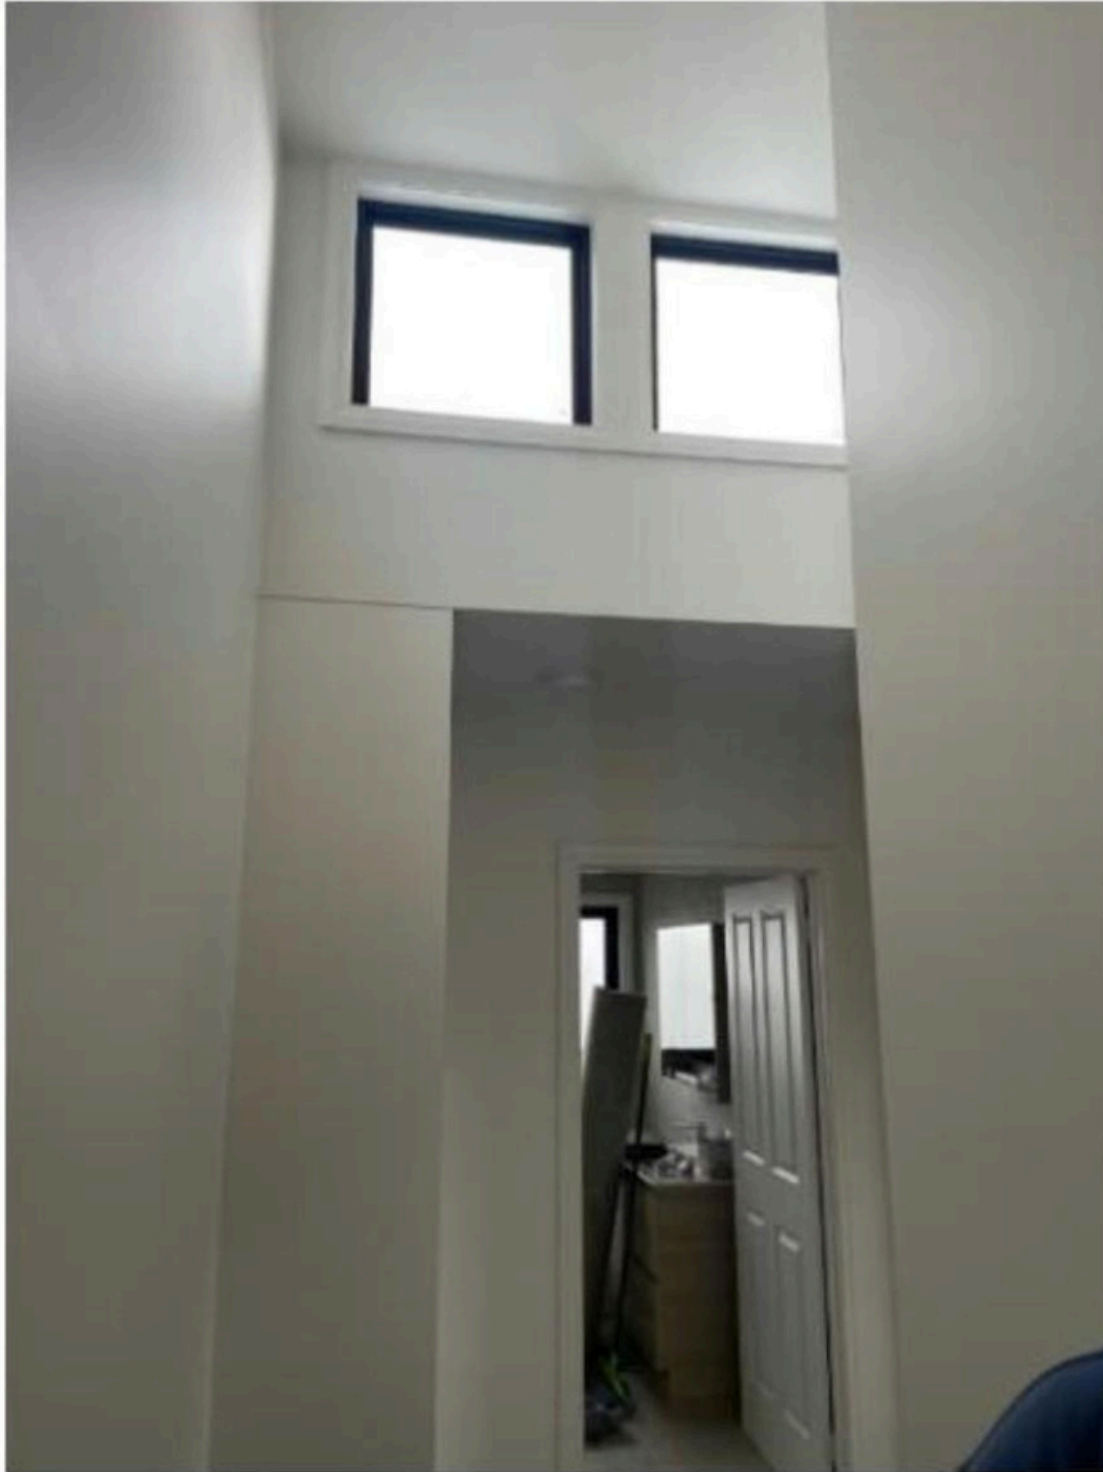
(9)

**First Floor Corridor**

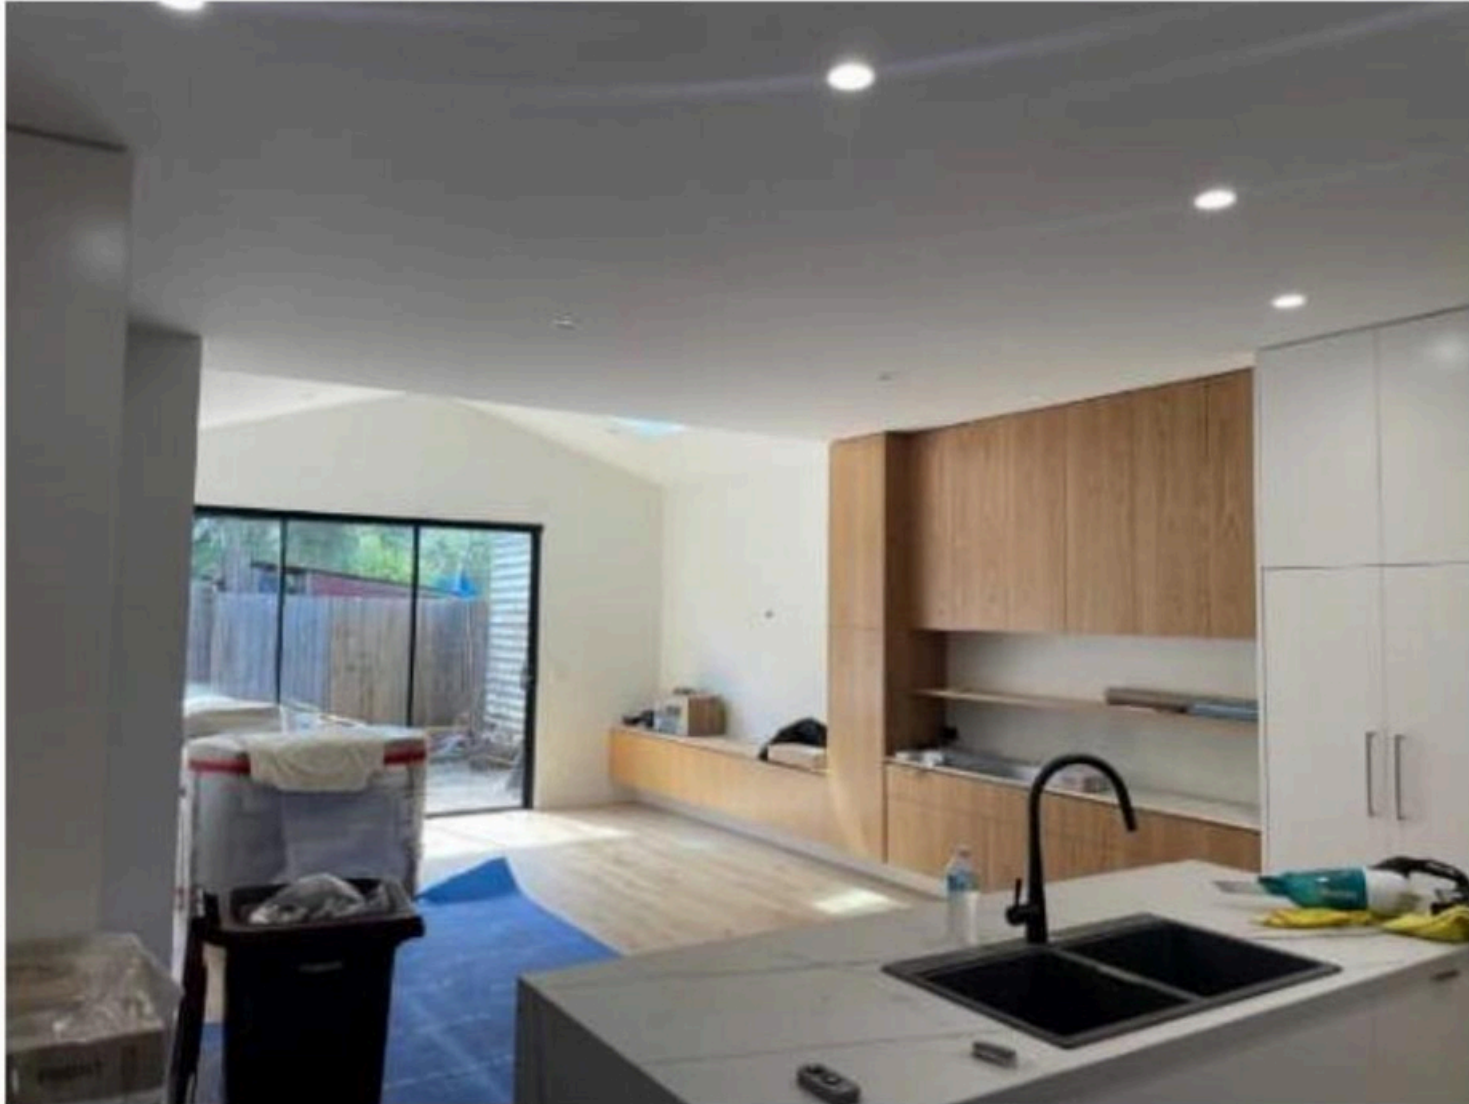
(12)

**Kitchen + Living**

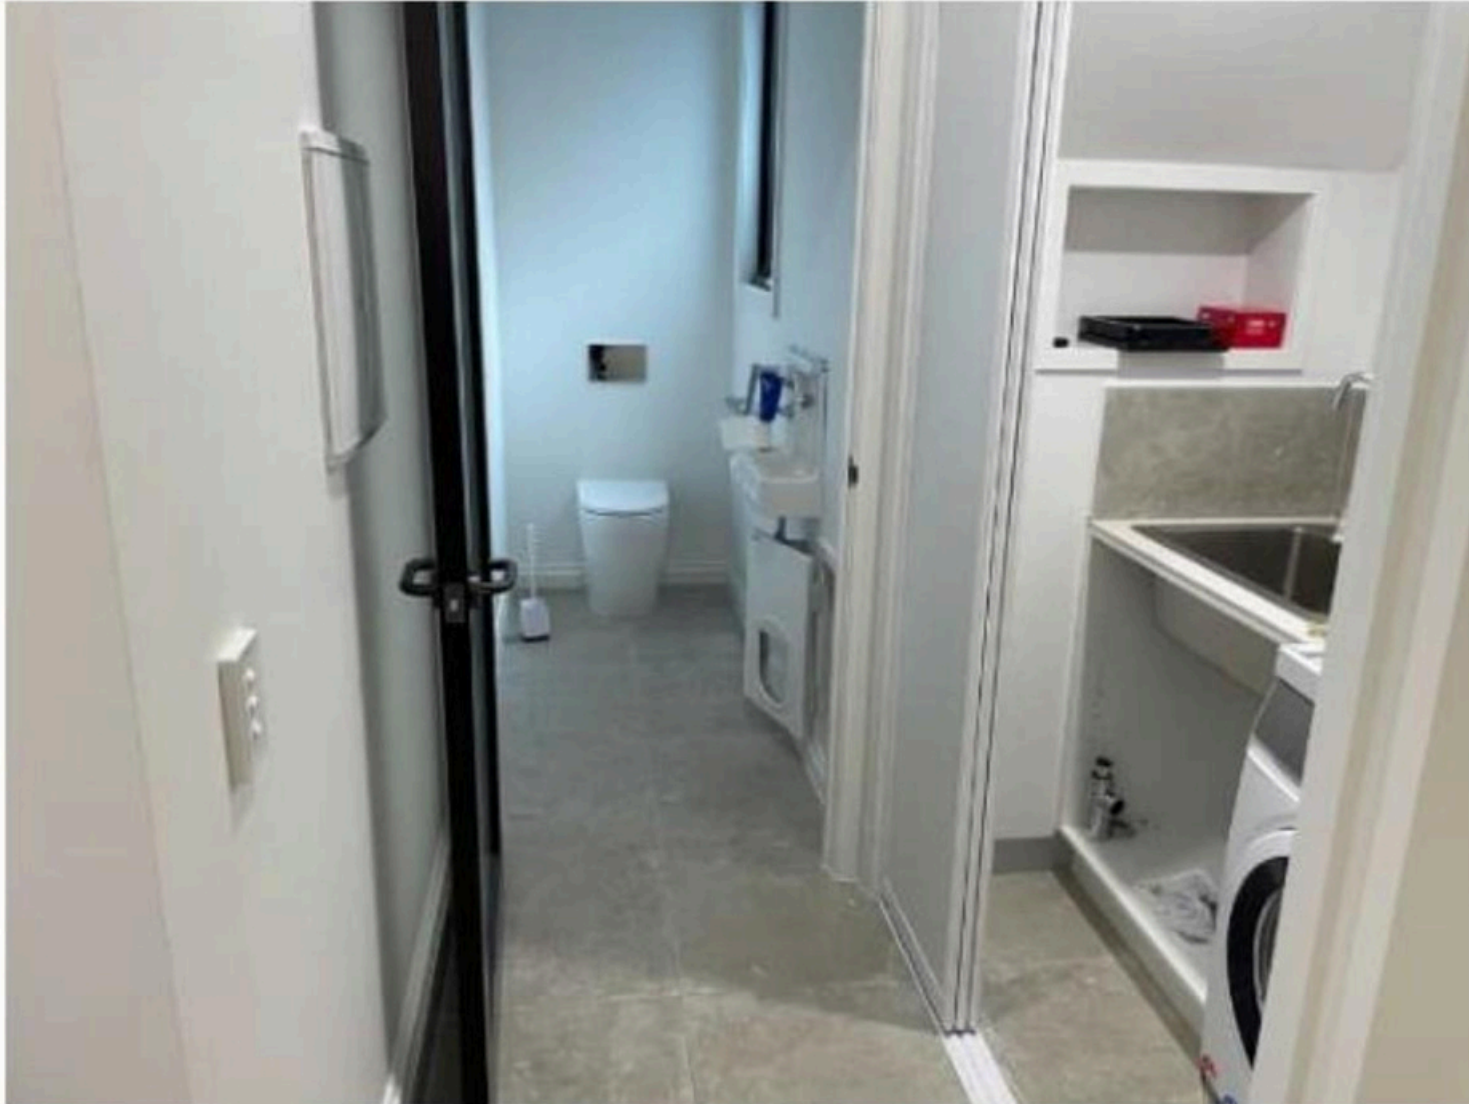
(13)

**Laundry + Powder Room**

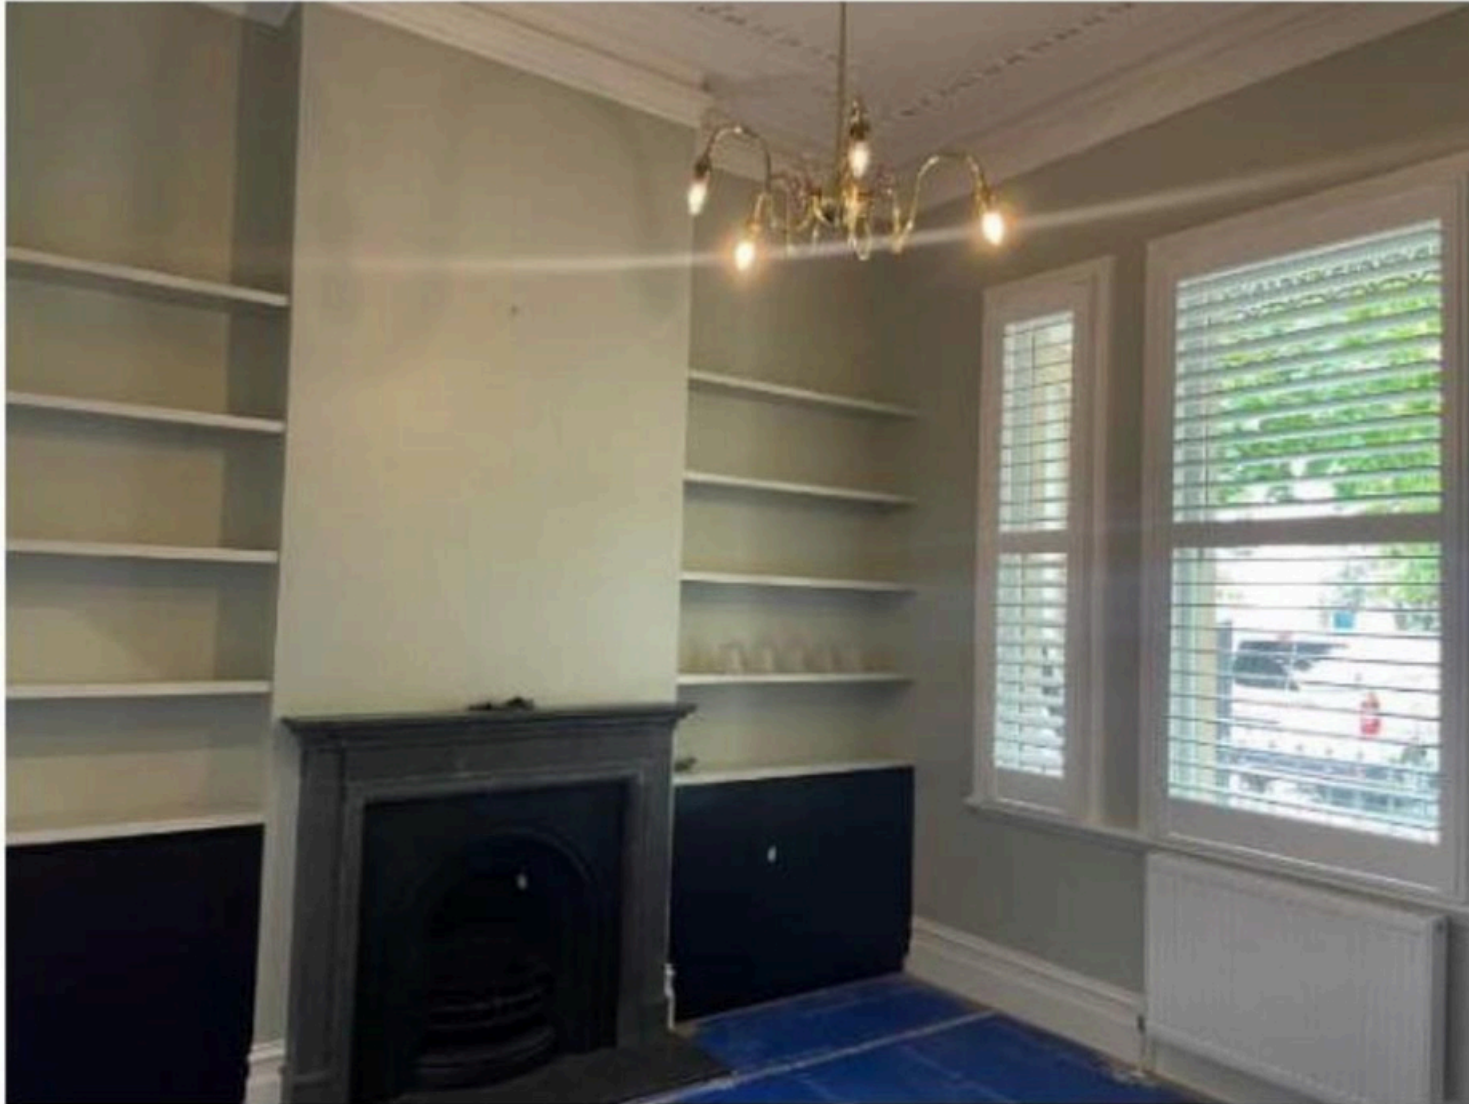
(15)

Multipurpose Room

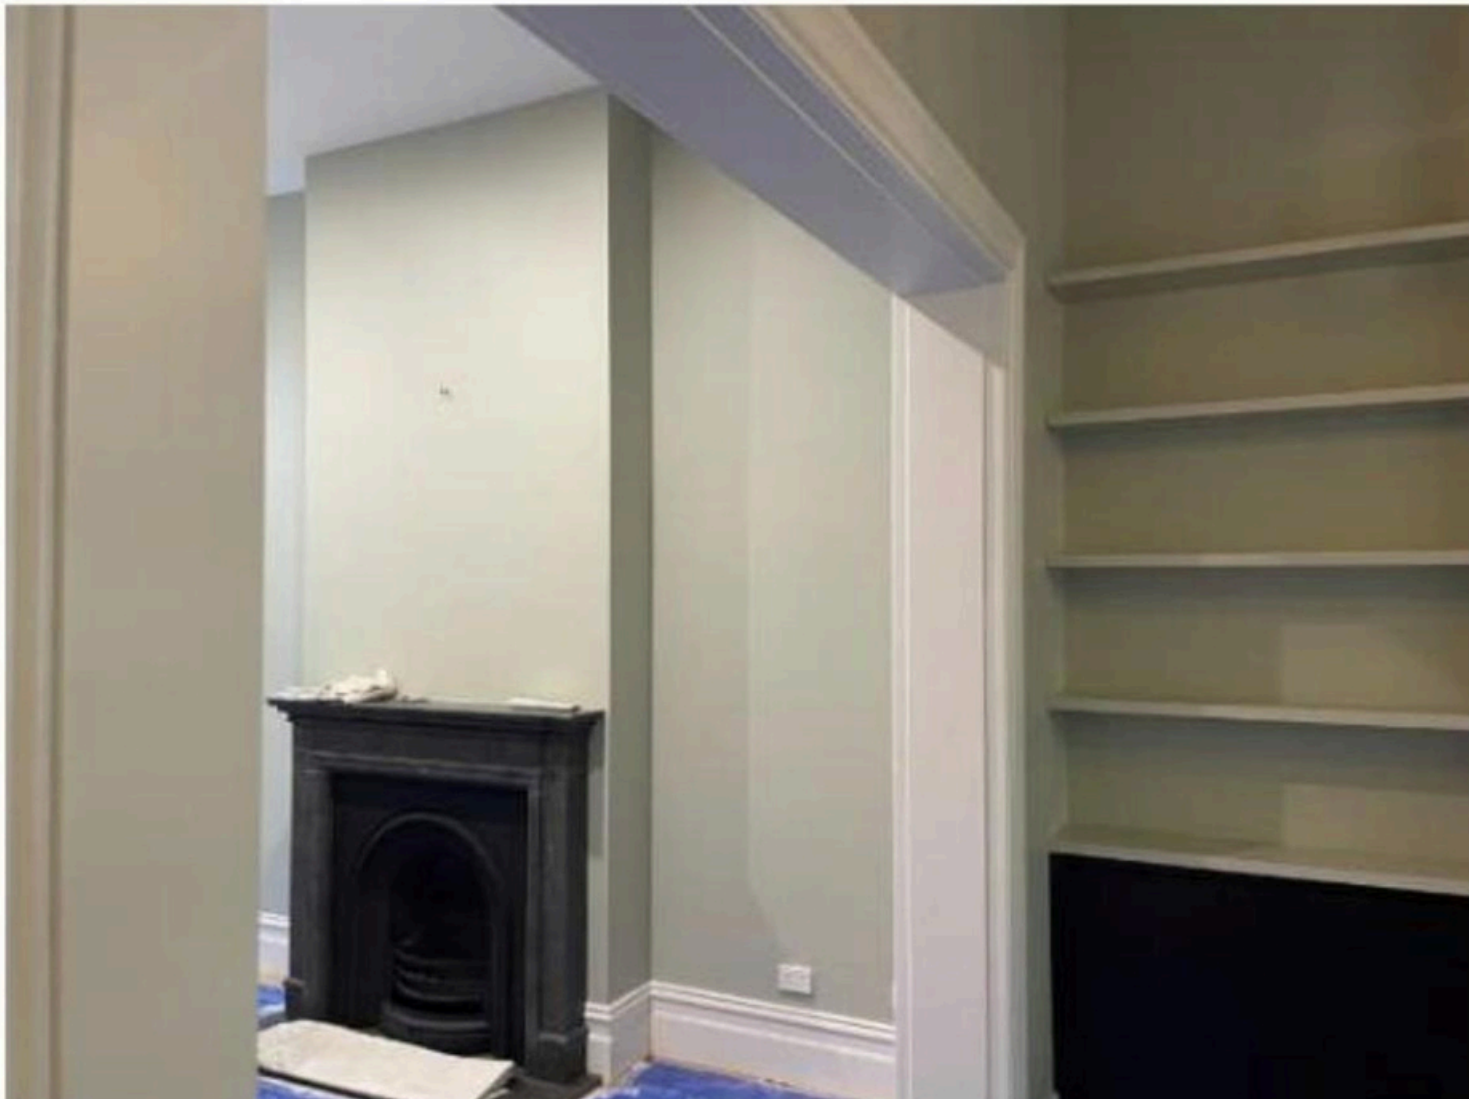
(16)

Study

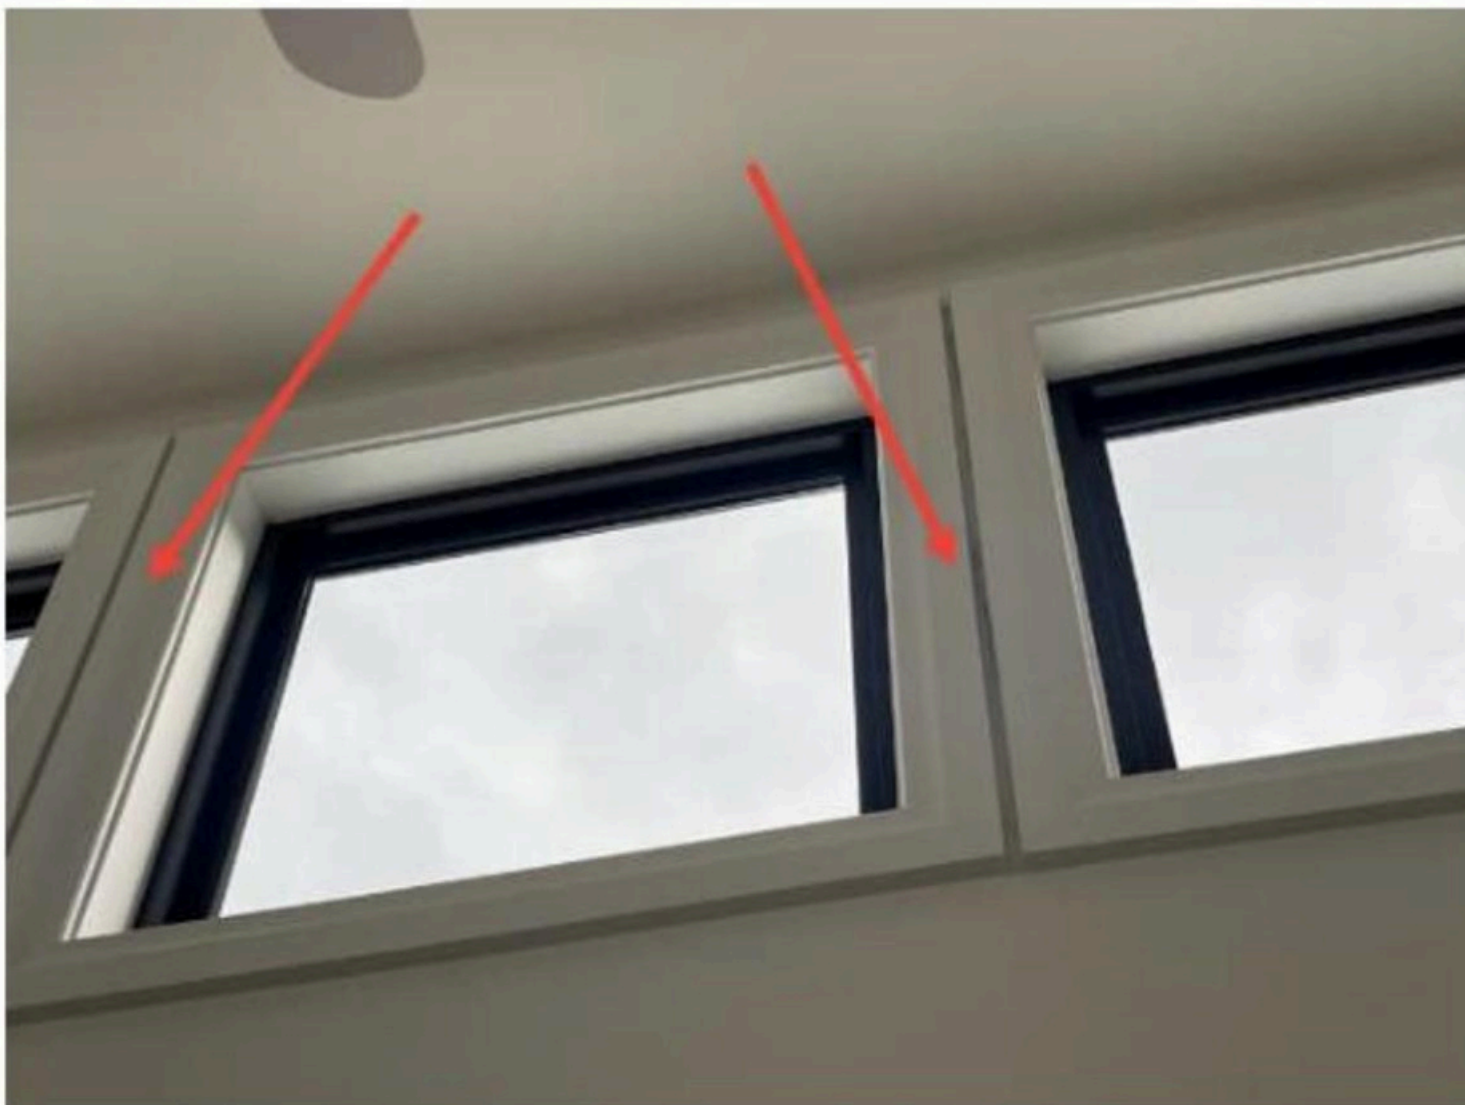
(36)

Gaps not completed or sealed properly around openings.

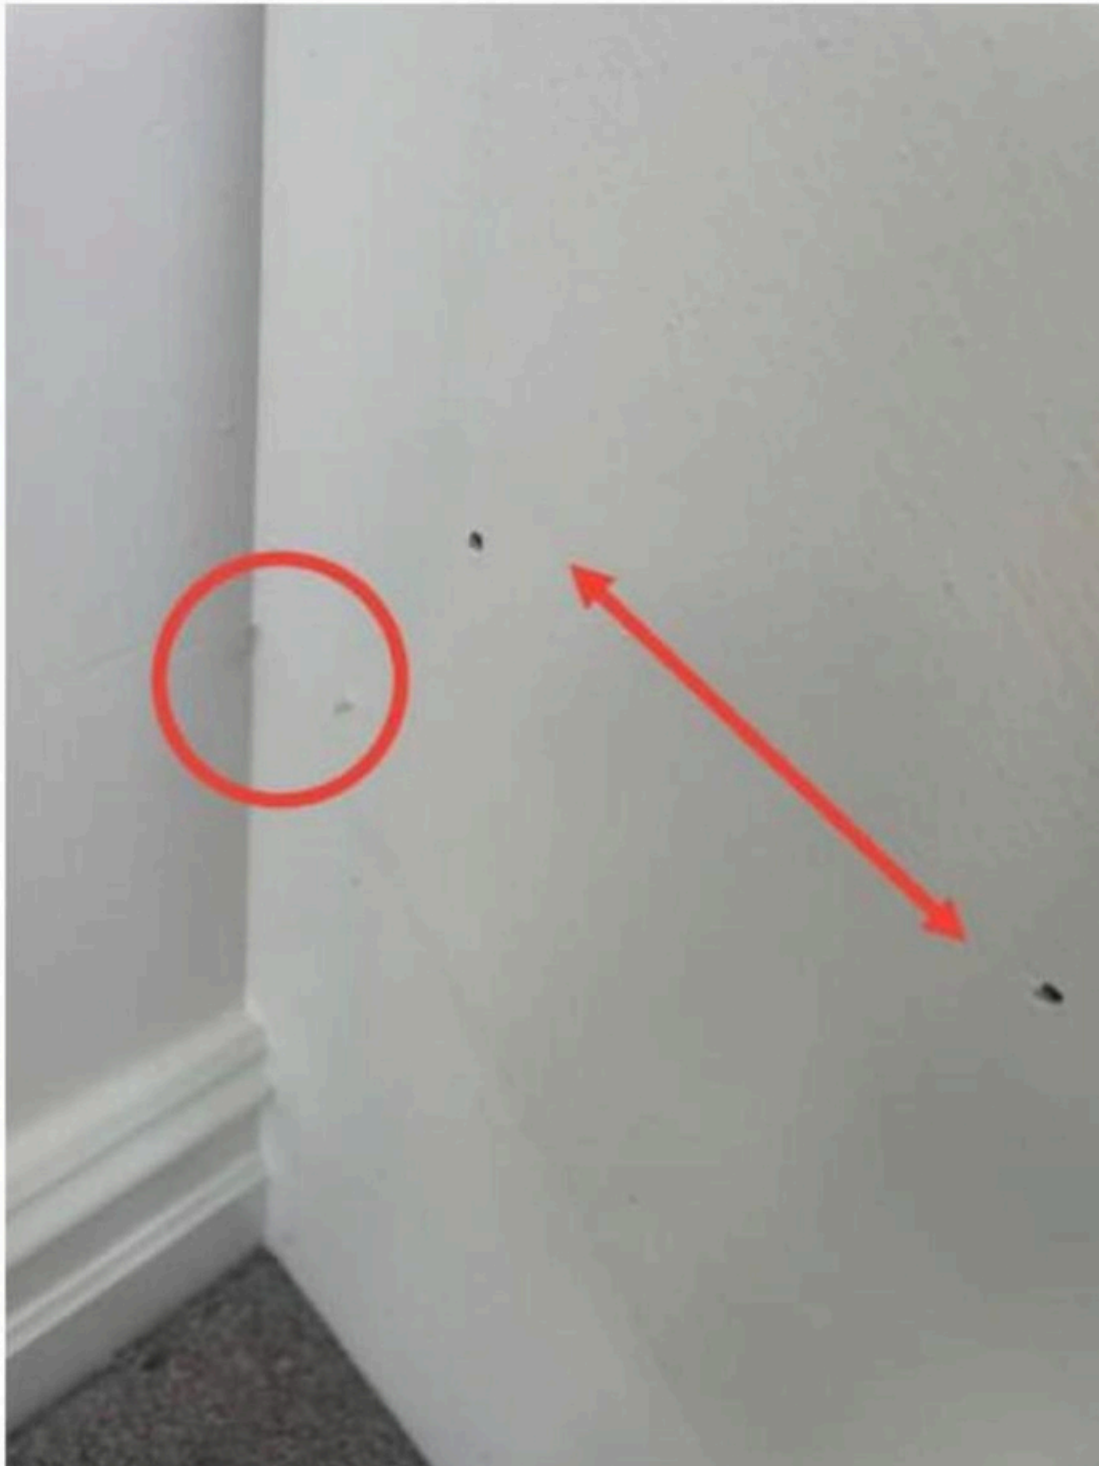
(49)

Nail holes not filled adequately and nail popping evident around corridor staircase.

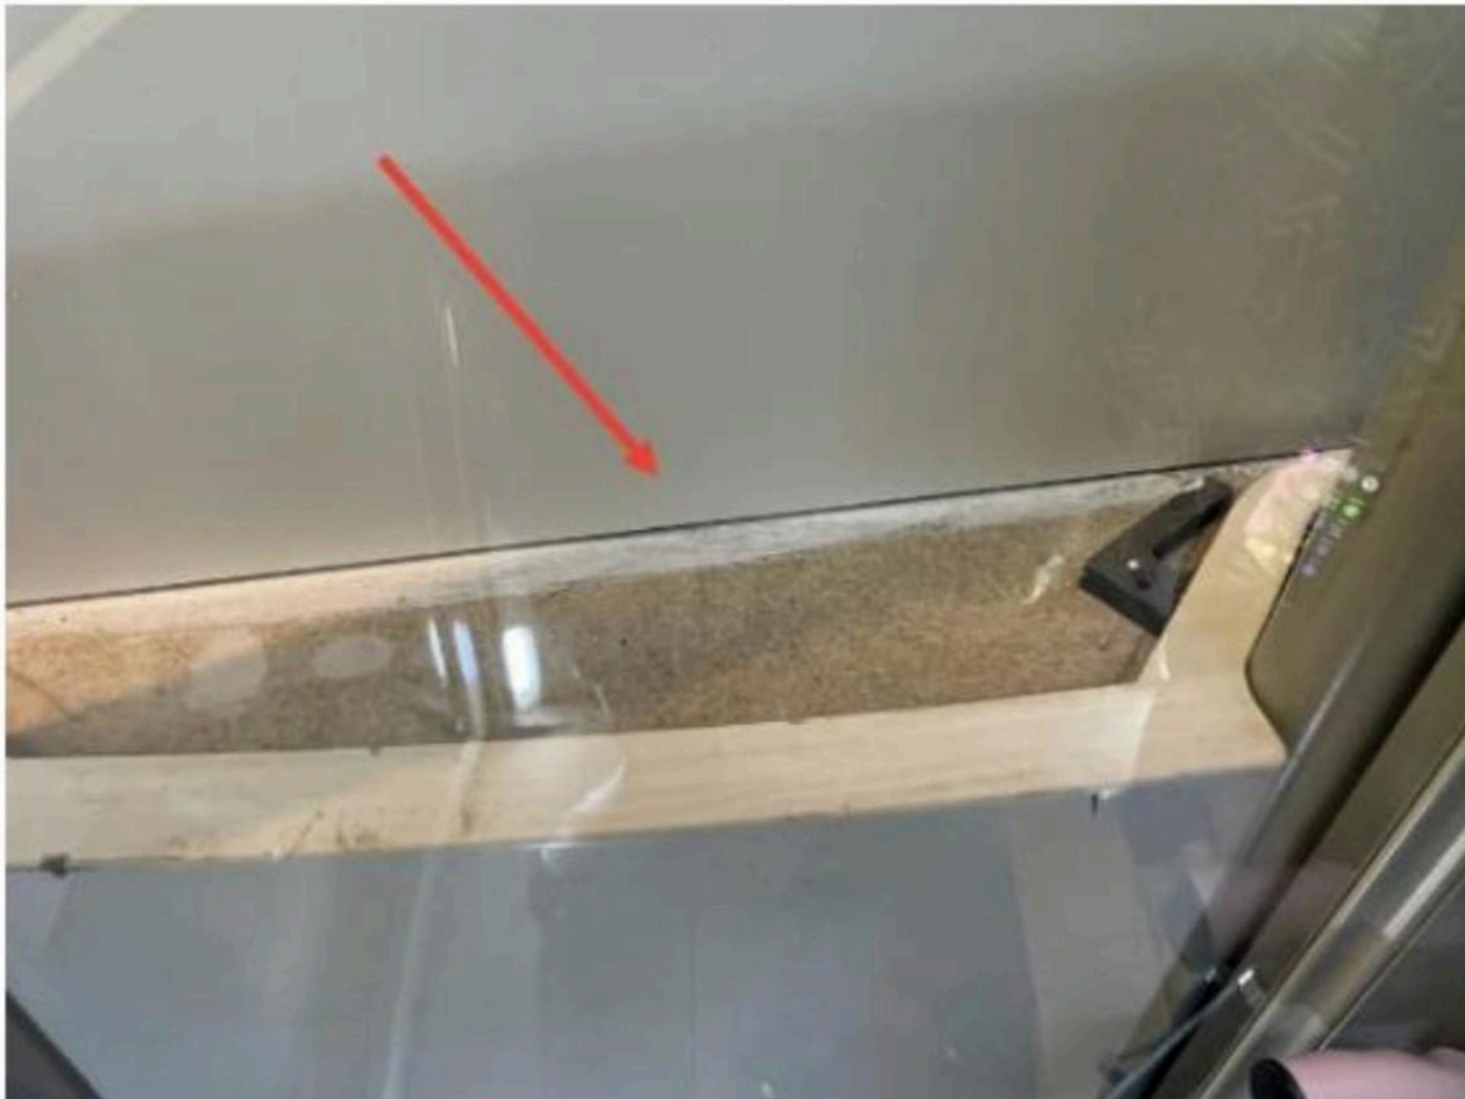
(67)

Damage and paint defects sighted to the lift well space as well as incomplected works.
