Thank you for the opportunity to carry out a dilapidation inspection at the above property in order to document existing cracking prior to the commencement of construction works at your property.

The two-storey property is of single skin brick and timber frame construction with brick veneer exterior walls, internal brick walls and timber ceilings, timber windows and a pitched roof clad with concrete tiles.

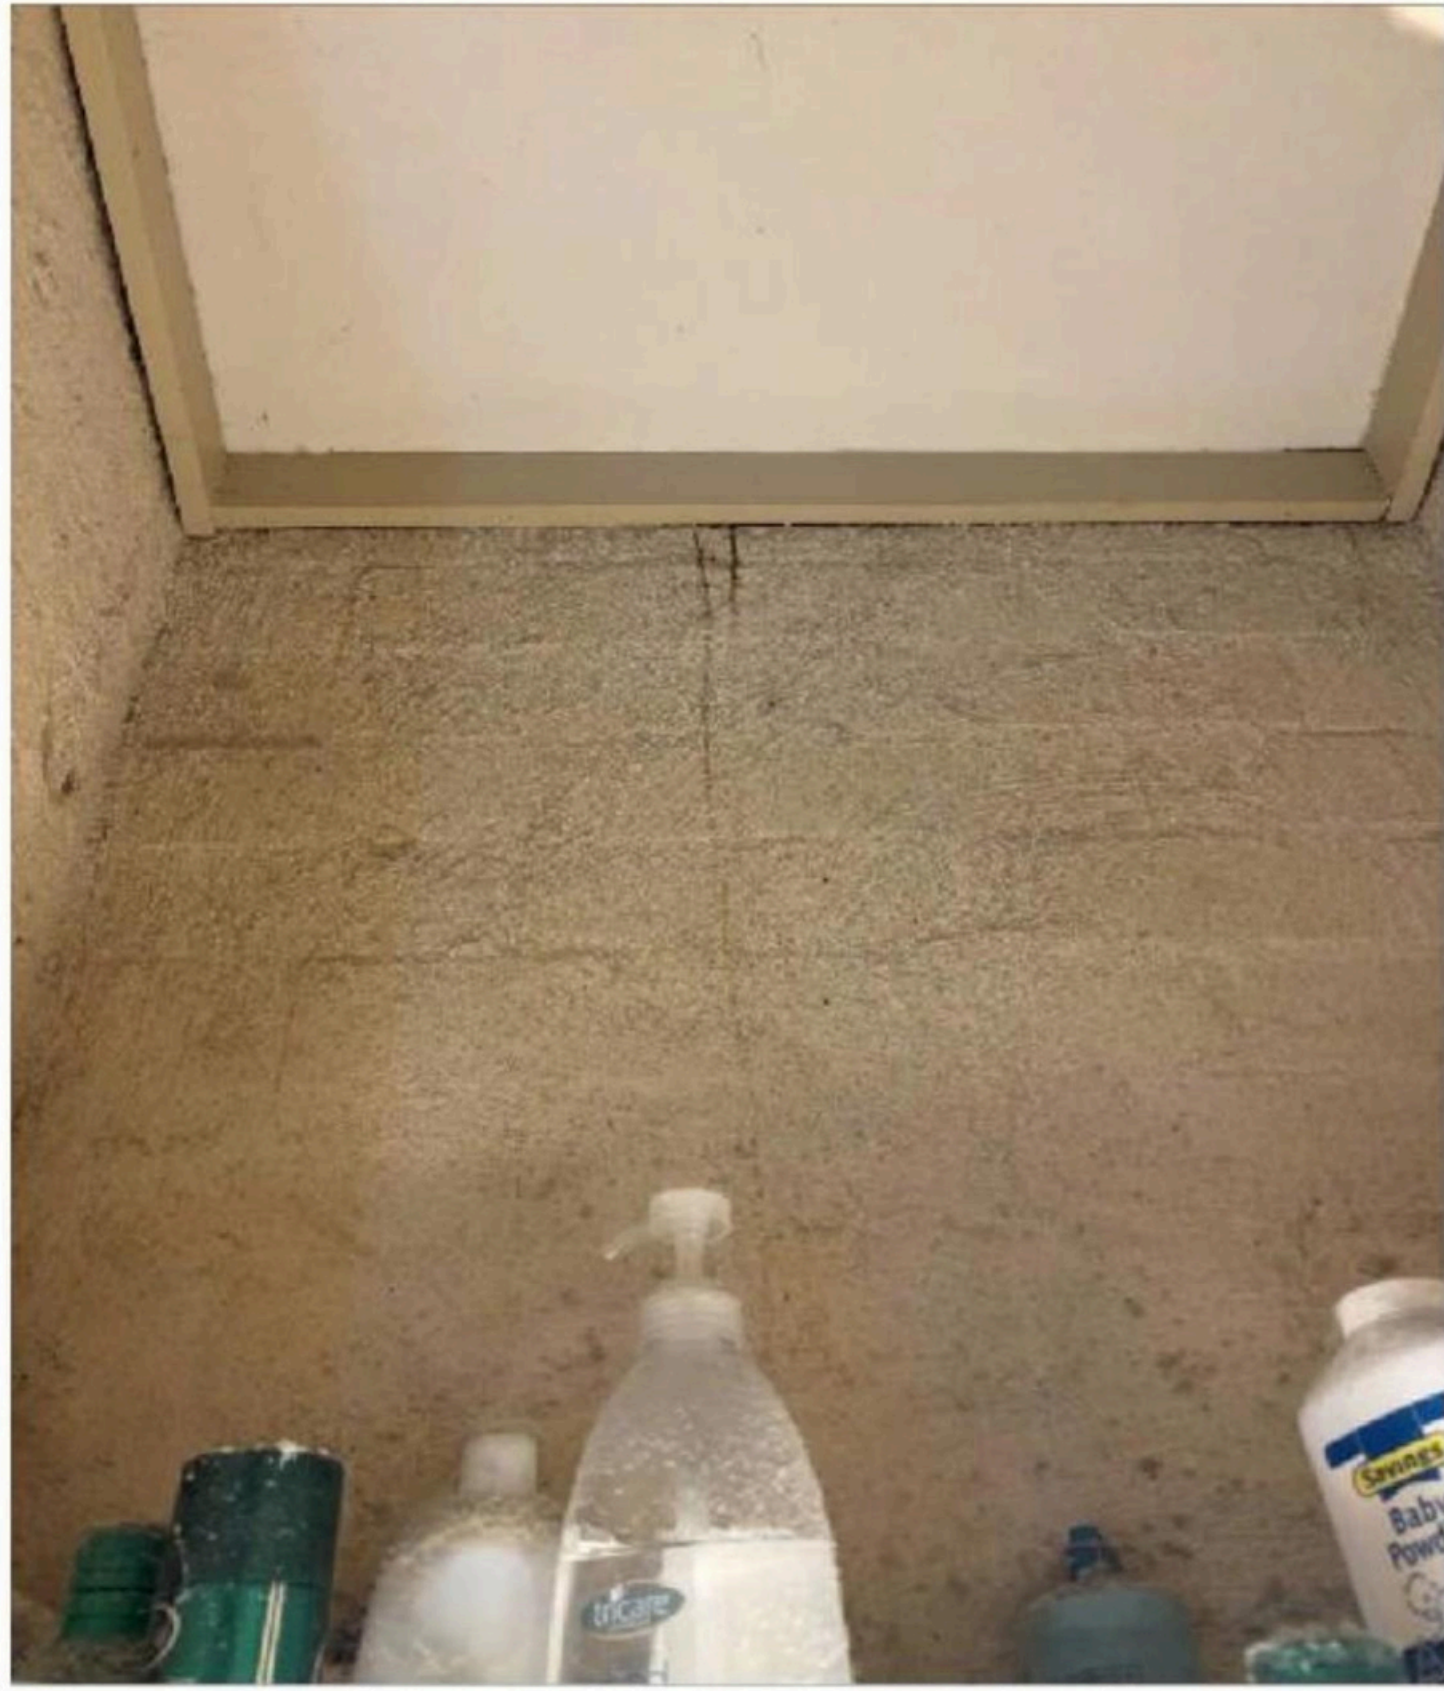
| Shower | Evidence of water ingress on western wall.<br>Fine cracking evident on eastern wall. |

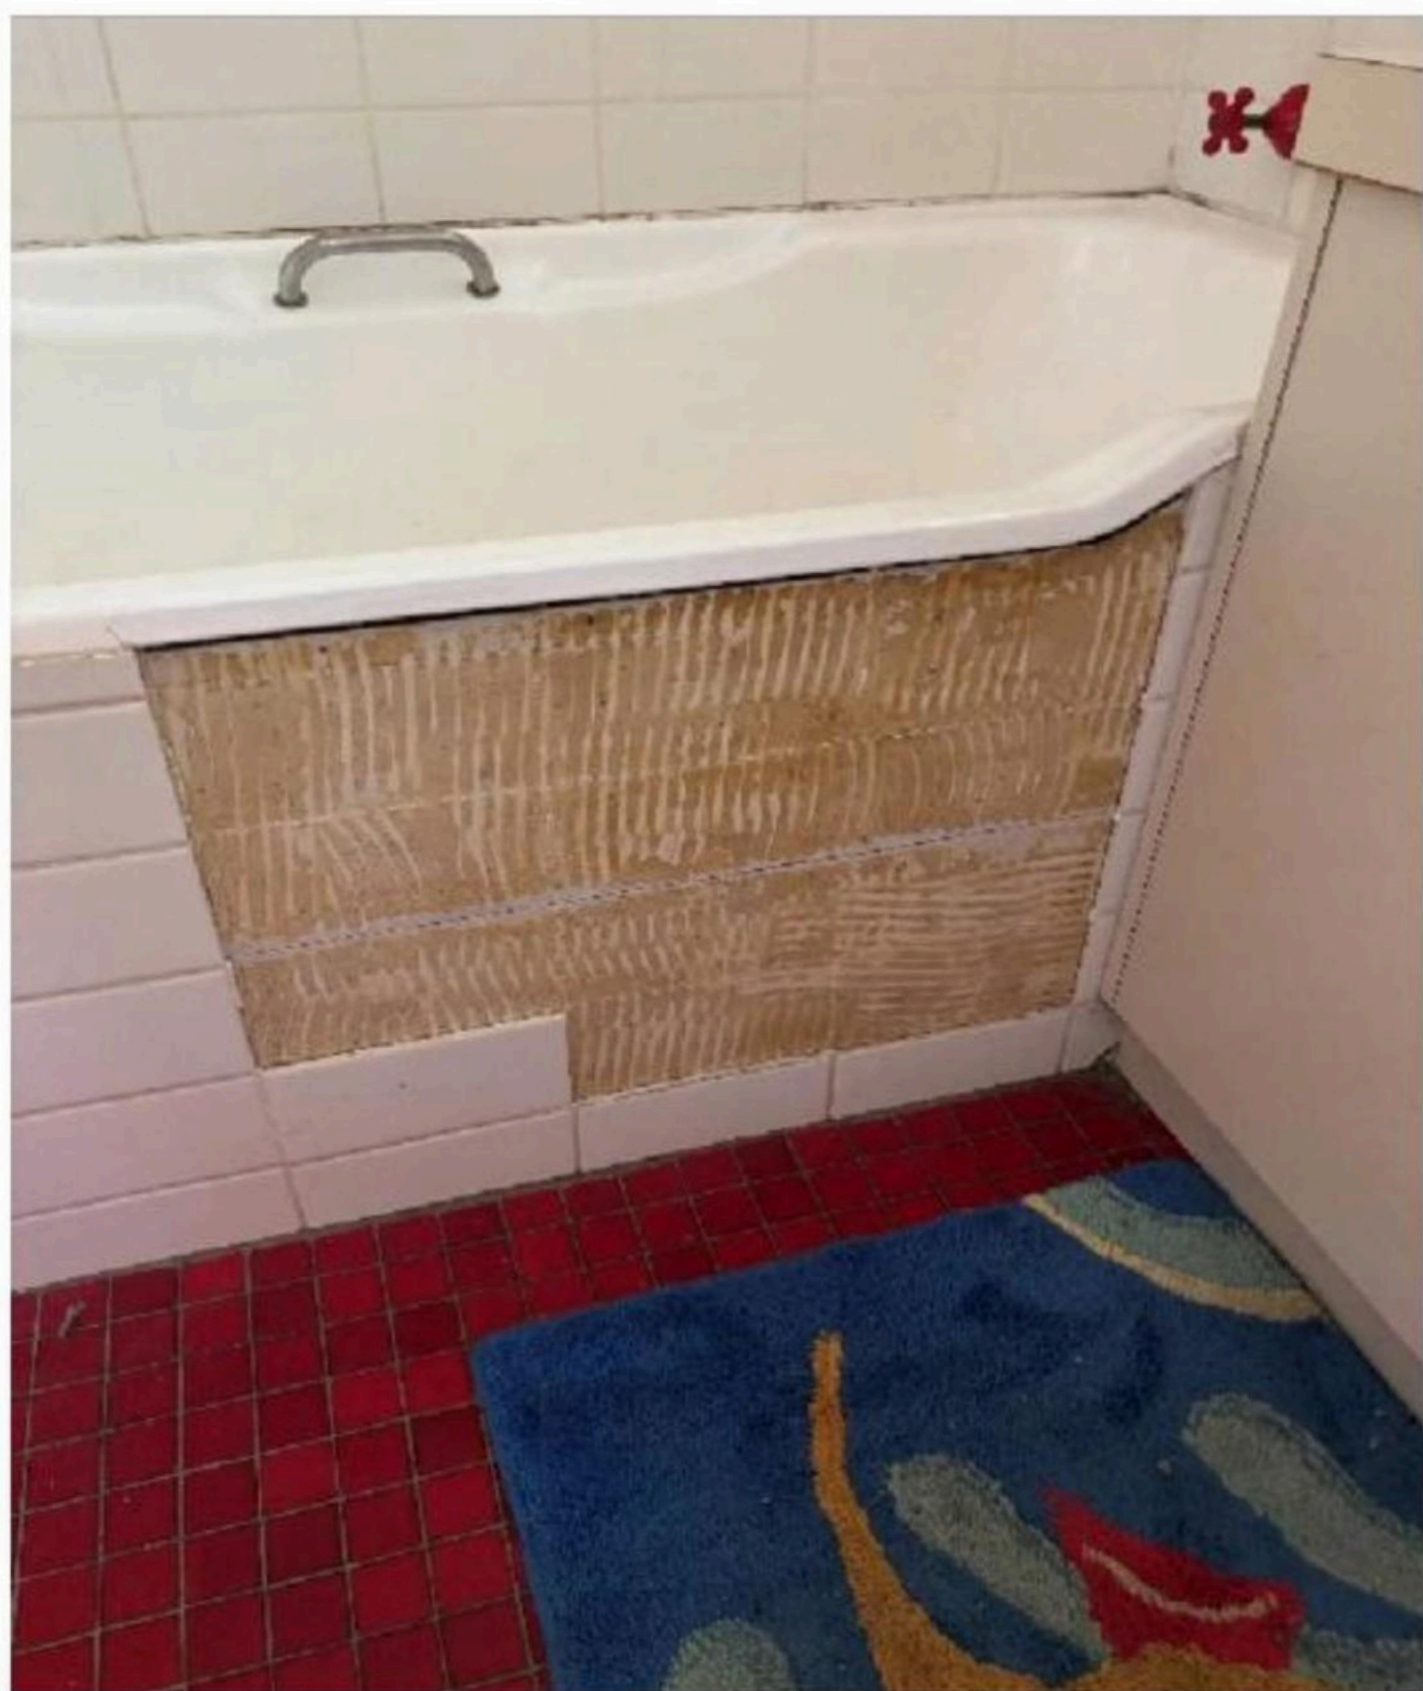
| Bathroom | Tiles have fallen off from bathtub.<br>Evidence of water damage on ceiling around exhaust fan.<br>Evidence of cracked tiles on walls (all sides).<br>Evidence of cracked tiles on walls in the shower.<br>Evidence of fine cracking on ceiling cornices.<br>Evidence of cracked walls (repairs conducted). |

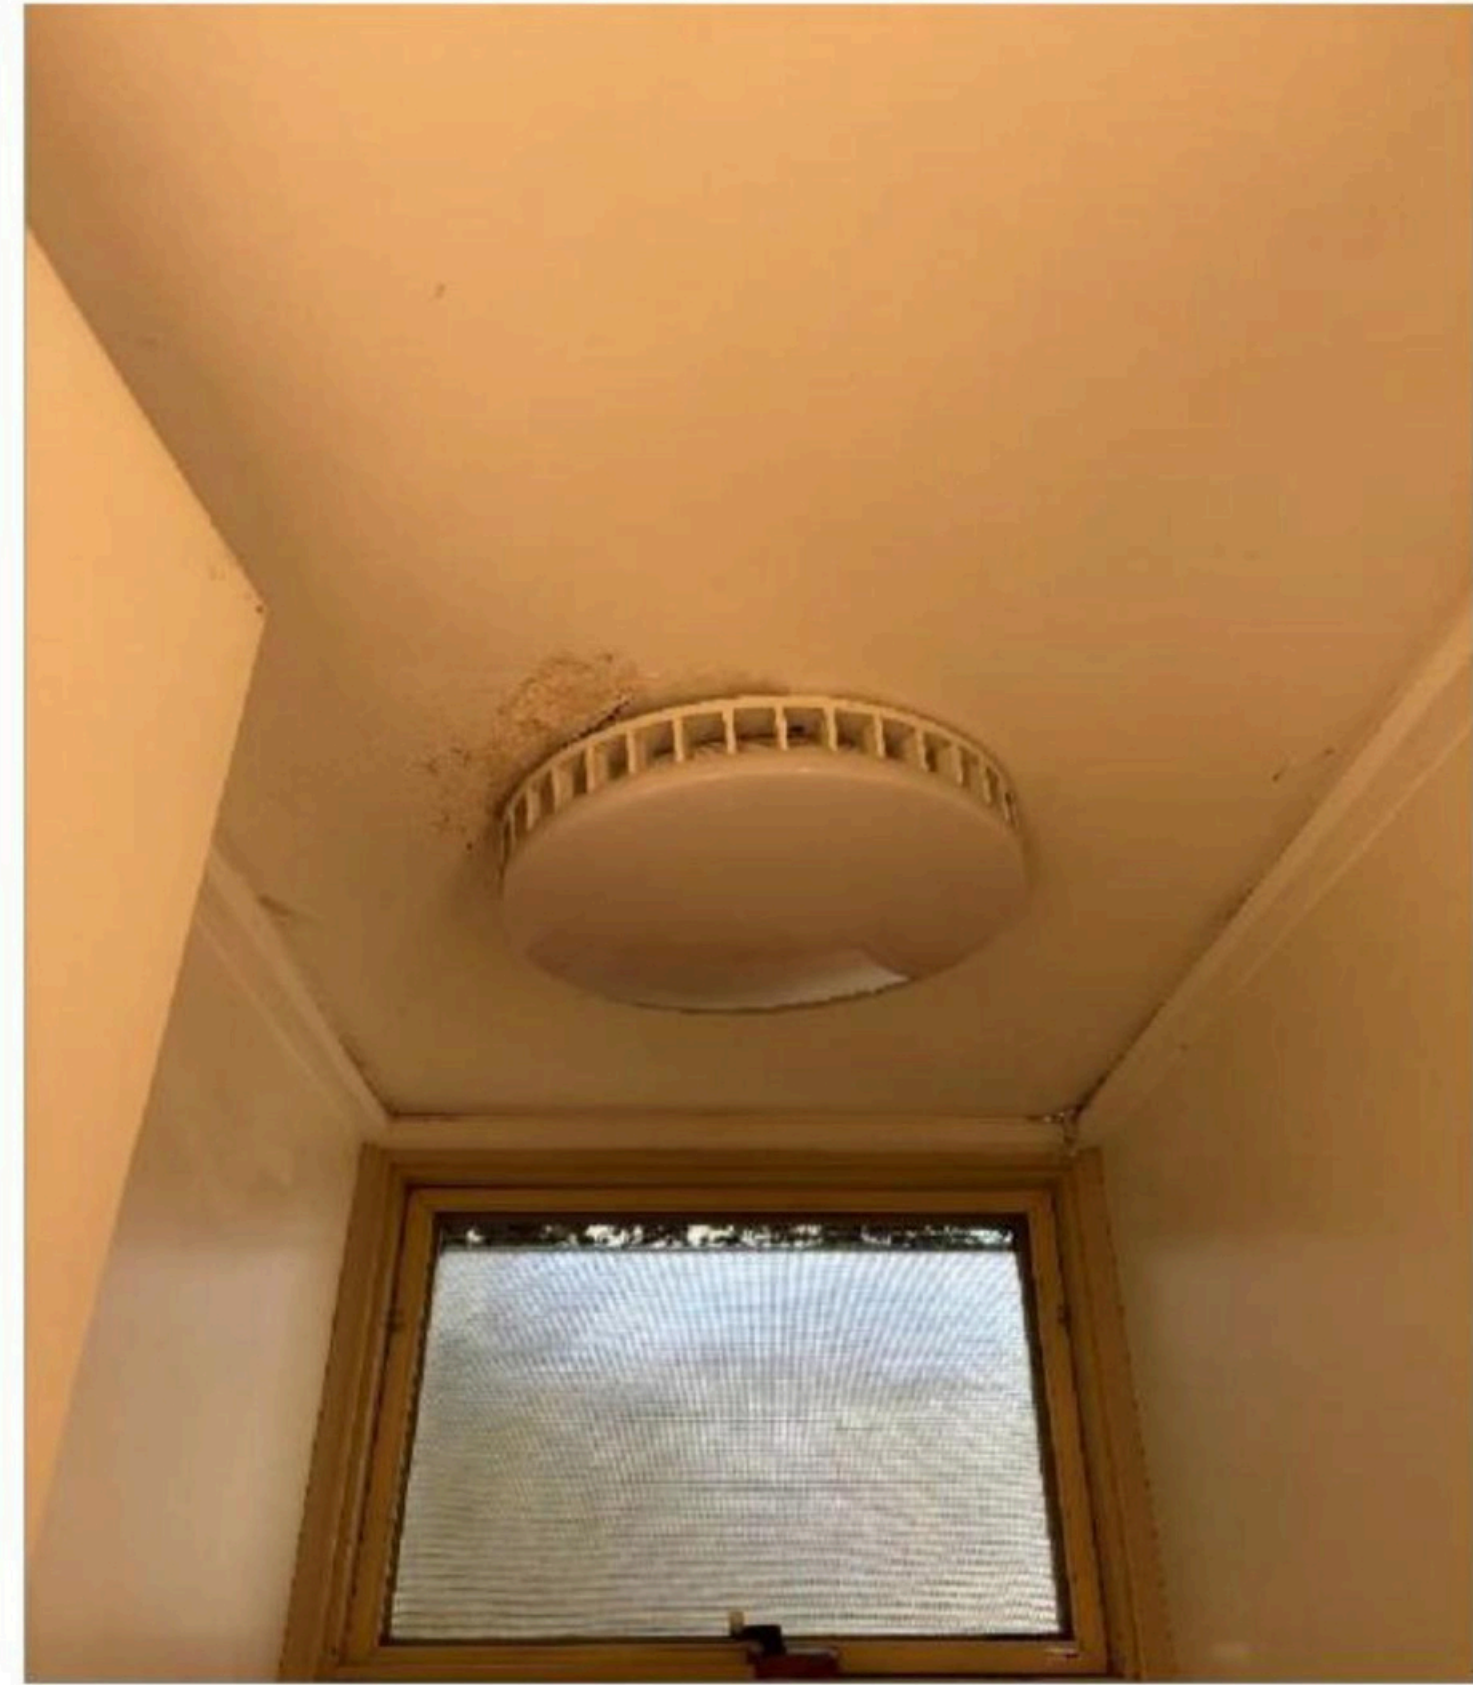
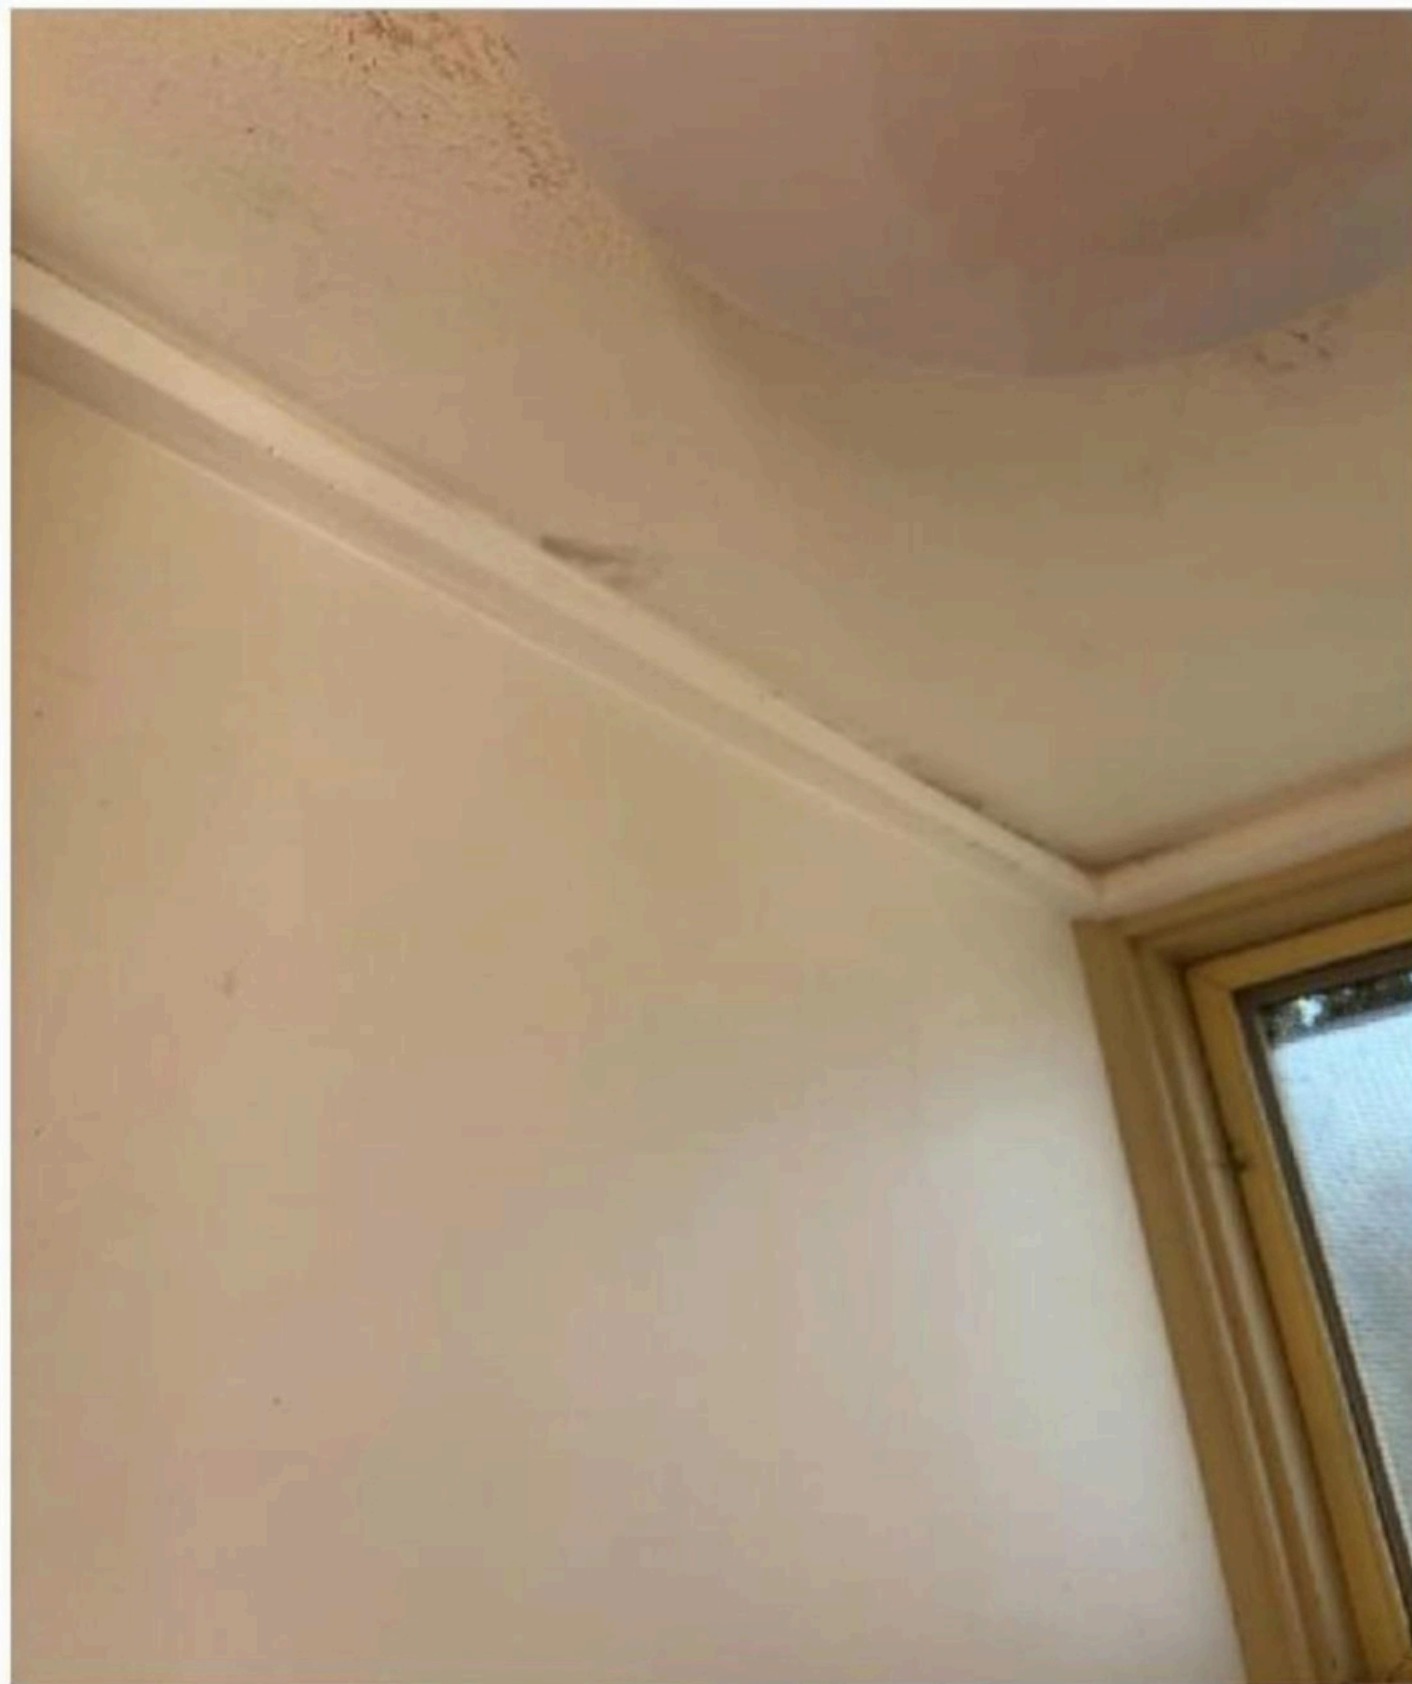
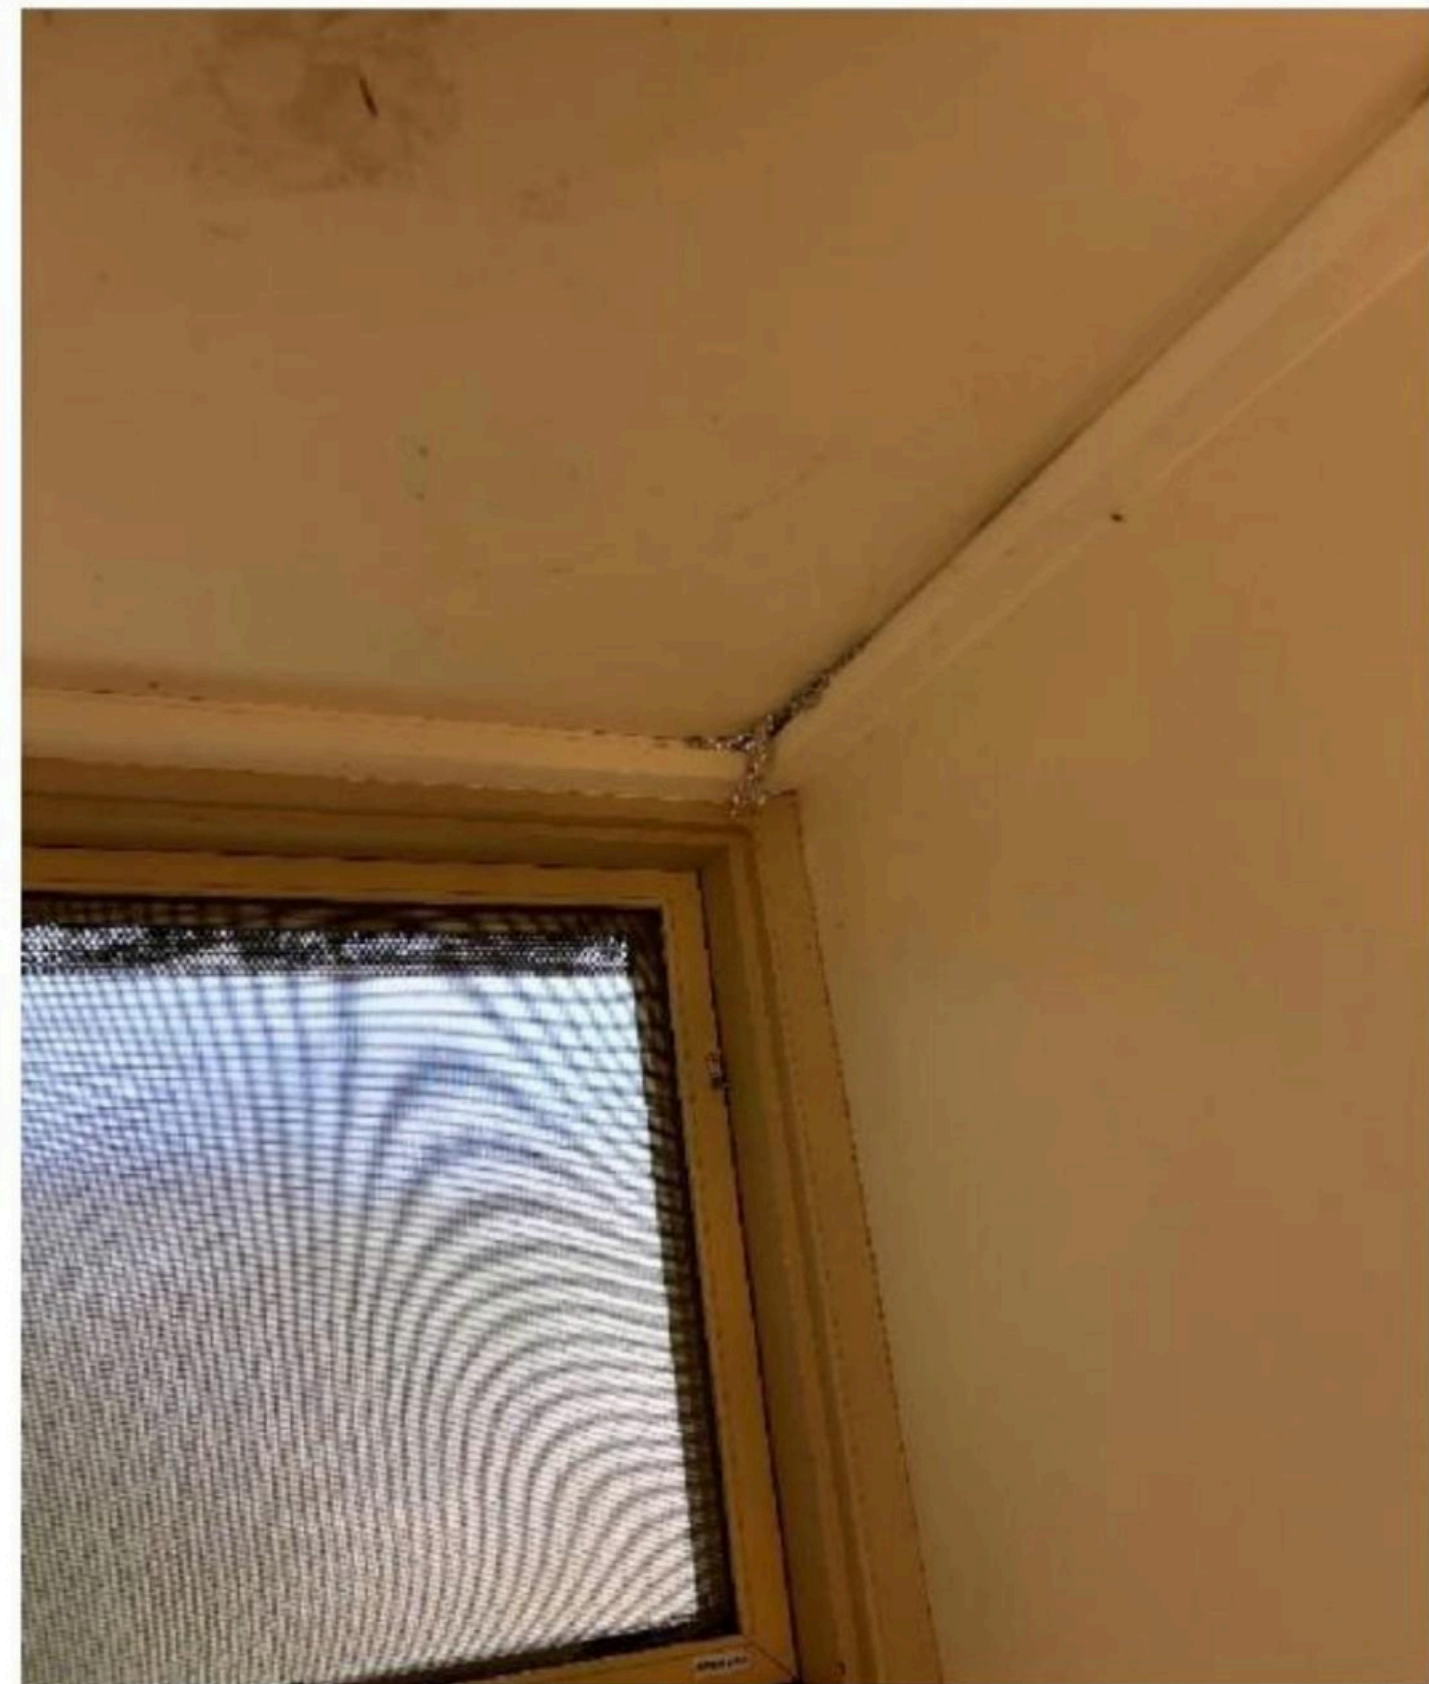
| Toilet (2) | Evidence of water damage on ceiling around exhaust fan, eastern wall, and western wall. |

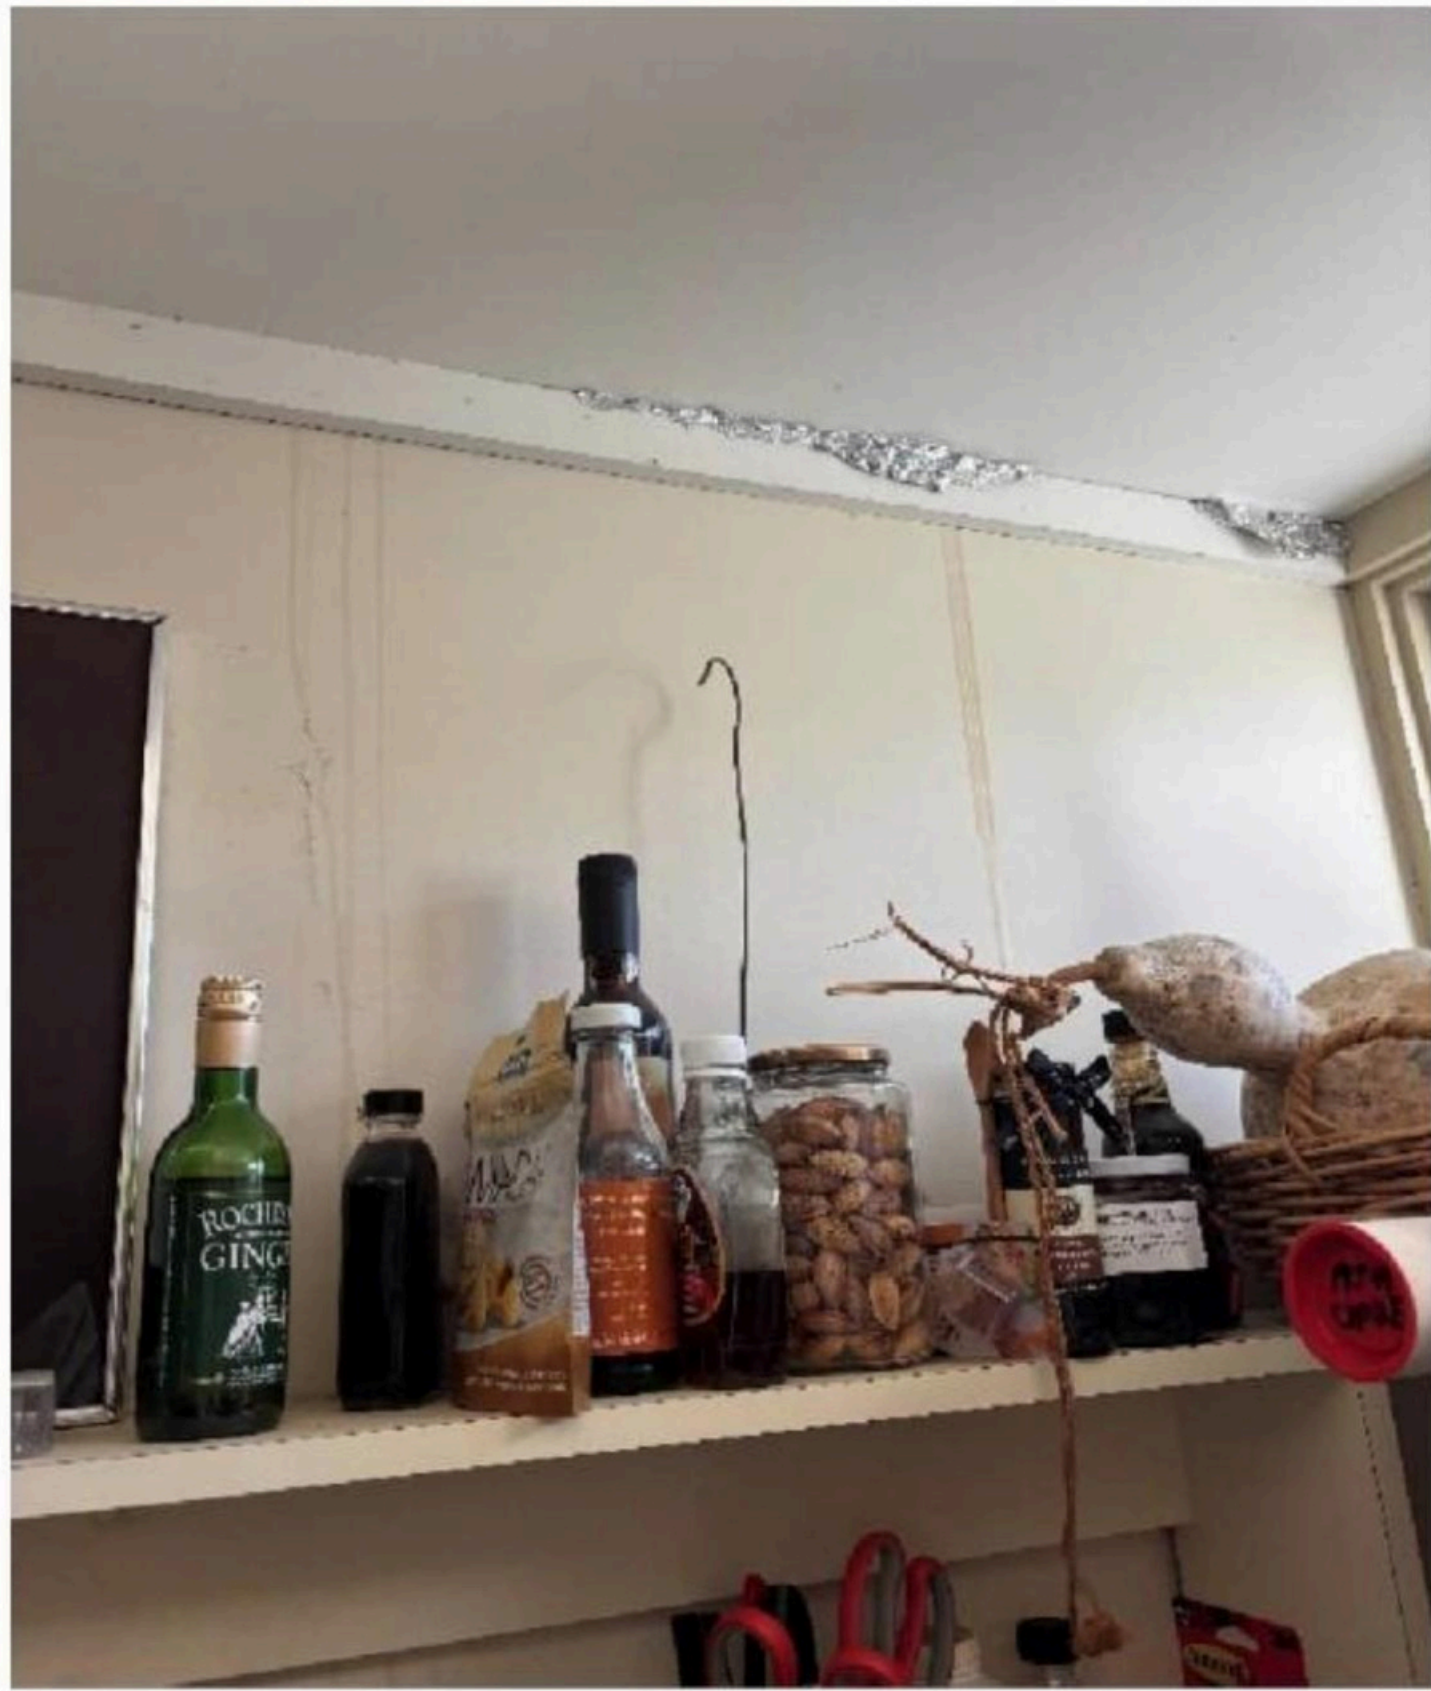
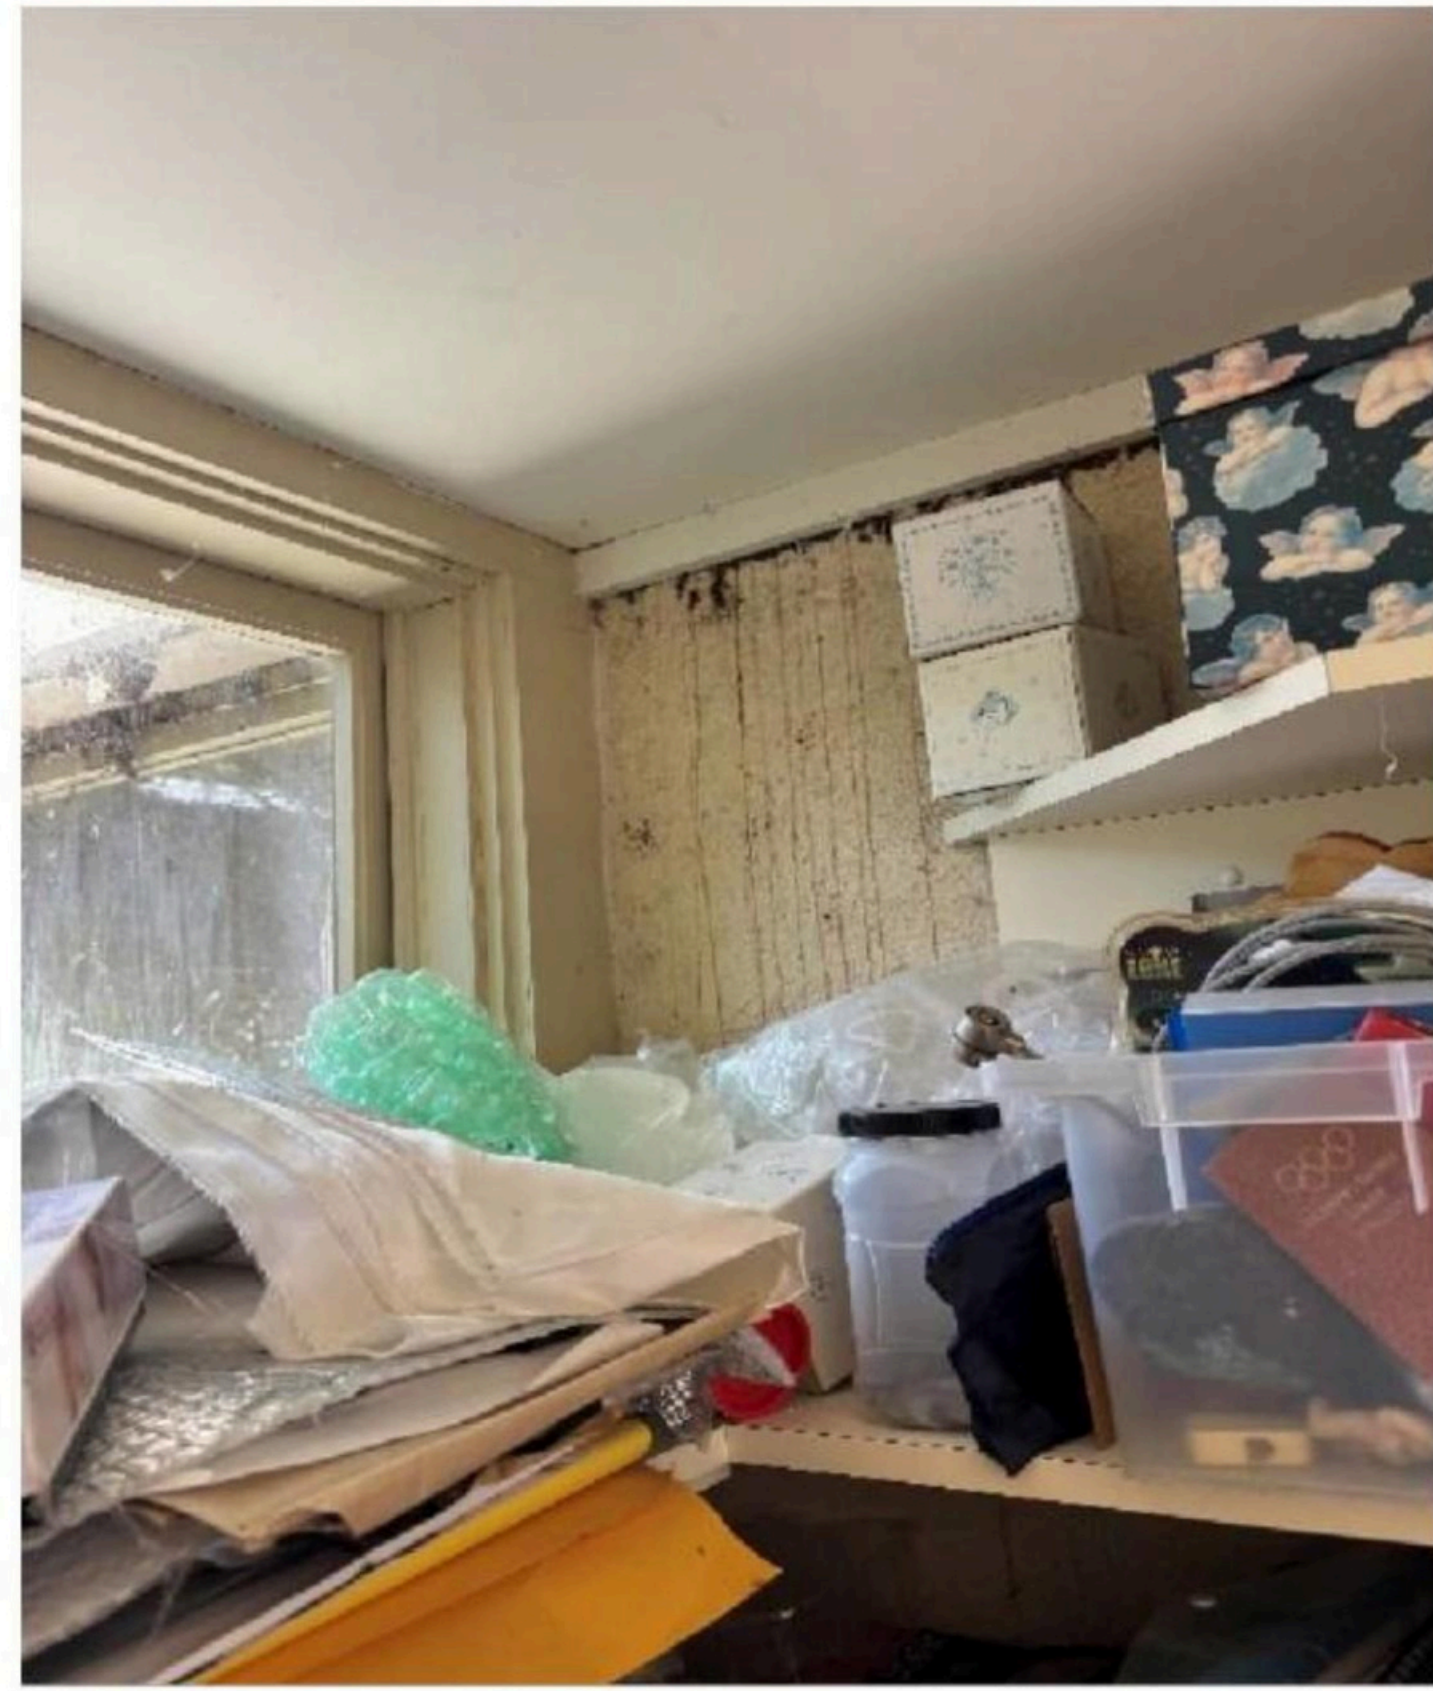
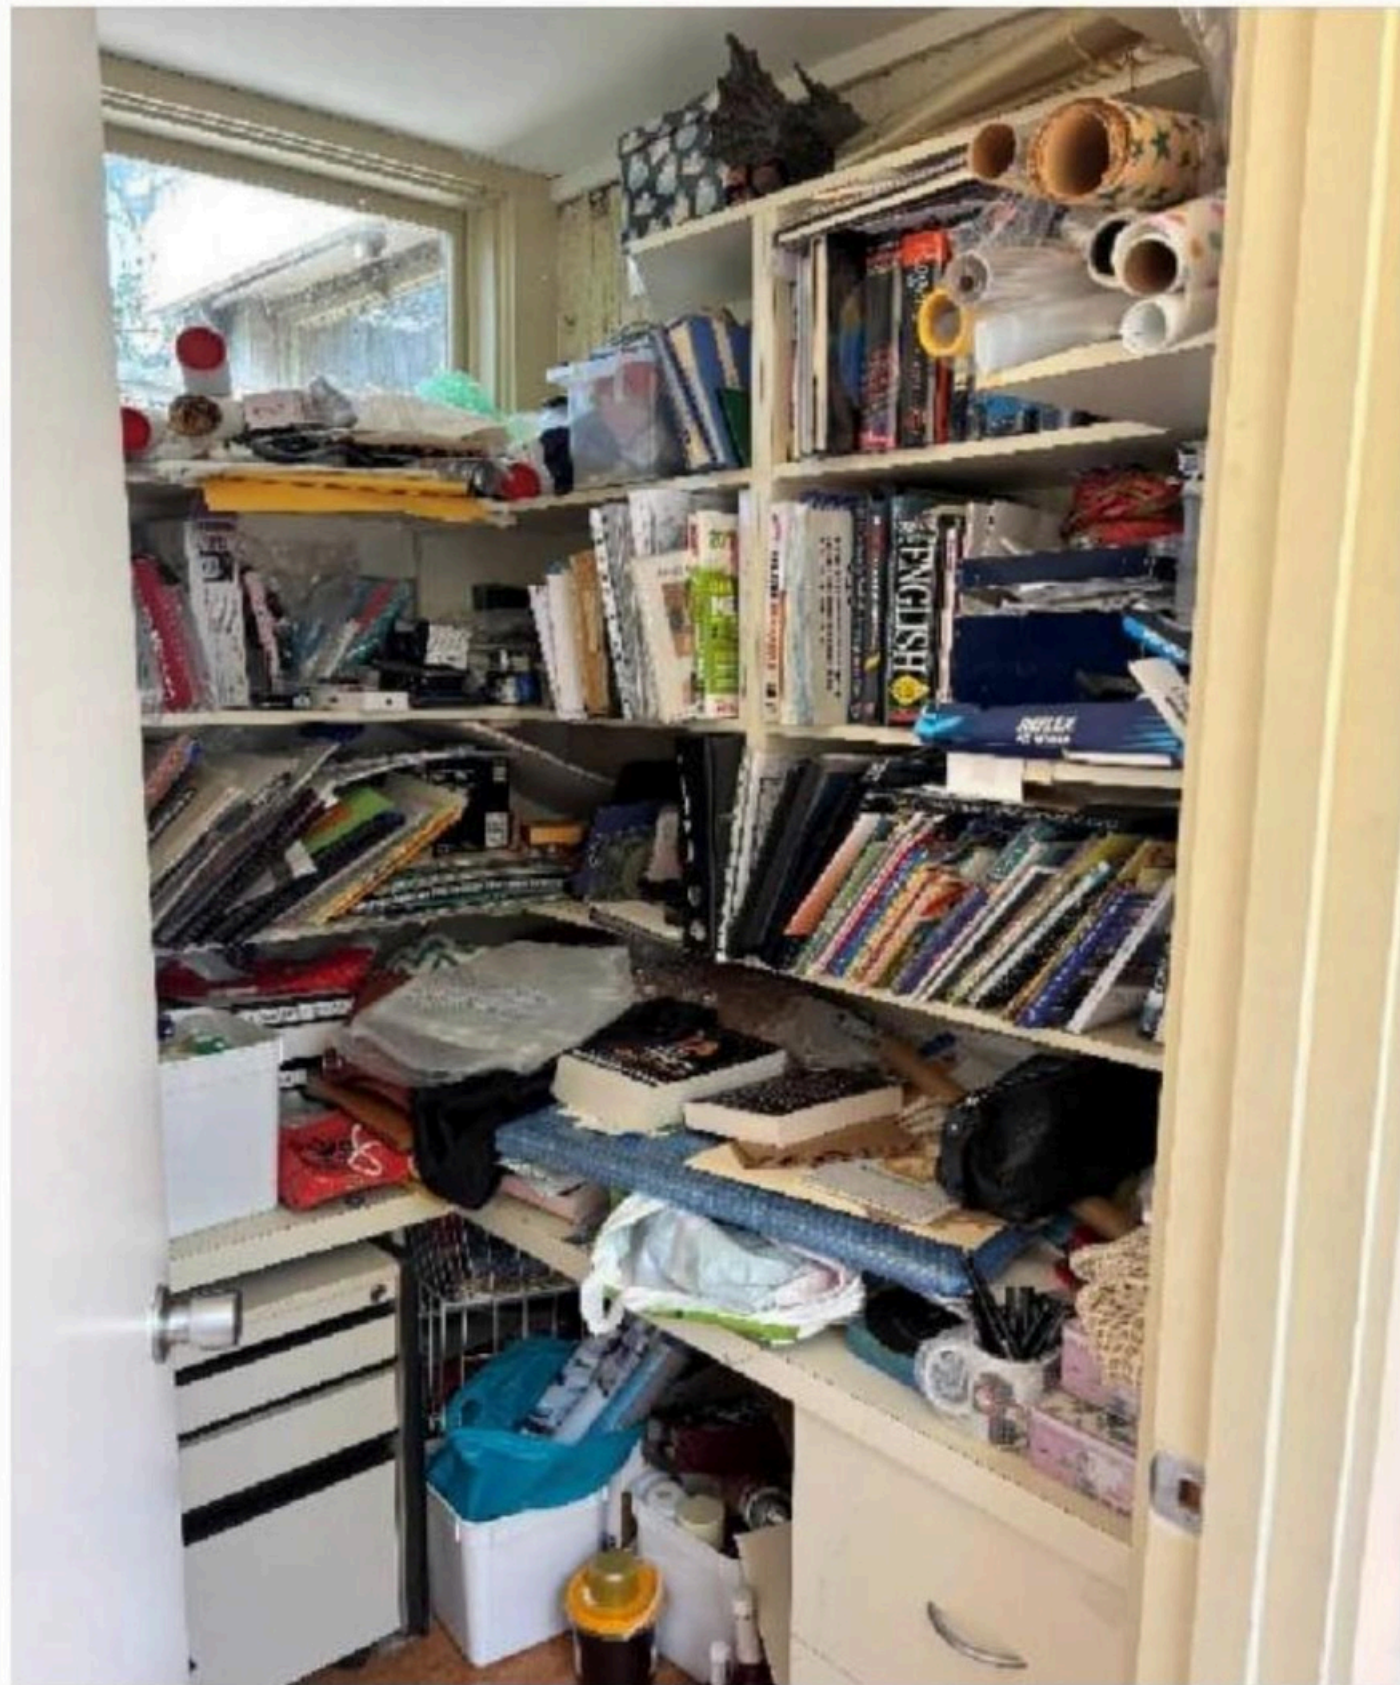
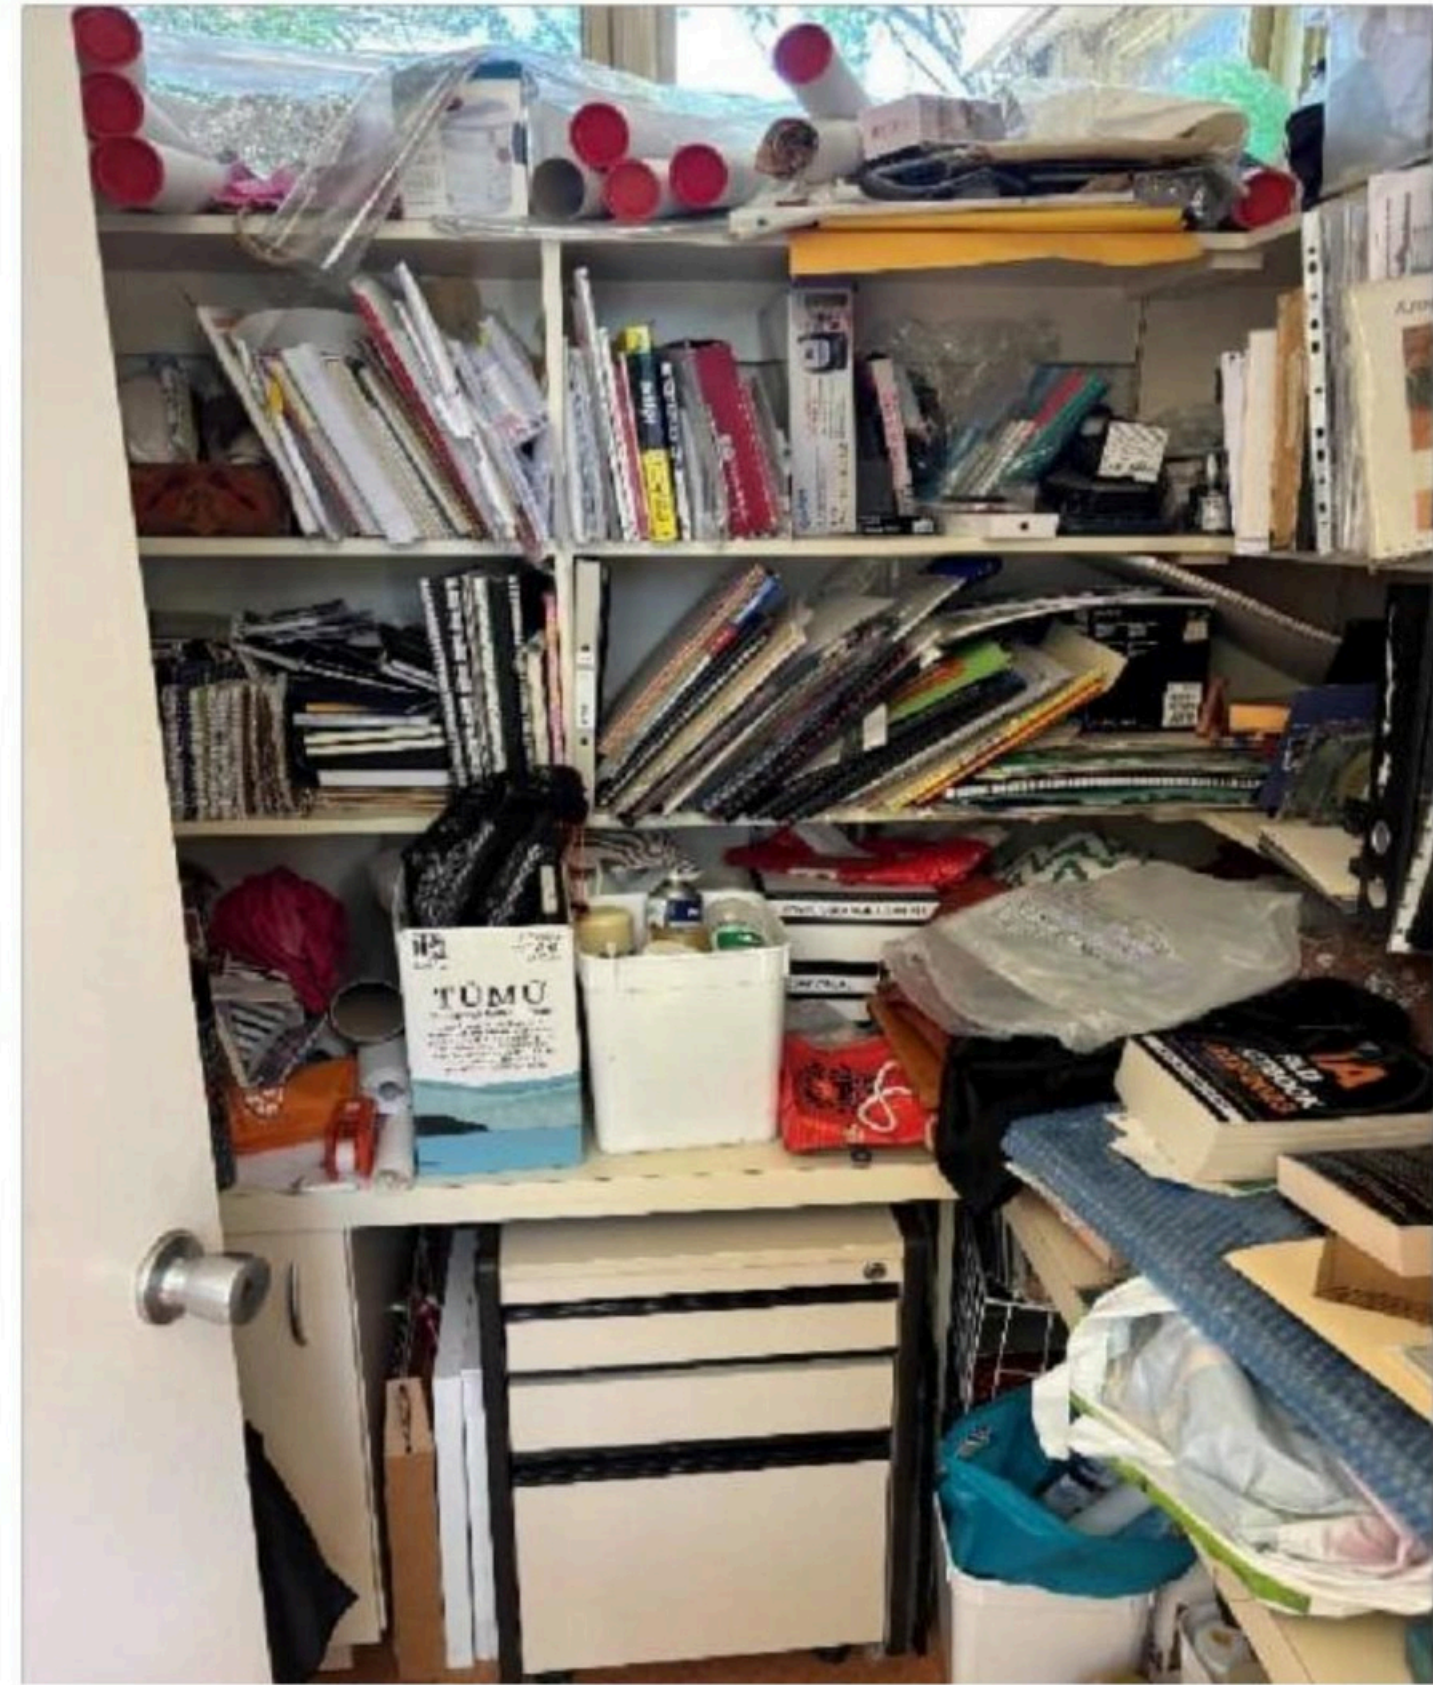
| Office | Evidence of water ingress and water stains on western and Eastern side walls. |
