Thank you for the opportunity to carry out a dilapidation inspection at the above property in order to document existing cracking prior to the commencement of construction works at your property.

The two-storey property is of single skin brick and timber frame construction with brick veneer exterior walls, internal brick walls and timber ceilings, timber windows and a pitched roof clad with concrete tiles.

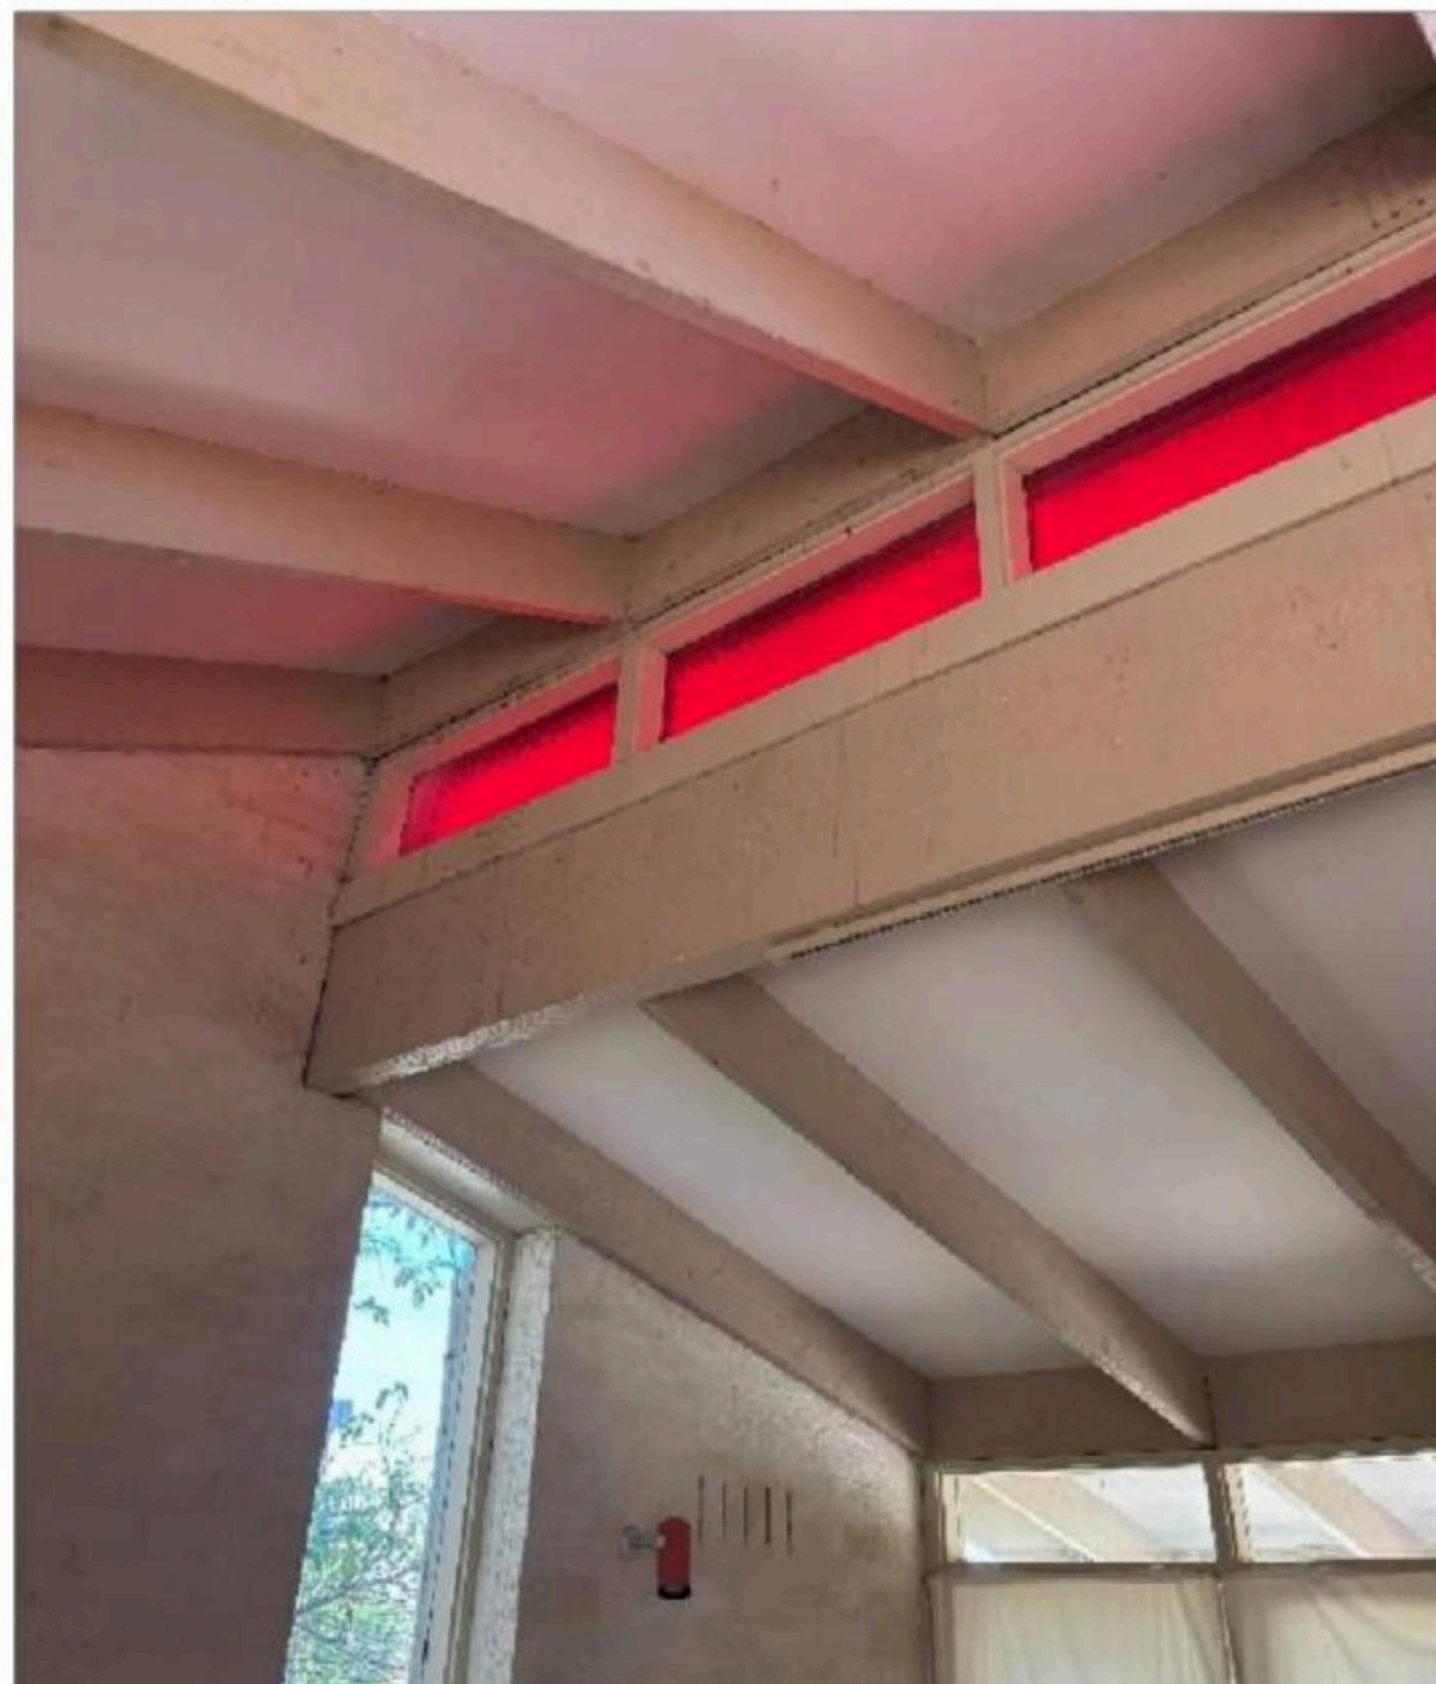
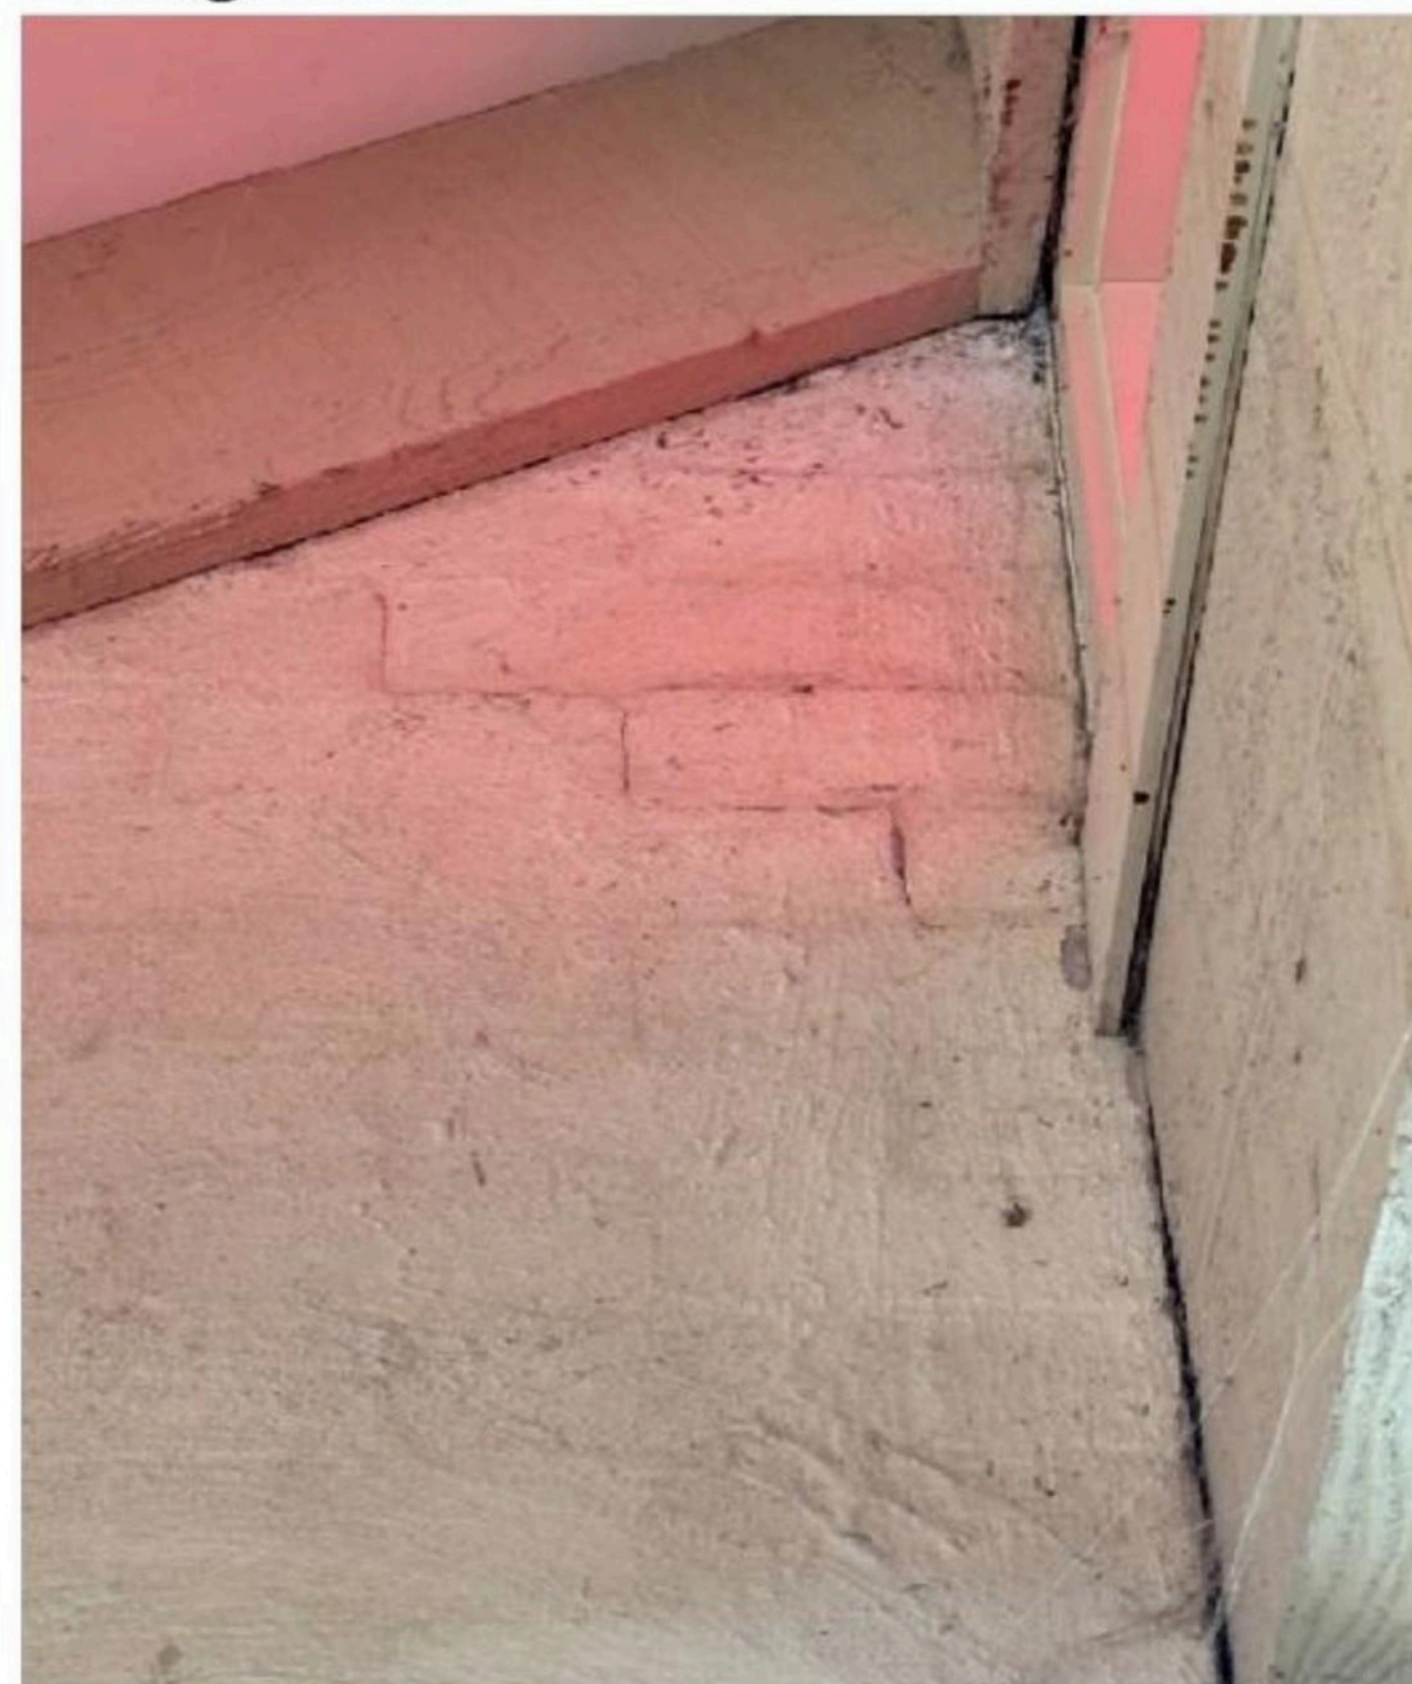
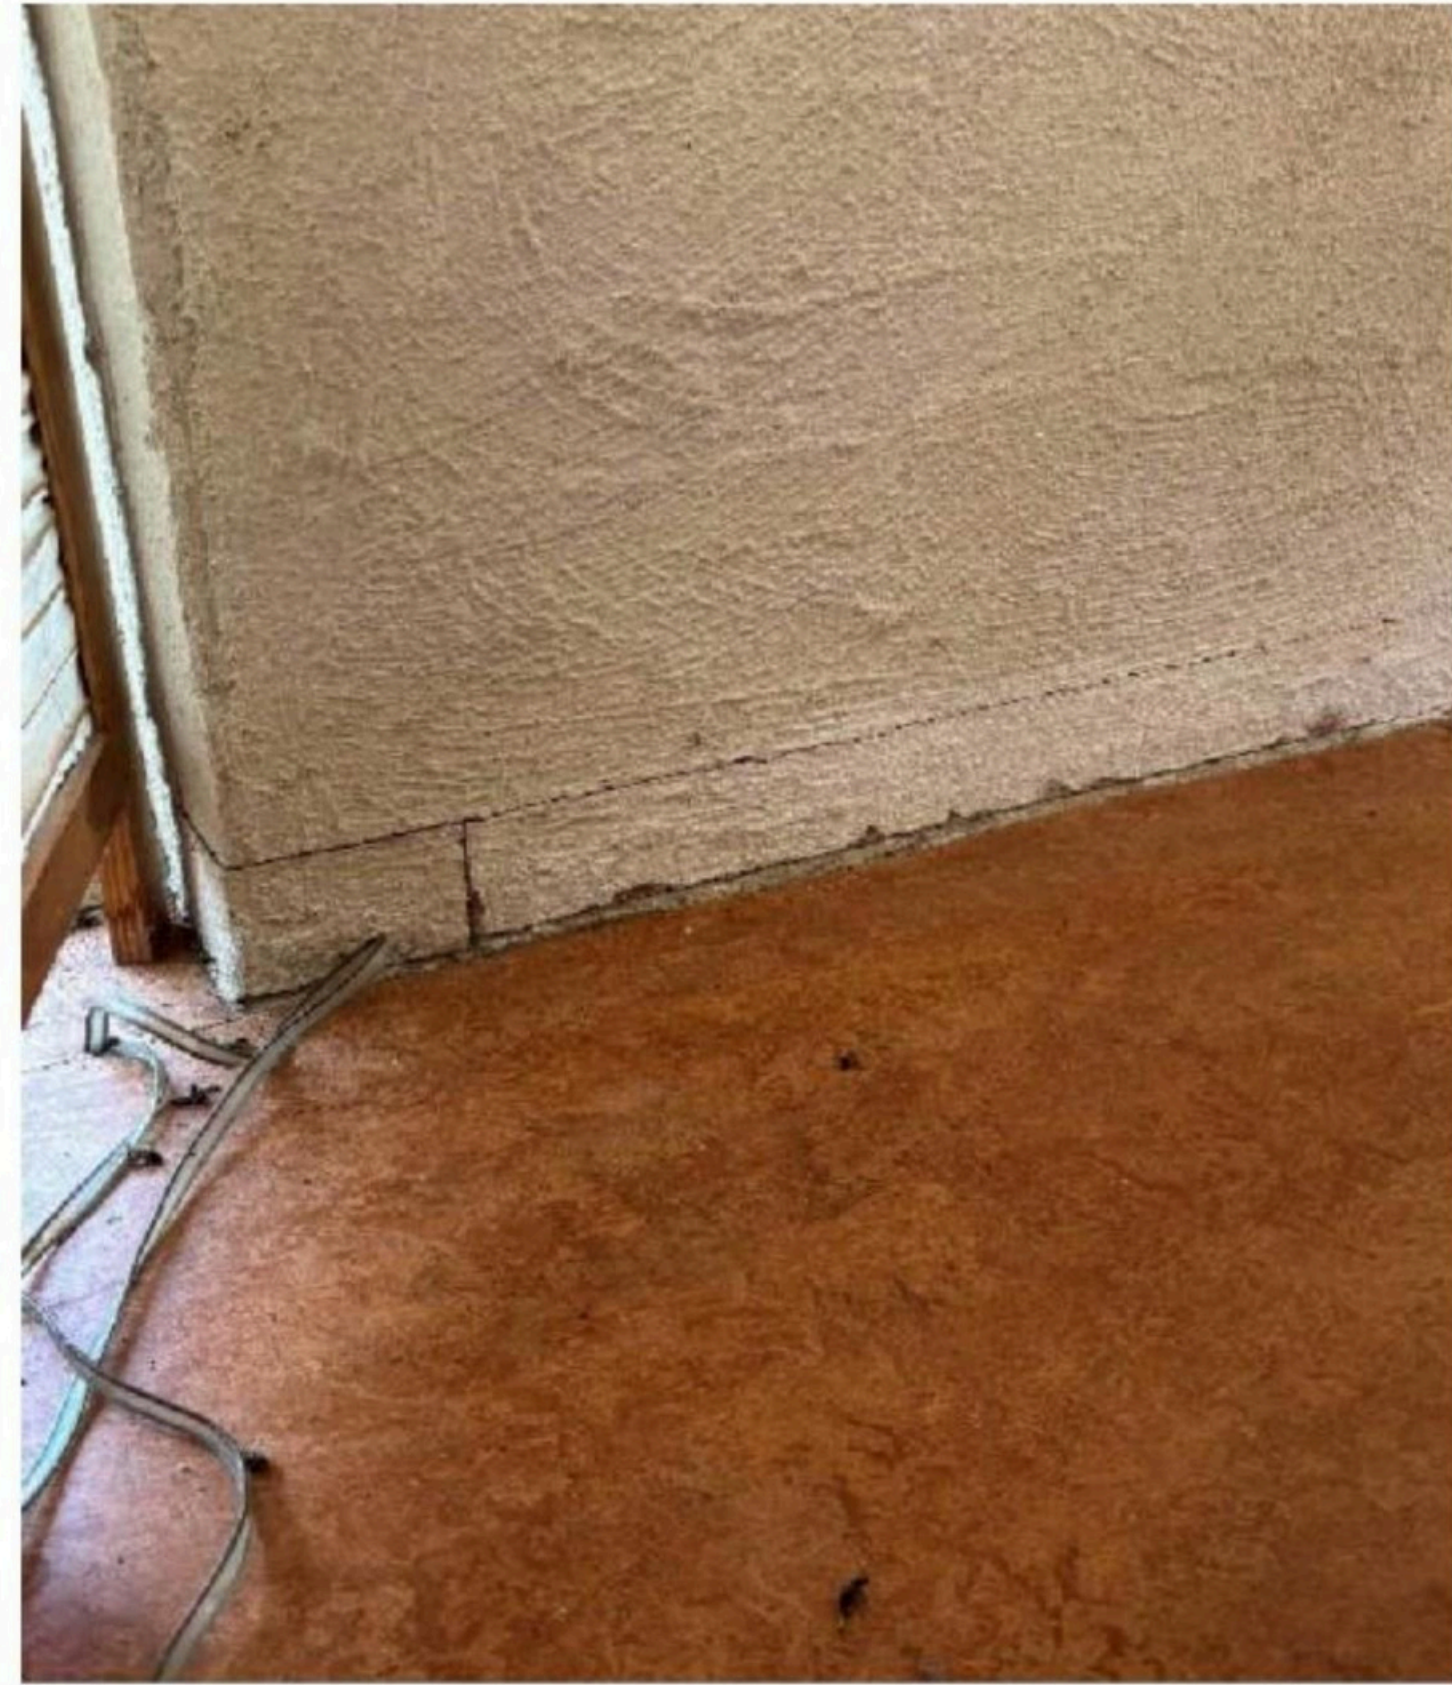
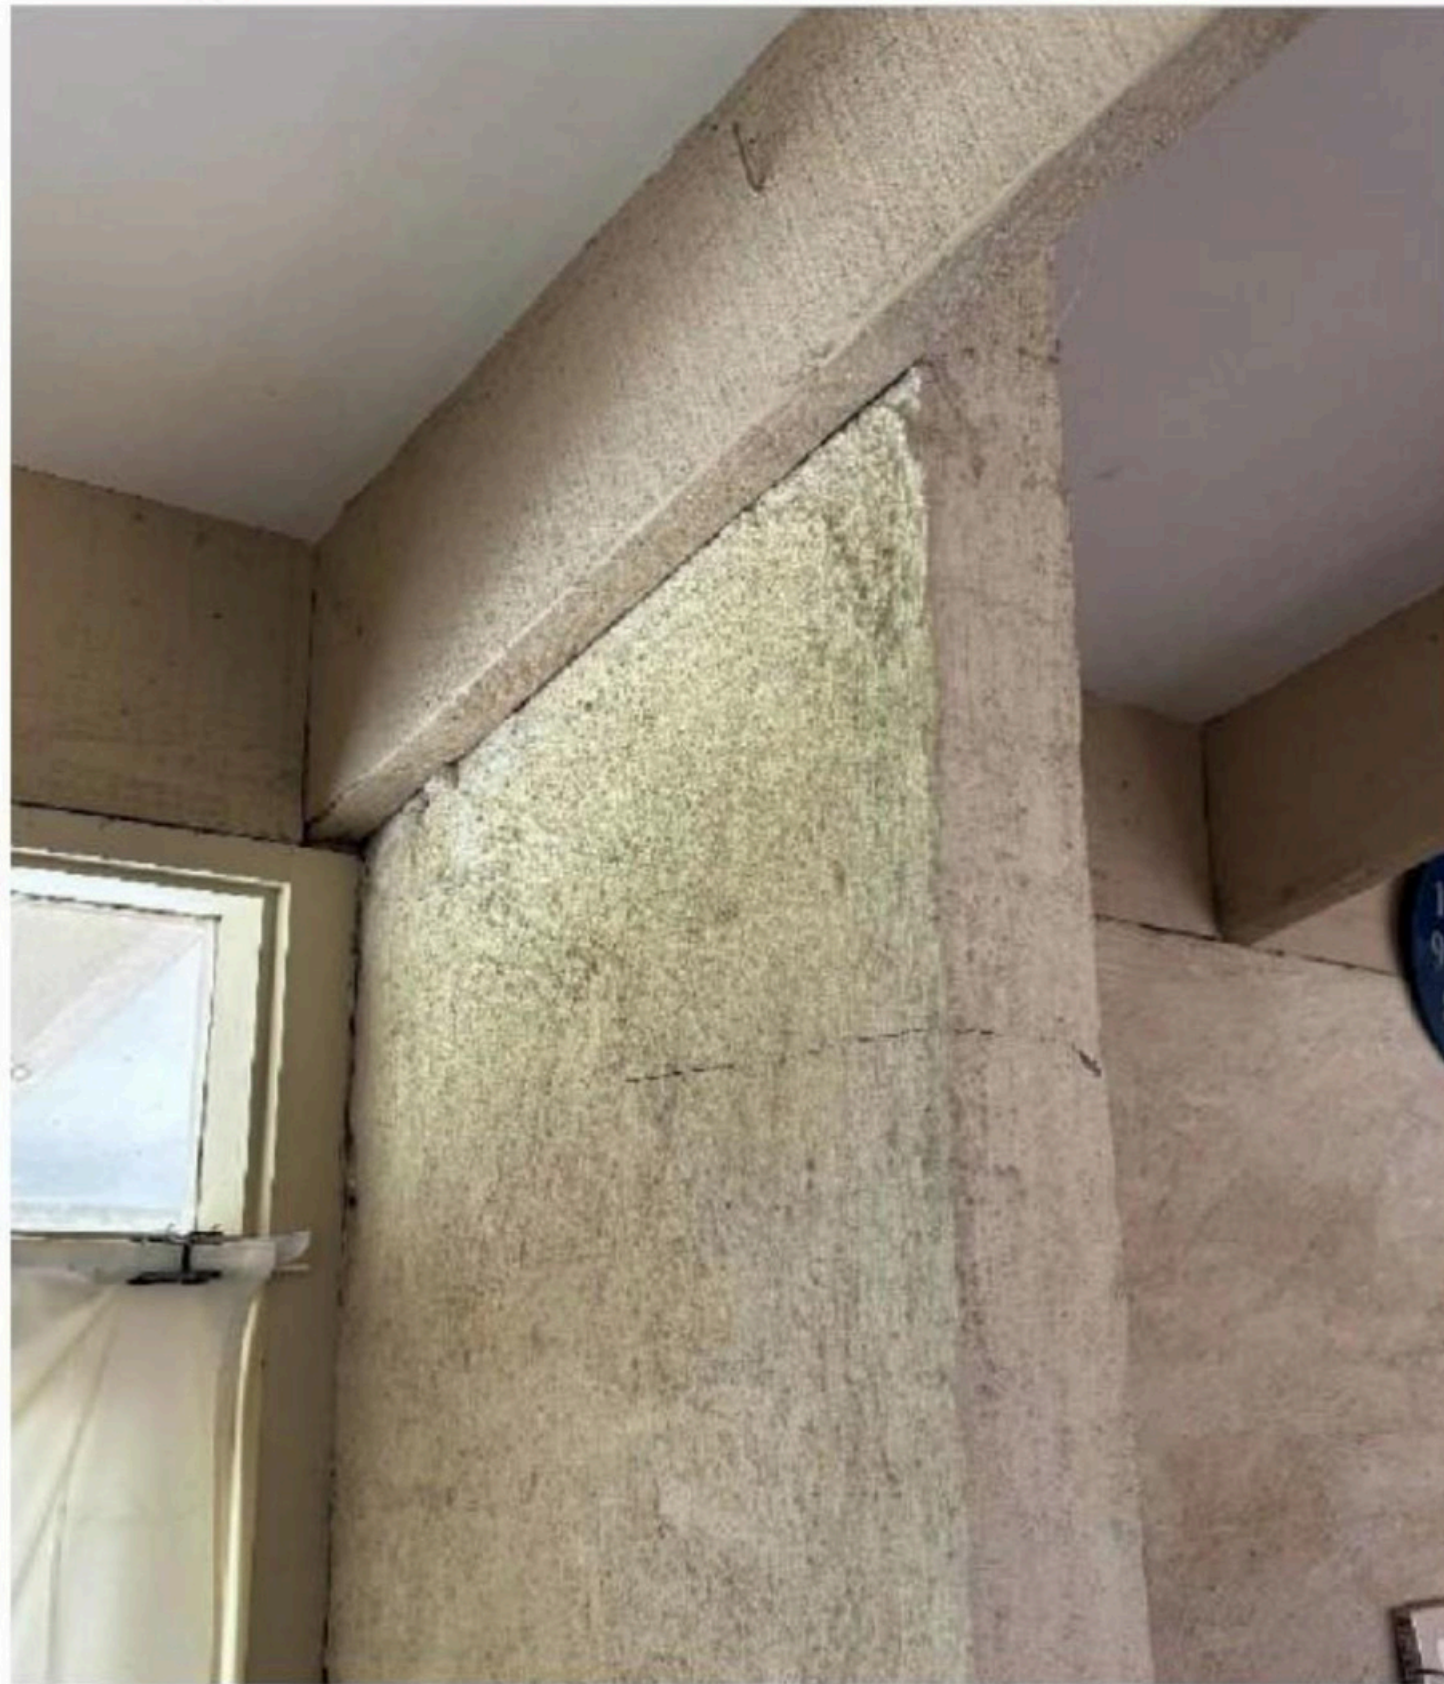
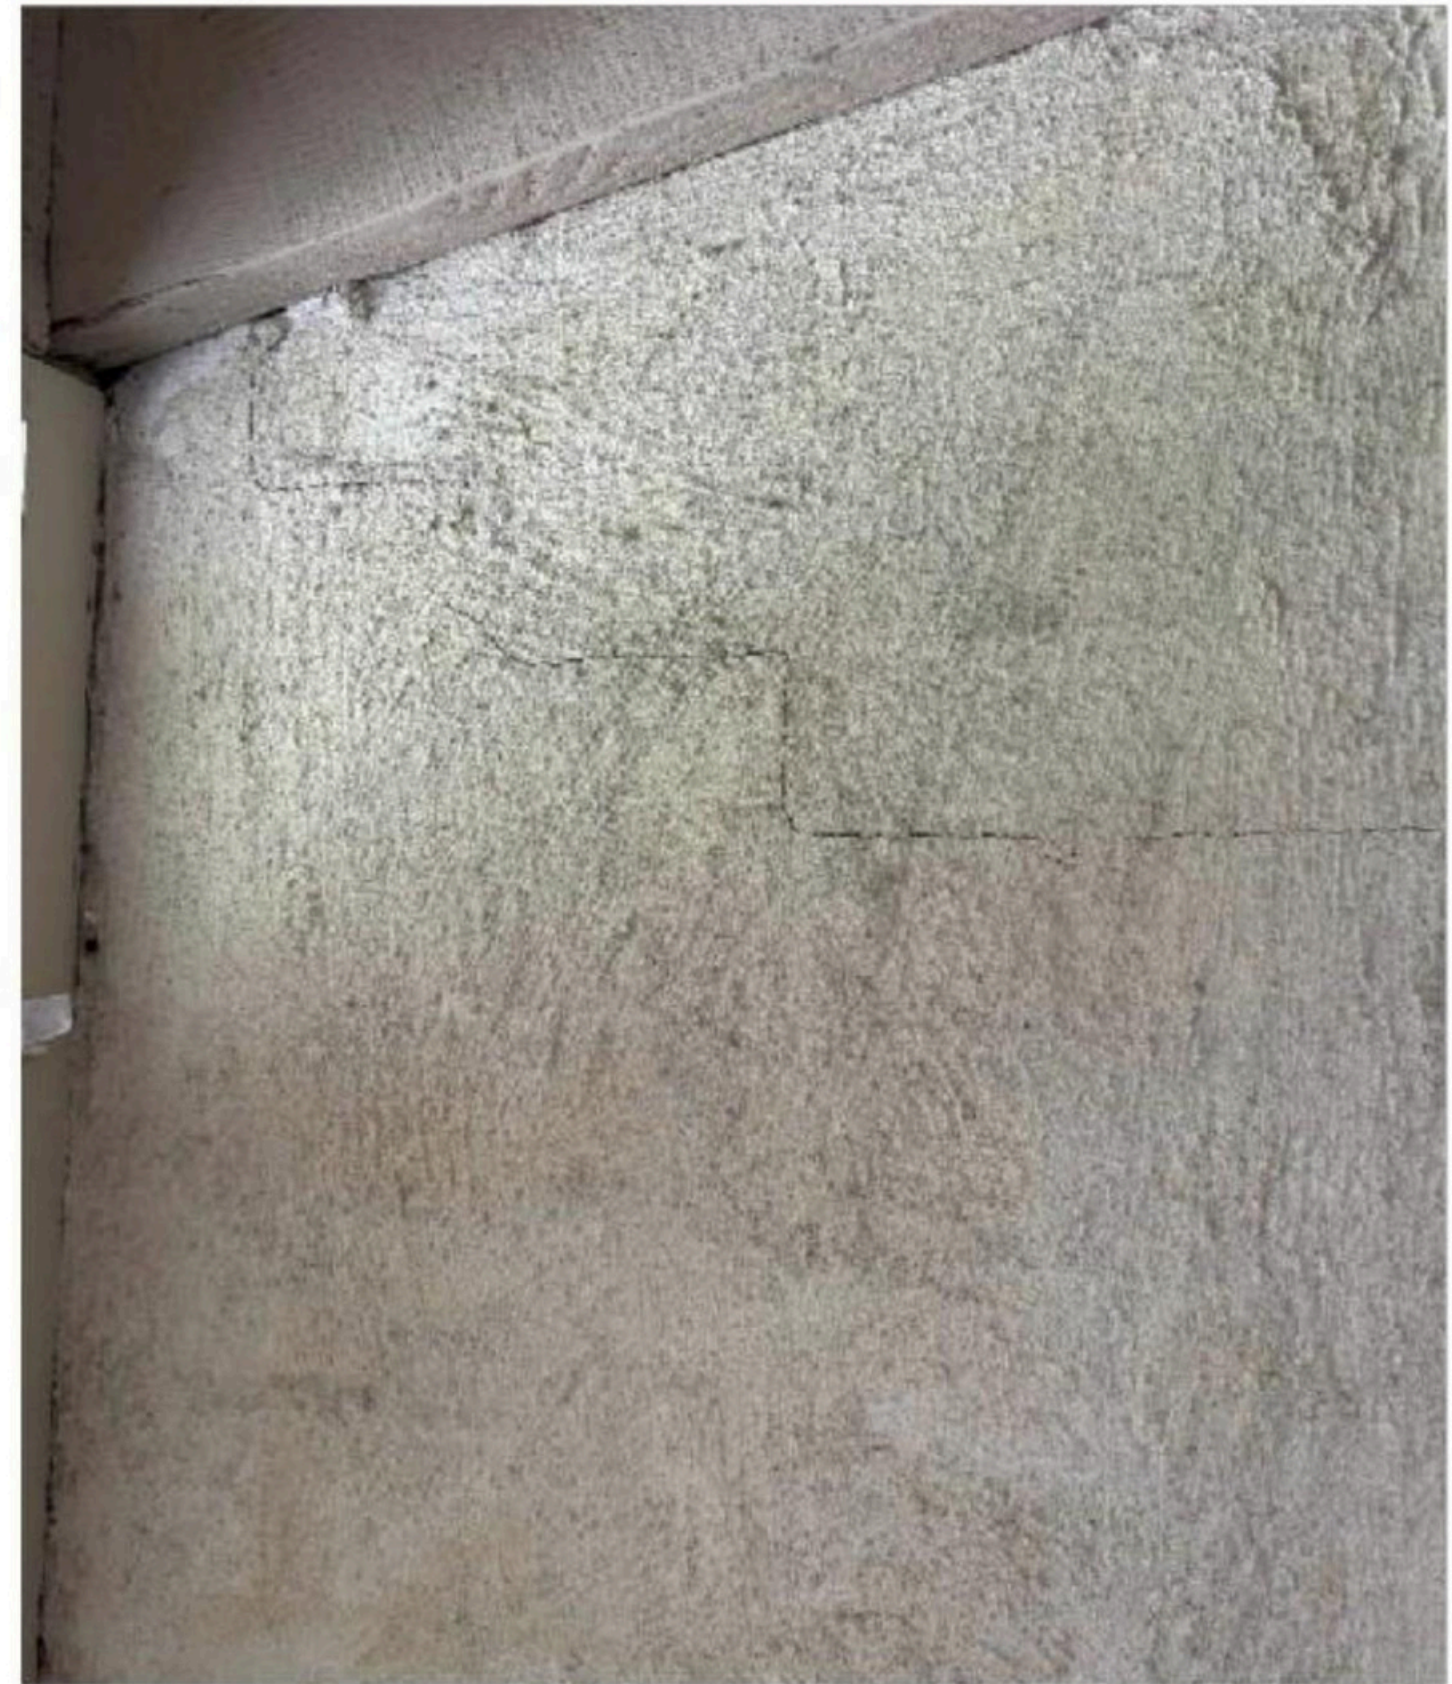
| Living Room | Evidence of water ingress and water stains on western and Eastern side walls.<br>Evidence of fine cracking (step cracking) to southern wall (2 locations).<br>Evidence of fine cracking to western wall at the bottom. |

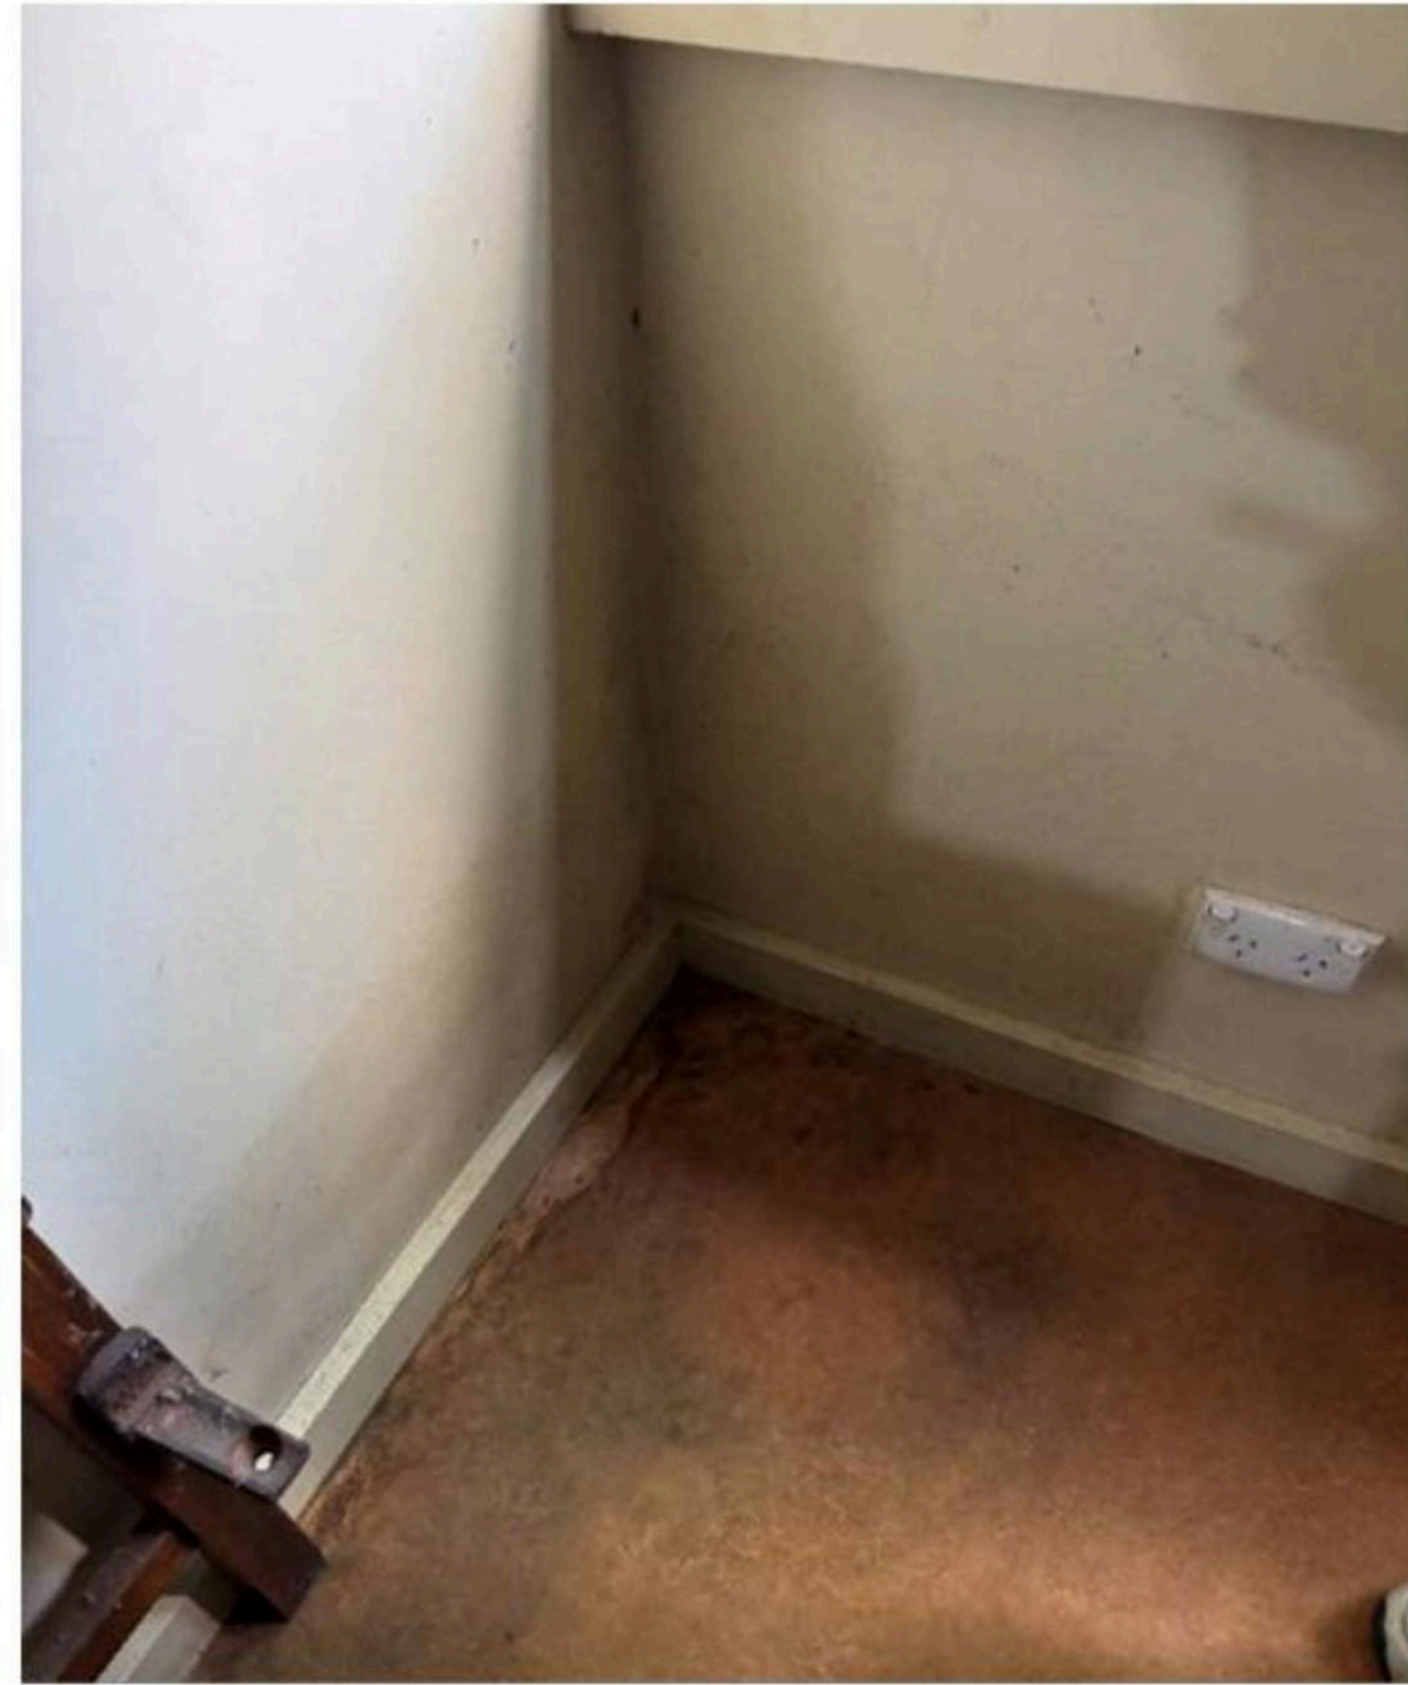
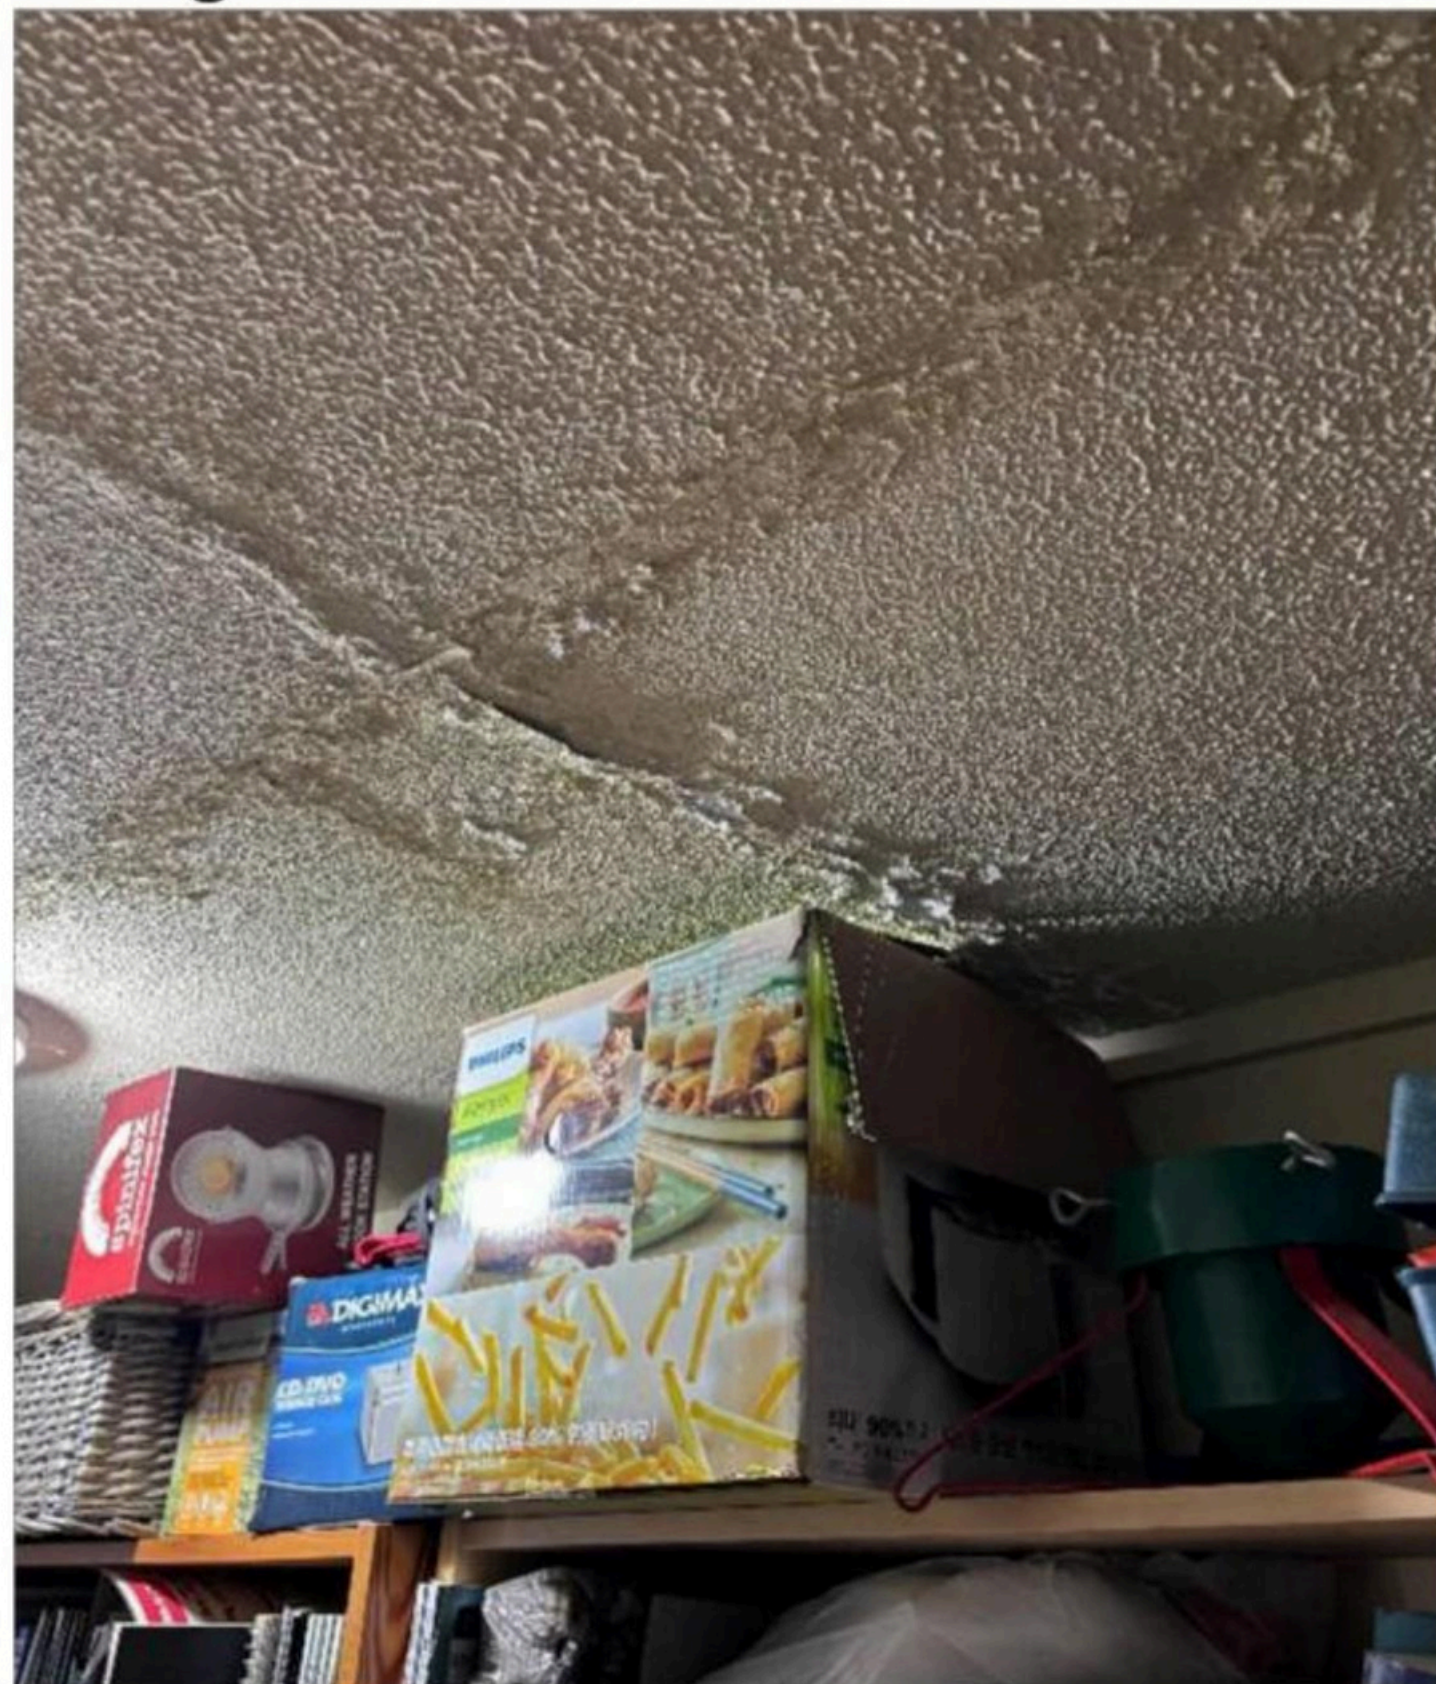
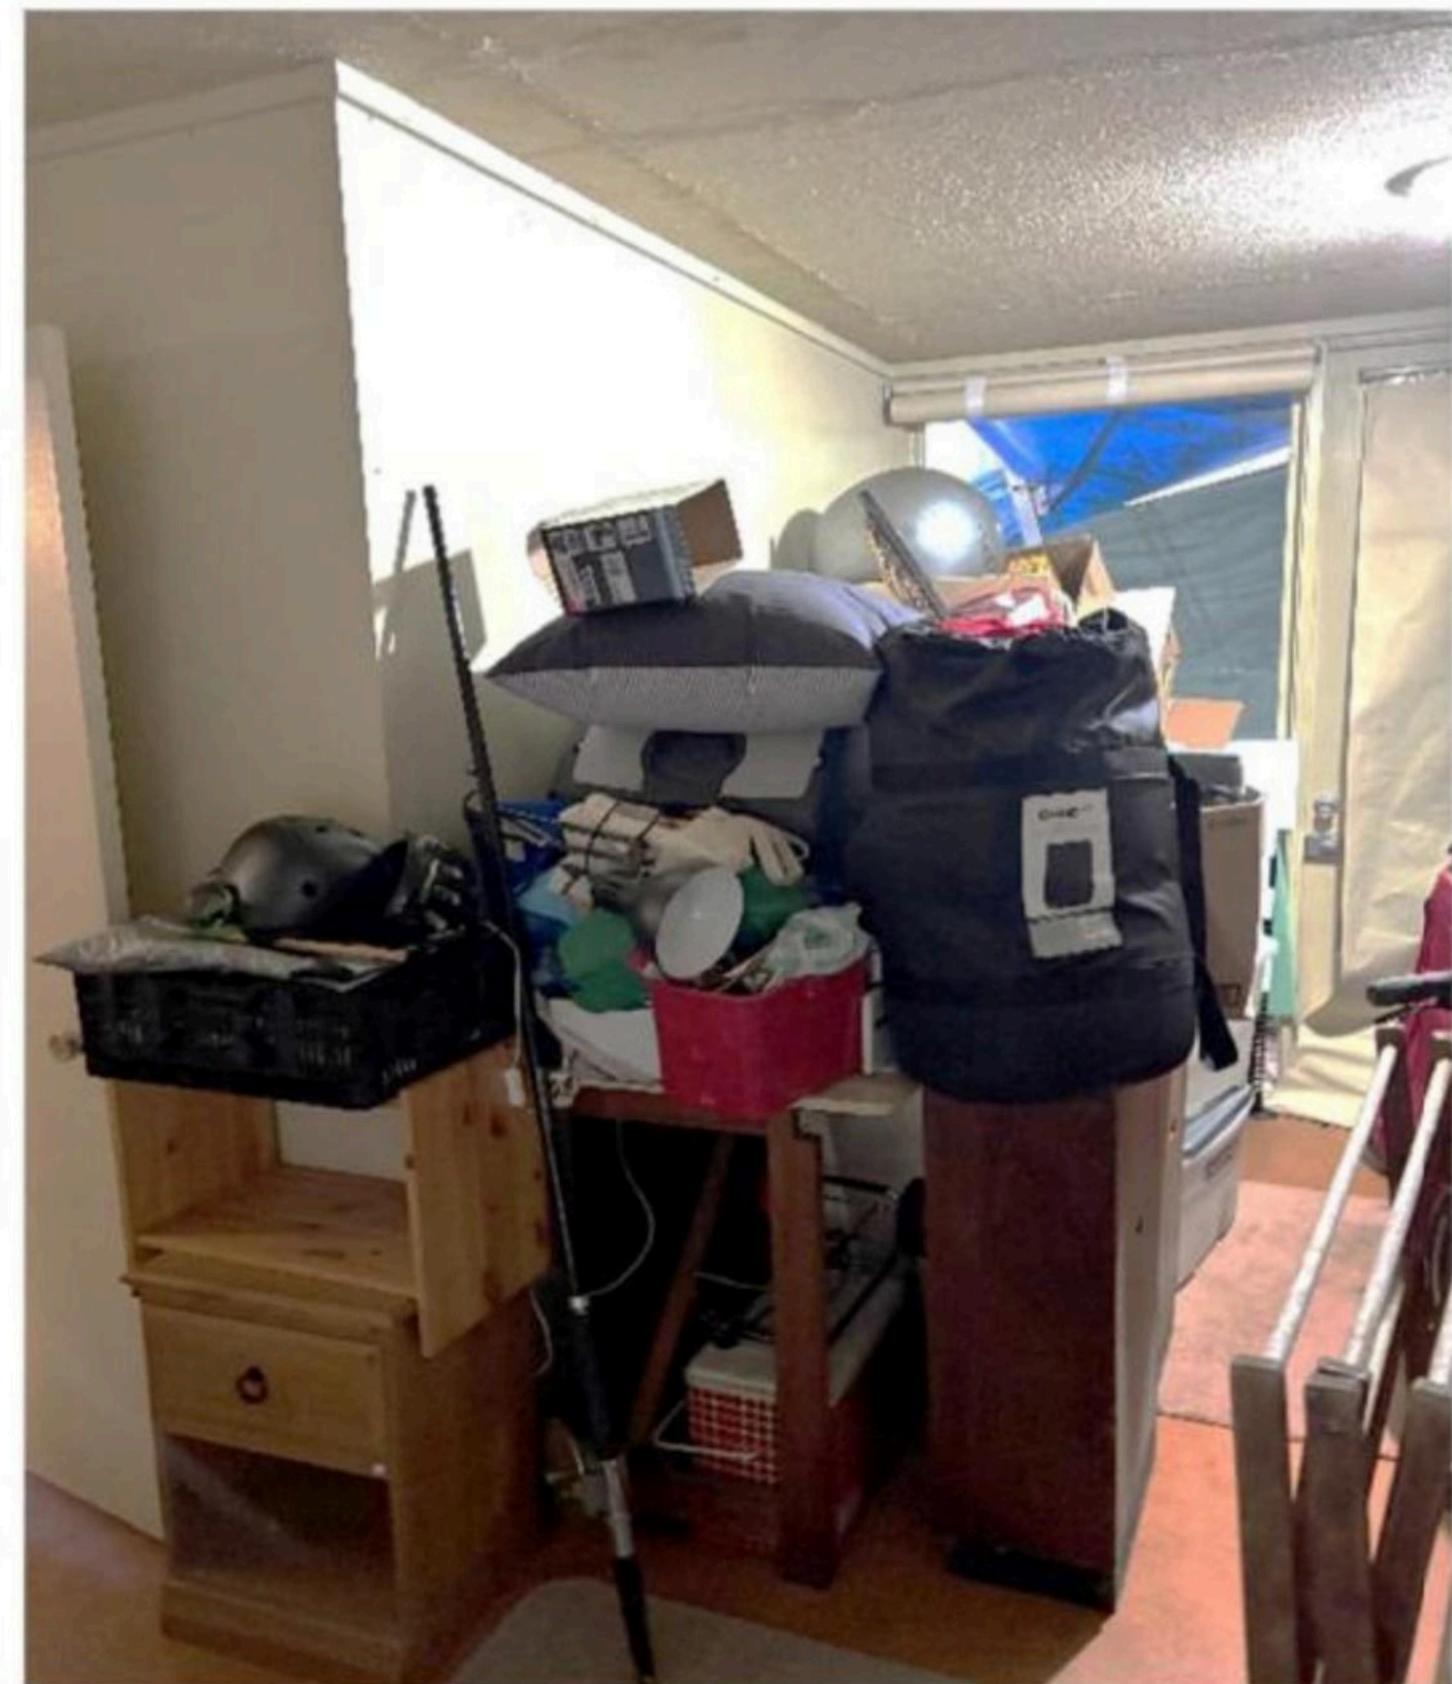
| Bedroom 4 | Evidence of water ingress on western wall.<br>Evidence of efflorescence on ceiling (concrete). |

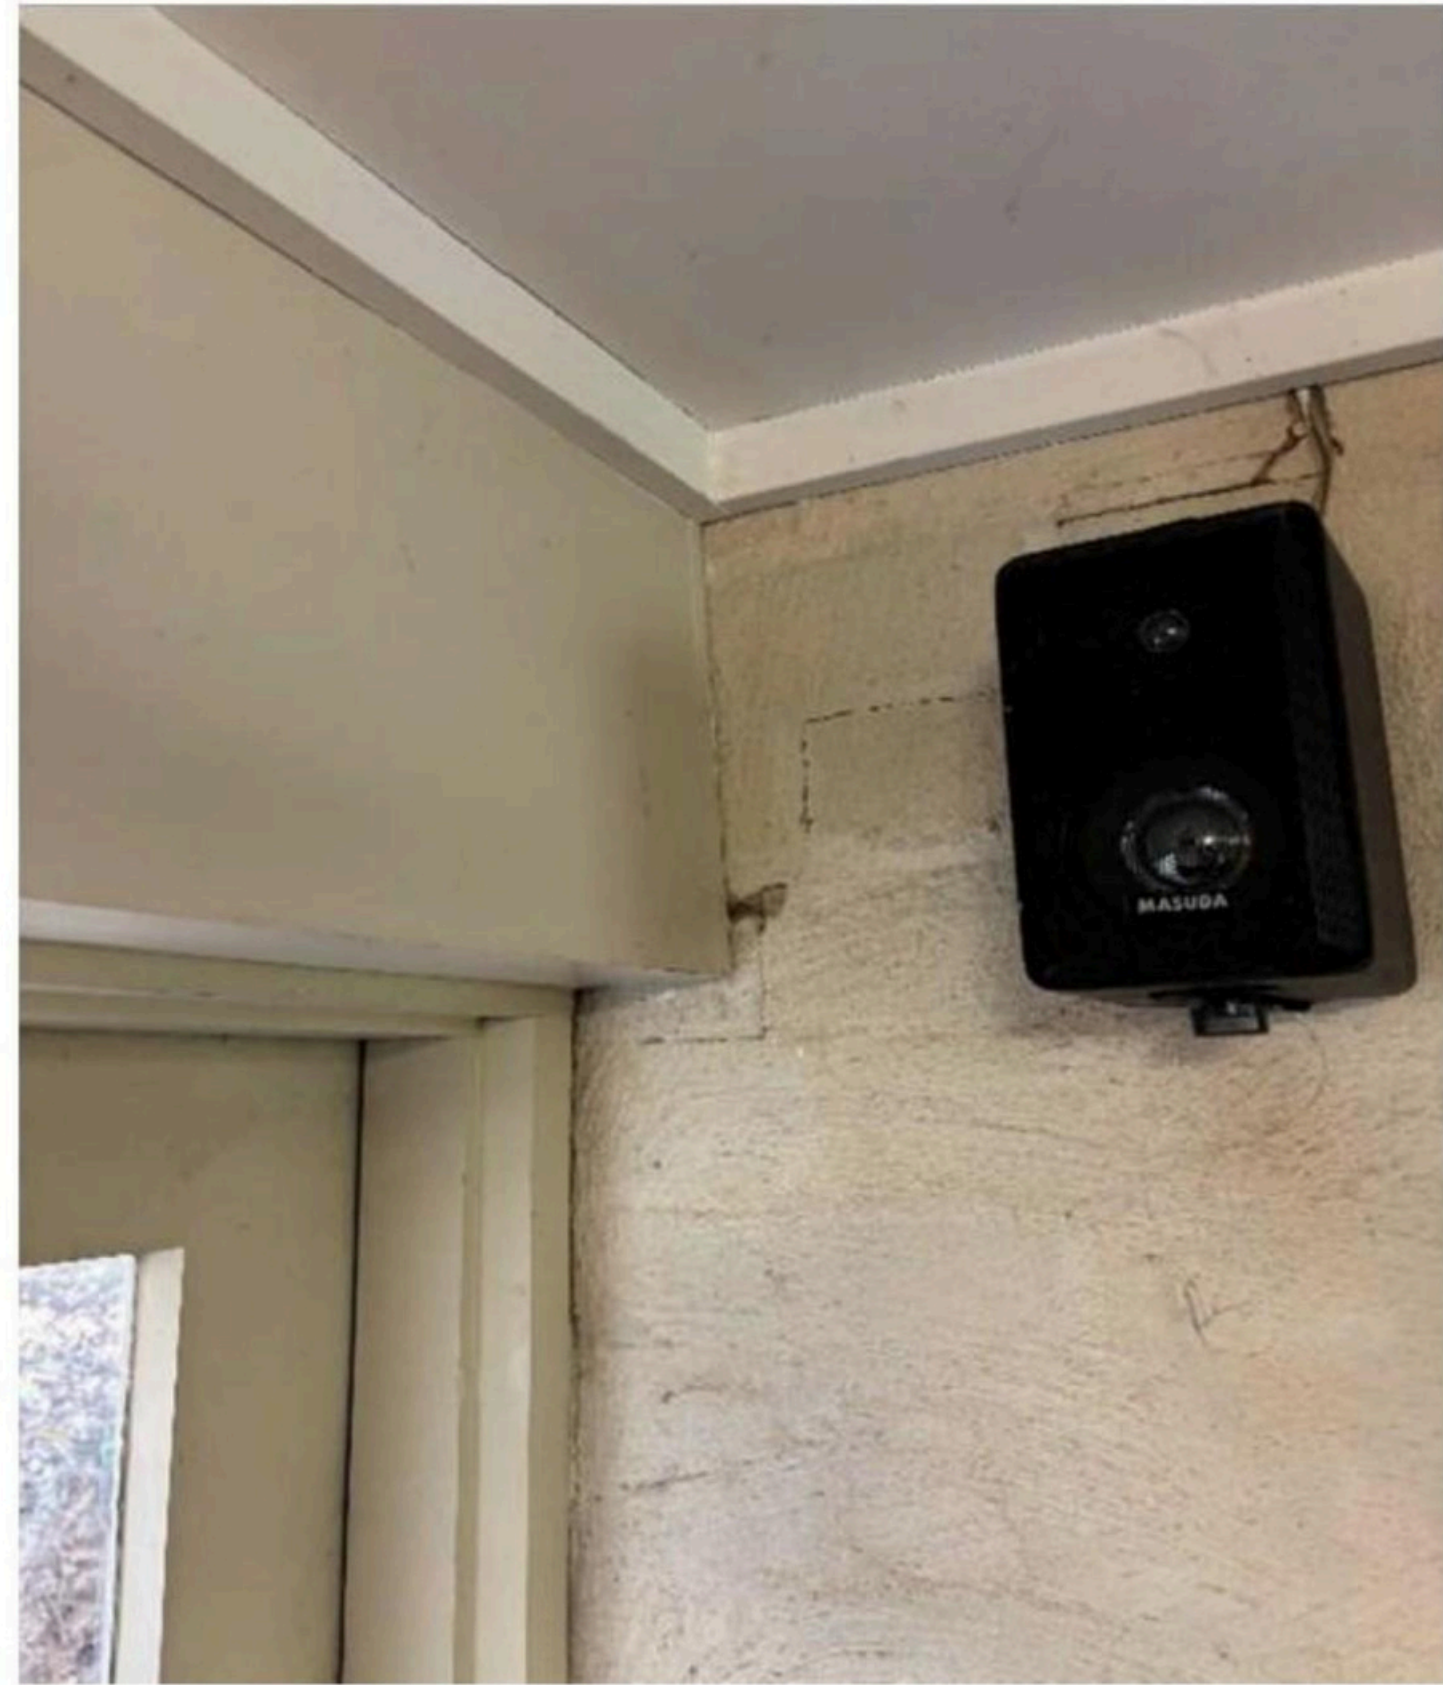
| Downstairs office | Evidence of fine cracking to northern wall adjacent to door.<br>Evidence of water ingress and water damage on south wall. |
