Thank you for the opportunity to carry out a dilapidation inspection at the above property in order to document existing cracking prior to the commencement of construction works at your property.

The two-storey property is of single skin brick and timber frame construction with brick veneer exterior walls, internal brick walls and timber ceilings, timber windows and a pitched roof clad with concrete tiles.

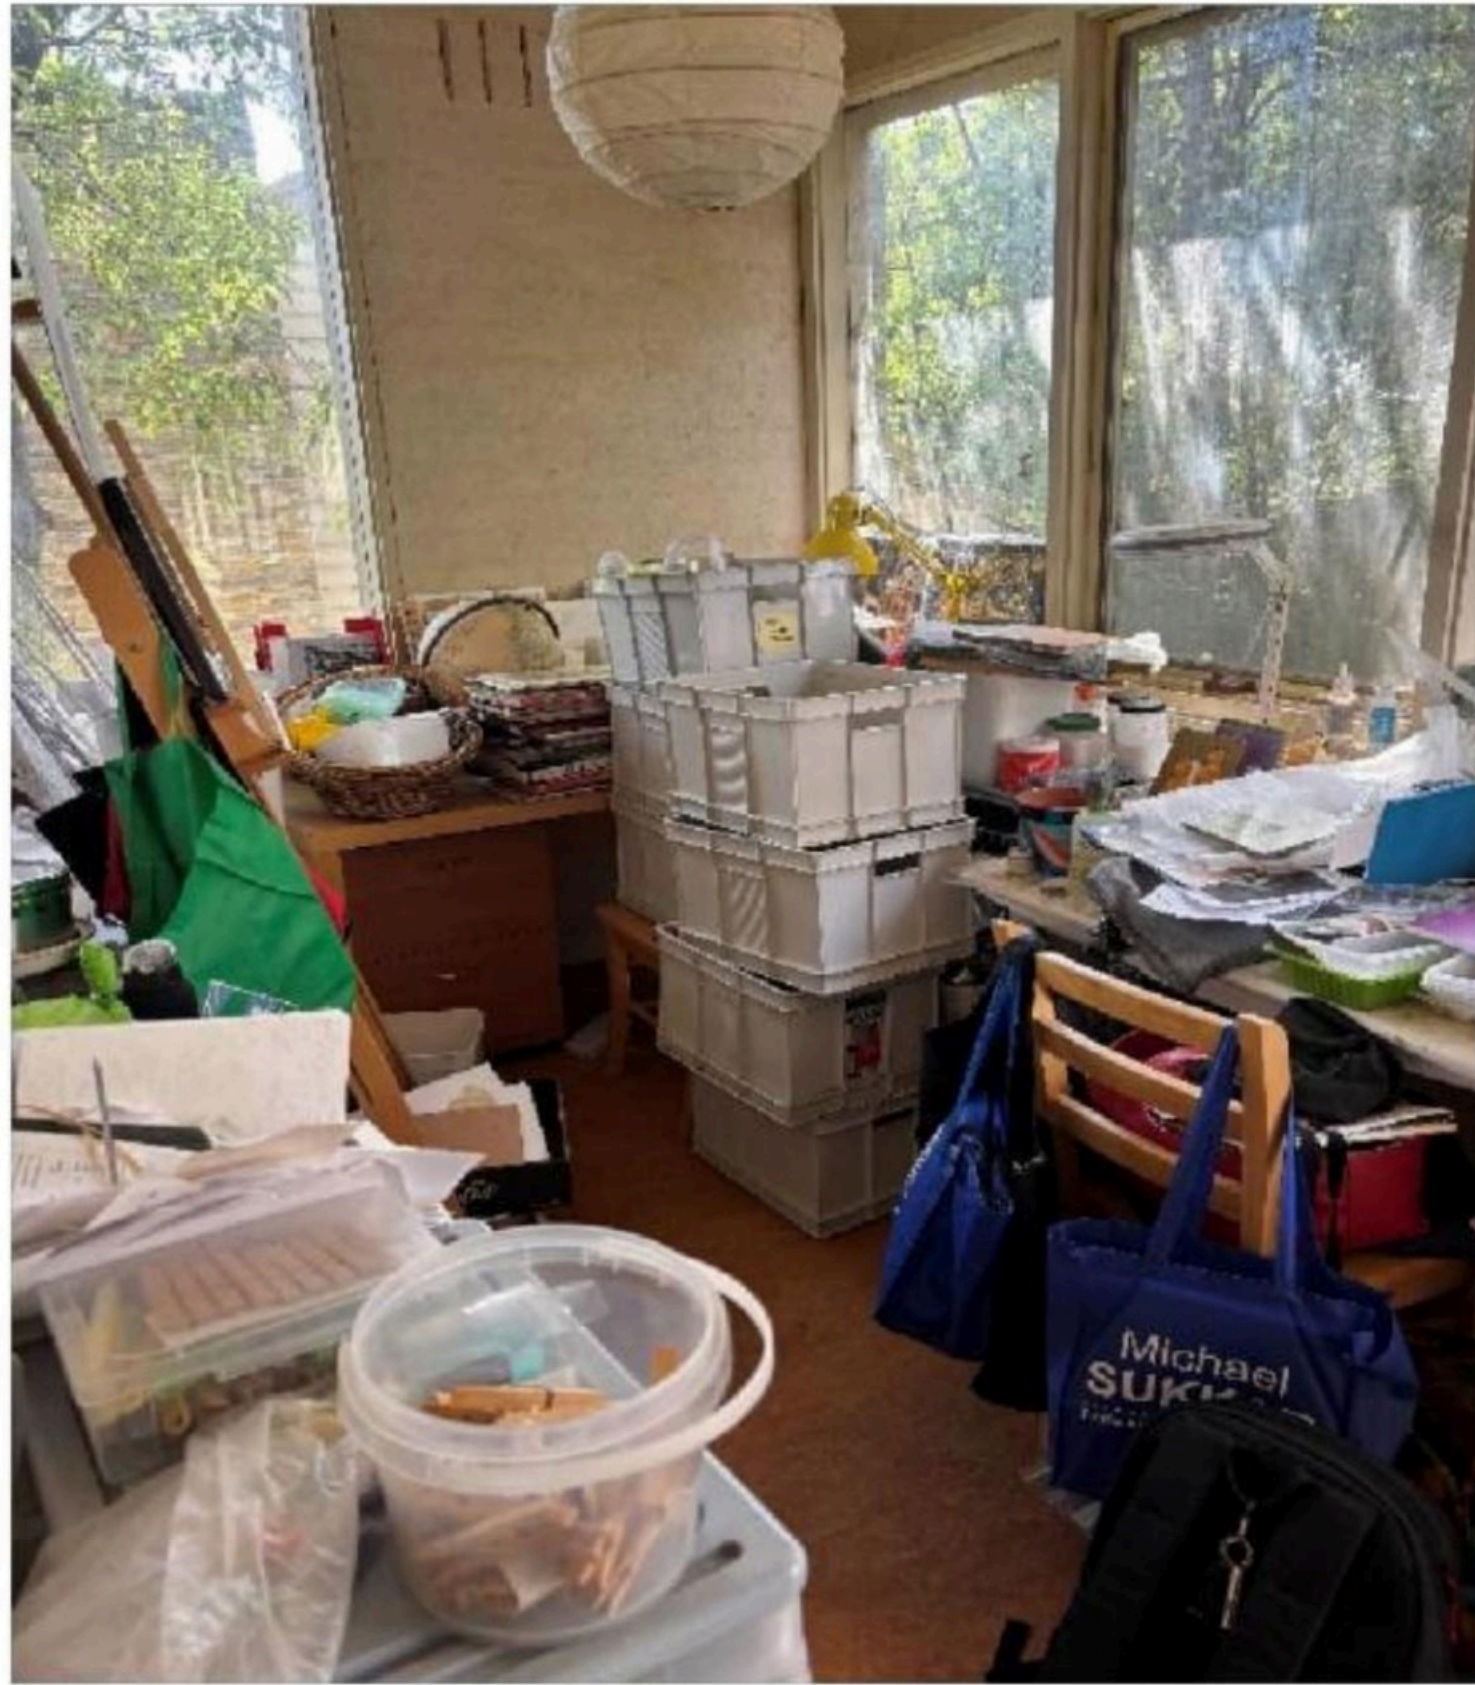
Art room

| Art Room | No defect evident. |
