## Just Inspections

## REPORT ON DOMESTIC BUILDING WORK

SECTION 137B OF THE BUILDING ACT 1993 (OWNER BUILDER CONSTRUCTION)

| Report Date | 07 Aug 2026 |

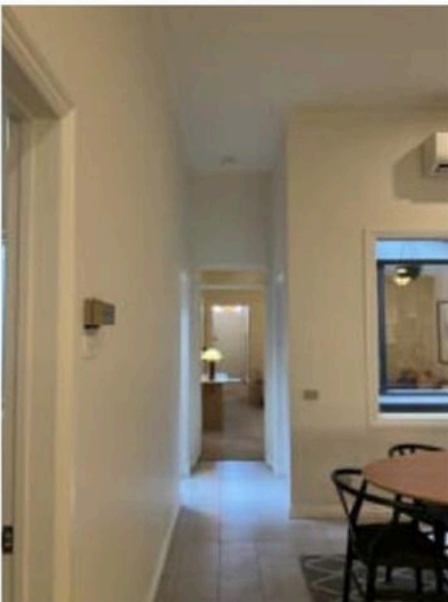
**Photos of Inspected Area**

**Floor** There are no defects visible or evident in the floor

**Floor tiles** There are no defects visible or evident in the floor tiles

**Walls** There are no defects visible or evident in the walls

**Ceiling** There are no defects visible or evident in the ceiling

**Windows (Internal)** There are no defects visible or evident internally. See also windows (external)

**Doors (Internal)** There are no defects visible or evident in the door(s)

**Electrical** • Installed adequately
